Your Ref: TP/IP/20345/2020
Our Ref : CI/TPD20005595/P

16th September 2020

MECHANICAL INSPECTION REPORT OF MOTOR BUS PC 6836K

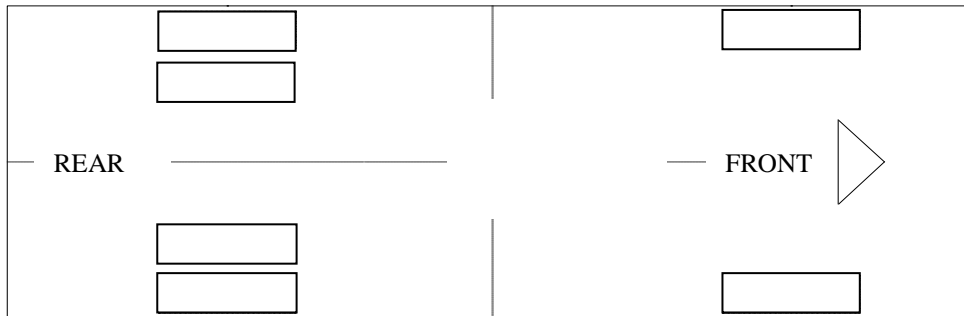
5. The 6 tyres of the Motor Bus were observed to be in serviceable condition and sufficiently inflated for vehicular operation. I did not find any tear, cut or burst mark(s) on the outer and the inner sidewalls as well as across the tread of the 6 tyres of the Motor Bus. The tyre brand, tyre size and remaining tread depth of the 6 tyres of the Motor Bus were recorded as follows:-

Aeolus 9 R22.5 (5.2mm)

Aeolus 9 R22.5 (12.2mm)

Double Coin 9 R22.5 (5.8mm)

Aeolus 9 R22.5 (12.1mm)

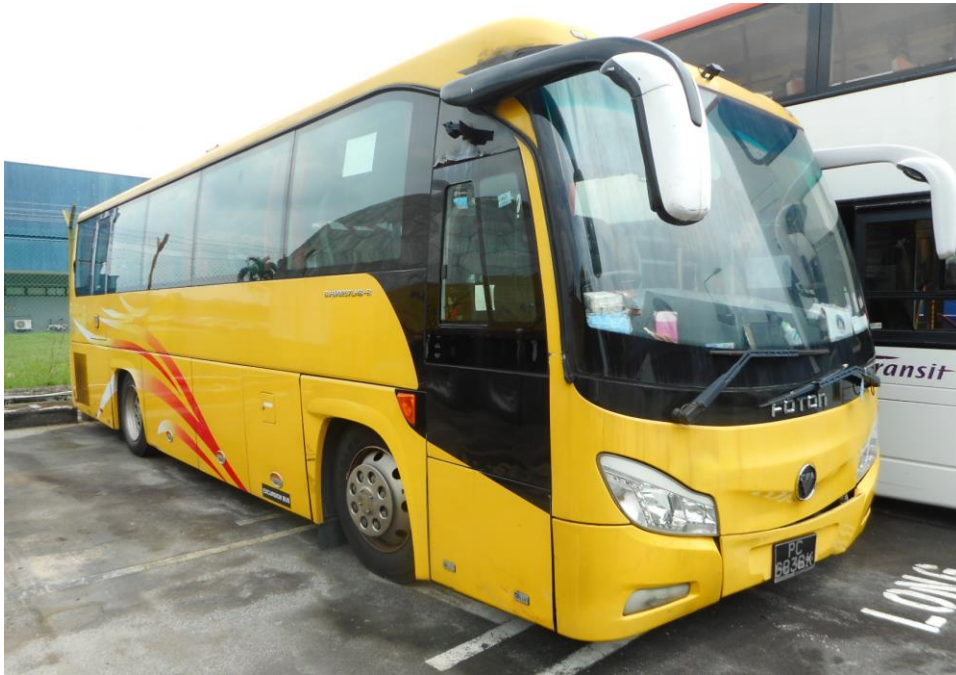
4. A visual inspection was conducted and the Motor Bus was observed to have sustained damage at its right portion. Its right body panel were amongst the body parts that were damaged as a result of the accident.

Photo 1 shows a general view of the front right body of the Motor Bus at the time of my inspection. The Motor Bus was observed to have sustained damage at its right portion. Its right body panel were amongst the body parts that were damaged as a result of the accident.

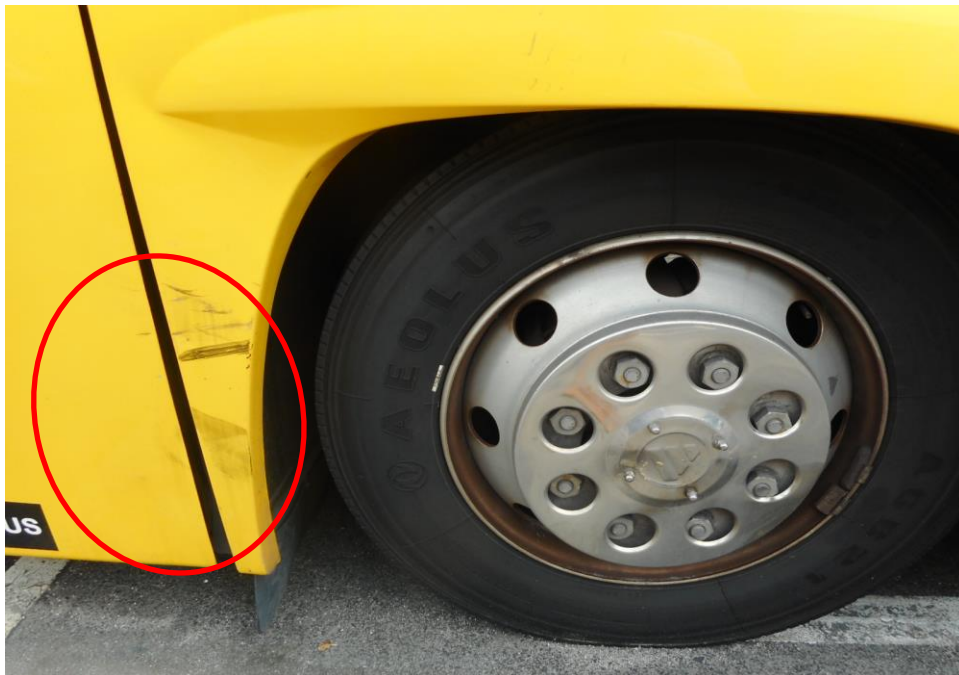
Photo 2 shows a close up view of the front right body of the Motor Bus at the time of my inspection. The Motor Bus was observed to have sustained damage at its right portion. Its right body panel (circled) were amongst the body parts that were damaged as a result of the accident.

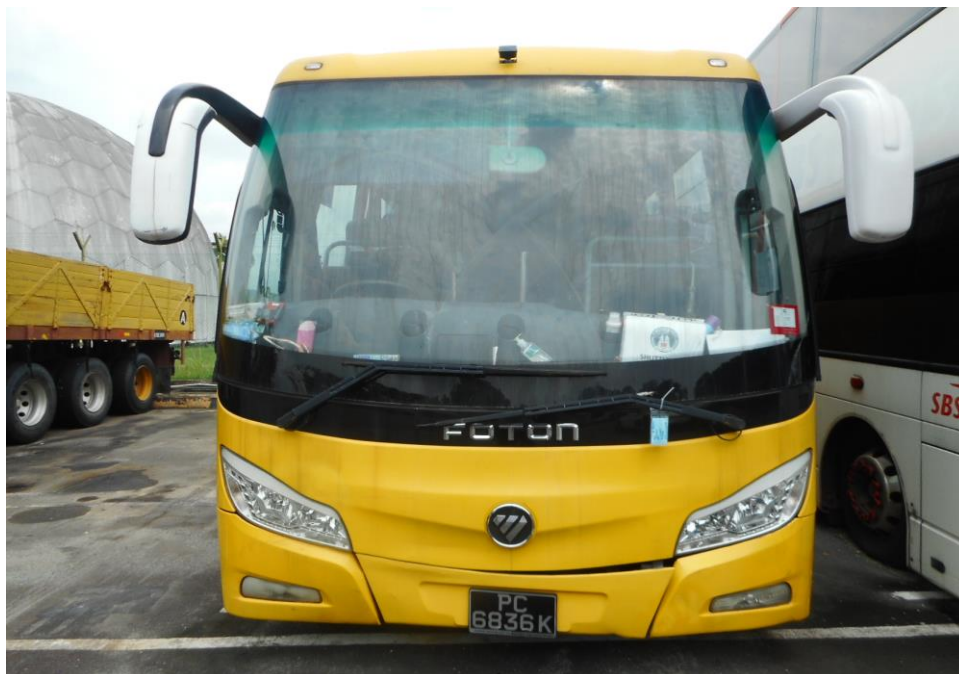
Photo 3 shows a general view of the front body of the Motor Bus front body at the time of my inspection. The front was observed to have been unaffected by the accident.

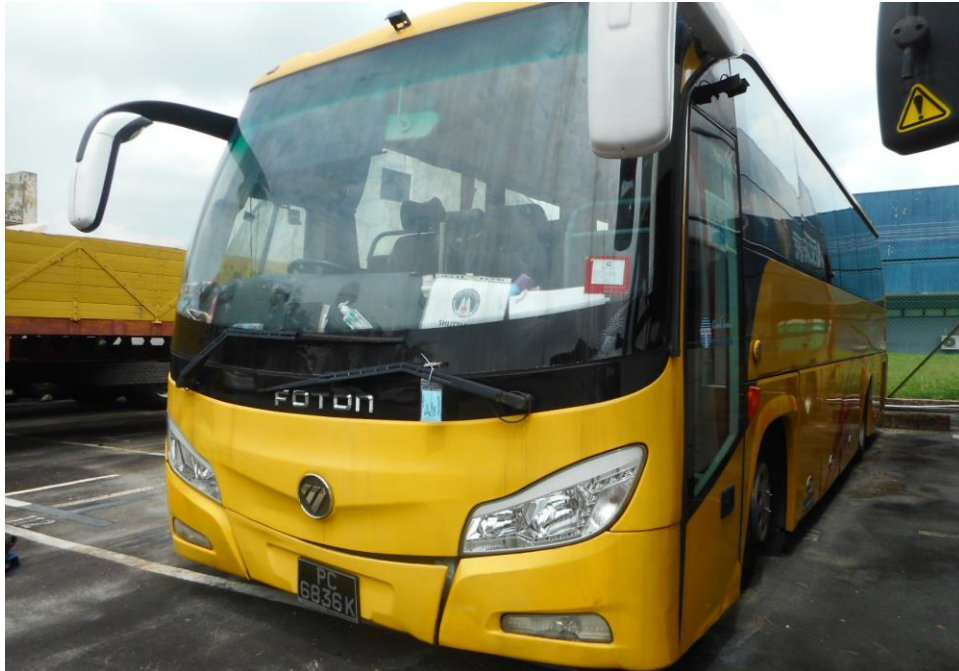
Photo 4 shows a general view of the front right body of the Motor Bus at the time of my inspection, observed to have been unaffected by the accident.

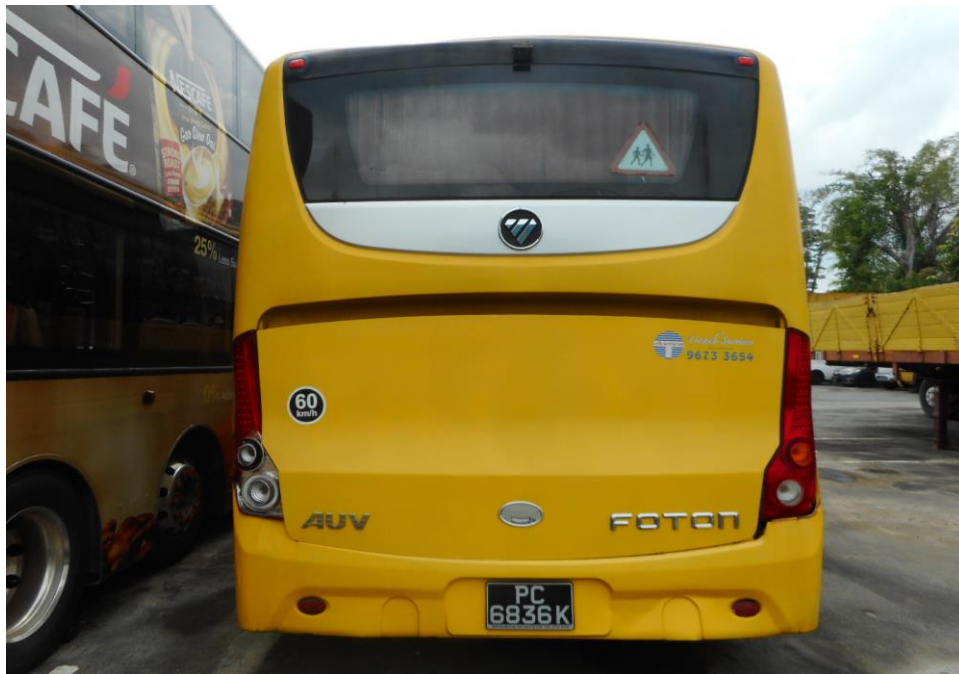
Photo 5 shows a general view of the Motor Bus's rear body at the time of my inspection. There was no damage found to the rear portion of the Motor Bus.

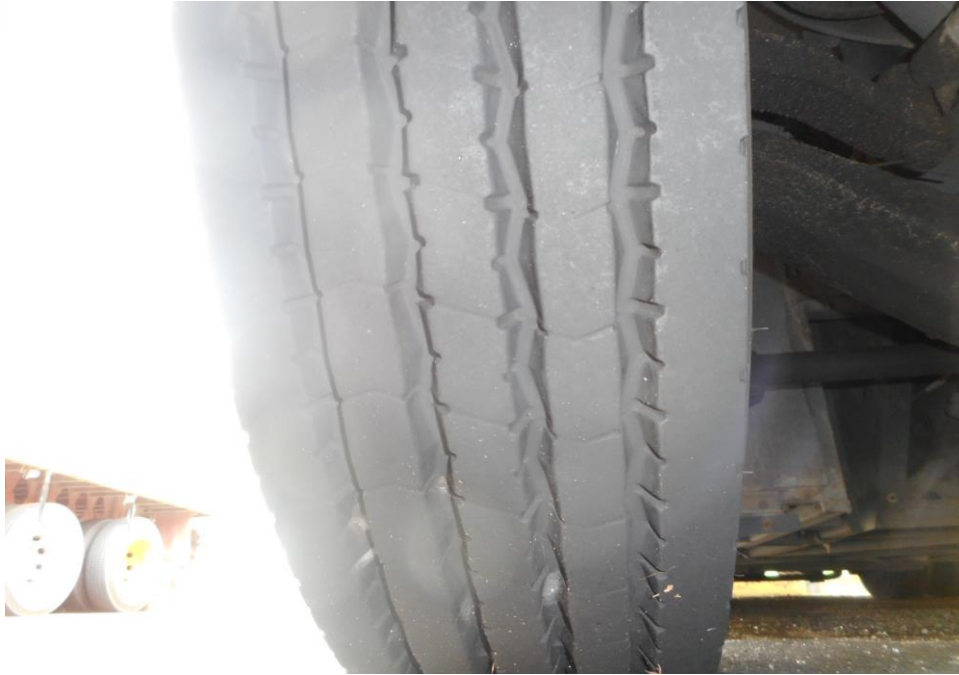
Photo 6 shows the condition of the front right tyre of the Motor Bus, which was observed to be in serviceable condition with remaining tread depth of approximately 12.1 mm. The tyre, which was wrapped around standard steel wheel rim, was also observed to be sufficiently inflated for vehicular operation. There was no tear, cut or burst mark(s) on the outer and the inner sidewalls as well as across the tread of the 6 tyres that were fitted on the Motor Bus.

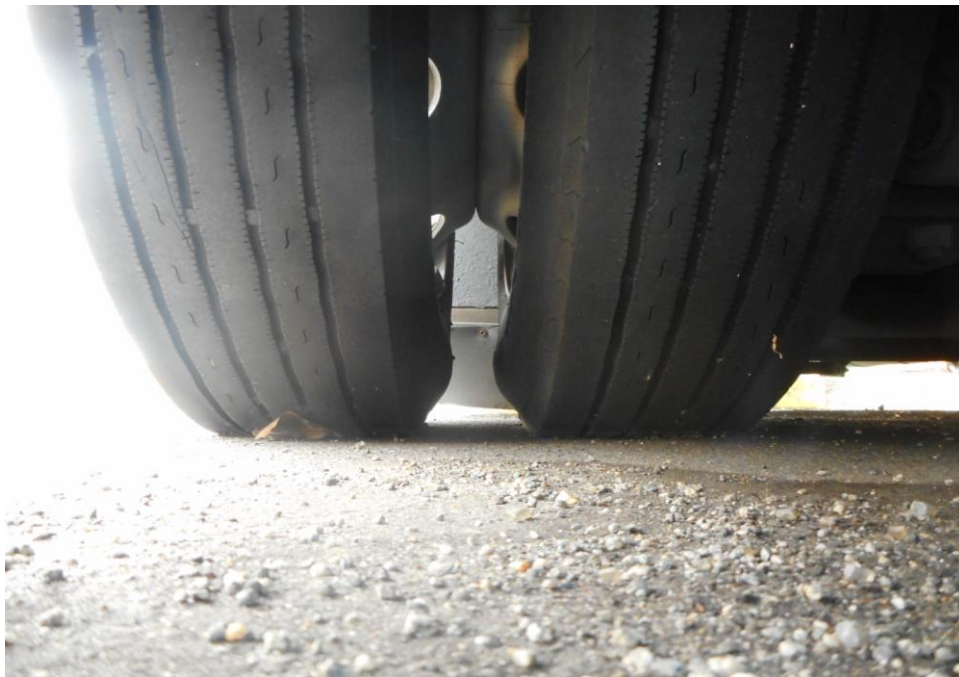
Photo 7 shows the condition of the rear right tyre of the Motor Bus, which was observed to be in serviceable condition with remaining tread depth of approximately 5.8mm. The tyre, which was wrapped around standard steel wheel rim, was also observed to be sufficiently inflated for vehicular operation.

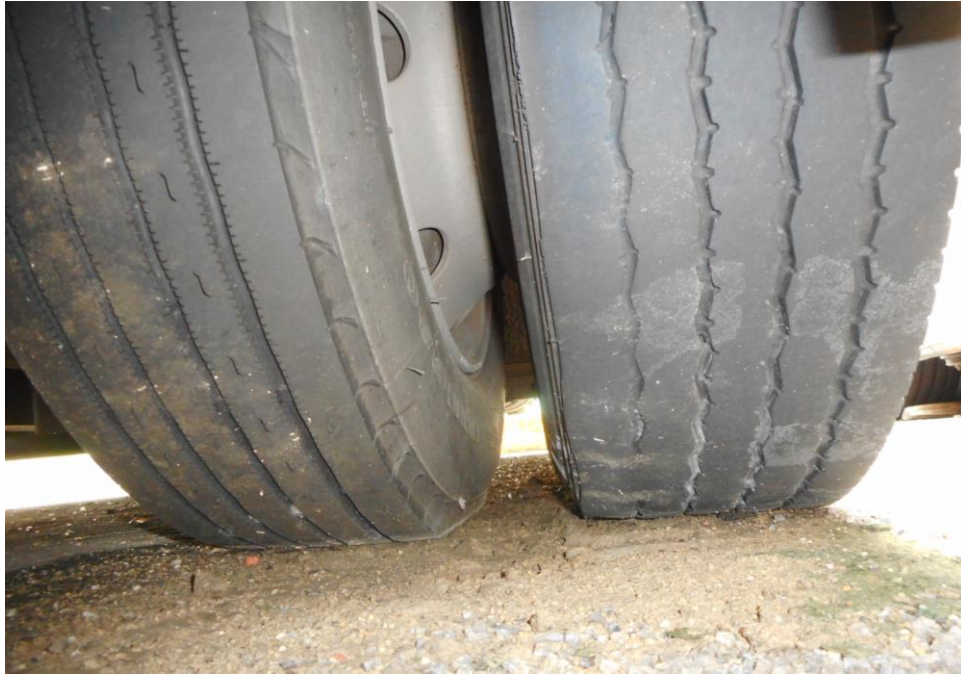
Photo 8 shows the condition of the rear left tyres of the Motor Bus, which was observed to be in serviceable condition with remaining tread depth of approximately 5.2mm. The tyres, which were wrapped around standard steel wheel rim, were also observed to be sufficiently inflated for vehicular operation. There was also no damage found on all 6 steel wheel rims of the Motor Bus.

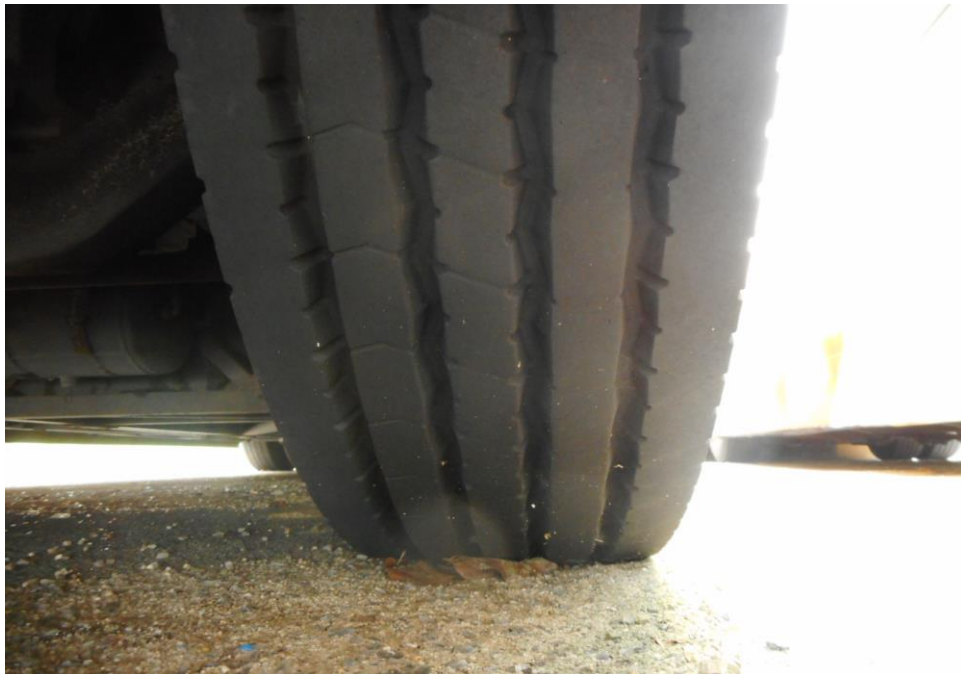
Photo 9 shows the condition of the front left tyres of the Motor Bus, which were observed to be in serviceable condition with remaining tread depth of approximately 12.2mm. There was also no tear, cut or burst mark(s) on the outer and the inner sidewalls as well as across the tread of the 6 tyres that were fitted on the Motor Bus.

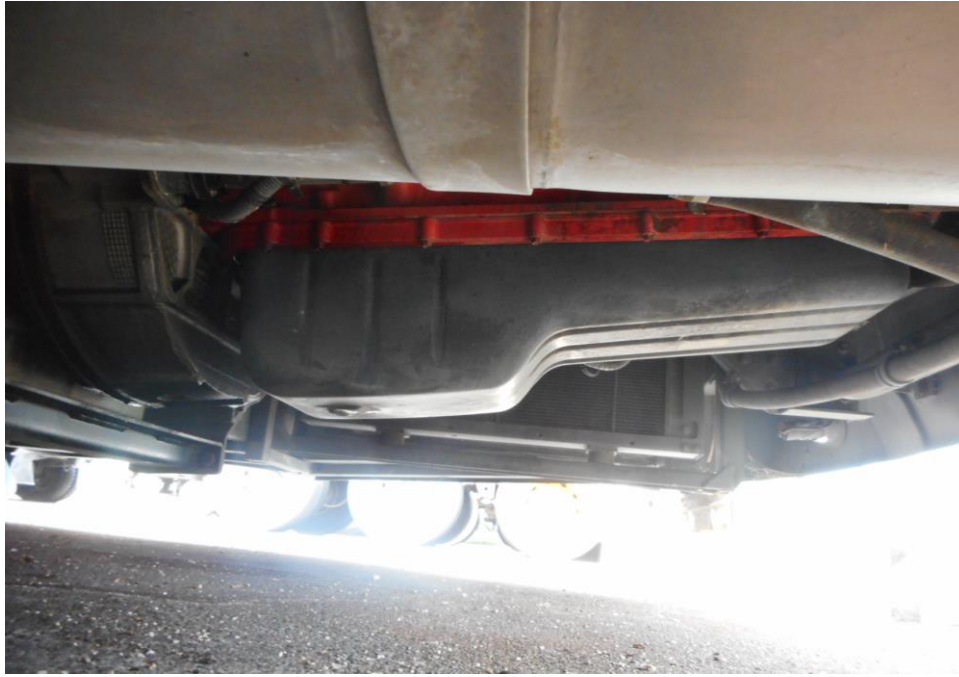
Photo 10 shows the undercarriage of the Motor Bus, at the area where the engine housing located. I did not find any sign(s) or indication(s) of fluid leak and/or fluid stain(s) on the underside of the Motor Bus.

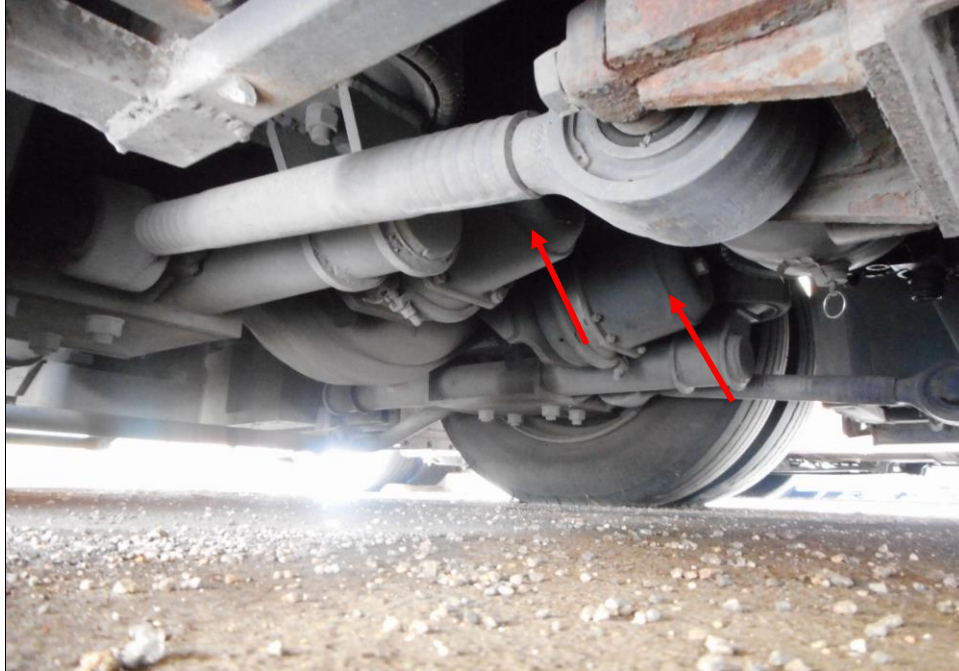
Photo 11 shows the brake air cylinder of both the rear left & right wheel (arrowed) of the Motor Bus. My visual inspection of the mechanical components of the Motor Bus braking system & i did not observe any leakage to suggest that its braking system was in serviceable condition at the material time of accident.

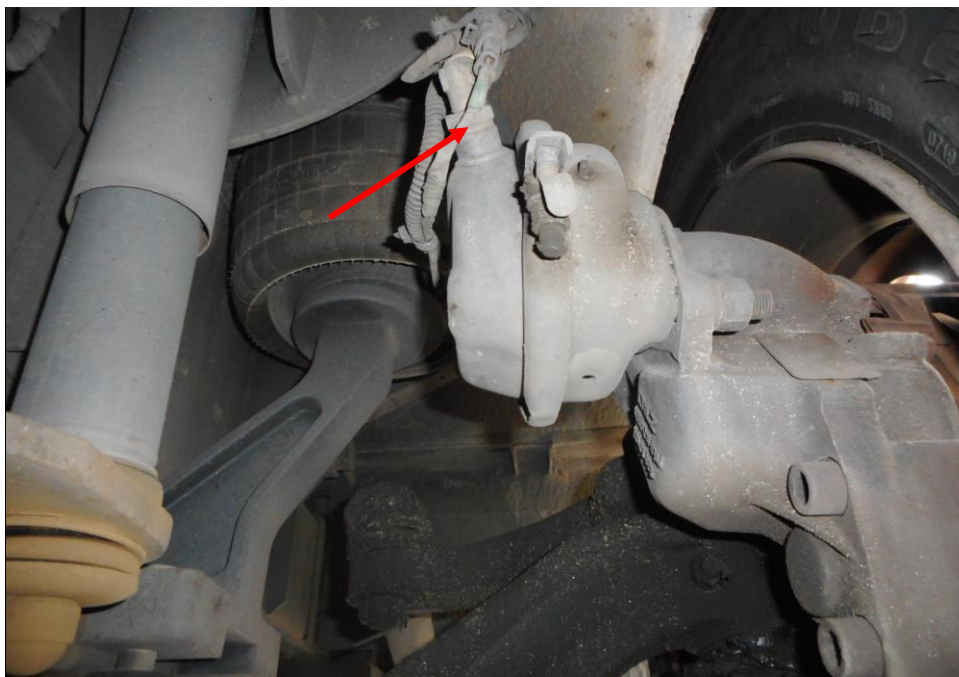
Photo 12 shows the brake air cylinder and air pipes at the front right wheel of the Motor Bus. My visual inspection of the mechanical components of the Motor Bus braking system appear to suggest that its braking system was in serviceable condition at the material time of accident.

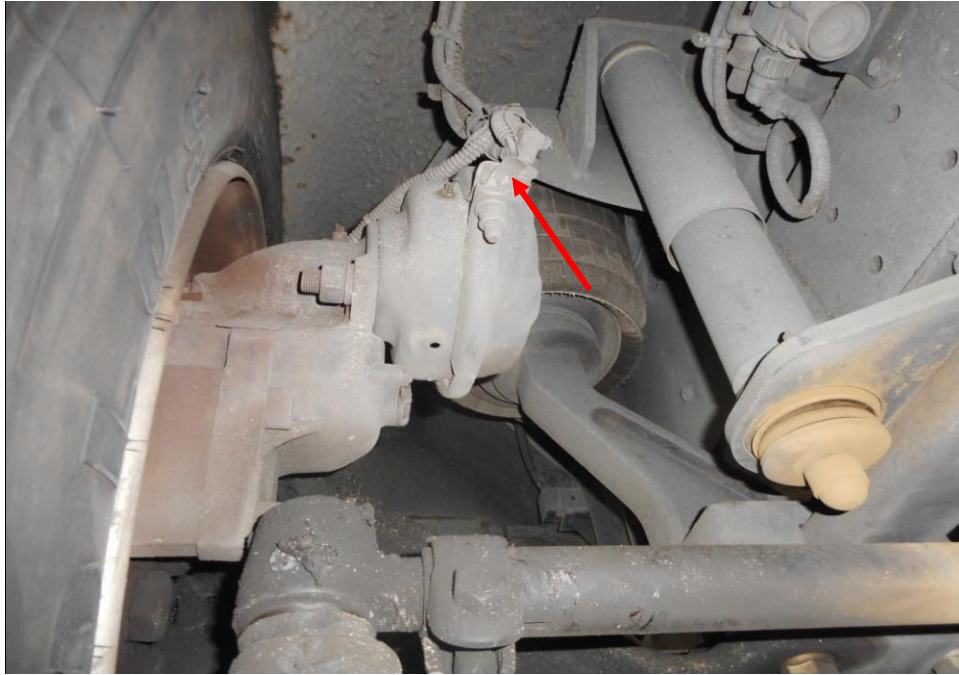
Photo 13 shows the brake air cylinder and air pipes at the front left wheel of the Motor Bus. My visual inspection of the mechanical components of the Motor Bus braking system appear to suggest that its braking system was in serviceable condition at the material time of accident.

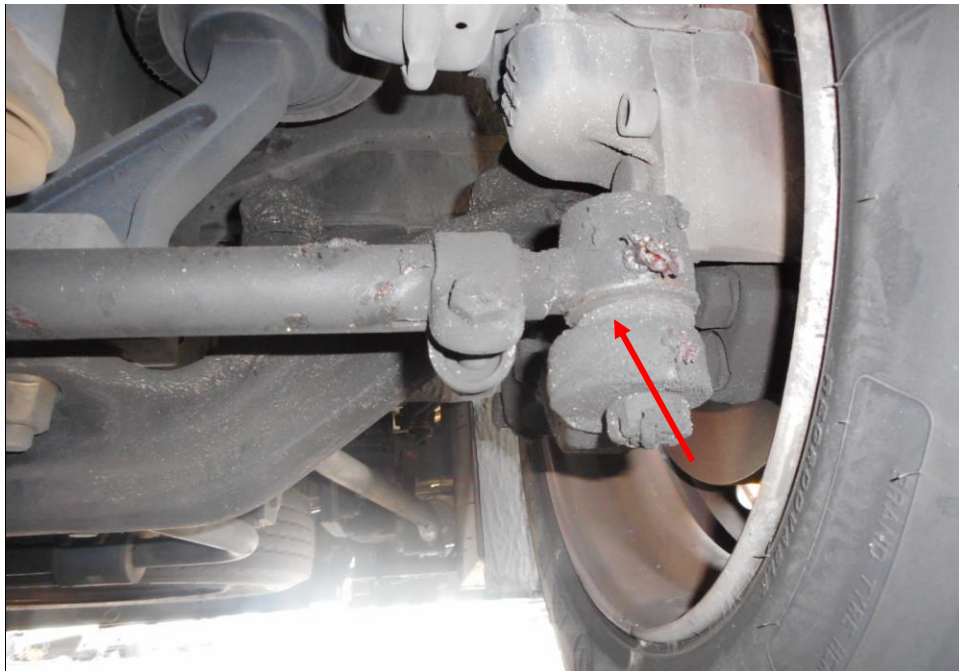
Photo 14 shows the various undercarriage components at the front right wheel of the Motor Bus, in particular the steering tie rod end (arrowed). The various steering components were all found to be intact, suggesting that the steering system of the Motor Bus was likely to be in serviceable condition at the material time of accident. There was also no sign of fluid stain(s) observed on the various undercarriage components.

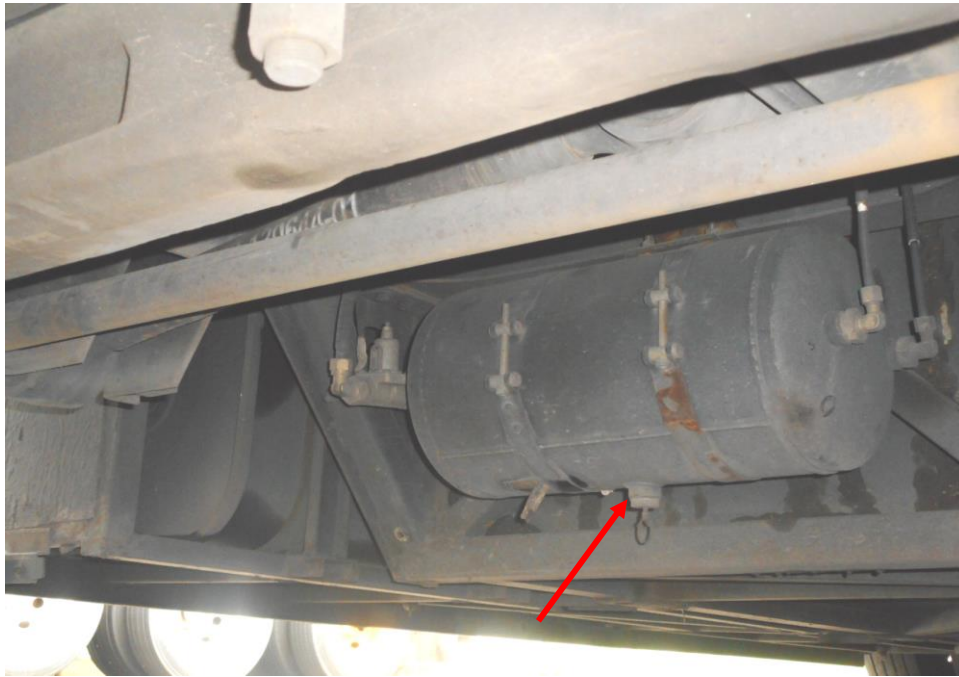
Photo 15 shows the air brake cylinders (arrowed) at the undercarriage of the Motor Bus. I did not observe any leakage of air brake fluid at the time of my inspection of the Motor Bus. My visual examination of the various mechanical components in the braking system had indicated that there was no internal leakage of pressure/vacuum. Hence the braking system of the Motor Bus was likely to be in serviceable condition at the material time of accident.

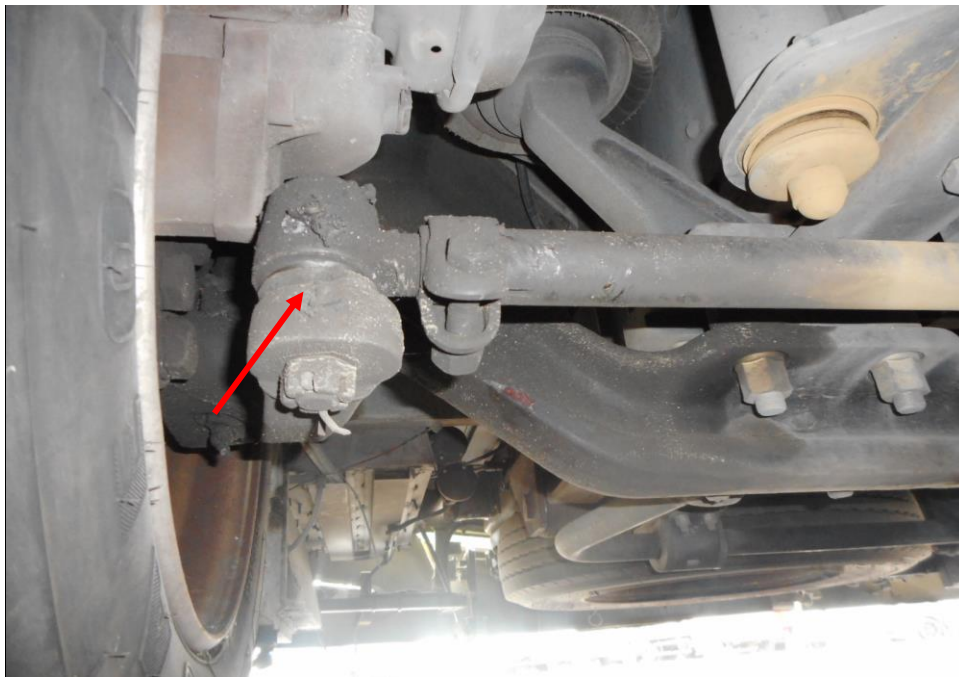
Photo 16 shows the various undercarriage components at the front left wheel of the Motor Bus, in particular the steering tie rod end (arrowed). The various undercarriage components of the Motor Bus were all found to be intact without any visible damage. There was also no sign of fluid stain(s) observed on the various undercarriage components.

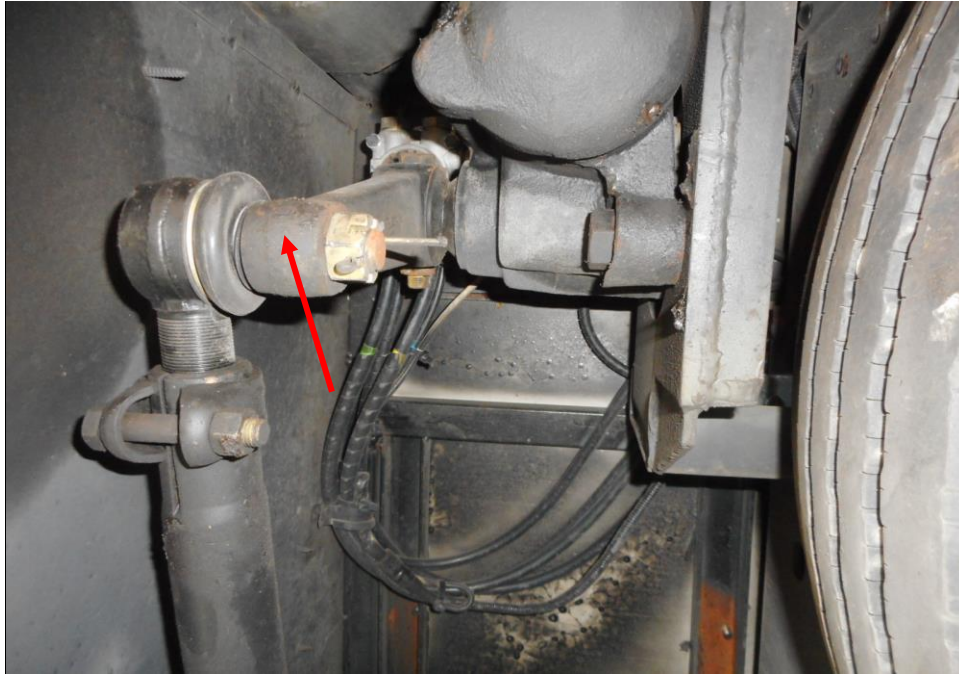
Photo 17 shows the steering box component (arrowed) at the undercarriage of the Motor Bus was found to be intact without any visible damage. There was also no sign of fluid stain(s) observed on the various undercarriage components.
