Your Ref: TP/IP/20467/2020
Our Ref : CI/TPD20005596/P

8th July 2020

Fatal Accident Investigation Team

MECHANICAL INSPECTION REPORT OF MOTOR TAXI SHC 7555J

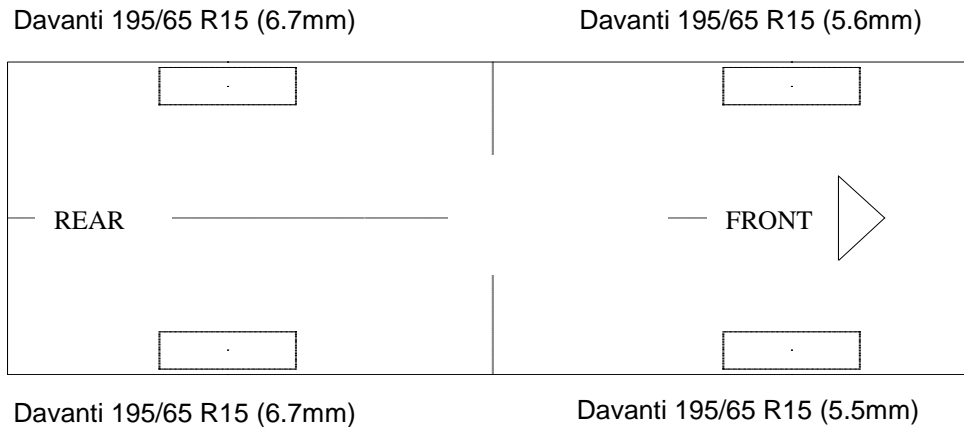
6. The condition of the Motor Taxi's 4 tyres was observed to be in serviceable condition. I did not find any tear, cut or burst mark(s) on the outer and the inner sidewalls as well as across the tread of the 4 tyres. The 4 tyres were also observed to be sufficiently inflated for vehicular operation. The tyre brand, tyre size and remaining tread depth of the 4 tyres were recorded as follows:-

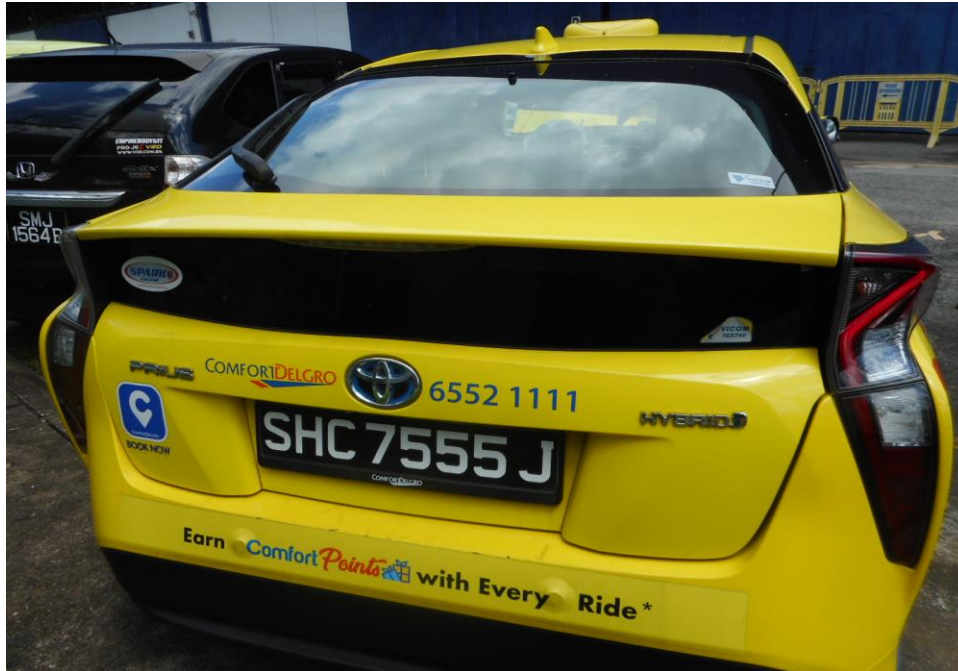
Photo 1 shows a general view of the Motor Taxi's rear body at the time of my inspection. The rear portion of the Motor Taxi was observed to have been undamaged by the accident.

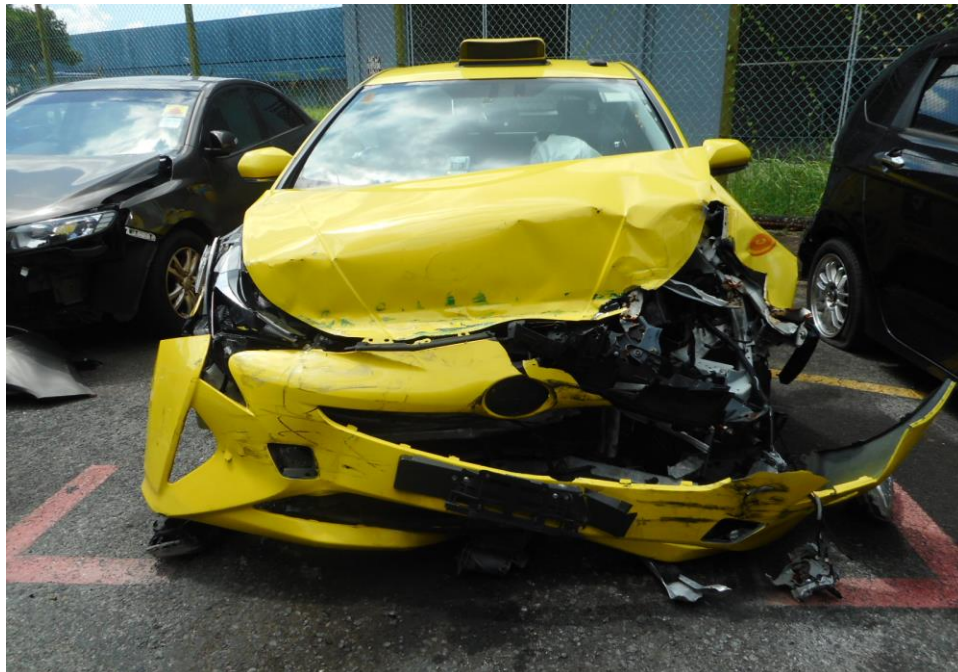
Photo 2 shows a general view of the Motor Taxi's front body at the time of my inspection. The Motor Taxi was observed to have sustained damage at its front portion. Its front bonnet, front bumper, front left fender, front left and right headlamp was amongst the body parts and various components in the engine compartments were also damaged as a result of the accident. The Supplemental Restraint System (SRS) was activated as a result of the accident.

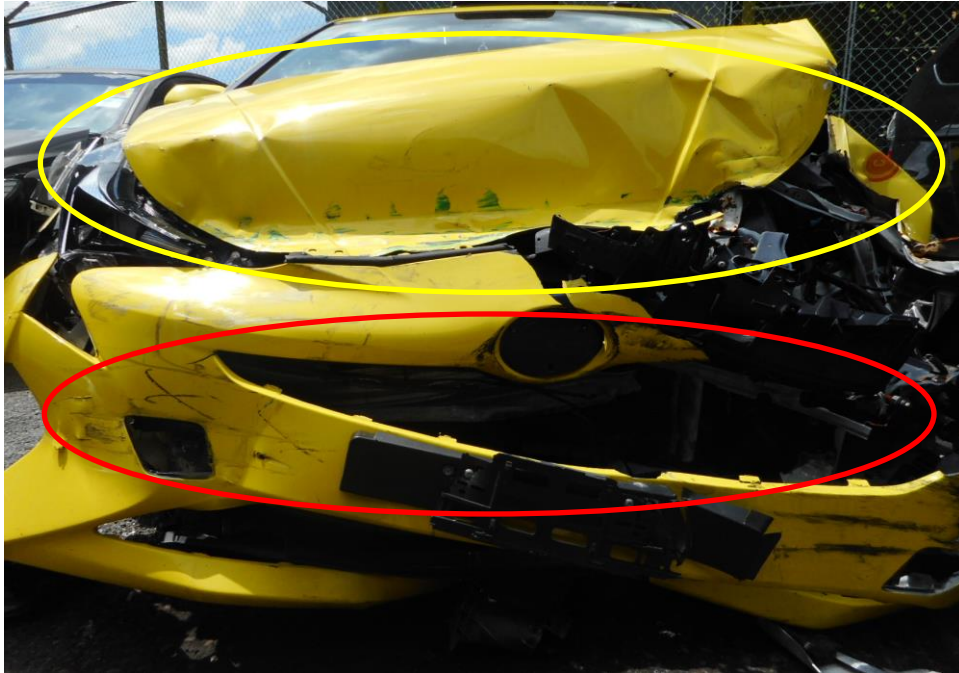
Photo 3 shows the close up view of the Motor Taxi's front body at the time of my inspection. The Motor Taxi was observed to have sustained damage at its front portion. Its front bonnet (yellow circle) and front bumper (red circle) was amongst the body parts and various components in the engine compartments were also damaged as a result of the accident.

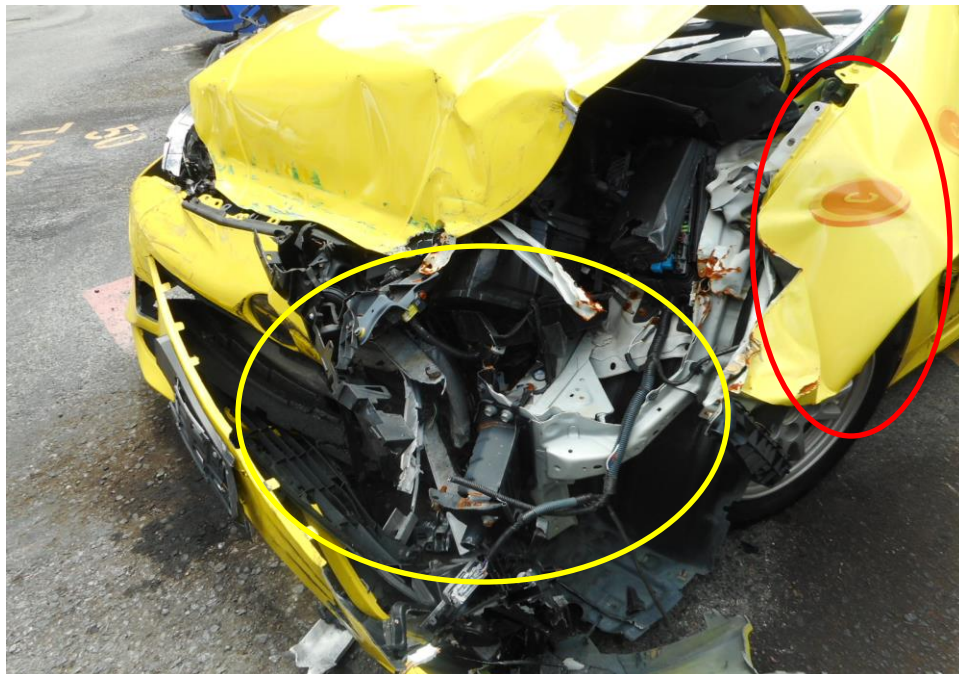
Photo 4 shows a general view of the Motor Taxi's engine compartment at the time of my inspection. The Motor Taxi was observed to have sustained damage at its front portion. Its front left fender (red circle) was amongst the body parts and various components (yellow circle) in the engine compartments were also damaged as a result of the accident.

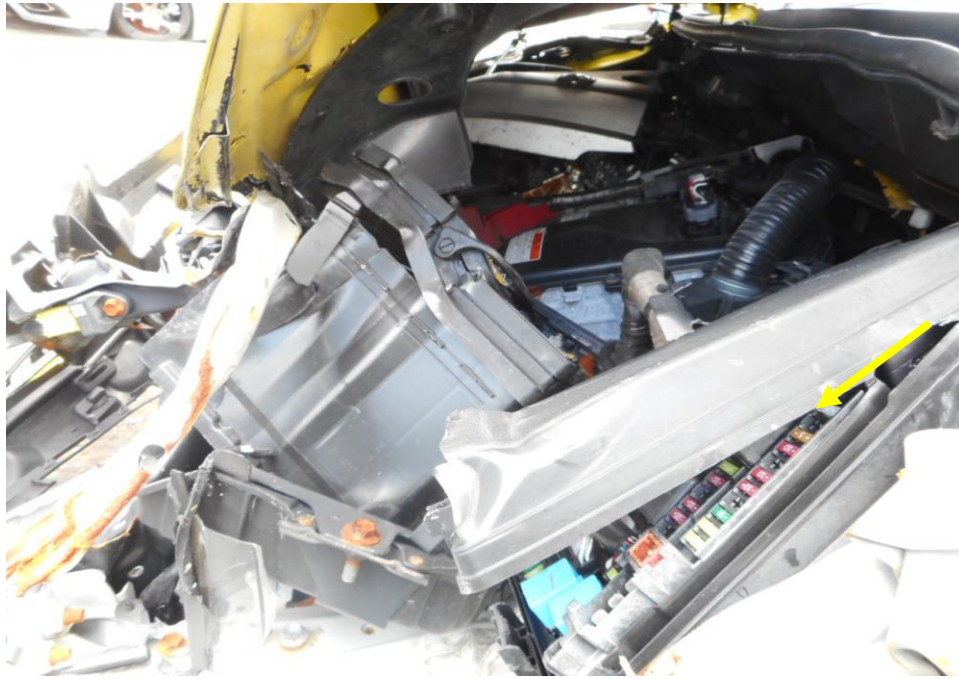
Photo 5 shows a close up view of the Motor Taxi's engine compartment at the time of my inspection. The Motor Taxi was observed to have sustained damage at its front portion. Various components in the engine compartments were also damaged as a result of the accident.

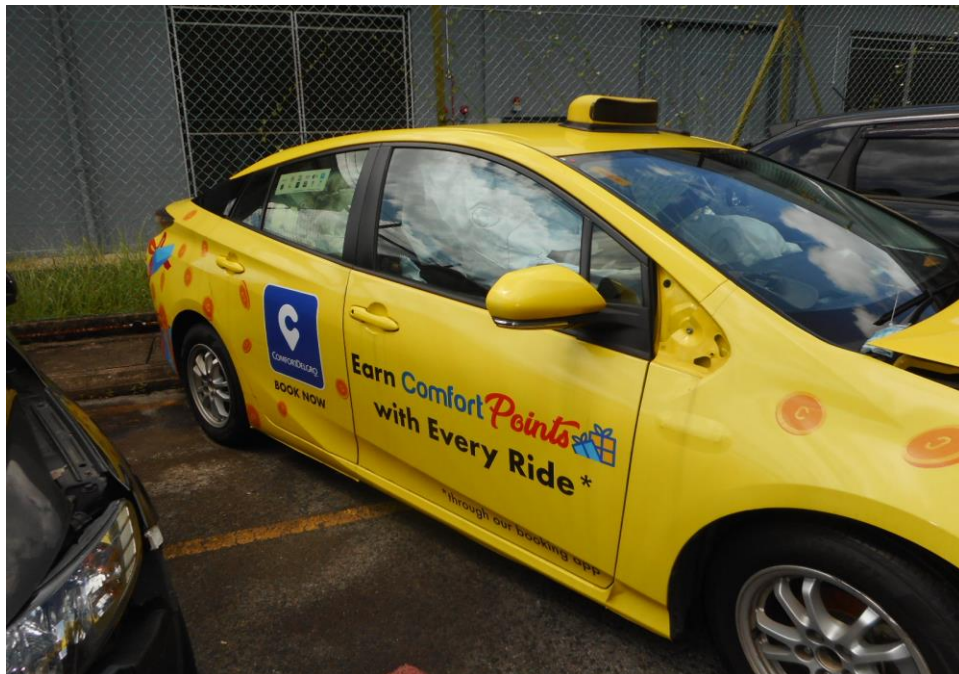
Photo 6 shows a general view of the Motor Taxi's rear right body at the time of my inspection. The rear right portion of the Motor Taxi was observed to have been undamaged by the accident.

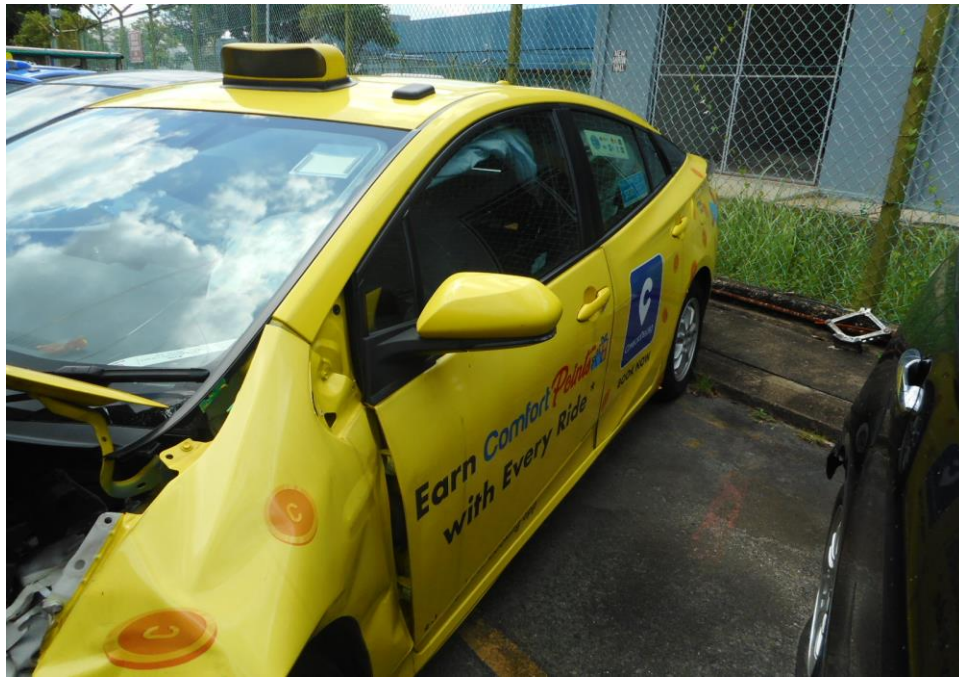
Photo 7 shows a general view of the Motor Taxi's rear left body at the time of my inspection. The rear left portion of the Motor Taxi was observed to have been undamaged by the accident.

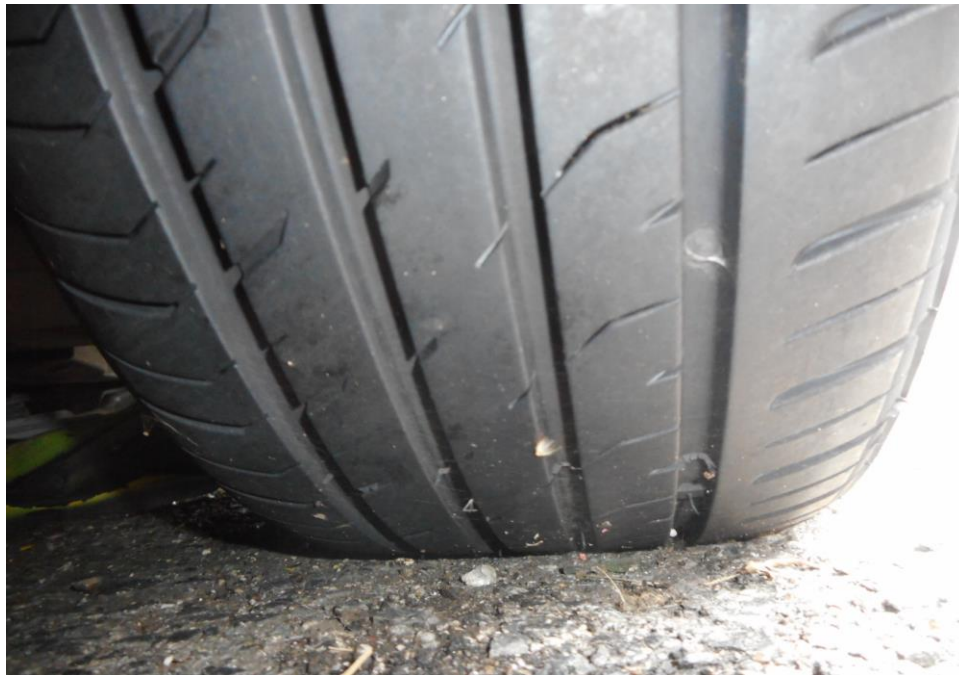
Photo 8 shows the condition of the front right tyre of the Motor Taxi, which was observed to be in serviceable condition with remaining tread depth of approximately 5.5mm. The tyre, which was wrapped around alloy wheel rim, was also observed to be sufficiently inflated for vehicular operation.

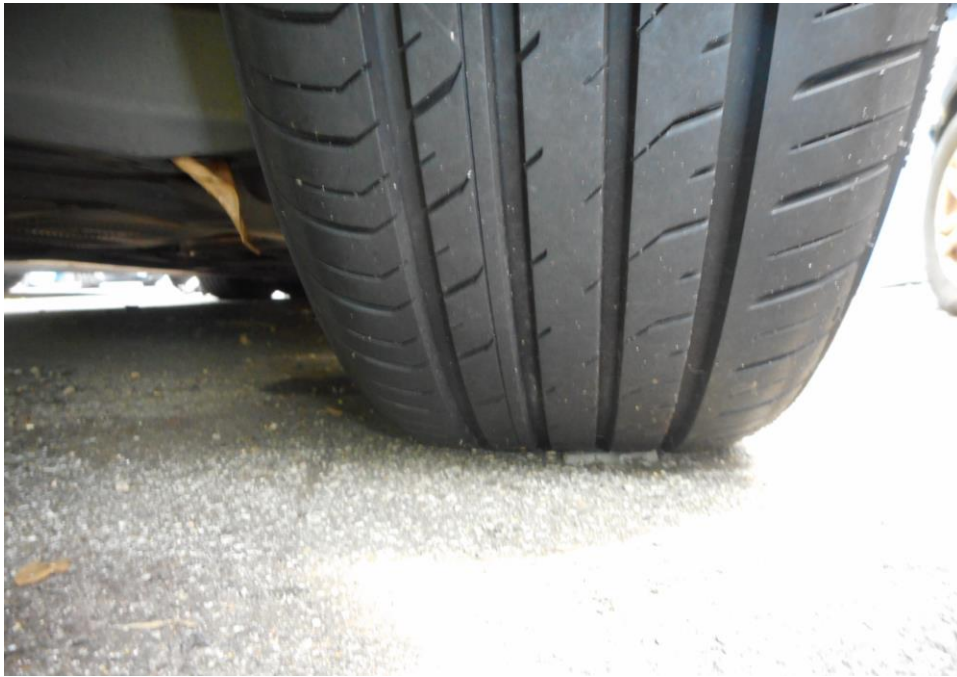
Photo 9 shows the condition of the rear right tyre of the Motor Taxi, which was observed to be in serviceable condition with remaining tread depth of approximately 6.7mm. The tyre was also observed to be sufficiently inflated for vehicular operation with no tear, cut or burst mark(s).

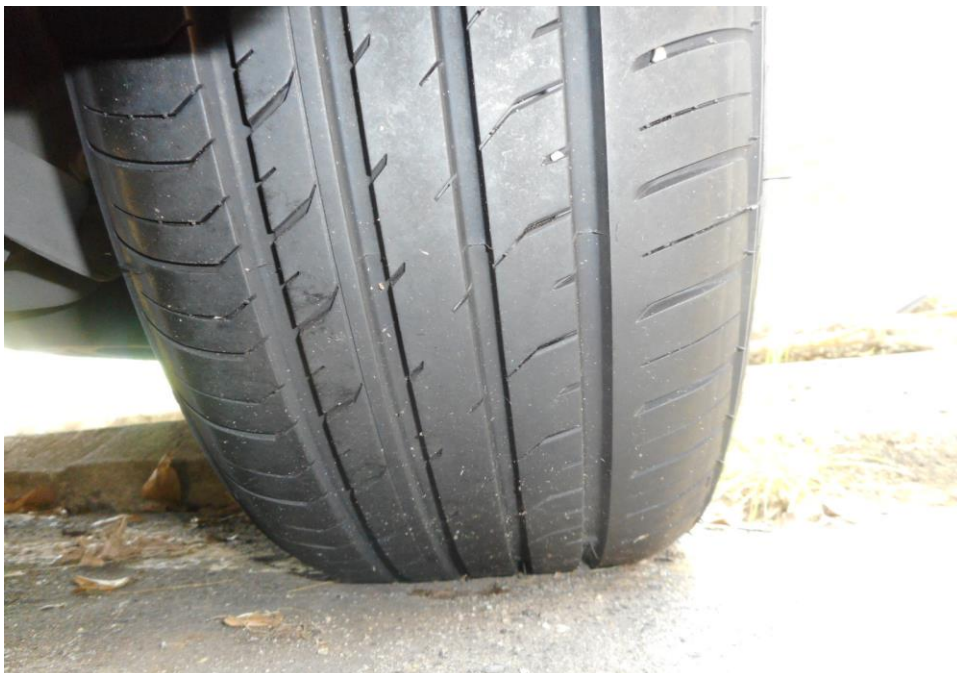
Photo 10 shows the condition of the rear left tyre of the Motor Taxi, which was observed to be in serviceable condition with remaining tread depth of approximately 6.7mm. The tyre was also observed to be sufficiently inflated for vehicular operation with no tear, cut or burst mark(s).

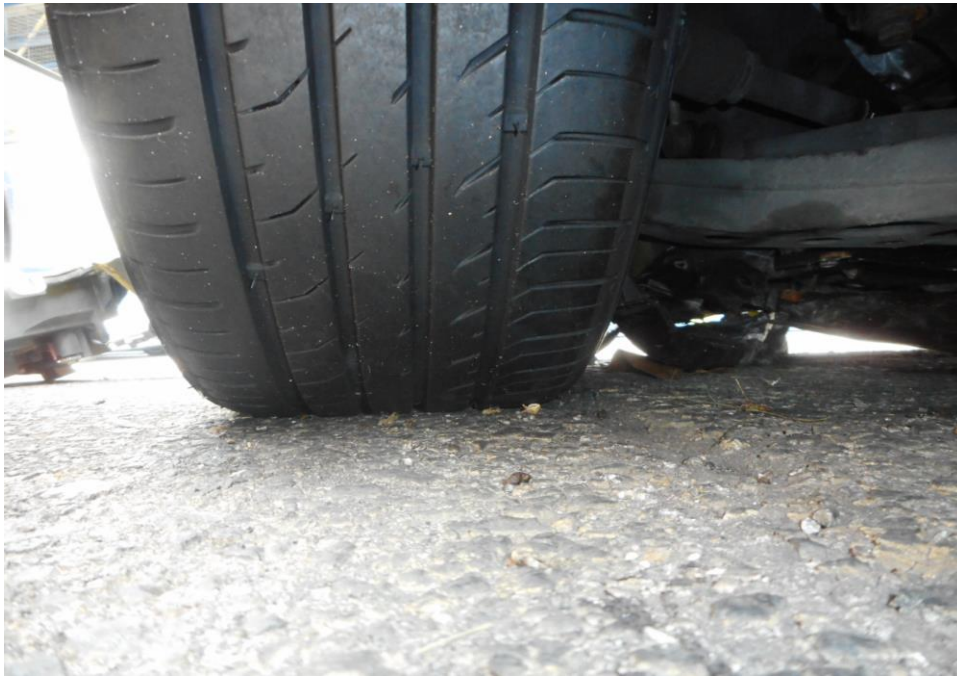
Photo 11 shows the condition of the front left tyre of the Motor Taxi, which was observed to be in serviceable condition with remaining tread depth of approximately 5.6mm. The tyre was also observed to be sufficiently inflated for vehicular operation with no tear, cut or burst mark(s).

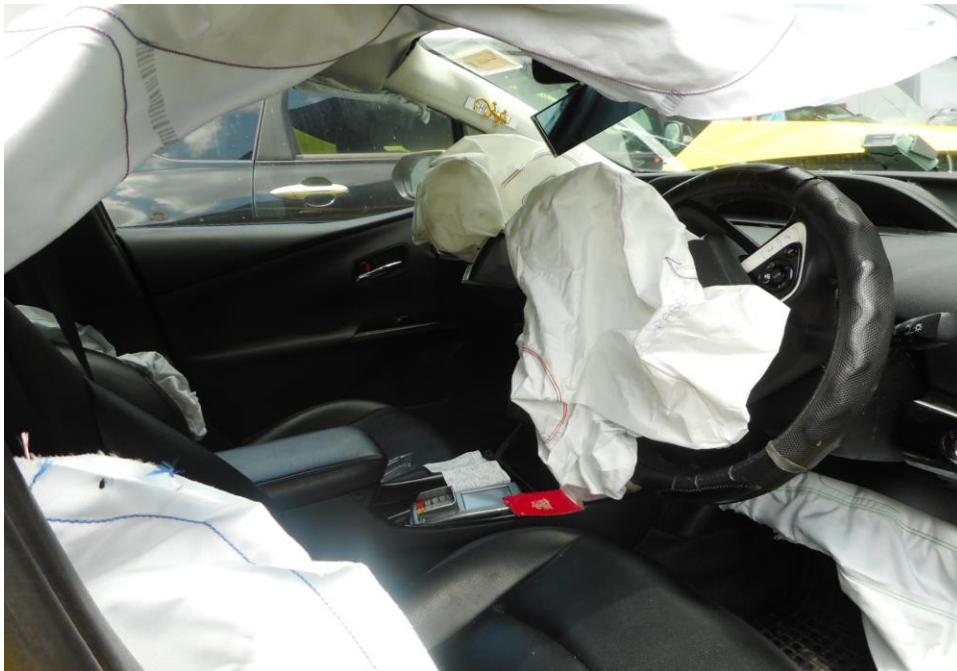
Photo 12 shows the deployment of the Supplemental Restraint System (SRS) airbag (arrowed) in the Motor Taxi as a result of the accident.

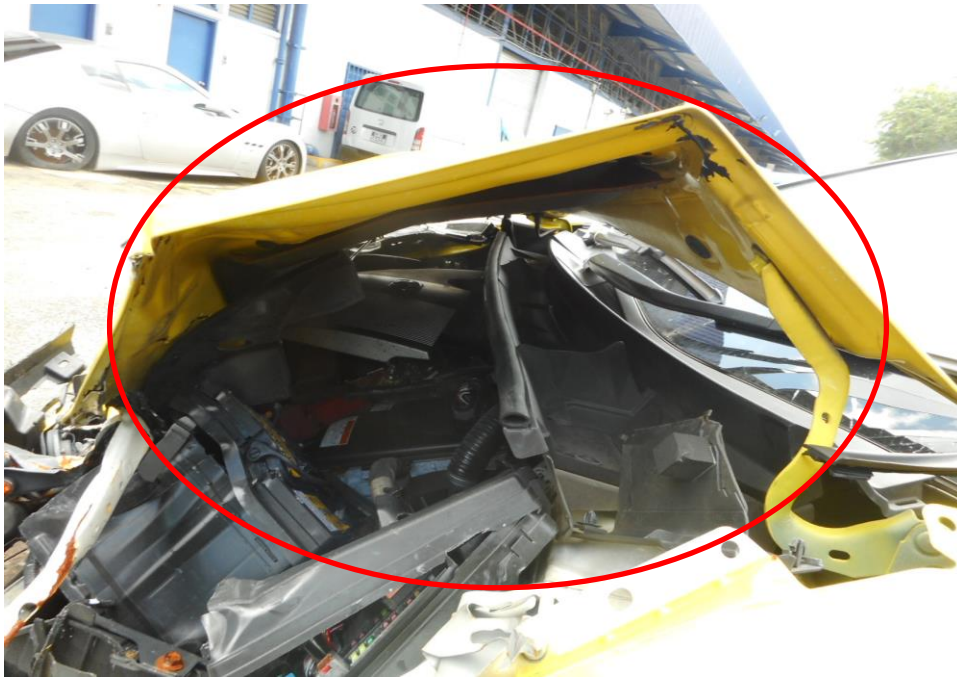
8. We were unable to raise the front bonnet of the Motor Taxi to conduct the examination of the Motor Taxi's engine compartment because the damage caused by the accident had resulted in the damages to the lock mechanism of the bonnet and the structure of the engine compartment. (unable to open)
See photo 13 below

Photo 13 shows a close up view of the damaged front bonnet lock mechanism and the structure of the engine compartment of the Motor Taxi at the time of my inspection resulting it unable to open a result of the accident (circled) (Unable to open)

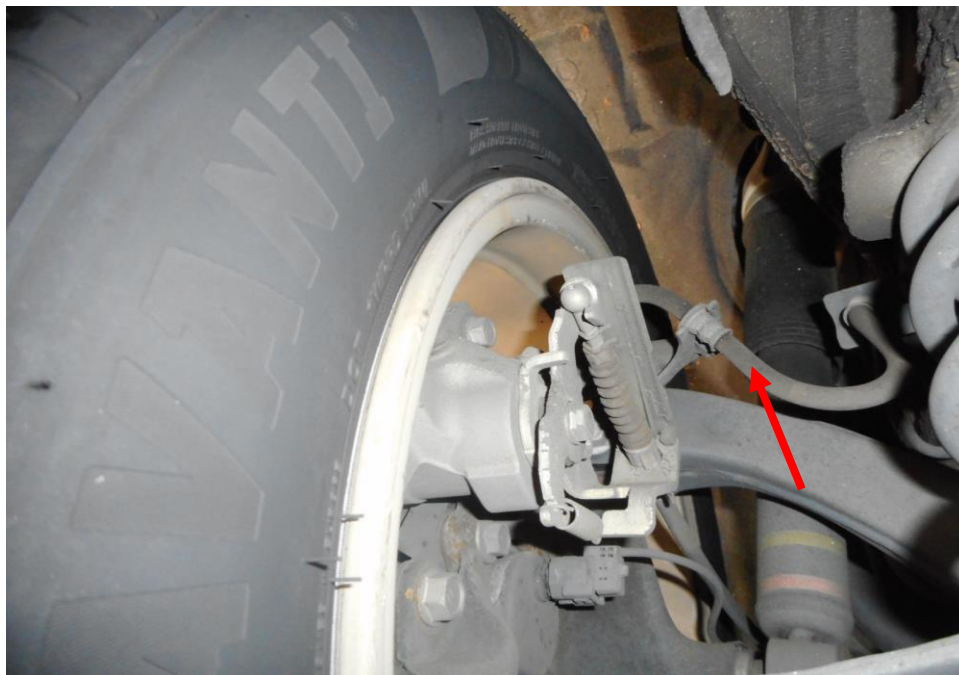
Photo 14 shows the brake hose/pipe (arrowed) at the rear left wheel of the Motor Taxi. No leakage of brake fluid was observed. Visual examination of the various components of the braking system like the drum brake, brake booster, brake pedal etc. had revealed all to be intact and without visible damage.

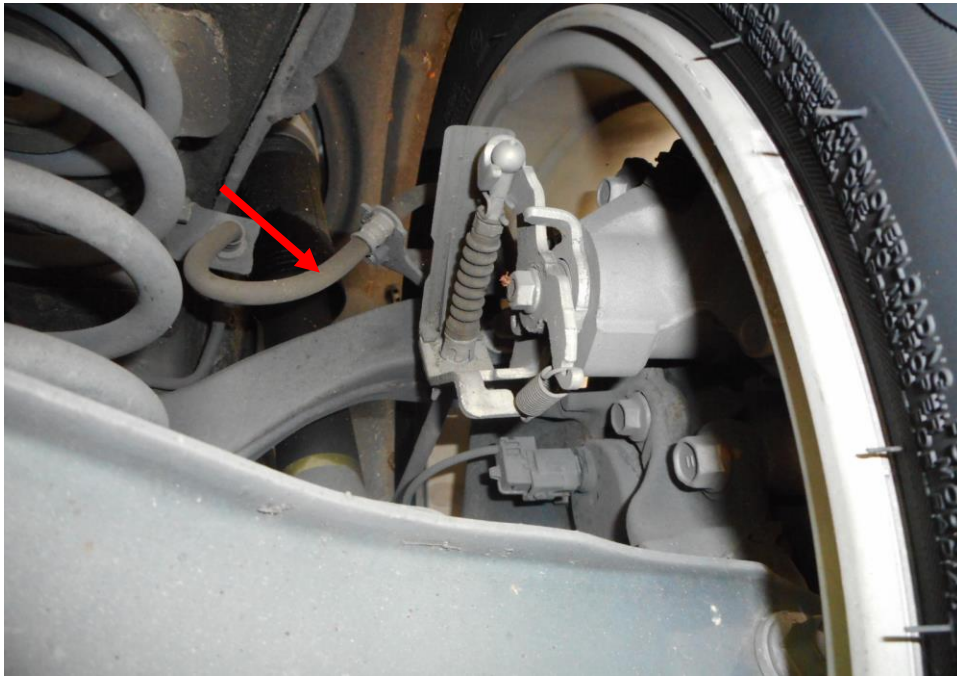
Photo 15 shows the brake hose/pipe (arrowed) at the rear right wheel of the Motor Taxi. No leakage of brake fluid was observed. Visual examination of the various components of the braking system like the drum brake, brake booster, brake pedal etc. had revealed all to be intact and without visible damage.

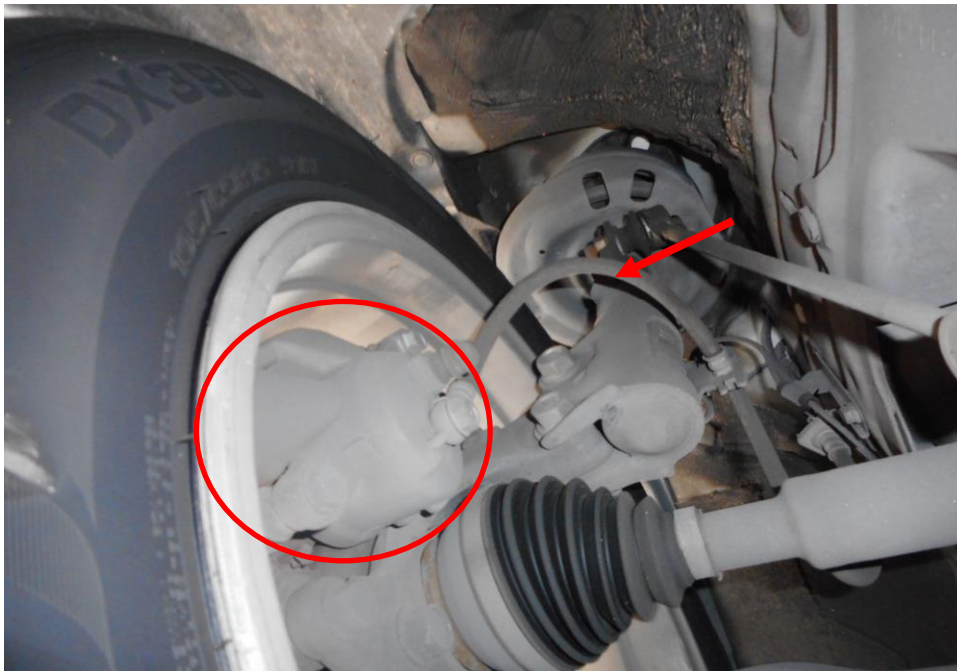
Photo 16 shows the brake hose/pipe (arrowed) at the front right wheel of the Motor Taxi. No leakage of brake fluid was observed. Visual examination of the various components of the braking system like the brake caliper (circled), brake booster, brake pedal etc. had revealed all to be intact and without visible damage at the time of accident. There was also no sign of fluid stain(s) observed on the various undercarriage components.

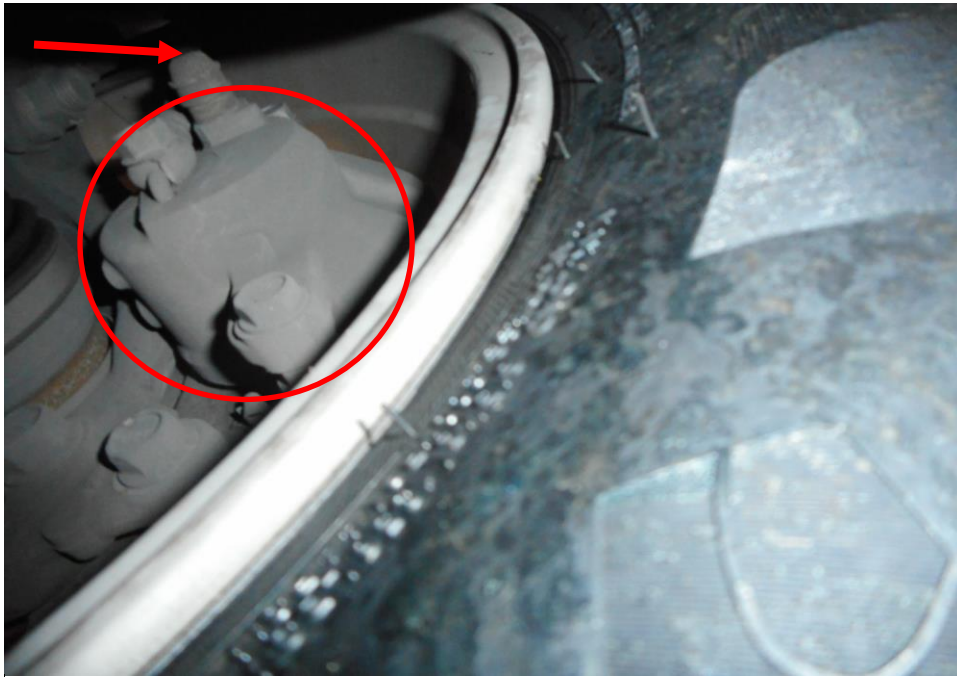
Photo 17 shows the brake hose/pipe (arrowed) at the front left wheel of the Motor Taxi. No leakage of brake fluid was observed. Visual examination of the various components of the braking system like the brake caliper (circled), brake booster, brake pedal etc had revealed all to be intact and without visible damage at the time of accident. There was also no sign of fluid stain(s) observed on the various undercarriage components.

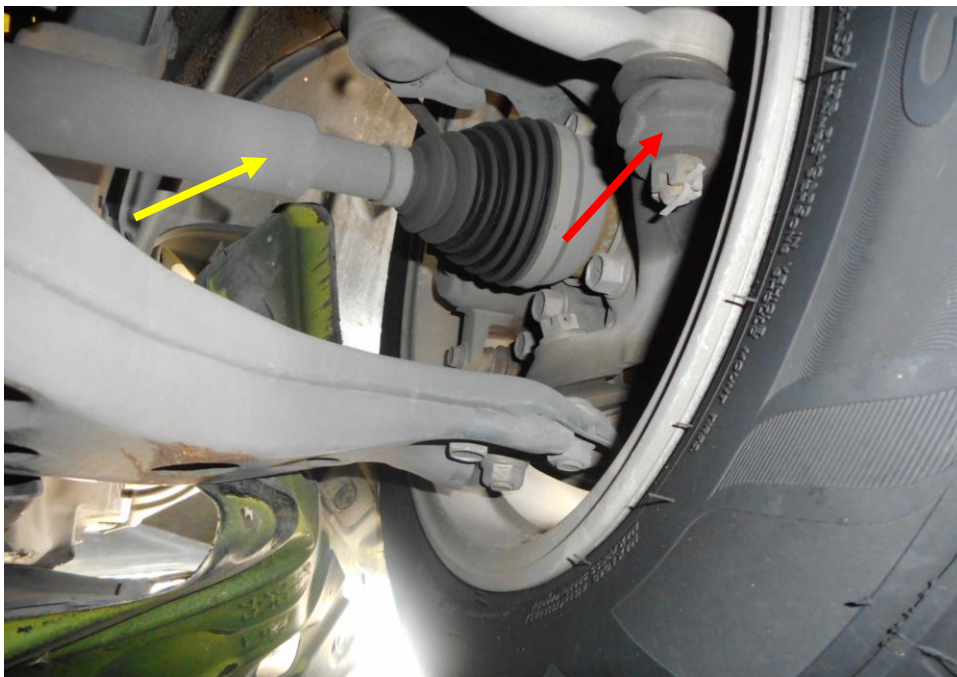
Photo 18 shows the various undercarriage components at the front right wheel of the Motor Taxi, in particular the steering tie rod end (arrowed) and drive shaft (yellow arrow). The various steering components were all found to be intact, suggesting that the steering system of the Motor Taxi was likely to be in serviceable condition at the material time of accident. There was also no sign of fluid stain(s) observed on the various undercarriage components.

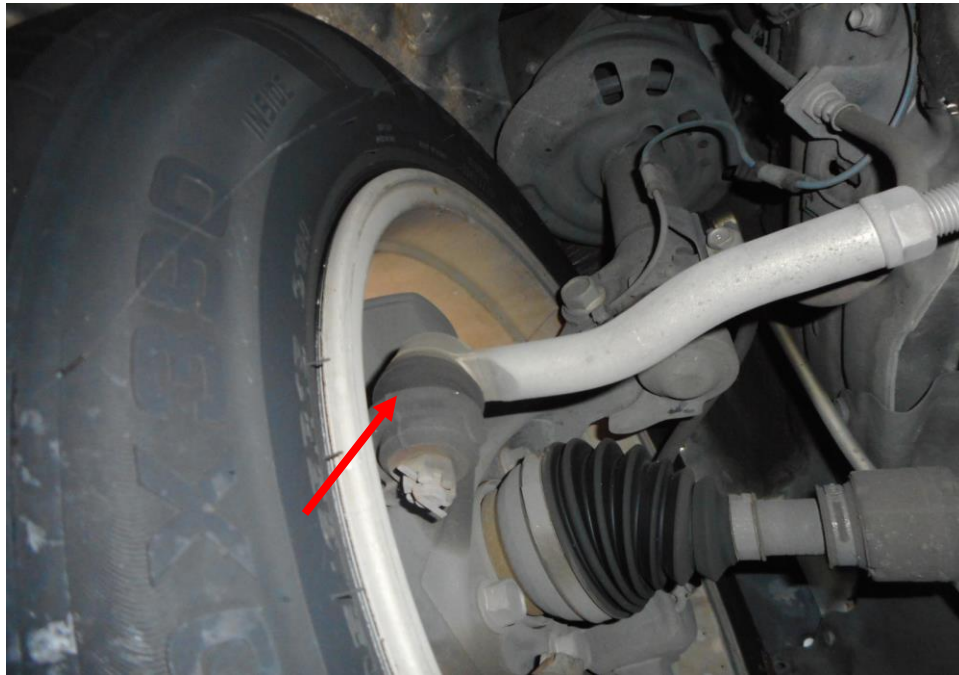
Photo 19 shows the various undercarriage components at the front left wheel of the Motor Taxi, in particular the steering tie rod end (arrowed). The various Undercarriage components of the Motor Taxi were all found to be intact without any visible damage. There was also no sign of fluid stain(s) observed on the various undercarriage components.

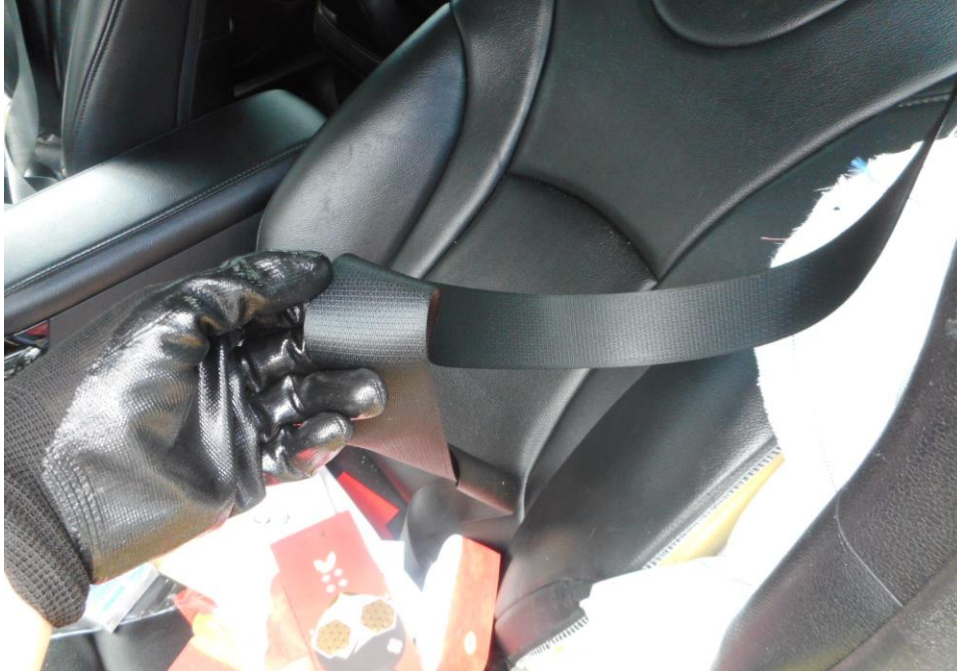
Photo 20 shows that the seat belt on the left seat was worn at the material time of accident as the safety pre-tensioners was activated at the moment of impact and caused the seat belt to be locked into the last position.

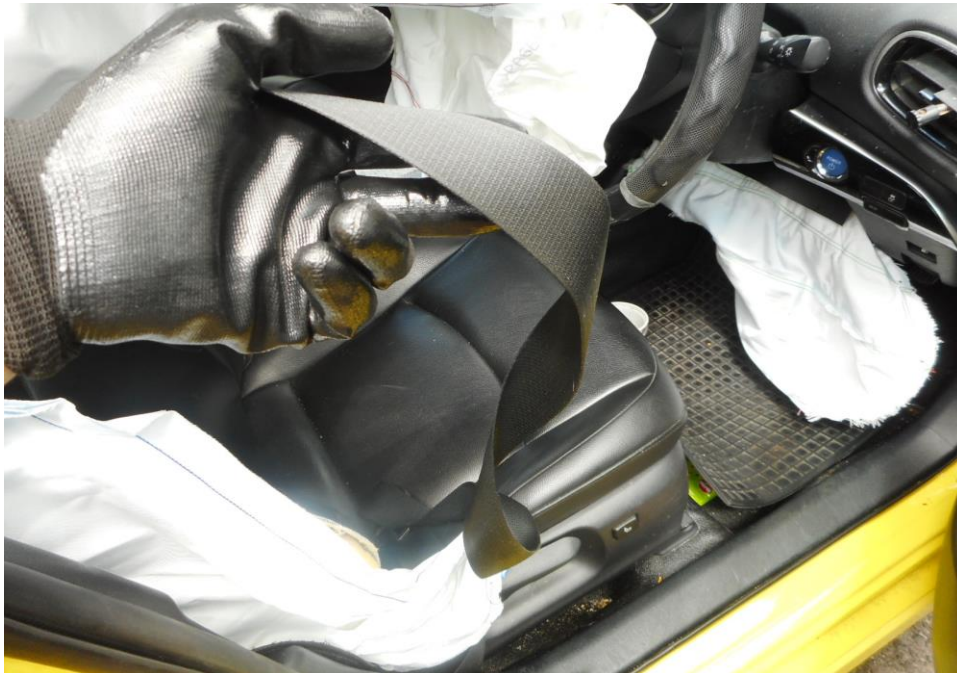
Photo 21 shows that the seat belt on the right seat was worn at the material time of accident as the safety pre-tensioners was activated at the moment of impact and caused the seat belts to be locked into the last position of the user.
