Your Ref: TP/IP/20467/2020  
Our Ref: CI/TPD20005597/P

**Fatal Accident Investigation Team**

**MECHANICAL INSPECTION REPORT OF MOTOR LORRY GBJ 9489M**

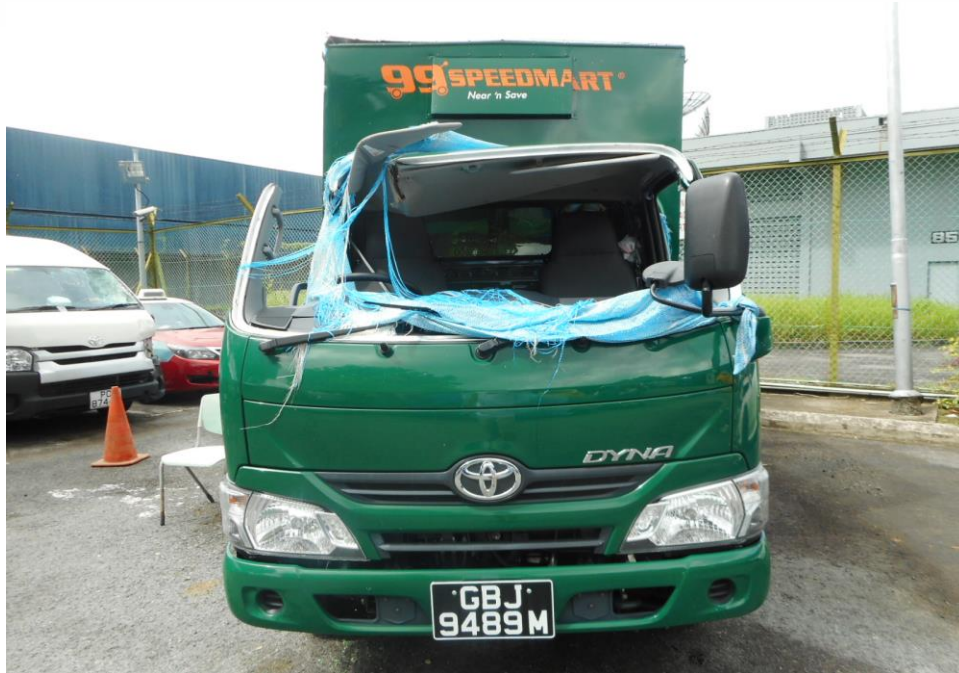
**Photo 1** shows a general view of the front windscreen and front cabin body panel of the Motor Lorry at the time of our inspection. The Motor Lorry was observed sustained extensive damage as a result of the accident.

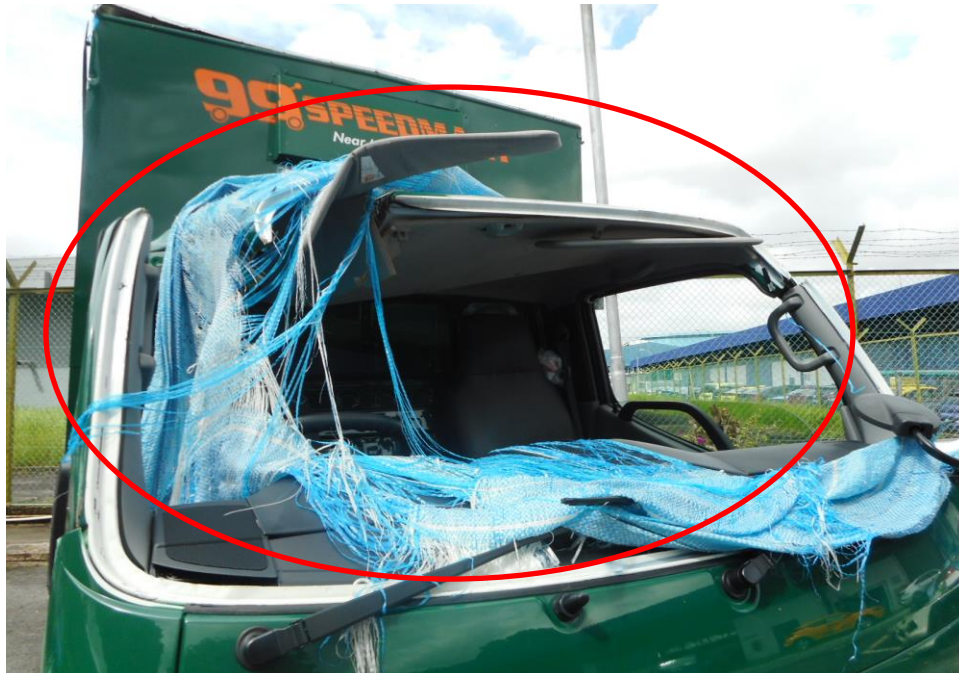
**Photo 2** shows a close up view of the front body of the Motor Lorry at the time of our inspection. The Motor Lorry was observed to have sustained extensive damages to its front windscreen and front cabin body panel (circled) as a result of the accident.

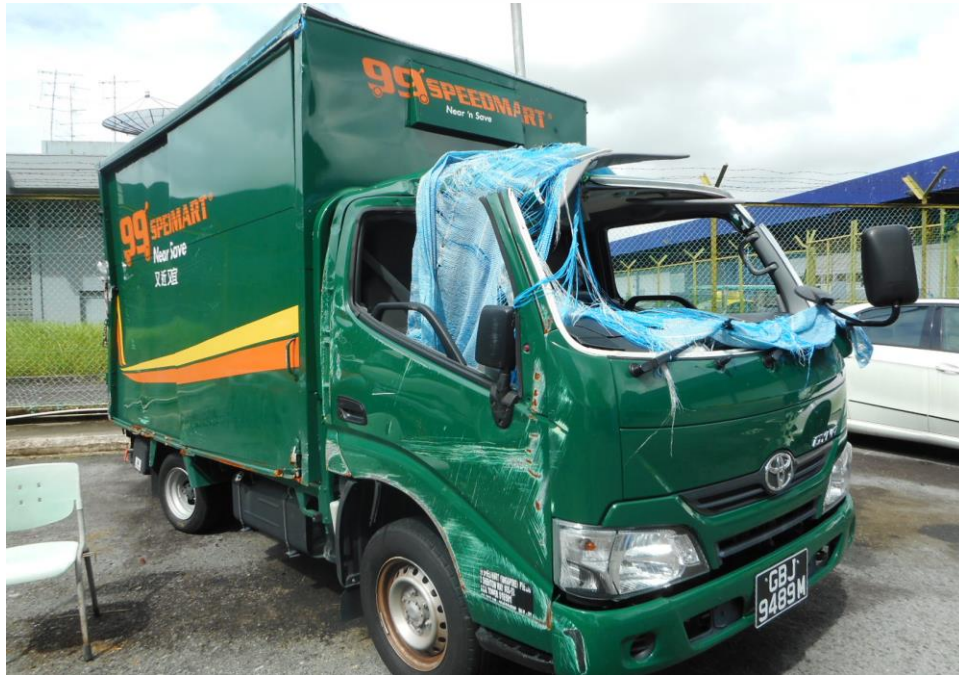
**Photo 3** shows a general view of the right body of the Motor Lorry at the time of our inspection. The Motor Lorry was observed to have sustained damages to its doors and rear cabin body panel as a result of the accident.

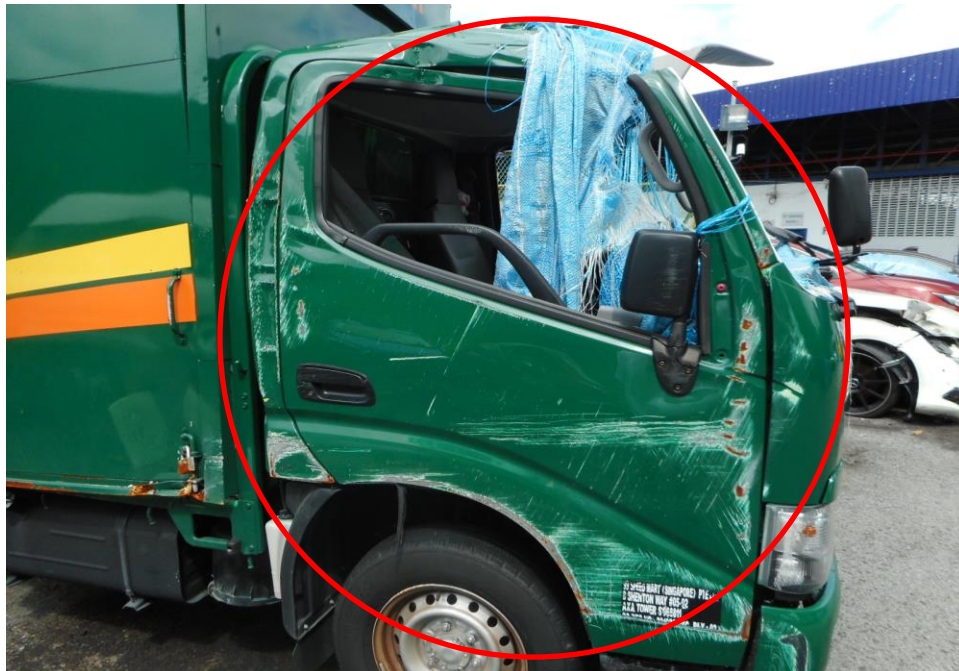
**Photo 4** shows a close up view of the right body of the Motor Lorry at the time of our inspection. The Motor Lorry was observed to have sustained damages to its right door (circled) as a result of the accident.

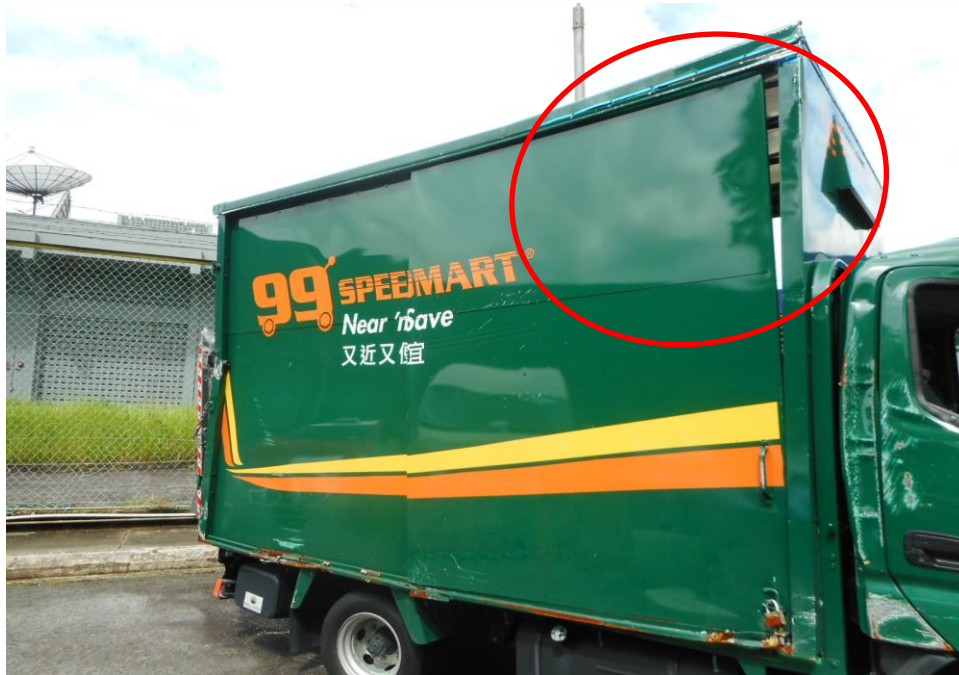
**Photo 5** shows a close up view of the right body of the Motor Lorry at the time of our inspection. The Motor Lorry was observed to have sustained damages to its rear cabin body panel (circled) as a result of the accident.

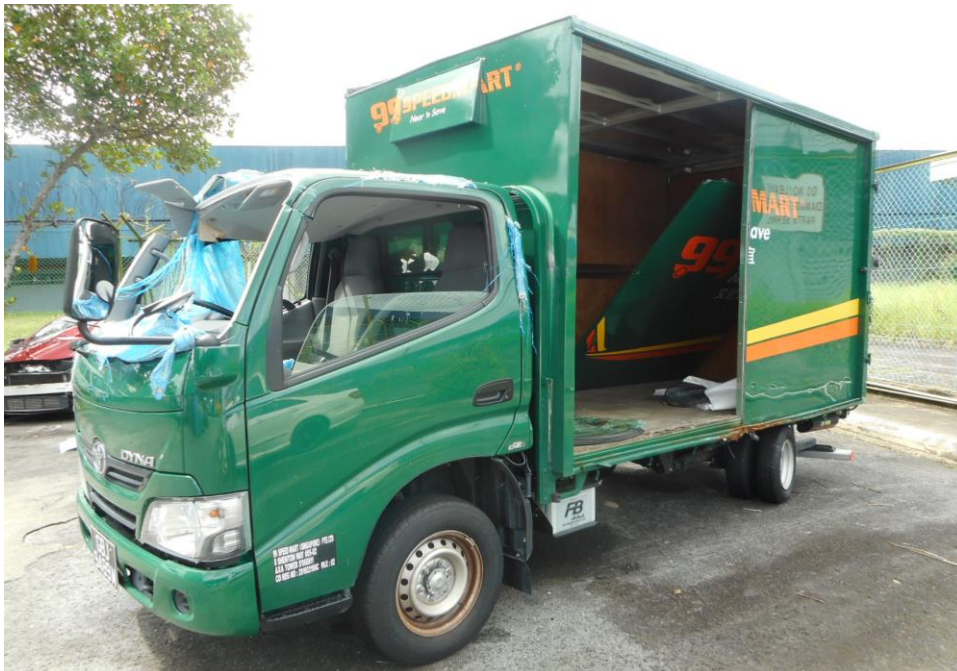
**Photo 6** shows a general view of the left body of the Motor Lorry at the time of our inspection. The Motor Lorry was observed to have sustained damages to its rear cabin body panel as a result of the accident.

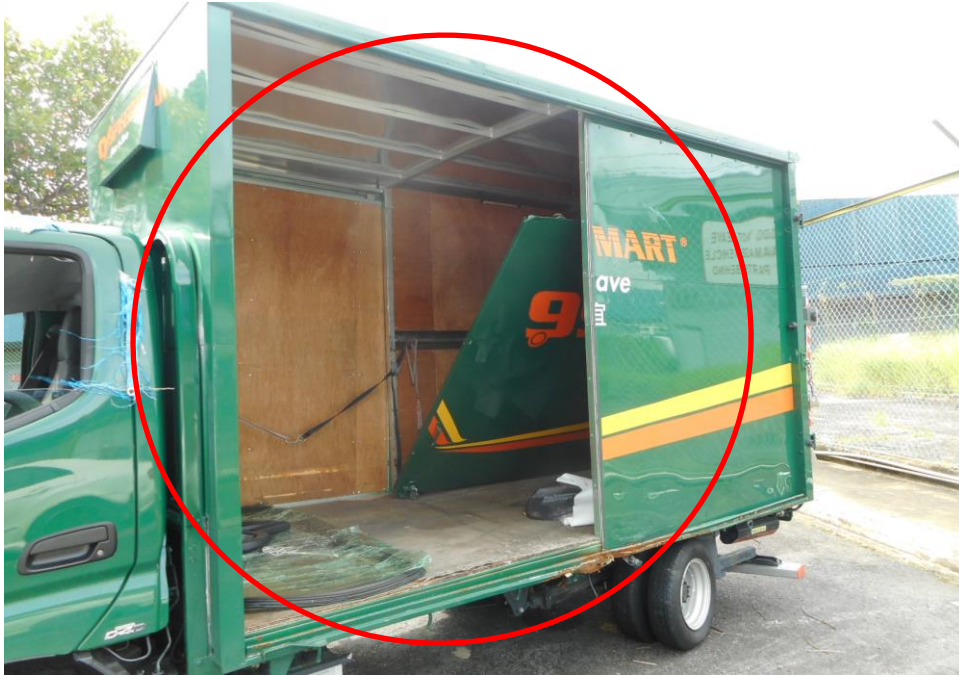
**Photo 7** shows a close up view of the left body of the Motor Lorry at the time of our inspection. The Motor Lorry was observed to have sustained damages to its rear cabin body panel (circled) as a result of the accident.

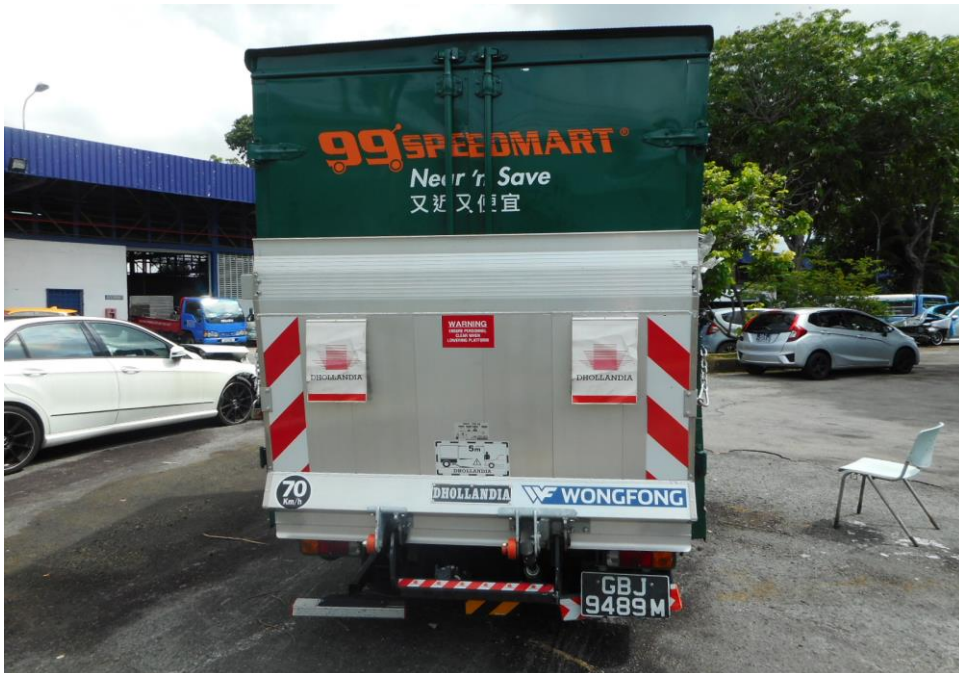
**Photo 8** shows the general view of the rear portion of the Motor Lorry at the time of our inspection. The Motor Lorry was observed to be unaffected by the accident.

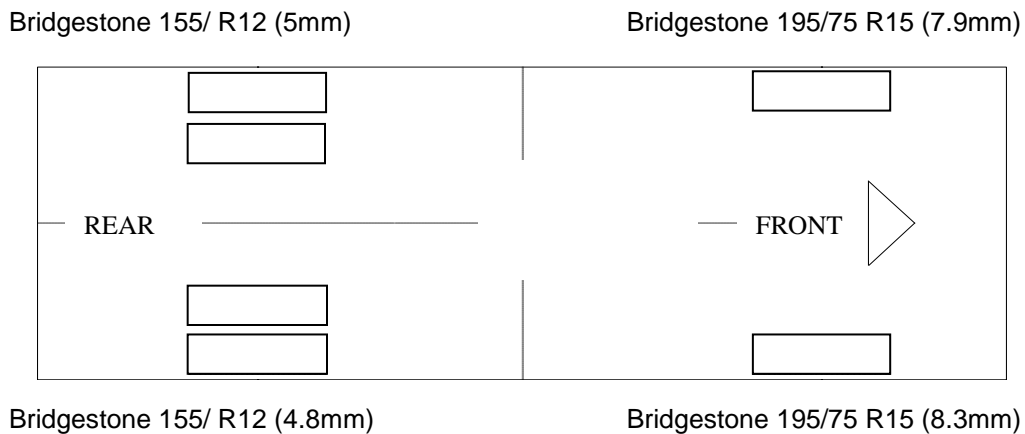
6. The 6 tyres of the Motor Lorry were observed to be in serviceable condition and sufficiently inflated for vehicular operation. I did not find any tear, cut or burst mark(s) on the outer and the inner sidewalls as well as across the tread of the 6 tyres. The tyre brand, tyre size and remaining tread depth of the 6 tyres of the Motor Lorry were recorded as follows:-

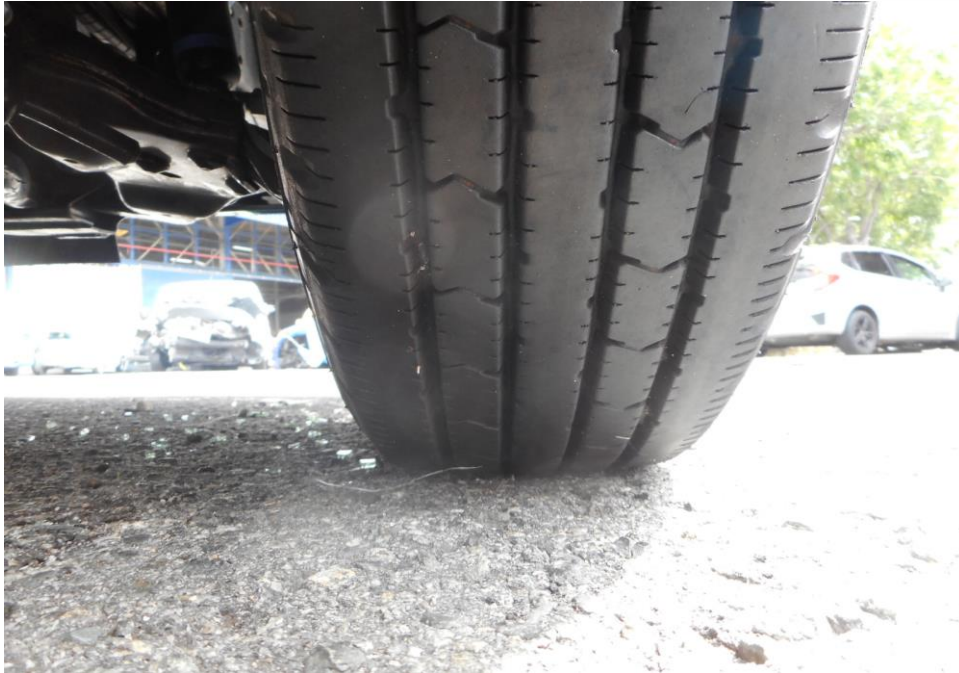
**Photo 9** shows the condition of the front right tyre of the Motor Lorry, which was observed to be in serviceable condition with remaining tread depth of approximately 8.3mm. The tyre, which was wrapped around standard steel wheel rim, was also observed to be sufficiently inflated for vehicular operation.

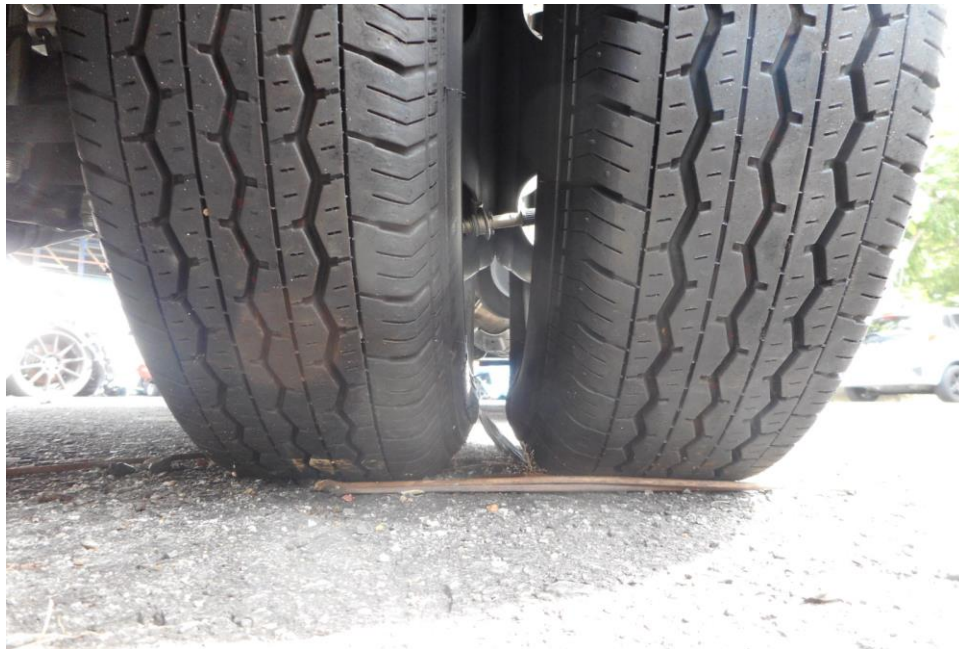
**Photo 10** shows the condition of the rear right tyres of the Motor Lorry, which was observed to be in serviceable condition with remaining tread depth of approximately 4.8mm. The tyre, which was wrapped around standard steel wheel rim, was also observed to be sufficiently inflated for vehicular operation.

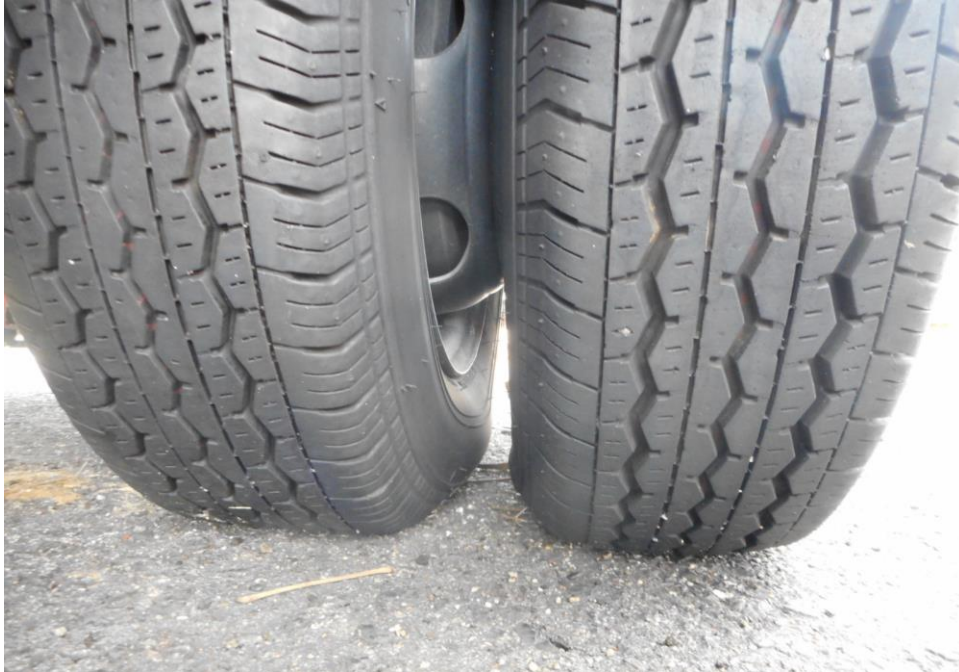
**Photo 11** shows the condition of the rear left tyre of the Motor Lorry, which was observed to be in serviceable condition with remaining tread depth of approximately 5mm. The tyre, which was wrapped around standard steel wheel rim, was also observed to be sufficiently inflated for vehicular operation.

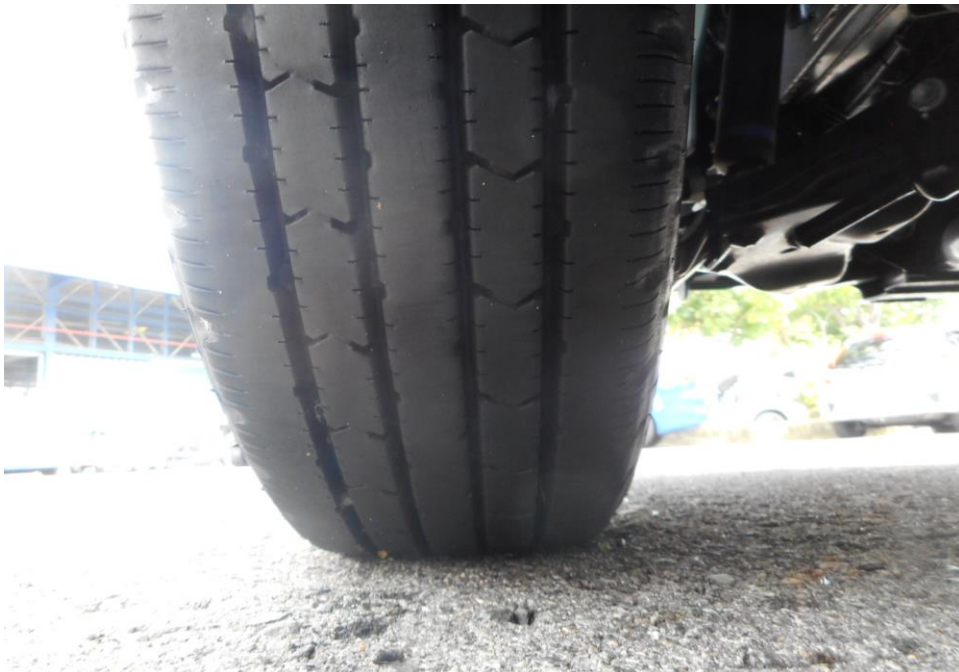
**Photo 12** shows the condition of the front left tyres of the Motor Lorry, which observed to be in serviceable condition with remaining tread depth of approximately 7.9mm. The tyres, which were wrapped around standard steel wheel rim, were also observed to be sufficiently inflated for vehicular operation.

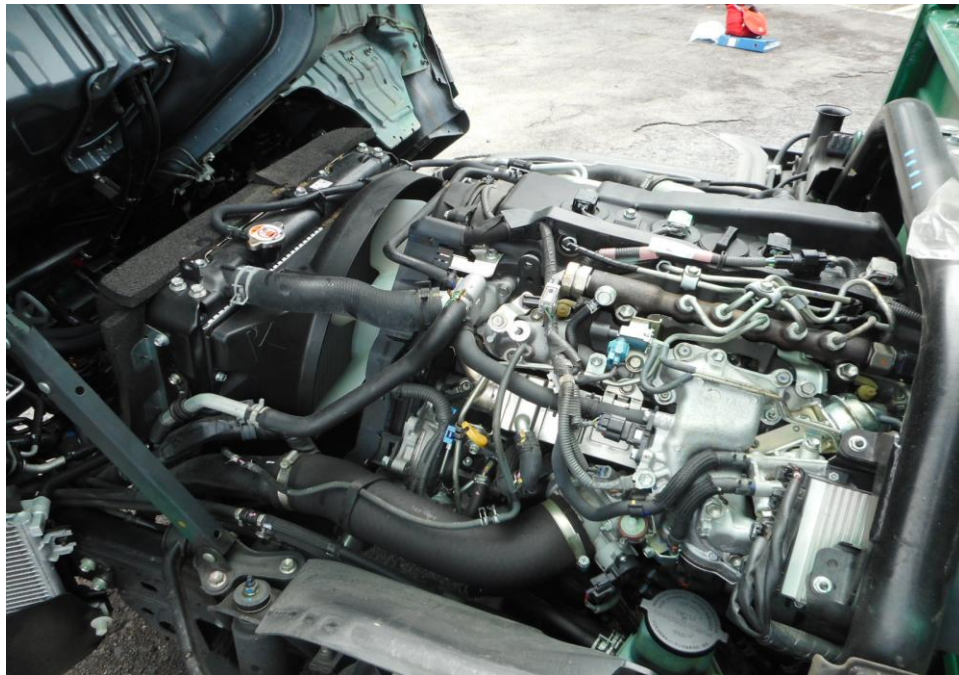
**Photo 13** shows a general view of the Motor Lorry's engine compartment, which was accessed by lifting the front cabin of the Motor Lorry. The various parts and components inside the engine compartment were unaffected by the accident. There was also no sign(s) or indication(s) of fresh fluid leakage and/or fluid stain within the engine compartment (photograph shows the engine compartment as viewed from the right front side of the Motor Lorry).

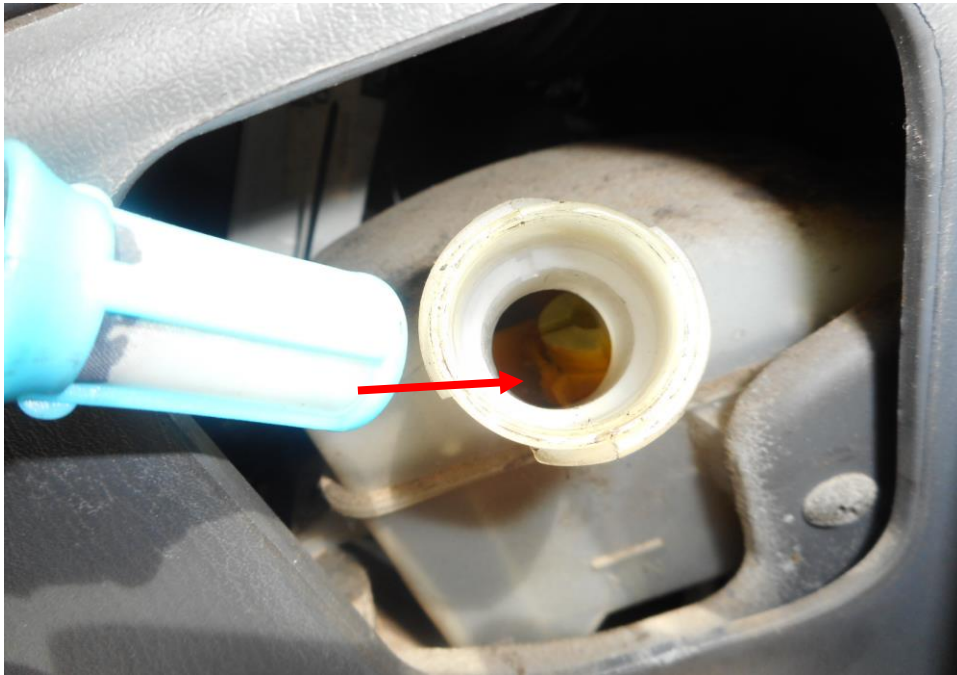
**Photo 14** shows the brake fluid reservoir of the Motor Lorry at the time of my inspection. The brake fluid was observed to be of sufficient level (arrowed) and without any visible contamination.

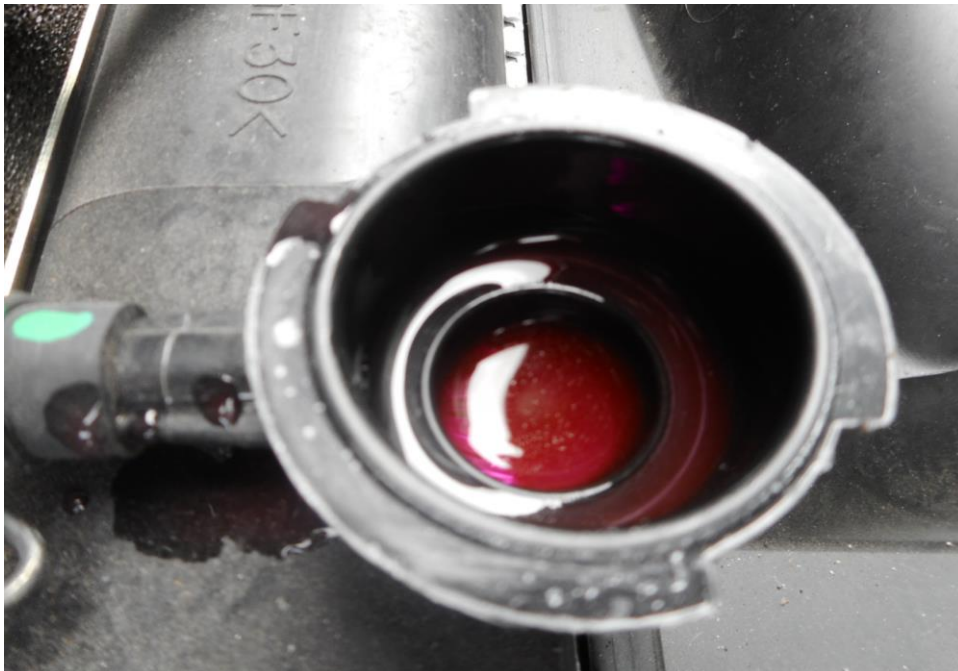
**Photo 15** shows the engine coolant reservoir of the Motor Lorry at the time of my inspection. The engine coolant was observed to be of sufficient level and without any visible contamination.

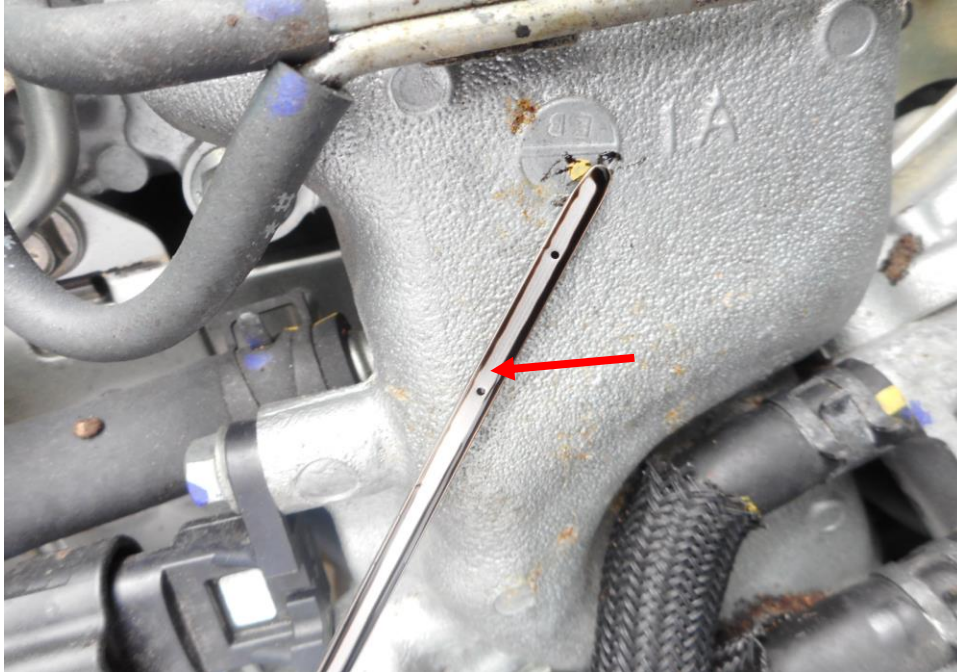
**Photo 16** shows the engine oil dip stick of the Motor Lorry at the time of my inspection. The engine oil was observed to be of sufficient level (arrowed) and without any visible contamination.

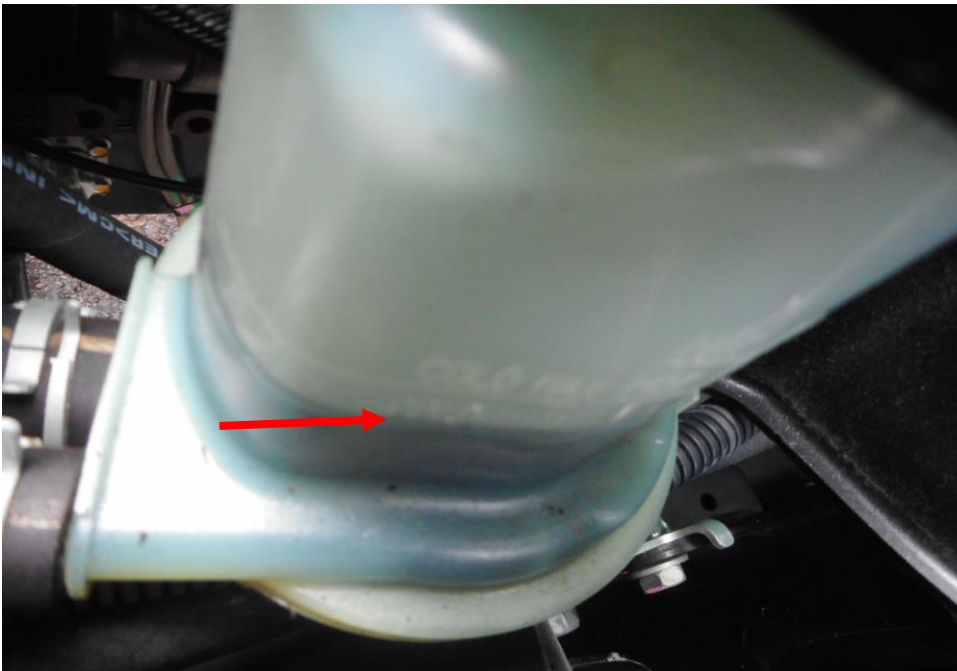
**Photo 17** shows the power steering fluid dip stick of the Motor Lorry at the time of my inspection. The steering fluid oil was observed to be of sufficient level (arrowed) and without any visible contamination.

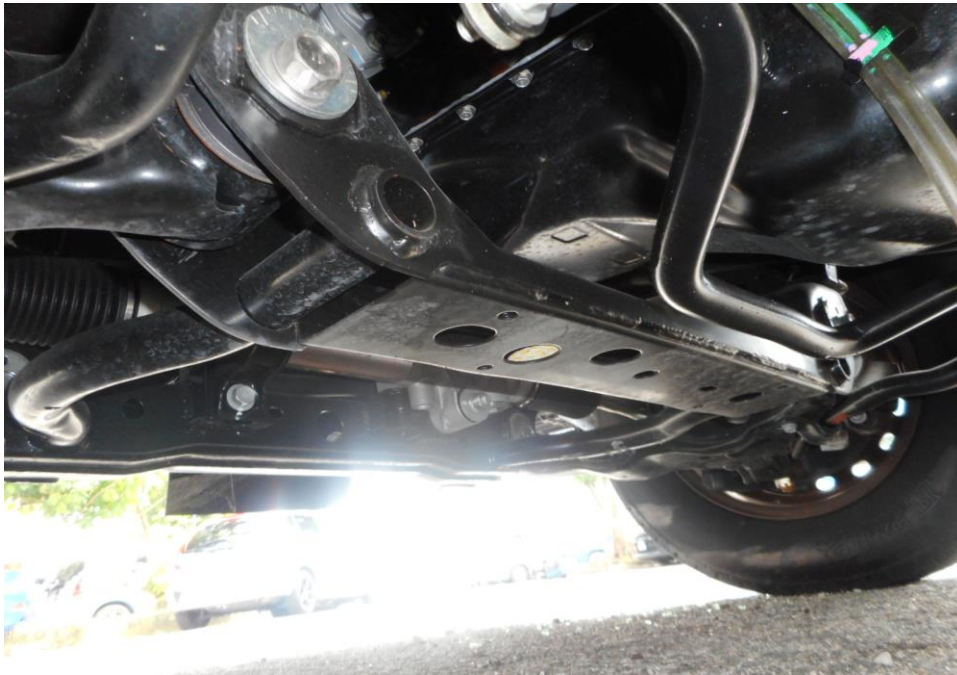
**Photo 18** shows the undercarriage of the Motor Lorry, at the area where the engine housing and transmission housing are located. . I did not find any sign(s) or indication(s) of fluid leak and/or fluid stain(s) on the underside of the Motor Lorry.

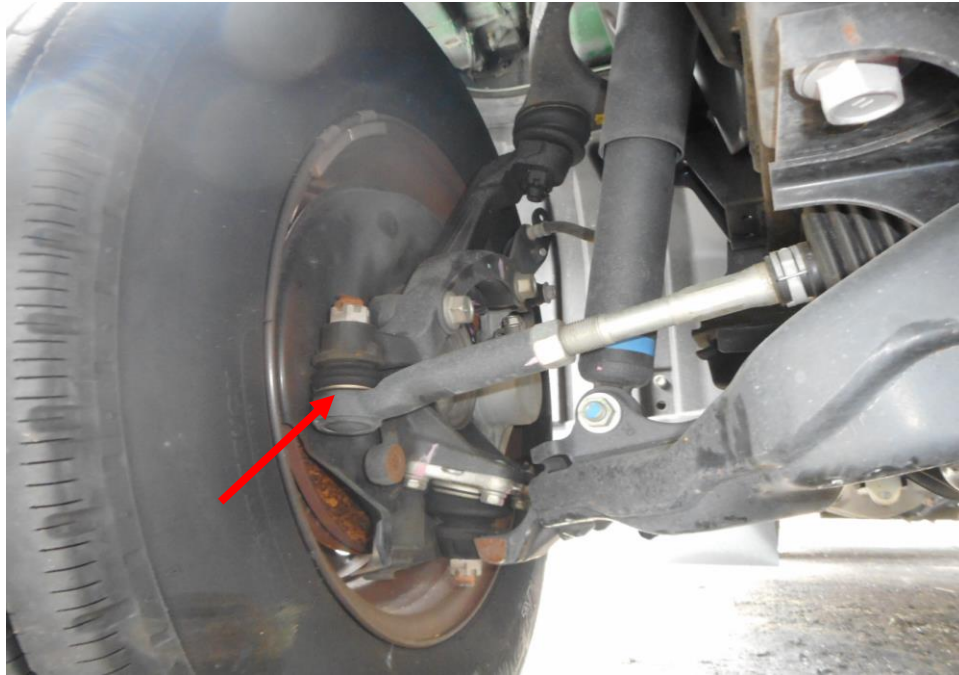
**Photo 19** shows the various undercarriage components at the front right wheel of the Motor Lorry, in particular the steering tie rod end (arrowed). The various steering components were all found to be intact, suggesting that the steering system of the Motor Lorry was likely to be in serviceable condition at the material time of accident. There was also no sign of fluid stain(s) observed on the various undercarriage components.

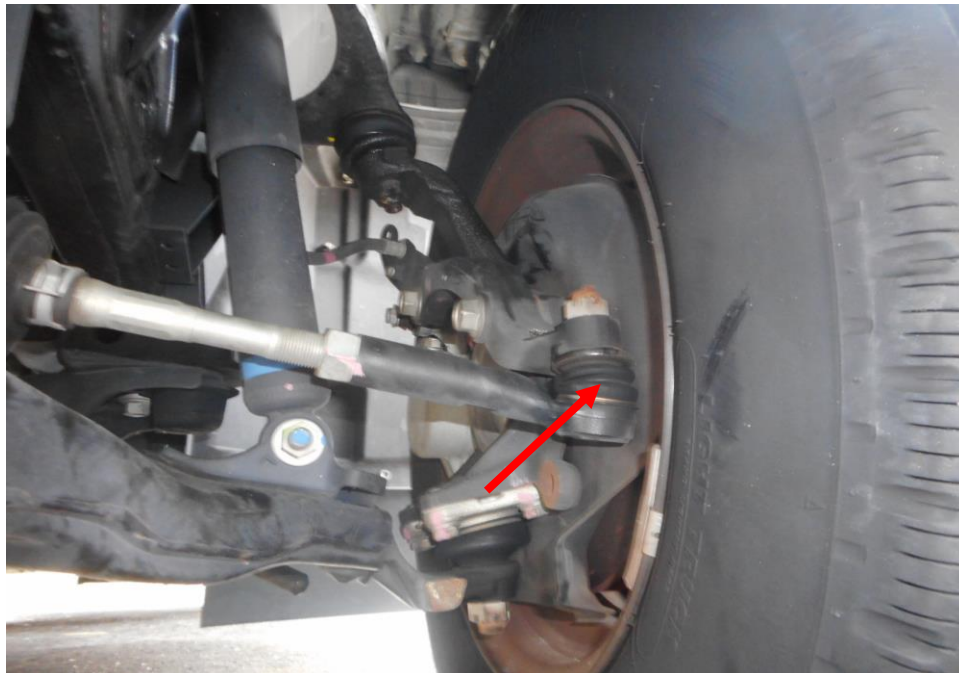
**Photo 20** shows the various undercarriage components at the front left wheel of the Motor Lorry, in particular the steering tie rod end (arrowed). The various undercarriage components of the Motor Lorry were all found to be intact without any visible damage. There was also no sign of fluid stain(s) observed on the various undercarriage components.

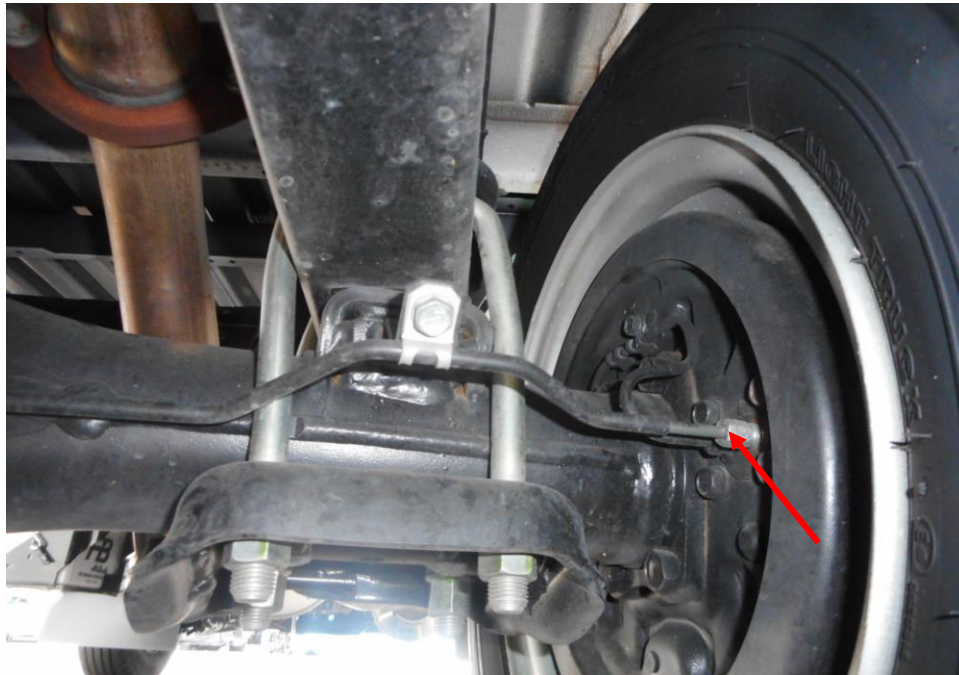
**Photo 21** shows the brake pipe (arrowed) at the rear right wheel of the Motor Lorry. I did not observe any leakage of brake fluid at the time of my inspection of the Motor Lorry. My static tests of the Motor Lorry's braking system, along with my visual examination of the various mechanical components in the braking system, had indicated that there was no internal leakage of pressure/vacuum.

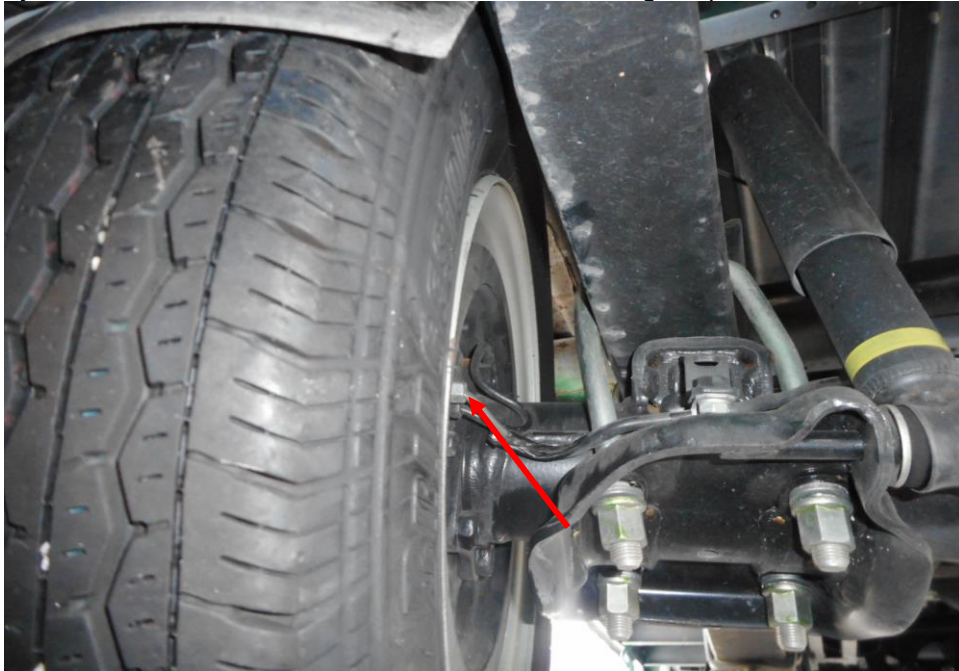
**Photo 22** shows the brake pipe (arrowed) at the rear left wheel of the Motor Lorry. I did not observe any leakage of brake fluid at the time of my inspection of the Motor Lorry. My static tests of the Motor Lorry's braking system, along with my visual examination of the various mechanical components in the braking System had indicated that there was no internal leakage of pressure/vacuum. Hence the braking system of the Motor Lorry was likely to be in serviceable condition at the material time of accident.

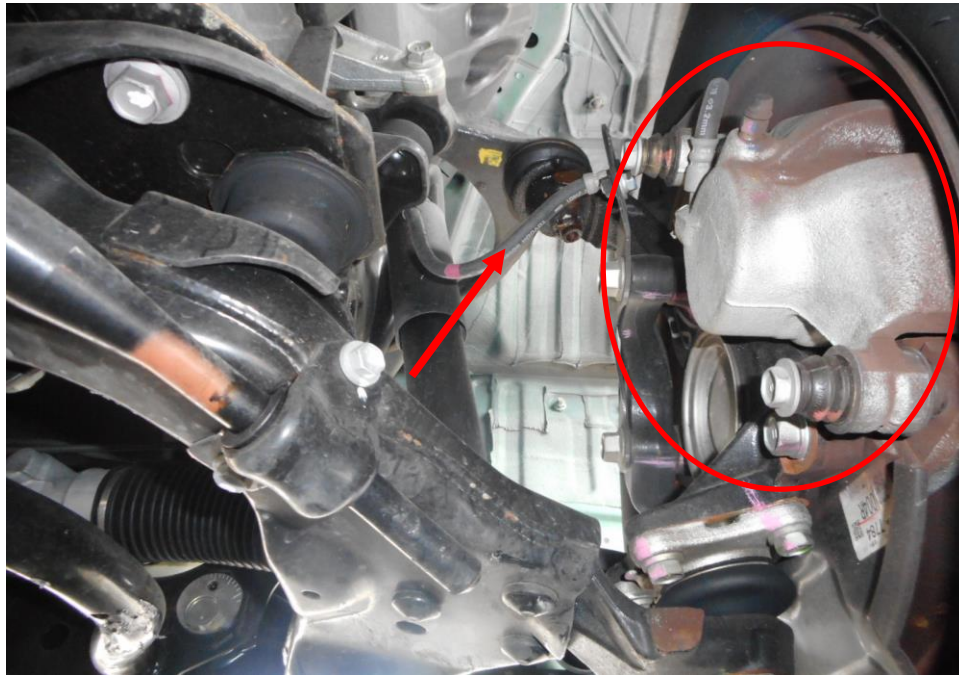
**Photo 23** shows the brake hose/pipe (arrowed) at the front right wheel of the Motor Lorry. No leakage of brake fluid was observed. Visual examination of the various components of the braking system like the brake caliper (circled), brake booster, brake pedal etc had revealed all to be intact and without visible damage at the time of accident. There was also no sign of fluid stain(s) observed on the various undercarriage components.

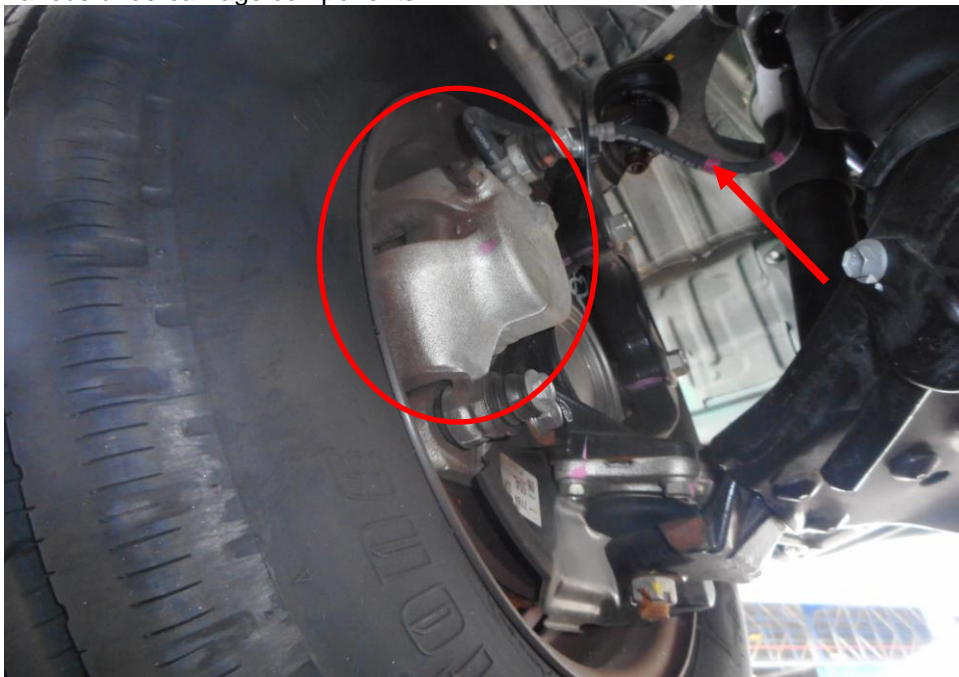
**Photo 24** shows the brake hose/pipe (arrowed) at the front left wheel of the Motor Lorry. No leakage of brake fluid was observed. Visual examination of the various components of the braking system like the brake caliper (circled), brake booster, brake pedal etc had revealed all to be intact and without visible damage at the time of accident. There was also no sign of fluid stain(s) observed on the various undercarriage components.

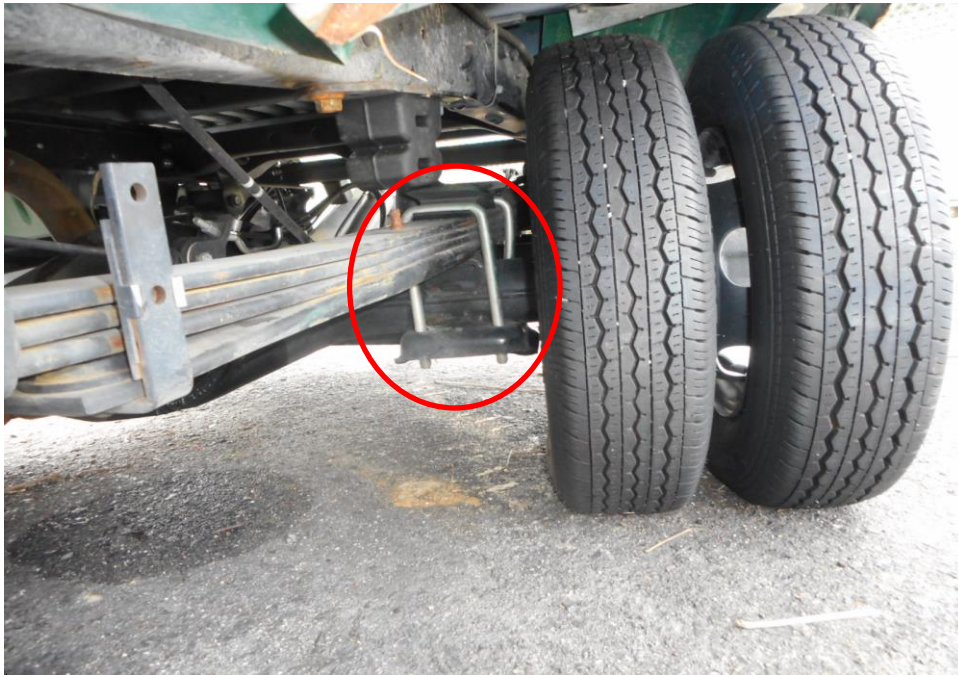
**Photo 25** shows the undercarriage chassis (circled) of the Motor Lorry. It was observed to shift out of position due to the impact it had sustained as a result of the accident.

16. An operational test by driving the Motor Lorry was not conducted as it was unsafe to be operated due to the damage it sustained to the front cabin and its undercarriage chassis as a result of the accident.

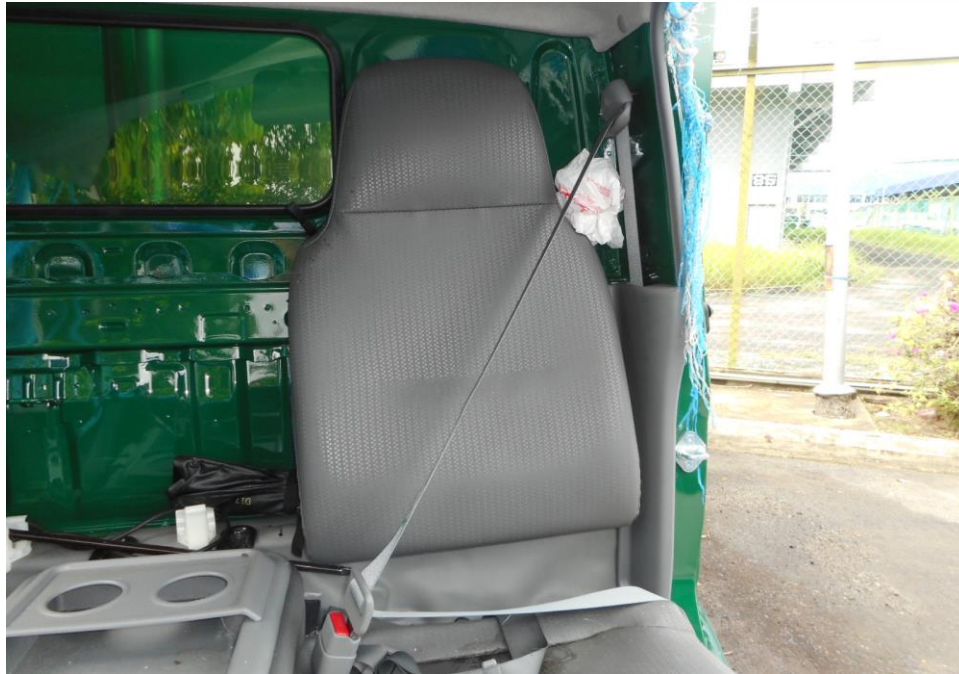
**Photo 26** shows that the seat belt on the left seat was tested and all the seat belts were able to be fastened securely into the respective pre-tensioners that were fitted at the sides of each seat.

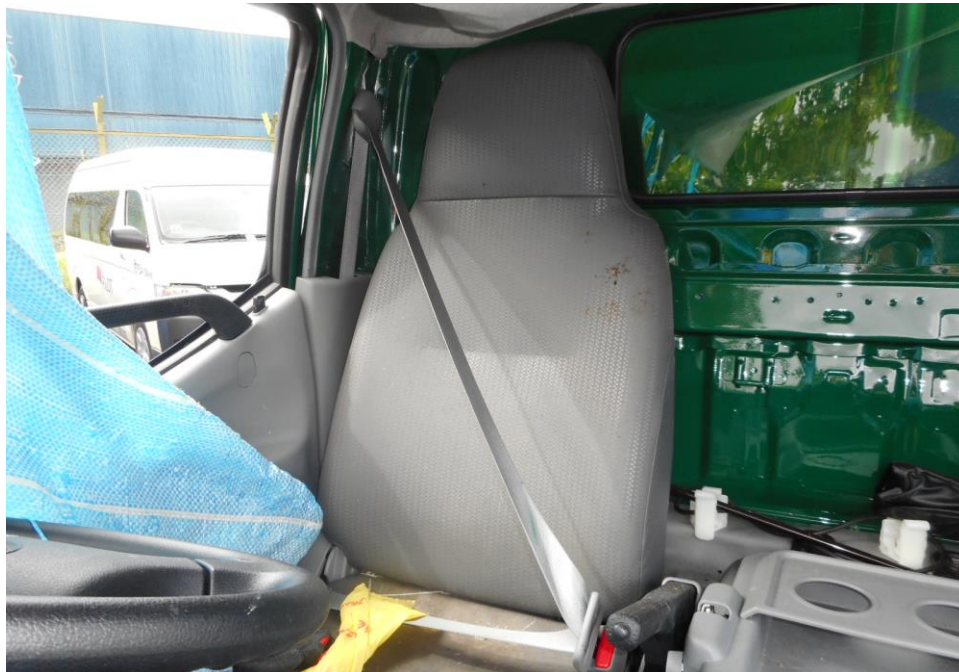
**Photo 27** shows that the seat belt on the right seat was tested and all the seat belts were able to be fastened securely into the respective pre-tensioners that were fitted at the sides of each seat.
