Your Ref: TP/IP/21061/2020
Our Ref : CI/TPD20005598/P

17th July 2020

Fatal Accident Investigation Team

MECHANICAL INSPECTION REPORT OF MOTOR CAR SLB 1471P

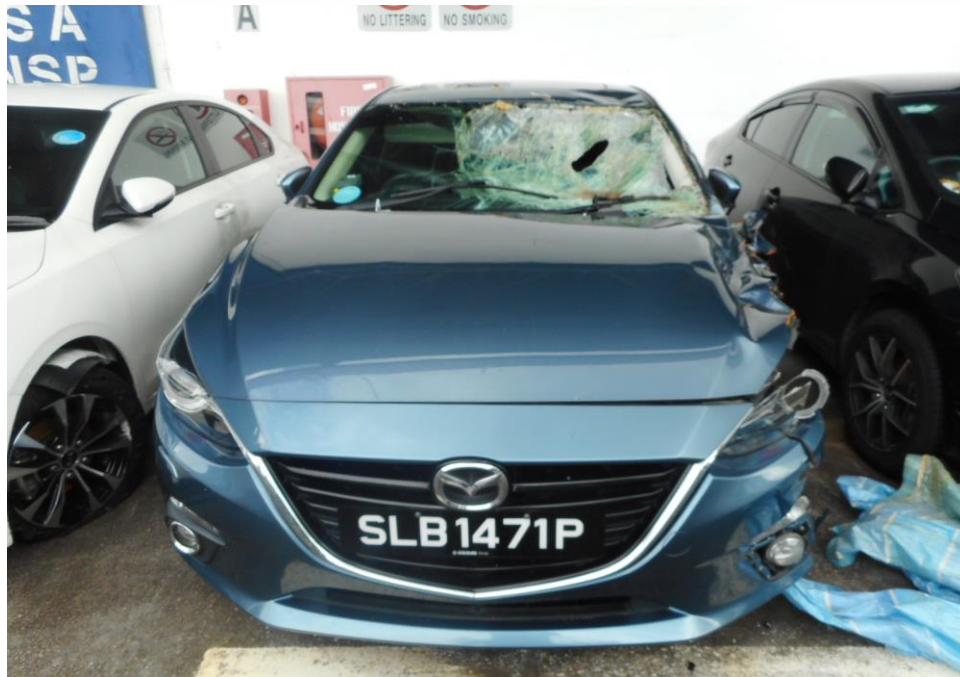
Photo 1 shows a general view of the Motor Car's front body at the time of my inspection. The Motor car was observed to have sustained damage at its front left portion. Its front windscreen, front bonnet, front bumper, front left fender and front left headlamp was amongst the body parts and various components in the engine compartments were also damaged as a result of the accident.

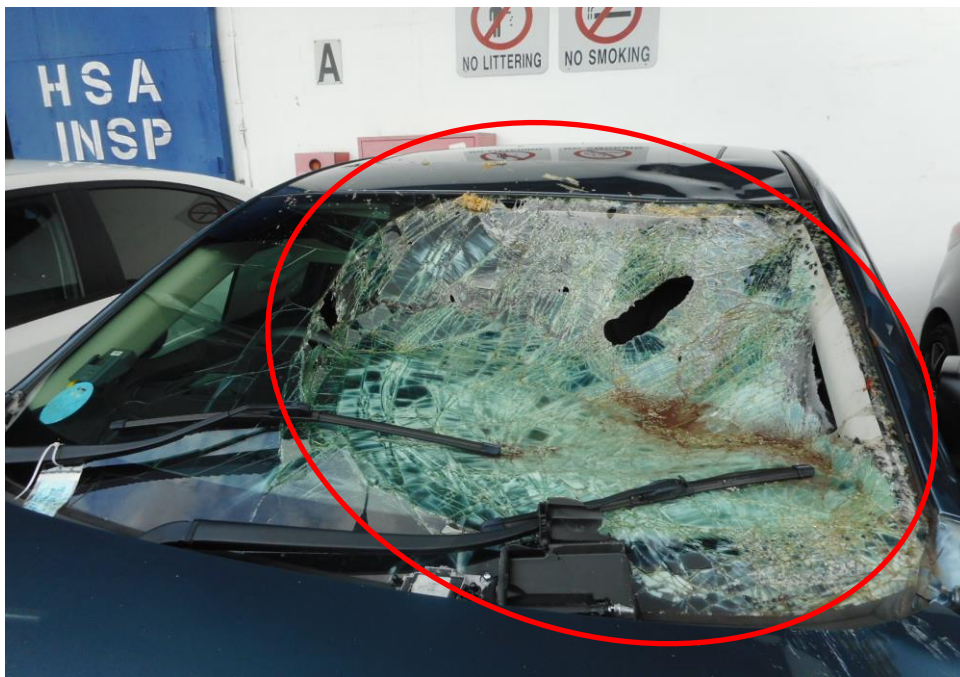
Photo 2 shows a general view of the Motor Car's front body at the time of my inspection. The Motor car was observed to have sustained damage at its front left portion. Its front windscreen (circled) was amongst the body parts and various components in the engine compartments were also damaged as a result of the accident.

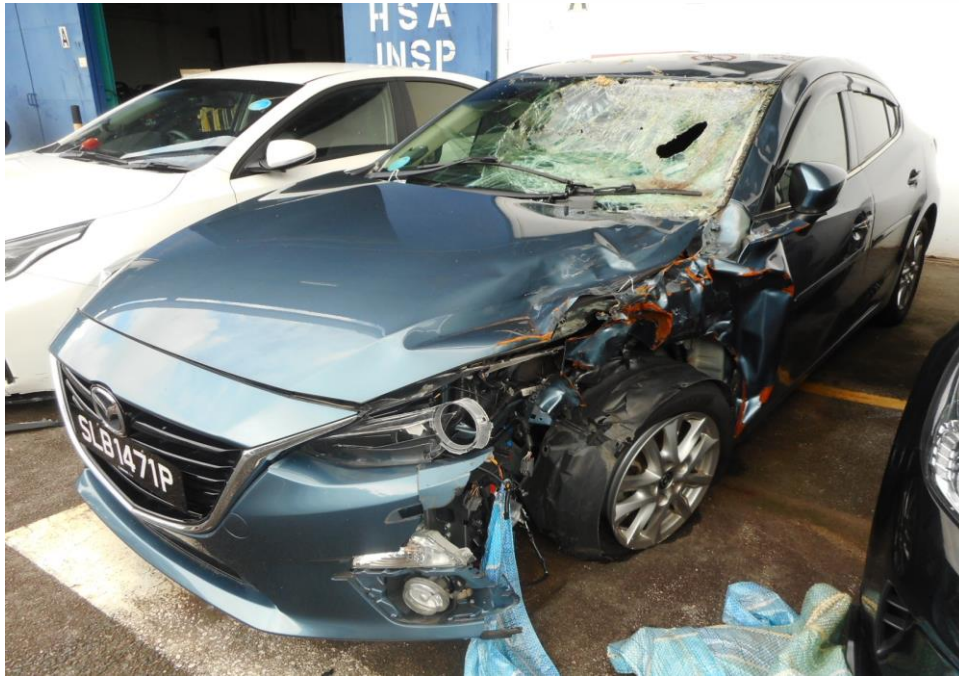
Photo 3 shows a general view of the Motor Car's left portion at the time of my inspection. The Motor car was observed to have sustained damage at its front left portion. Its front windscreen, front bonnet, front bumper, front left fender and front left headlamp was amongst the body parts and various components in the engine compartments were also damaged as a result of the accident.

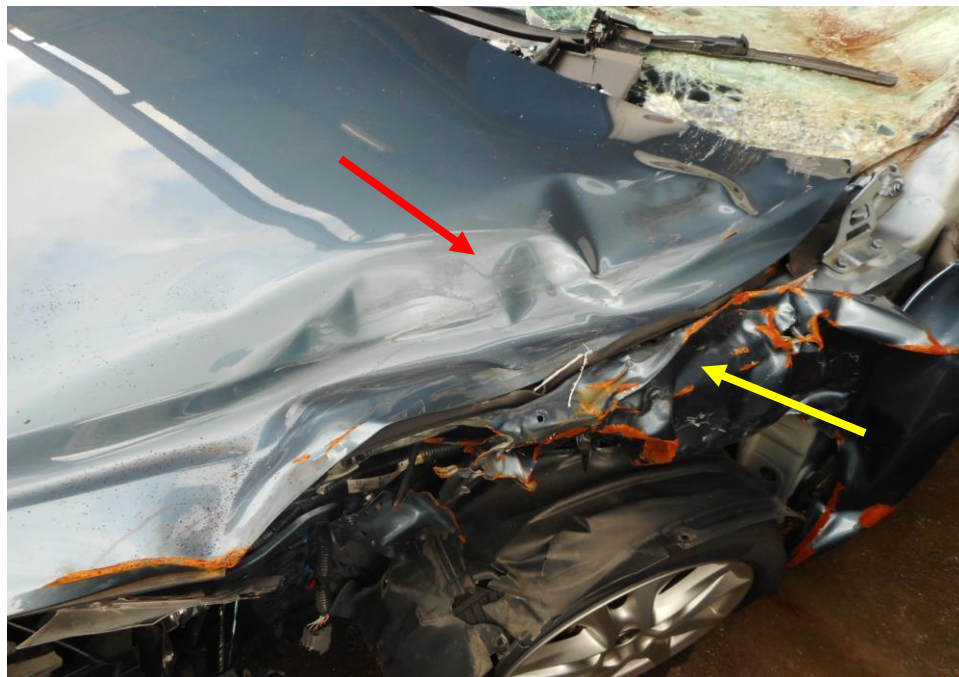
Photo 4 shows a close up view of the Motor Car's left portion at the time of my inspection. The Motor car was observed to have sustained damage at its front left portion. Its front bonnet (red arrow) and front left fender (yellow arrow) was amongst the body parts and various components in the engine compartments were also damaged as a result of the accident.

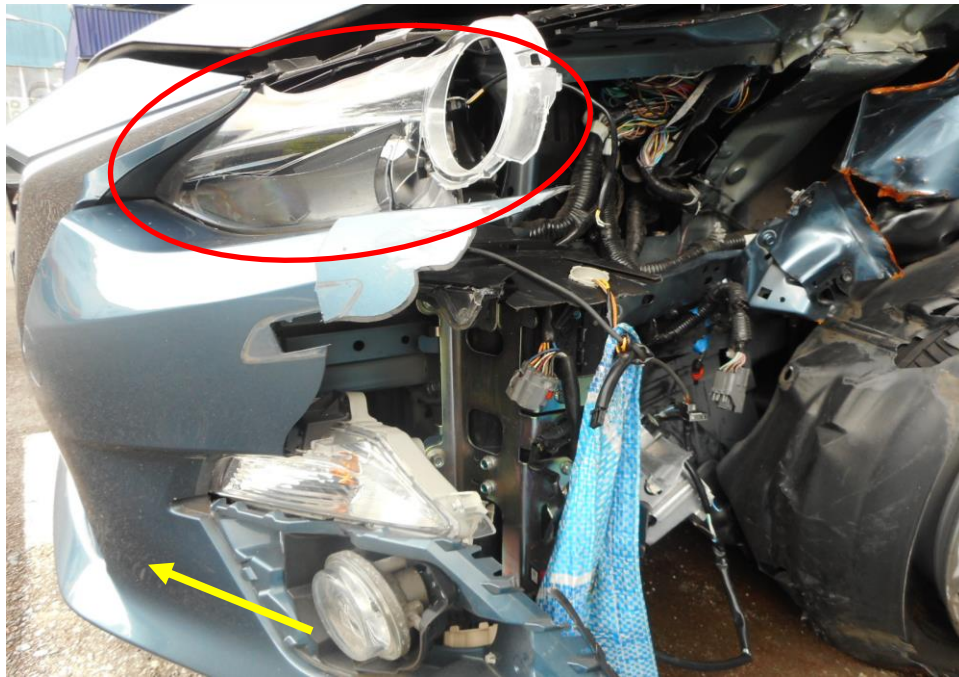
Photo 5 shows a close up view of the Motor Car's left portion at the time of my inspection. The Motor car was observed to have sustained damage at its front left portion. Its front bumper (arrowed) and front left headlamp (circled) was amongst the body parts and various components in the engine compartments were also damaged as a result of the accident.

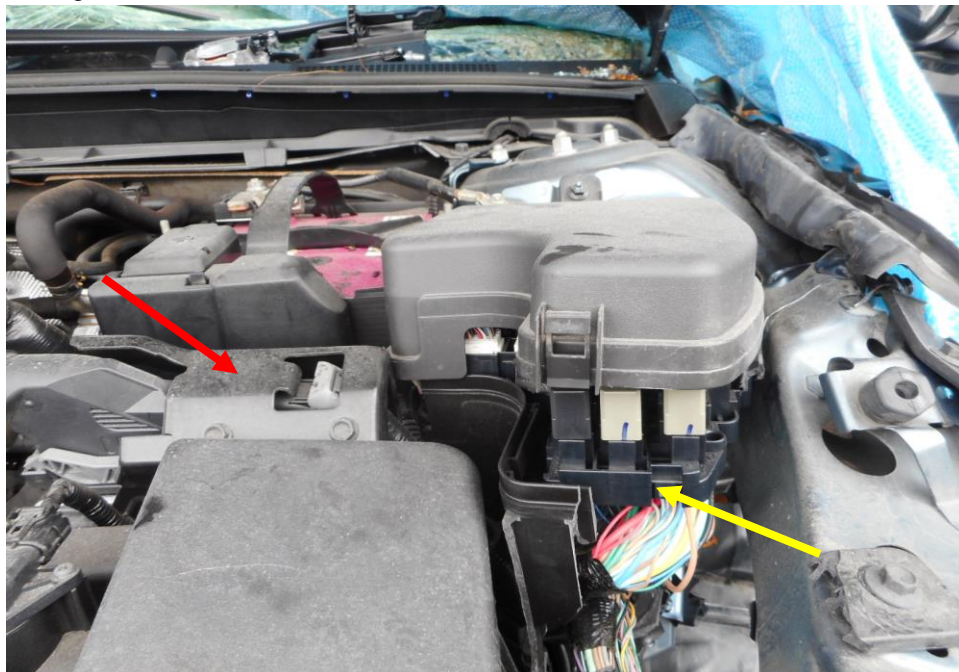
Photo 6 shows a close up view of the Motor Car's engine compartment at the time of my inspection. The Motor car was observed to have sustained damage at its engine compartment portion. Its various components in the engine compartments as the fuse box (yellow arrow), Electronic computing unit (red arrow) and ignition system were also damaged as a result of the accident.

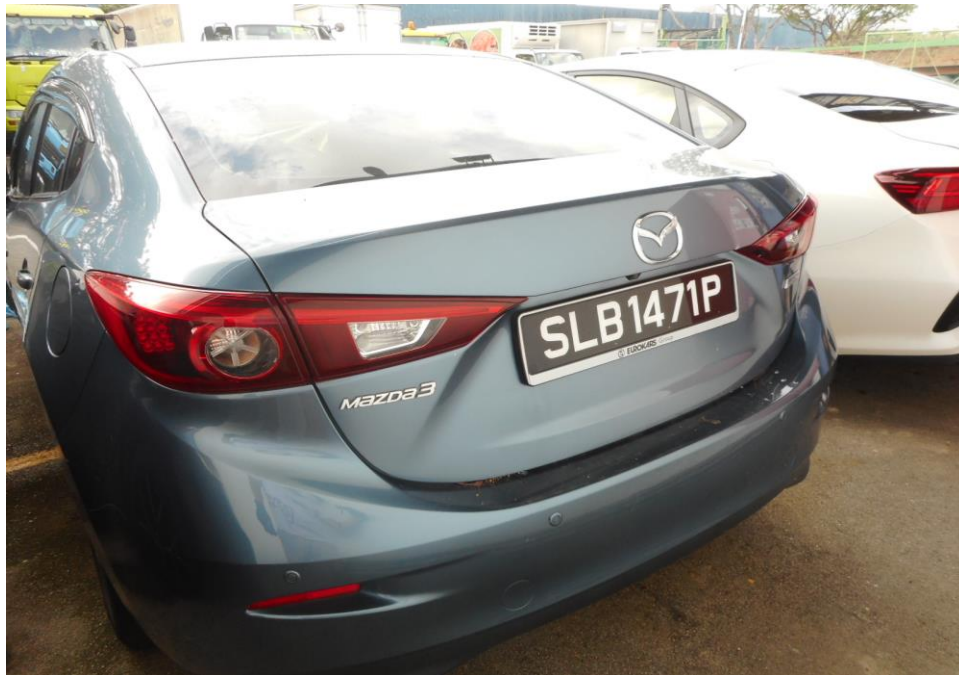
Photo 8 shows a general view of the Motor Car's rear body at the time of my inspection. The rear portion of the Motor Car was observed to have been undamaged by the accident.

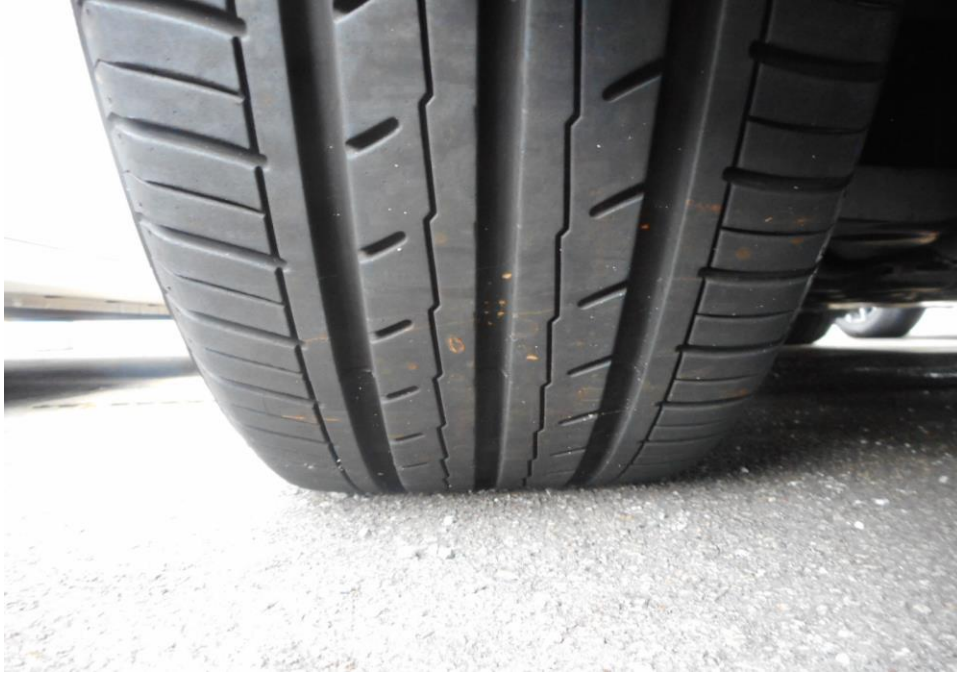
Photo 9 shows the condition of the front right tyre of the Motor Car, which was observed to be in serviceable condition with remaining tread depth of approximately 5.8mm. The tyre, which was wrapped around alloy wheel rim, was also observed to be sufficiently inflated for vehicular operation.

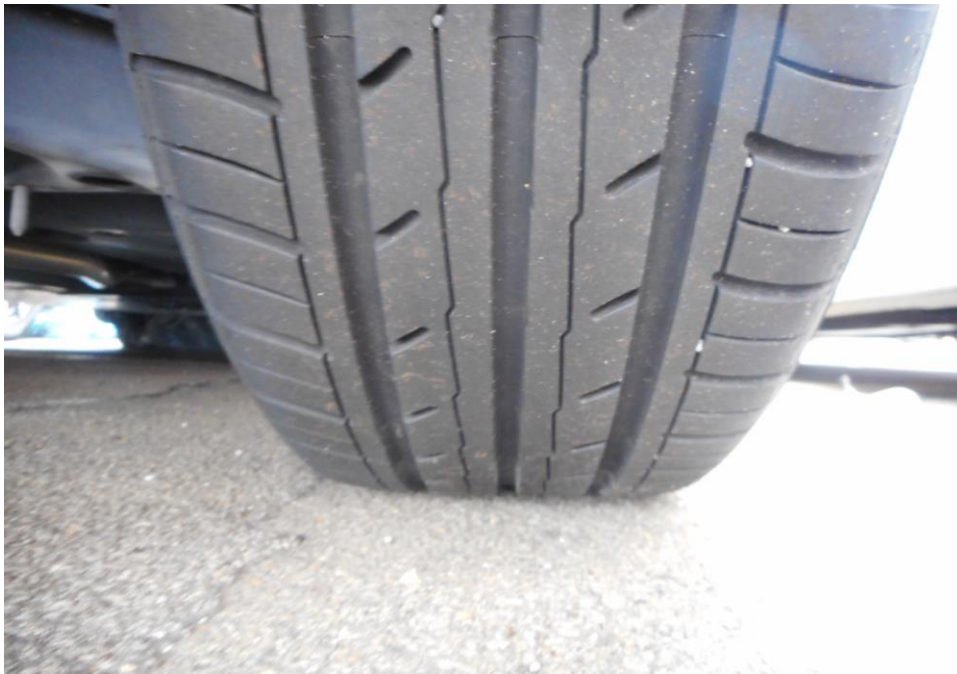
Photo 10 shows the condition of the rear right tyre of the Motor Car, which was observed to be in serviceable condition with remaining tread depth of approximately 5.2mm. The tyre was also observed to be sufficiently inflated for vehicular operation with no tear, cut or burst mark(s).

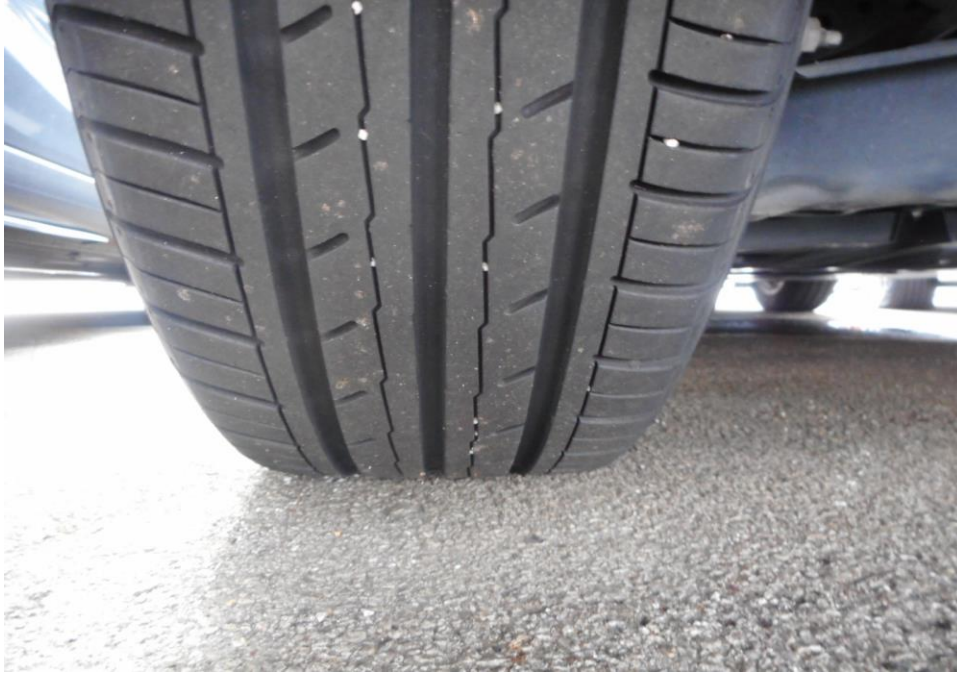
Photo 11 shows the condition of the rear left tyre of the Motor Car, which was observed to be in serviceable condition with remaining tread depth of approximately 5.4mm. The tyre was also observed to be sufficiently inflated for vehicular operation with no tear, cut or burst mark(s).

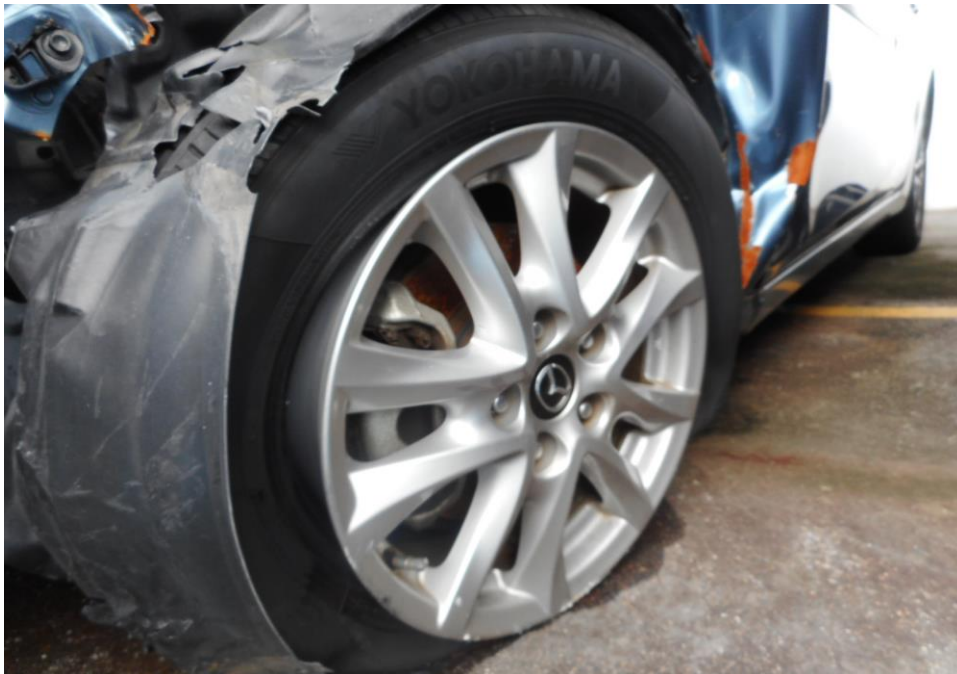
Photo 12 shows the condition of the front left tyre of the Motor Car, which was observed to be in unserviceable condition as the tyres had slipped off the rim as a result of the accident. The remaining tread depth of approximately 5.1mm. The tyre was also observed with no tear, cut or burst mark(s).

20. The front left tyres was found to be slipped off the rims as a result of the accident, however the other 3 tyres of the Motor Car were found to be in serviceable condition. I did not find any tear, cut or burst mark(s) on the outer and the inner sidewalls as well as across the tread of the 4 tyres. The 3 tyres were also observed to be sufficiently inflated for vehicular operation with remaining tread depth of approximately 5.2mm to 5.8mm and 5.1mm for the front left tyre.

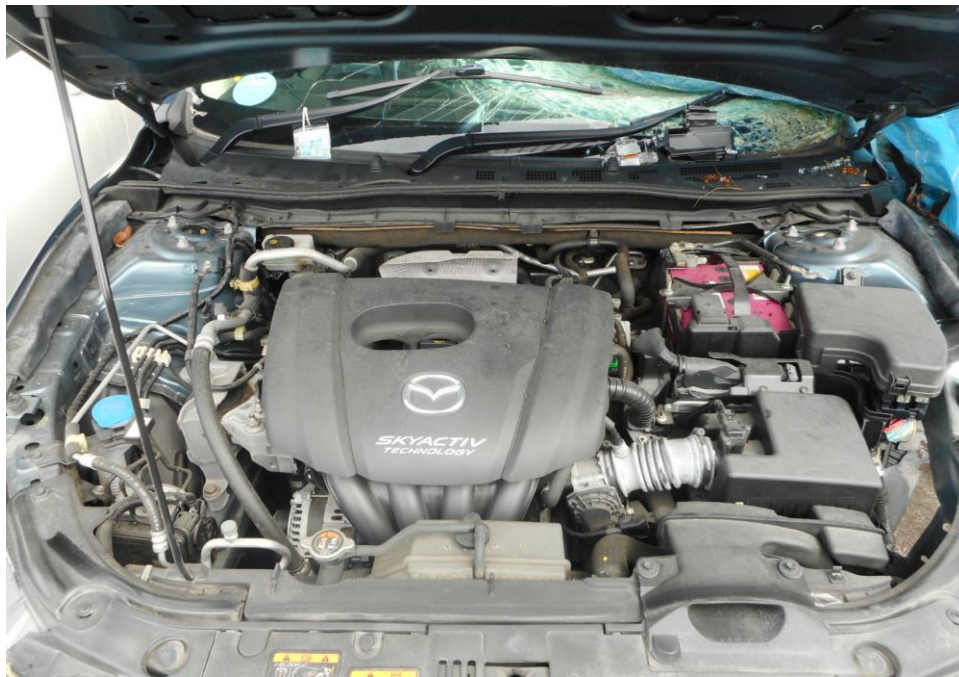
Photo 13 shows a general view of the Motor Car's engine compartment, which was accessed by lifting the front cabin of the Motor Car. The various parts and components inside the engine compartment were unaffected by the accident. There was also no sign(s) or indication(s) of fresh fluid leakage and/or fluid stain within the engine compartment

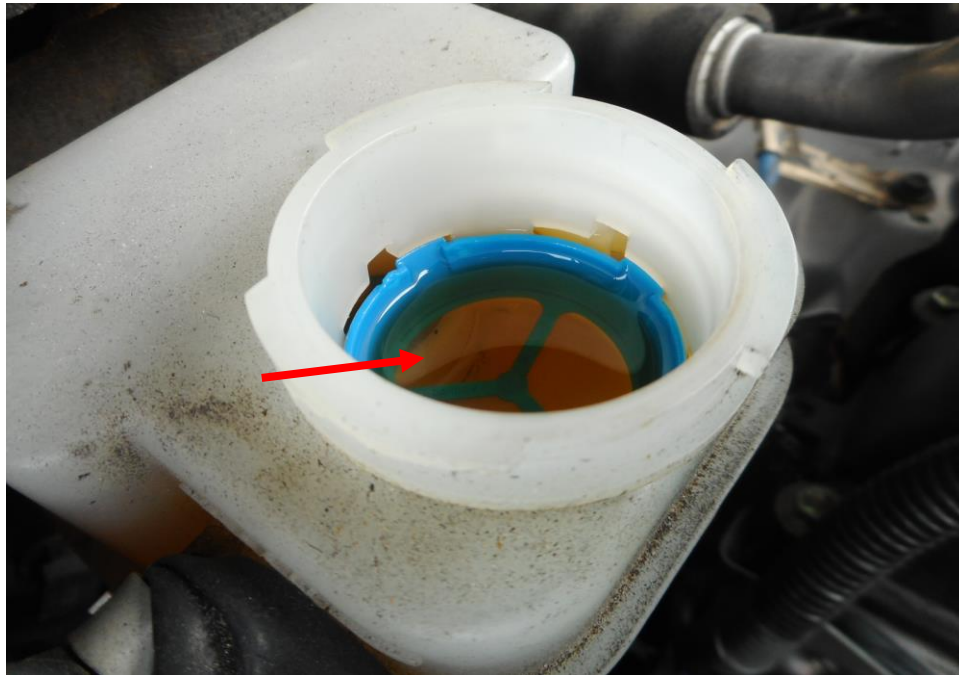
Photo 14 shows the brake fluid reservoir of the Motor Car at the time of my inspection. The brake fluid was observed to be of sufficient level (arrowed) and without any visible contamination.

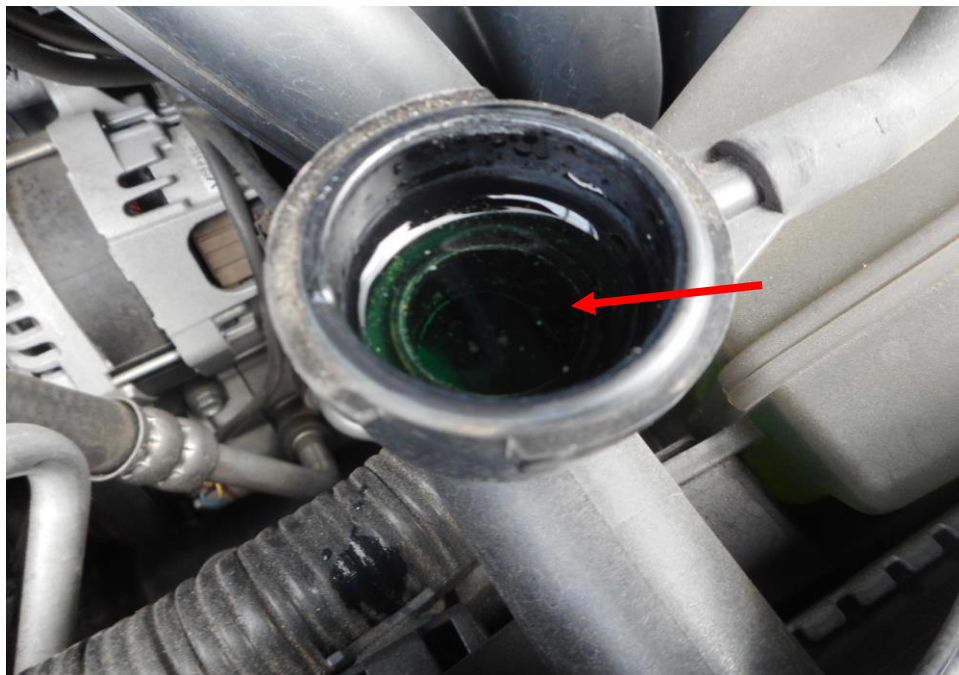
Photo 15 shows the engine coolant reservoir of the Motor Car at the time of my inspection. The engine coolant was observed to be of sufficient level (arrowed) and without any visible contamination.

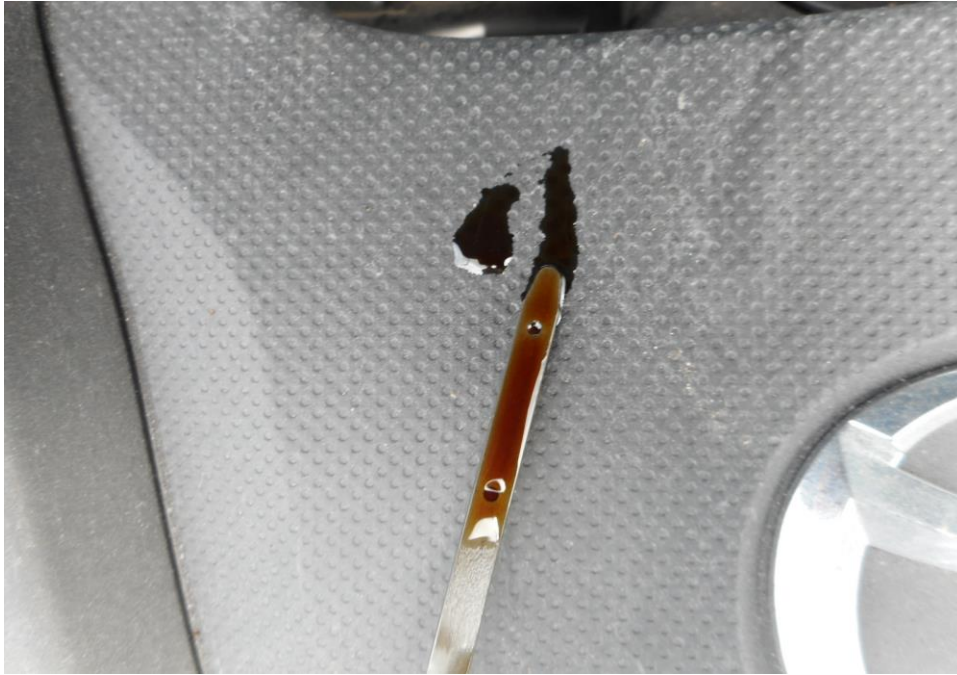
Photo 16 shows the engine oil dip stick of the Motor Car at the time of my inspection. The engine oil was observed to be of sufficient level and without any visible contamination.

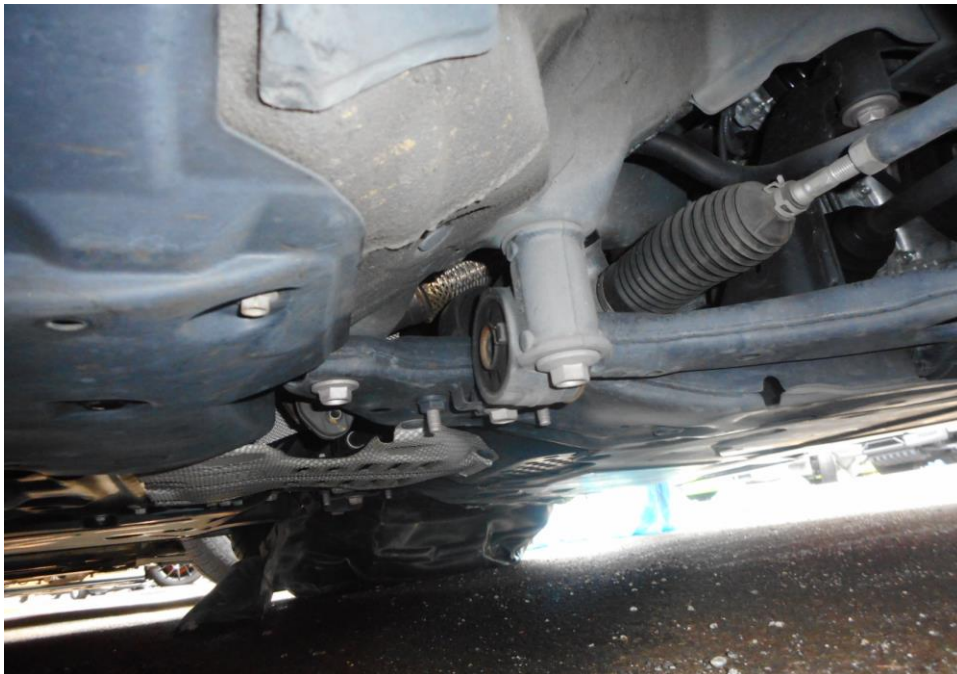
Photo 17 shows the undercarriage of the Motor Car, at the area where the engine housing and transmission housing are located. . I did not find any sign(s) or indication(s) of fluid leak and/or fluid stain(s) on the underside of the Motor Car.

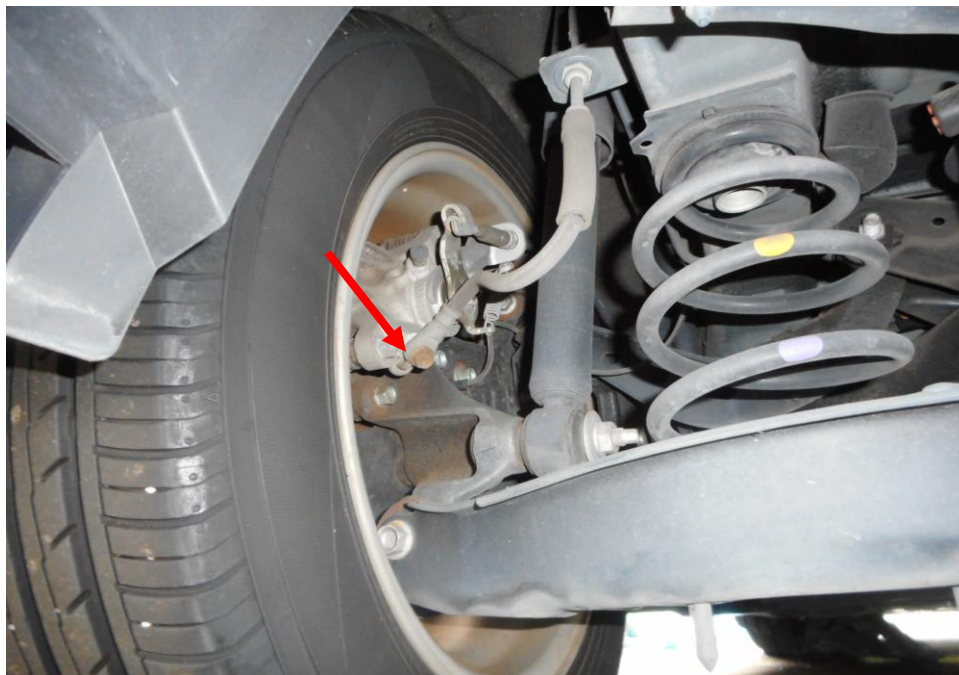
Photo 18 shows the brake hose/pipe (arrowed) at the rear left wheel of the Motor Car. No leakage of brake fluid was observed. Visual examination of the various components of the braking system like the drum brake, brake booster, brake pedal etc. had revealed all to be intact and without visible damage.

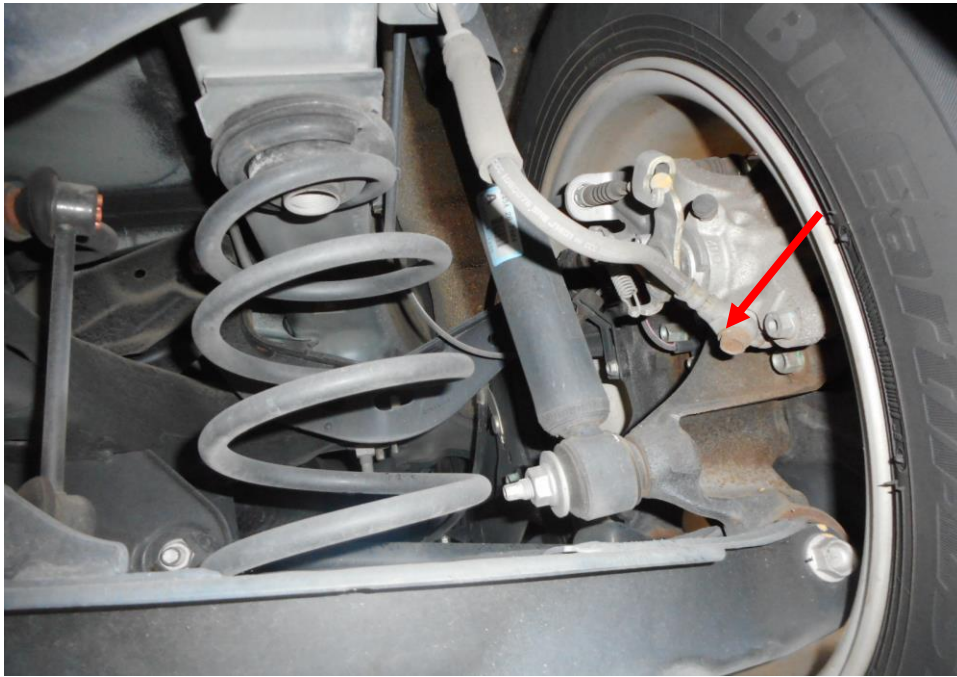
Photo 19 shows the brake hose/pipe (arrowed) at the rear right wheel of the Motor Car. No leakage of brake fluid was observed. Visual examination of the various components of the braking system like the drum brake, brake booster, brake pedal etc. had revealed all to be intact and without visible damage.

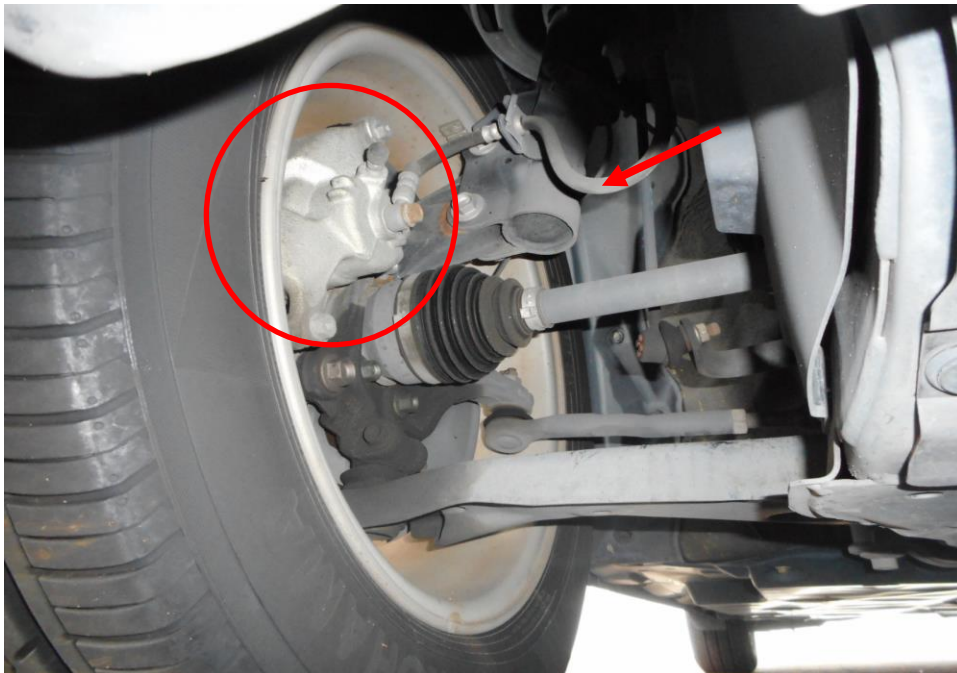
Photo 20 shows the brake hose/pipe (arrowed) at the front right wheel of the Motor Car. No leakage of brake fluid was observed. Visual examination of the various components of the braking system like the brake caliper (circled), brake booster, brake pedal etc. had revealed all to be intact and without visible damage at the time of accident. There was also no sign of fluid stain(s) observed on the various undercarriage components.

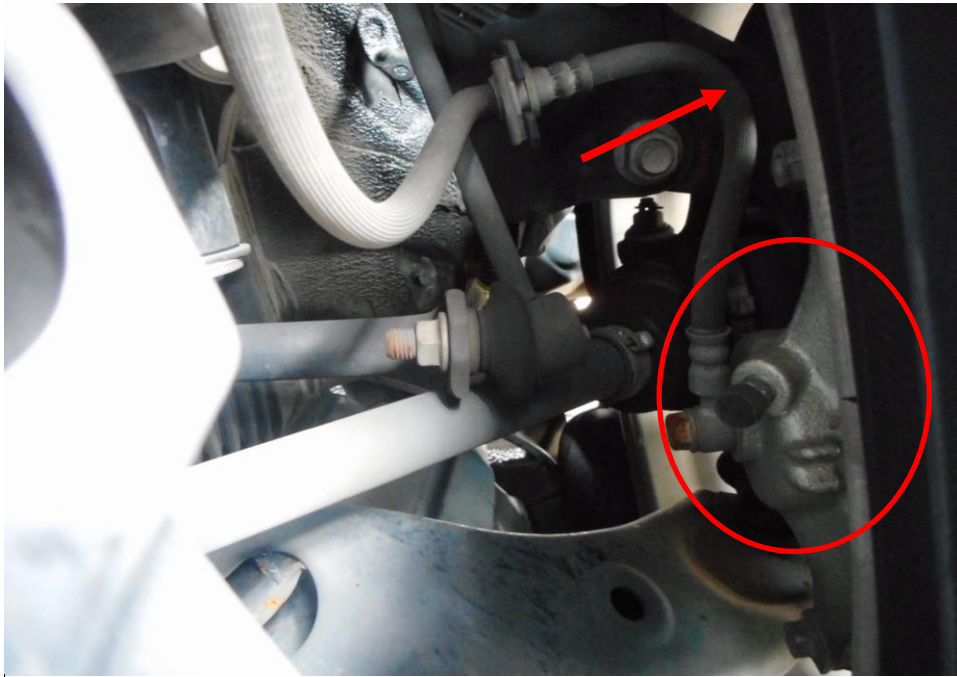
Photo 21 shows the brake hose/pipe (arrowed) at the front left wheel of the Motor Car. No leakage of brake fluid was observed. Visual examination of the various components of the braking system like the brake caliper (circled), brake booster, brake pedal etc had revealed all to be intact and without visible damage at the time of accident. There was also no sign of fluid stain(s) observed on the various undercarriage components.

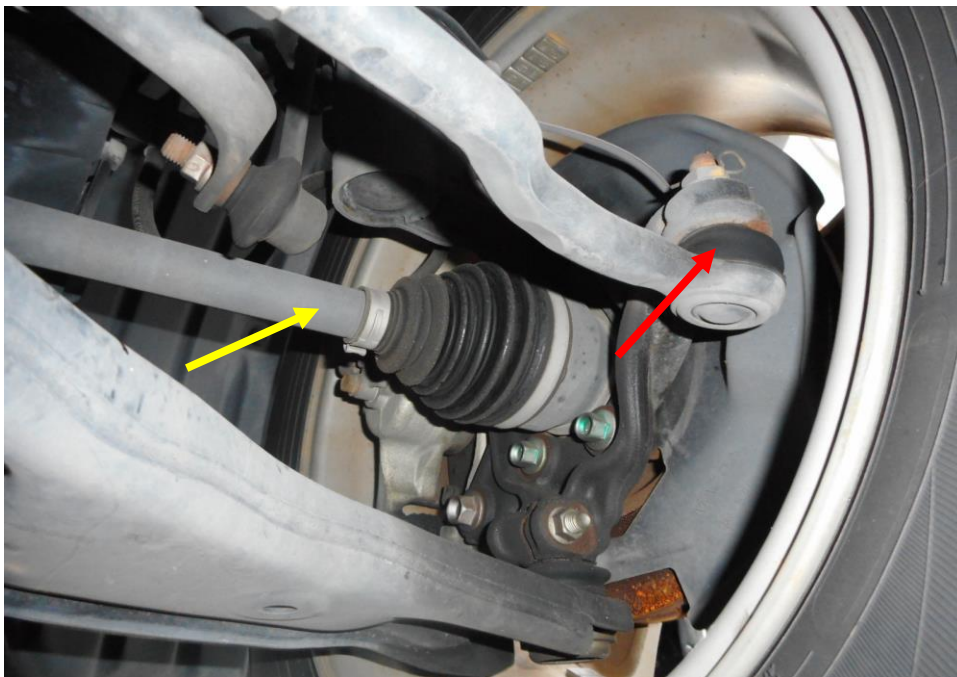
Photo 22 shows the various undercarriage components at the front right wheel of the Motor Car, in particular the steering tie rod end (arrowed) and drive shaft (yellow arrow). The various steering components were all found to be intact, suggesting that the steering system of the Motor Car was likely to be in serviceable condition at the material time of accident. There was also no sign of fluid stain(s) observed on the various undercarriage components.

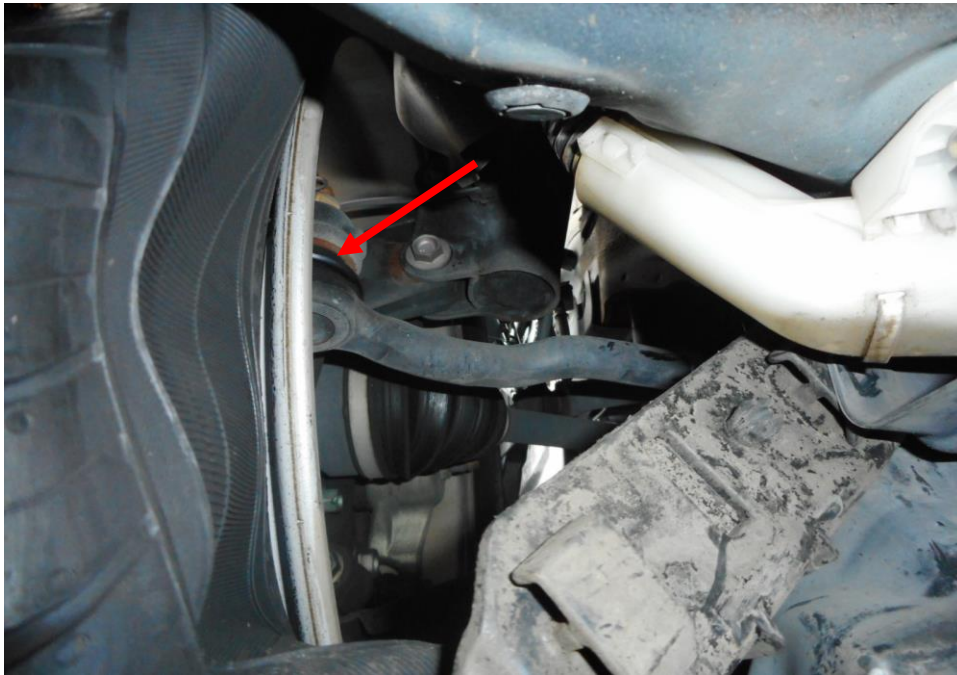
Photo 23 shows the various undercarriage components at the front left wheel of the Motor Car, in particular the steering tie rod end (arrowed). The various Undercarriage components of the Motor Car were all found to be intact without any visible damage. There was also no sign of fluid stain(s) observed on the various undercarriage components.
