LKK Auto Consultants Pte Ltd

Policy Particulars :- THIRD PARTY CLAIM

Preliminary Advice

VEHICLE DAMAGE INSPECTION REPORT

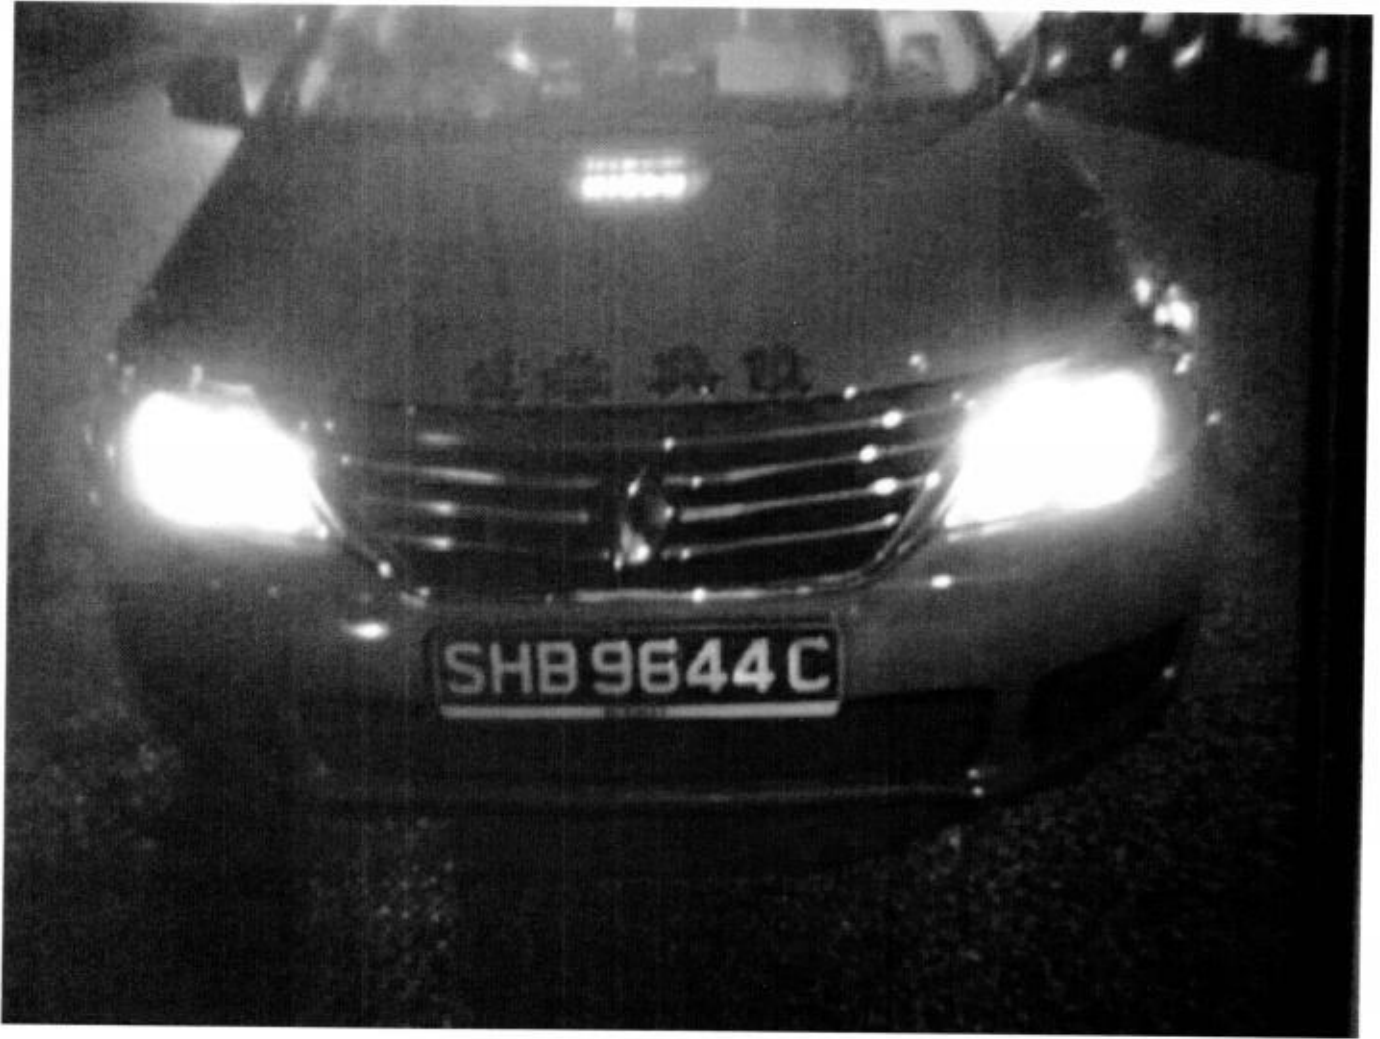
Accident Photo

The vehicle sustained impact / damagesRear & Front... portion and parts claimed are consistent to the accident.

Basing on the circumstances of the accident reported that your vehicle had rear ended the third party vehicle SHB 9644C. As such, we are of the opinion that we cannot be absolved from liability.
