LKK Auto Consultants Pte Ltd

Vehicle No. SMP 3573E
Insured Veh. PC 5541S
Claim No. DM20HO00809/JT
Policy No. DMCFHQ19-000106
Accident Date 09/05/2020
Inspection Date 22/06/2020

ADJUSTMENT ON REPAIR COST FOR VEHICLE NO. SMP 3573E

PHOTOGRAPHS FOR VEHICLE NO. SMP 3573E

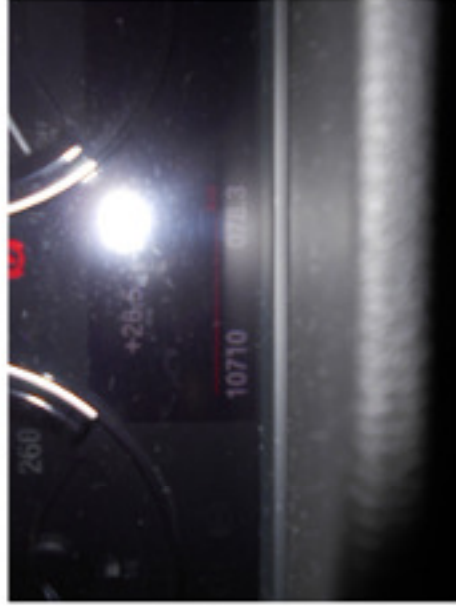
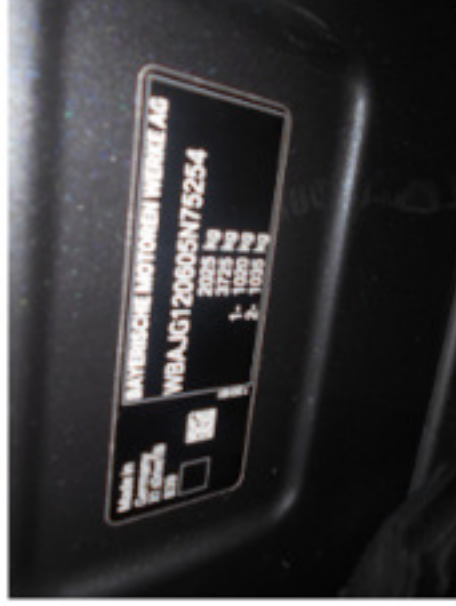
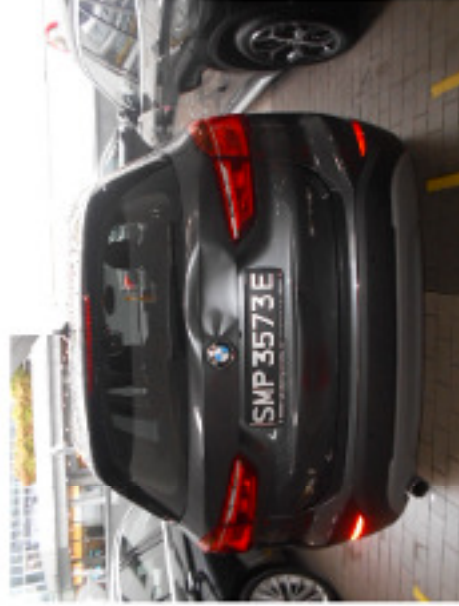
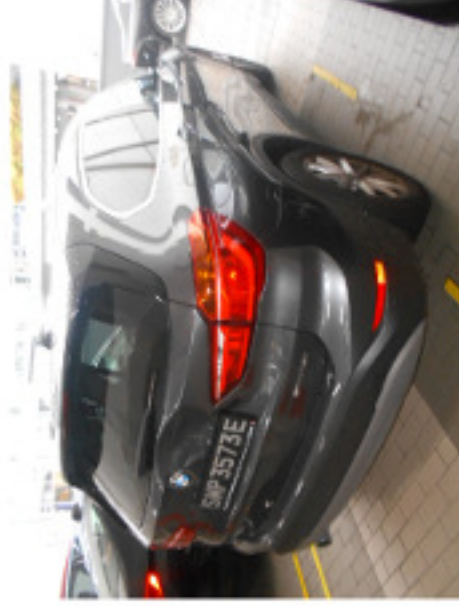
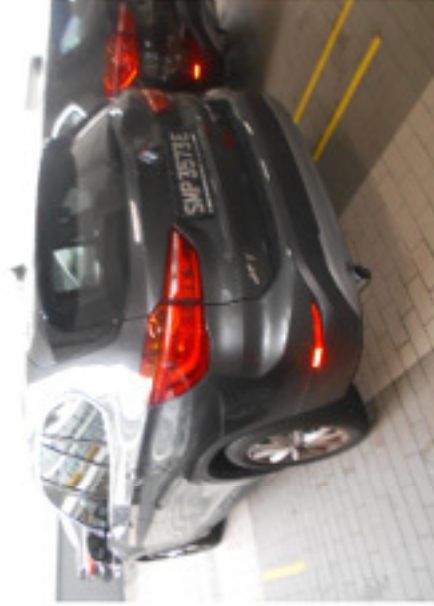
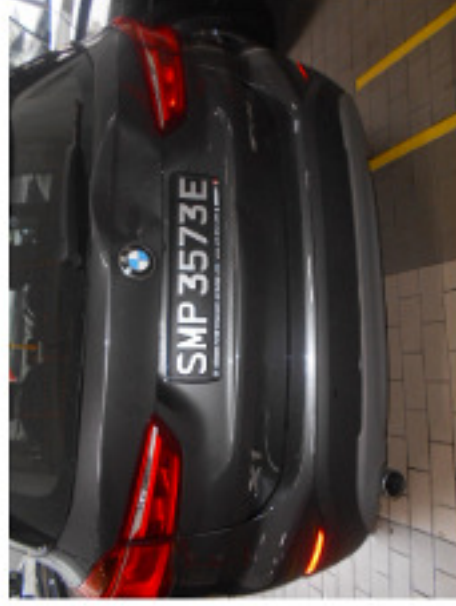
INSPECTION

THE VEHICLE SUSTAINED DAMAGES AT THE REAR PORTION. DAMAGES SEE DETAILS.
--
