Your Ref: TP/IP/22757/2020  
Our Ref : CI/TPD20005819/P

17<sup>th</sup> June 2020

**MECHANICAL INSPECTION REPORT OF MOTOR CAR SMJ 321S**

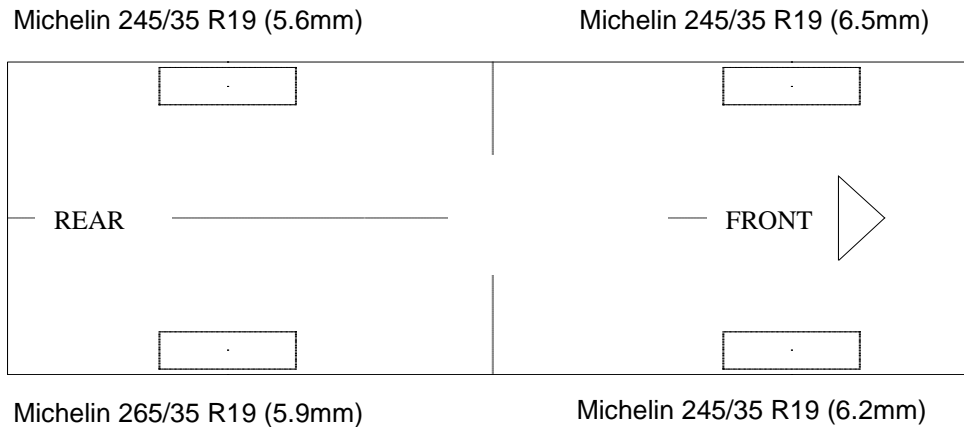
6. The condition of the Motor Car's 4 tyres was observed to be in serviceable condition. I did not find any tear, cut or burst mark(s) on the outer and the inner sidewalls as well as across the tread of the 4 tyres. The 4 tyres were also observed to be sufficiently inflated for vehicular operation. The tyre brand, tyre size and remaining tread depth of the 4 tyres were recorded as follows:-

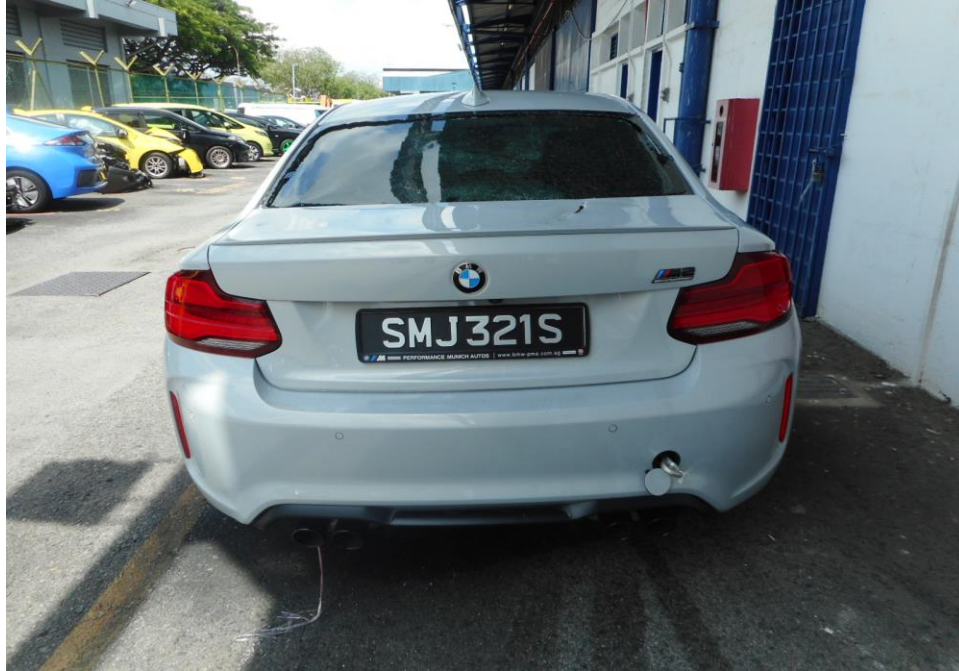
**Photo 1** shows a general view of the Motor Car's rear body at the time of my inspection. The rear portion of the Motor Car was observed to have been damaged by the accident.

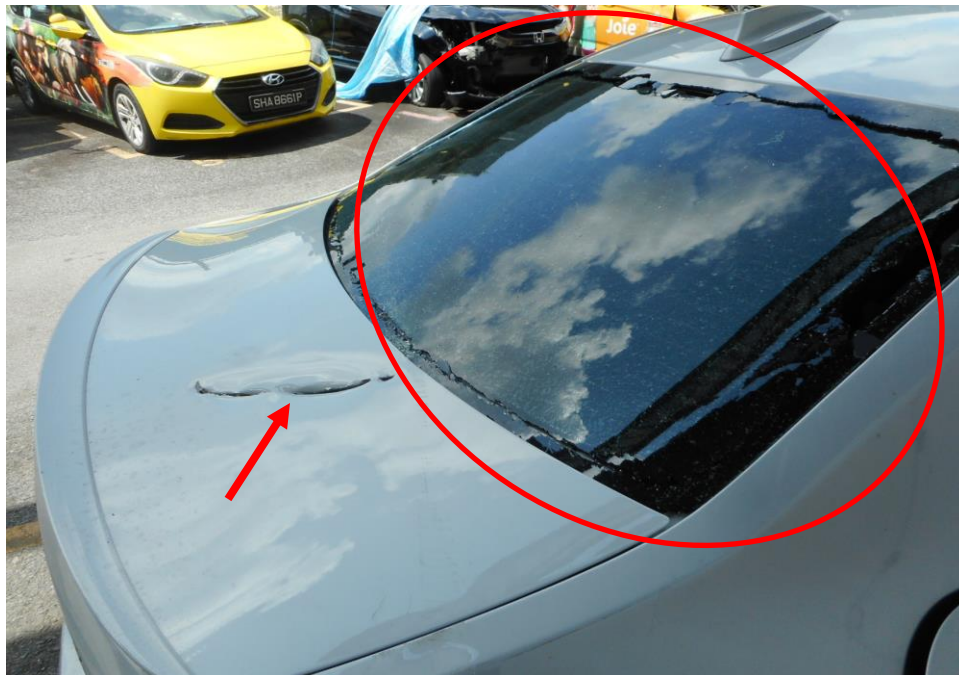
**Photo 2** shows a close up view of the Motor Car's rear body at the time of my inspection. The rear portion of the Motor Car was observed to have been damaged. Its rear boot (arrowed) and rear windscreen (circled) was damaged as a result of the accident.

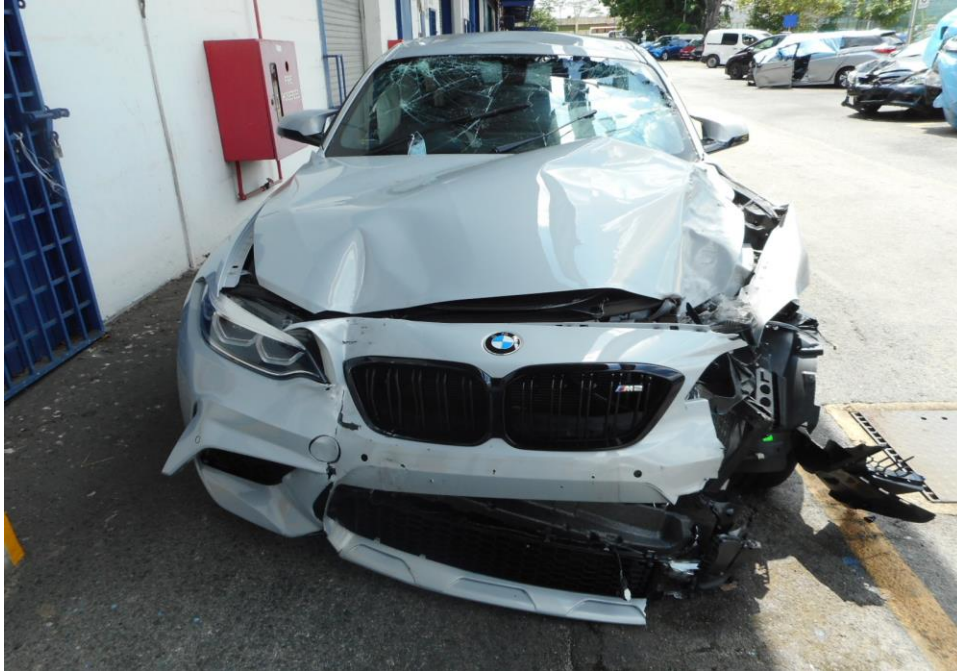
**Photo 3** shows a general view of the Motor Car's front body at the time of my inspection. The Motor car was observed to have sustained damage at its front portion. Its front windscreen, front bonnet, front bumper, left fender and front left headlamp was amongst the body parts and various components in the engine compartments were also damaged as a result of the accident. The Supplemental Restraint System (SRS) was activated as a result of the accident.

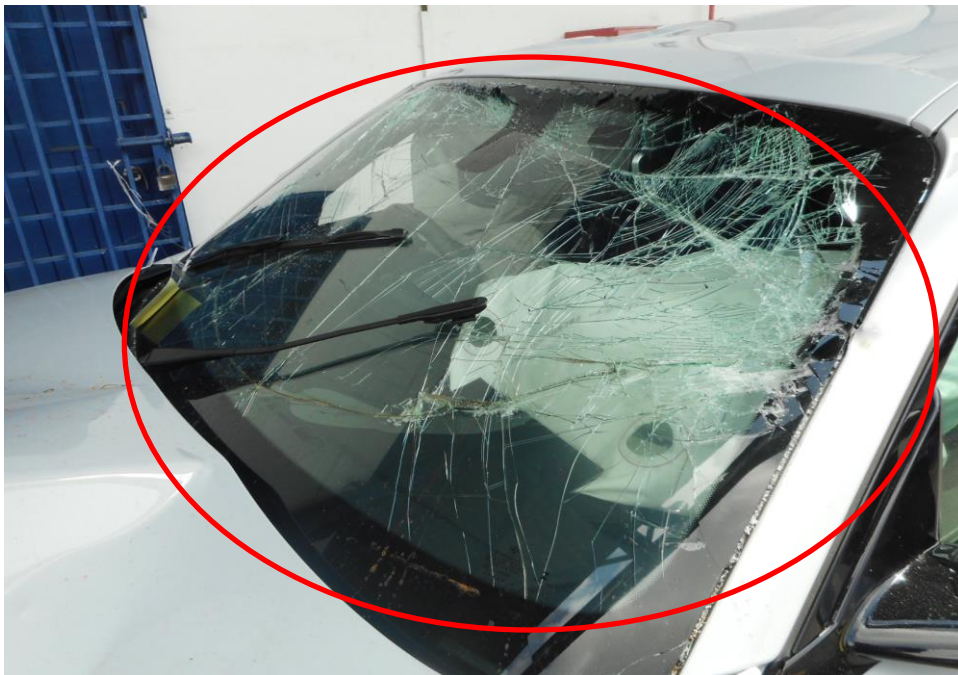
**Photo 4** shows the close up view of the Motor Car's front body at the time of my inspection. The Motor car was observed to have sustained damage at its front portion. Its front windscreen (yellow circle) was amongst the body parts damaged as a result of the accident.

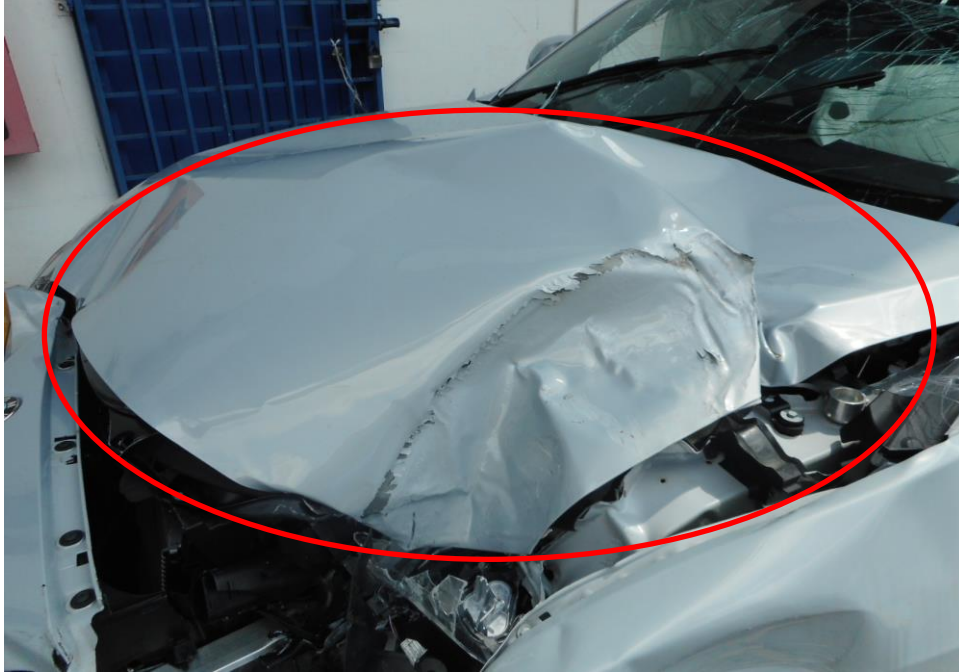
**Photo 5** shows the close up view of the Motor Car's front body at the time of my inspection. The Motor car was observed to have sustained damage at its front portion. Its front bonnet (red circle) was amongst the body parts and various components were also damaged as a result of the accident.

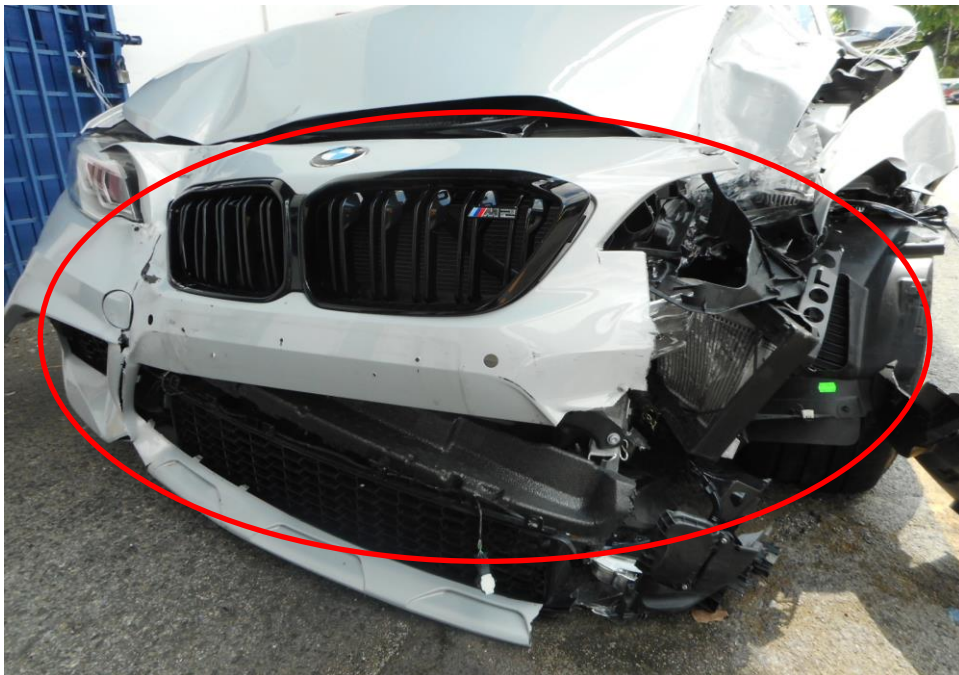
**Photo 6** shows the close up view of the Motor Car's front body at the time of my inspection. The Motor car was observed to have sustained damage at its front portion. Its front bumper (red circle) was amongst the body parts and various components in the engine compartments were also damaged as a result of the accident.

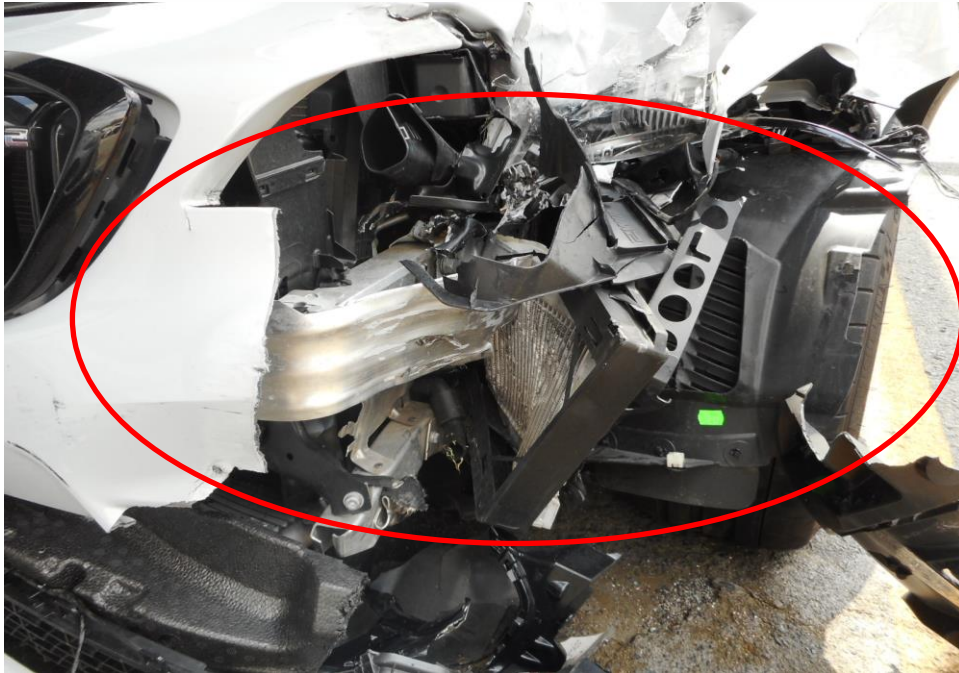
**Photo 7** shows the close up view of the Motor Car's front body at the time of my inspection. The Motor car was observed to have sustained damage at its front portion. Its front engine compartments (red circle) was amongst the body parts and various components were also damaged as a result of the accident.

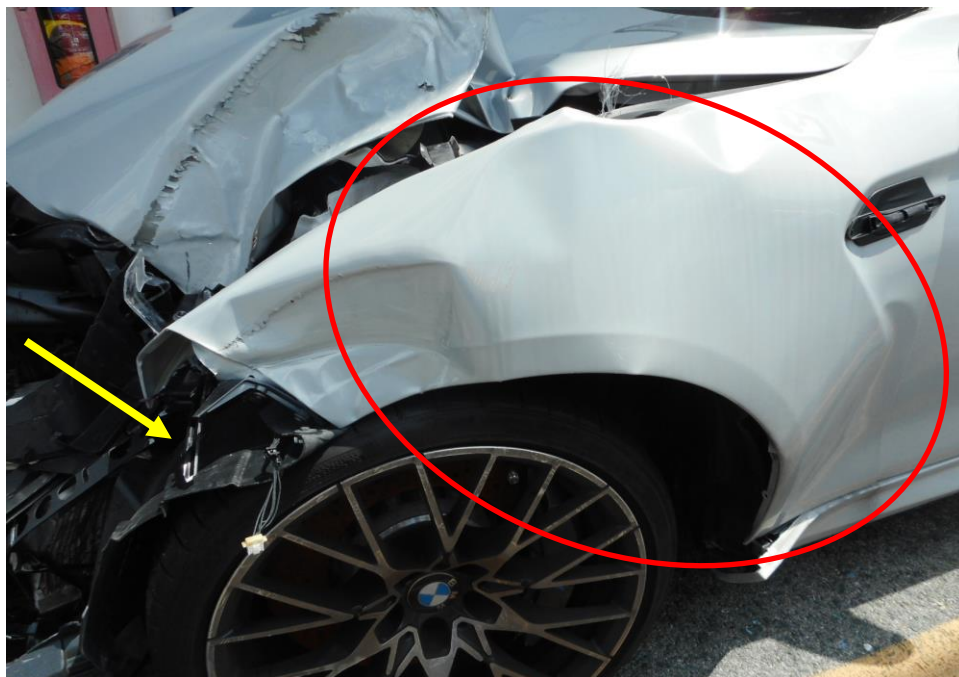
**Photo 8** shows a close up view of the Motor Car's engine compartment at the time of my inspection. The Motor car was observed to have sustained damage at its front portion. Its front left fender (red circle) and front left headlamp (yellow arrow) was amongst the body parts damaged as a result of the accident.

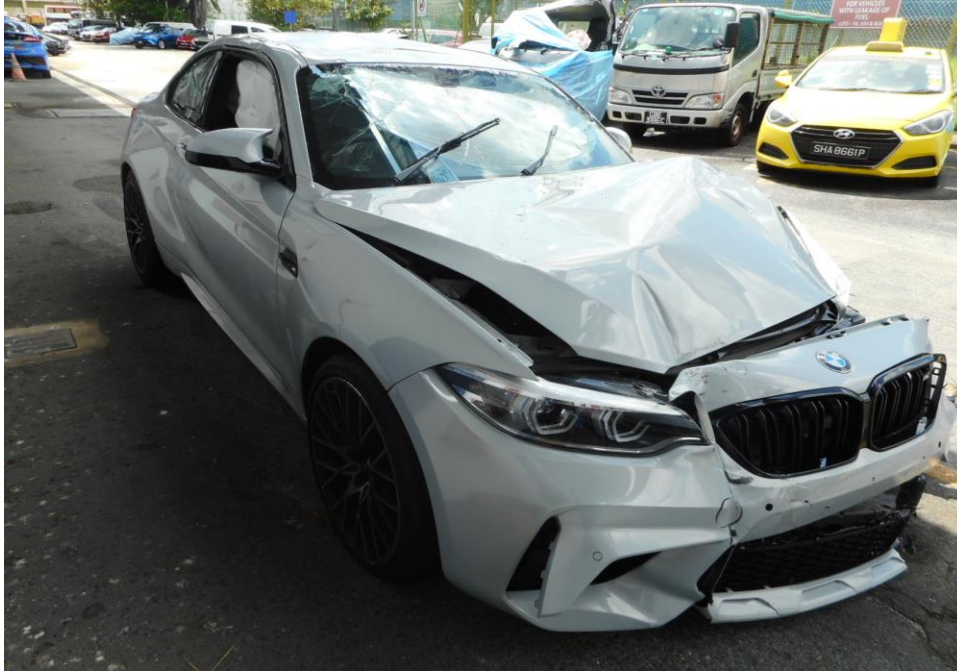
**Photo 9** shows a general view of the Motor Car's right body at the time of my inspection. The right portion of the Motor Car was observed to have been undamaged by the accident.

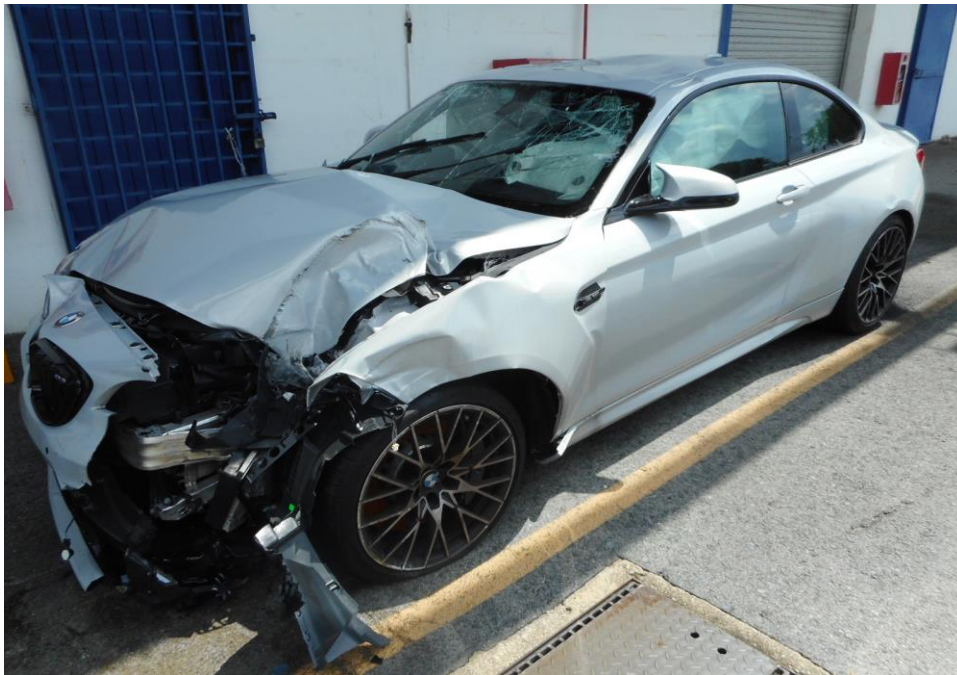
**Photo 10** shows a general view of the Motor Car's left body at the time of my inspection. The left portion of the Motor Car was observed to have been undamaged by the accident.

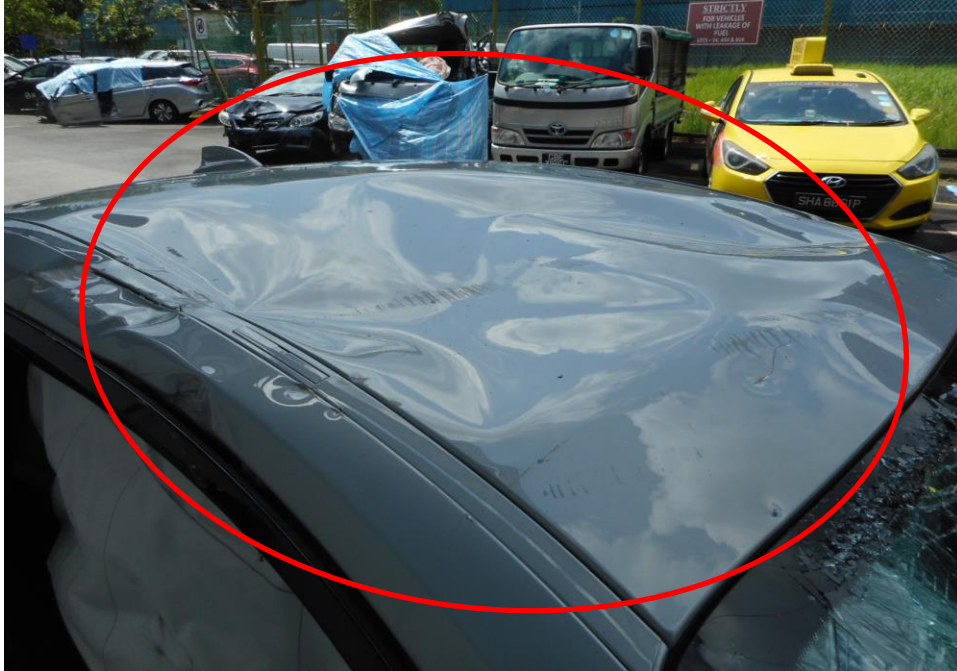
**Photo 11** shows a close up view of the Motor Car's roof top at the time of my inspection. The Motor car was observed to have sustained damage at its roof portion. Its roof (red circle) was amongst the body parts damaged as a result of the accident.

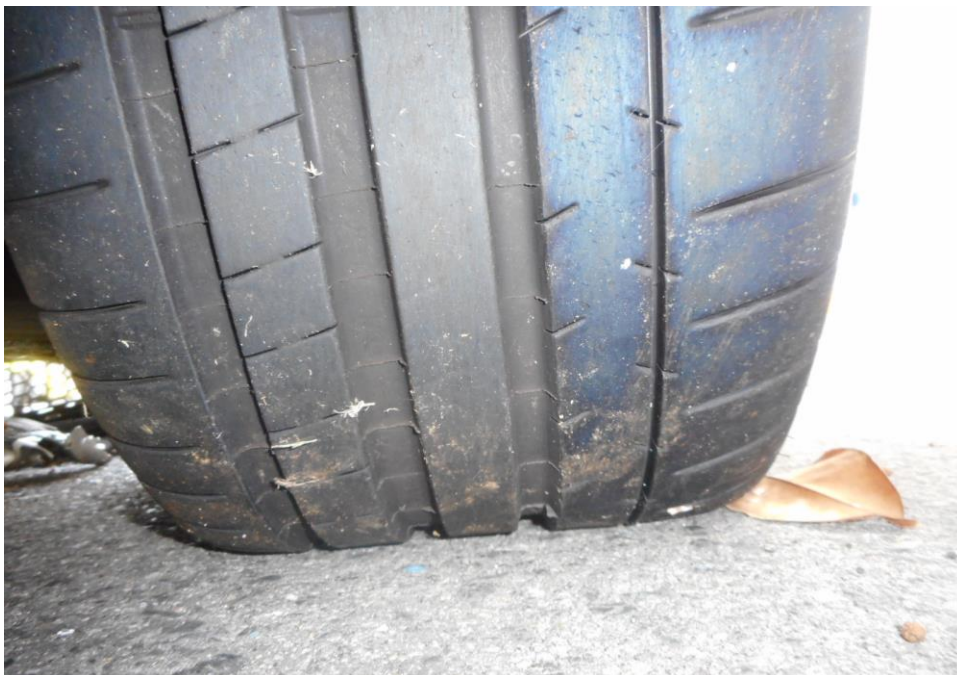
**Photo 12** shows the condition of the front right tyre of the Motor Car, which was observed to be in serviceable condition with remaining tread depth of approximately 6.2mm. The tyre, which was wrapped around alloy wheel rim, was also observed to be sufficiently inflated for vehicular operation.

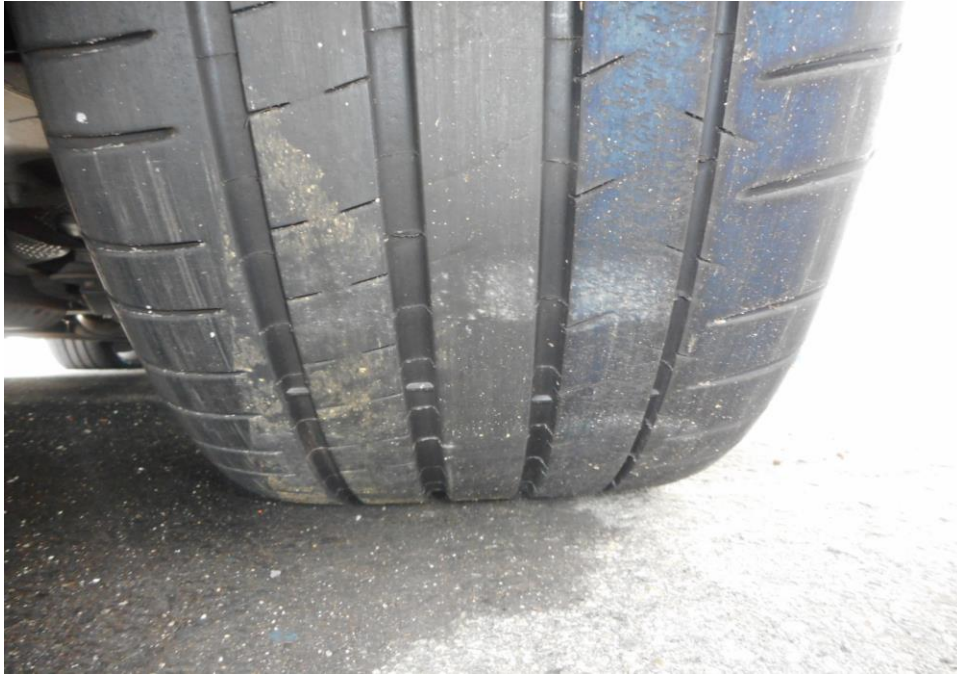
**Photo 13** shows the condition of the rear right tyre of the Motor Car, which was observed to be in serviceable condition with remaining tread depth of approximately 5.9mm. The tyre was also observed to be sufficiently inflated for vehicular operation with no tear, cut or burst mark(s).

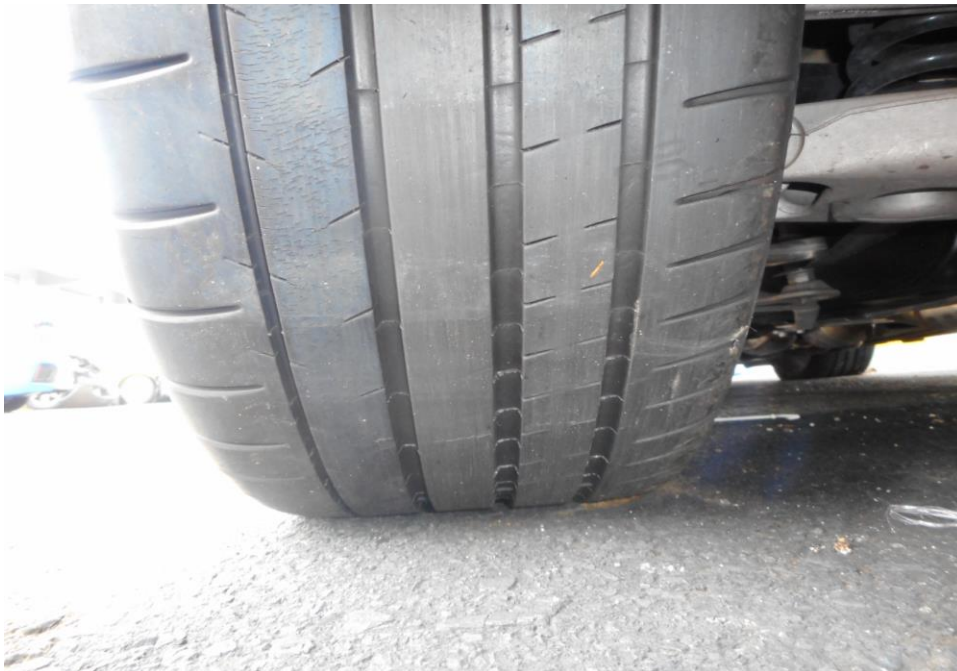
**Photo 14** shows the condition of the rear left tyre of the Motor Car, which was observed to be in serviceable condition with remaining tread depth of approximately 5.6mm. The tyre was also observed to be sufficiently inflated for vehicular operation with no tear, cut or burst mark(s).

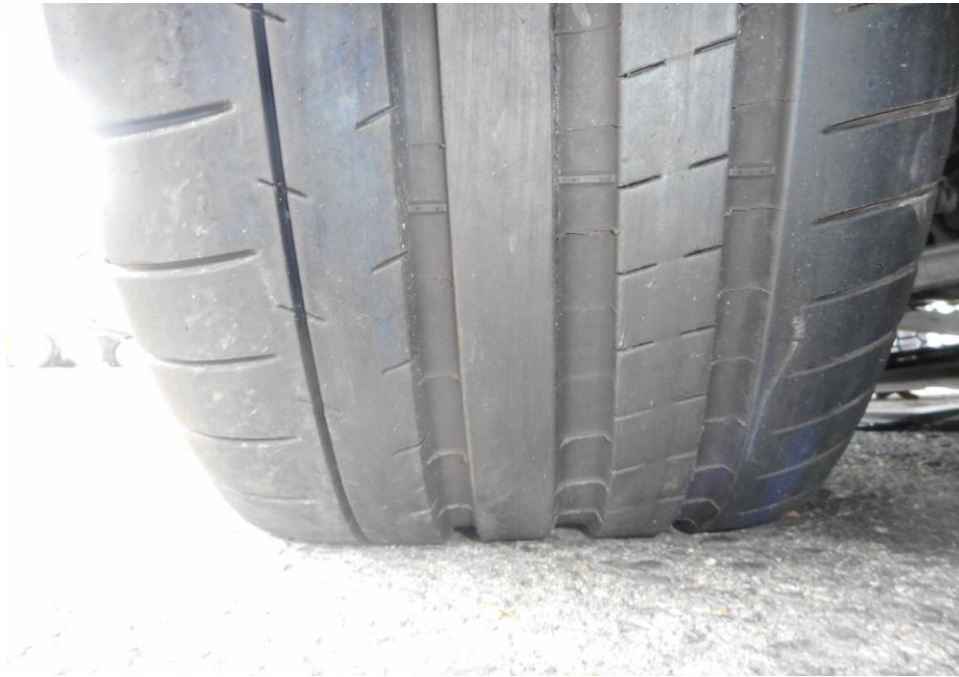
**Photo 15** shows the condition of the front left tyre of the Motor Car, which was observed to be in serviceable condition with remaining tread depth of approximately 6.5mm. The tyre was also observed to be sufficiently inflated for vehicular operation with no tear, cut or burst mark(s).

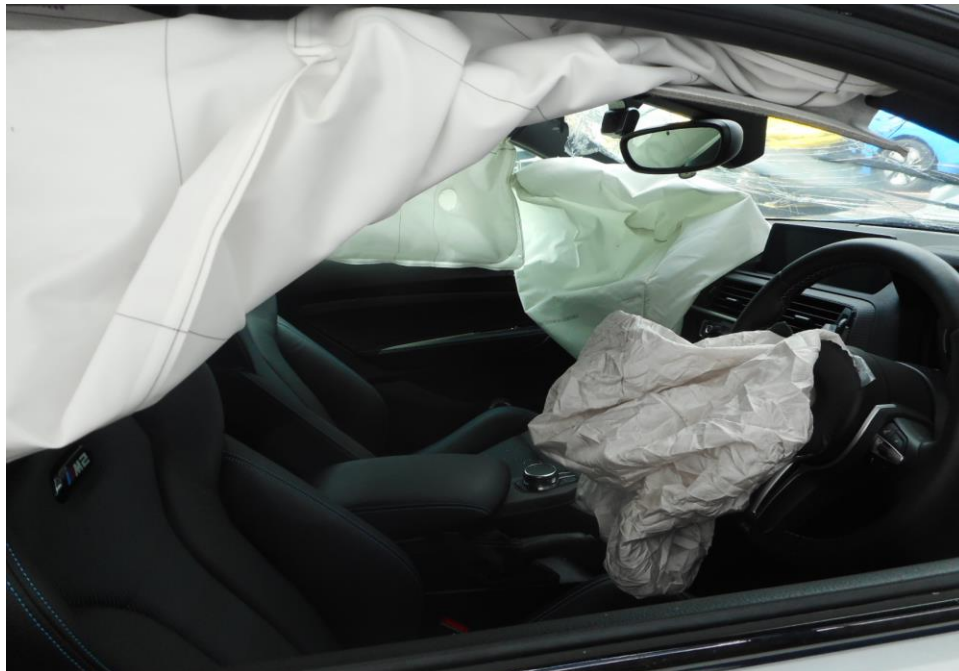
**Photo 16** shows the deployment of the Supplemental Restraint System (SRS) airbag (arrowed) in the Motor Car as a result of the accident.

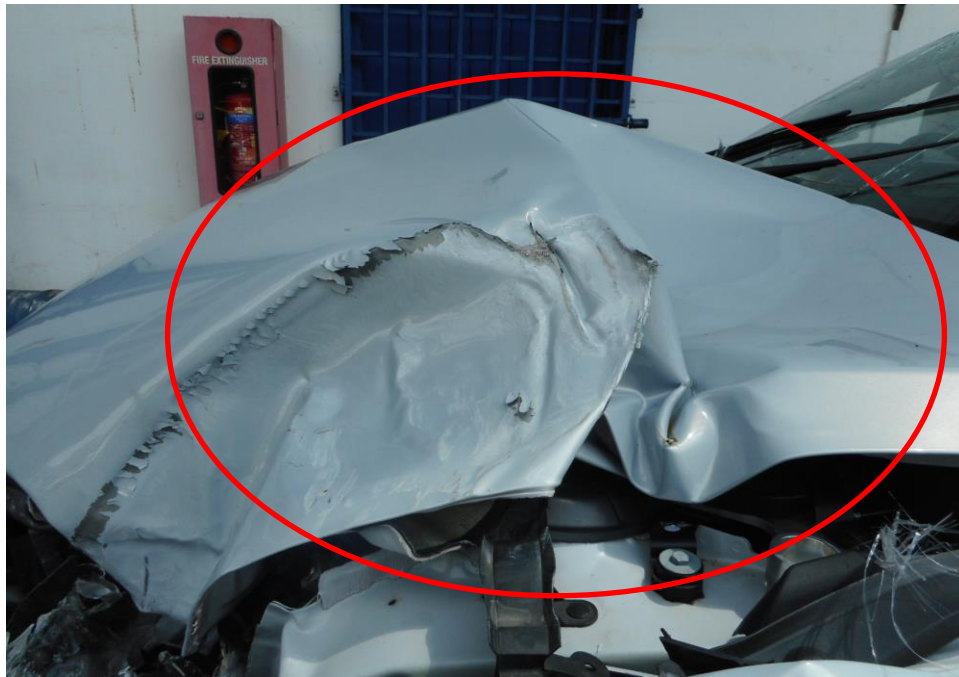
8. We were unable to raise the front bonnet of the Motor car to conduct the examination of the Motor Car's engine compartment because the damage caused by the accident had resulted in the damages to the lock mechanism of the bonnet and the structure of the engine compartment. (unable to open)  
See photo 17 below

**Photo 17** shows a close up view of the damaged front bonnet lock mechanism and the structure of the engine compartment of the Motor Car at the time of my inspection resulting it unable to open a result of the accident. (circled) (Unable to open)

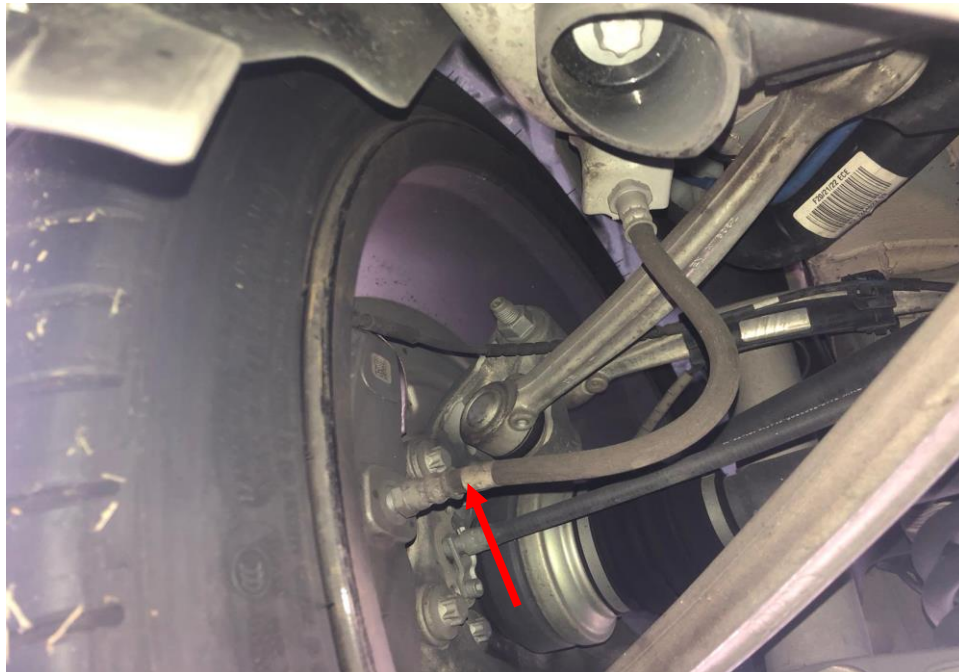
**Photo 18** shows the brake hose/pipe (arrowed) at the rear left wheel of the Motor Car. No leakage of brake fluid was observed. Visual examination of the various components of the braking system like the drum brake, brake booster, brake pedal etc. had revealed all to be intact and without visible damage.

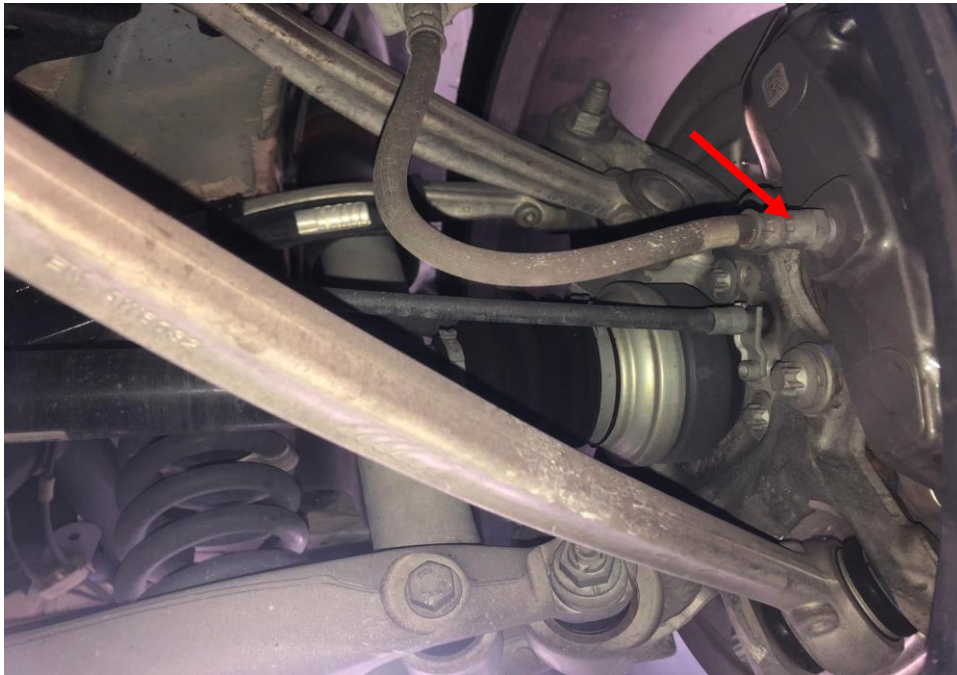
**Photo 19** shows the brake hose/pipe (arrowed) at the rear right wheel of the Motor Car. No leakage of brake fluid was observed. Visual examination of the various components of the braking system like the drum brake, brake booster, brake pedal etc. had revealed all to be intact and without visible damage.

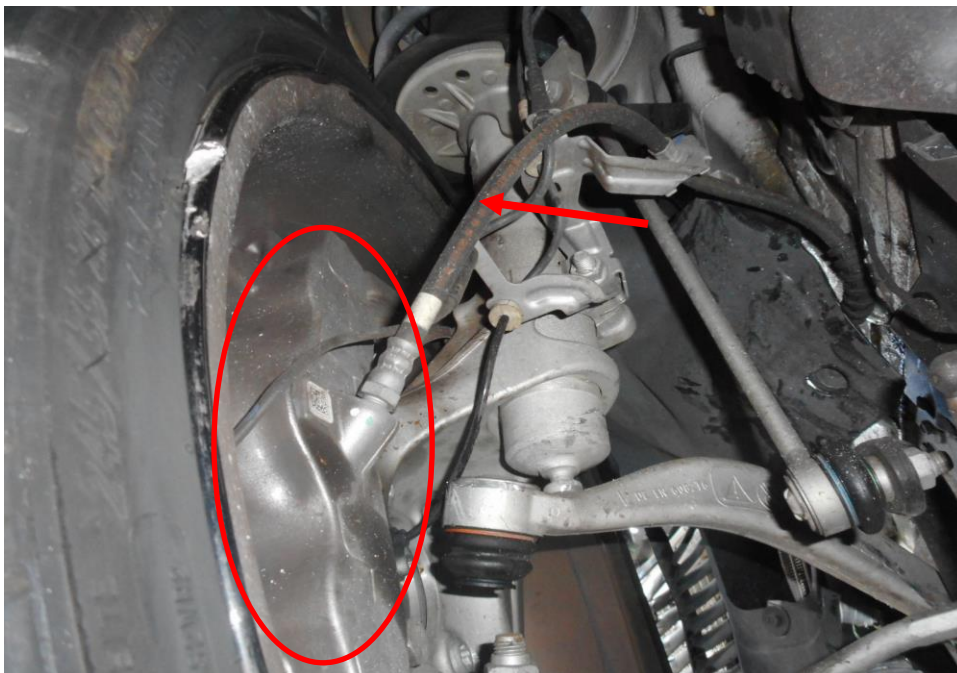
**Photo 20** shows the brake hose/pipe (arrowed) at the front right wheel of the Motor Car. No leakage of brake fluid was observed. Visual examination of the various components of the braking system like the brake caliper (circled), brake booster, brake pedal etc. had revealed all to be intact and without visible damage at the time of accident. There was also no sign of fluid stain(s) observed on the various undercarriage components.

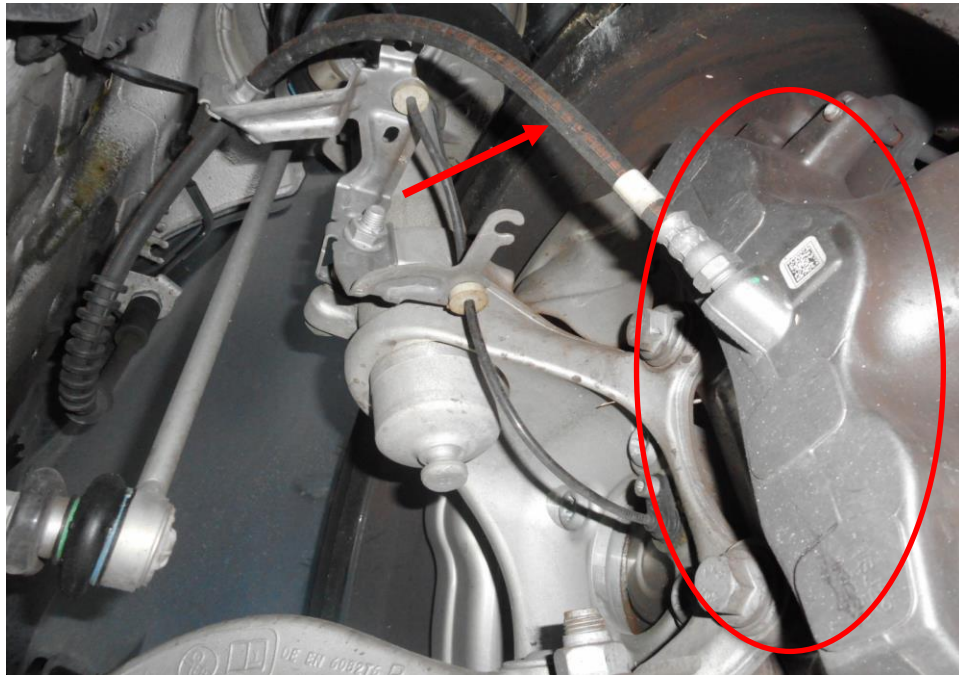
**Photo 21** shows the brake hose/pipe (arrowed) at the front left wheel of the Motor Car. No leakage of brake fluid was observed. Visual examination of the various components of the braking system like the brake caliper (circled), brake booster, brake pedal etc had revealed all to be intact and without visible damage at the time of accident. There was also no sign of fluid stain(s) observed on the various undercarriage components.

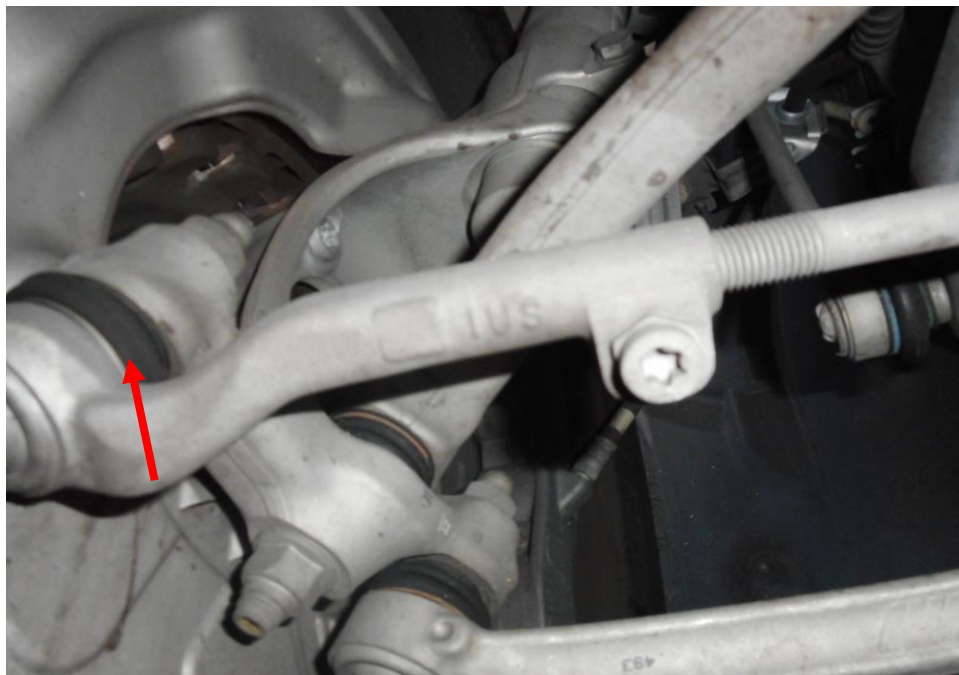
**Photo 22** shows the various undercarriage components at the front right wheel of the Motor Car, in particular the steering tie rod end (arrowed). The various steering components were all found to be intact, suggesting that the steering system of the Motor Car was likely to be in serviceable condition at the material time of accident. There was also no sign of fluid stain(s) observed on the various undercarriage components.

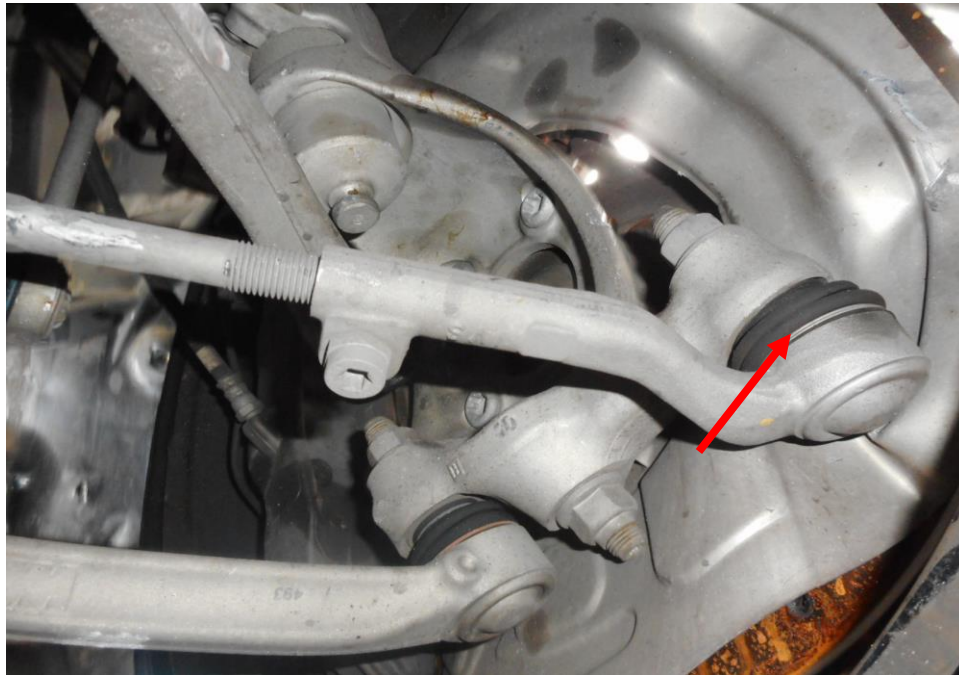
**Photo 23** shows the various undercarriage components at the front left wheel of the Motor Car, in particular the steering tie rod end (arrowed). The various Undercarriage components of the Motor Car were all found to be intact without any visible damage. There was also no sign of fluid stain(s) observed on the various undercarriage components.

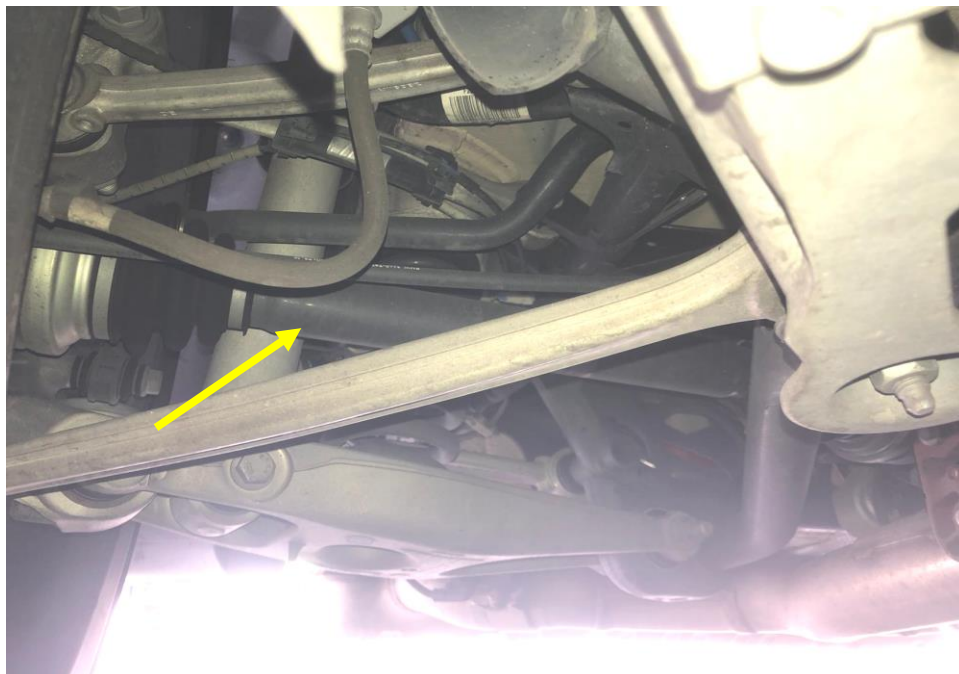
**Photo 24** shows the various undercarriage components at the front right wheel of the Motor Car, in particular the drive shaft (yellow arrow). The various steering components were all found to be intact, suggesting that the steering system of the Motor Car was likely to be in serviceable condition at the material time of accident. There was also no sign of fluid stain(s) observed on the various undercarriage components.

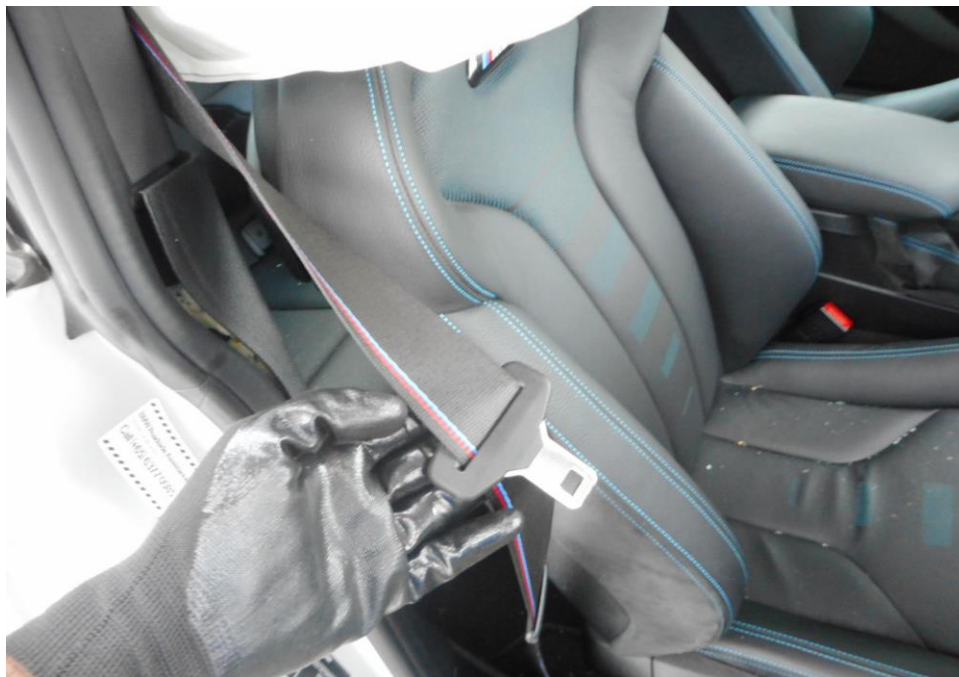
**Photo 25** shows that the seat belt on the right seat was worn at the material time of accident as the safety pre-tensioners was activated at the moment of impact and caused the seat belts to be locked into the last position of the user.

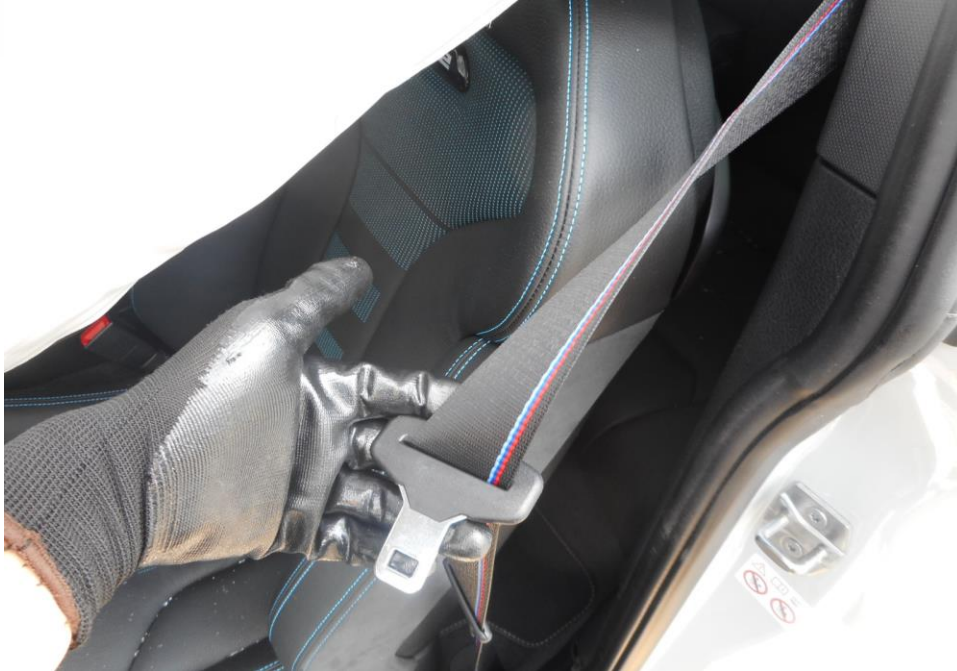
**Photo 26** shows that the seat belt on the right seat was worn at the material time of accident as the safety pre-tensioners was activated at the moment of impact and caused the seat belts to be locked into the last position of the user.
