Your Ref: TP/IP/20683/2020
Our Ref : CI/TPD20005820/P

11th August 2020

MECHANICAL INSPECTION REPORT OF MOTOR TAXI SHF 1565D

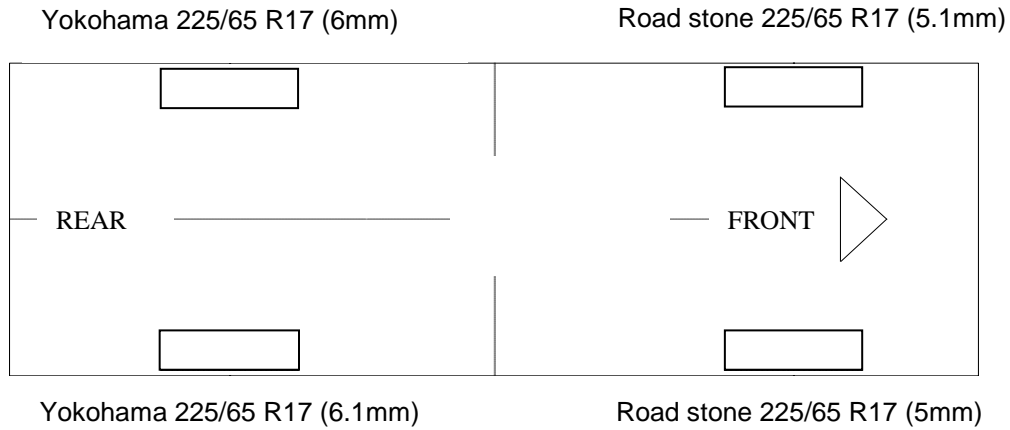
6. The 4 tyres of the Motor Taxi were observed to be in serviceable condition and sufficiently inflated for vehicular operation. I did not find any tear, cut or burst mark(s) on the outer and the inner sidewalls as well as across the tread of the 4 tyres. The tyre brand, tyre size and remaining tread depth of the 4 tyres of the Motor Taxi were recorded as follows:-

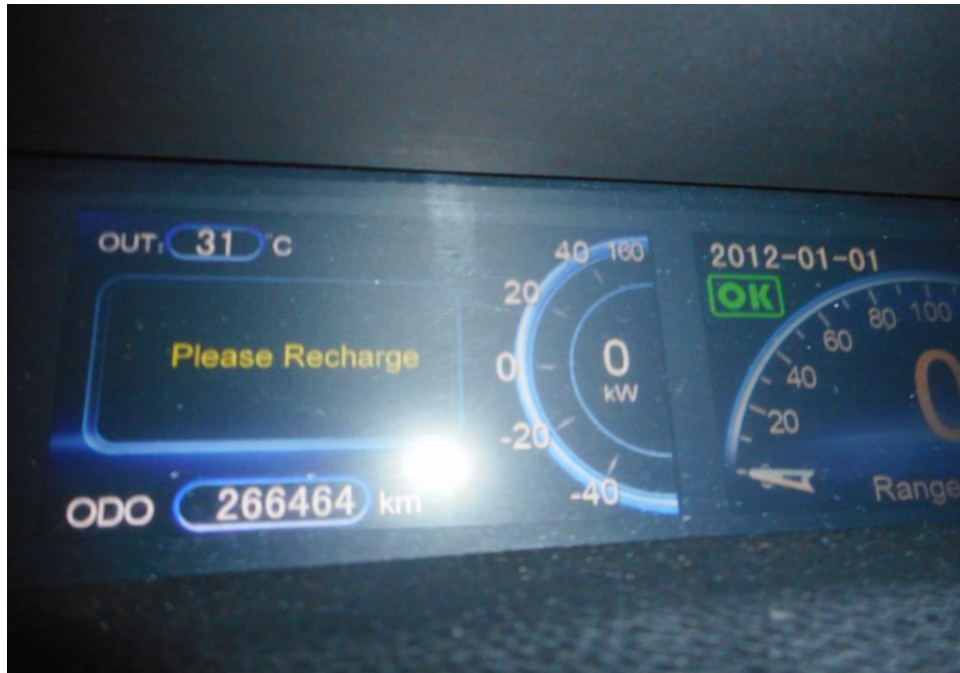
Photo 1 shows a general view of the instrument cluster of the Motor Taxi at the time of my inspection. The mileage of the Motor Taxi was 266,464km

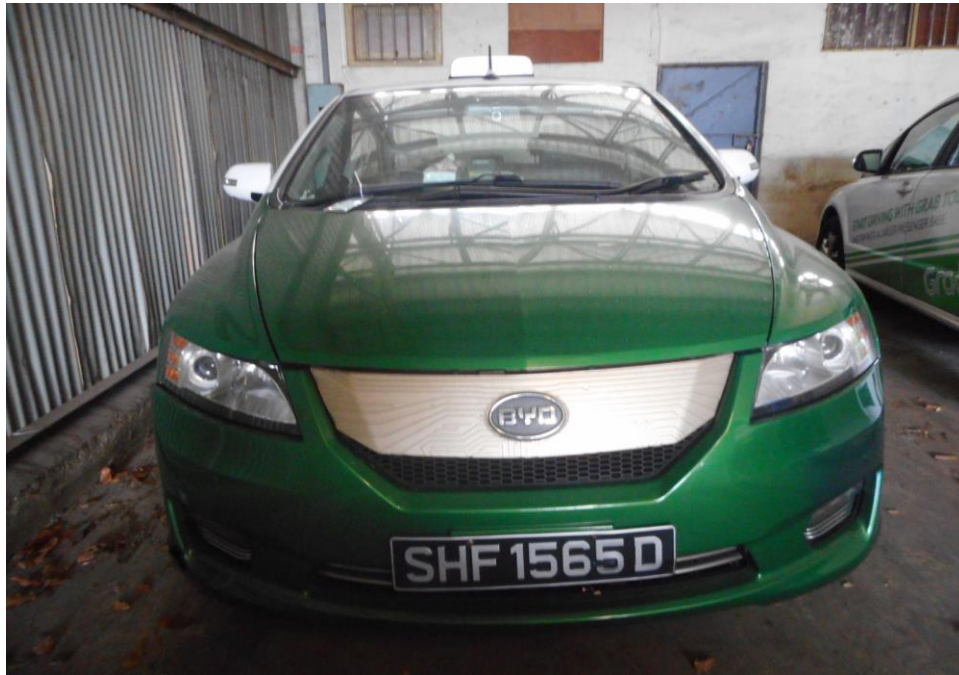
4. The mileage of the Motor Taxi at the time of my inspection was 266,464km.
5. There was visible damage observed on Motor Taxi's front bumper at the time of my inspection.

Photo 2 shows a general view of the Motor Taxi front portion at the time of my inspection. The Motor Taxi was observed to visually sustain damage at its front bumper at the time of inspection.

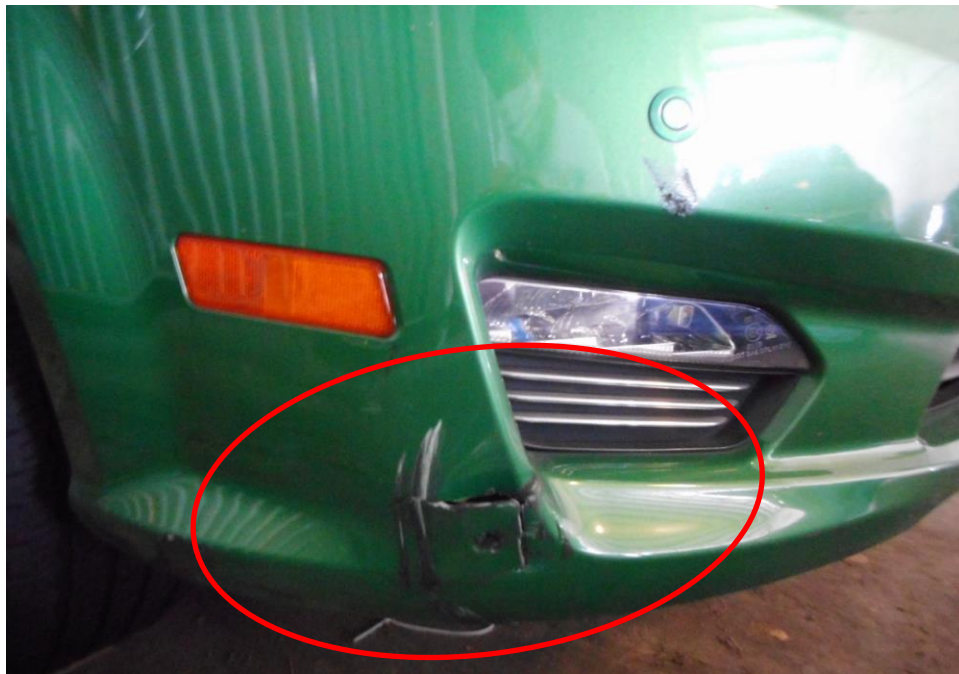
Photo 3 shows a close up view of the front body of the Motor Taxi at the time of my inspection. The Motor Taxi was observed to visually sustain damage at its front bumper (circled) at the time of inspection.

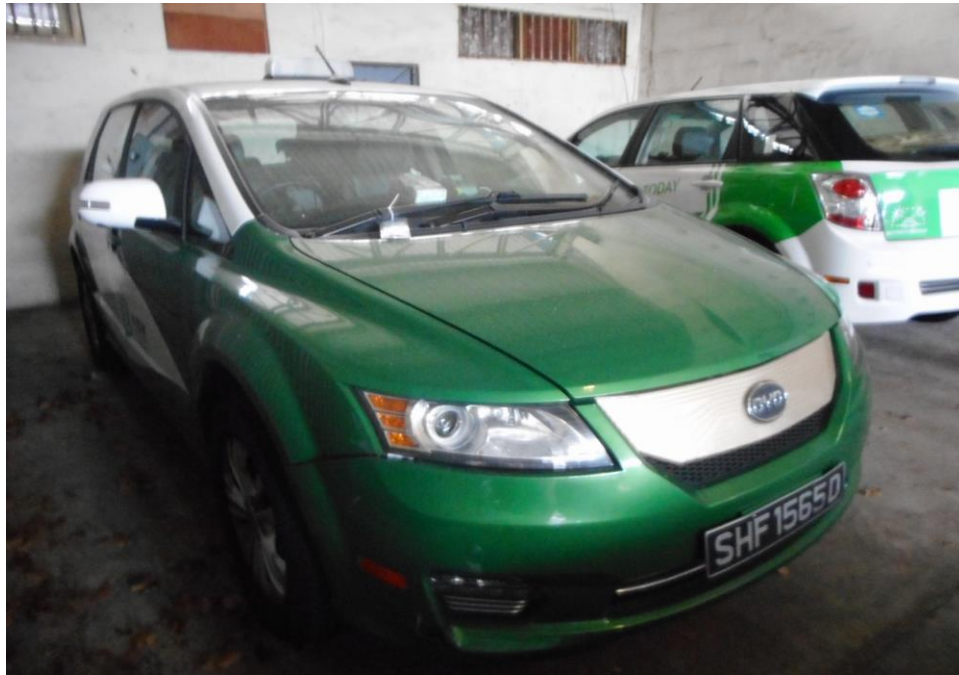
Photo 4 shows a general view of the right body of the Motor Taxi at the time of my inspection. The Motor Taxi was observed to be intact and unaffected by the accident.

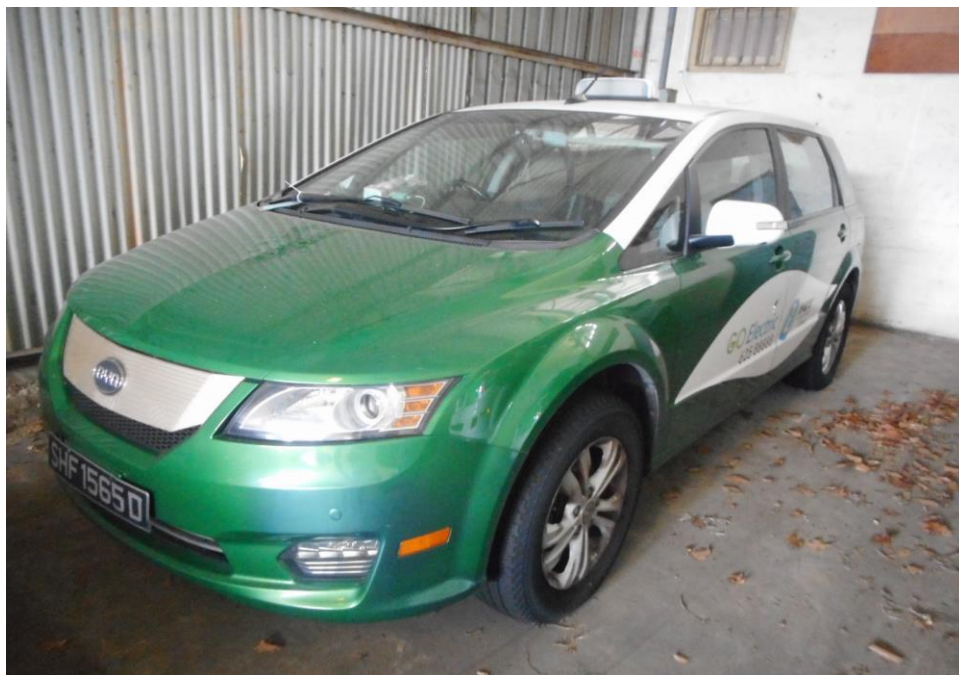
Photo 5 shows a general view of the left body of the Motor Taxi at the time of my inspection. The Motor Taxi was observed to be intact and unaffected by the accident.

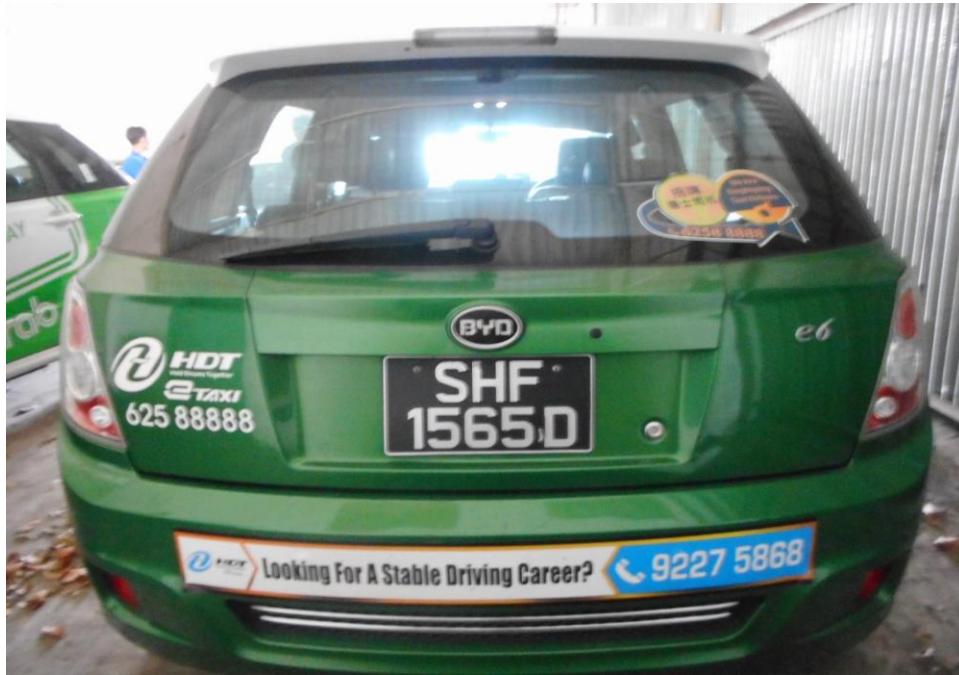
Photo 6 shows a general view of the rear body of the Motor Taxi at the time of my inspection. The Motor Taxi was observed to be intact and unaffected by the accident.

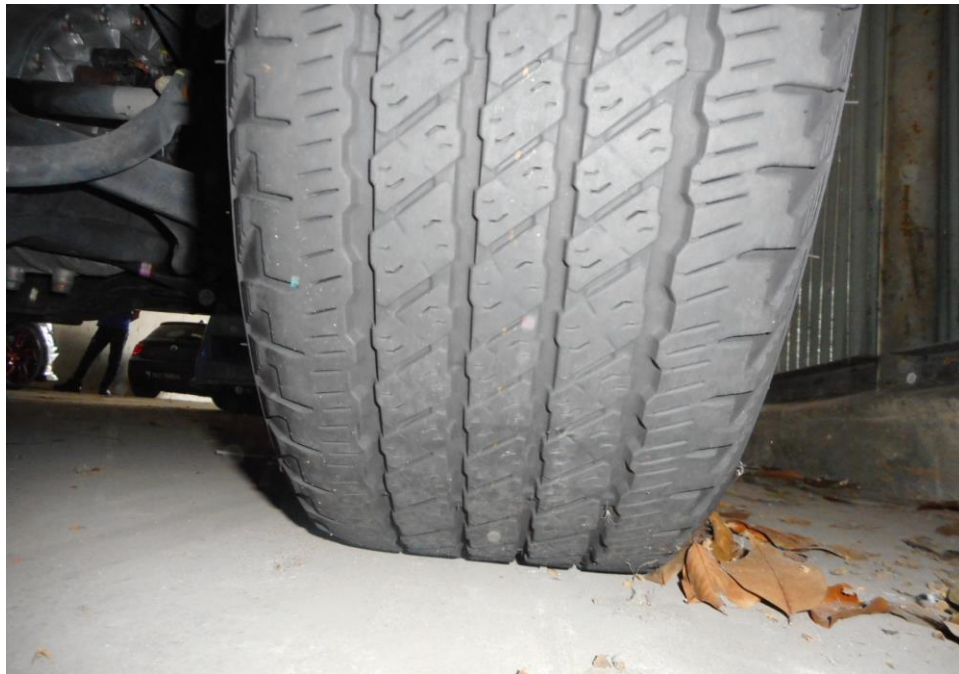
Photo 7 shows the condition of the front right tyre of the Motor Taxi, which was observed to be in serviceable condition with remaining tread depth of approximately 5mm. The tyre, which was wrapped around standard alloy wheel rim, was also observed to be sufficiently inflated for vehicular operation. There was no tear, cut or burst mark(s) on the outer and the inner sidewalls as well as across the tread of the 4 tyres that were fitted on the Motor Taxi.

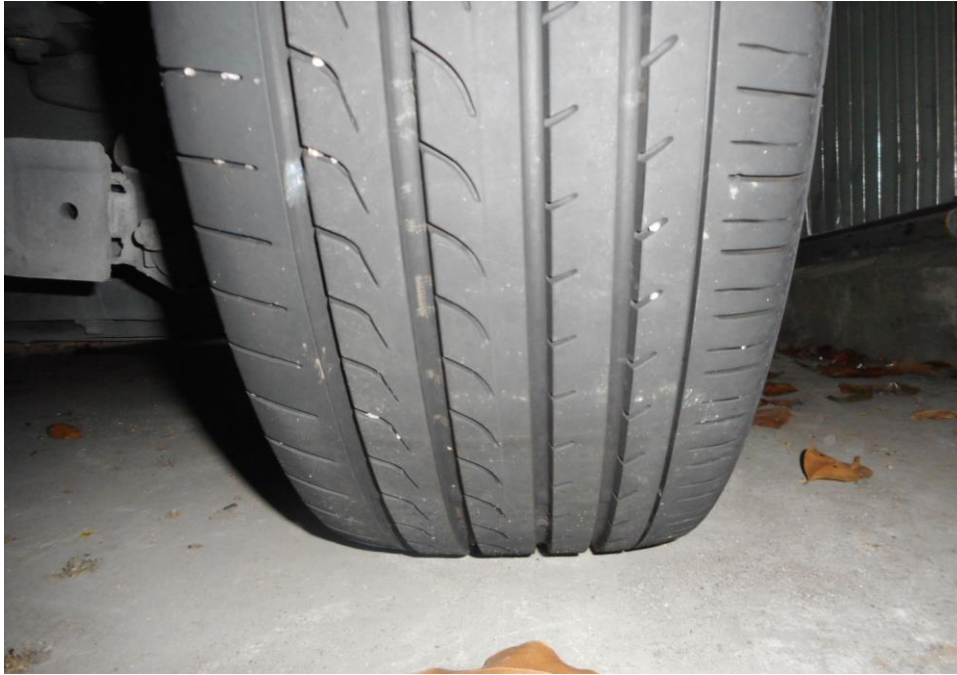
Photo 8 shows the condition of the rear right tyre of the Motor Taxi, which was observed to be in serviceable condition with remaining tread depth of approximately 6.1mm. The tyre, which was wrapped around standard alloy wheel rim, was also observed to be sufficiently inflated for vehicular operation.

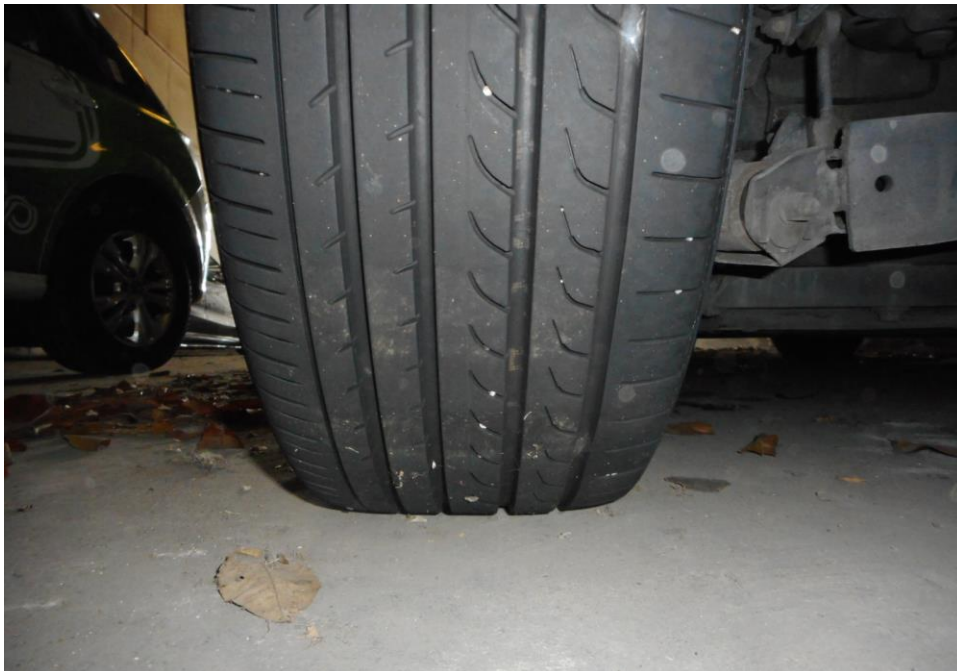
Photo 9 shows the condition of the rear left tyres of the Motor Taxi, which was observed to be in serviceable condition with remaining tread depth of approximately 6mm. The tyres, which were wrapped around standard alloy wheel rim, were also observed to be sufficiently inflated for vehicular operation. There was also no damage found on all 4 alloy wheel rims of the Motor Taxi.

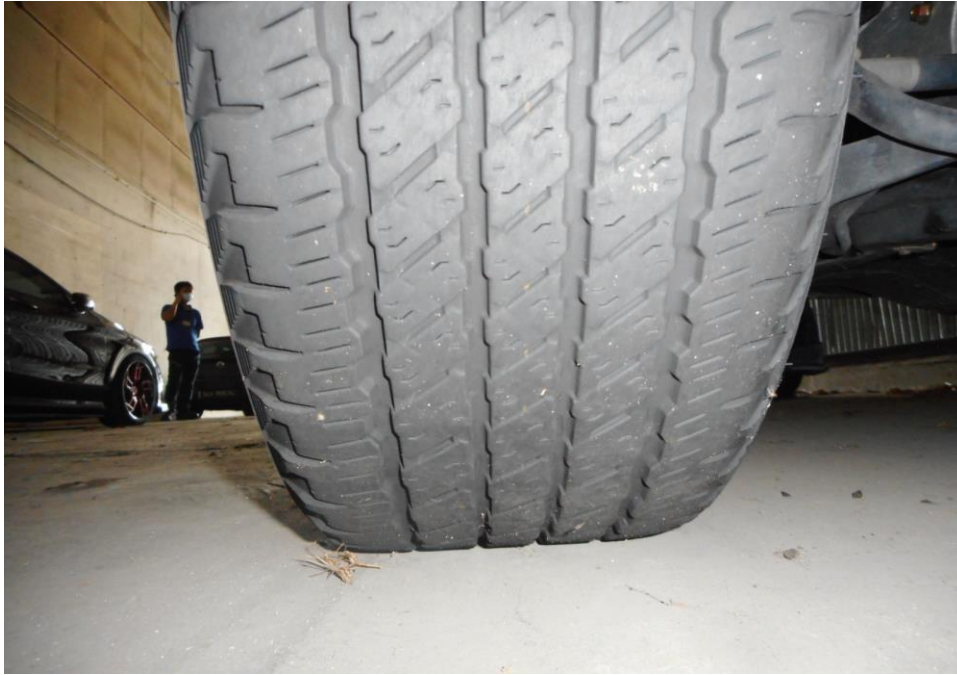
Photo 10 shows the condition of the rear right tyres of the Motor Taxi, which were observed to be in serviceable condition with remaining, tread depth of approximately 5.1mm. There was also no tear, cut or burst mark(s) on the outer and the inner sidewalls as well as across the tread of the 4 tyres that were fitted on the Motor Taxi.

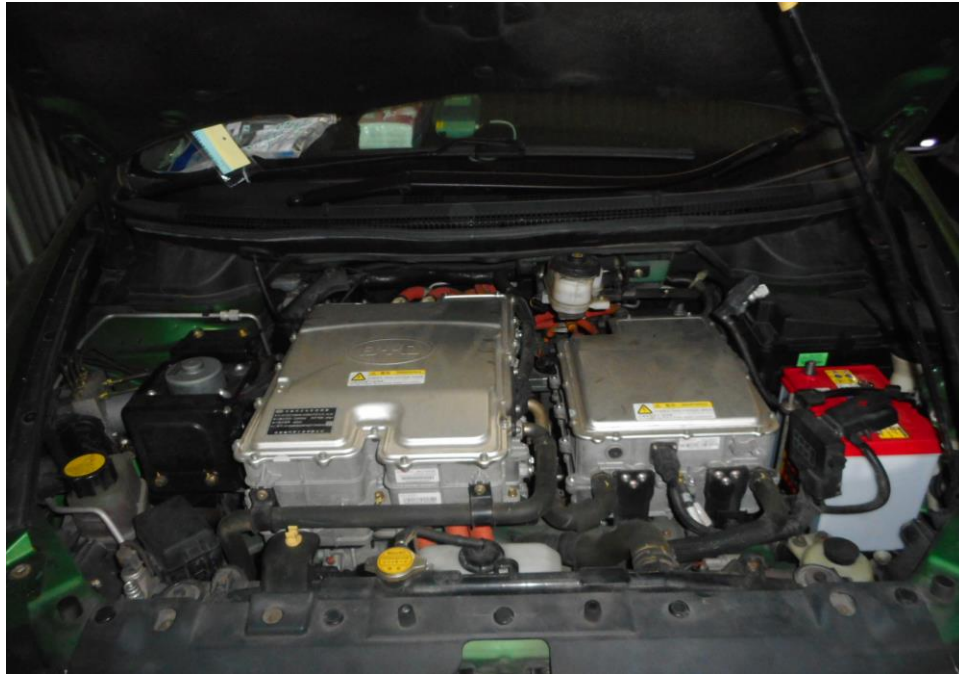
Photo 11 shows a general view of the Motor Taxi's engine compartment, which was accessed by lifting the front cabin of the Motor Taxi. The various parts and components inside the engine compartment were unaffected by the accident. There was also no sign(s) or indication(s) of fresh fluid leakage and/or fluid stain within the engine compartment

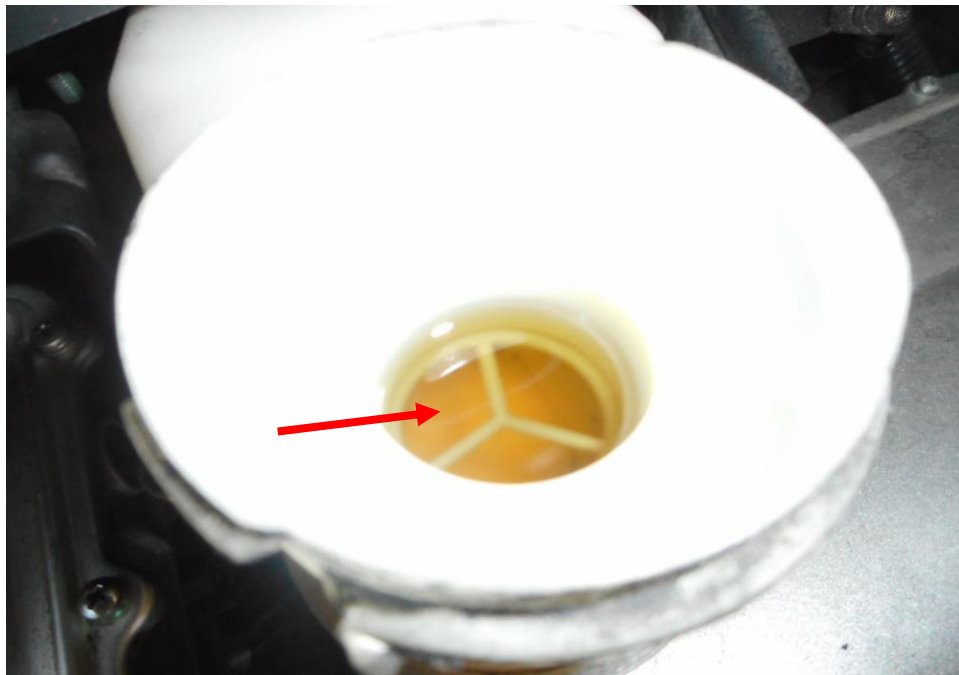
Photo 12 shows the brake fluid reservoir of the Motor Taxi at the time of my inspection. The brake fluid was observed to be of sufficient level (arrowed) and without any visible contamination.

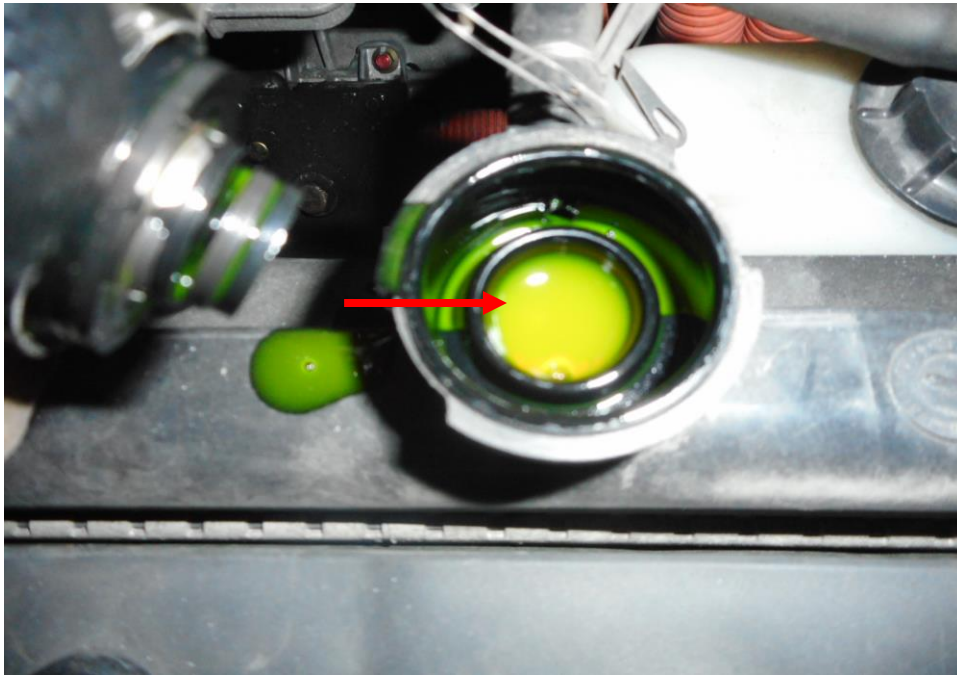
Photo 13 shows the engine coolant reservoir of the Motor Taxi at the time of my inspection. The engine coolant was observed to be of sufficient level (arrowed) and without any visible contamination.

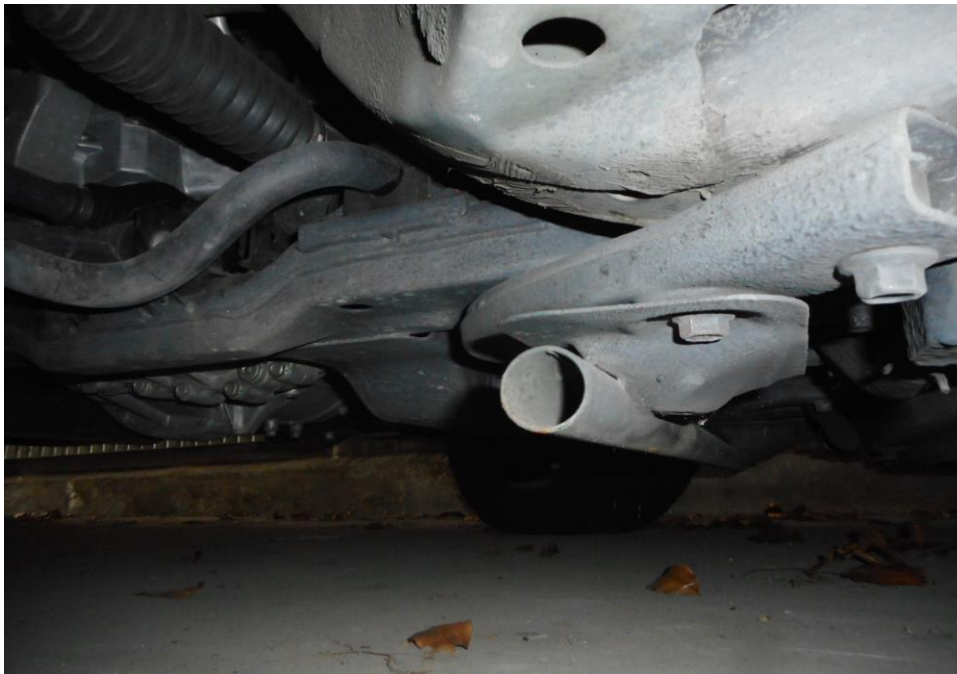
Photo 14 shows the undercarriage of the Motor Taxi, at the area where the engine housing and transmission housing are located. . I did not find any sign(s) or indication(s) of fluid leak and/or fluid stain(s) on the underside of the Motor Taxi.

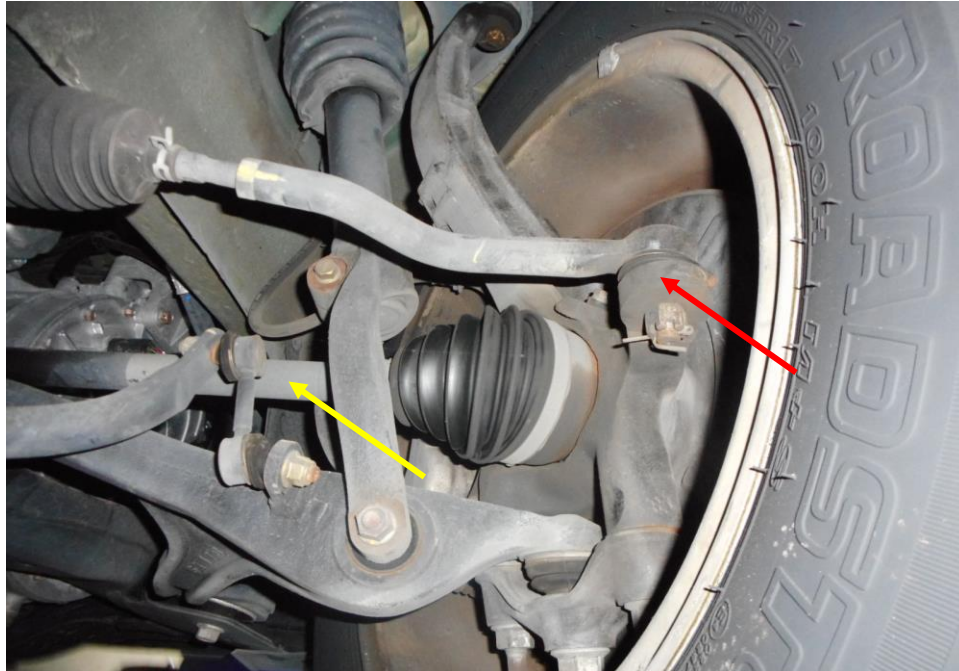
Photo 15 shows the various undercarriage components at the front right wheel of the Motor Taxi, in particular the steering tie rod end (arrowed) and drive shaft (yellow arrow). The various steering components were all found to be intact, suggesting that the steering system of the Motor Taxi was likely to be in serviceable condition at the material time of accident. There was also no sign of fluid stain(s) observed on the various undercarriage components.

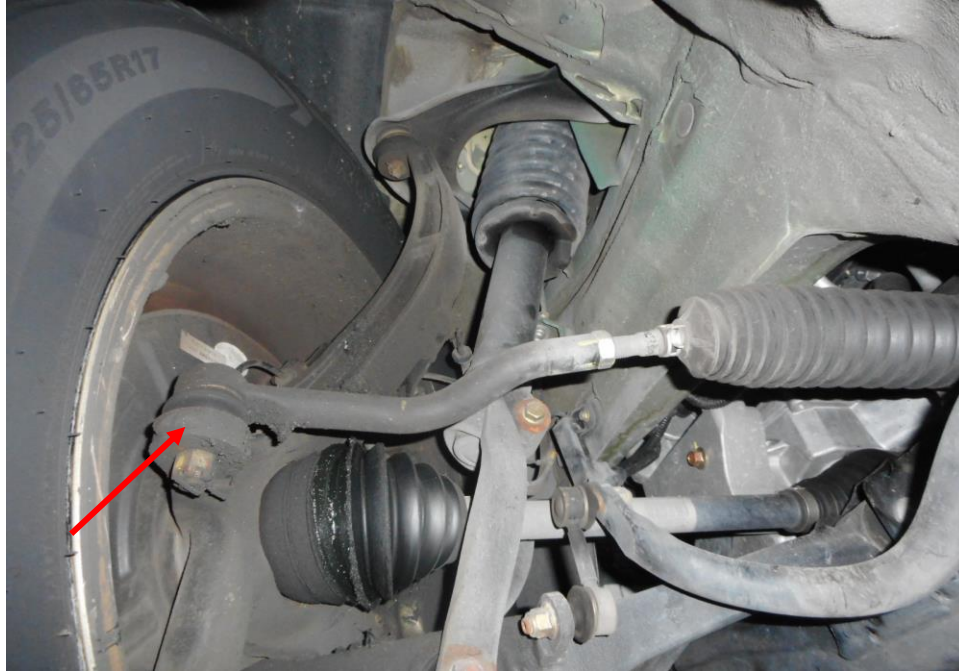
Photo 16 shows the various undercarriage components at the front left wheel of the Motor Taxi, in particular the steering tie rod end (arrowed). The various Undercarriage components of the Motor Taxi were all found to be intact without any visible damage. There was also no sign of fluid stain(s) observed on the various undercarriage components.

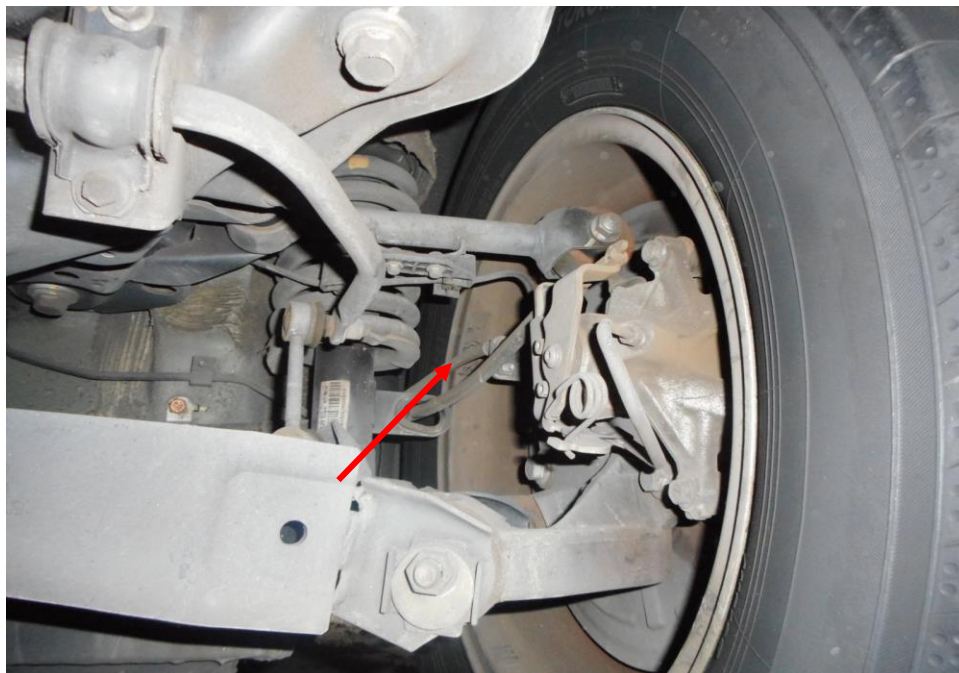
Photo 17 shows the brake pipe (arrowed) at the rear right wheel of the Motor Taxi. I did not observe any leakage of brake fluid at the time of my inspection of the Motor Taxi. My static tests of the Motor Taxi's braking system, along with my visual examination of the various mechanical components in the braking system, had indicated that there was no internal leakage of pressure/vacuum. Hence the braking system of the Motor Taxi was likely to be in serviceable condition at the material time of accident.

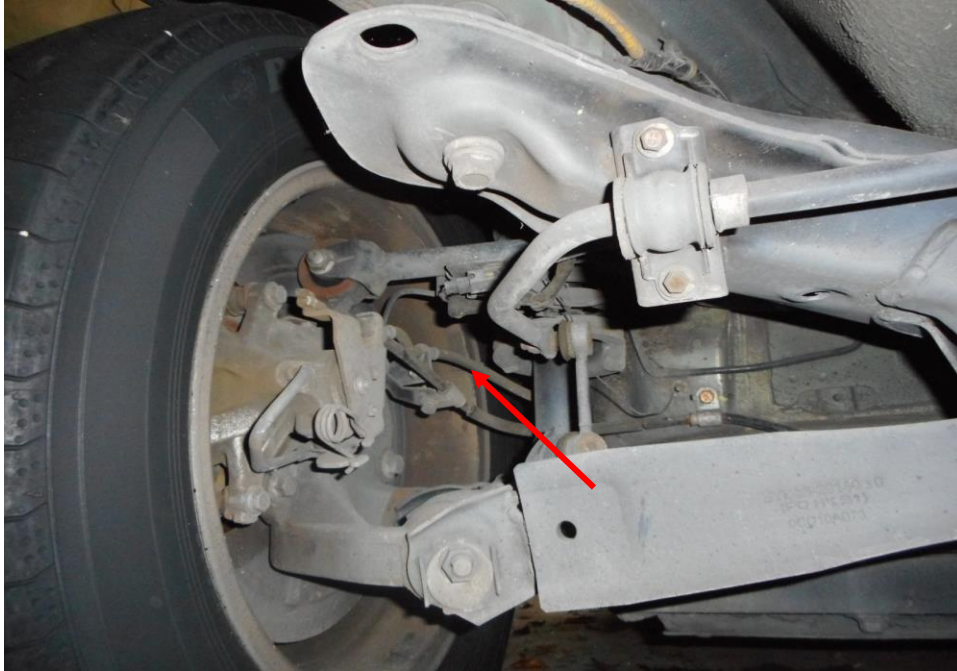
Photo 18 shows the brake pipe (arrowed) at the rear left wheel of the Motor Taxi. I did not observe any leakage of brake fluid at the time of my inspection of the Motor Taxi. My static tests of the Motor Taxi's braking system, along with my visual examination of the various mechanical components in the braking system had indicated that there was no internal leakage of pressure/vacuum. Hence the braking system of the Motor Taxi was likely to be in serviceable condition at the material time of accident.

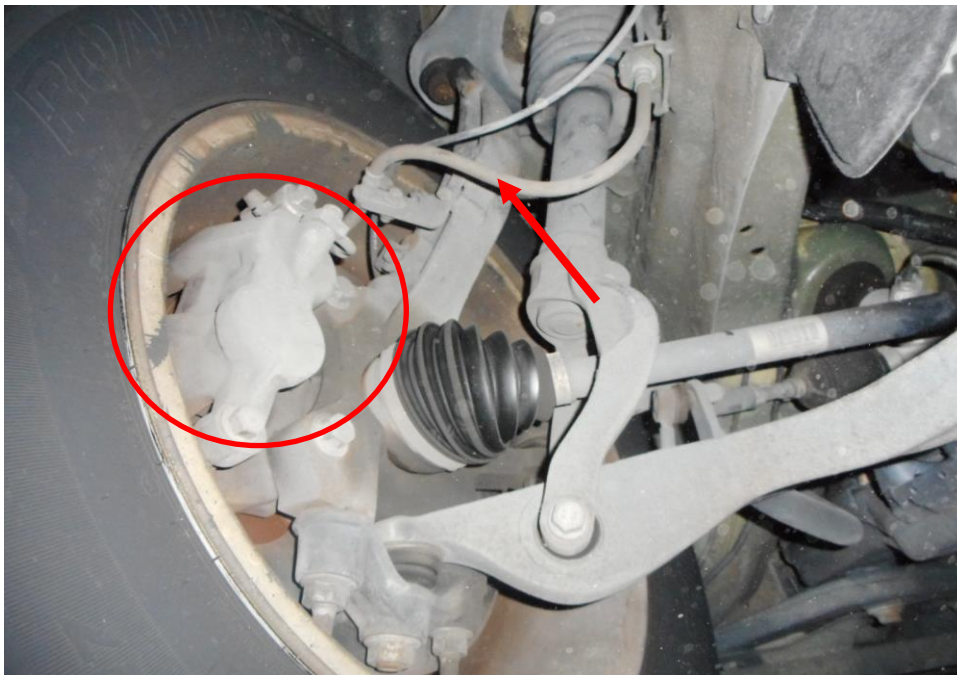
Photo 19 shows the brake hose/pipe (arrowed) at the front right wheel of the Motor Taxi. No leakage of brake fluid was observed. Visual examination of the various components of the braking system like the brake caliper (circled), brake booster, brake pedal etc had revealed all to be intact and without visible damage at the time of accident. There was also no sign of fluid stain(s) observed on the various undercarriage components.

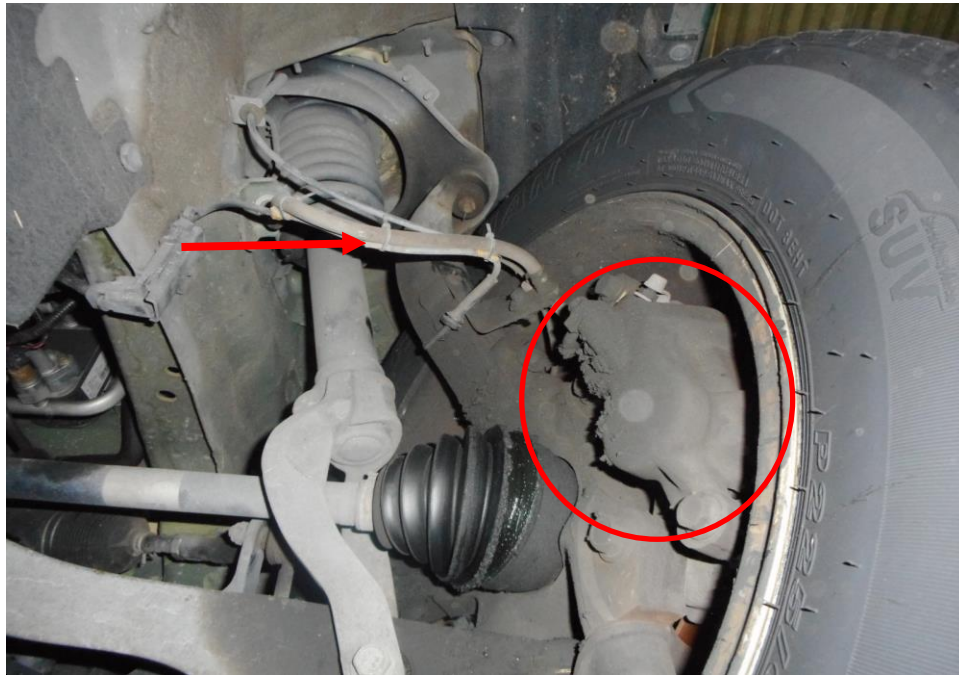
Photo 20 shows the brake hose/pipe (arrowed) at the front left wheel of the Motor Taxi. No leakage of brake fluid was observed. Visual examination of the various components of the braking system like the brake caliper (circled), brake booster, brake pedal etc had revealed all to be intact and without visible damage at the time of accident. There was also no sign of fluid stain(s) observed on the various undercarriage components.

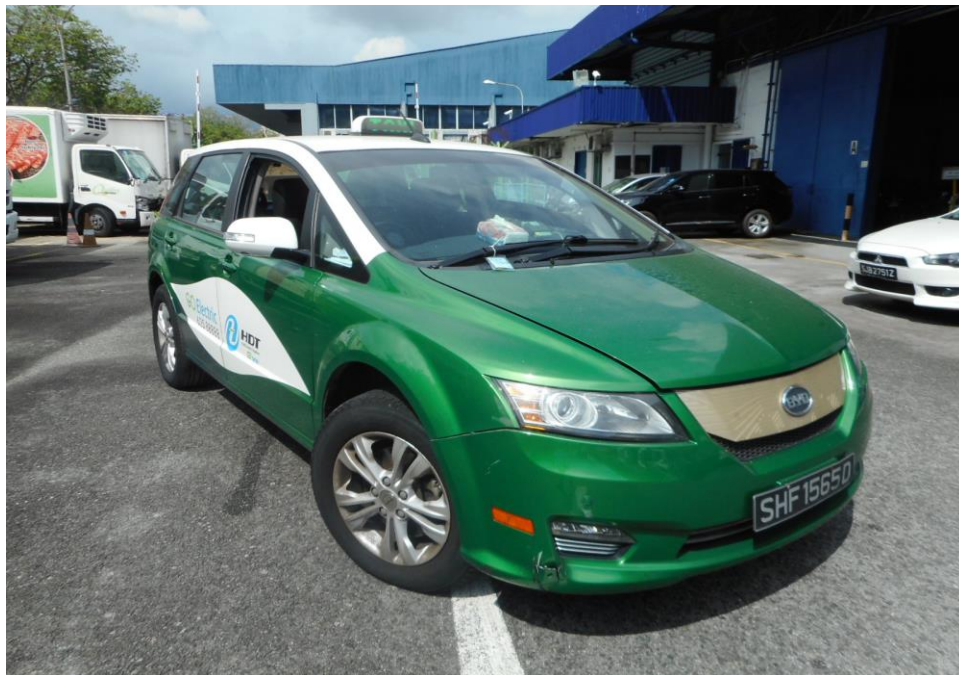
Photo 21 shows the front right wheel of the Motor Taxi turned to its full left. During my steering system test, I did not experience any abnormal free play and/or resistance when I had turned the steering wheel towards full left and full right. This would suggest that the steering system of the Motor Taxi was likely to be in serviceable condition at the material time of accident.

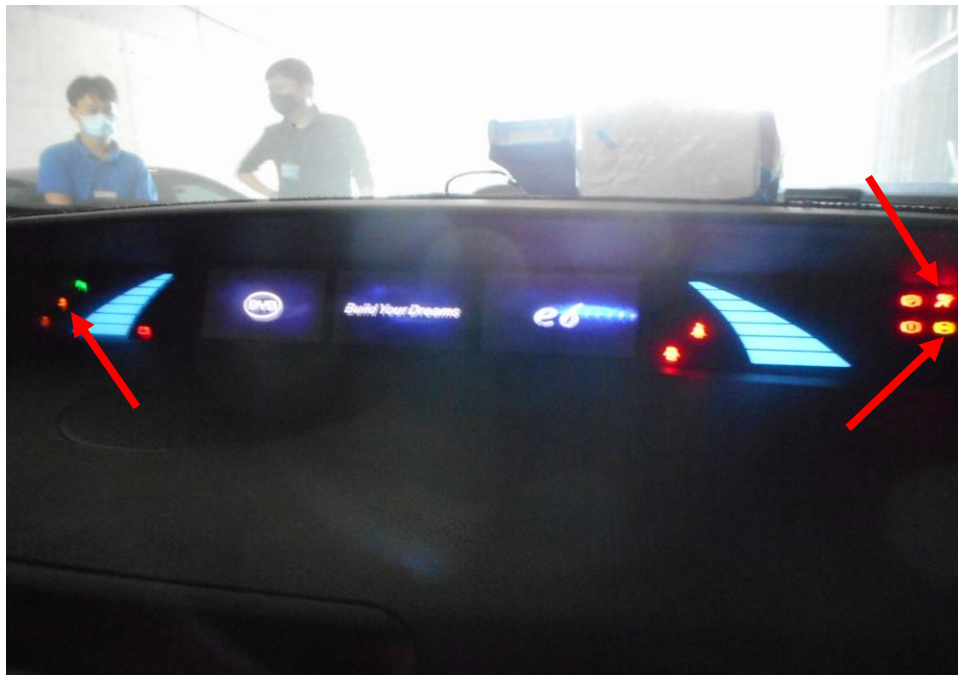
Photo 22 shows the warning light for Anti-Lock Brake System (ABS), Supplemental Restraint System (SRS) and Traction Control System (TC) appearing on the instrument panel of the Motor Taxi during the self-test of its various electronic operating systems when its engine was cranked.

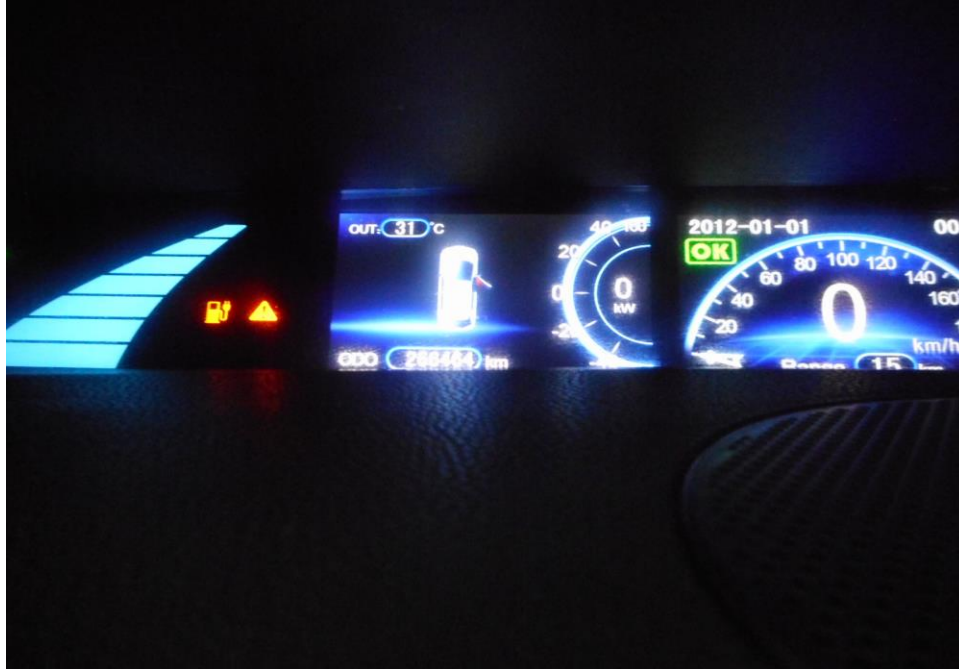
Photo 23 shows no warning lights illuminated on the instrument panel of the Motor Taxi after the engine was cranked. This would suggest that there was no abnormality to the various electronic operating systems of the Motor Taxi, like the ABS, SRS and TC.
