Your Ref: TP/IP/21299/2020
Our Ref : CI/TPD20005821/P

18th June 2020

MECHANICAL INSPECTION REPORT OF MOTOR CAR SLR 3826C

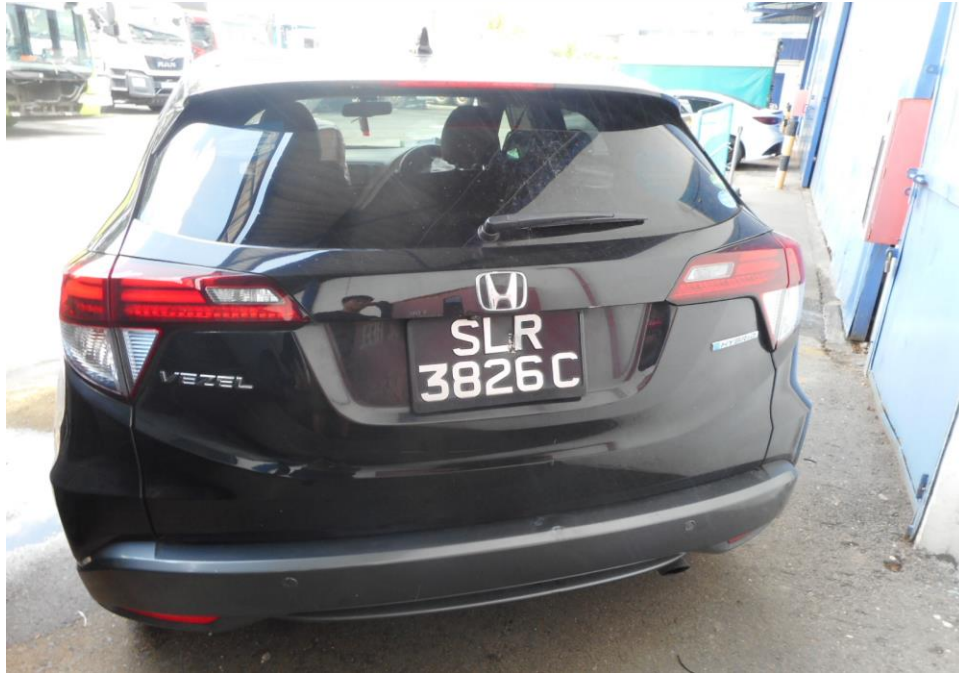
Photo 1 shows a general view of the Motor Car's rear body at the time of my inspection. The rear portion of the Motor Car was observed to have been undamaged by the accident.

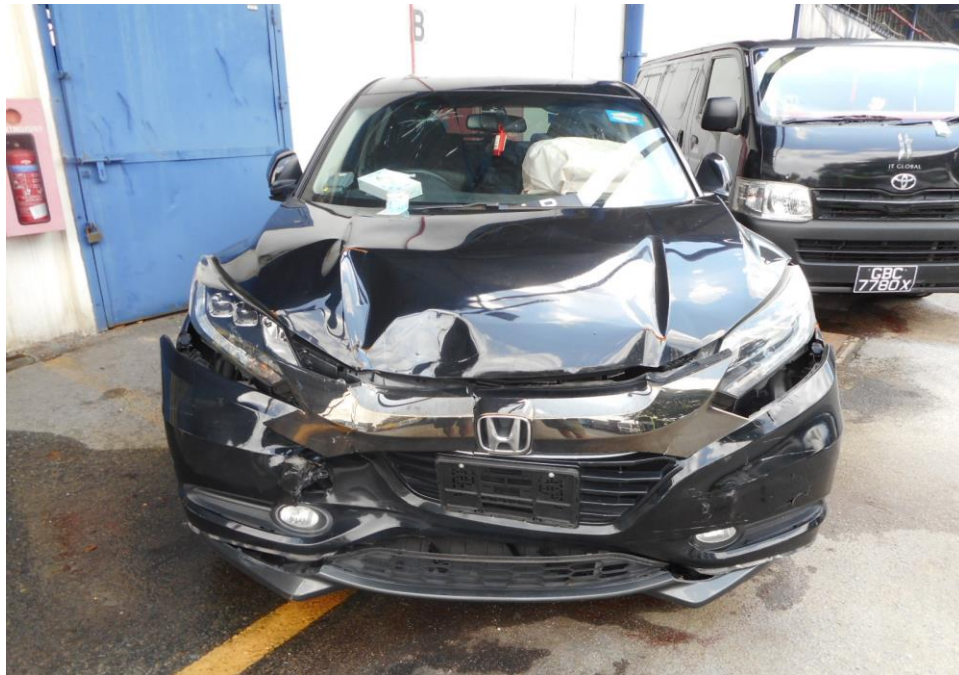
4. The mileage of the Motor car was not recorded due to damage to the ignition system and engine system as a result of the accident.
5. The Motor car was observed to have sustained damage at its front portion. Its front windscreen, front bonnet and front bumper was amongst the body parts and various components in the engine compartments were also damaged as a result of the accident. The Supplemental Restraint System (SRS) was activated as a result of the accident.

Photo 2 shows a general view of the Motor Car's front body at the time of my inspection. The Motor car was observed to have sustained damage at its front portion. Its front windscreen, front bonnet, front bumper was amongst the body parts and various components in the engine compartments were also damaged as a result of the accident. The Supplemental Restraint System (SRS) was activated as a result of the accident.

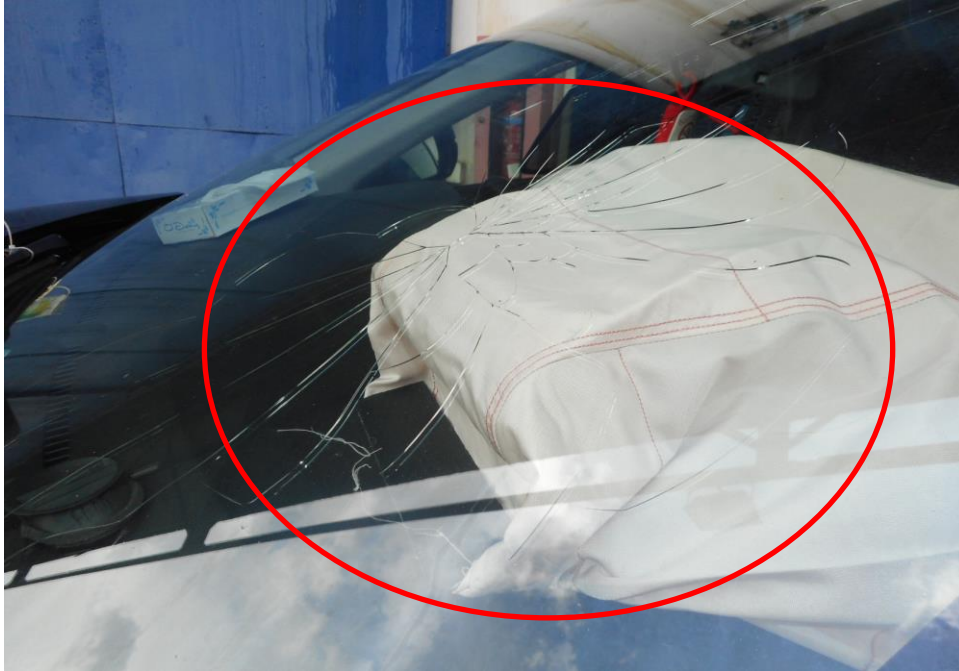
Photo 3 shows the close up view of the Motor Car's front body at the time of my inspection. The Motor car was observed to have sustained damage at its front portion. Its front windscreen (circled) was damaged as a result of the accident.

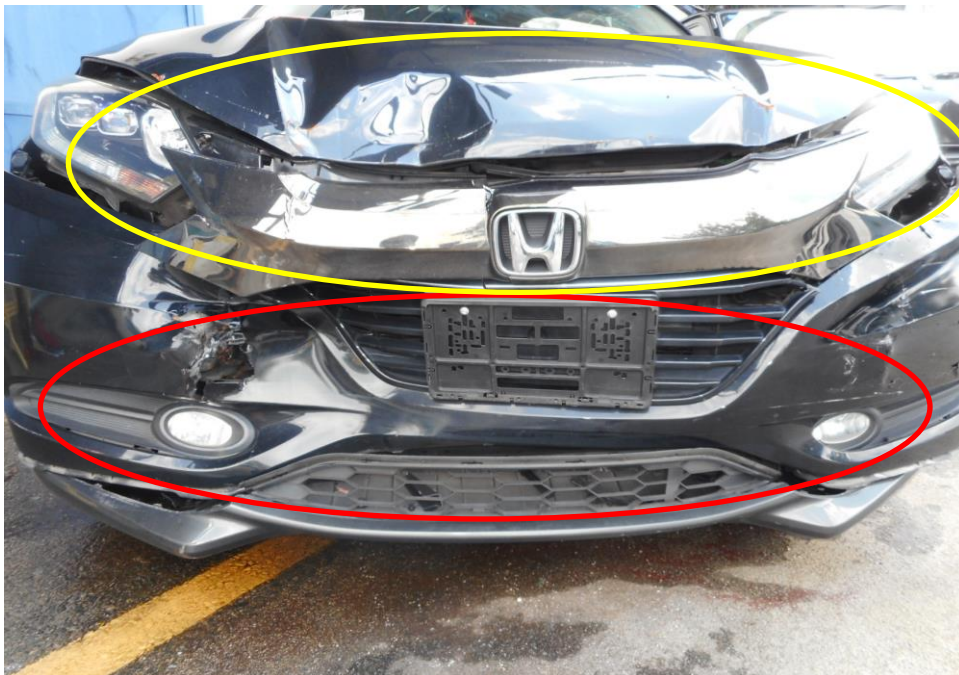
Photo 4 shows the close up view of the Motor Car's front body at the time of my inspection. The Motor car was observed to have sustained damage at its front portion. Its front bonnet (yellow circle) and front bumper (red circle) was amongst the body parts and various components in the engine compartments were also damaged as a result of the accident.

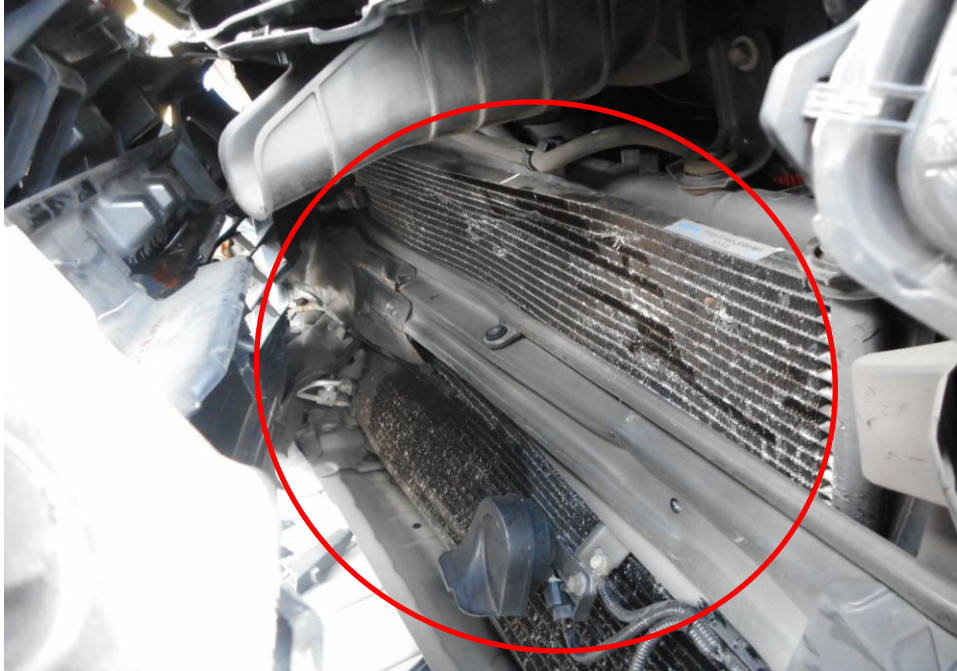
Photo 5 shows a close up view of the Motor Car's engine compartment at the time of my inspection. The Motor car was observed to have sustained damage at its front portion. Its front engine radiator (red circle) was amongst the body parts and various components in the engine compartments were also damaged as a result of the accident.

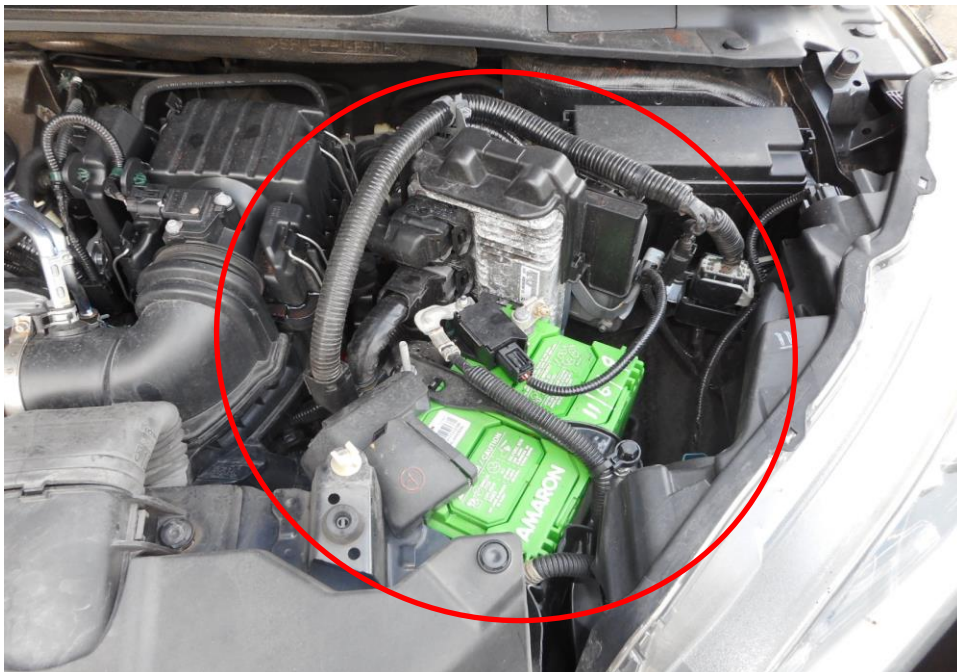
Photo 6 shows a close up view of the Motor Car's engine compartment at the time of my inspection. The Motor car was observed to have sustained damage at its front portion. Its battery and ECU (red circle) was amongst the body parts and various components in the engine compartments were also damaged as a result of the accident.

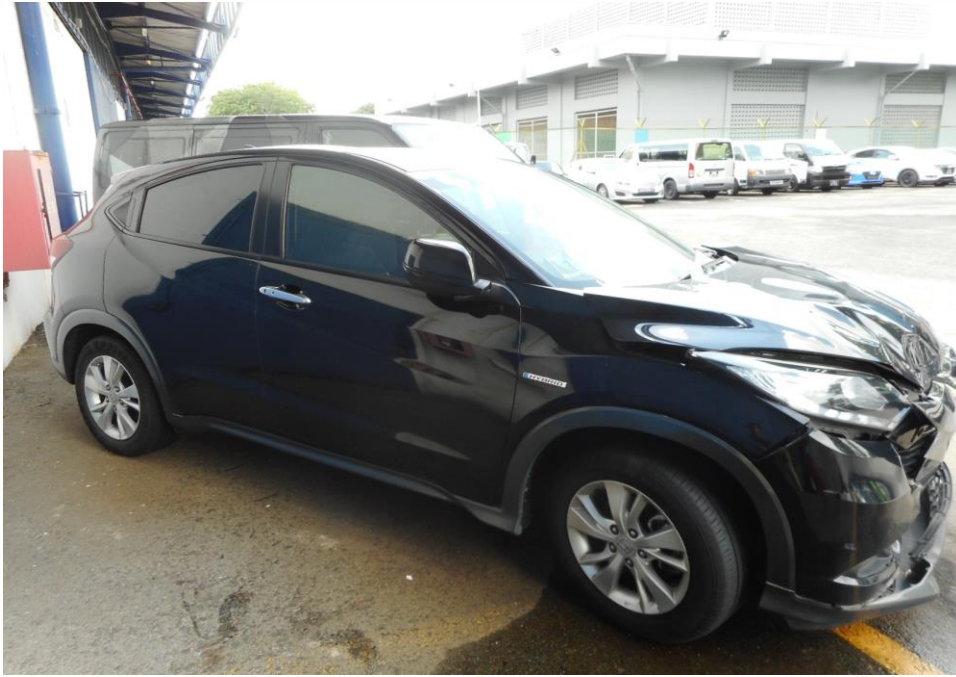
Photo 7 shows a general view of the Motor Car's right body at the time of my inspection. The right portion of the Motor Car was observed to have been undamaged by the accident.

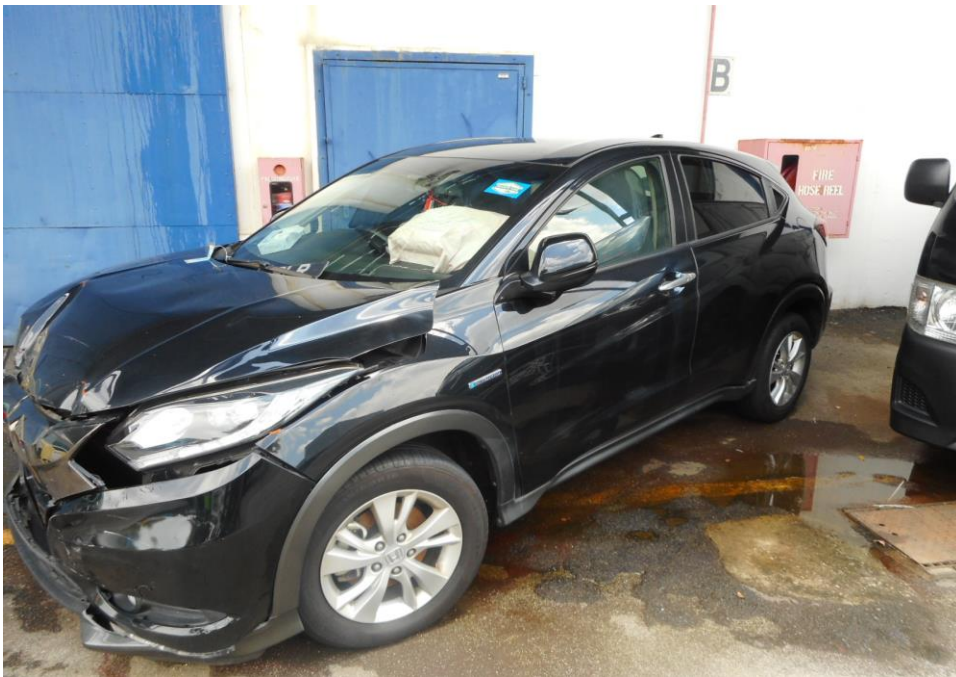
Photo 8 shows a general view of the Motor Car's left body at the time of my inspection. The left portion of the Motor Car was observed to have been undamaged by the accident.

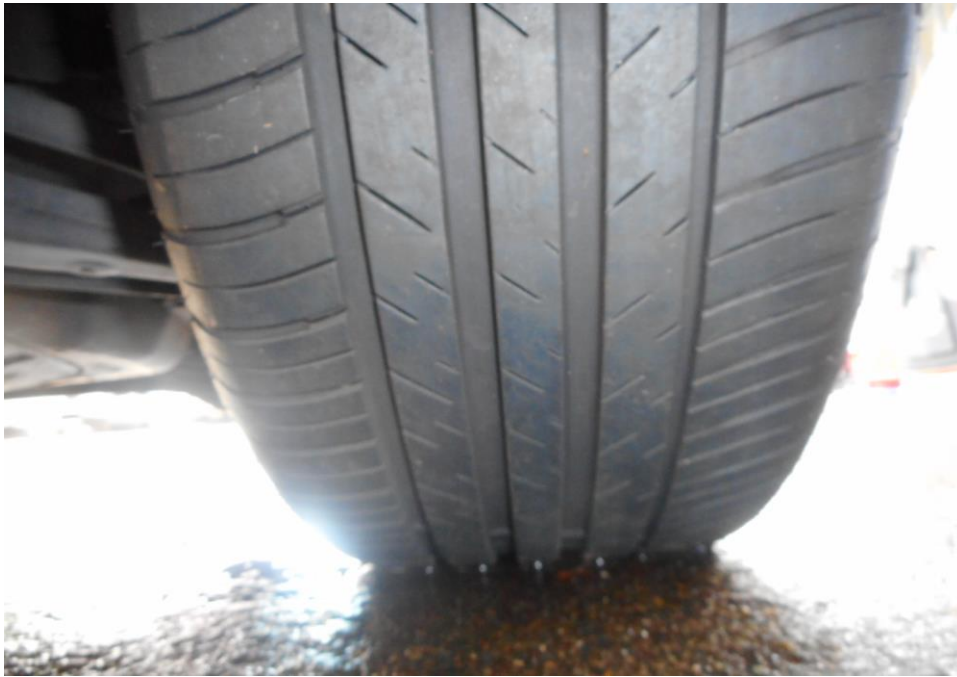
Photo 9 shows the condition of the front right tyre of the Motor Car, which was observed to be in serviceable condition with remaining tread depth of approximately 5.2mm. The tyre, which was wrapped around alloy wheel rim, was also observed to be sufficiently inflated for vehicular operation.

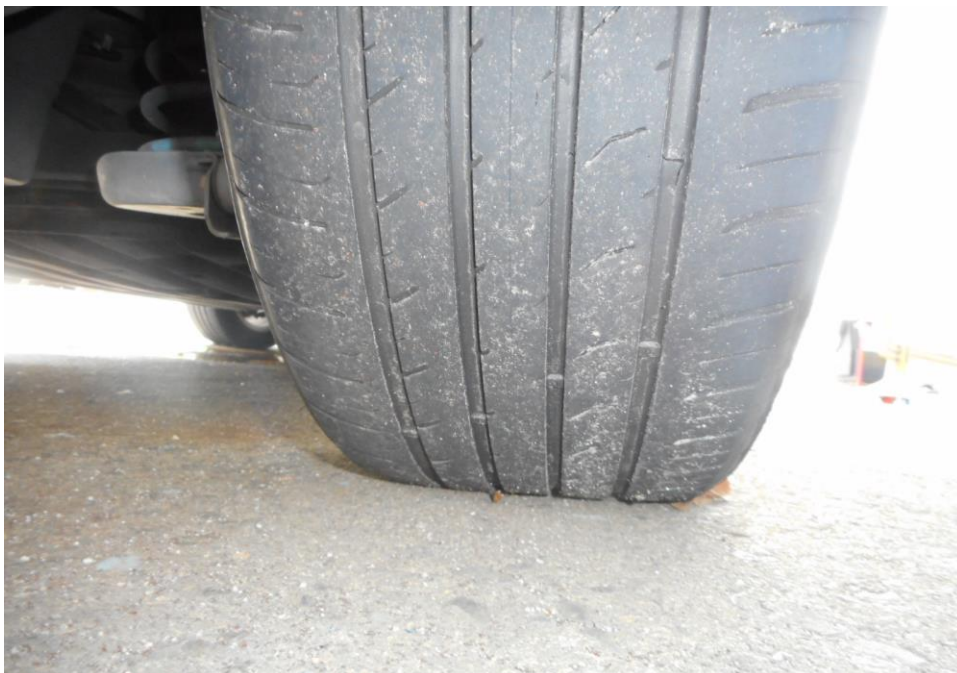
Photo 10 shows the condition of the rear right tyre of the Motor Car, which was observed to be in serviceable condition with remaining tread depth of approximately 4.2mm. The tyre was also observed to be sufficiently inflated for vehicular operation with no tear, cut or burst mark(s).

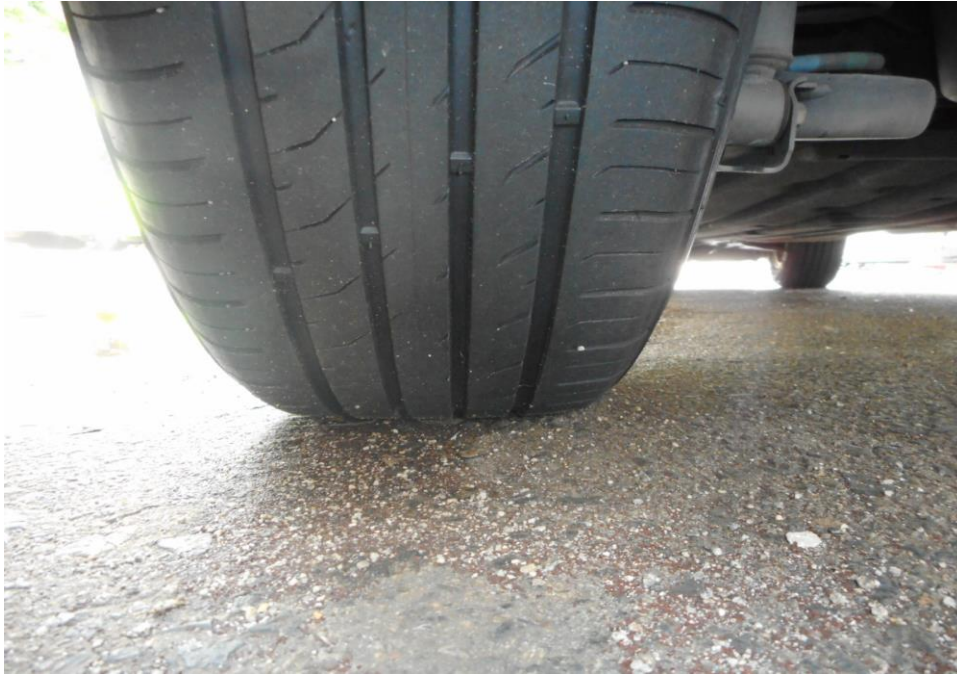
Photo 11 shows the condition of the rear left tyre of the Motor Car, which was observed to be in serviceable condition with remaining tread depth of approximately 4.5mm. The tyre was also observed to be sufficiently inflated for vehicular operation with no tear, cut or burst mark(s).

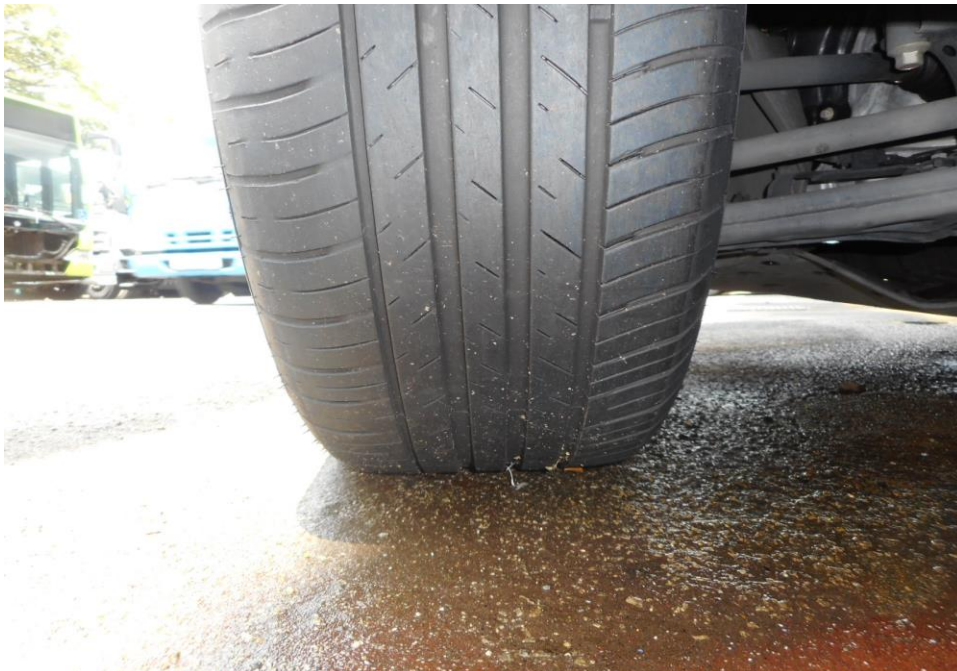
Photo 12 shows the condition of the front left tyre of the Motor Car, which was observed to be in serviceable condition with remaining tread depth of approximately 4.7mm. The tyre was also observed to be sufficiently inflated for vehicular operation with no tear, cut or burst mark(s).

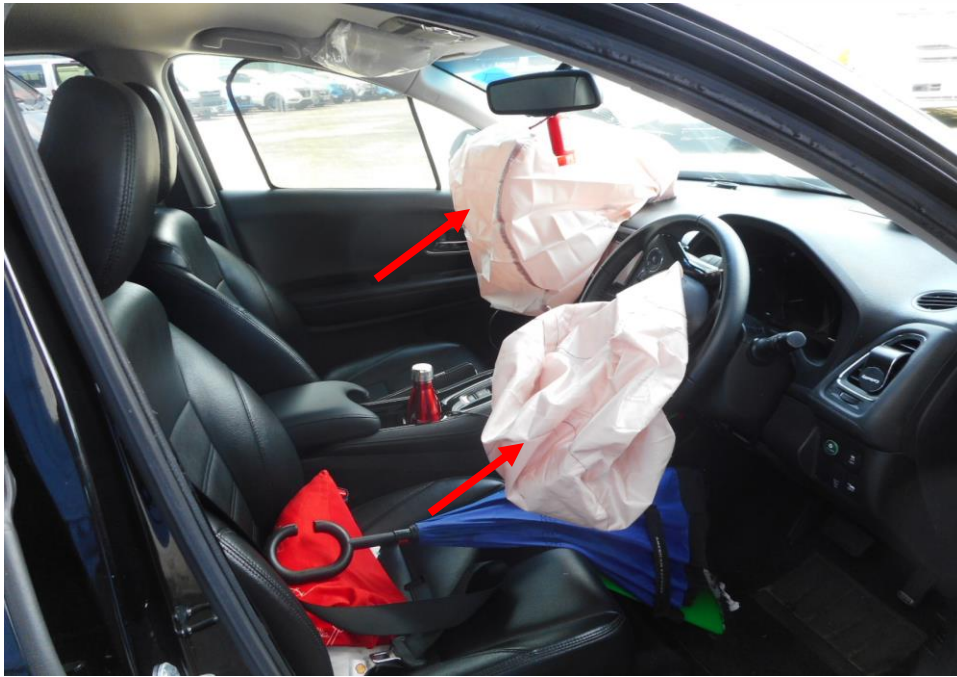
Photo 13 shows the deployment of the Supplemental Restraint System (SRS) airbag (arrowed) in the Motor Car as a result of the accident.

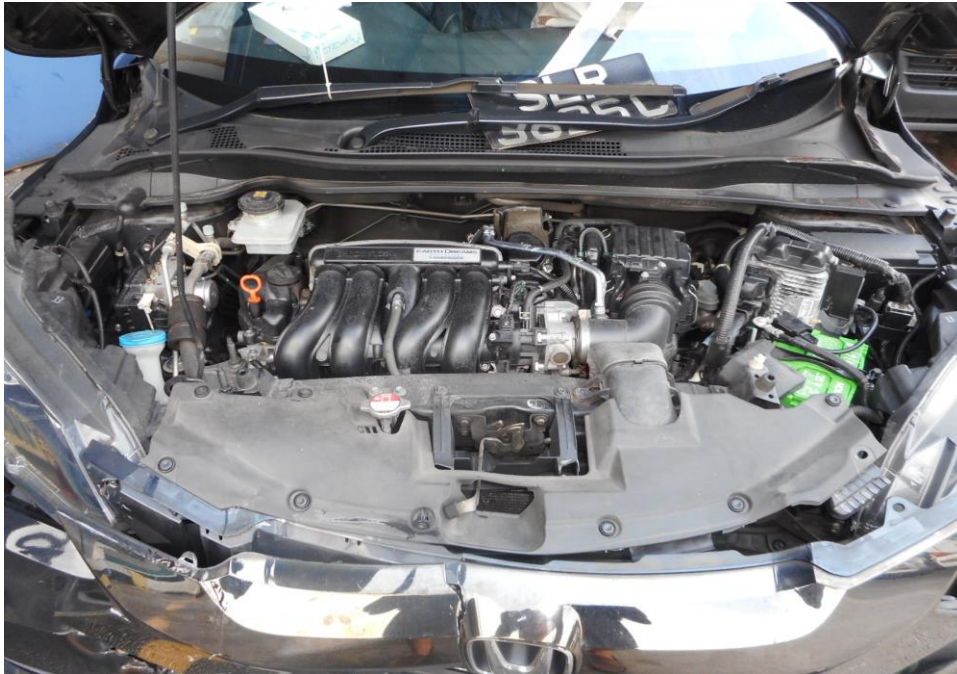
Photo 14 shows a general view of the Motor Car's engine compartment, which was accessed by lifting the front cabin of the Motor Car. The various parts and components inside the engine compartment were unaffected by the accident. There was also no sign(s) or indication(s) of fresh fluid leakage and/or fluid stain within the engine compartment

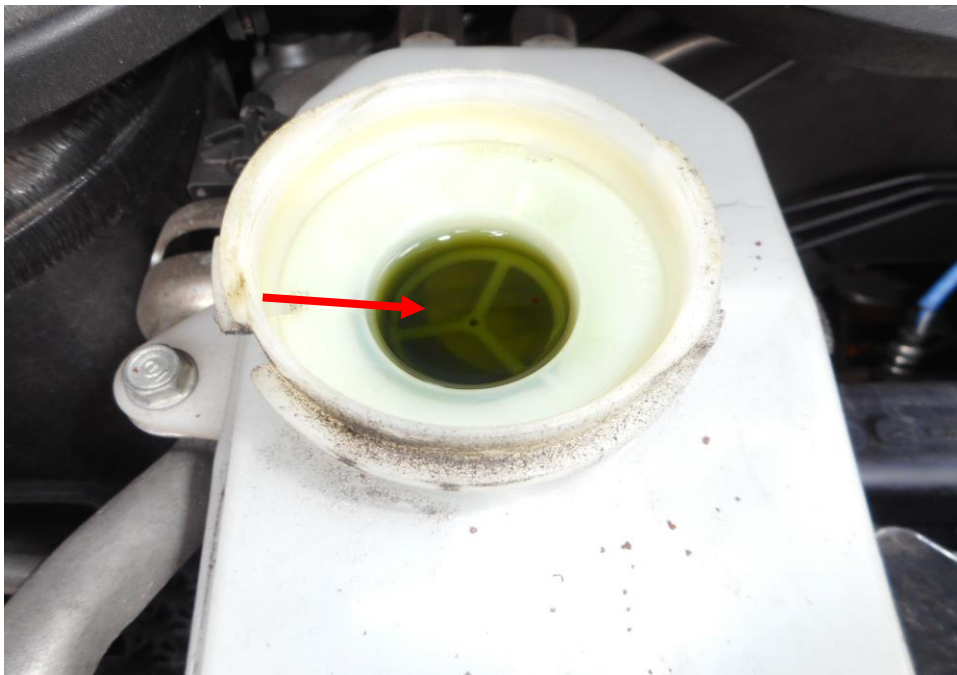
Photo 15 shows the brake fluid reservoir of the Motor Car at the time of my inspection. The brake fluid was observed to be of sufficient level (arrowed) and without any visible contamination.

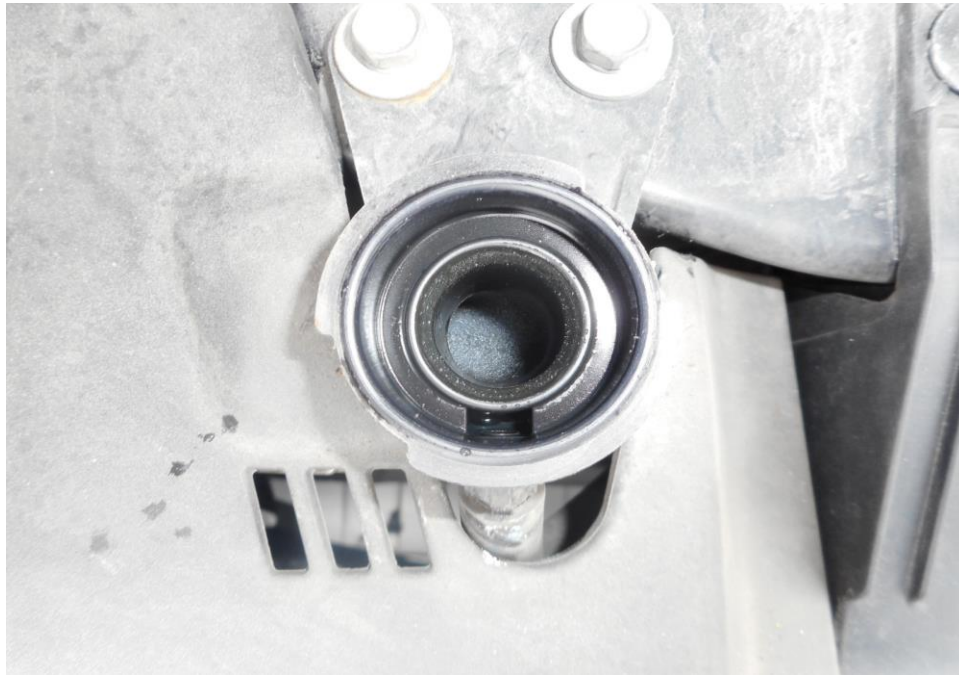
Photo 16 shows the engine coolant reservoir of the Motor Car at the time of my inspection. The engine coolant was observed to be of insufficient level due to the damaged to the radiator that cause all the coolant to depleted from the coolant reservoir.

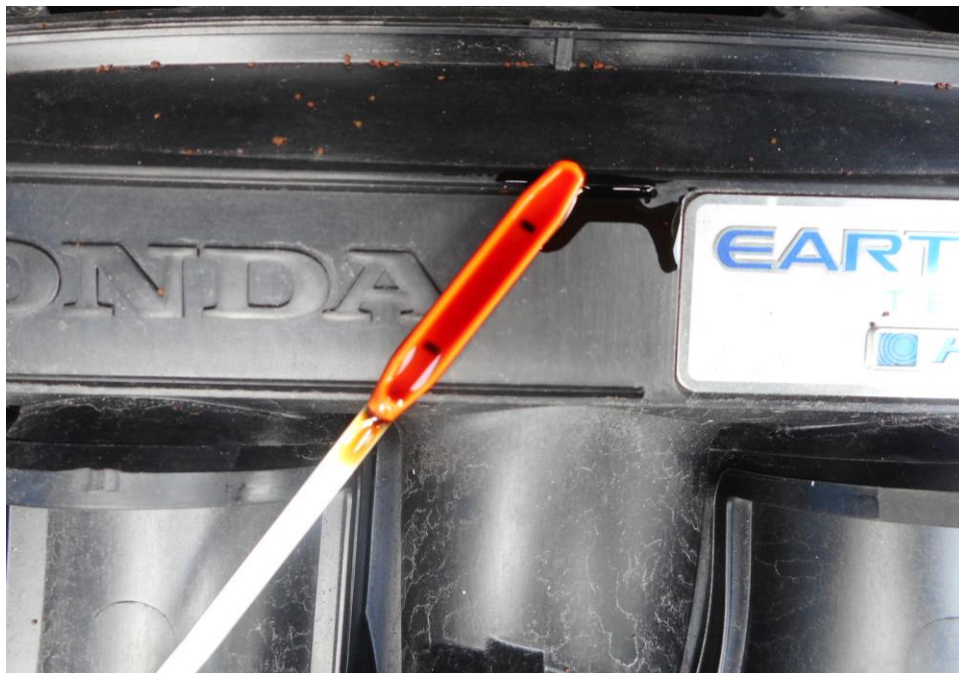
Photo 17 shows the engine oil dip stick of the Motor Car at the time of my inspection. The engine oil was observed to be of sufficient level and without any visible contamination.

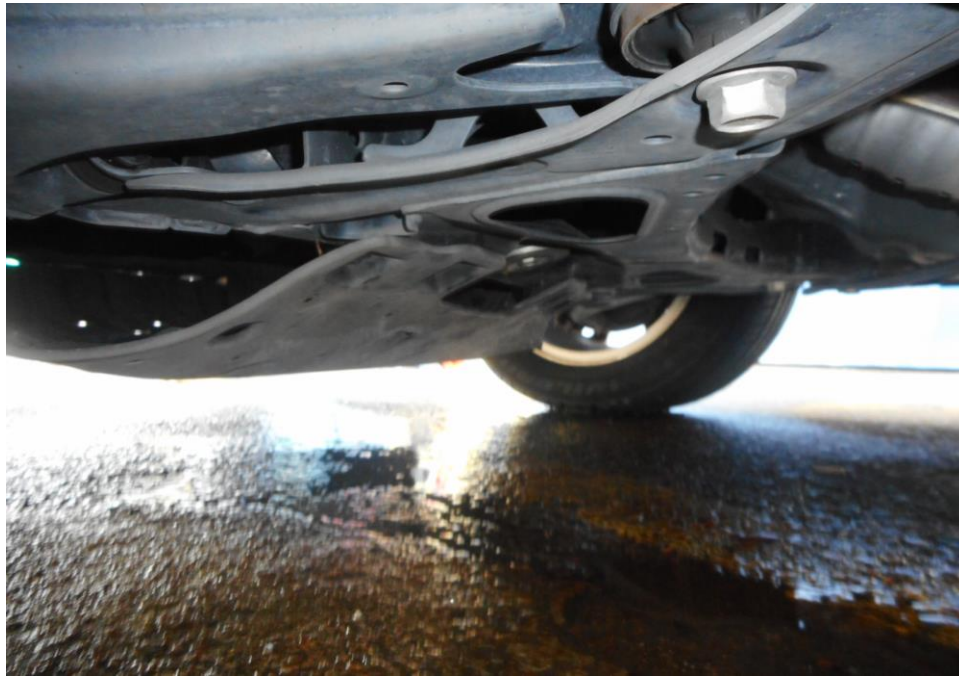
Photo 18 shows the undercarriage of the Motor Car, at the area where the engine housing and transmission housing are located. . I did not find any sign(s) or indication(s) of fluid leak and/or fluid stain(s) on the underside of the Motor Car.

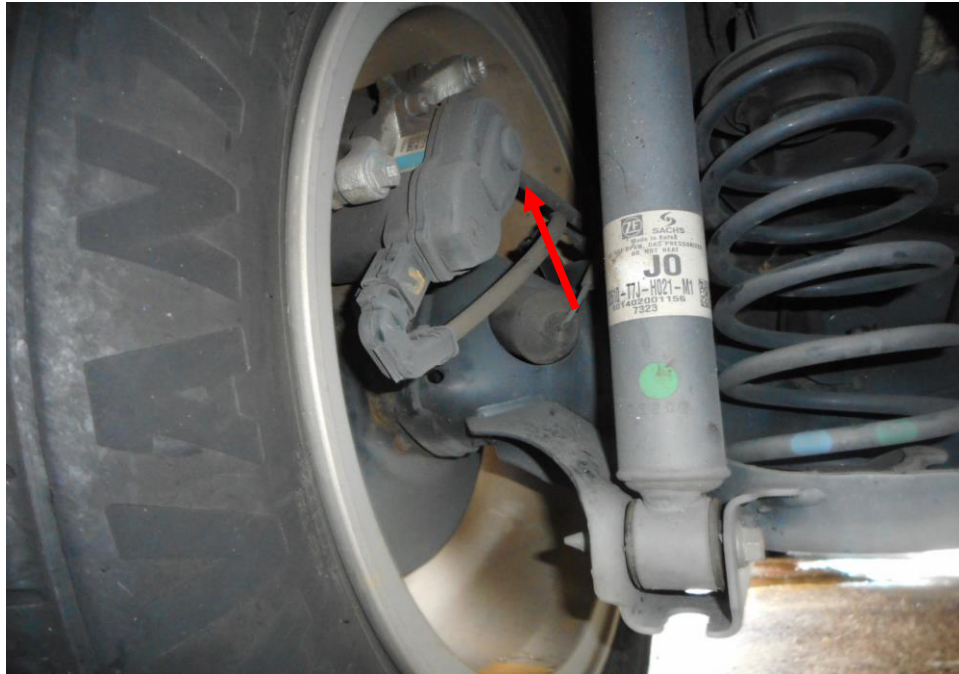
Photo 19 shows the brake hose/pipe (arrowed) at the rear left wheel of the Motor Car. No leakage of brake fluid was observed. Visual examination of the various components of the braking system like the drum brake, brake booster, brake pedal etc. had revealed all to be intact and without visible damage.

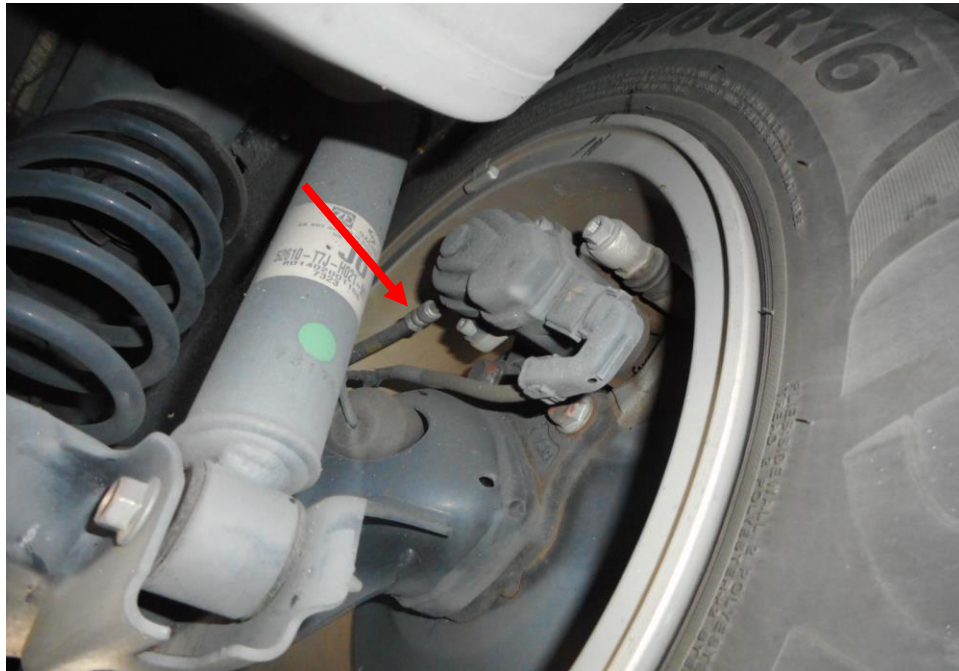
Photo 20 shows the brake hose/pipe (arrowed) at the rear right wheel of the Motor Car. No leakage of brake fluid was observed. Visual examination of the various components of the braking system like the drum brake, brake booster, brake pedal etc. had revealed all to be intact and without visible damage.

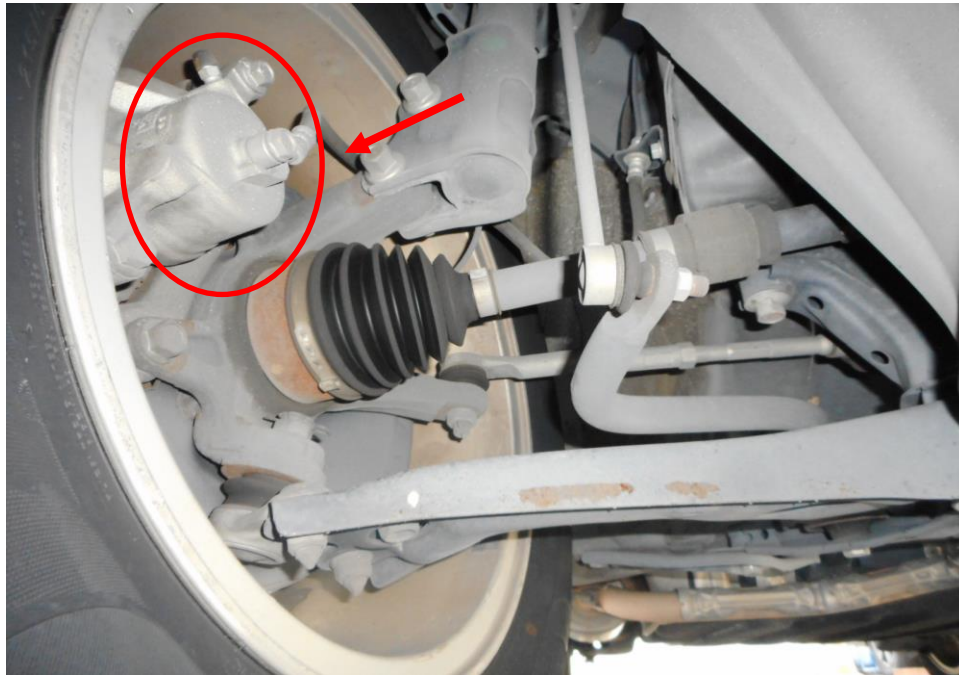
Photo 21 shows the brake hose/pipe (arrowed) at the front right wheel of the Motor Car. No leakage of brake fluid was observed. Visual examination of the various components of the braking system like the brake caliper (circled), brake booster, brake pedal etc had revealed all to be intact and without visible damage at the time of accident. There was also no sign of fluid stain(s) observed on the various undercarriage components.

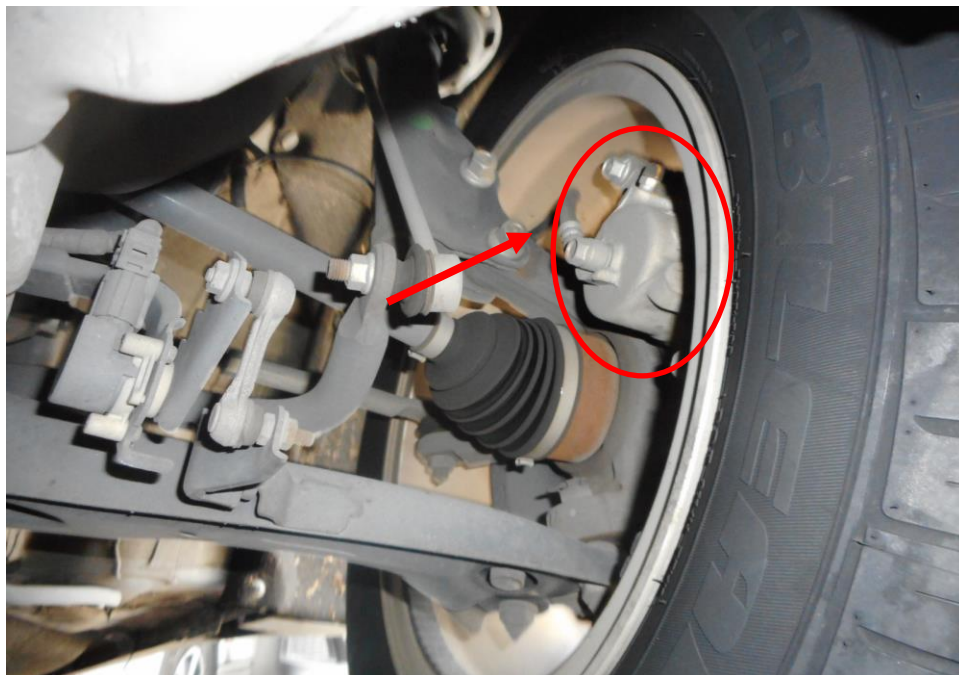
Photo 22 shows the brake hose/pipe (arrowed) at the front left wheel of the Motor Car. No leakage of brake fluid was observed. Visual examination of the various components of the braking system like the brake caliper (circled), brake booster, brake pedal etc had revealed all to be intact and without visible damage at the time of accident. There was also no sign of fluid stain(s) observed on the various undercarriage components.

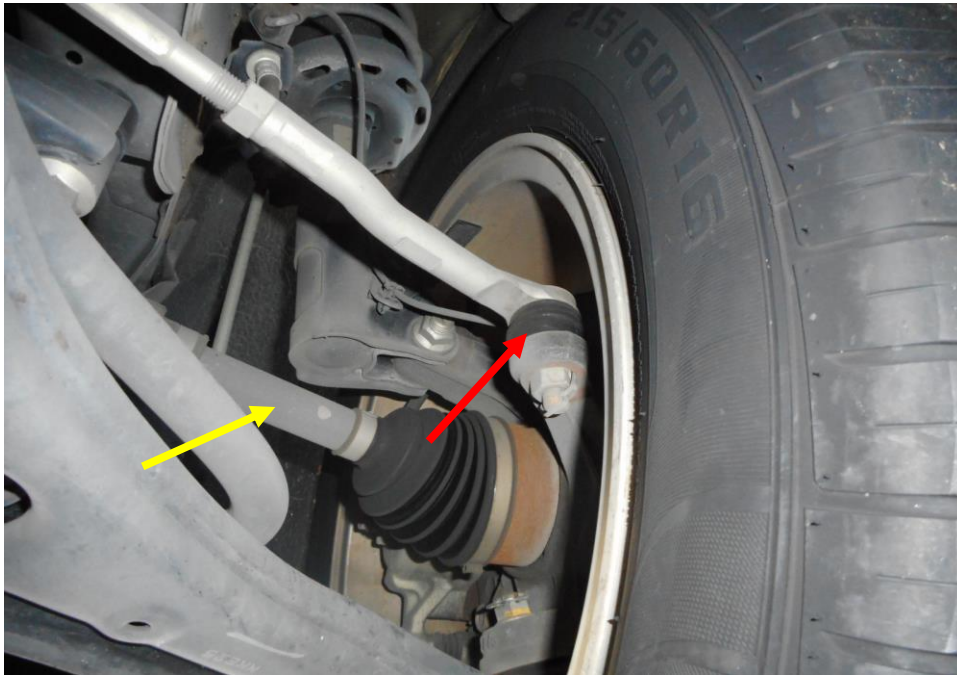
Photo 23 shows the various undercarriage components at the front right wheel of the Motor Car, in particular the steering tie rod end (arrowed) and drive shaft (yellow arrow). The various steering components were all found to be intact, suggesting that the steering system of the Motor Car was likely to be in serviceable condition at the material time of accident. There was also no sign of fluid stain(s) observed on the various undercarriage components.

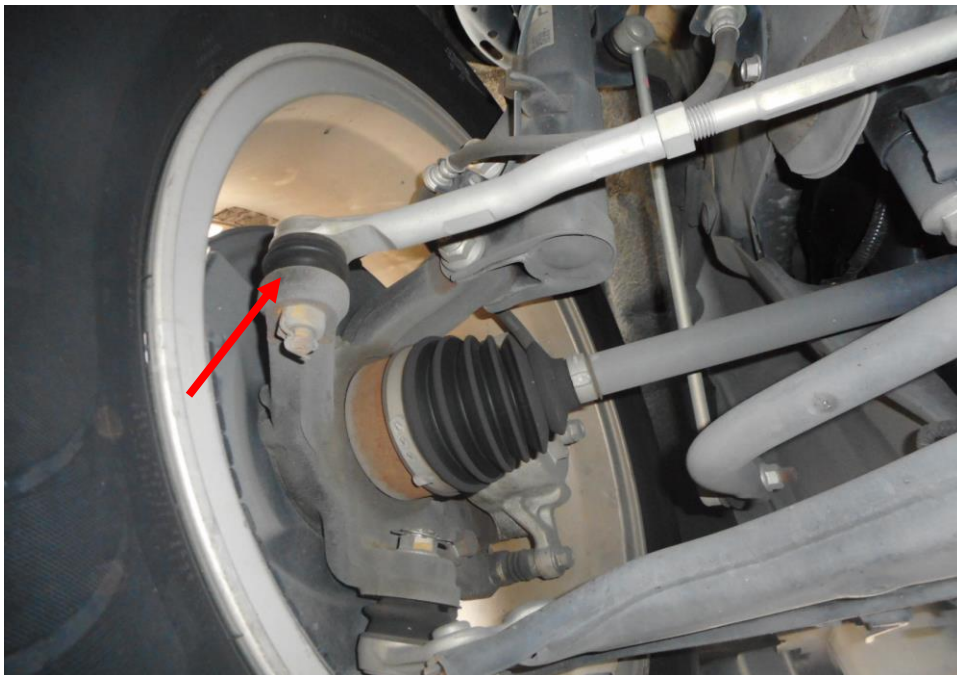
Photo 24 shows the various undercarriage components at the front left wheel of the Motor Car, in particular the steering tie rod end (arrowed). The various Undercarriage components of the Motor Car were all found to be intact without any visible damage. There was also no sign of fluid stain(s) observed on the various undercarriage components.

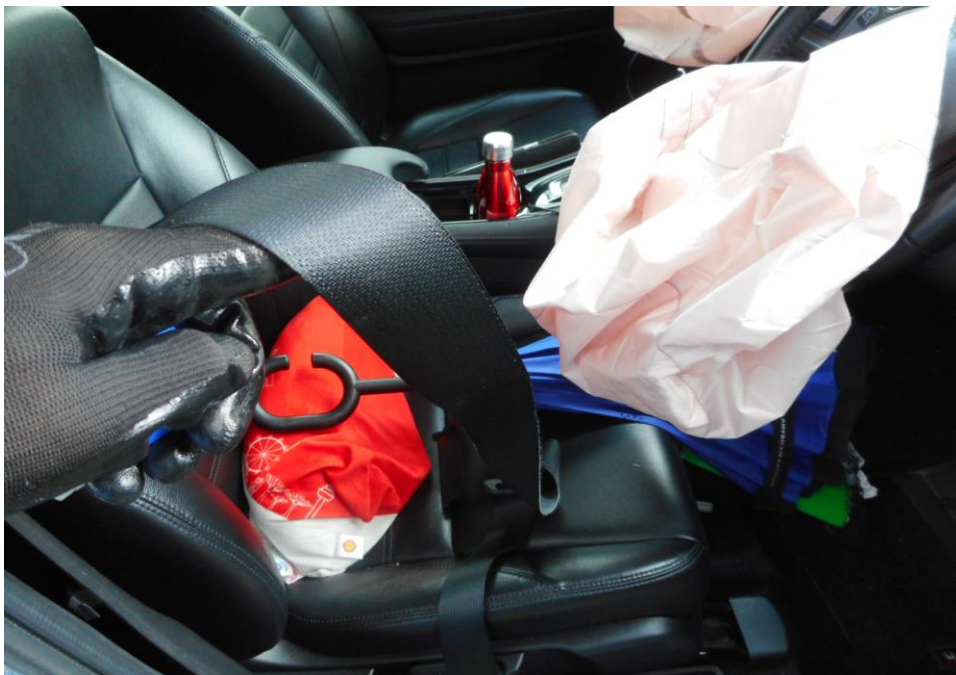
16. The front right seat belt of the "Motor Car" were worn at the material time of accident as the respective pre-tensioners that were fitted at the side of each seat was activated upon the material time. See photo 25 below.

Photo 25 shows that the seat belt on the right seat was worn at the material time of accident as the safety pre-tensioners was activated at the moment of impact and caused the seat belt to be locked into the last position.
