LKK Auto Consultants Pte Ltd

Vehicle No. SKG 2686R
Insured Veh. SMR 9875J
Claim No. CMTD2001564/MYE
Policy No.
Accident Date 08/05/2020
Inspection Date 20/05/2020

ADJUSTMENT ON REPAIR COST FOR VEHICLE NO. SKG 2686R

PHOTOGRAPHS FOR VEHICLE NO. SKG 2686R

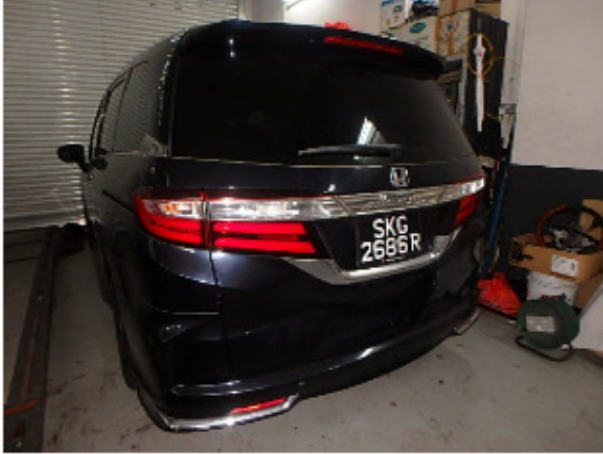
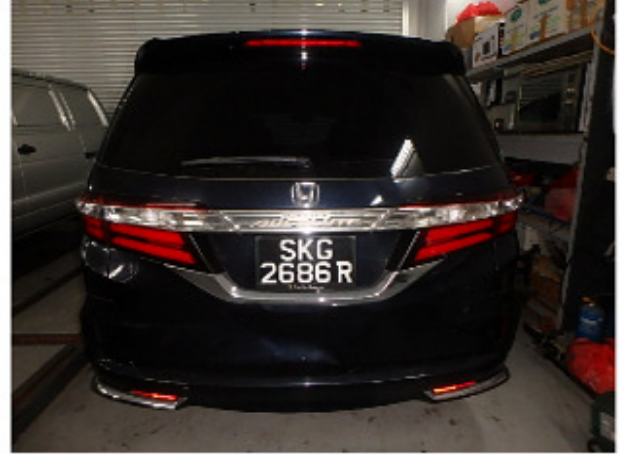
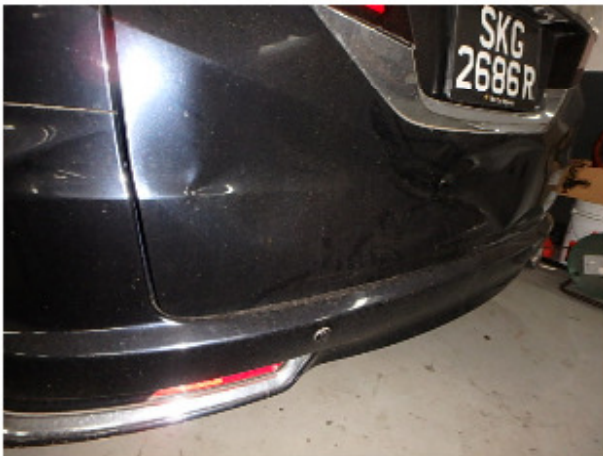
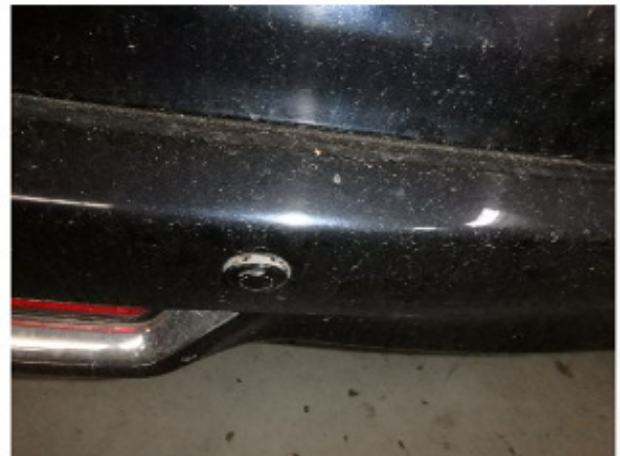
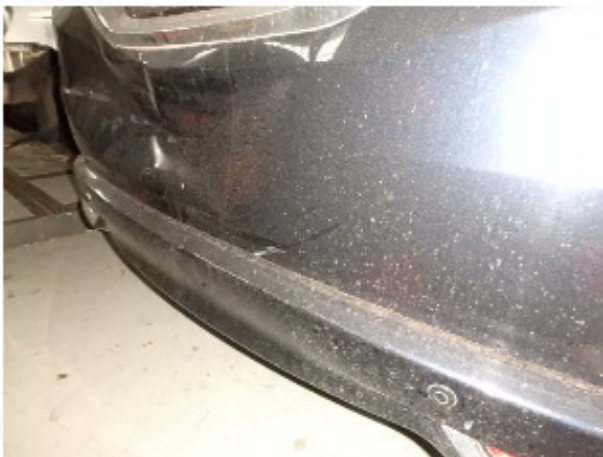
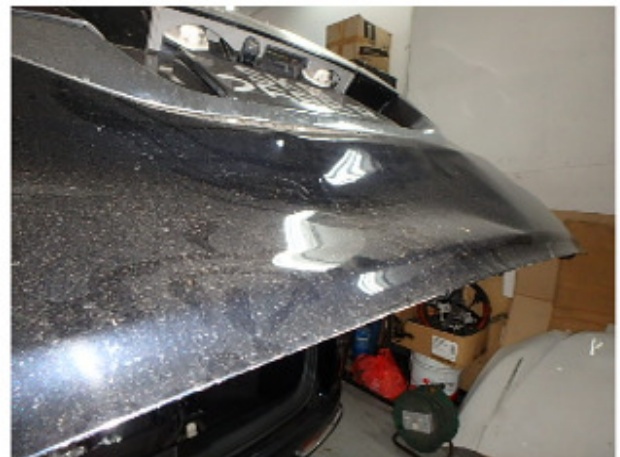
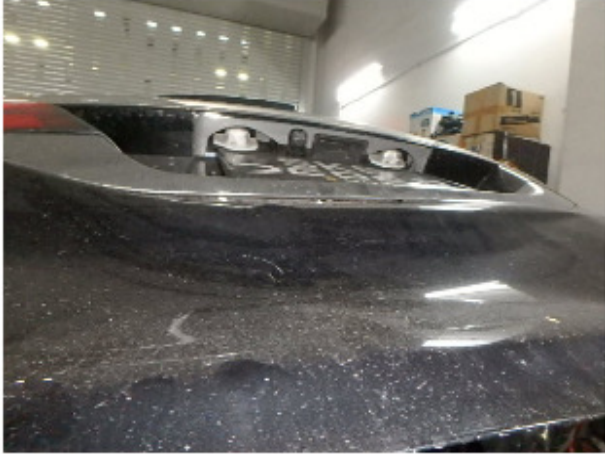
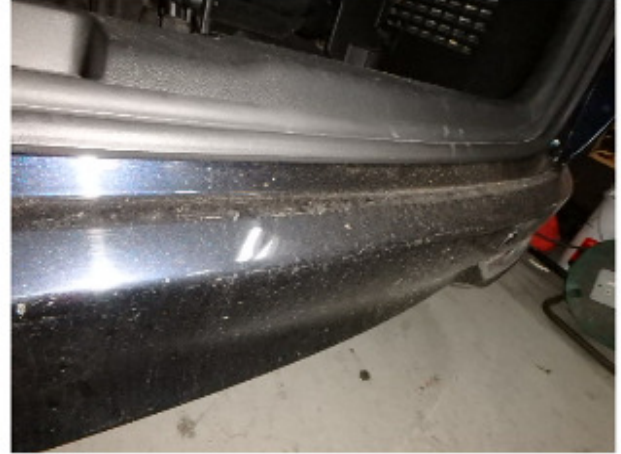
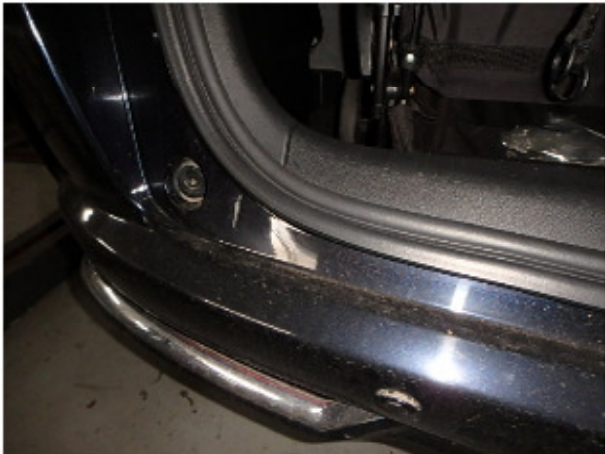
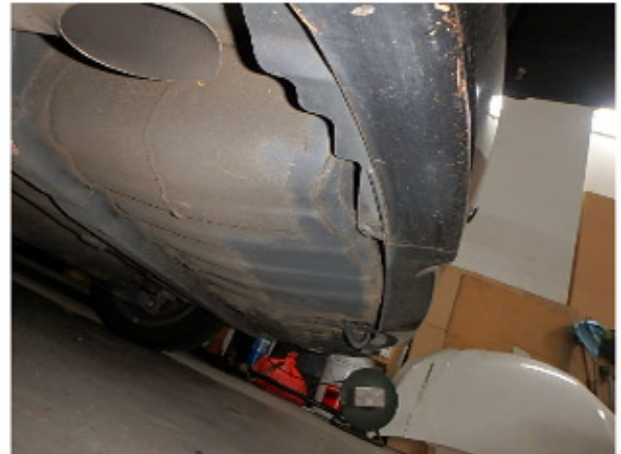
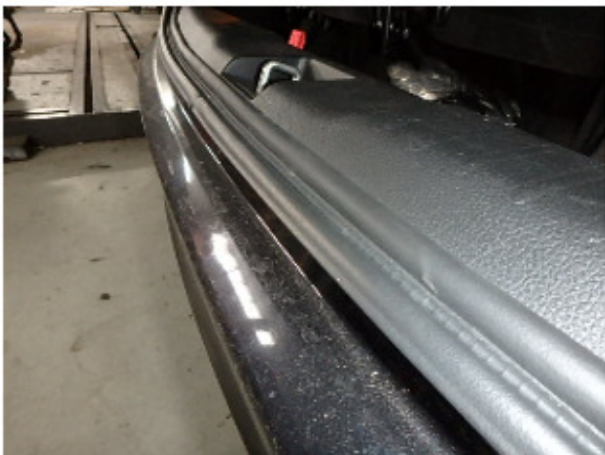
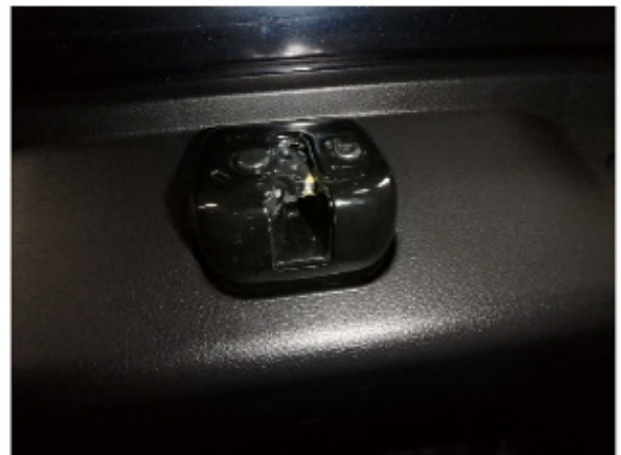
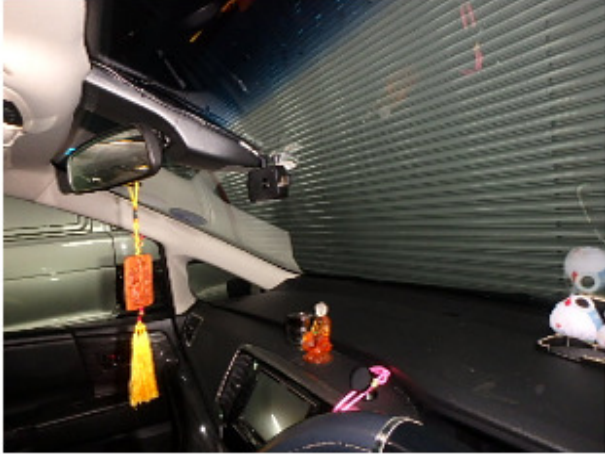
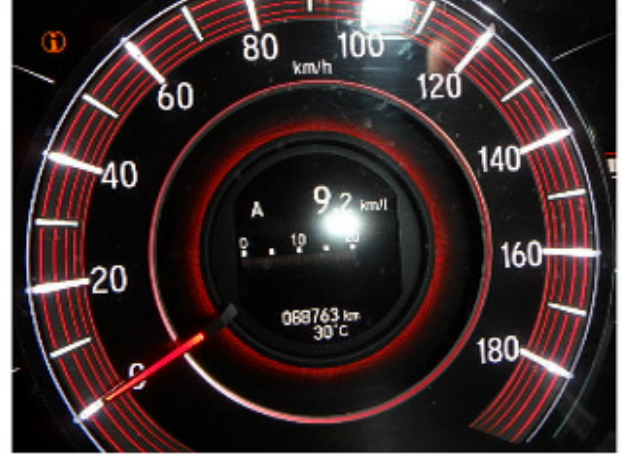
INSPECTION

THE VEHICLE SUSTAINED DAMAGES AT THE REAR PORTION.
