LKK Auto Consultants Pte Ltd

Vehicle No. SMP 7358J
Insured Veh. SHD 7208G
Claim No. D20002231MFSH
Policy No. D-20094922MFSH
Accident Date 26/05/2020
Inspection Date 27/05/2020

ADJUSTMENT ON REPAIR COST FOR VEHICLE NO. SMP 7358J

PHOTOGRAPHS FOR VEHICLE NO. SMP 7358J

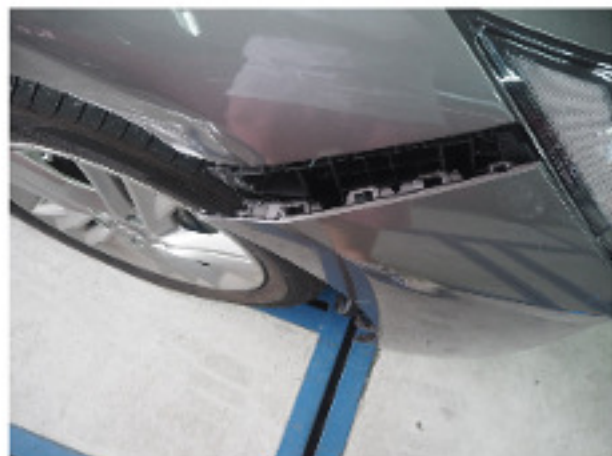
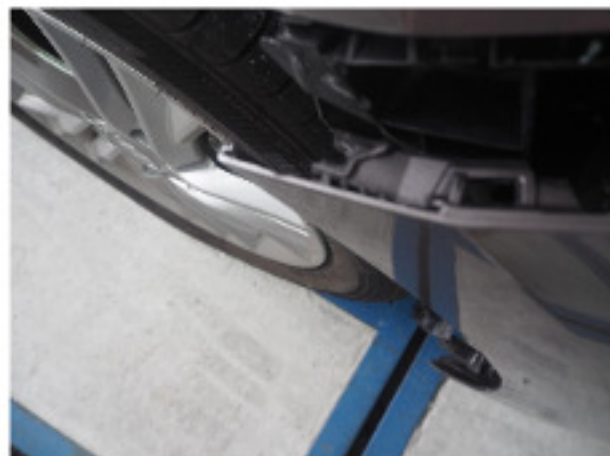
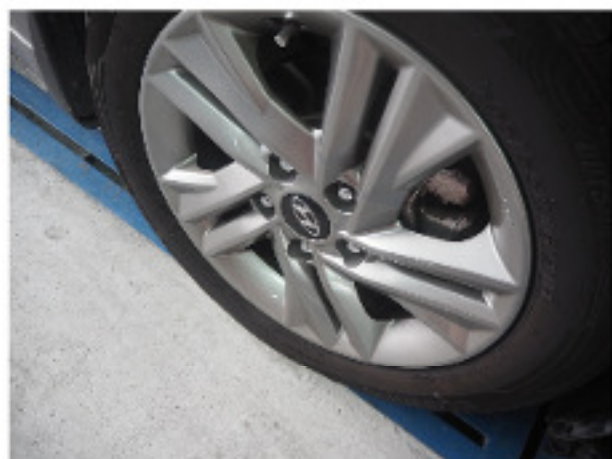
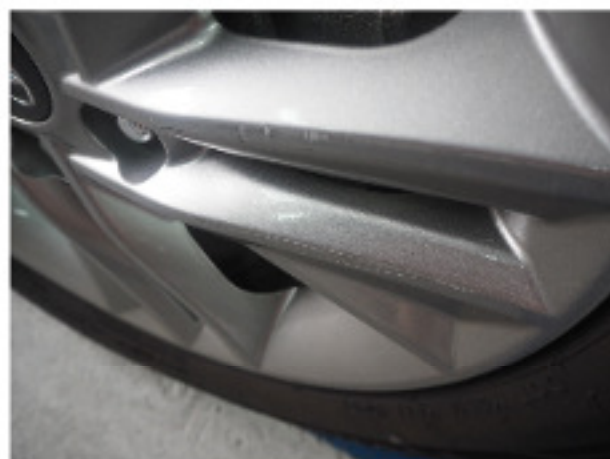
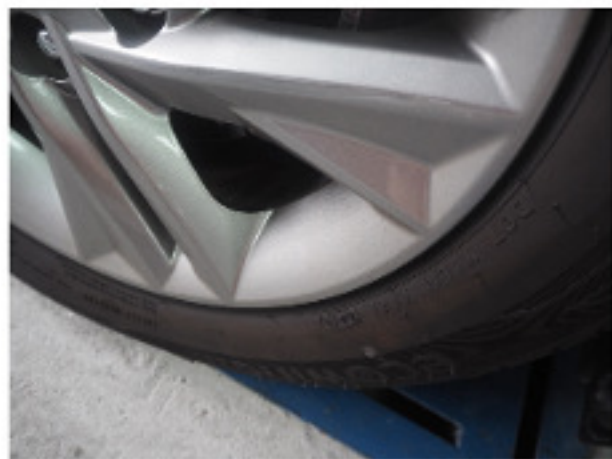
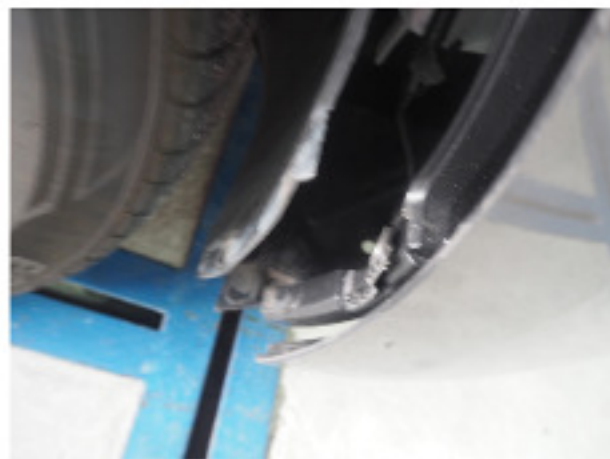
THE VEHICLE SUSTAINED DAMAGES AT THE FRONT O/S PORTION.
