Our Reference : KAAS/TA/5878/7425/TP/01.20  
Date : 20 February 2020

## VEHICLE APPRAISAL REPORT

Registration No.	: SKC 7425R	Chassis Frame No.	: WAUZZZ4G8BN023912
Make / Model	: Audi A6 2.8 FSI MU	Engine No. ( Logcard )	: CHV003670
Year of Manufacture/Reg	: 2011	Odometer Reading	: 164,374 KM
Colour	: Black		
Class / Type	: Saloon

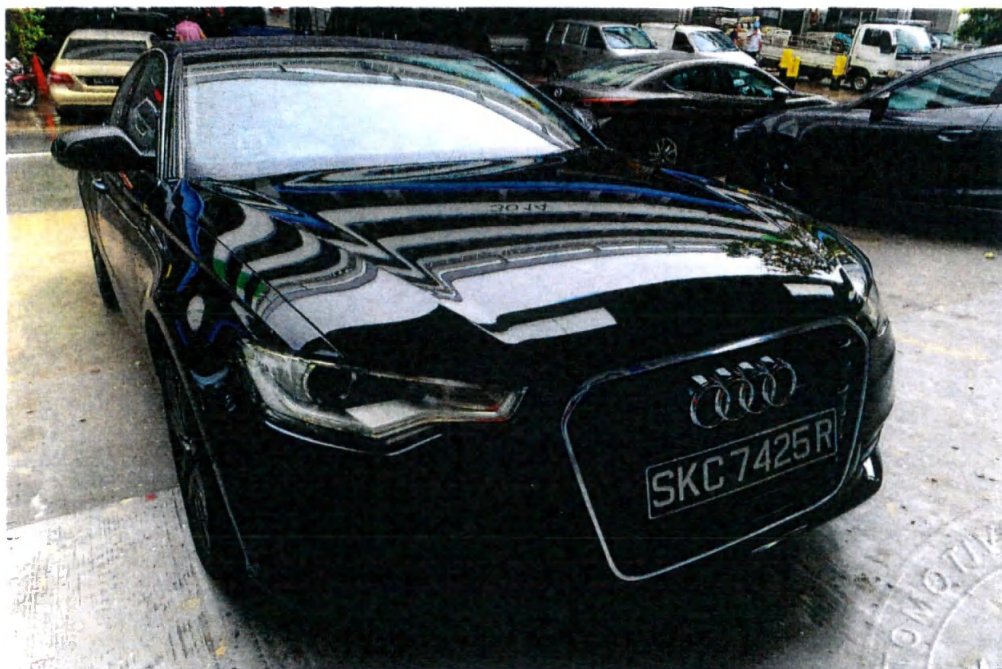
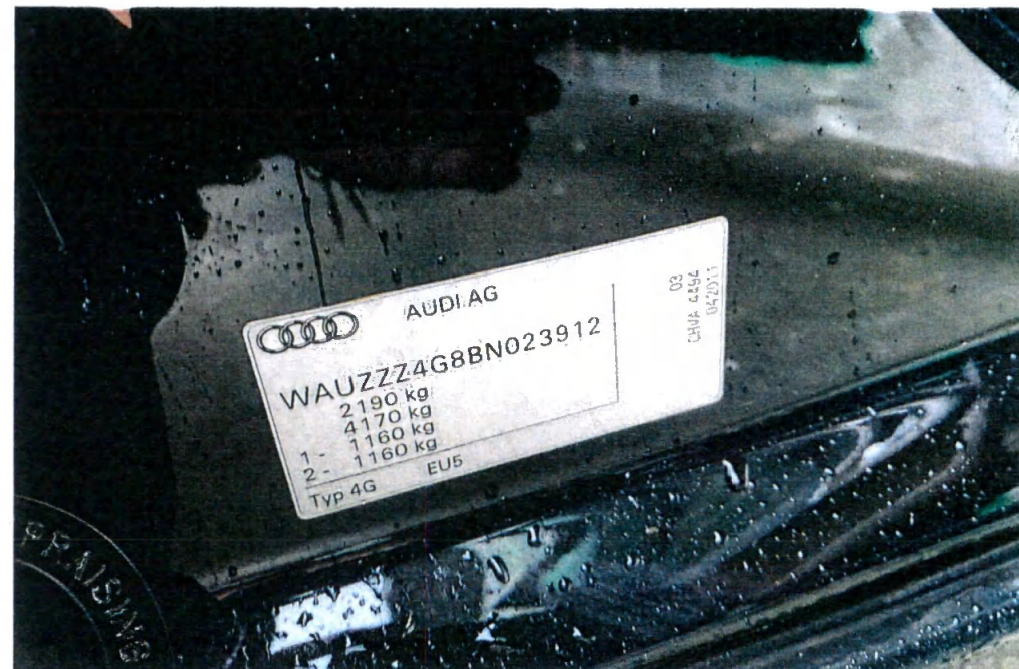
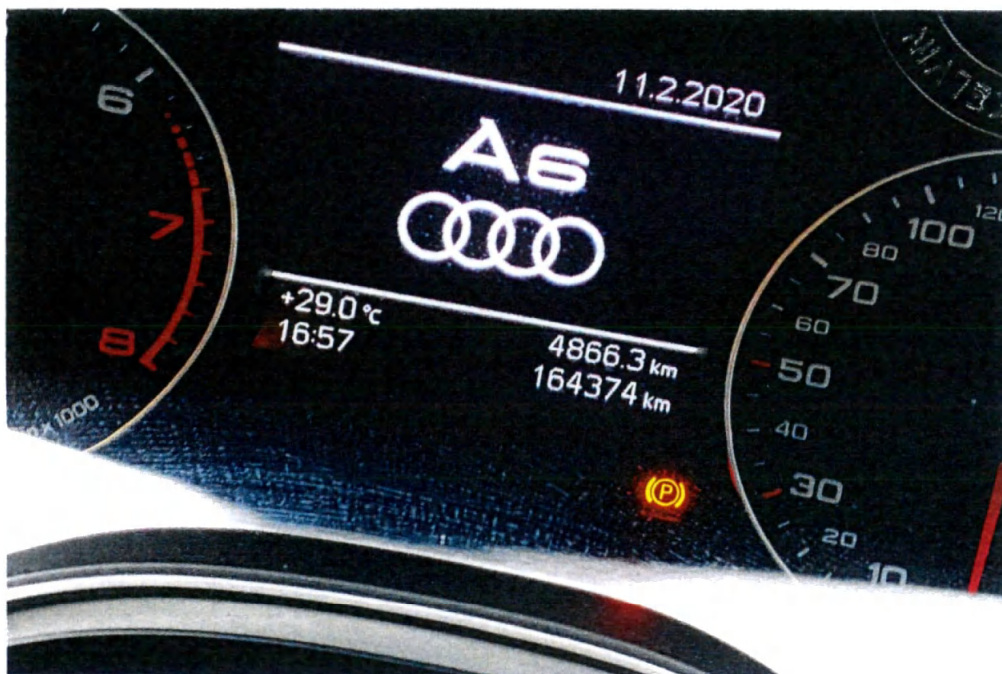
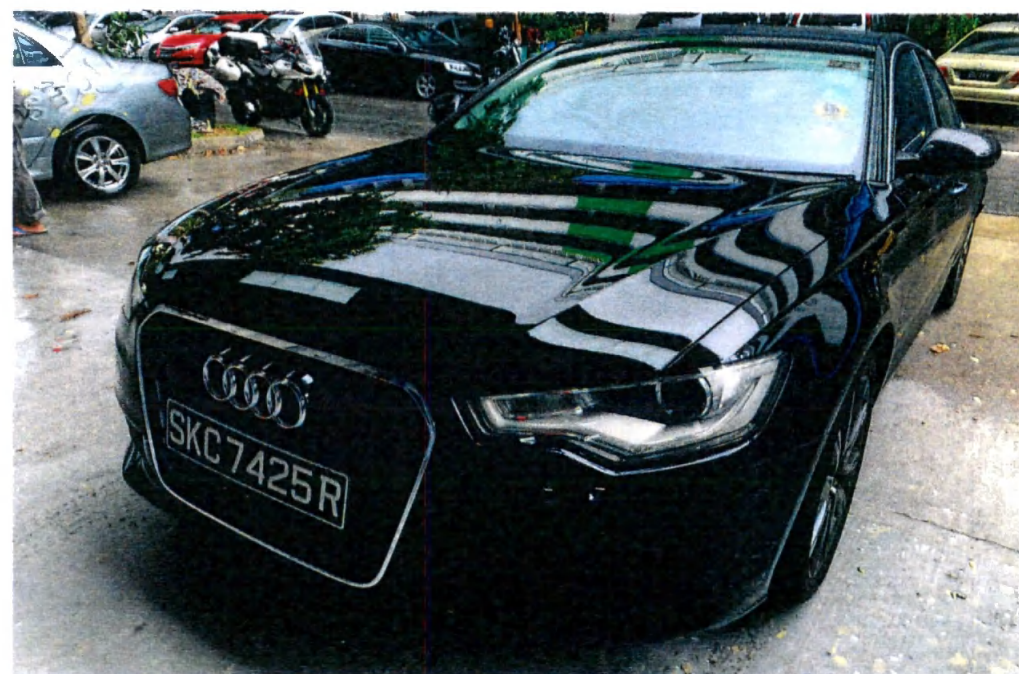
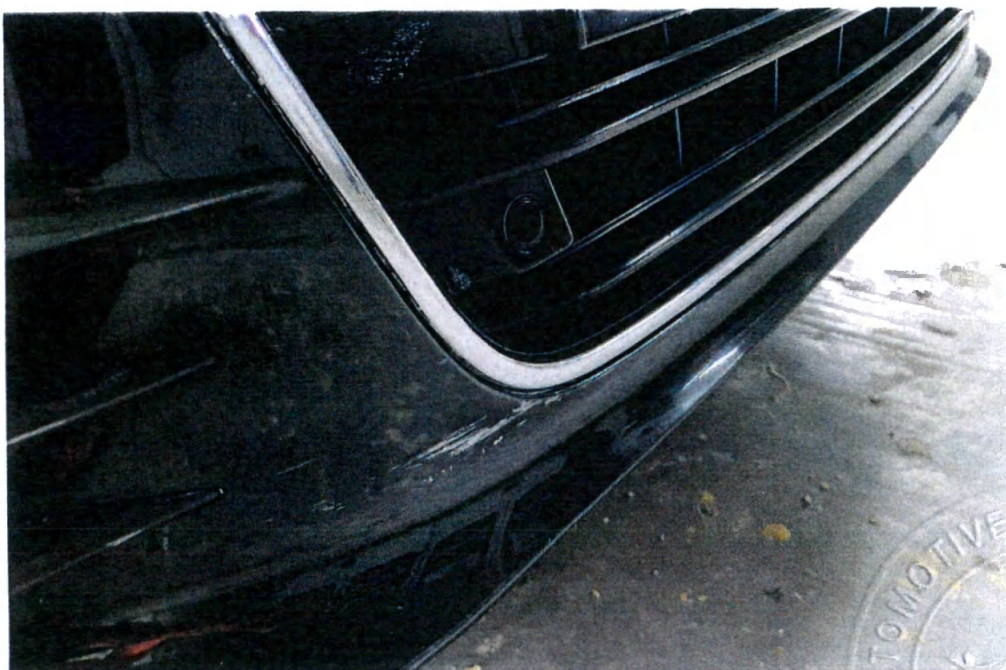
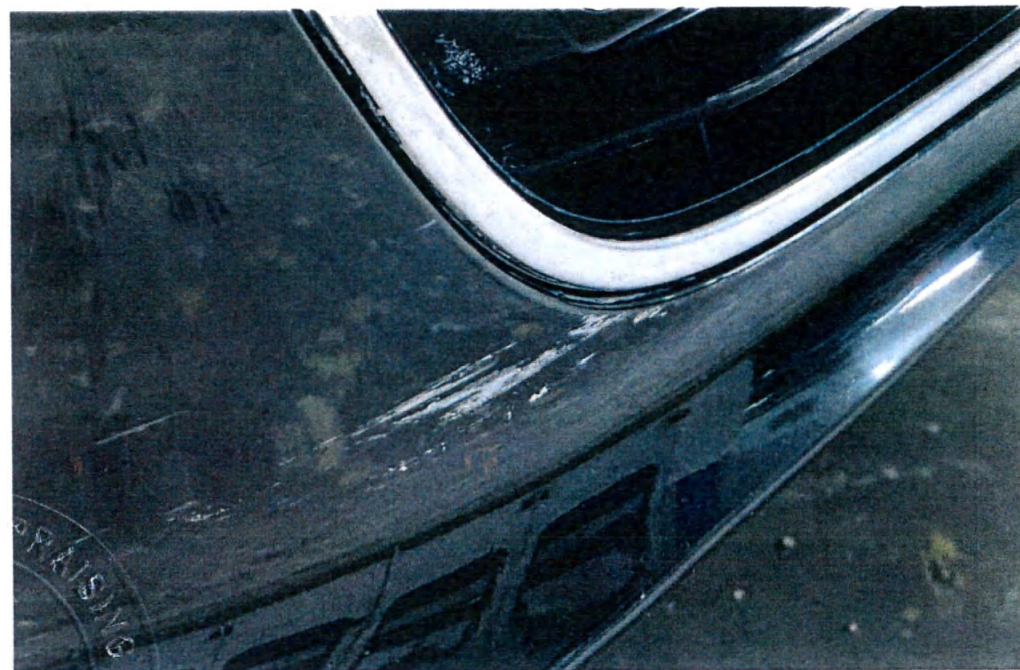
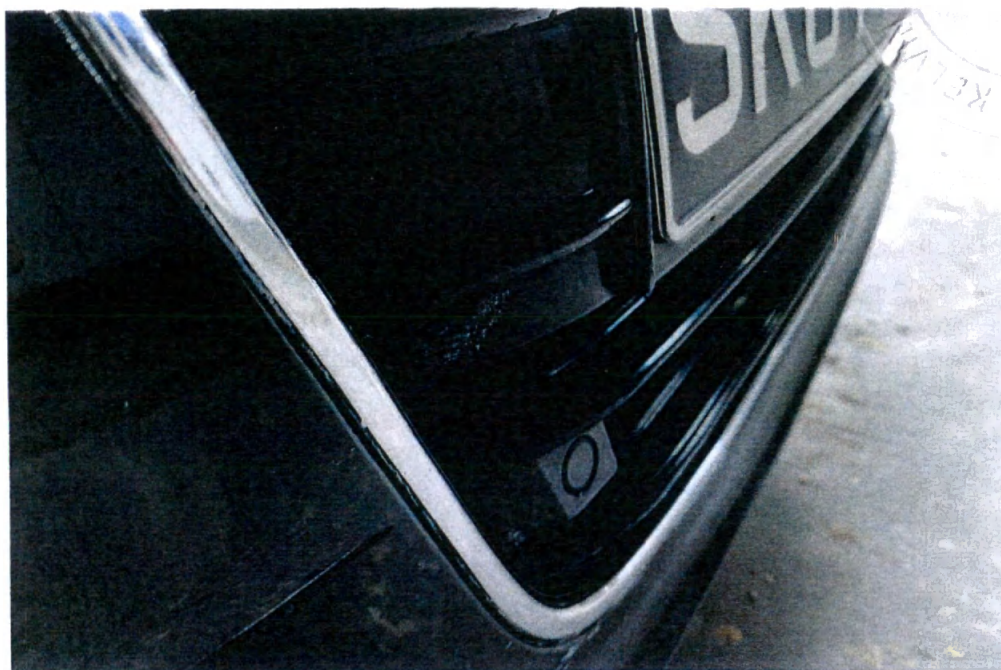
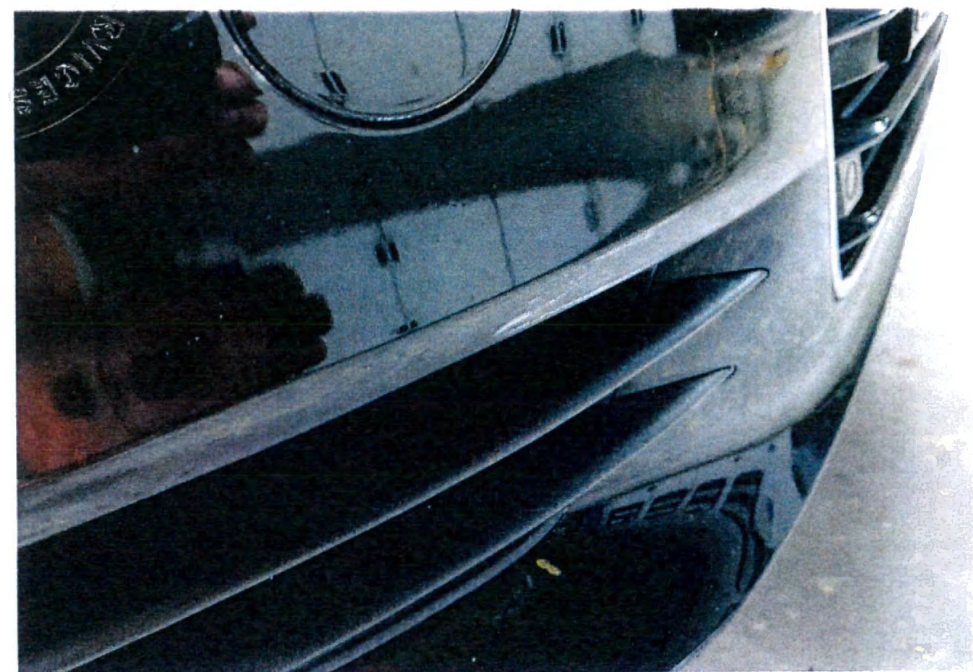
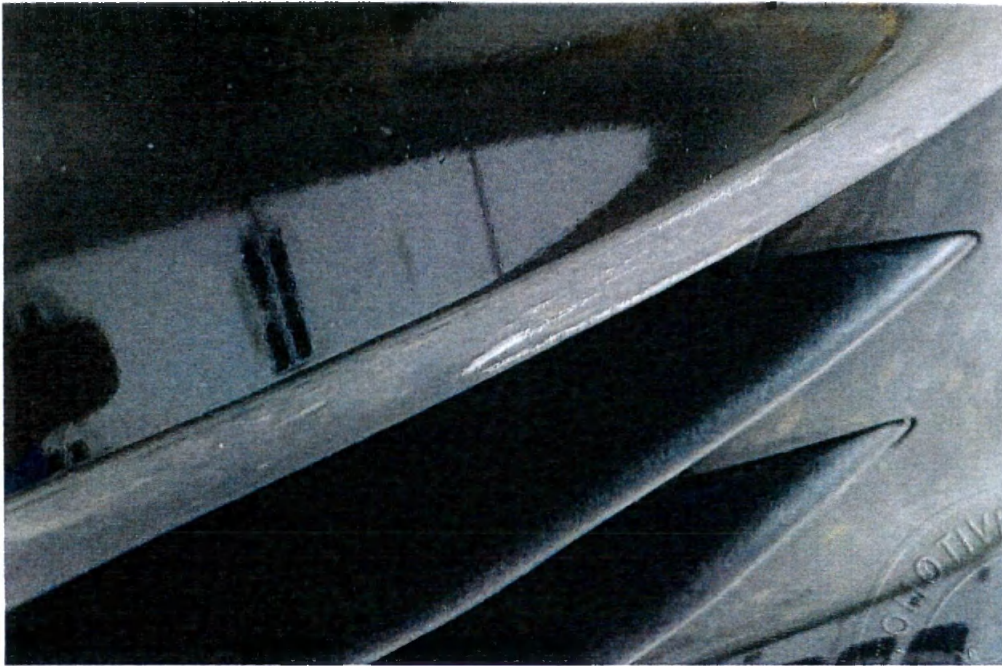
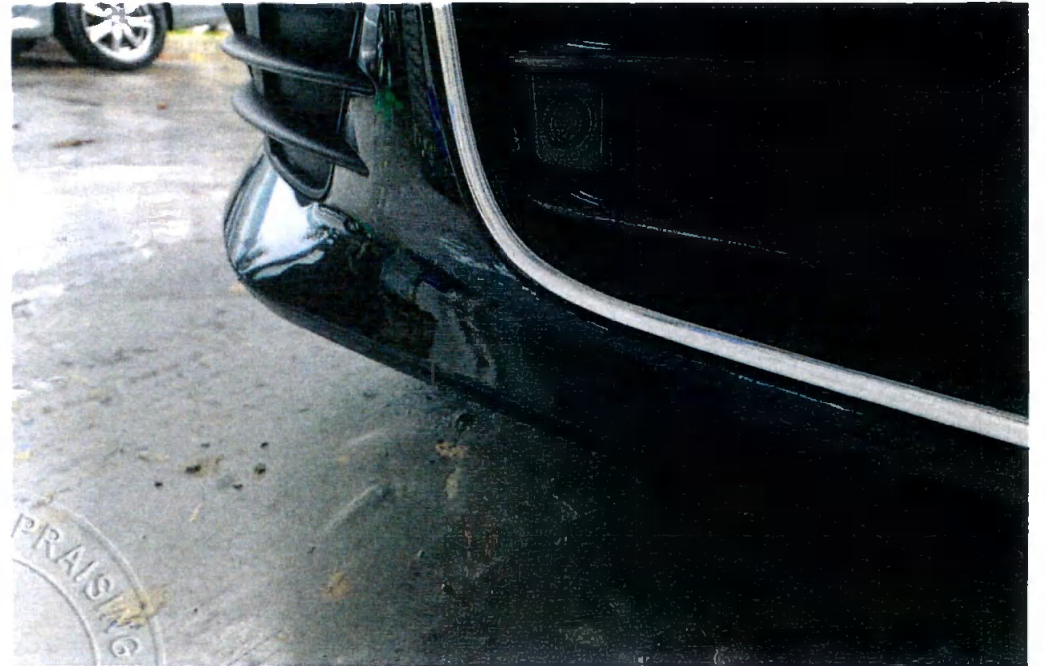
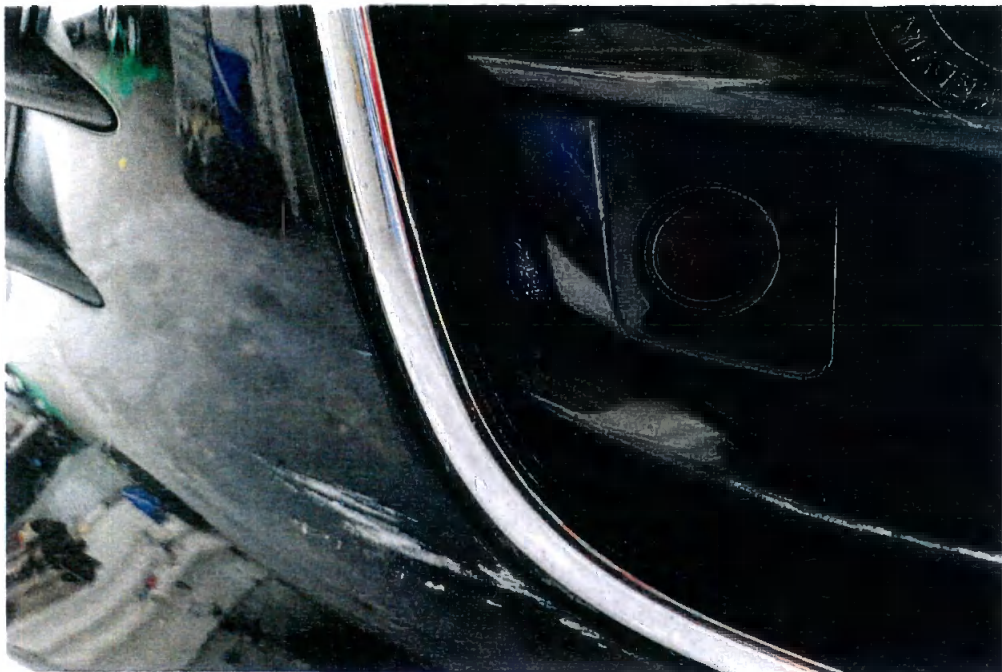
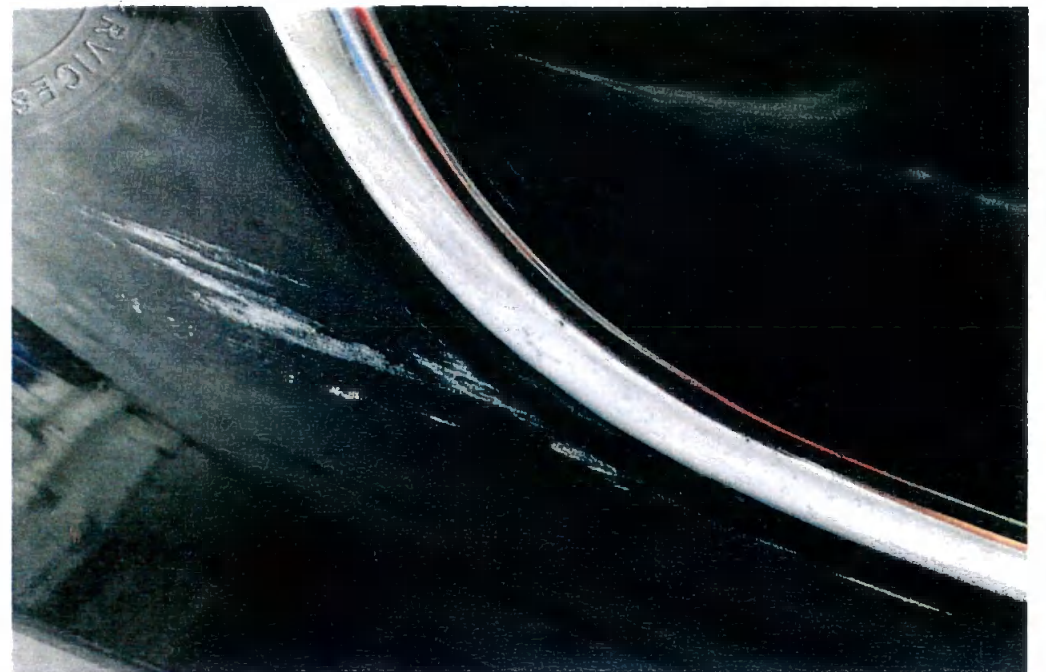
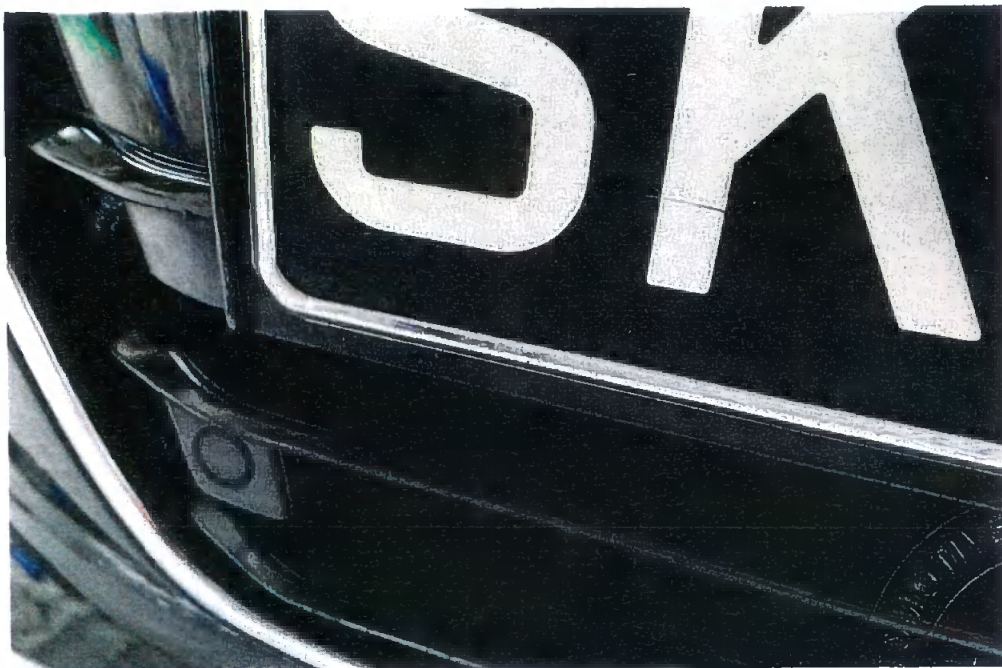
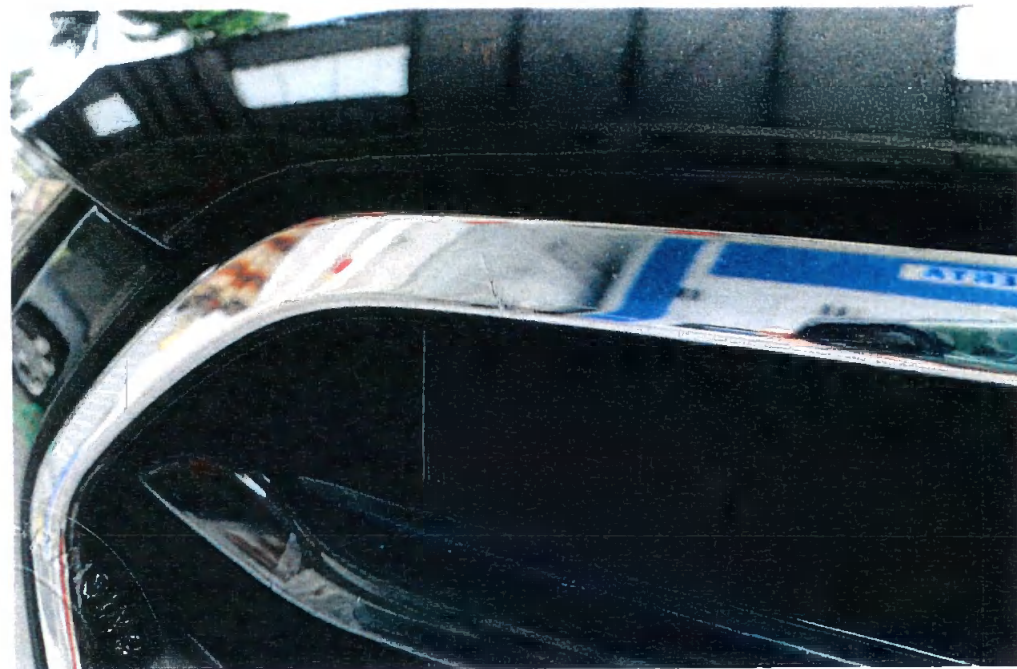
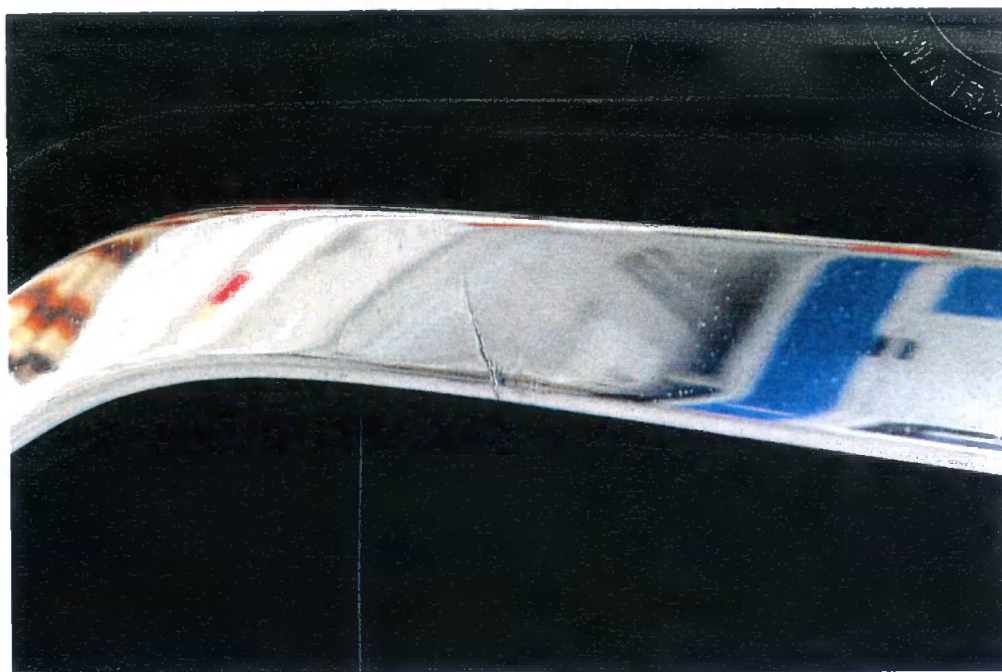
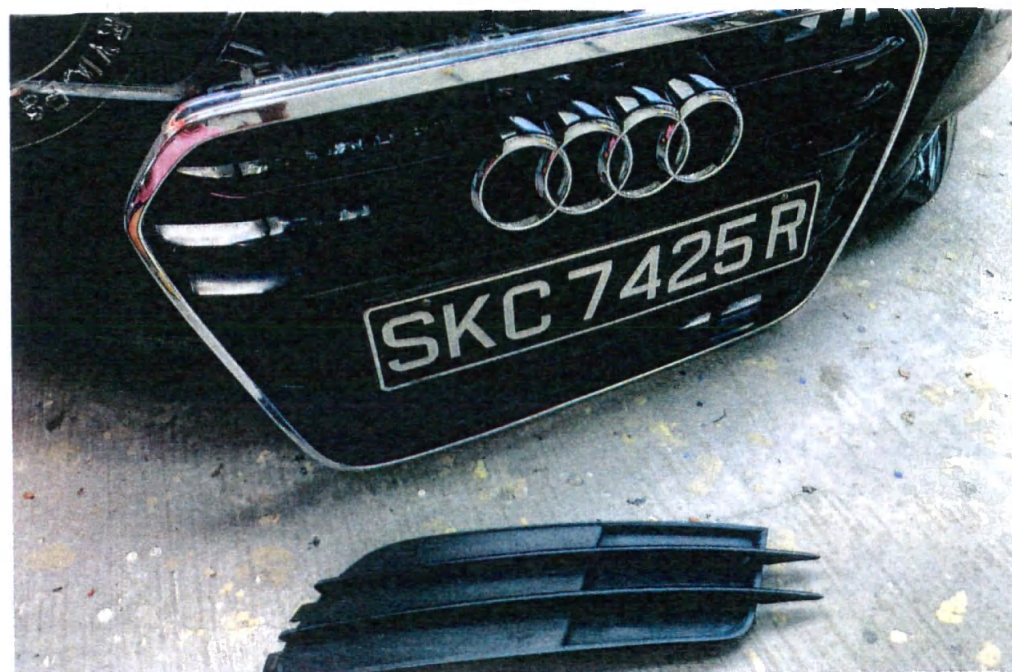
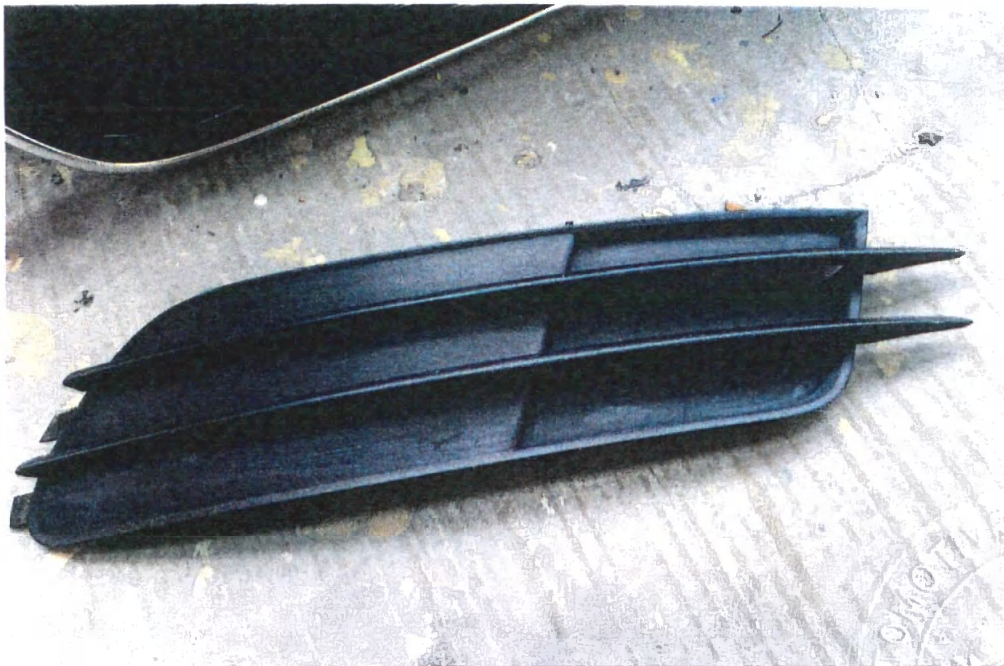
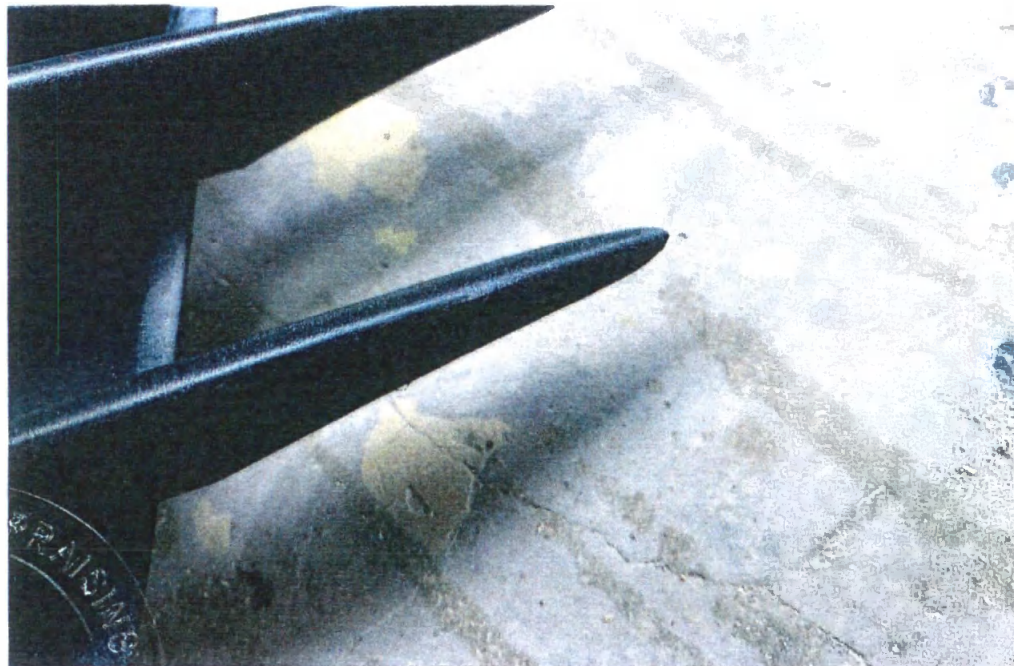
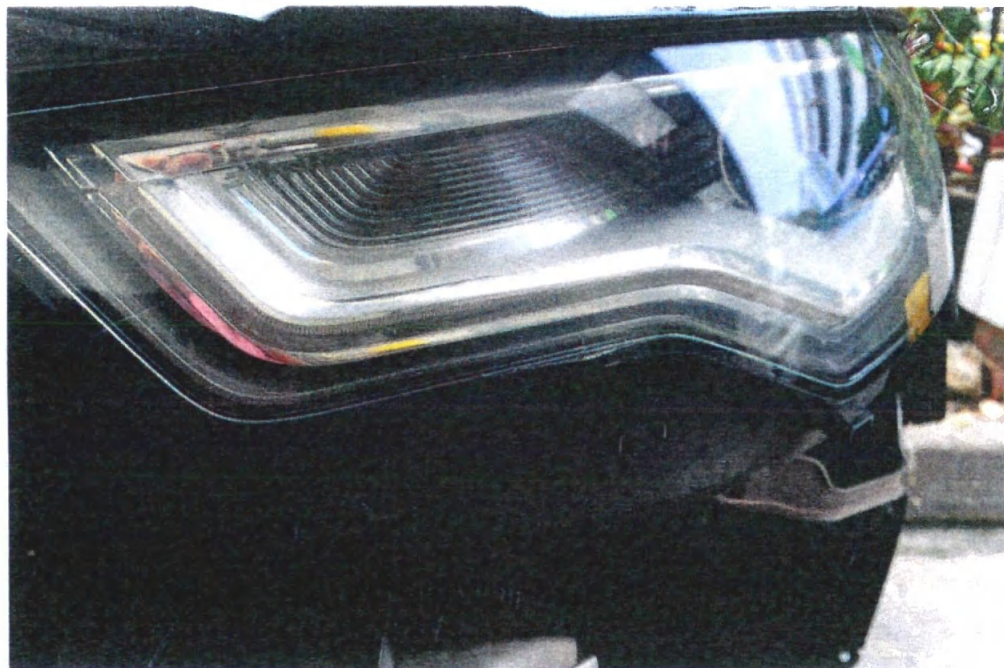
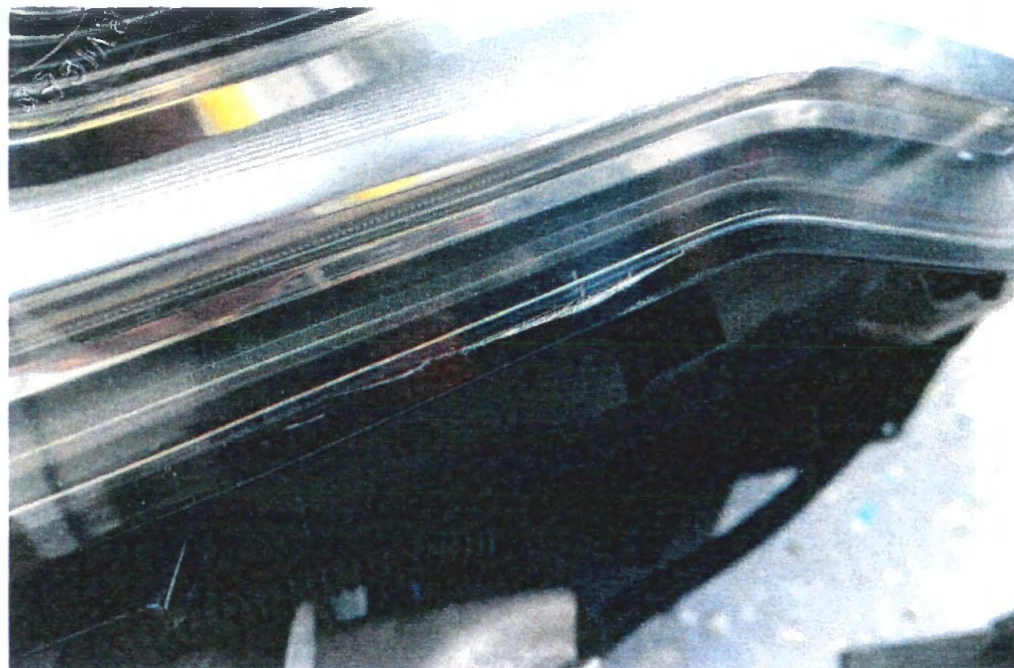
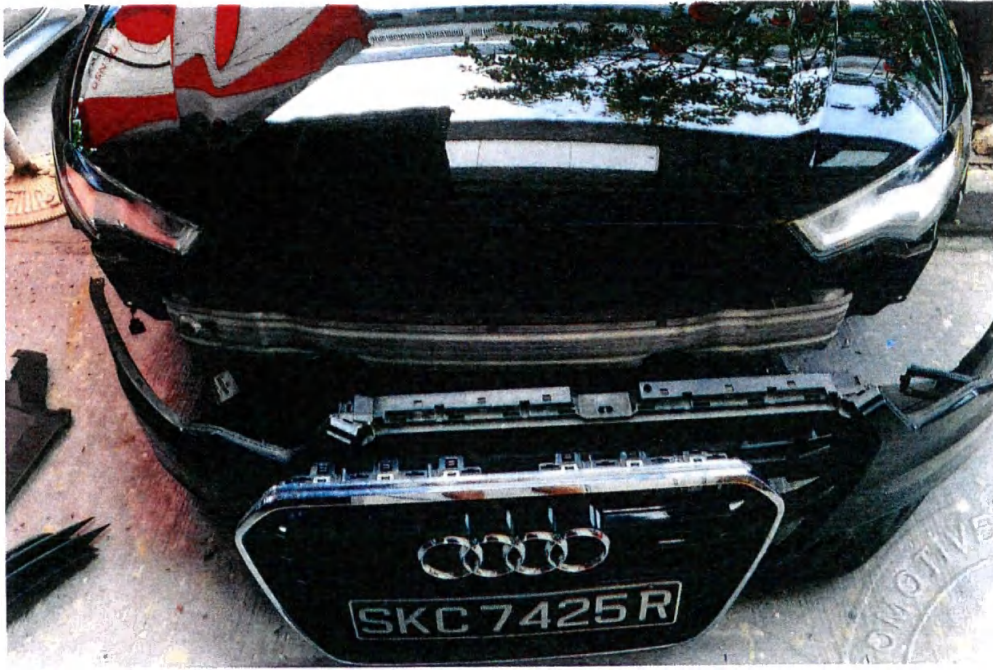
Damages sustained were consistent with the subject vehicle being involved in a collision with another vehicle and the impact was delivered to the Front portion of the vehicle.

The general area of damages is at the Front portion  
( Please refer to the parts list and photographs as attached for more information )

The estimated repair costs submitted by Messrs Leng Wang Motor is \$ 8,759.10 .  
We have adjusted the cost to \$ 7,669.87 and the repairer has agreed to undertake the repairs at a  
Contract Lump Sum of \$ 6,150.00 to a acceptable quality and standards.  
However, we have not given authorization and instruction to the repairer to proceed with the repairs.
