**K A A S**  
kelvin automotive appraising services

Our Reference : KAAS/TA/5878/7425/TP/01.20  
Date : 20 February 2020

## VEHICLE APPRAISAL REPORT

| Registration No. | : SKC 7425R | Chassis Frame No. | : WAUZZZ4G8BN023912 |

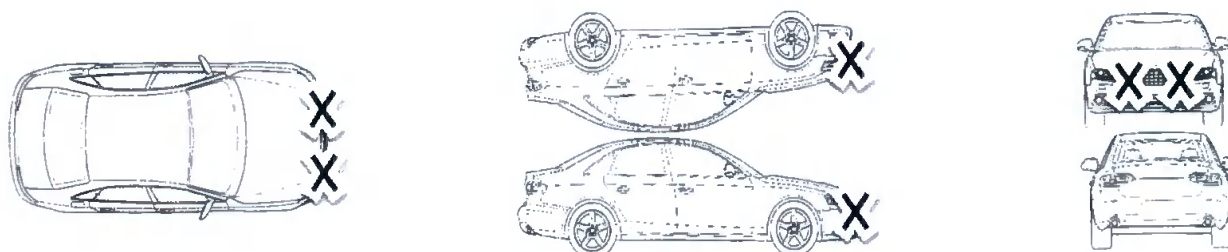
Damages sustained were consistent with the subject vehicle being involved in a collision with another vehicle and the impact was delivered to the Front portion of the vehicle.

The general area of damages is at the Front portion  
( Please refer to the parts list and photographs as attached for more information )
