Your Ref: TP/IP/19051/2020
Our Ref : CI/TPD20005979/N

11 September 2020

Fatal Accident Investigation Team

INSPECTION REPORT OF MOTORCYCLE FP 8084A

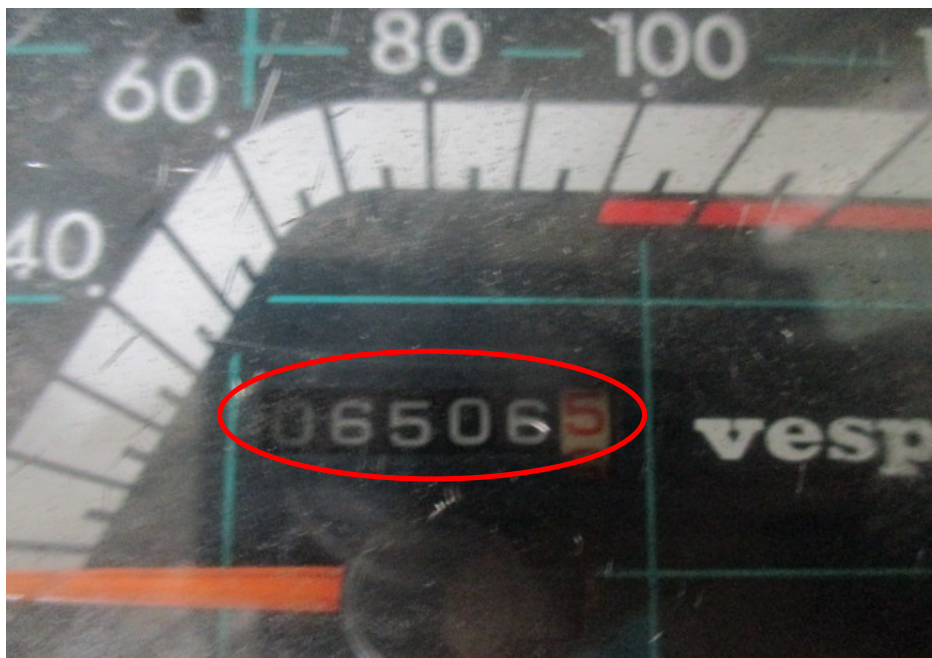
Photo 1 shows the speedometer gauge of the Motorcycle where the mileage recorded at the time of our inspection was 6, 506km (circled).

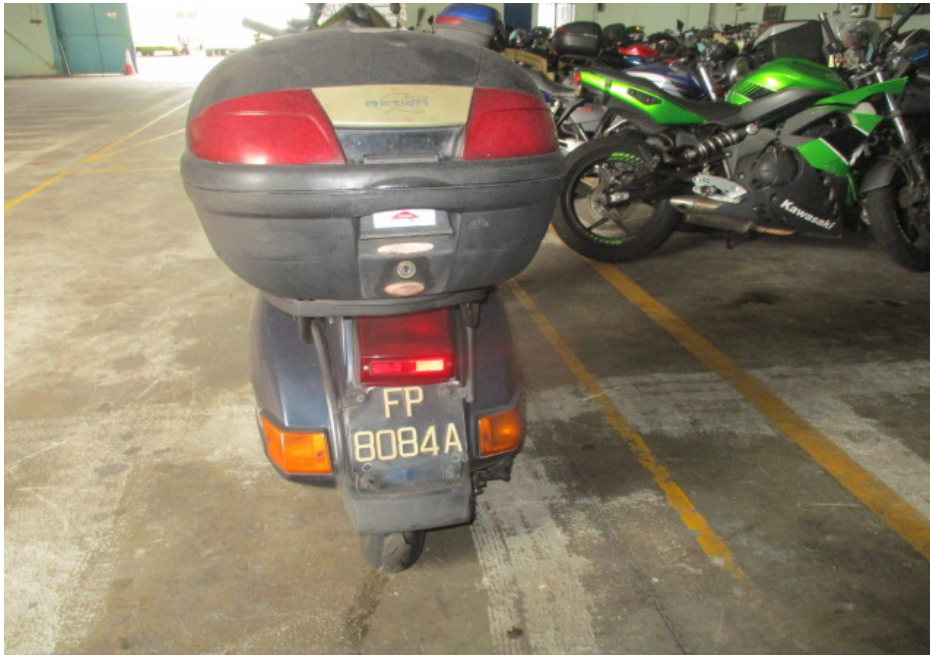
Photo 2 shows a general view of the rear portion of the Motorcycle at the time of our inspection. The Motorcycle was observed to have sustained damages along its frontal portion and right body.

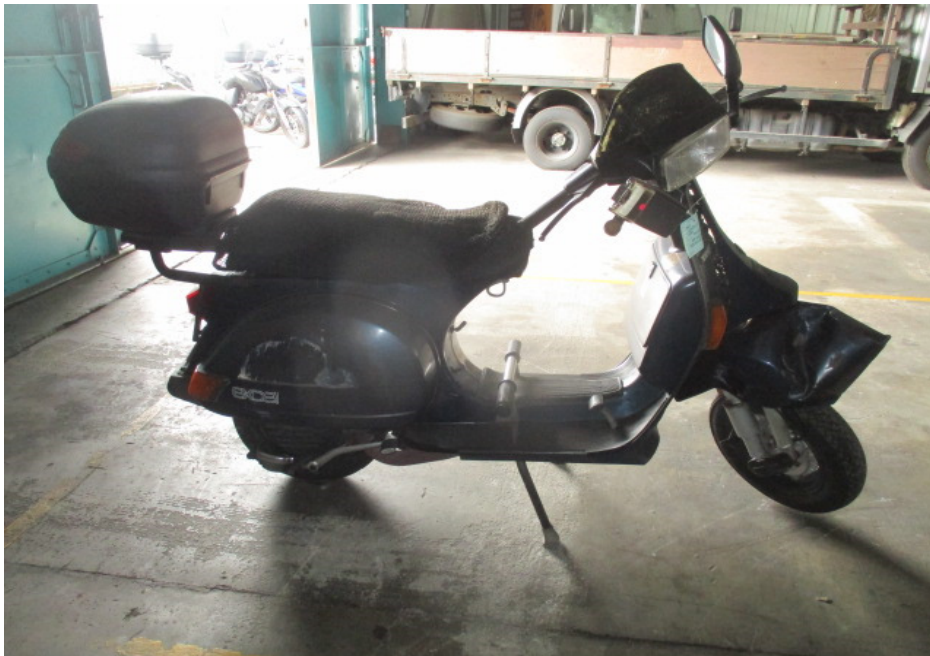
Photo 3 shows a general view of the right body of the Motorcycle at the time of our inspection. The Motorcycle was observed to have sustained damages along its frontal portion and right body.

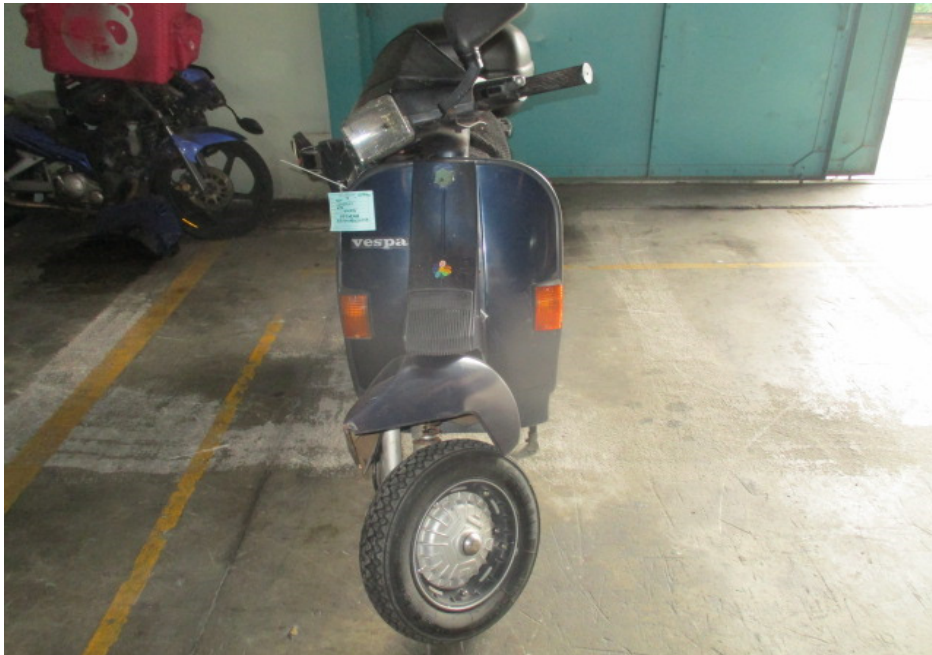
4. The mileage of the Motorcycle at the time of our inspection was 6,506km.
5. The Motorcycle was observed to have sustained damages along its frontal portion and right body. The body parts that were found to have been damaged include its headlight assembly, headlight, front mudguard, right side mirror, front brake lever, right handlebar grip, steering column cover and right rear side cover, amongst others.

Photo 4 shows a general view of the frontal portion of the Motorcycle at the time of our inspection. The Motorcycle was observed to have sustained damages along its frontal portion and right body. Amongst the body parts that were found to have been damaged include its headlight assembly, headlight, front mudguard, right side mirror, front brake lever, right handlebar grip, steering column cover and right rear side cover, amongst others.

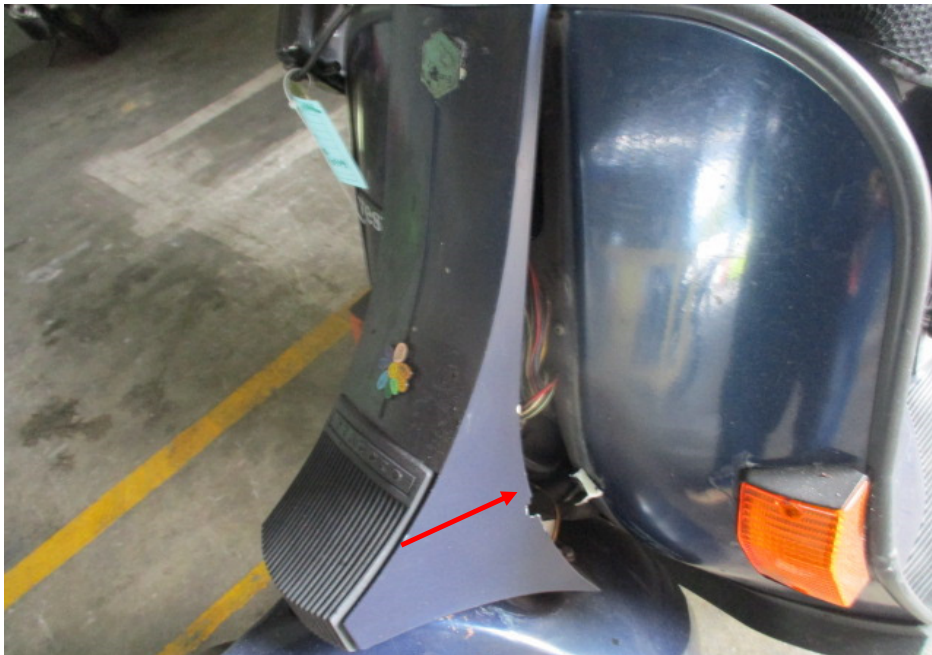
Photo 5 shows a closer view of the damaged steering column cover of the Motorcycle at the time of our inspection (arrowed).

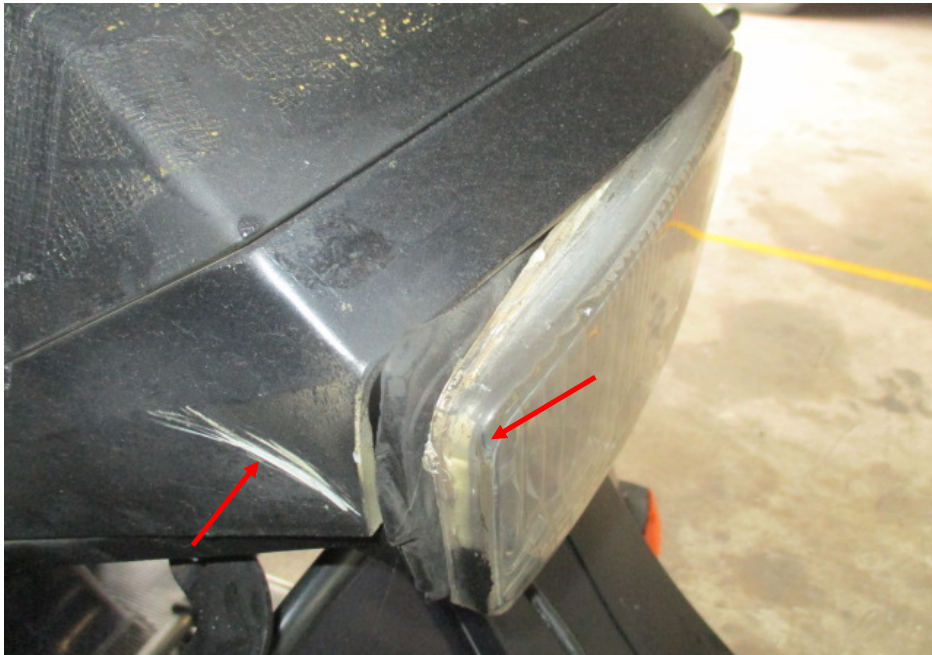
Photo 6 shows a close up view of the headlamp assembly of the Motorcycle at the time of our inspection. Amongst the body parts damaged were its headlight assembly and headlight (arrowed).

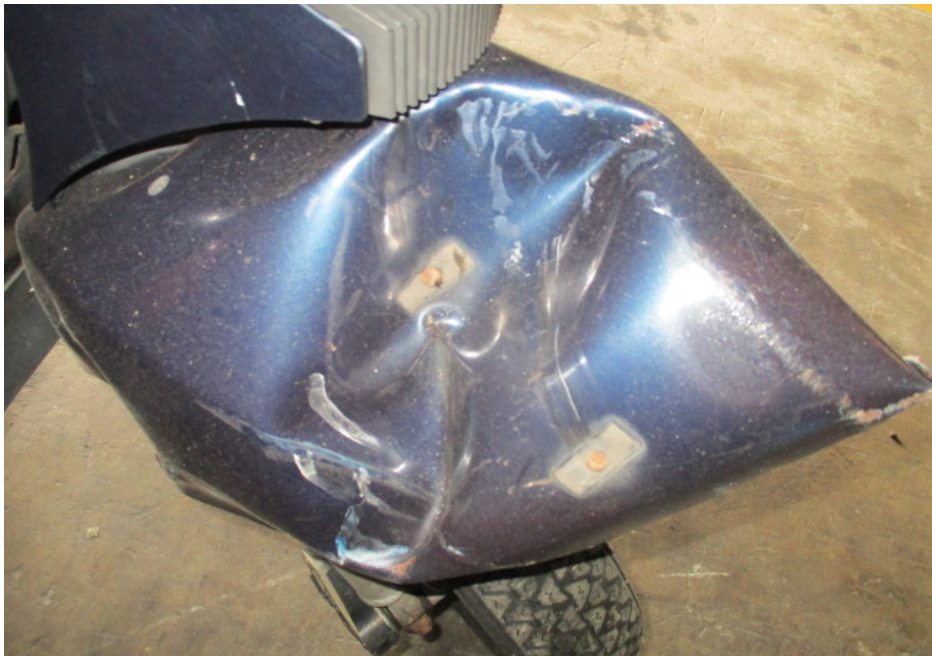
Photo 7 shows the dented front mudguard of the Motorcycle as a result of the accident.

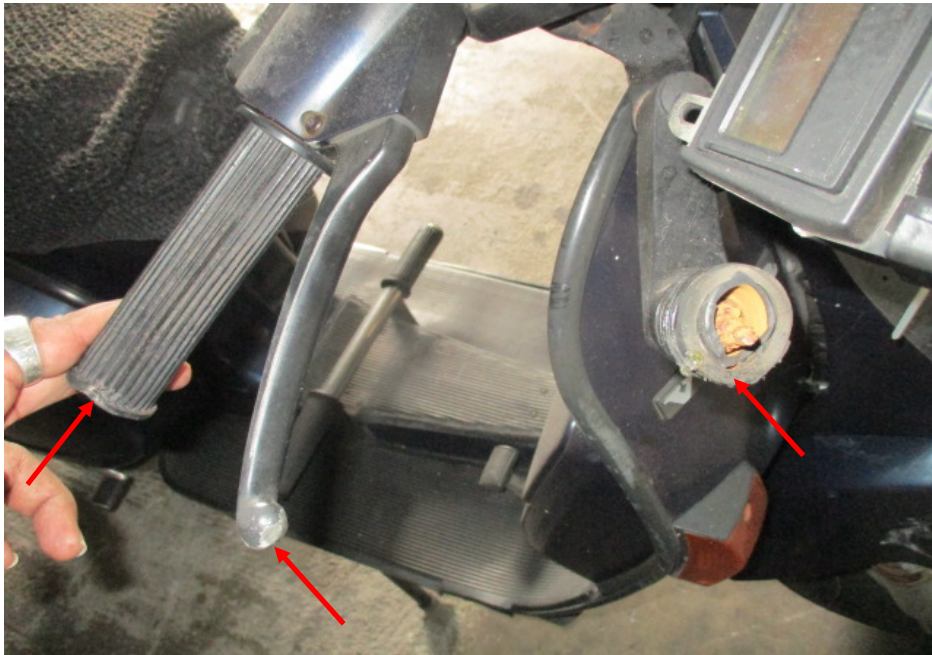
Photo 8 shows a close up view of the right handlebar grip, front brake lever and broken right side mirror of the Motorcycle which had sustained damage as a result of the accident (arrowed).

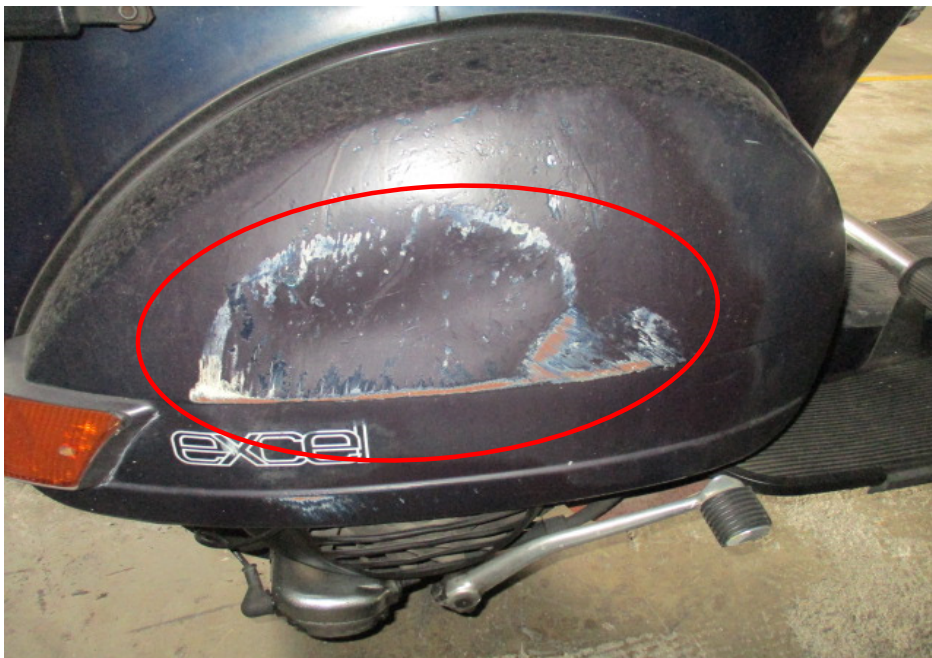
Photo 9 shows the damaged right rear side cover of the Motorcycle. The damage sustained was mainly of grazing nature (circled).

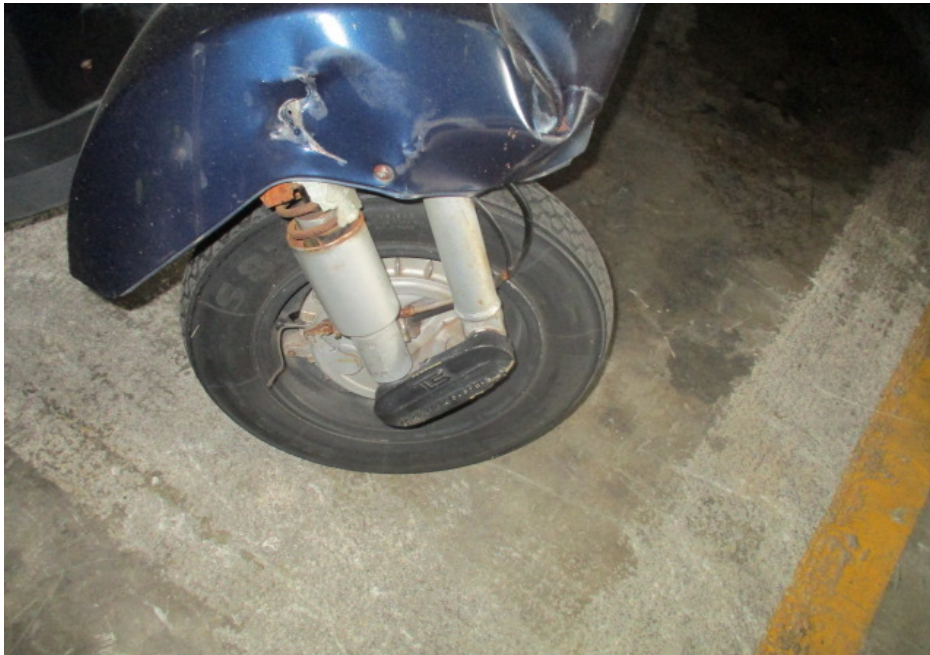
Photo 10 shows the front wheel rim and front tyre of the Motorcycle at the time of our inspection. The front tyre was observed to be in serviceable condition with remaining tread depth of approximately 3mm. The tyre was also observed to be sufficiently inflated for vehicular operation. There was no significant damage observed on the front wheel rim.

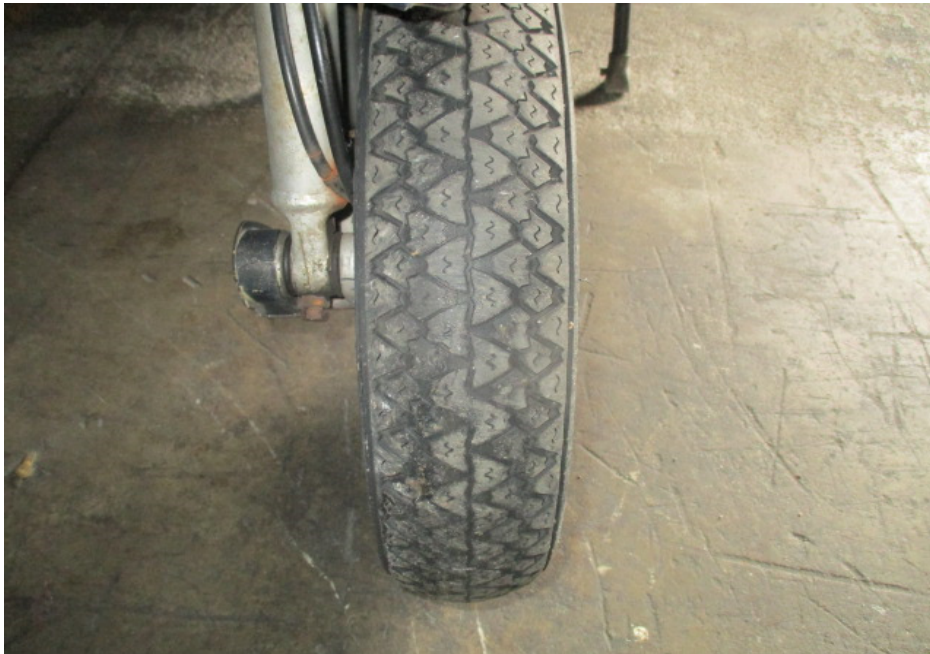
Photo 11 shows the front tyre of the Motorcycle at the time of our inspection. The front tyre was observed to be in serviceable condition. The pattern of the tread was also clearly visible. There was no tear, burst mark(s) and/or punctured hole(s) on the sidewalls as well as across the tread of the front tyre.

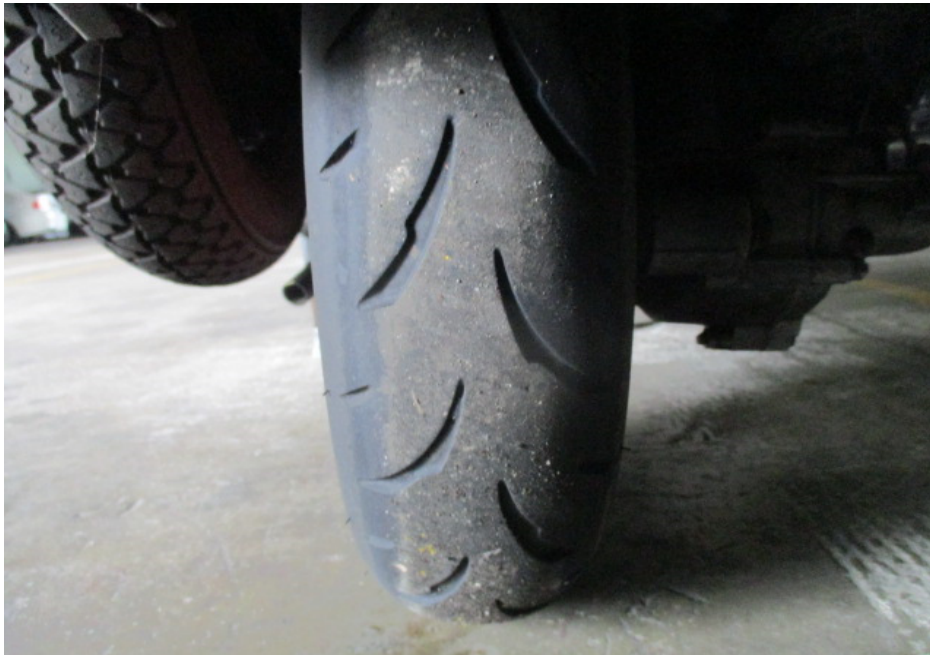
Photo 12 shows the condition of the Motorcycle's rear tyre. The rear tyre was observed to be in serviceable condition with remaining tread depth of approximately 4mm. The tyre was also observed to be sufficiently inflated for vehicular operation. We did not observe any tear, burst mark(s) and/or punctured hole(s) on the sidewalls as well as across the tread of the rear tyre.

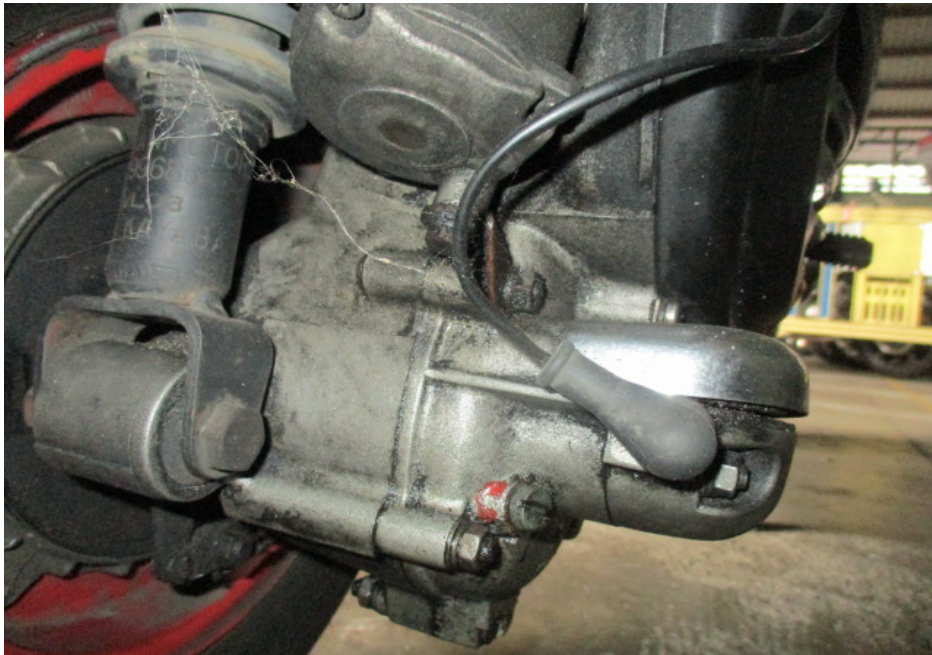
Photo 13 shows the bottom of the Motorcycle's engine area where upon closer examination, we had observed that the various engine related parts and components were intact with no visible damage. There was also no sign(s) or indication(s) of fluid leak observed around the engine area of the Motorcycle.

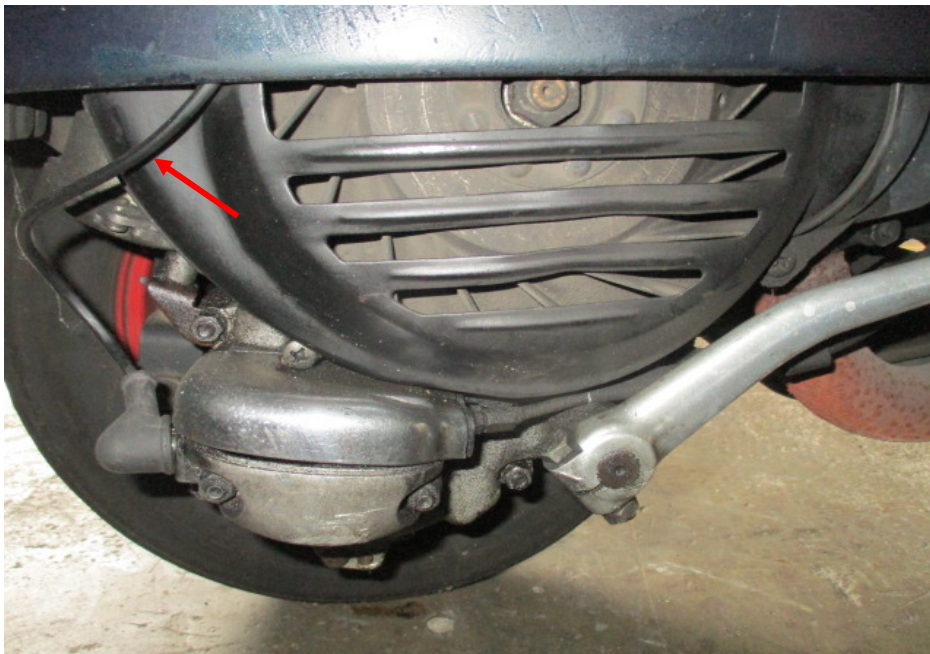
Photo 14 shows the general view of the drive train of the Motorcycle, which was observed to be intact with no misalignment. There was also no visible tear or cut observed on the connecting hoses and cables (arrowed).

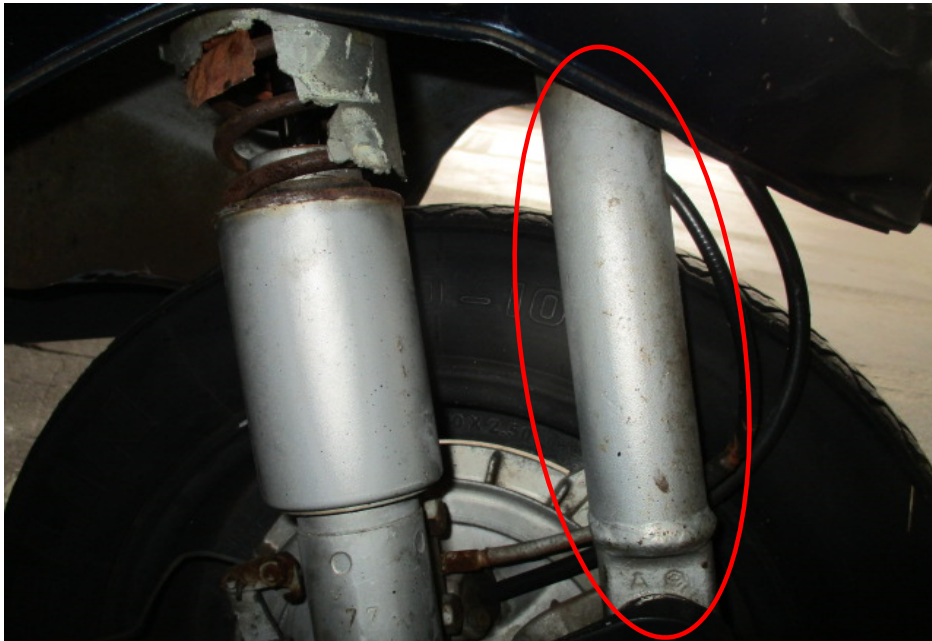
Photo 15 shows the front fork (circled) of the Motorcycle. The front fork of the Motorcycle was both found to be intact and undamaged. Turning the Motorcycle's handle bar towards the left and right did not produce any abnormal free play and/or resistance. The steering system of the Motorcycle was in serviceable condition at the time of our inspection.

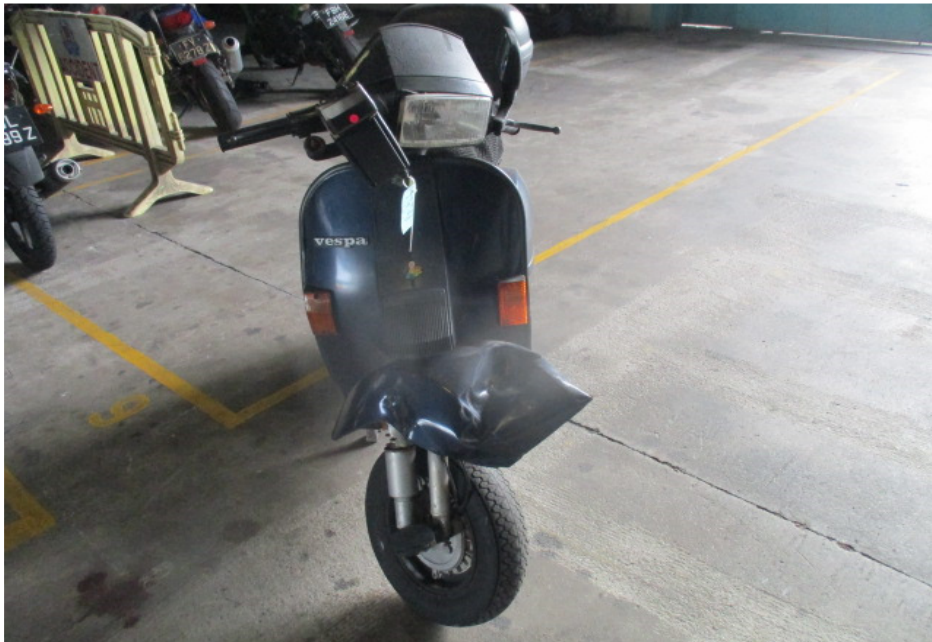
Photo 16 shows the front wheel of the Motorcycle turned towards its full left. Turning the Motorcycle's handle bar towards the left and right did not produce any abnormal free play and/or resistance. This would indicate that the steering system of the Motorcycle was in serviceable condition at the time of our inspection.

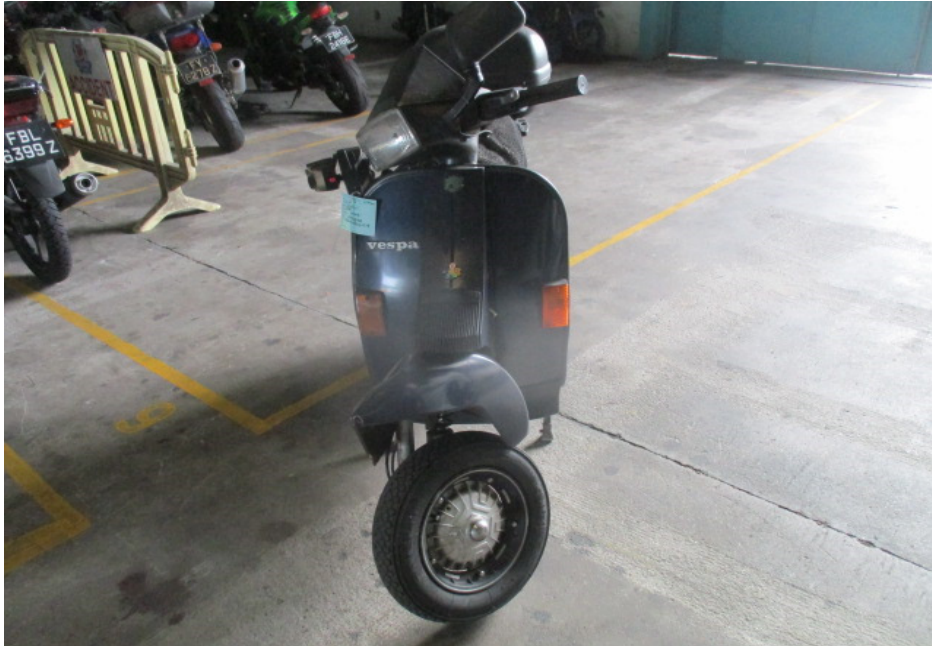
Photo 17 shows the front wheel of the Motorcycle turned towards its full right. Turning the Motorcycle's handle bar towards the left and right did not produce any abnormal free play and/or resistance. This would indicate that the steering system of the Motorcycle was in serviceable condition at the time of our inspection.

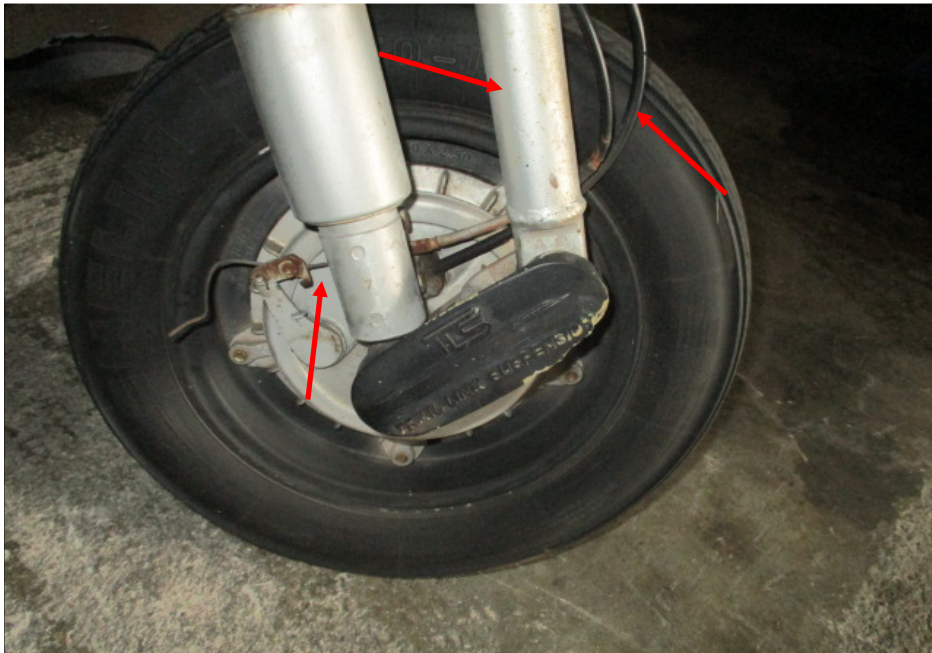
13. We subsequently carried out an operational test of the Motorcycle's braking system. This was done by manually pushing the Motorcycle forward and backward, simulating the Motorcycle in motion, and thereafter engaging the front and rear brake of the Motorcycle. At the end of the short operational test, we did not observe any abnormal behaviour of the Motorcycle's rear braking system. The rear wheel of the Motorcycle was able to stop rotating immediately upon stepping on the brake pedal. However the front wheel of the Motorcycle was still able to rotate upon depressing the brake lever.

14. In general, the observations gathered during the brake test had indicated that only the rear braking system of the Motorcycle was in serviceable condition. See photos 15 – 18 below.

Photo 18 shows a close up view of the front fork, front brake cable and spring of the Motorcycle (arrowed), which are all part of the components in the mechanical front brake system of the Motorcycle. Our visual checks of these various components had revealed all to be intact with no visible damage.
