12 June 2020

**INSPECTION REPORT OF MOTORCYCLE FBQ 9540K**

1. We refer to your request dated 28 April 2020 to conduct a physical inspection of a motorcycle bearing registration number FBQ 9540K (herein referred to as "**Motorcycle**"), which was involved in a fatal road traffic accident on 9 April 2020.
2. The purpose of this inspection is to primarily determine if there was any possible mechanical failure to the Motorcycle that may have contributed to the accident.
3. Following the request, we had carried out a physical inspection of the Motorcycle on 12 June 2020 at the premises of Traffic Police vehicle pound, 517 Airport Road Singapore 539942. We now set out below our observations and comments with respect to this inspection.

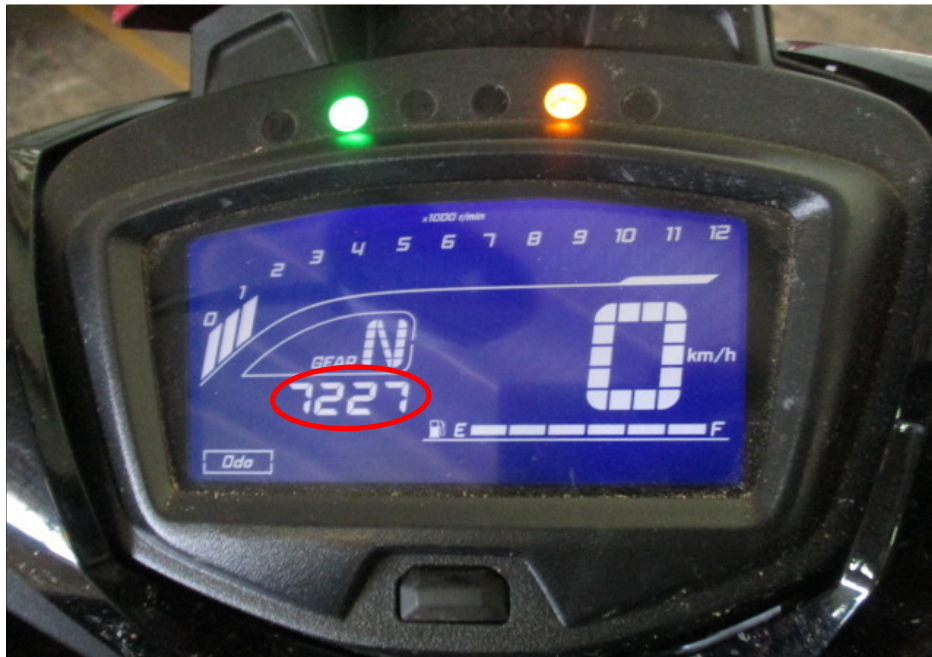
**Photo 1** shows the speedometer gauge of the Motorcycle. The mileage of the Motorcycle at the time of our inspection was 7, 227km (circled).

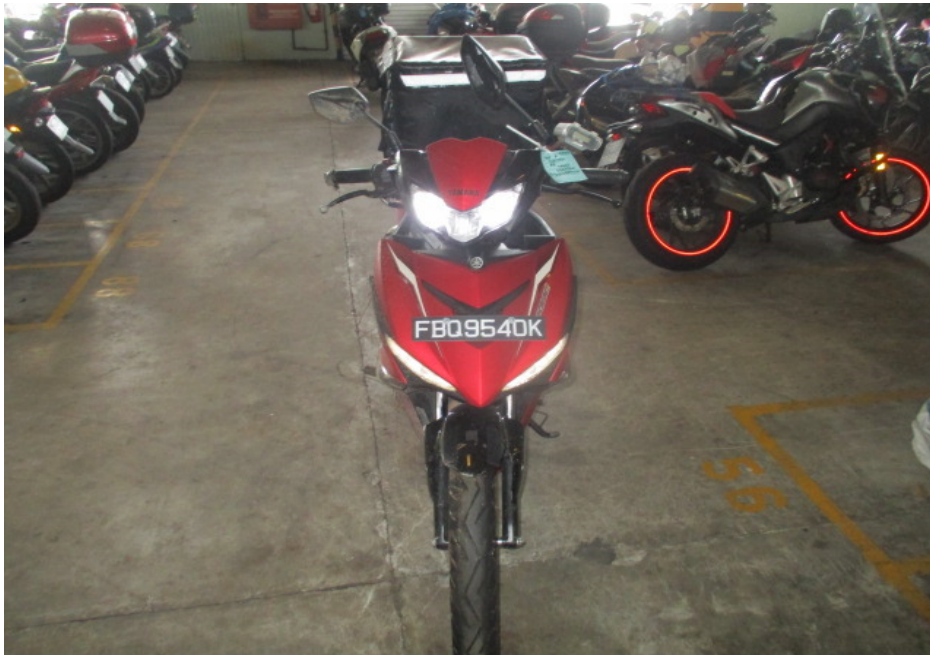
**Photo 2** shows a general view of the front body of the Motorcycle at the time of our inspection. The Motorcycle was observed to have sustained damages along its frontal portion, right body and rear portion.

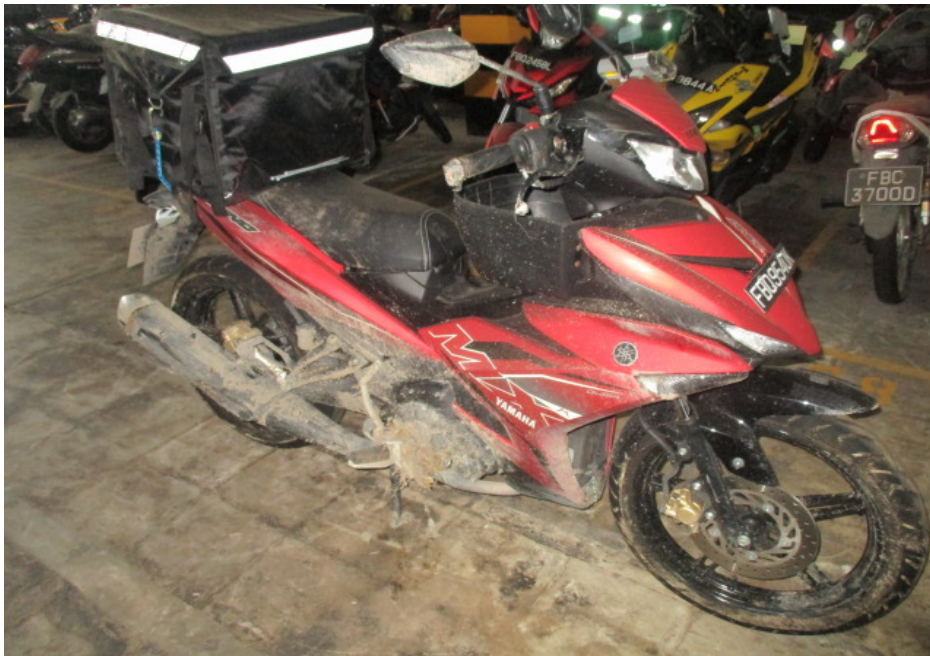
4. The mileage of the Motorcycle at the time of our inspection was 7, 227km.
5. The Motorcycle was observed to have sustained damages along its frontal portion, right body and rear portion. The body parts that were found to have been damaged include its head cowling, right cowling, front mudguard, right handlebar end, front brake lever, right side mirror, rear brake pedal, right rear side cover, exhaust muffler and left rear signal lamp, amongst others.

**Photo 3** shows a general view of the right body of the Motorcycle at the time of our inspection. The Motorcycle was observed to have sustained damages along its frontal portion, right body and rear portion. The body parts that were found to have been damaged include its head cowl, right cowl, front mudguard, right handlebar end, front brake lever, right side mirror, rear brake pedal, right rear side cover, exhaust muffler and left rear signal lamp, amongst others.

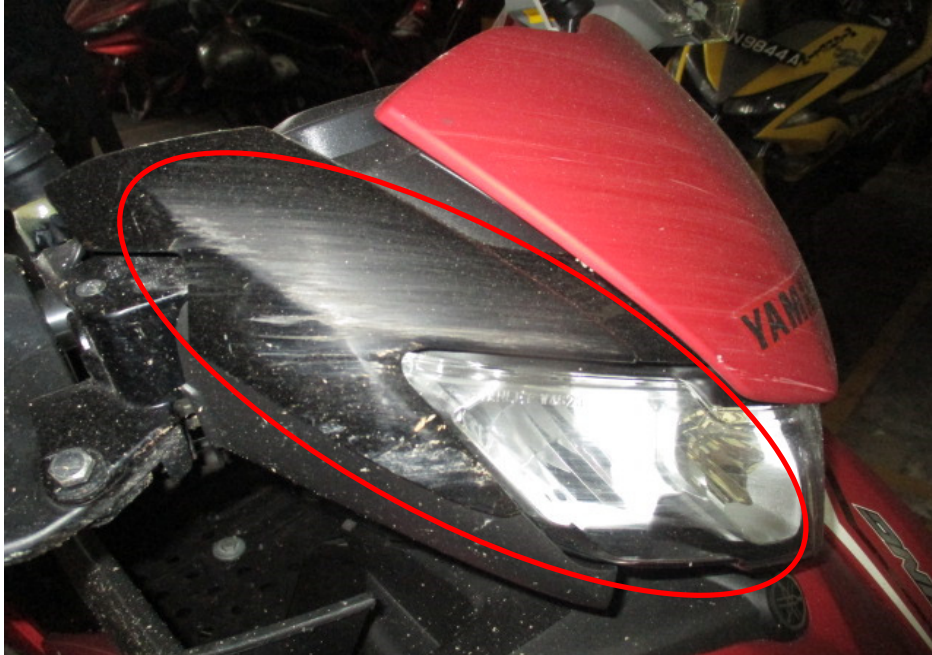
**Photo 4** shows a close up view of the head cowling (circled) which was amongst the body parts of the Motorcycle that had sustained damage as a result of the accident.

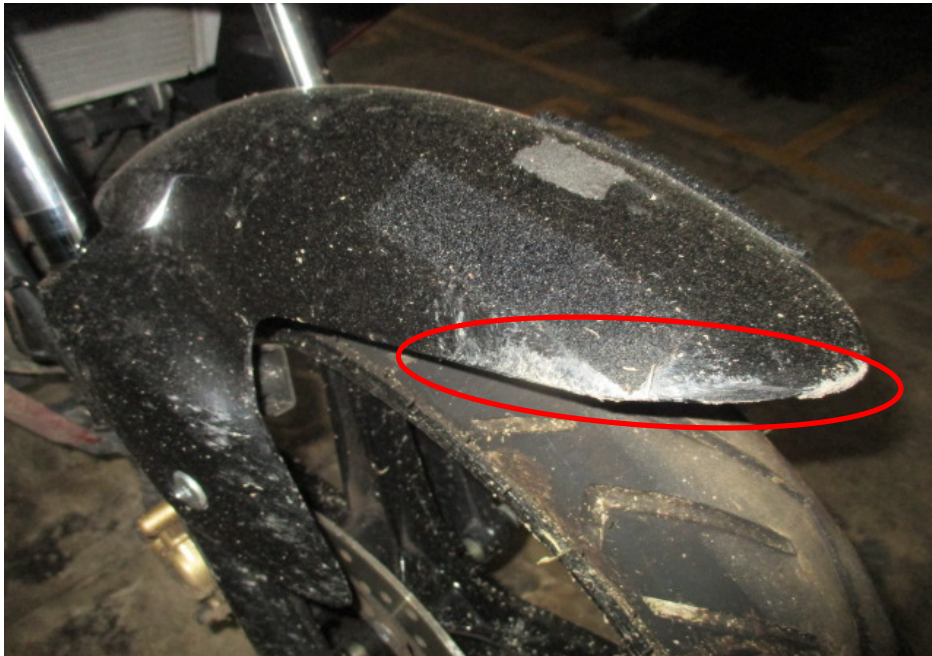
**Photo 5** shows a closer view of the front mudguard (circled) which was amongst the body parts at the front body of the Motorcycle that had sustained damage as a result of the accident.

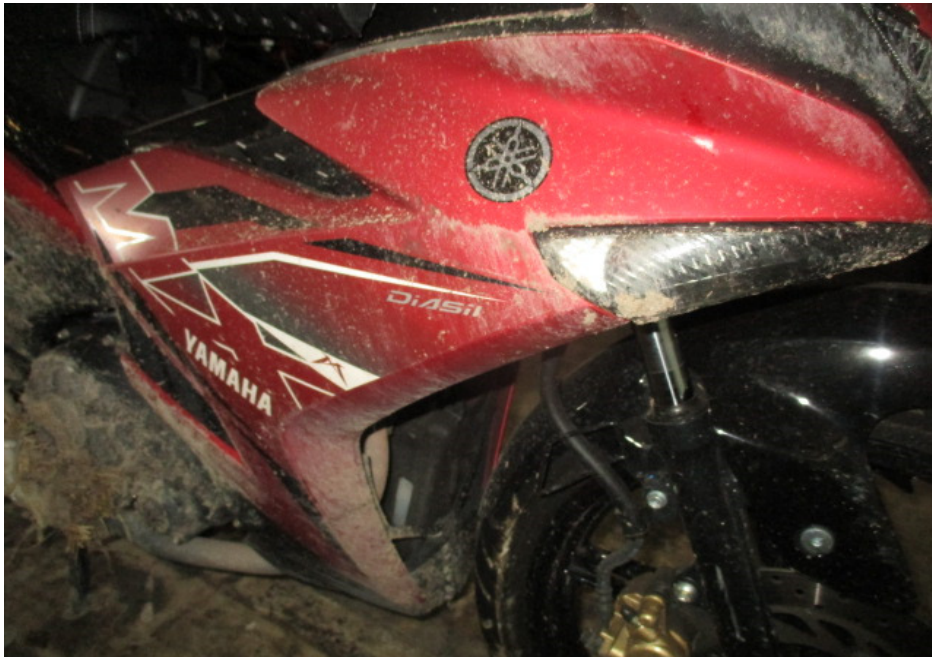
**Photo 6** shows a closer view of the right cowling which was amongst the body parts of the Motorcycle that had sustained damage as a result of the accident.

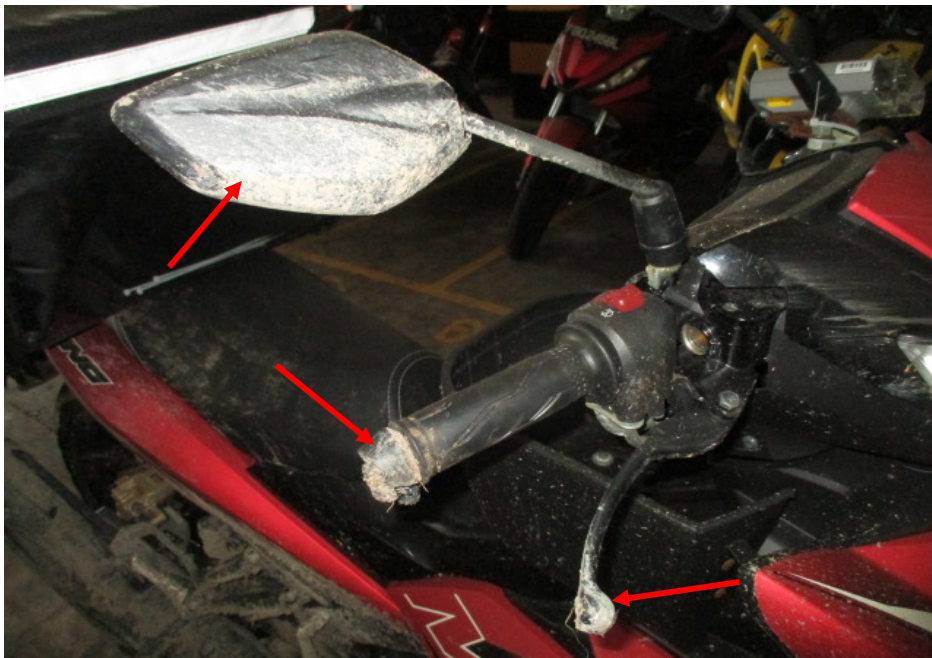
**Photo 7** shows the front brake lever, right handlebar end and right side mirror (arrowed), which were amongst the body parts of the Motorcycle that had sustained damage as a result of the accident.

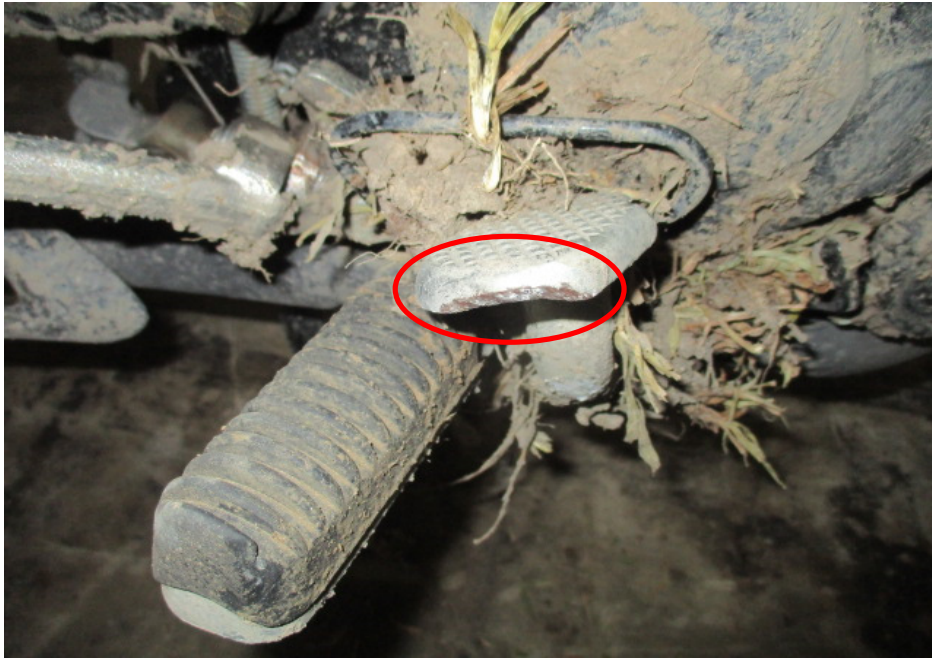
**Photo 8** shows a closer view of the rear brake pedal (circled) which was amongst the body parts of the Motorcycle that had sustained damage as a result of the accident.

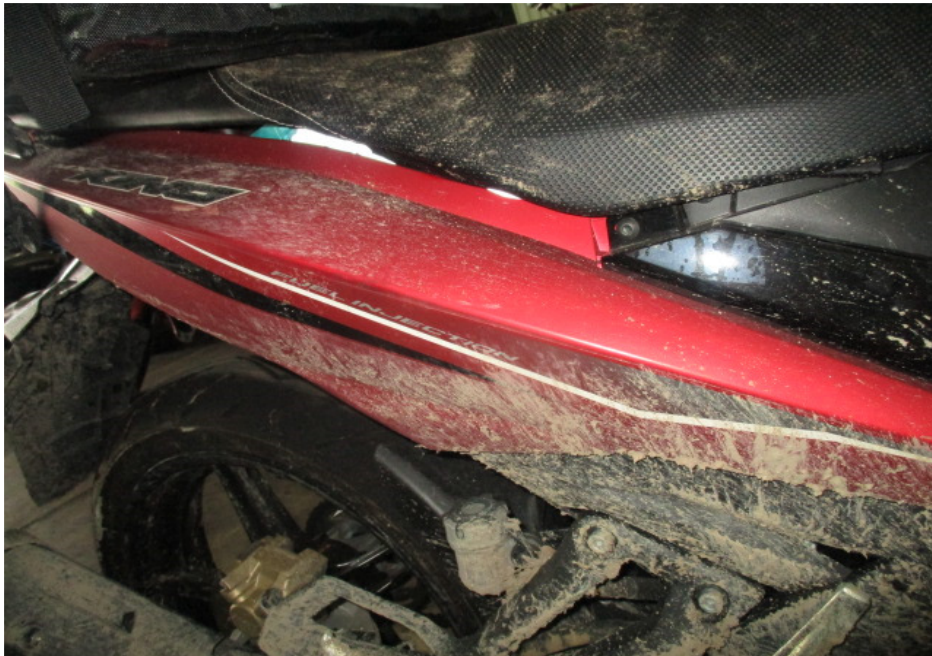
**Photo 9** shows a closer view of right rear side cover which was amongst the body parts of the Motorcycle that had sustained damages of grazing nature as a result of the accident.

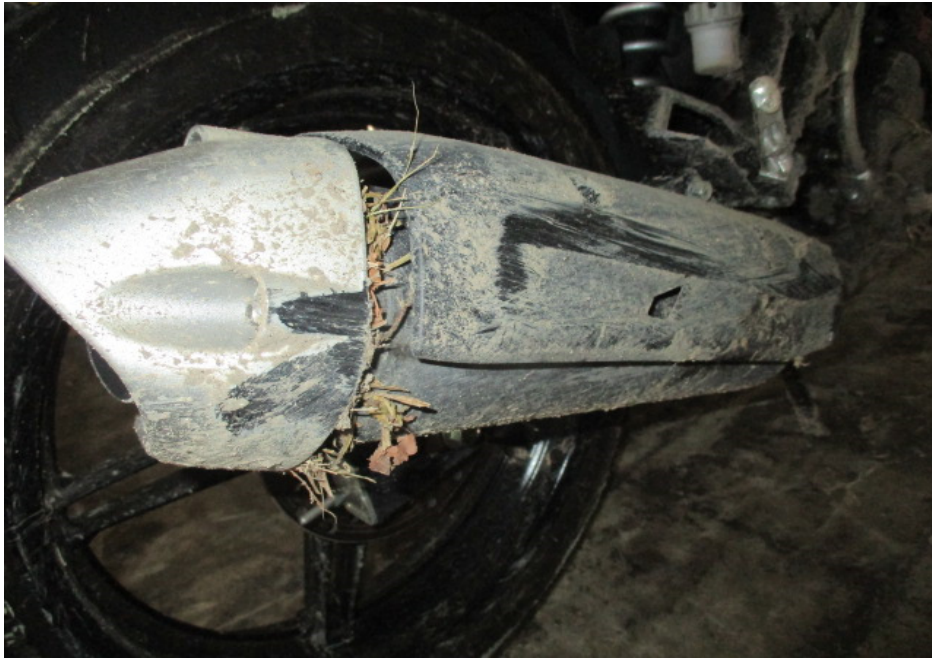
**Photo 10** shows the exhaust muffler and exhaust muffler heat shield of the Motorcycle that had sustained damage as a result of the accident.

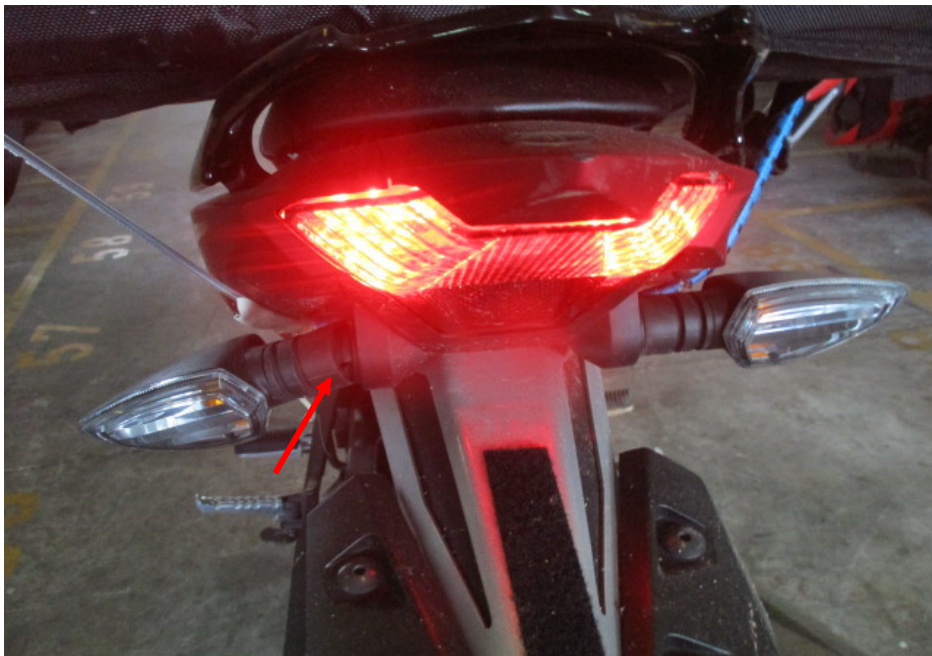
**Photo 11** shows the deformed left rear signal lamp of the Motorcycle as a result of the accident (arrowed).

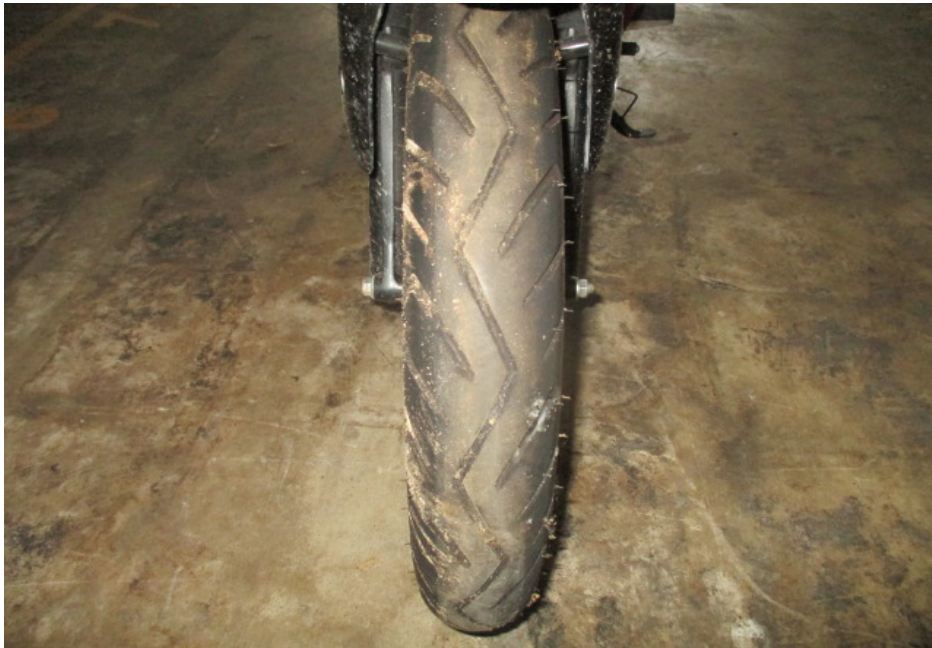
**Photo 12** shows the front tyre of the Motorcycle at the time of our inspection. The front tyre was observed to be in serviceable condition with remaining tread depth of approximately 3mm. The pattern of the tread was also clearly visible. There was no tear, burst mark(s) and/or punctured hole(s) on the sidewalls as well as across the tread of the front tyre.

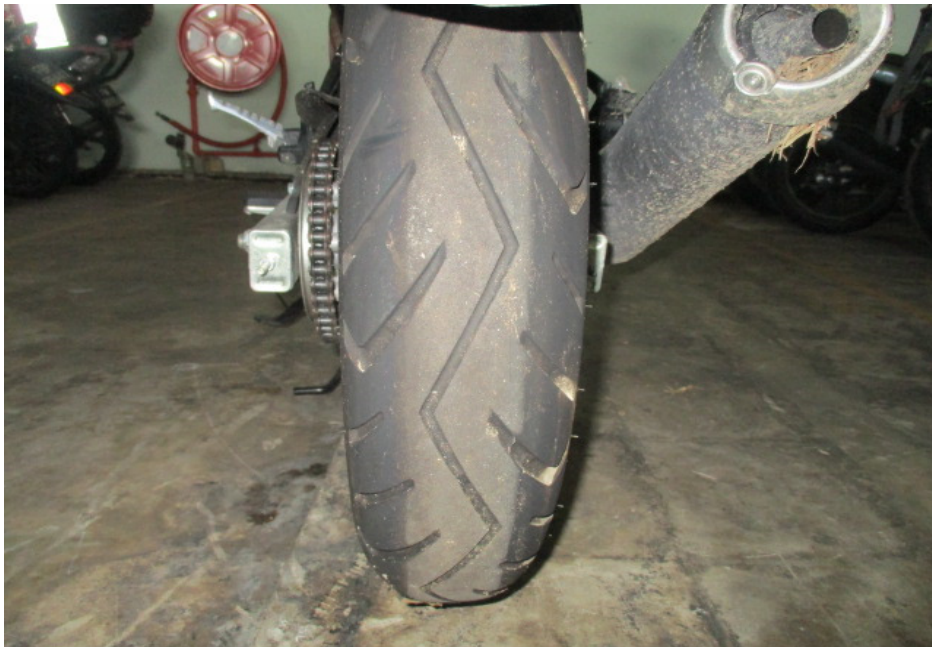
**Photo 13** shows the condition of the Motorcycle's rear tyre. The rear tyre was observed to be in serviceable condition with remaining tread depth of approximately 4mm. The tyre was also observed to be sufficiently inflated for vehicular operation. We did not observe any tear, burst mark(s) and/or punctured hole(s) on the sidewalls as well as across the tread of the rear tyre.

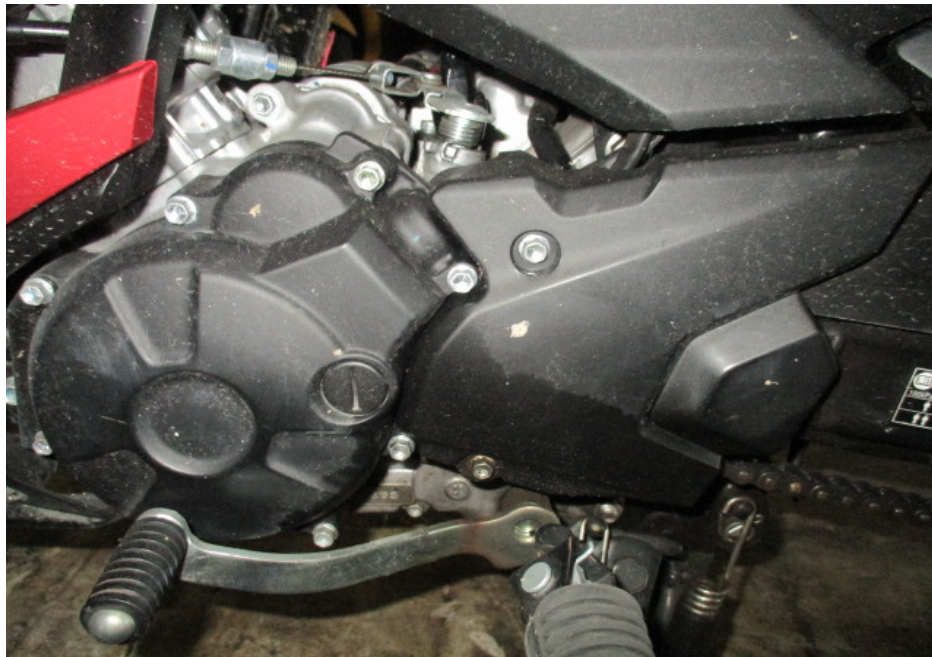
**Photo 14** shows the left side of the engine of the Motorcycle at the time of our inspection. The various engine related parts and components were found to be intact with no visible damage. There was also no sign(s) or indication(s) of fluid leak observed around the left engine area of the Motorcycle.

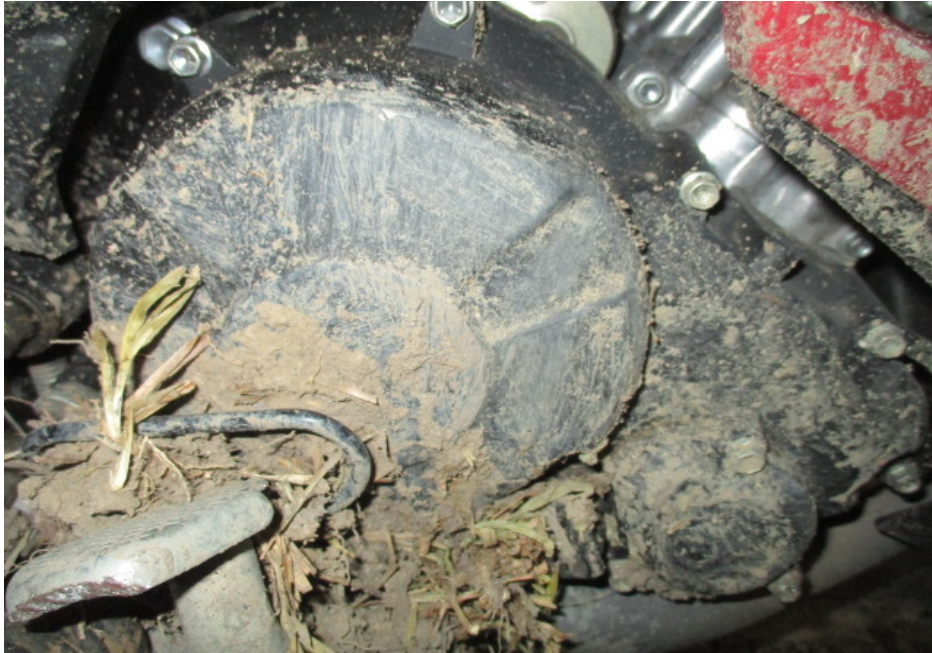
**Photo 15** shows the right side of the engine of the Motorcycle at the time of our inspection. The various right engine components had sustained damage of grazing nature as a result of the accident however the engine components were still intact. There was also no fluid leak and/or fluid stain found around the right engine area of the Motorcycle.

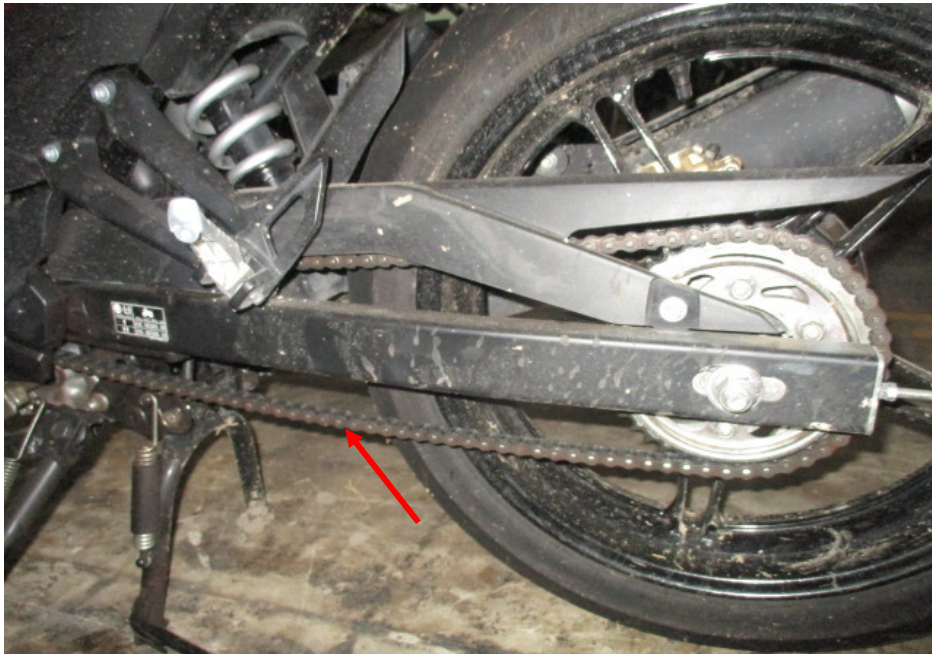
**Photo 16** shows the general view of the gear train (arrowed) of the Motorcycle, which was observed to be intact with no misalignment. It was also adequately lubricated for operating purposes.

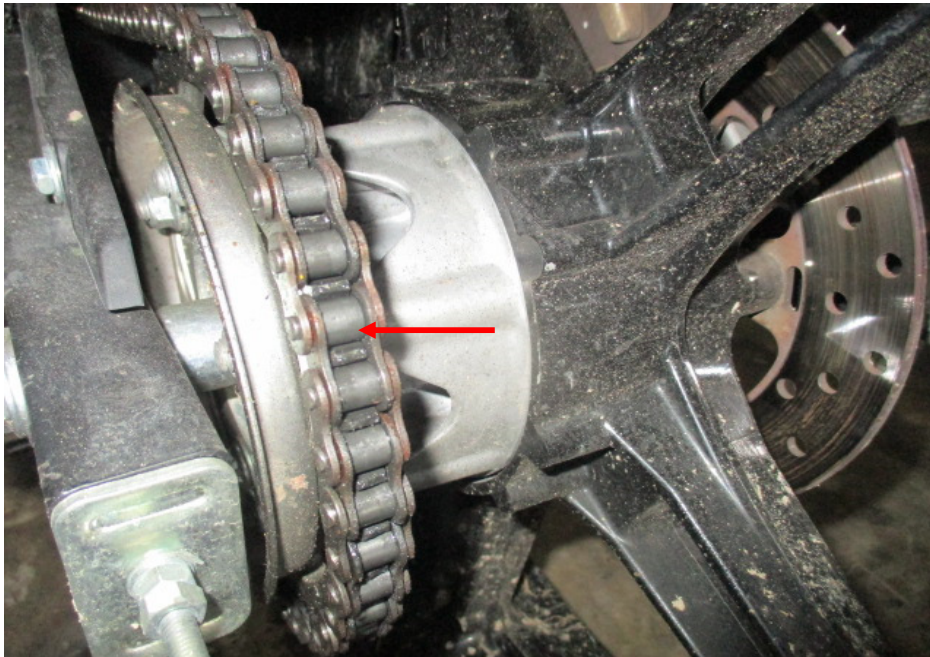
**Photo 17** shows a closer view of the gear train (arrowed) of the Motorcycle, which was observed to be intact with no misalignment. It was also adequately lubricated for operating purposes.

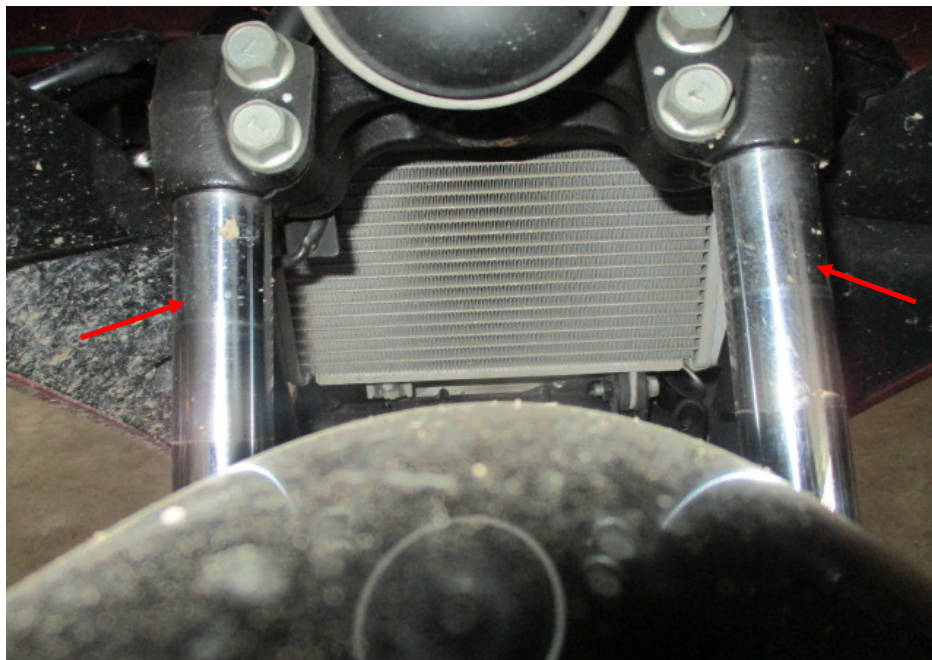
**Photo 18** shows the front fork (arrowed) of the Motorcycle. The front fork and fork bracket of the Motorcycle were both found to be intact and undamaged. Turning the Motorcycle's handle bar towards the left and right did not produce any abnormal free play. The steering system of the Motorcycle was in serviceable condition at the time of our inspection.

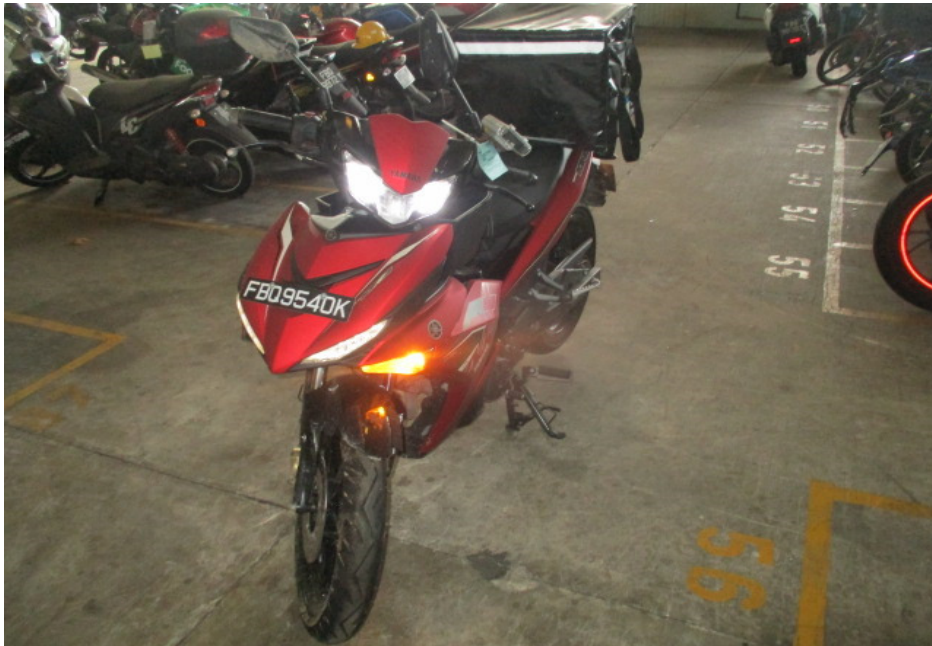
**Photo 19** shows the front wheel of the Motorcycle turned towards its full left. Turning the Motorcycle's handle bar towards the left did not produce any abnormal free play and/or resistance. This would indicate that the steering system of the Motorcycle was in serviceable condition at the time of our inspection.

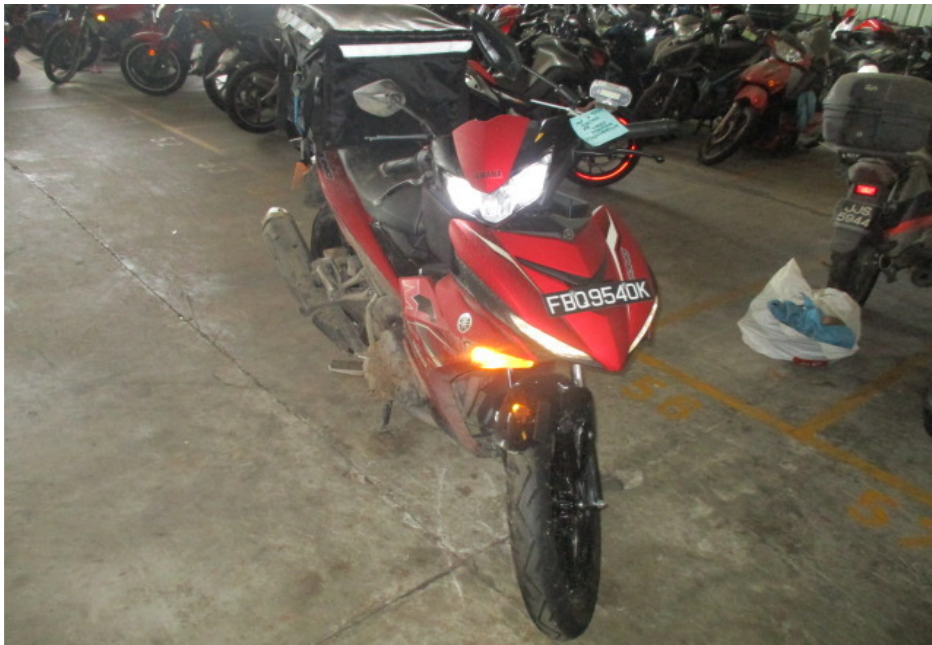
**Photo 20** shows the front wheel of the Motorcycle turned towards its full right. Turning the Motorcycle's handle bar towards the right did not produce any abnormal free play and/or resistance. This would indicate that the steering system of the Motorcycle was in serviceable condition at the time of our inspection.

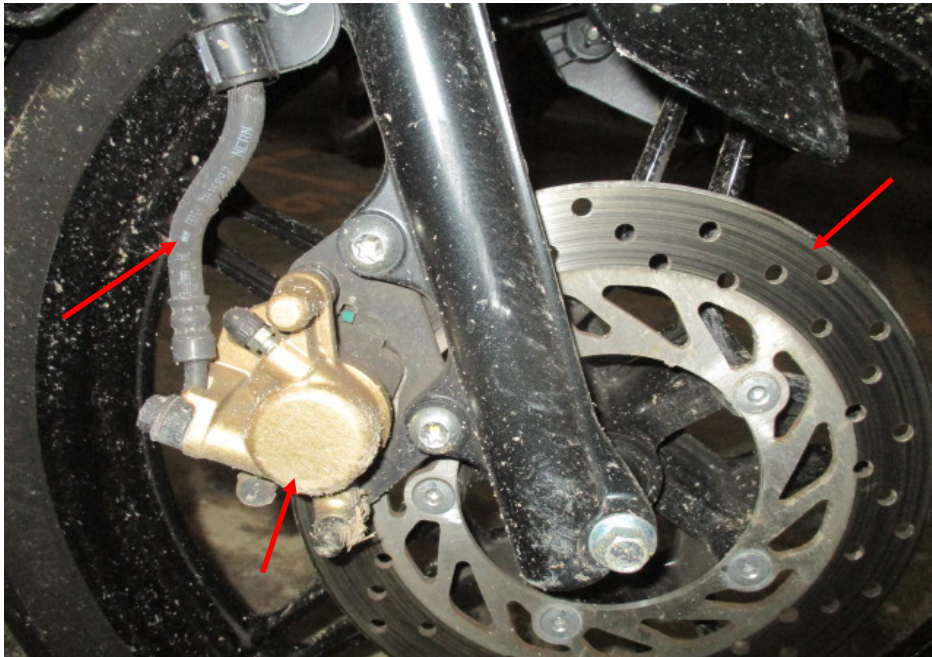
**Photo 21** shows a close up view of the front brake caliper, front brake disc and front brake hose (arrowed) of the Motorcycle, which are all part of the components in the hydraulic front brake system of the Motorcycle. Our visual checks of these various components had revealed all to be intact with no visible damage. No leakage of brake fluid was also observed.

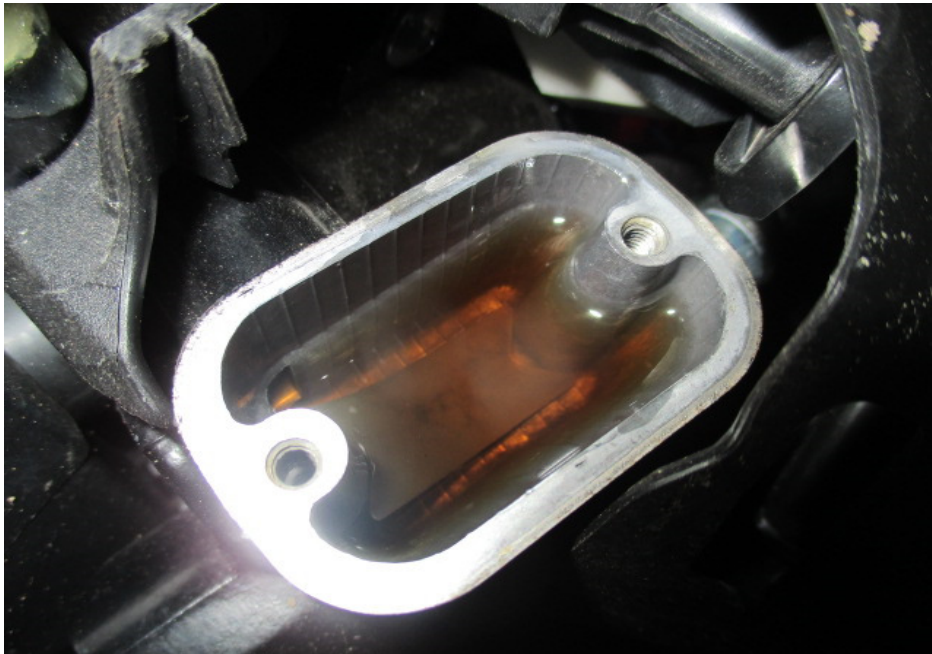
**Photo 22** shows the brake fluid reservoir for the front brake of the Motorcycle. The brake fluid was observed to be of sufficient level and without contamination for operational purposes.

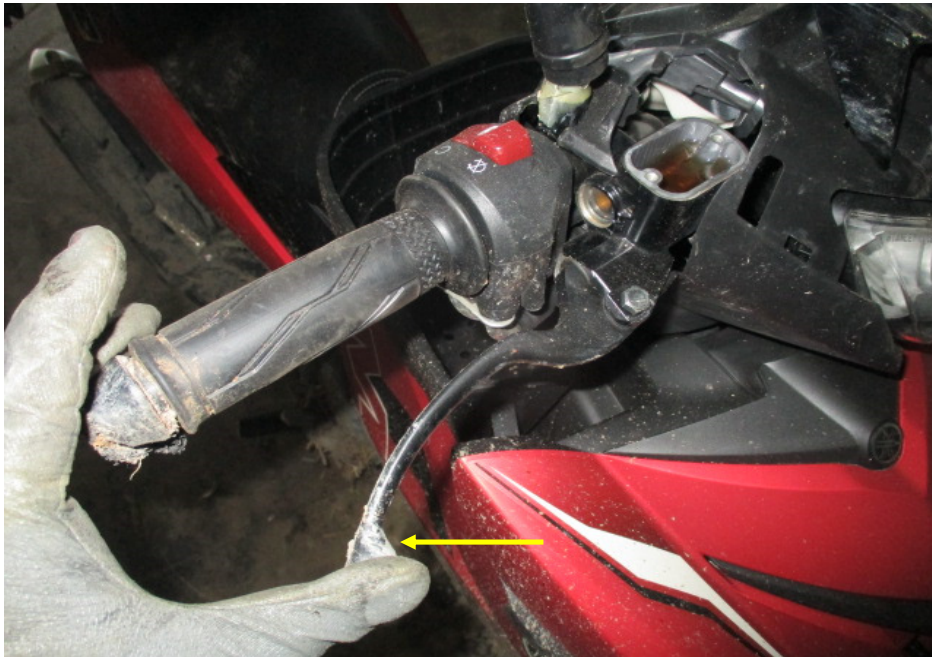
**Photo 23** shows the front brake lever being depressed. There was some resistance felt (spongy like feel) upon pressing the front brake lever (arrowed). This would indicate that there is no leakage of pressure/vacuum in the brake system.

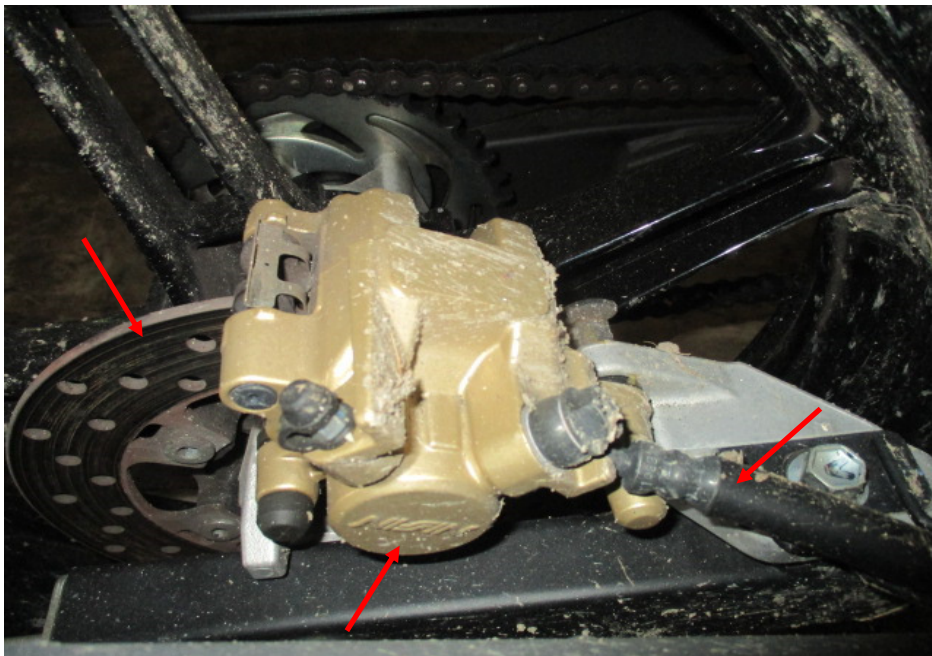
**Photo 24** shows a close up view of the rear brake caliper, rear brake disc and rear brake hose (arrowed) of the Motorcycle, which are all part of the components in the hydraulic rear brake system of the Motorcycle. Our visual checks of these various components had revealed all to be intact with no visible damage. No leakage of brake fluid was also observed.
