Your Ref: TP/IP/20345/2020  
Our Ref : CI/TPD20005982/N

11 September 2020

**Fatal Accident Investigation Team**

**INSPECTION REPORT OF MOTORCYCLE FBN 364C**

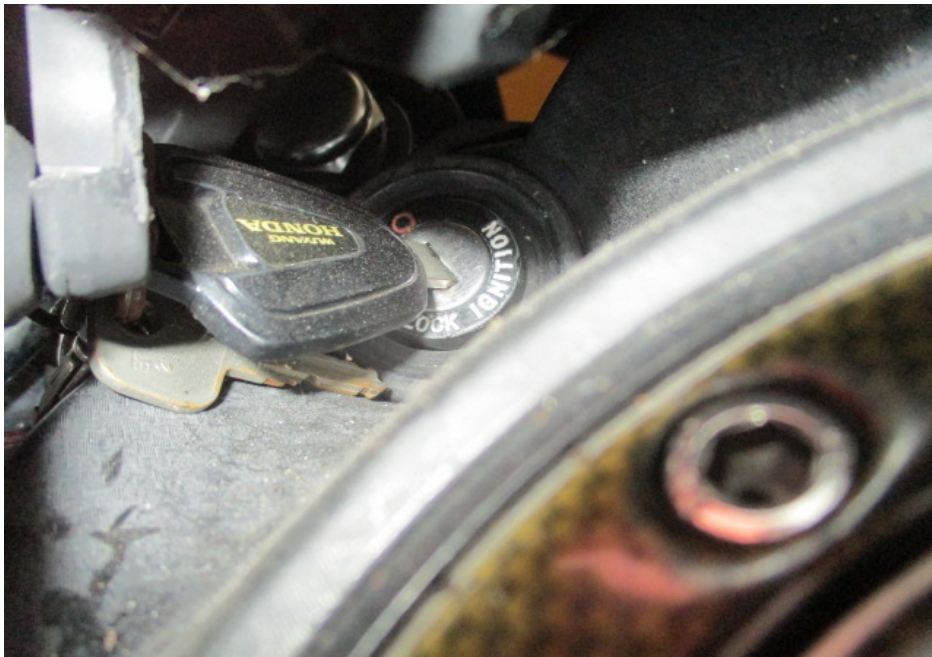
**Photo 1** shows the mileage of the Motorcycle which could not be recorded at the time of our inspection due to a bent key as a result of the accident.

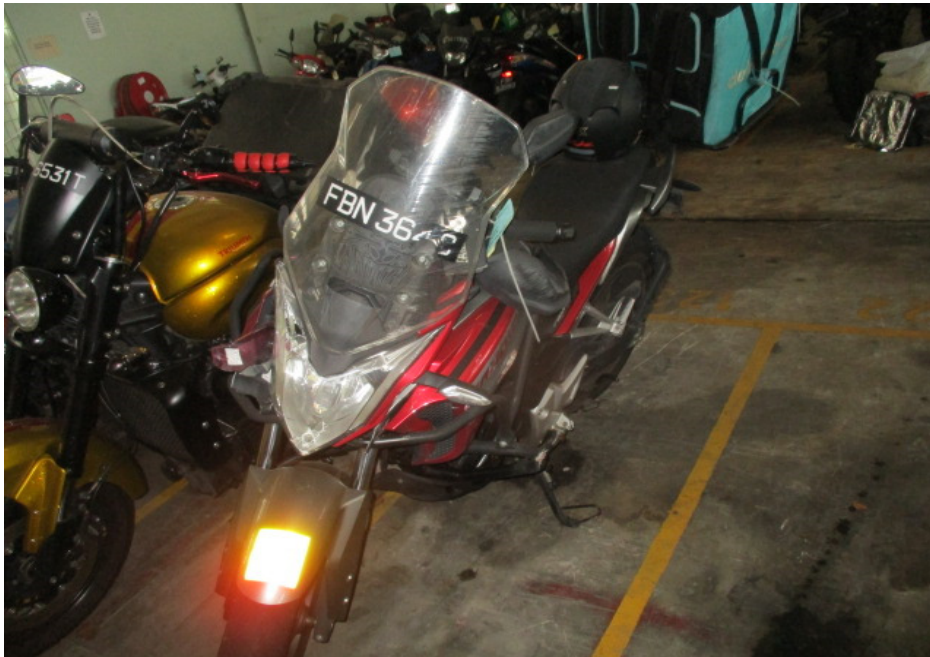
**Photo 2** shows a general view of the frontal portion of the Motorcycle at the time of our inspection. The Motorcycle was observed to have sustained damages along its frontal portion and left body.

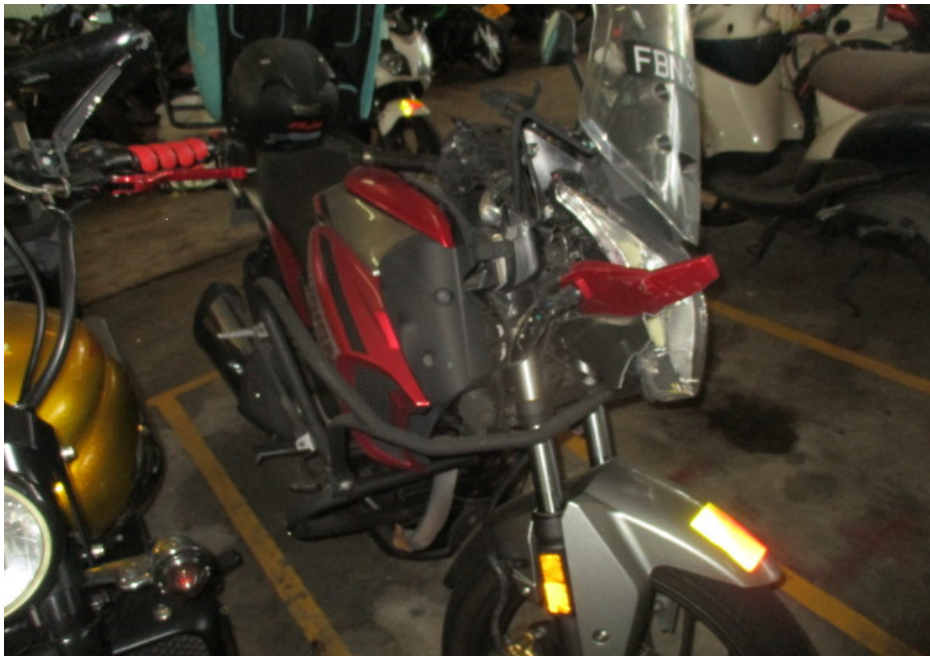
**Photo 3** shows a general view of the right frontal portion of the Motorcycle at the time of our inspection. The Motorcycle was observed to have sustained damages along its frontal portion and left body.

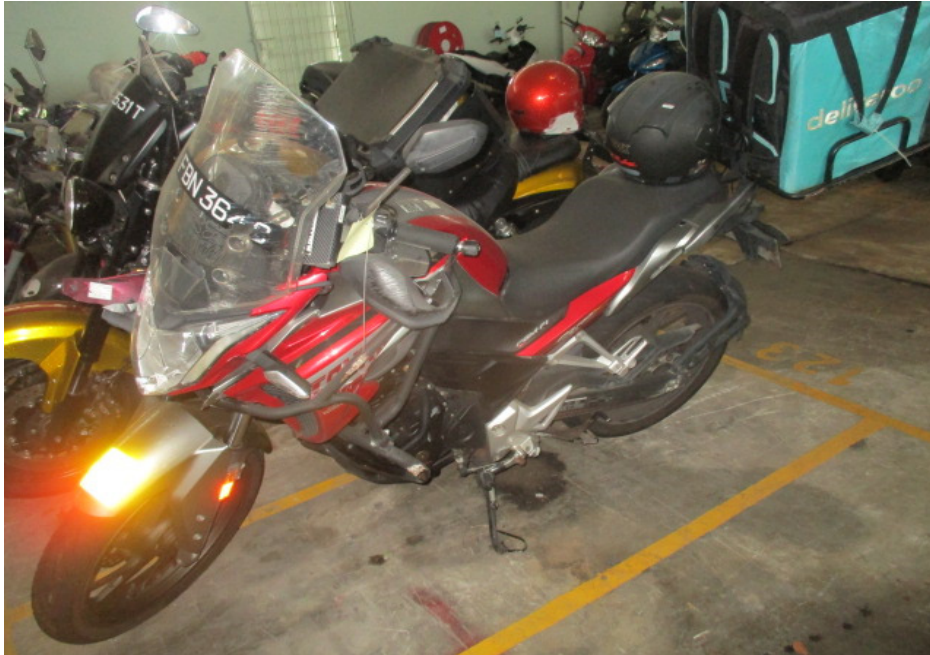
**Photo 4** shows a general view of the left body of the Motorcycle at the time of our inspection. The Motorcycle was observed to have sustained damages along its frontal portion and left body. Amongst the body parts that were found to have been damaged include its headlight assembly, front mudguard, front brake lever, left crash bars, gear shift pedal, left front footrest and top rack, amongst others.

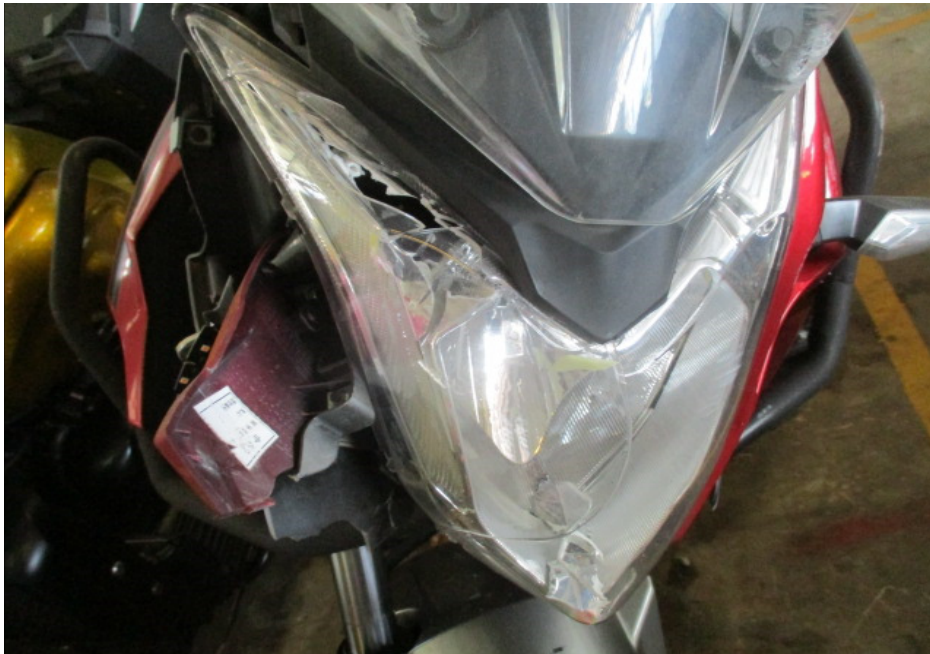
**Photo 5** shows a close up view of the cracked headlight assembly of the Motorcycle as a result of the accident.

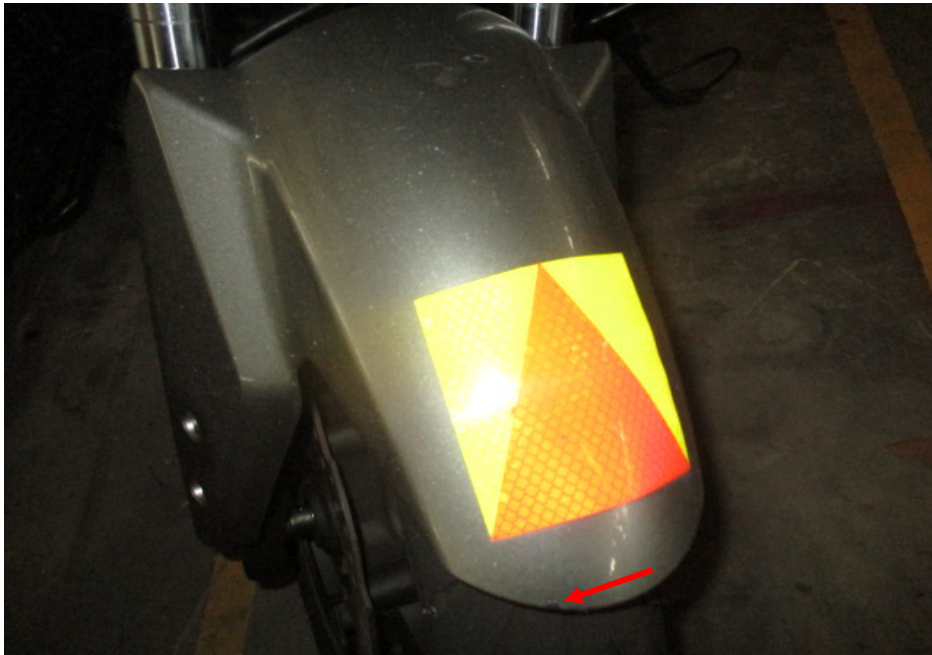
**Photo 6** shows a closer view of the front mudguard (arrowed) which was amongst the body parts at the front body of the Motorcycle that had sustained damage as a result of the accident.

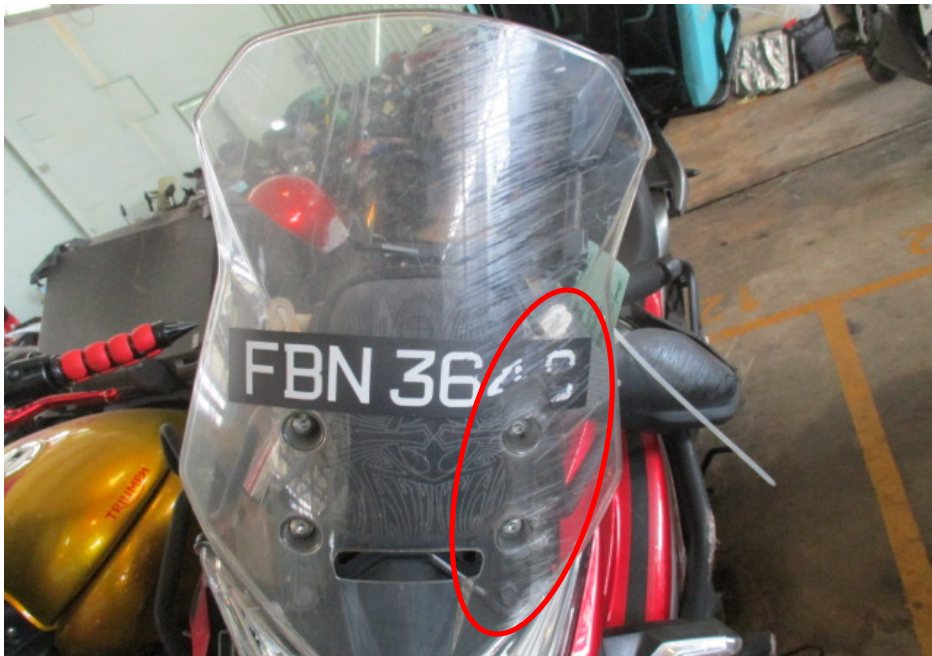
**Photo 7** shows a closer view of the windshield (circled) which was amongst the body parts of the Motorcycle that had sustained damage as a result of the accident.

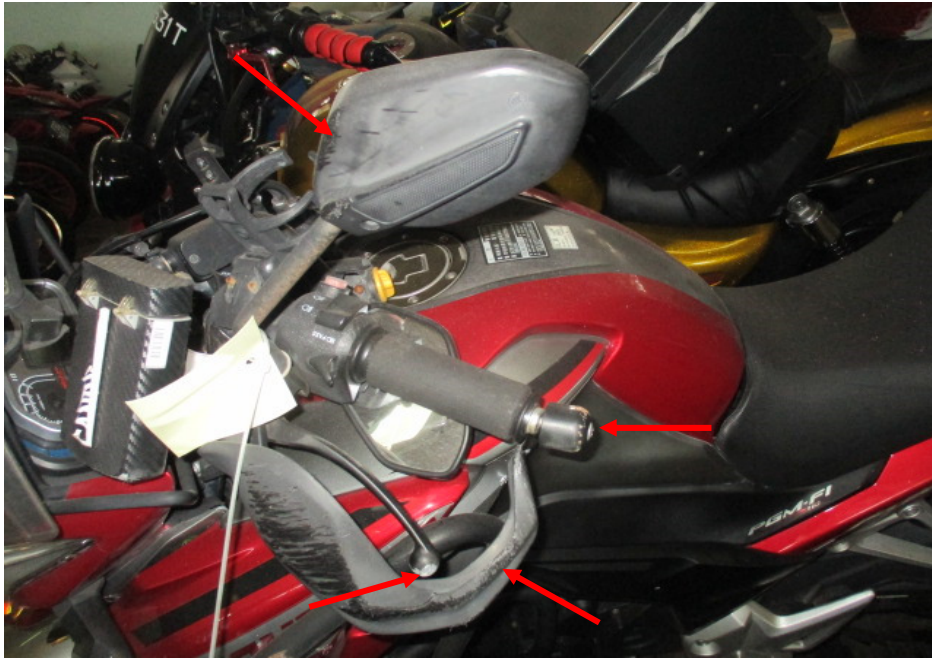
**Photo 8** shows the clutch lever, left handlebar end and clutch lever guard (arrowed), which were amongst the body parts of the Motorcycle that had sustained damage as a result of the accident.

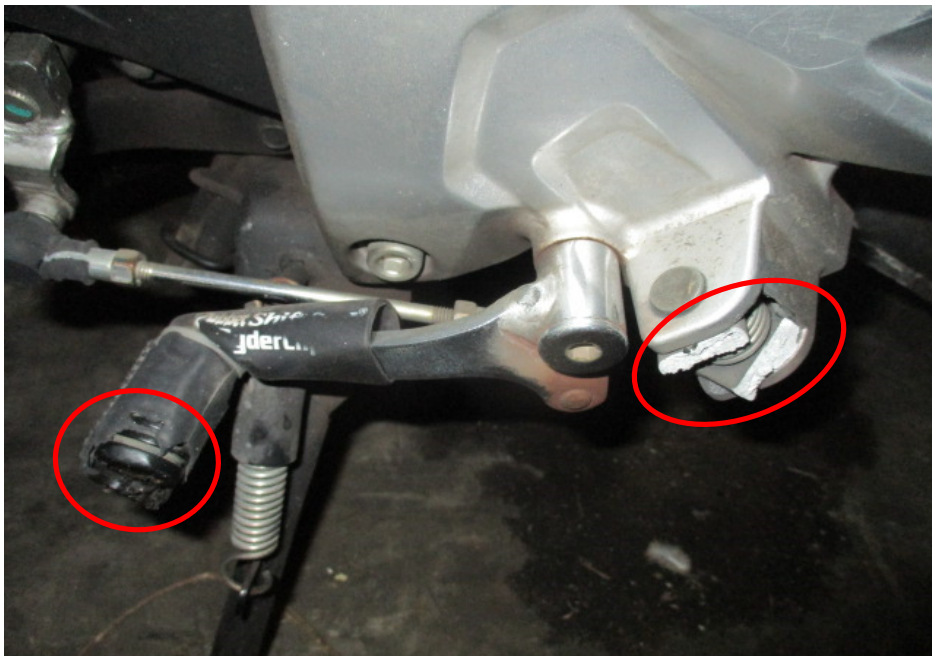
**Photo 9** shows a closer view of the gear shift pedal and left front footrest (circled) which were amongst the body parts of the Motorcycle that had sustained damage as a result of the accident.

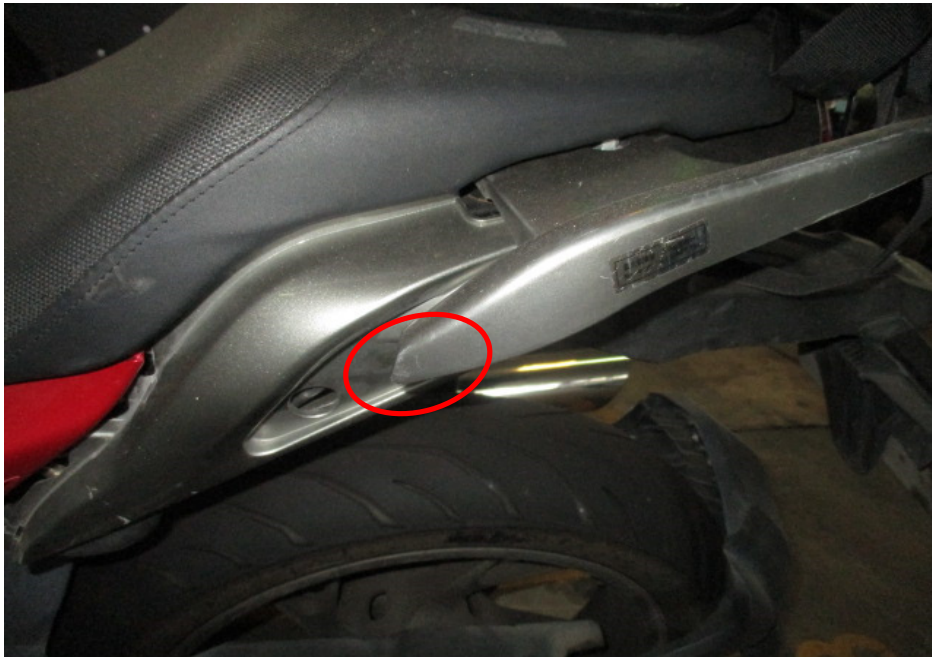
**Photo 10** shows a closer view of left rear side cover which was amongst the body parts of the Motorcycle that had sustained damages of grazing nature as a result of the accident (circled).

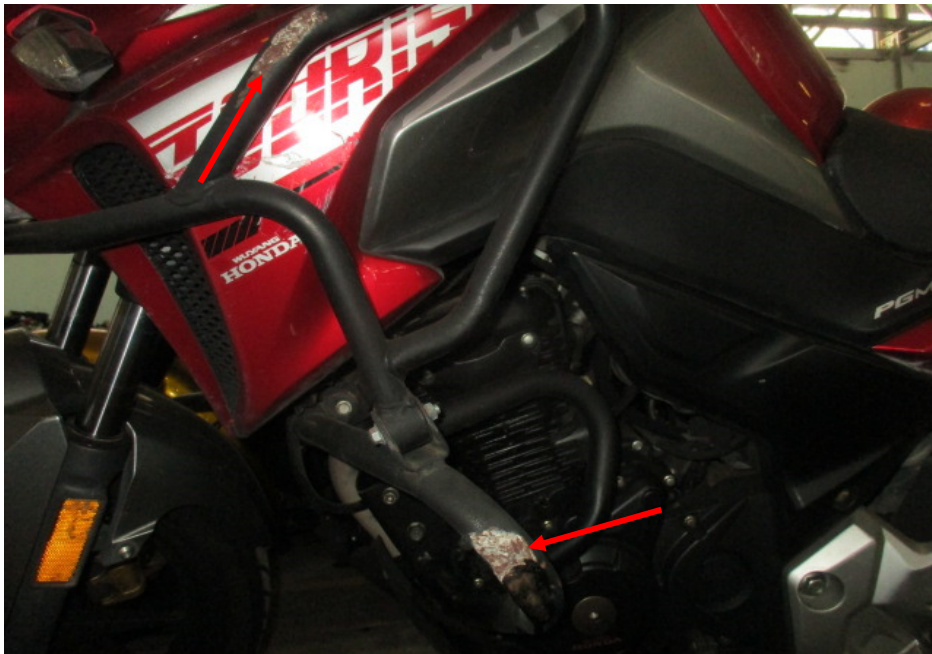
**Photo 11** shows the left crash bars (arrowed) of the Motorcycle which sustained damages of grazing nature as a result of the accident.

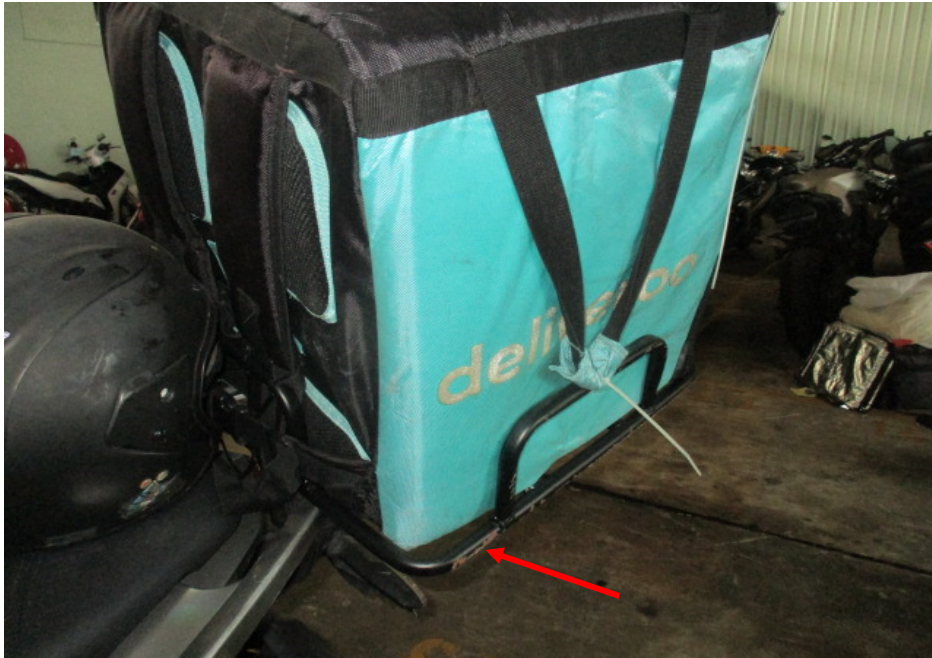
**Photo 12** shows the top rack which was amongst the body parts of the Motorcycle that had sustained damage as a result of the accident (arrowed).

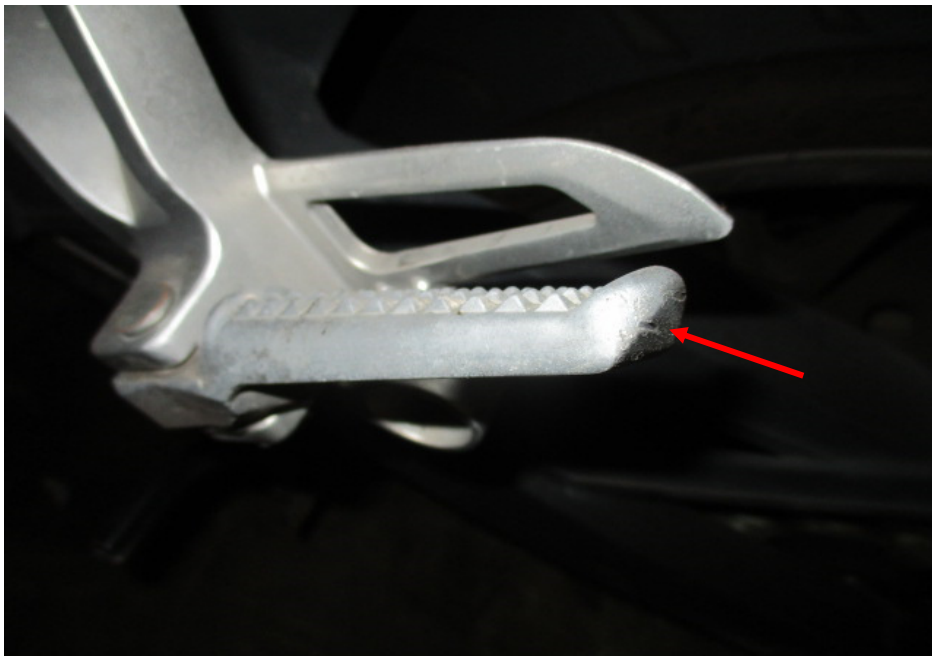
**Photo 13** shows the left pillion foot peg which was amongst the body parts of the Motorcycle that had sustained damage as a result of the accident (arrowed).

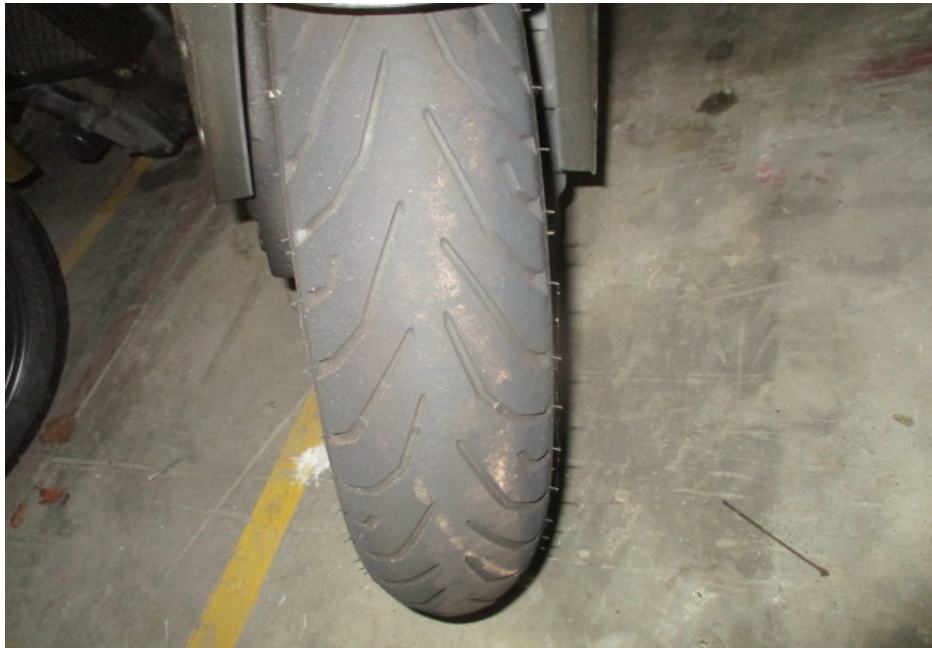
**Photo 14** shows the front tyre of the Motorcycle at the time of our inspection. The front tyre was observed to be in serviceable condition with remaining tread depth of approximately 3mm. The pattern of the tread was also clearly visible. There was no tear, burst mark(s) and/or punctured hole(s) on the sidewalls as well as across the tread of the front tyre.

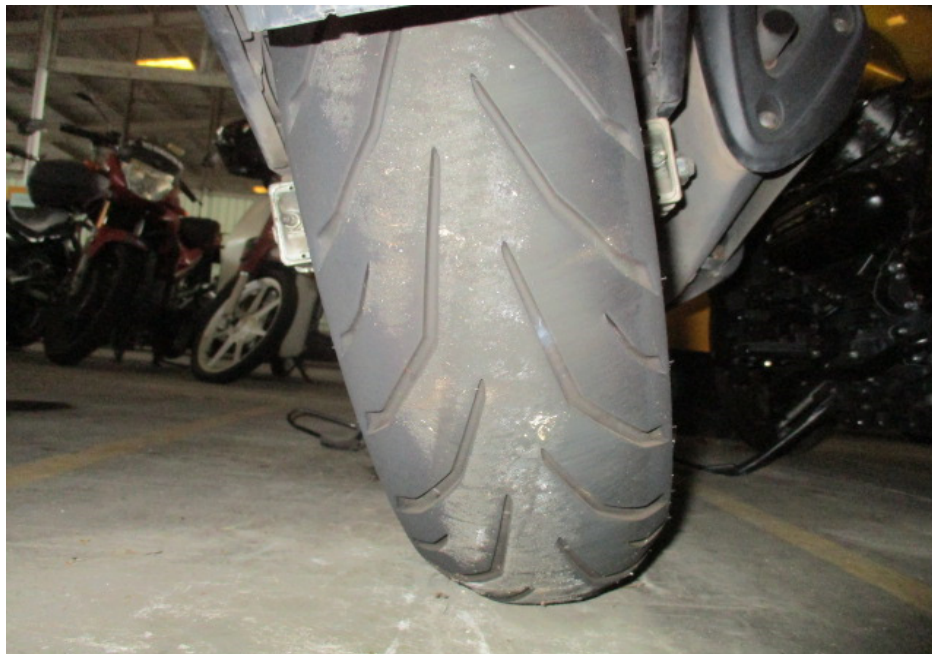
**Photo 15** shows the condition of the Motorcycle's rear tyre. The rear tyre was observed to be in serviceable condition with remaining tread depth of approximately 4mm. The tyre was also observed to be sufficiently inflated for vehicular operation. We did not observe any tear, burst mark(s) and/or punctured hole(s) on the sidewalls as well as across the tread of the rear tyre.

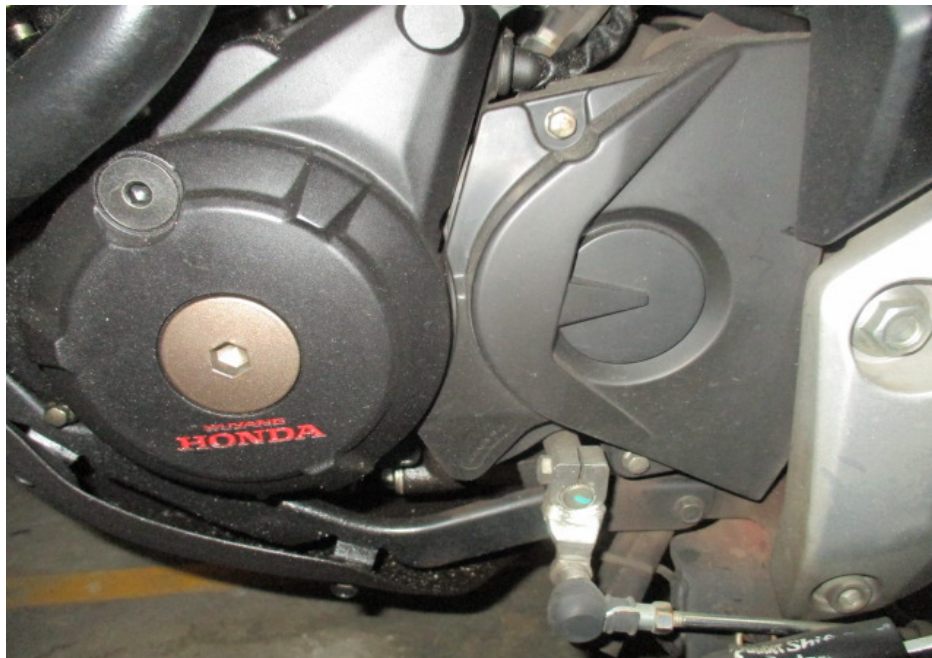
**Photo 16** shows the left side of the engine of the Motorcycle at the time of our inspection. The various engine related parts and components were found to be intact with no visible damage. There was also no sign(s) or indication(s) of fluid leak observed around the left engine area of the Motorcycle.

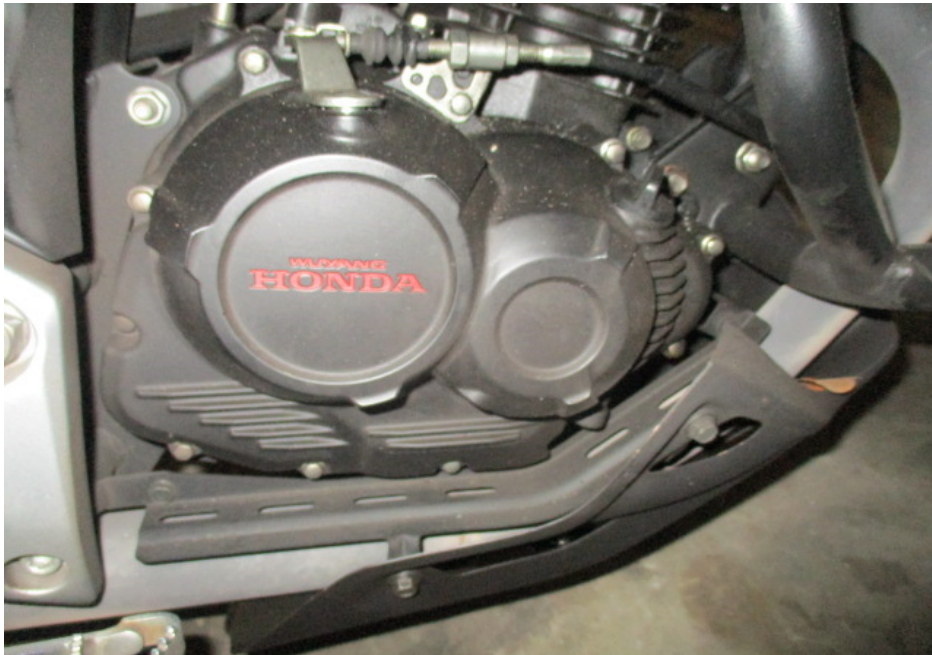
**Photo 17** shows the right side of the engine of the Motorcycle at the time of our inspection. The various engine related parts and components were found to be intact with no visible damage. There was also no sign(s) or indication(s) of fluid leak observed around the right engine area of the Motorcycle.

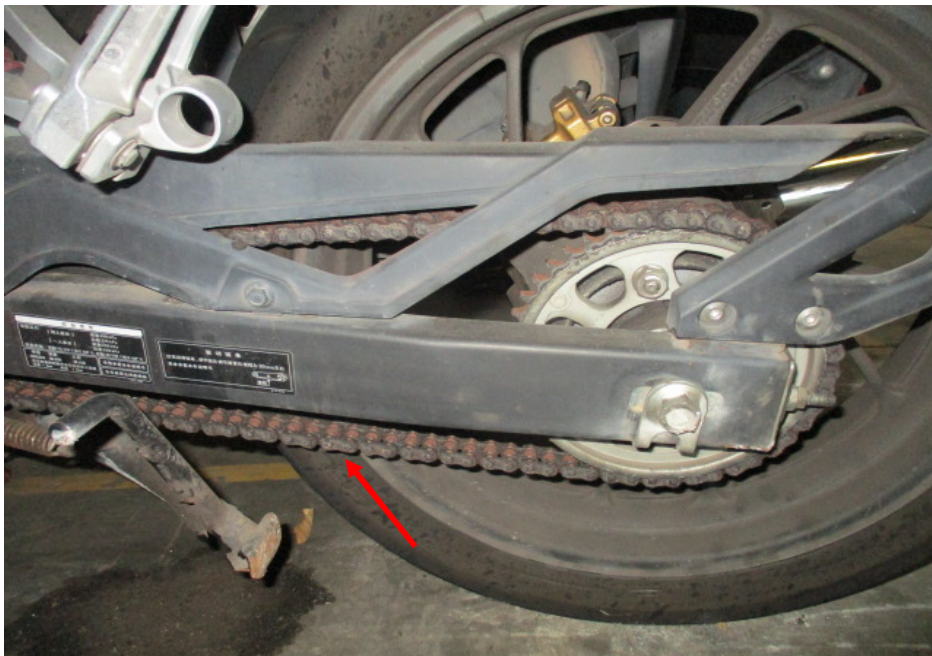
**Photo 18** shows the general view of the gear train (arrowed) of the Motorcycle, which was observed to be intact with no misalignment. It was also adequately lubricated for operating purposes.

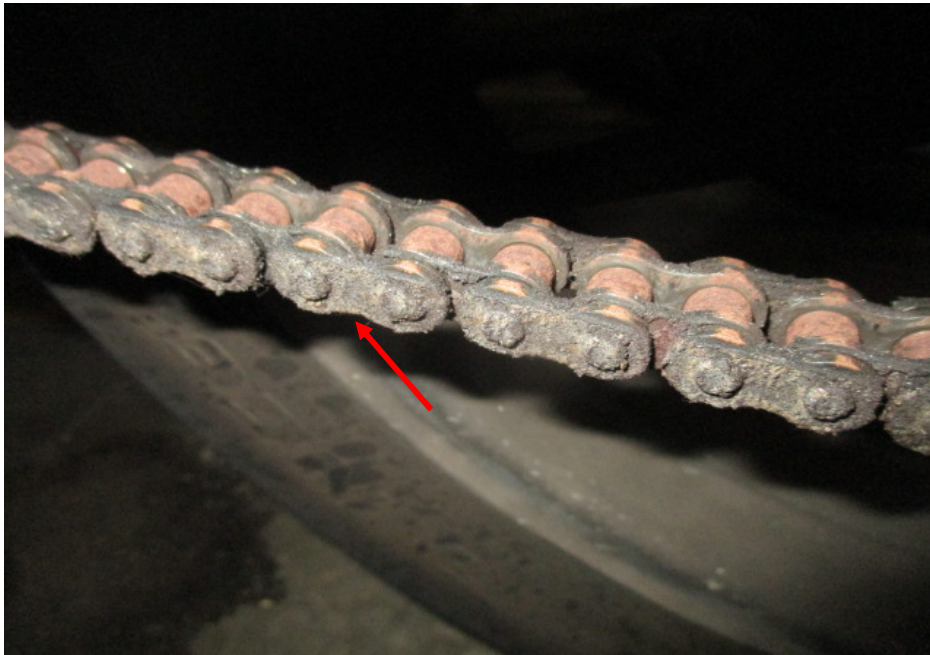
**Photo 19** shows a closer view of the gear train (arrowed) of the Motorcycle, which was observed to be intact with no misalignment. It was also adequately lubricated for operating purposes.

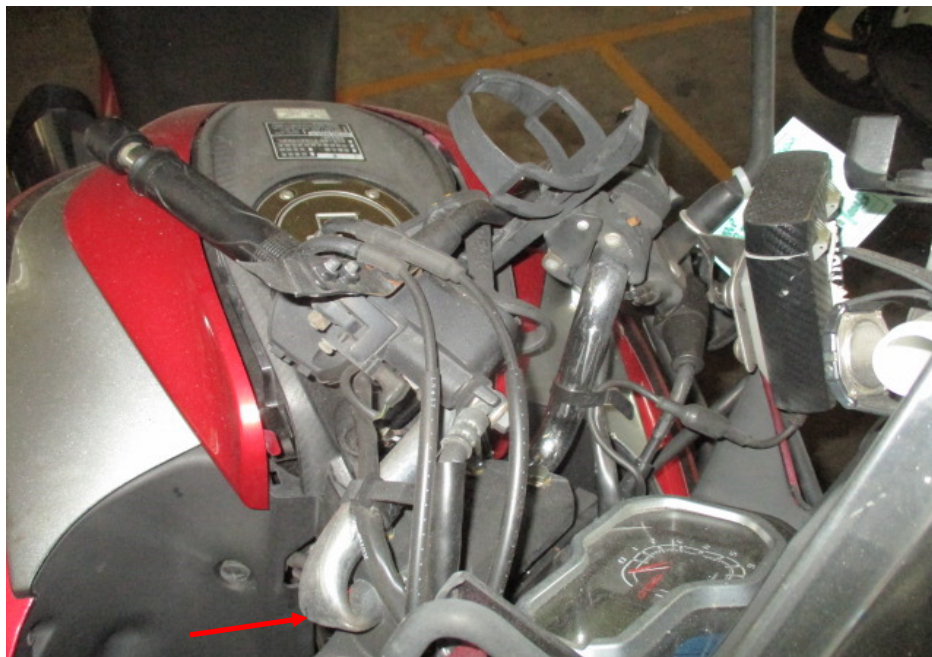
11. For this case, we were not able to conduct any test(s) on the steering system of the Motorcycle due to the damage to its handlebar. The impact of the accident had caused the handlebar to be bent. Hence we were unable to turn the handle bar towards the left or right.

**Photo 20** shows the bent handlebar of the Motorcycle as a result of the accident (arrowed). We were hence not able to turn the handlebar of the Motorcycle towards the left or right.

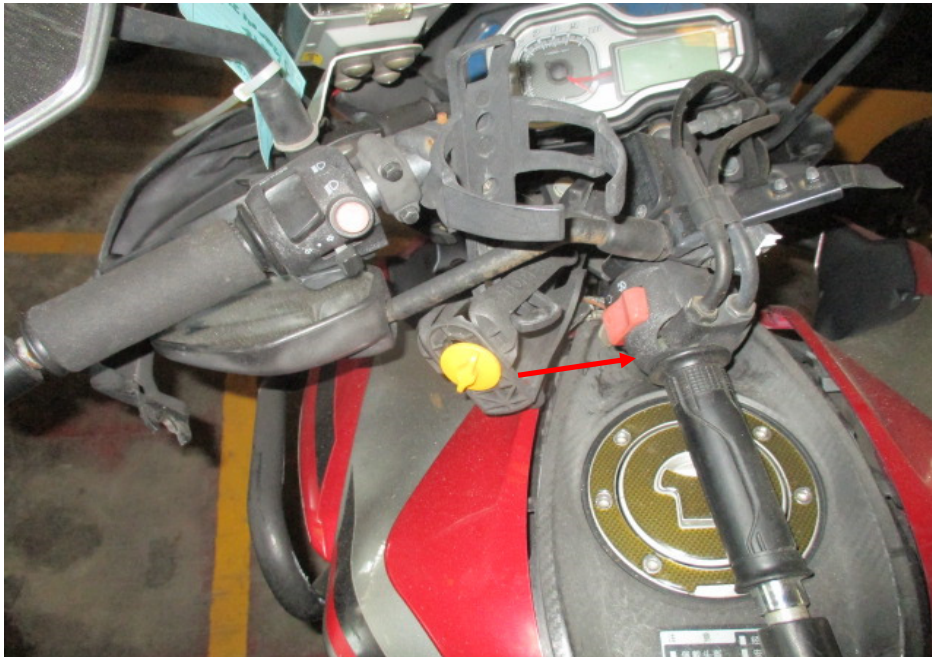
**Photo 21** shows a close up view of the bent handlebar of the Motorcycle as a result of the accident (arrowed). We were hence not able to turn the handlebar of the Motorcycle towards the left or right.

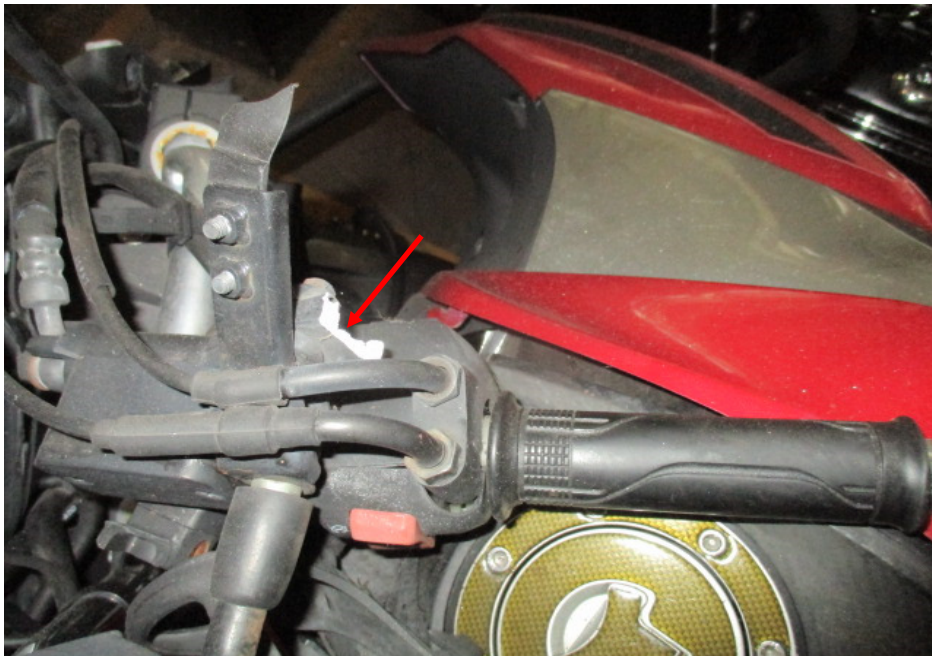
16. We were unable to conduct static brake tests on the front braking system of the Motorcycle due to the broken front brake lever. Hence we were unable to indicate if there was any leakage of pressure/vacuum in the front braking system.

**Photo 22** shows the broken front brake lever of the Motorcycle as a result of the accident (arrowed). We were hence not able to conduct any static tests on the front braking system of the Motorcycle.

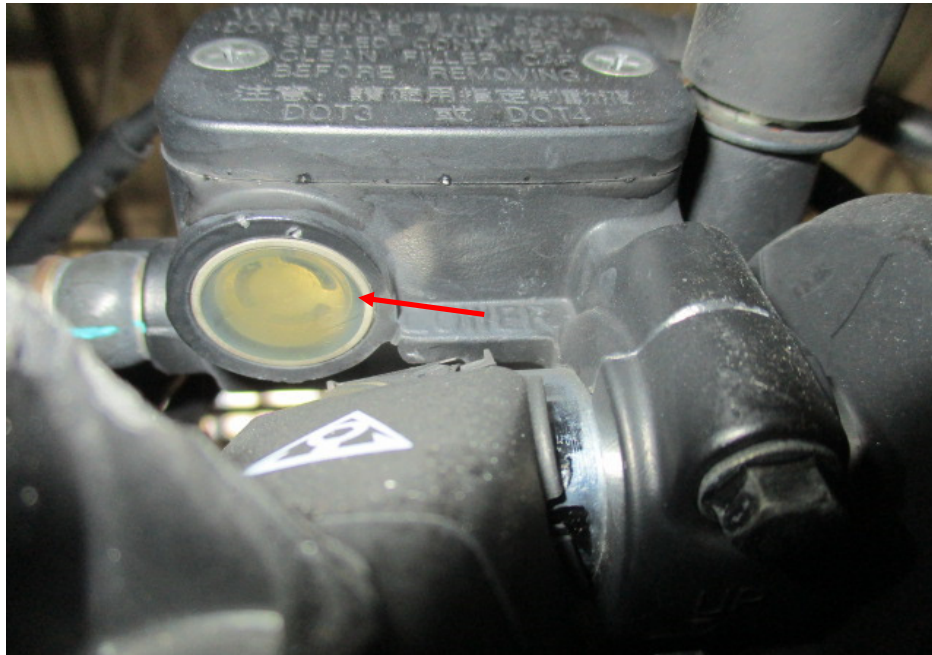
**Photo 23** shows the brake fluid for the front brake was found to be without contamination and of sufficient level for operating purposes (arrowed).

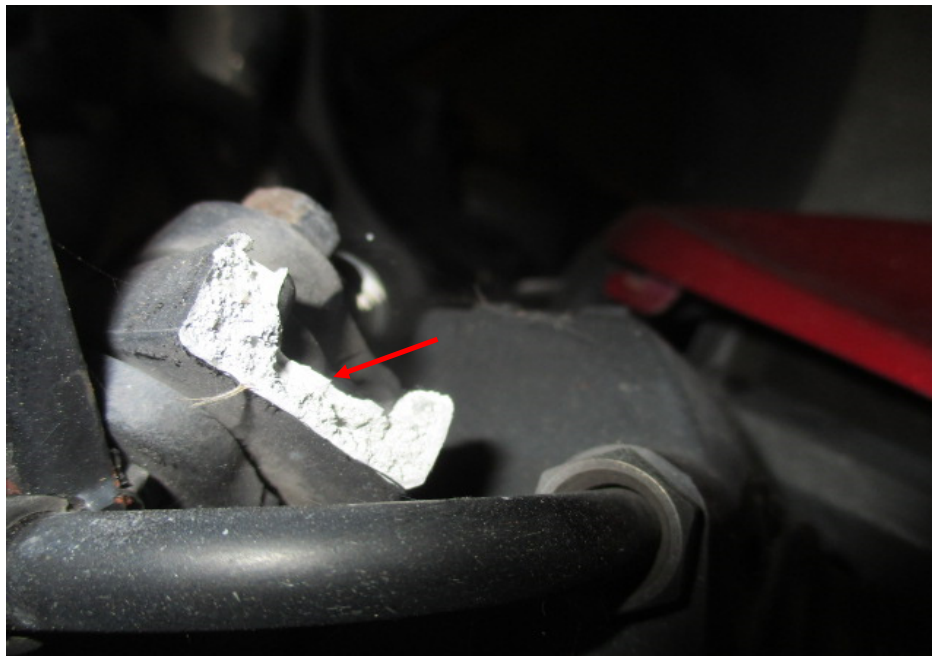
**Photo 24** shows a close up view of the broken front brake lever of the Motorcycle as a result of the accident (arrowed). We were hence not able to conduct any static tests on the front braking system of the Motorcycle. We were unable to indicate if there was any leakage of pressure/vacuum in the front brake system.

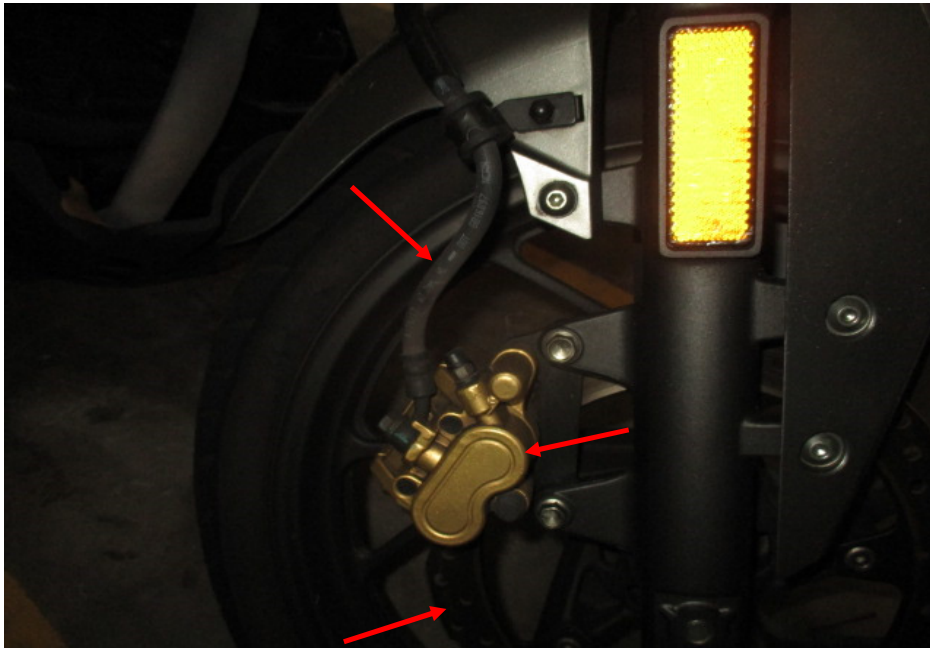
**Photo 25** shows a close up view of the front brake caliper, front brake disc and front brake hose (arrowed) of the Motorcycle, which are all part of the components in the hydraulic front brake system of the Motorcycle. Our visual checks of these various components had revealed all to be intact with no visible damage.

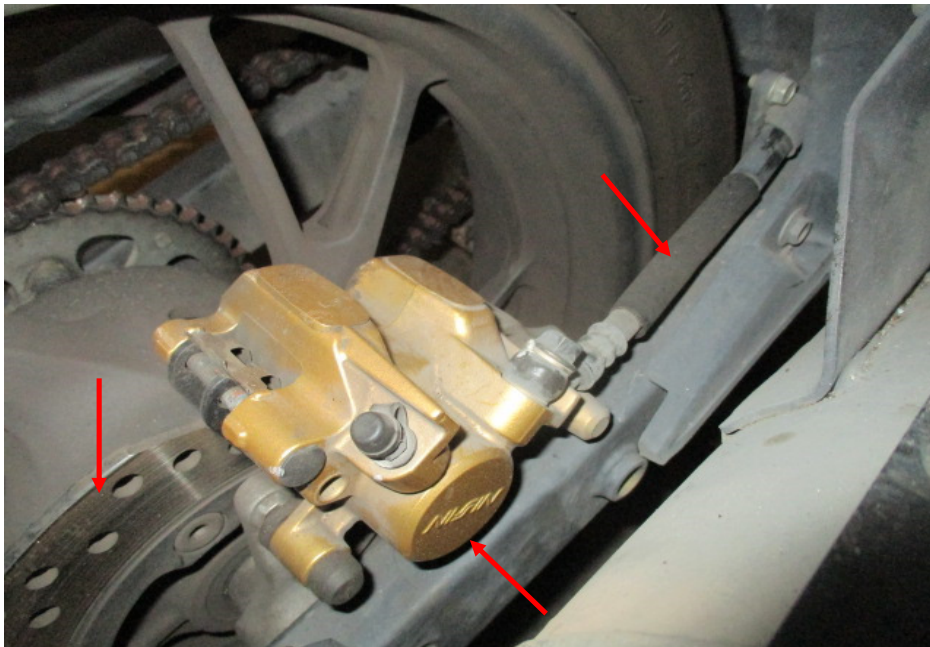
**Photo 26** shows a close up view of the rear brake caliper, rear brake disc and rear brake hose (arrowed) of the Motorcycle, which are all part of the components in the hydraulic rear brake system of the Motorcycle. Our visual checks of these various components had revealed all to be intact with no visible damage. No leakage of brake fluid was also observed.
