Your Ref: TP/IP/21913/2020  
Our Ref : CI/TPD20005987/N

12 June 2020

**Fatal Accident Investigation Team**

**INSPECTION REPORT OF MOTORCYCLE FBJ 2272S**

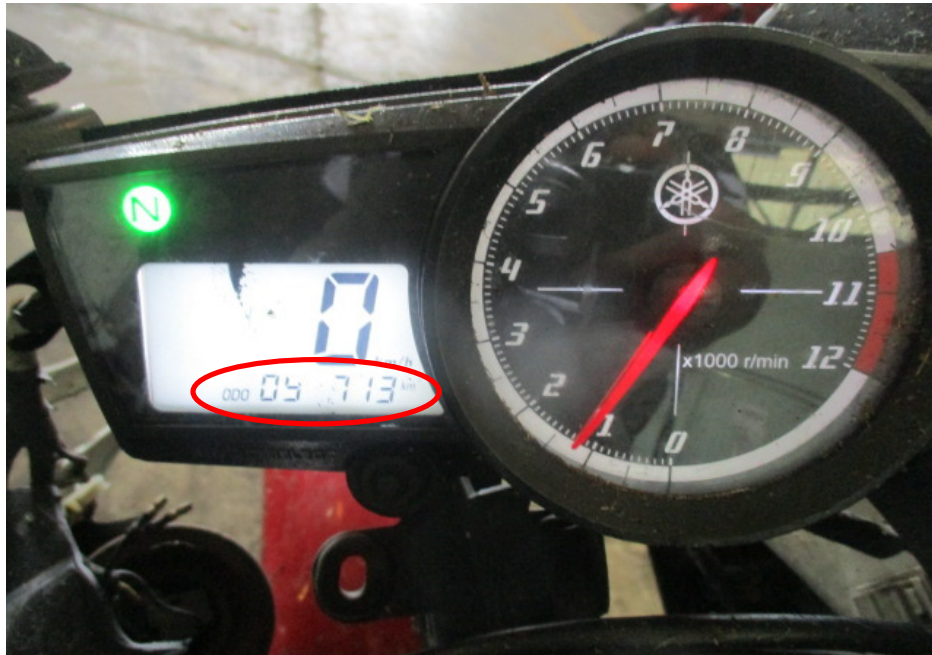
4. The mileage of the Motorcycle could not be recorded at the time of our inspection due to the damage sustained to the speedometer gauge as a result of the accident.
5. The Motorcycle was observed to have sustained damages all around. The body parts that were found to have been damaged include its headlight assembly, head cowl, front mudguard, side cowlings, right handlebar end, right side mirror, front brake lever, rear brake pedal, right front footrest, rear side covers and exhaust muffler, amongst others.

**Photo 1** shows the speedometer gauge of the Motorcycle which sustained damage as a result of the accident (circled).

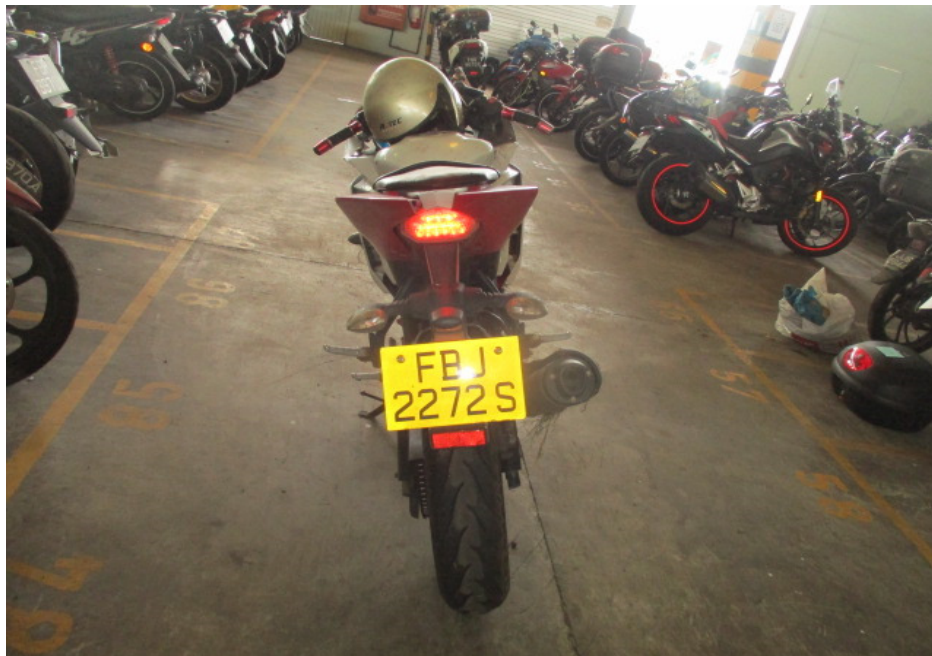
**Photo 2** shows a general view of the rear portion of the Motorcycle at the time of our inspection. The Motorcycle was observed to have sustained damages all around.

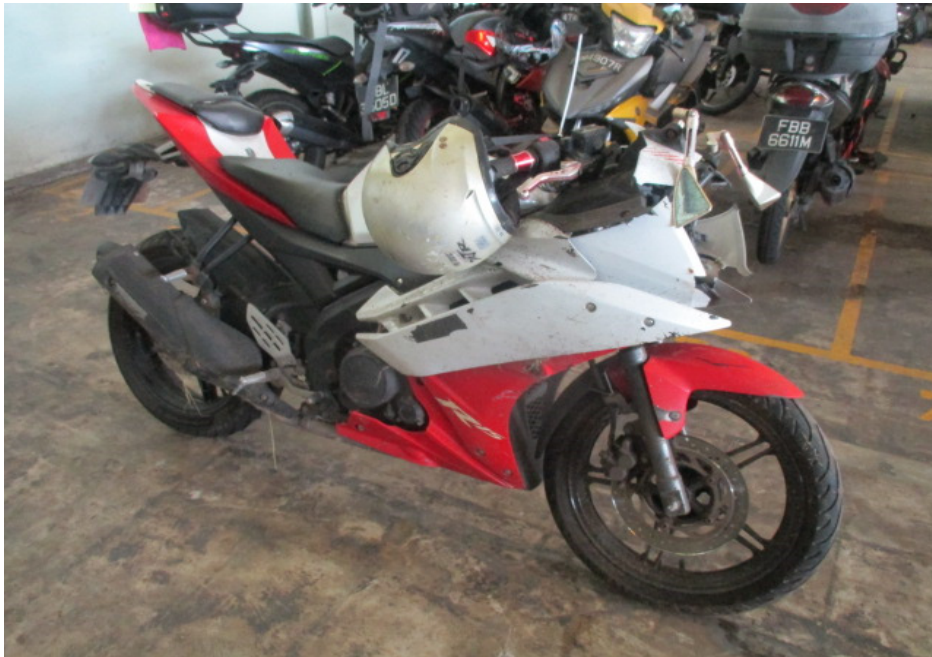
**Photo 3** shows a general view of the right body of the Motorcycle at the time of our inspection. The Motorcycle was observed to have sustained damages all around.

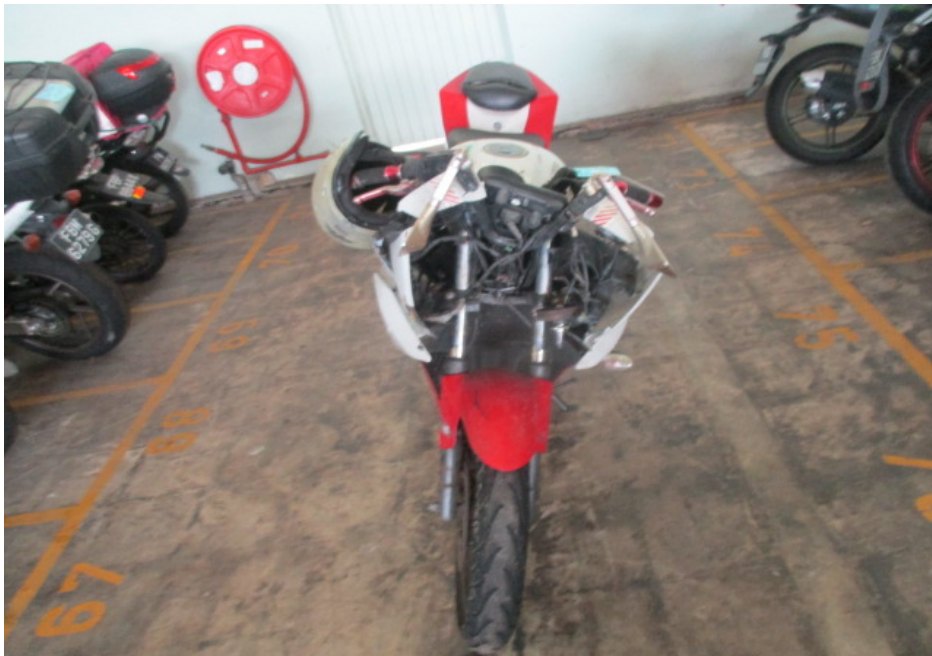
**Photo 4** shows a general view of the frontal portion of the Motorcycle at the time of our inspection. The Motorcycle was observed to have sustained damages all around. Amongst the body parts that were found to have been damaged include its headlight assembly, head cowl, front mudguard, side cowlings, right handlebar end, right side mirror, front brake lever, rear brake pedal, right front footrest, rear side covers and exhaust muffler, amongst others.

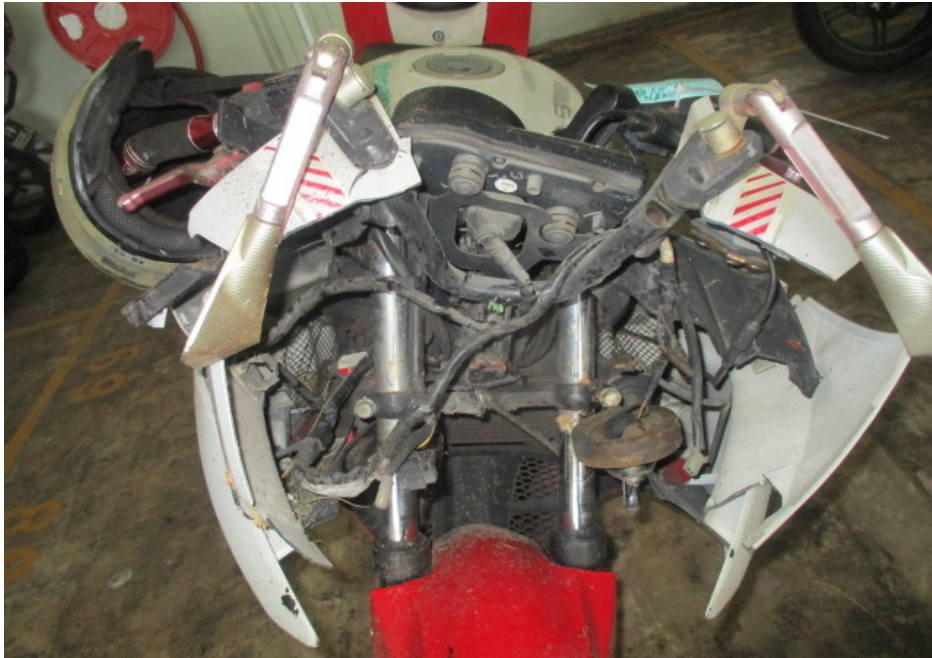
**Photo 5** shows a closer view of the missing headlight assembly and head cowling which were amongst the body parts at the front body of the Motorcycle that had sustained damage as a result of the accident.

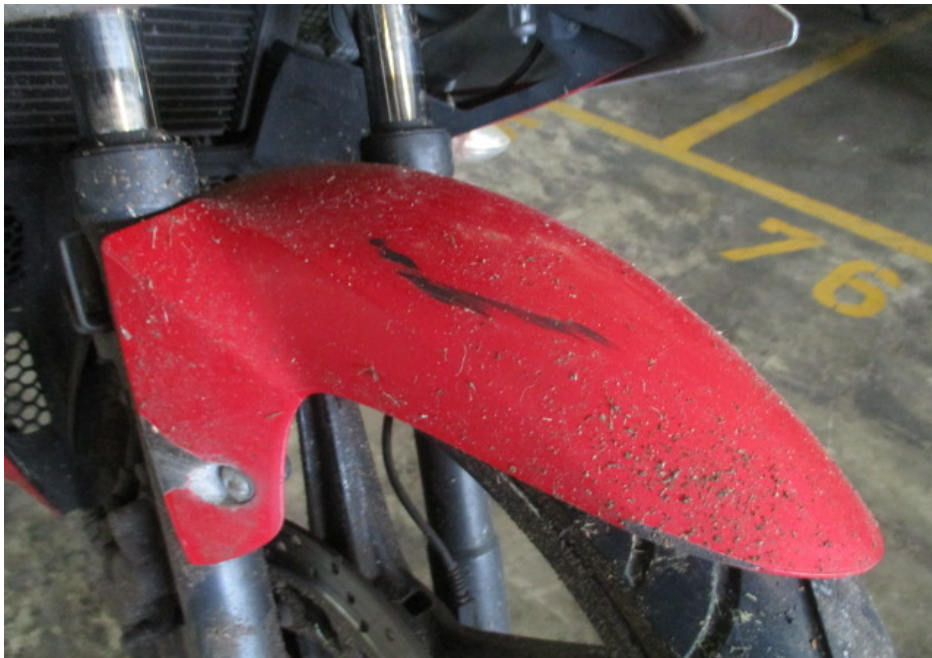
**Photo 6** shows a close up view of the front mudguard cowling which was amongst the body parts of the Motorcycle that had sustained damage as a result of the accident.

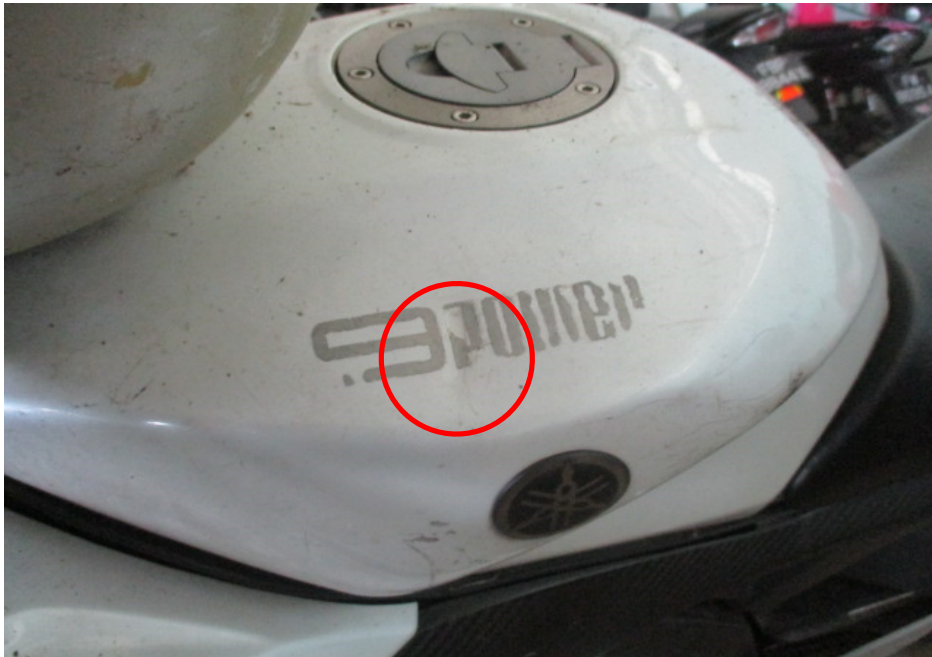
**Photo 7** shows a closer view of the dented fuel tank (circled) which was amongst the body parts at the front body of the Motorcycle that had sustained damage as a result of the accident.

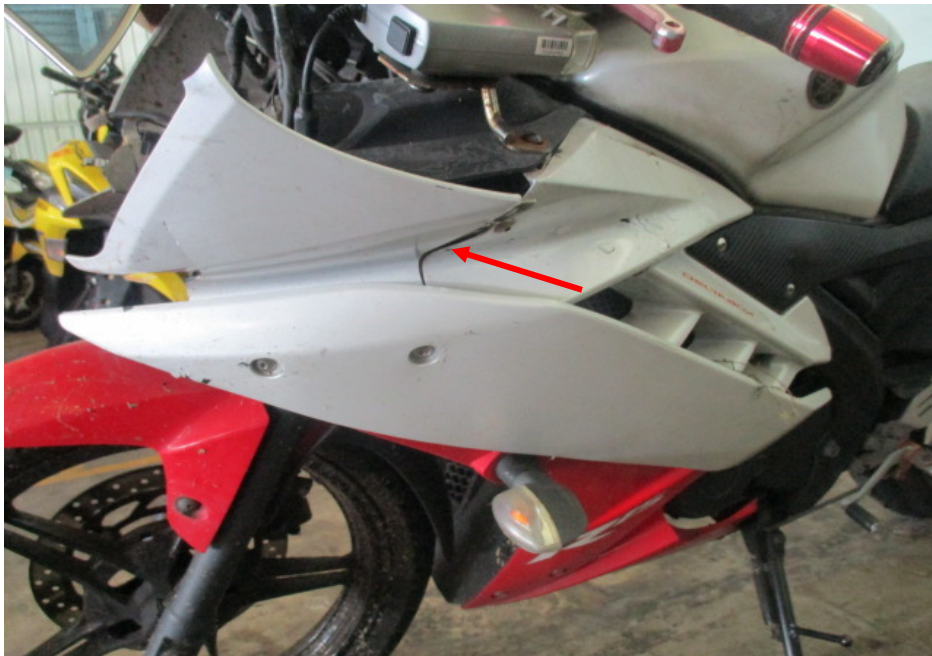
**Photo 8** shows a closer view of the cracked left cowling of the Motorcycle as a result of the accident (arrowed).

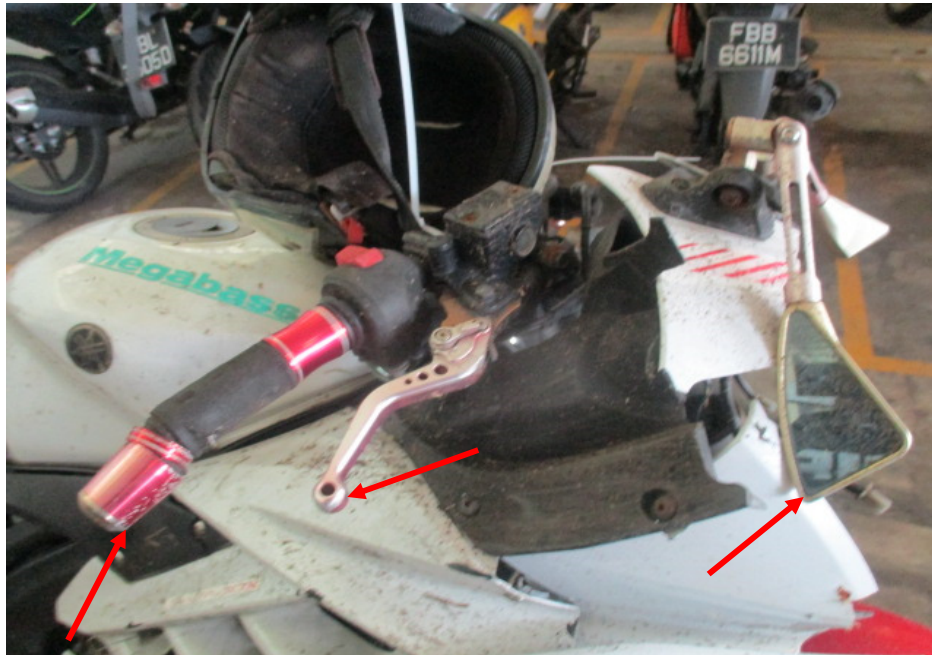
**Photo 9** shows a closer view of the right handlebar end, front brake lever and right side mirror (arrowed) which were amongst the body parts of the Motorcycle that had sustained damage as a result of the accident.

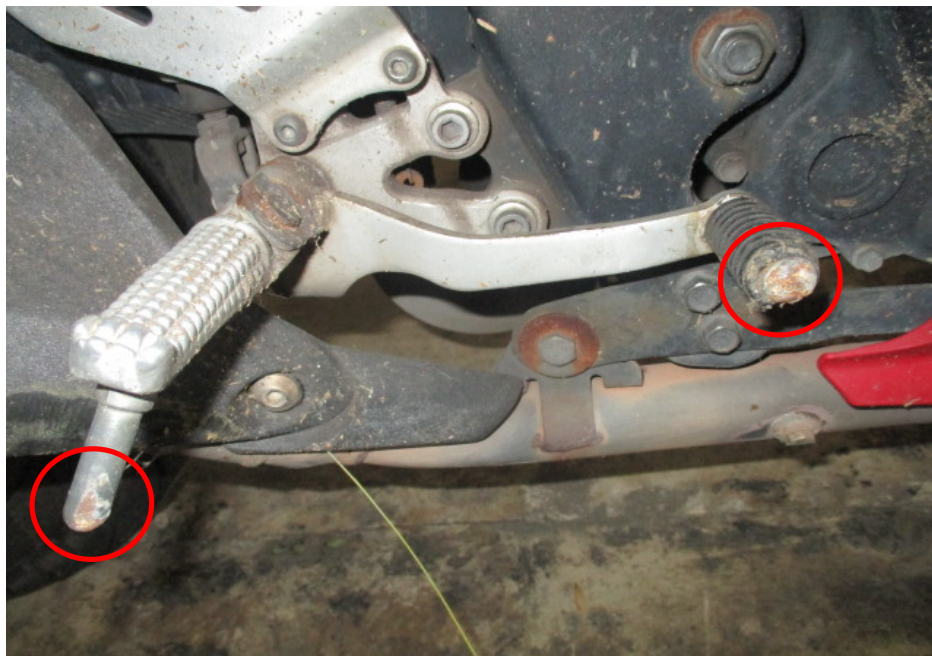
**Photo 10** shows a closer view of the rear brake pedal and right front footrest (circled) which were amongst the body parts of the Motorcycle that had sustained damage as a result of the accident.

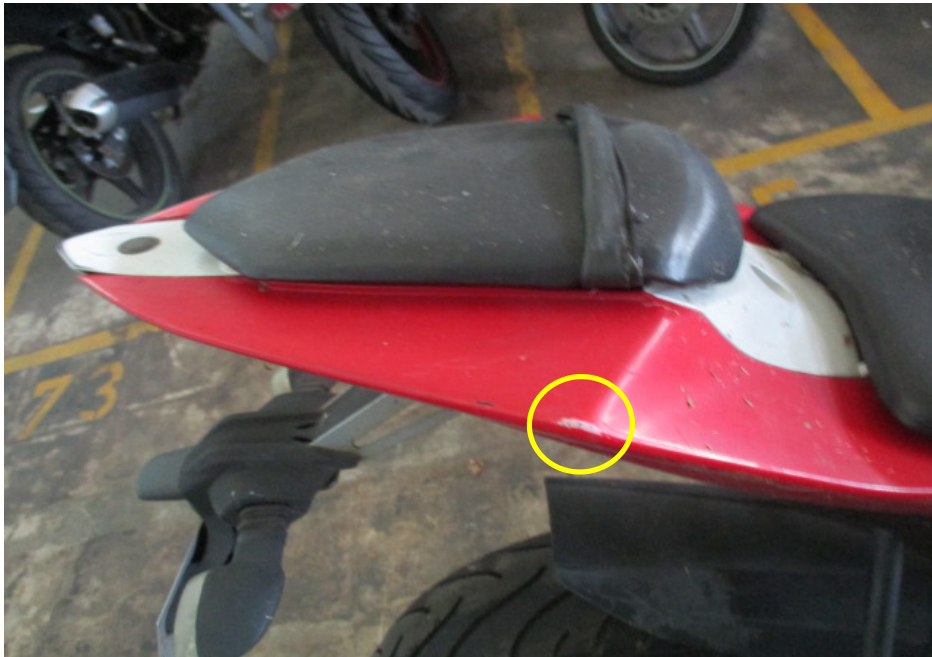
**Photo 11** shows the right rear side cover of the Motorcycle which was amongst the body parts of the Motorcycle that had sustained damages of grazing nature as a result of the accident (circled).

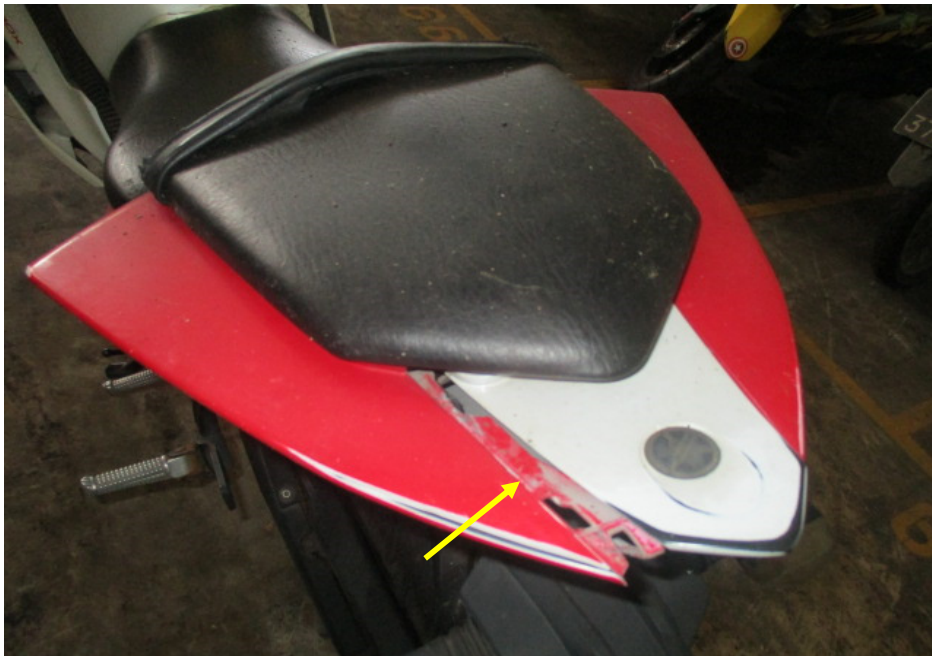
**Photo 12** shows a closer view of the deformed left rear side cover which was amongst the body parts of the Motorcycle that had sustained damage as a result of the accident (arrowed).

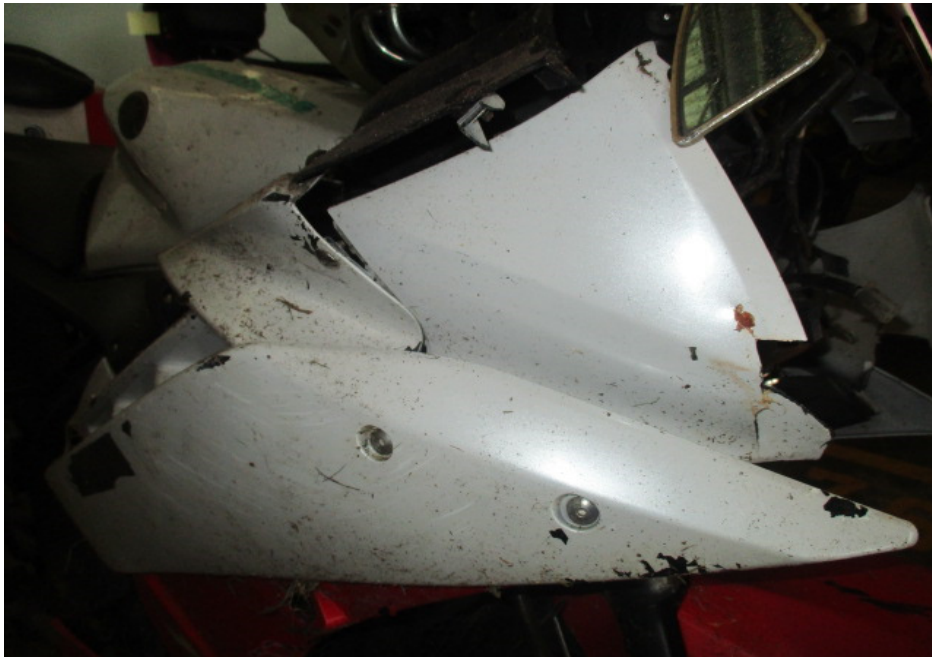
**Photo 13** shows a closer view of the cracked right cowling of the Motorcycle as a result of the accident.

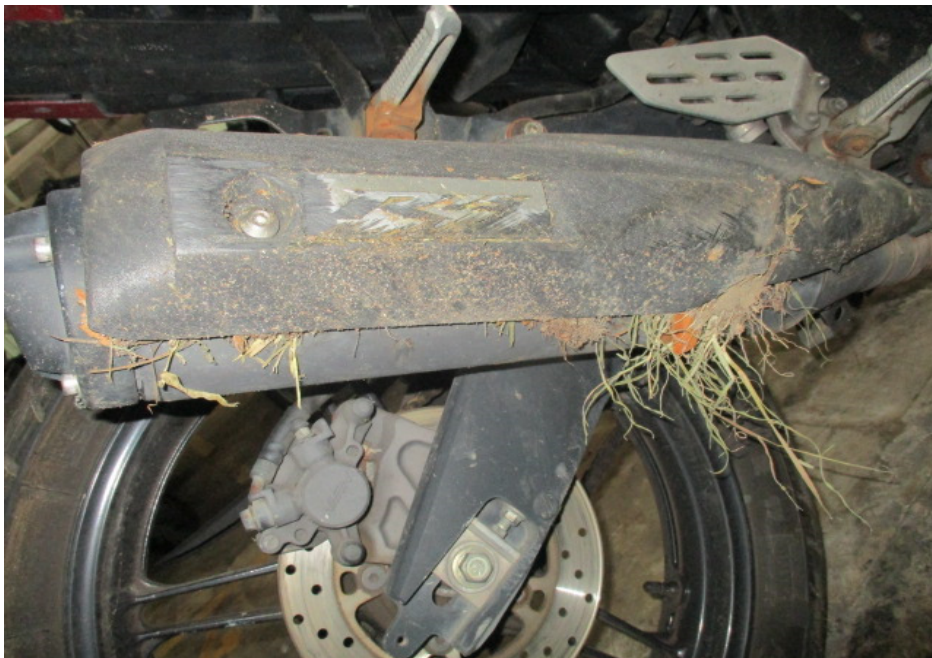
**Photo 14** shows a closer view of the exhaust muffler of the Motorcycle that had sustained damages of grazing nature as a result of the accident.

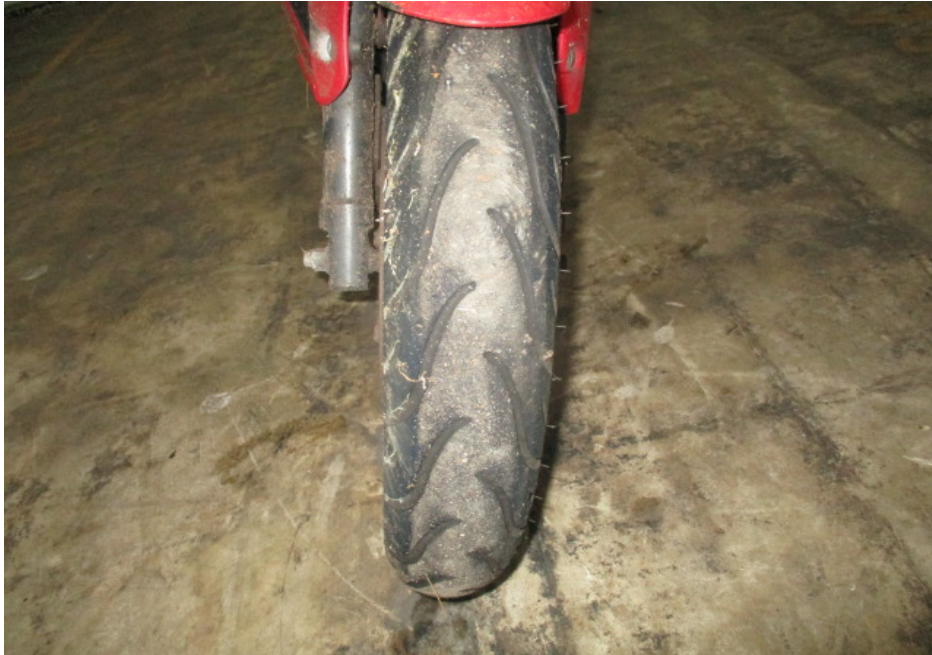
**Photo 15** shows the condition of the Motorcycle's front tyre. The front tyre was observed to be in serviceable condition with remaining tread depth of approximately 3mm. There was no tear, burst mark(s) and/or punctured hole(s) on the sidewalls as well as across the tread of the front tyre.

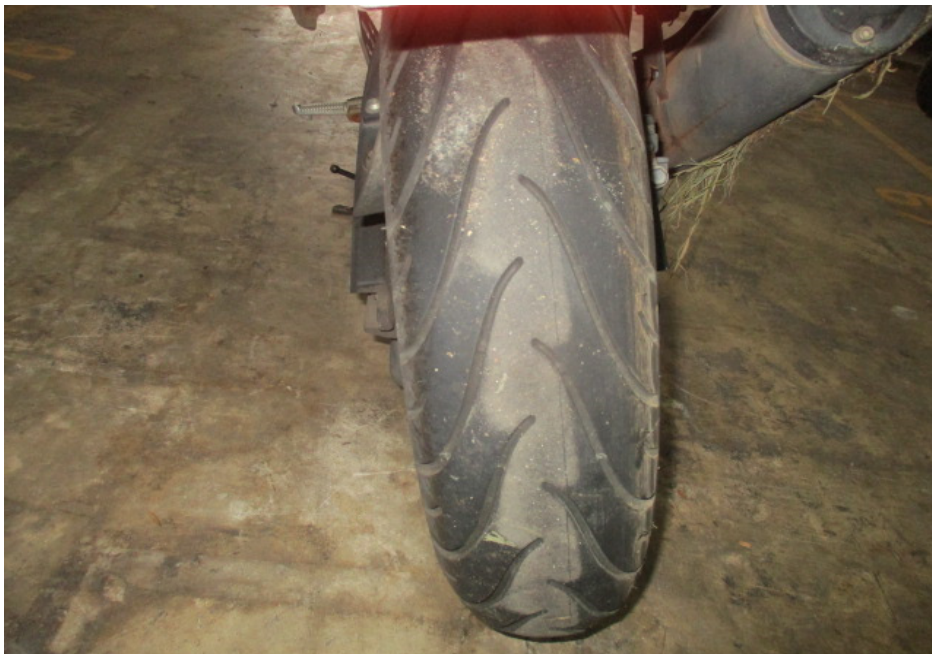
**Photo 16** shows the condition of the Motorcycle's rear tyre. The rear tyre was observed to be in serviceable condition with remaining tread depth of approximately 3mm. The tyre was also observed to be sufficiently inflated for vehicular operation. We did not observe any tear, burst mark(s) and/or punctured hole(s) on the sidewalls as well as across the tread of the rear tyre.

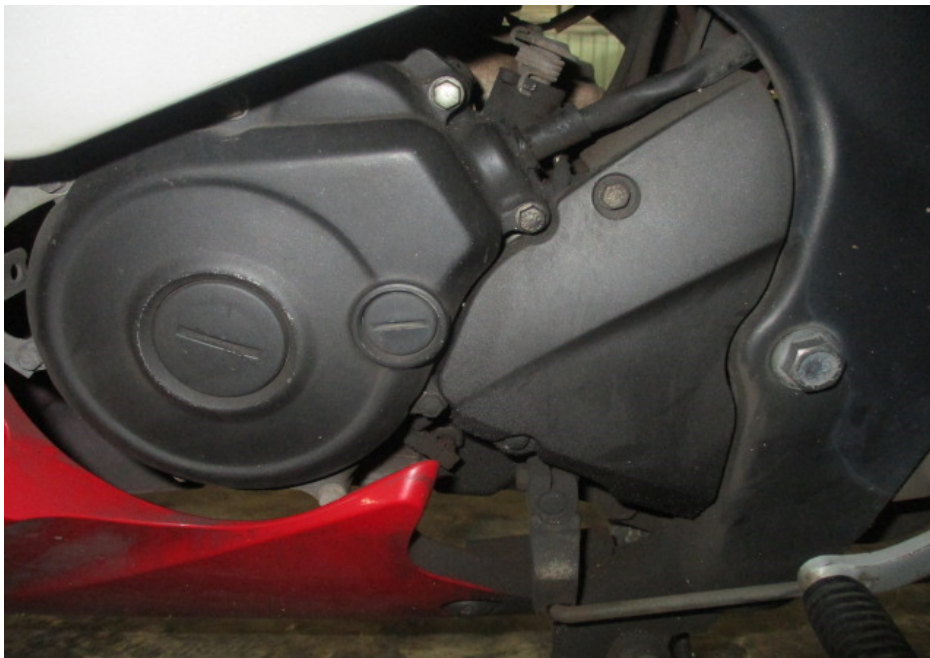
**Photo 17** shows the left side of the engine of the Motorcycle at the time of our inspection. The various engine related parts and components were found to be intact with no visible damage. There was also no sign(s) or indication(s) of fluid leak observed around the left engine area of the Motorcycle.

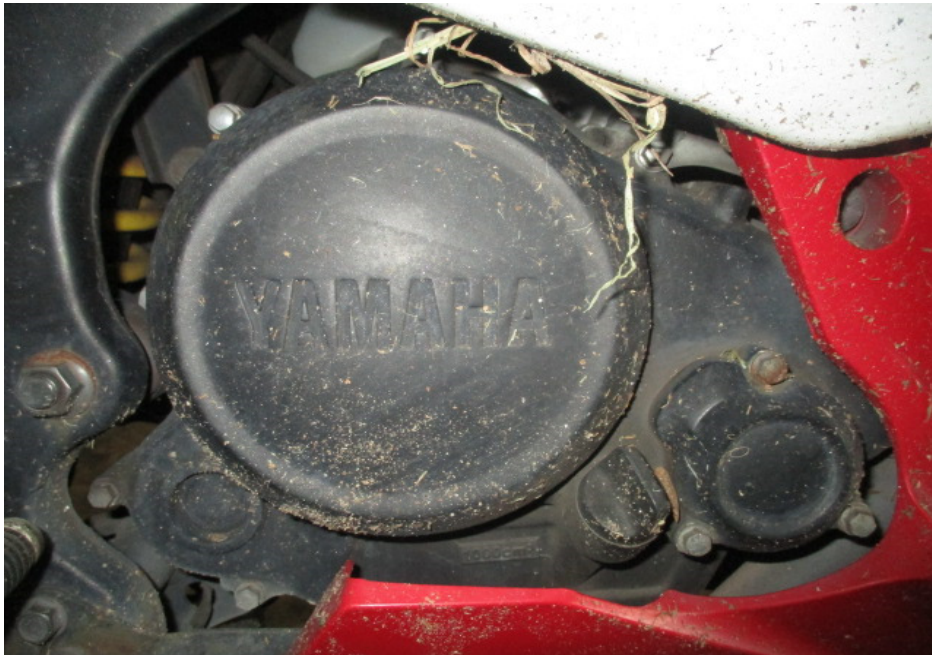
**Photo 18** shows the right side of the engine of the Motorcycle at the time of our inspection. The various engine related parts and components were found to be intact with no visible damage. There was also no sign(s) or indication(s) of fluid leak observed around the right engine area of the Motorcycle.

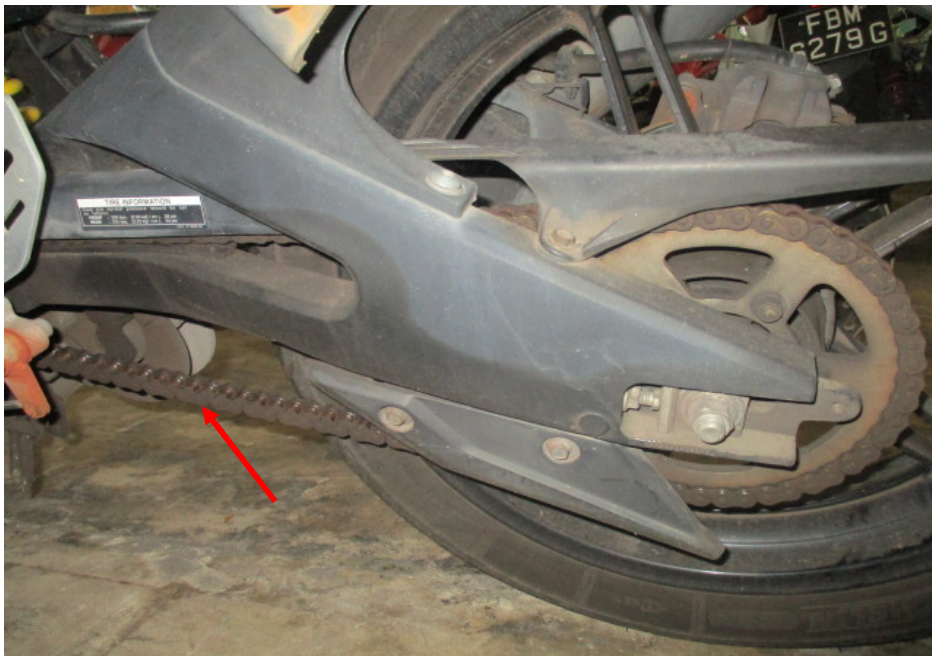
**Photo 19** shows the general view of the gear train (arrowed) of the Motorcycle, which was observed to be intact with no misalignment. It was also adequately lubricated for operating purposes.

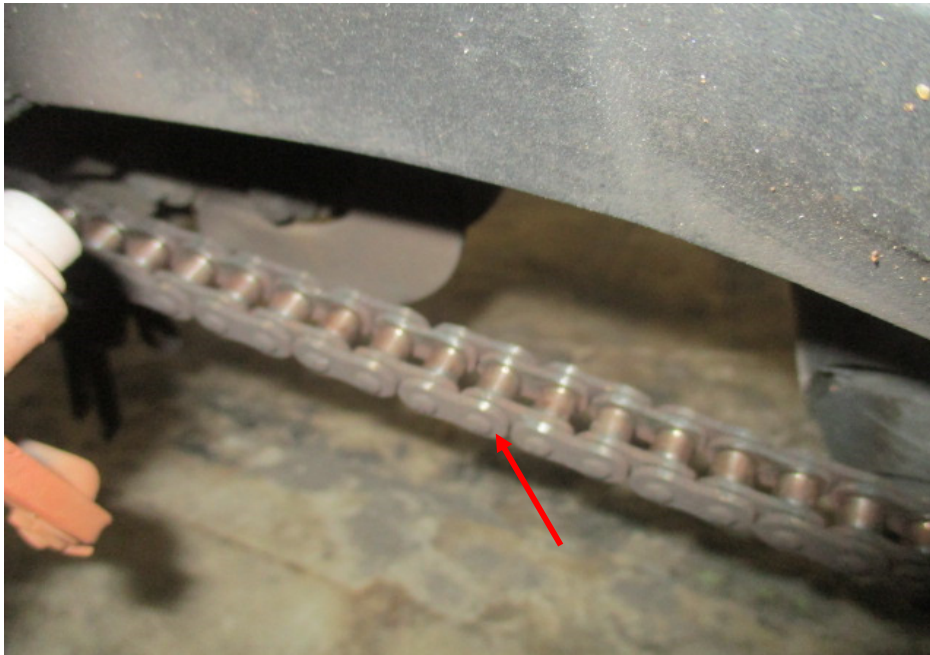
**Photo 20** shows a closer view of the gear train (arrowed) of the Motorcycle, which was observed to be intact with no misalignment. It was also adequately lubricated for operating purposes.

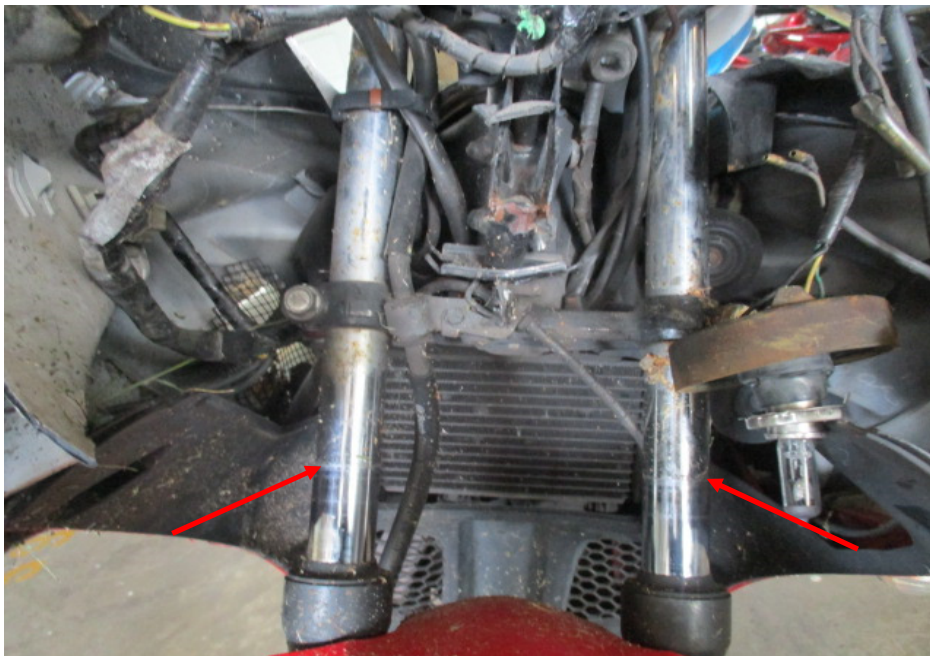
**Photo 21** shows the front fork (arrowed) of the Motorcycle. The front fork and fork bracket of the Motorcycle were both found to be intact and undamaged. Turning the Motorcycle's handle bar towards the left and right did not produce any abnormal free play and/or resistance. The steering system of the Motorcycle was in serviceable condition at the time of our inspection.

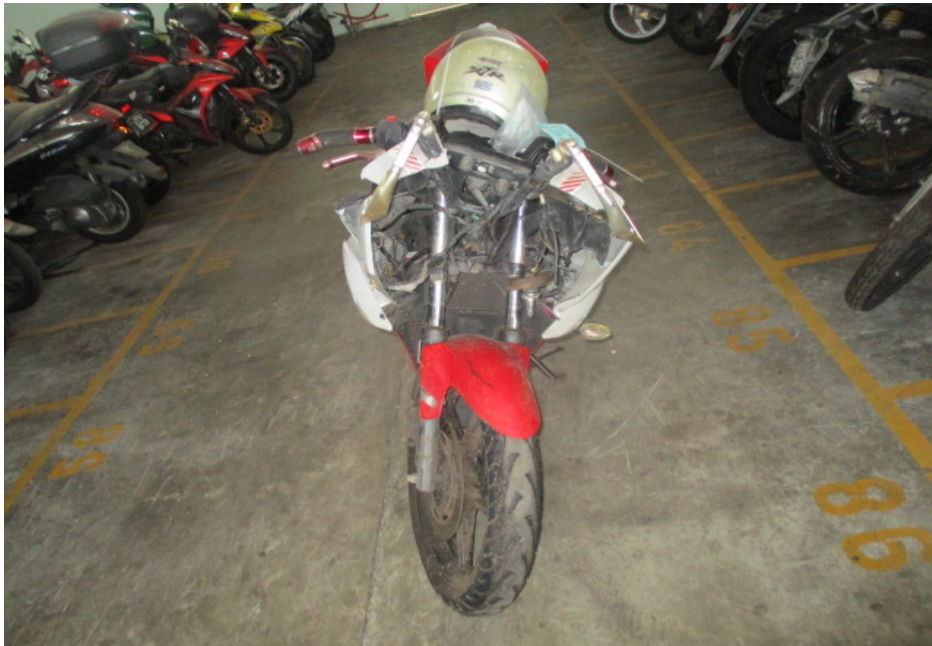
**Photo 22** shows the front wheel of the Motorcycle turned towards its full left. Turning the Motorcycle's handle bar towards the left and right did not produce any abnormal free play and/or resistance. This would indicate that the steering system of the Motorcycle was in serviceable condition at the time of our inspection.

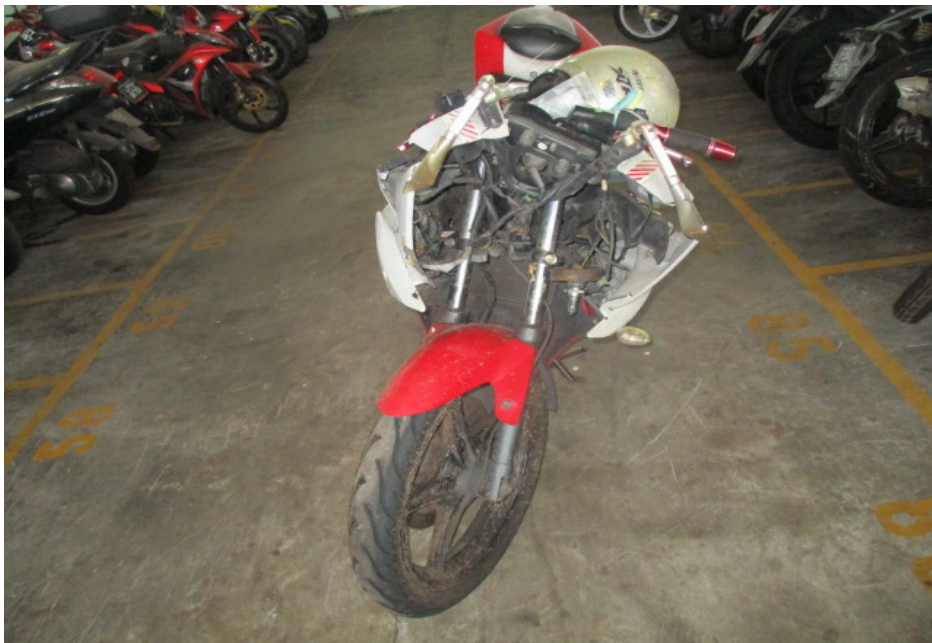
**Photo 23** shows the front wheel of the Motorcycle turned towards its full right. Turning the Motorcycle's handle bar towards the left and right did not produce any abnormal free play and/or resistance. This would indicate that the steering system of the Motorcycle was in serviceable condition at the time of our inspection.

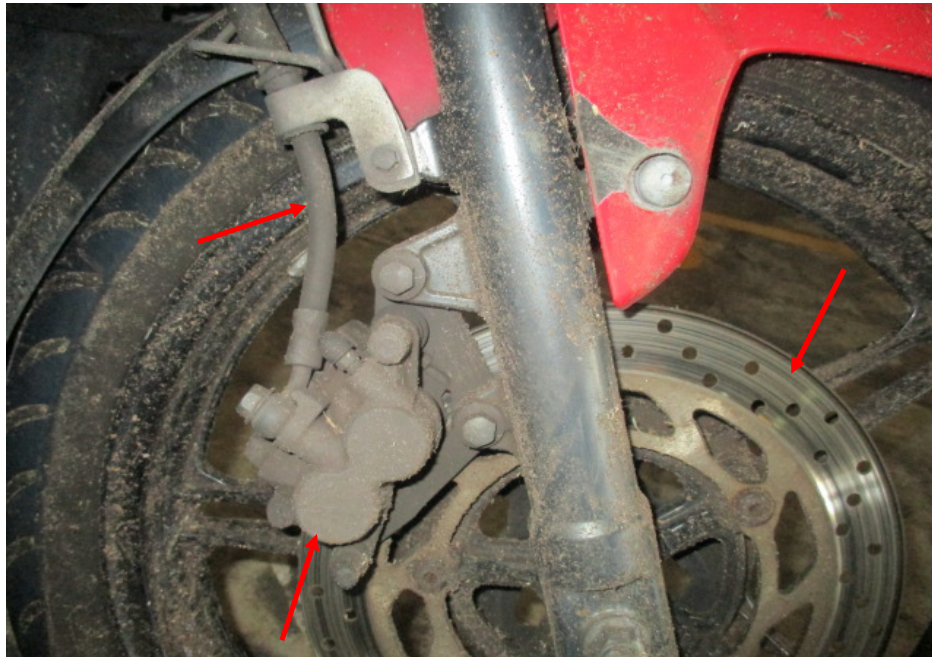
**Photo 24** shows a close up view of the front brake caliper, front brake disc and front brake hose (arrowed) of the Motorcycle, which are all part of the components in the hydraulic front brake system of the Motorcycle. Our visual checks of these various components had revealed all to be intact with no visible damage. No leakage of brake fluid was also observed.

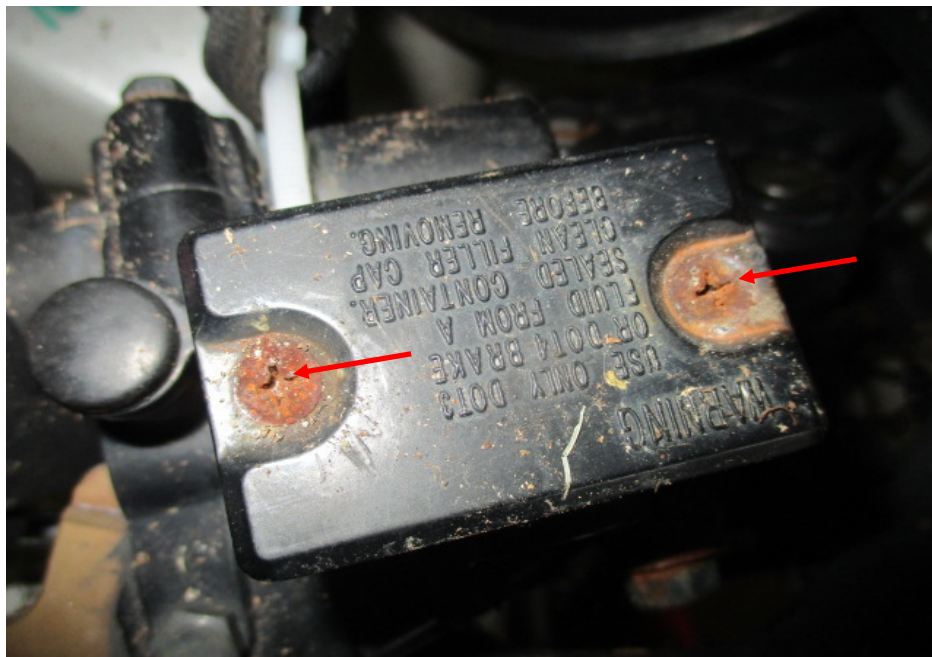
14. However we were unable remove the front brake reservoir cover to examine whether the brake fluid was of sufficient level and without contamination for operational purposes due to worn out screws .The brake fluid for the rear brake was also found to be of sufficiently level and without any contamination.

**Photo 25** shows the brake fluid reservoir cover for the front brake of the Motorcycle. We were unable to examine whether the brake fluid was of sufficient level and without contamination for operational purposes due to the worn out screws (arrowed).

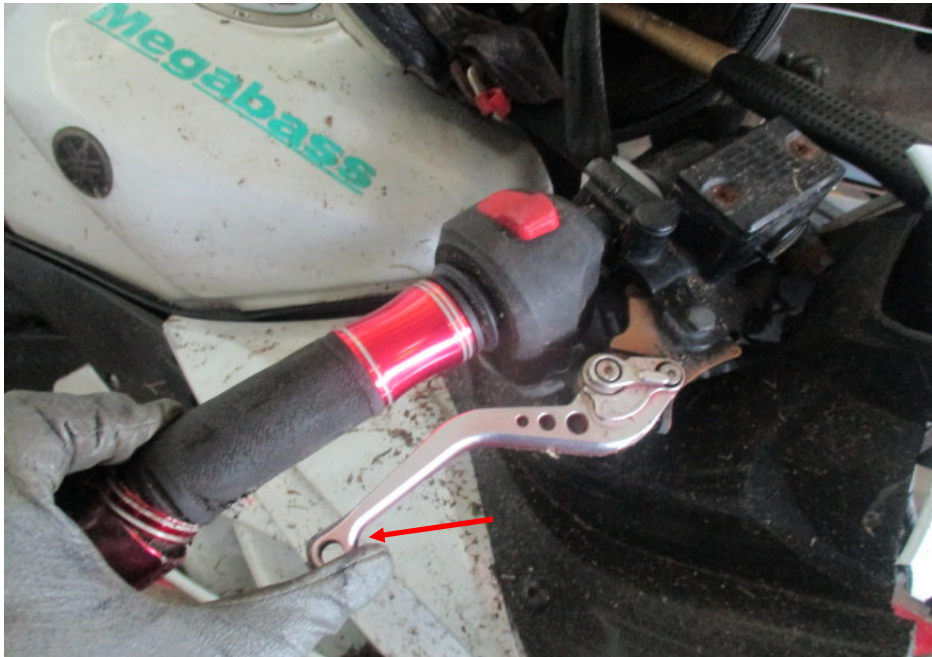
15. Static brake tests conducted on the Motorcycle had appear to indicate that the braking system of the Motorcycle was in serviceable condition. There was some resistance felt (spongy like feel) upon pressing the brake lever and upon stepping on the brake pedal. This would indicate that there was no leakage of pressure/vacuum in the brake system.

**Photo 26** shows the front brake lever being depressed. There was some resistance felt (spongy like feel) upon pressing the front brake lever (arrowed). This would indicate that there is no leakage of pressure/vacuum in the brake system.

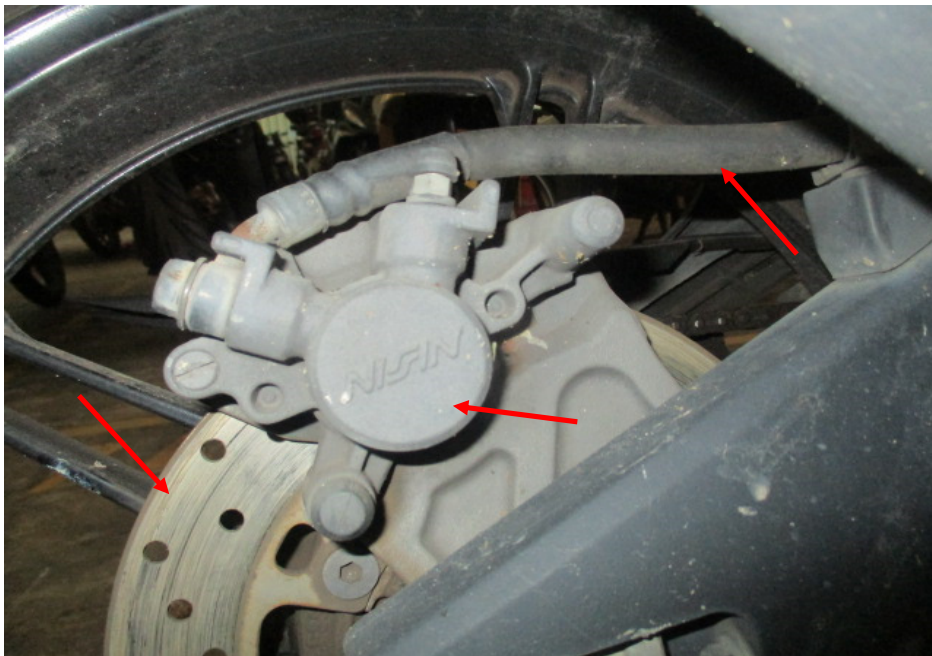
**Photo 27** shows a close up view of the rear brake caliper, rear brake disc and rear brake hose (arrowed) of the Motorcycle, which are all part of the components in the hydraulic rear brake system of the Motorcycle. Our visual checks of these various components had revealed all to be intact with no visible damage. No leakage of brake fluid was also observed.
