Your Ref: TP/IP/20683/2020
Our Ref : CI/TPD20005989/N

16 June 2020

INSPECTION REPORT OF MOTORCYCLE JRA 7270

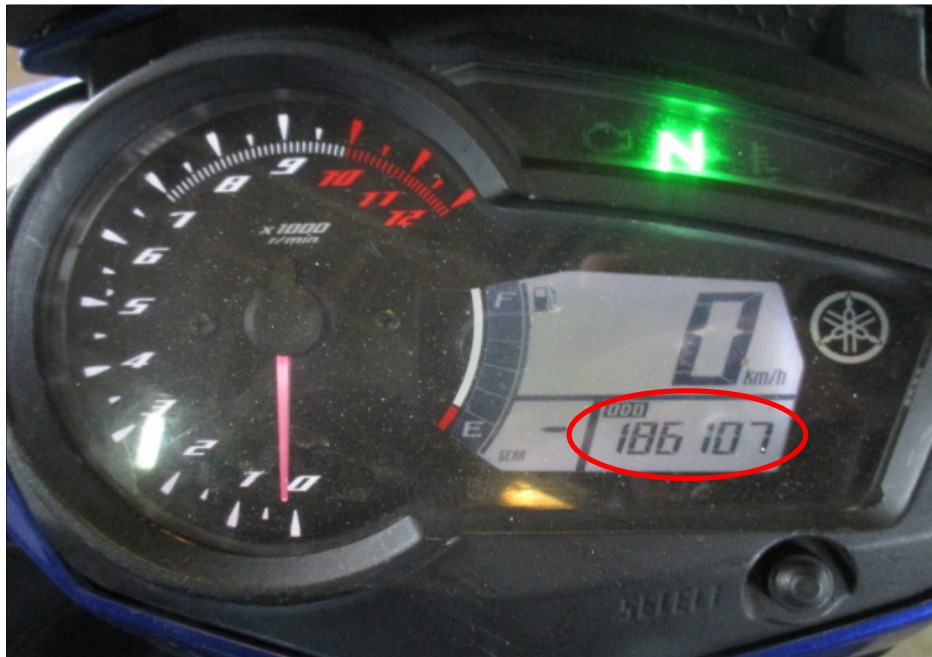
Photo 1 shows the speedometer gauge of the Motorcycle. The mileage of the Motorcycle at the time of our inspection was 186, 107km (circled).

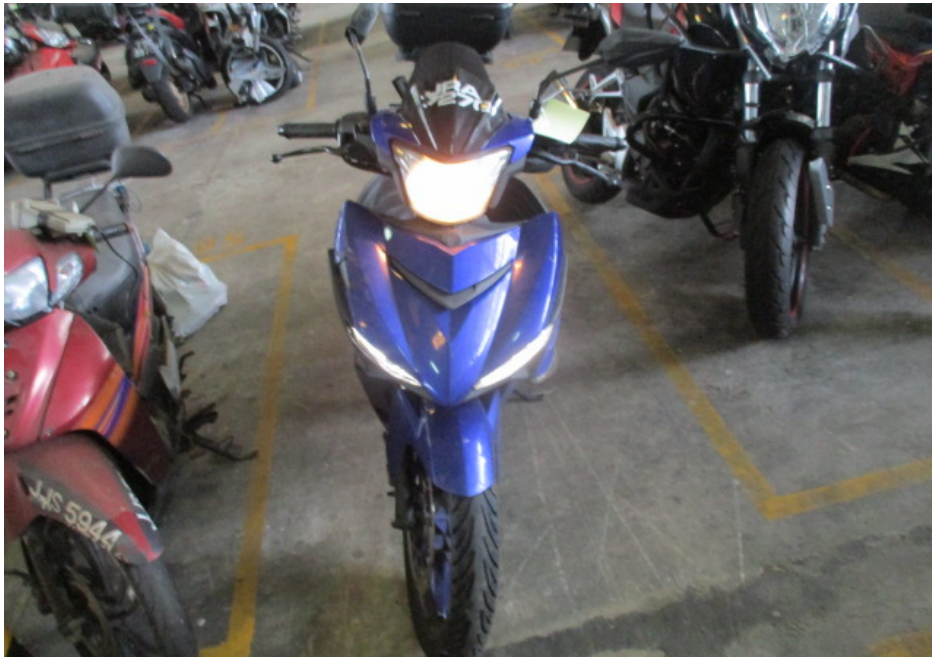
Photo 2 shows a general view of the front body of the Motorcycle at the time of our inspection. The Motorcycle was observed to have sustained damages frontal portion and right body.

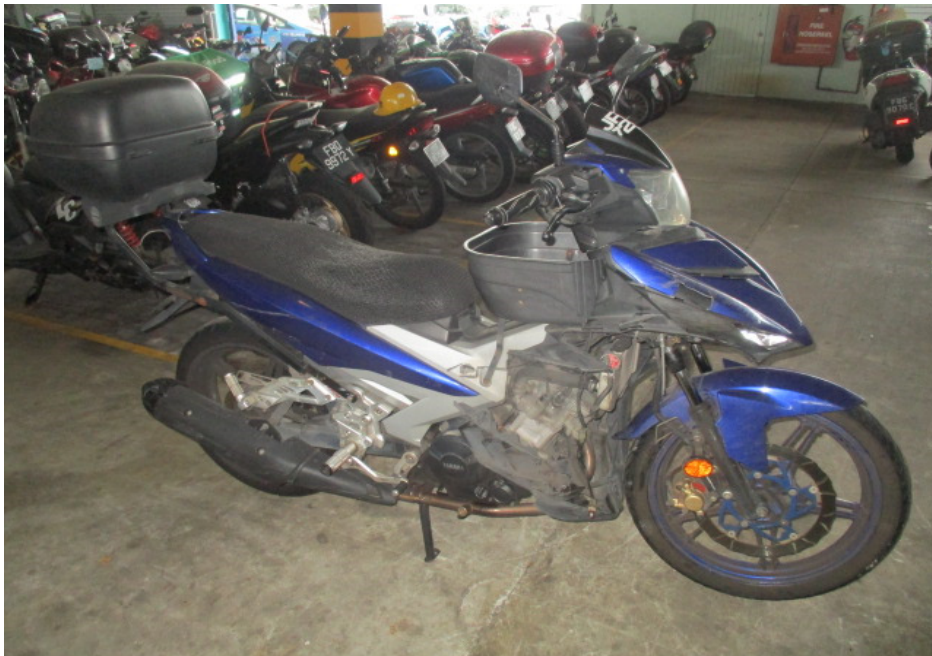
Photo 3 shows a general view of the right body of the Motorcycle at the time of our inspection. The Motorcycle was observed to have sustained damages along its frontal portion and right body. The body parts that were found to have been damaged include its front cowling, right cowling, front mudguard, right handlebar end, front brake lever, right side mirror, right front footrest, right rear side cover, exhaust muffler and top, amongst others.

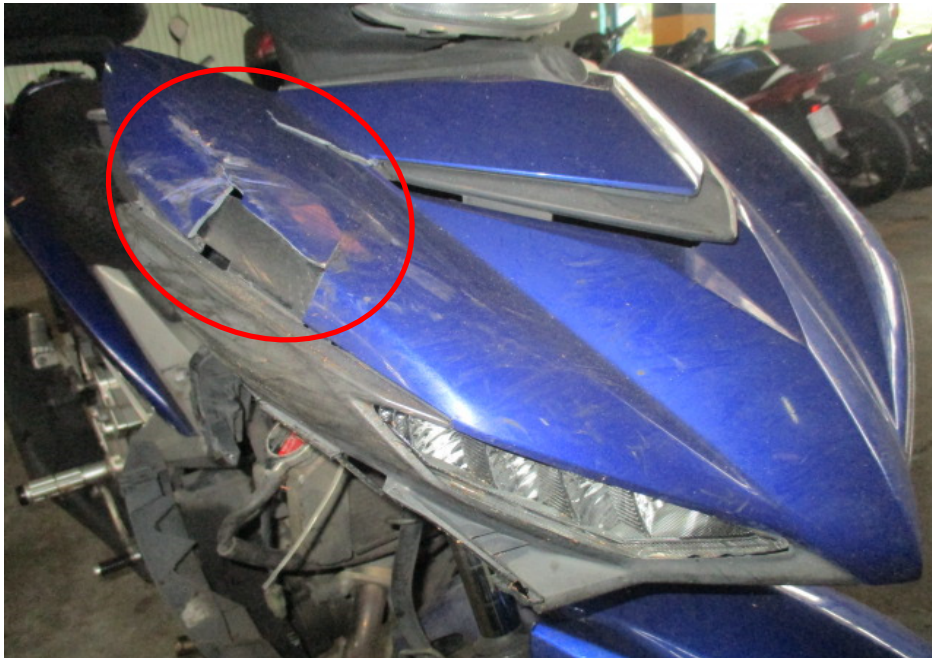
Photo 4 shows a close up view of the cracked front cowling (circled) which was amongst the body parts of the Motorcycle that had sustained damage as a result of the accident.

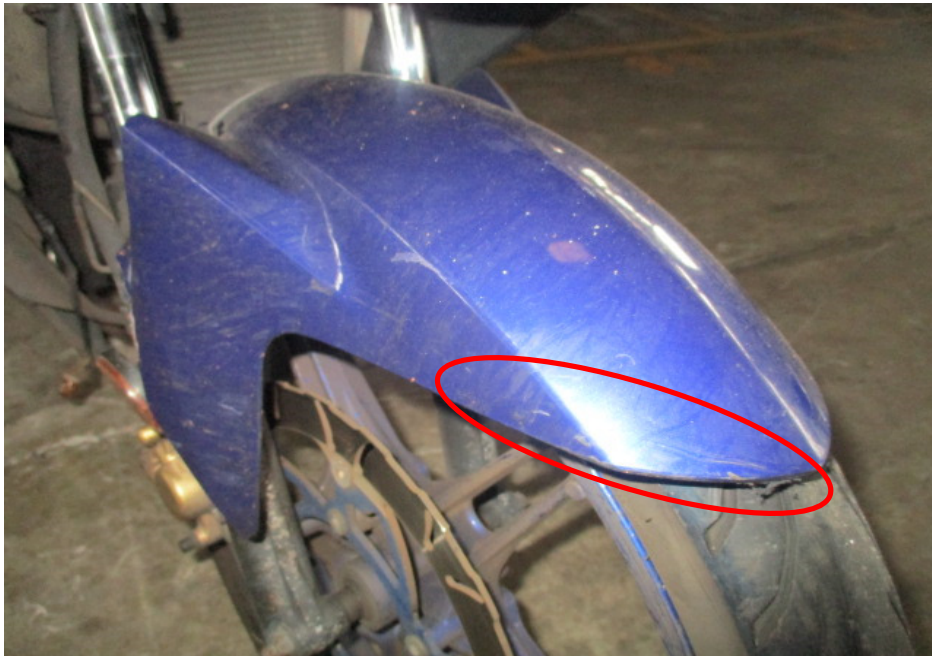
Photo 5 shows a closer view of the front mudguard (circled) which was amongst the body parts at the front body of the Motorcycle that had sustained damage as a result of the accident.

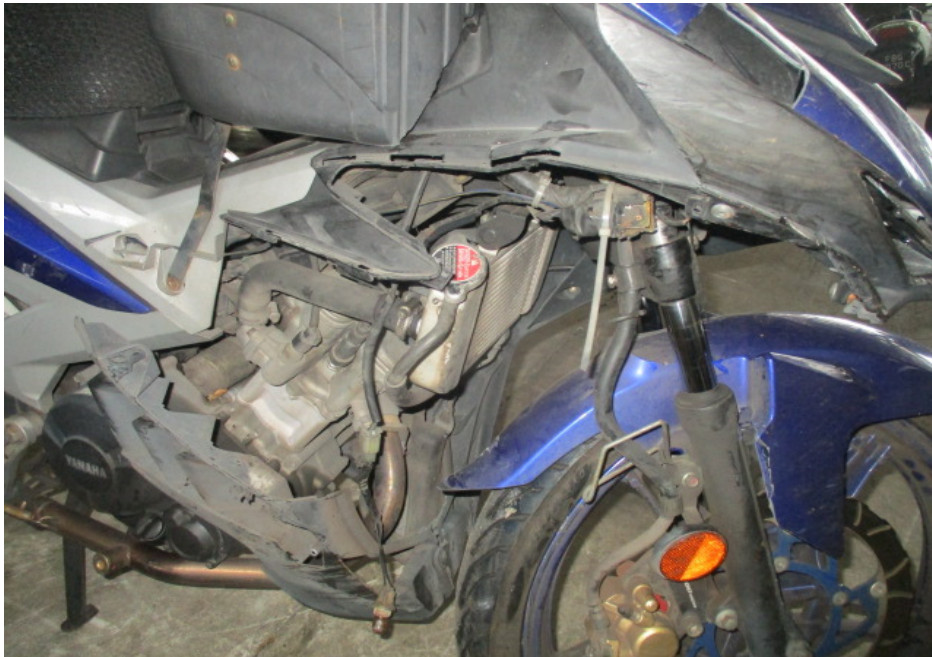
Photo 6 shows a closer view of the cracked right cowling which was amongst the body parts of the Motorcycle that had sustained damage as a result of the accident.

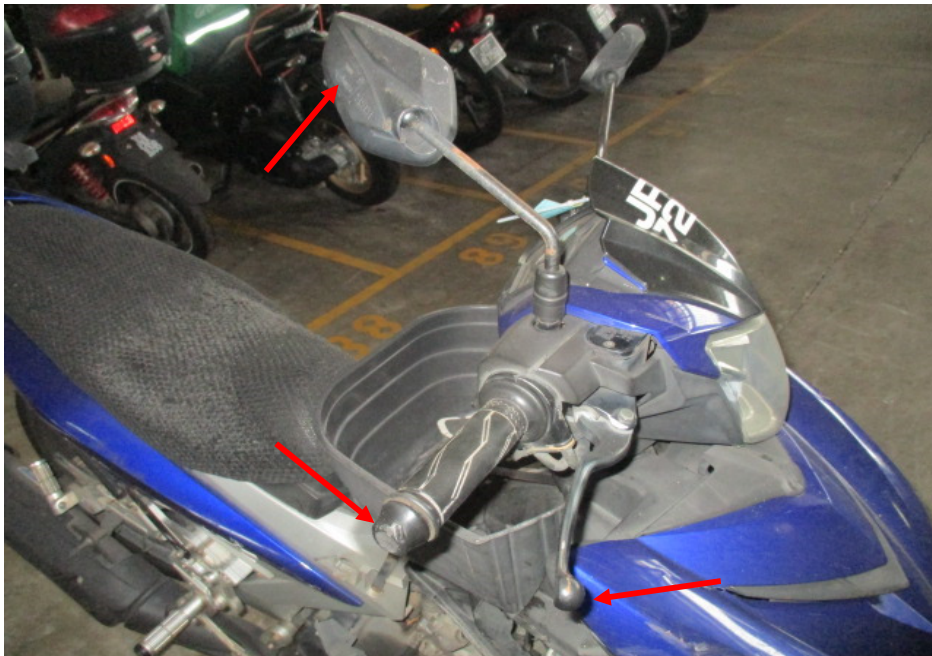
Photo 7 shows the front brake lever, right handlebar end and right side mirror (arrowed), which were amongst the body parts of the Motorcycle that had sustained damage as a result of the accident.

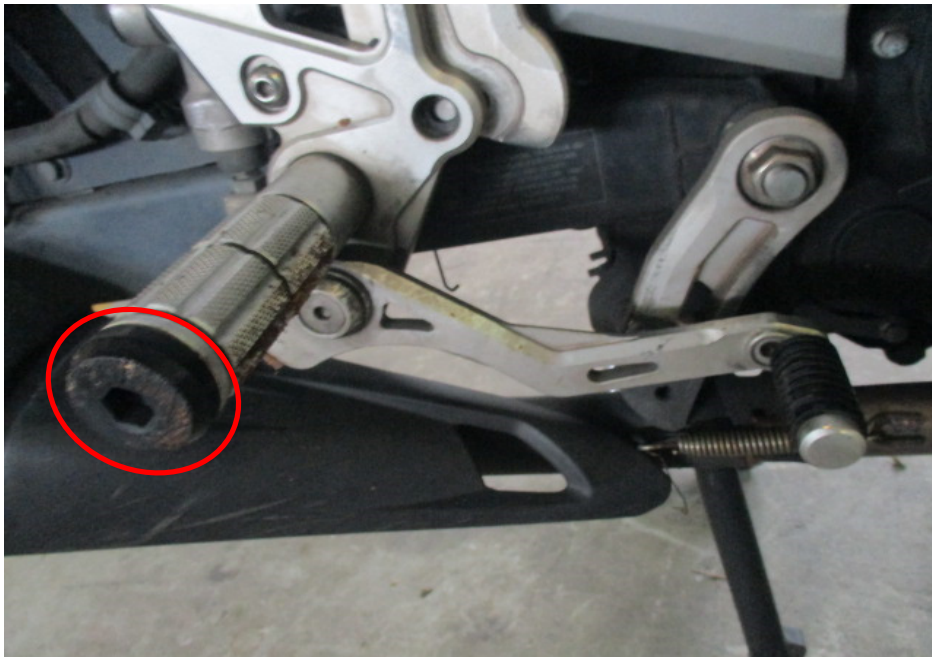
Photo 8 shows a closer view of the right front footrest (circled) which was amongst the body parts of the Motorcycle that had sustained damage as a result of the accident.

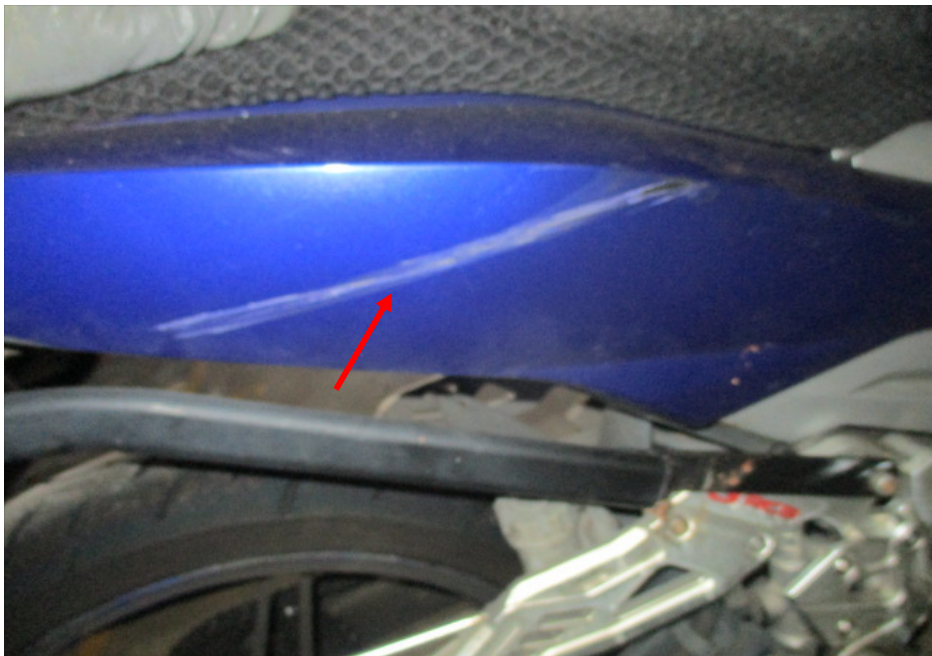
Photo 9 shows a closer view of the right rear side cover which was amongst the body parts of the Motorcycle that had sustained damages of grazing nature as a result of the accident.

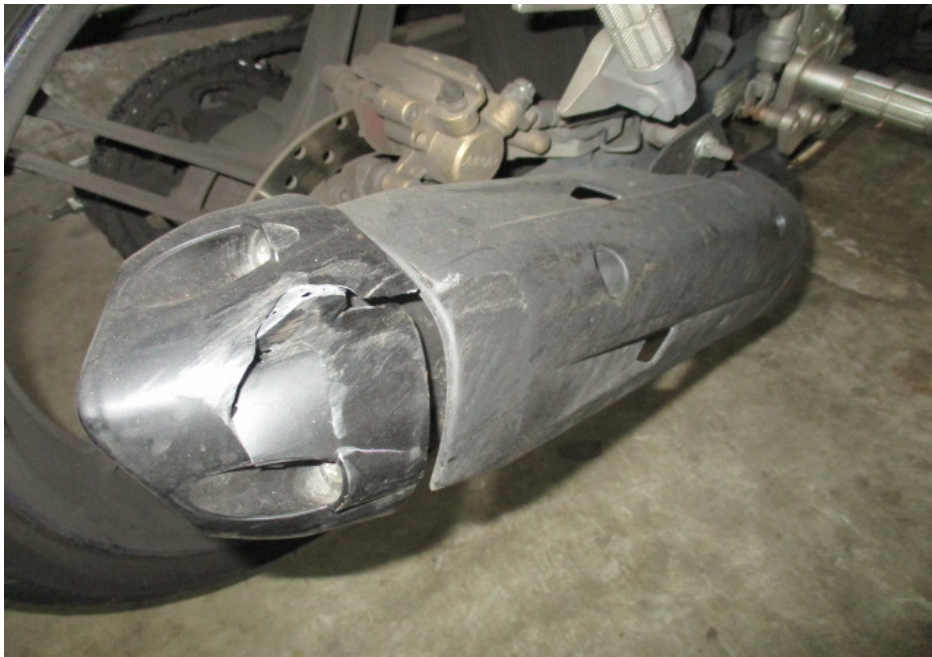
Photo 10 shows the exhaust muffler and exhaust muffler heat shield of the Motorcycle that had sustained damage as a result of the accident.

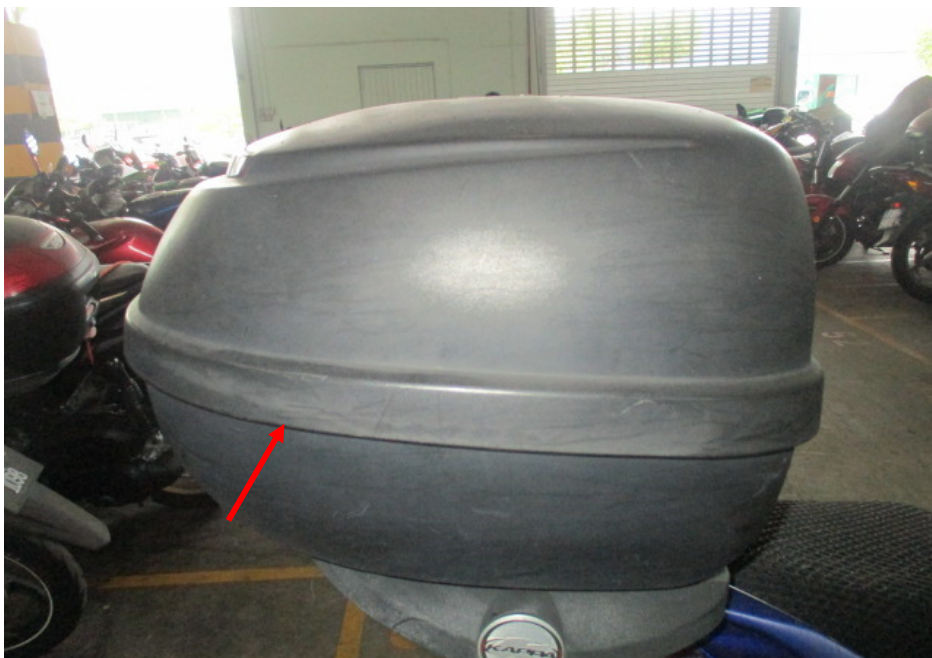
Photo 11 shows a closer view of the top box which was amongst the body parts of the Motorcycle that had sustained damages of grazing nature as a result of the accident (arrowed).

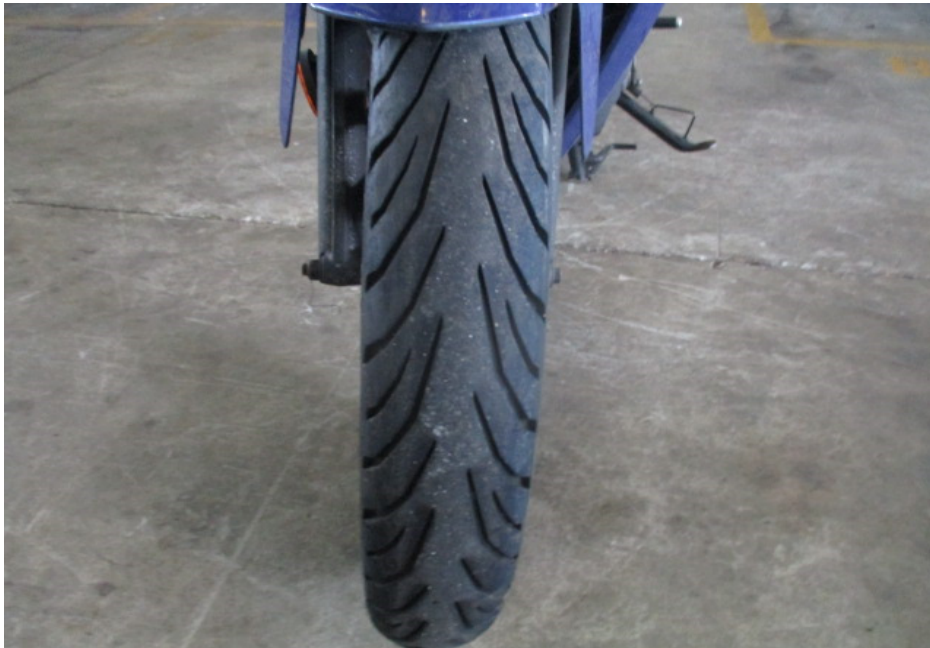
Photo 12 shows the front tyre of the Motorcycle at the time of our inspection. The front tyre was observed to be in serviceable condition with remaining tread depth of approximately 4mm. The pattern of the tread was also clearly visible. There was no tear, burst mark(s) and/or punctured hole(s) on the sidewalls as well as across the tread of the front tyre.

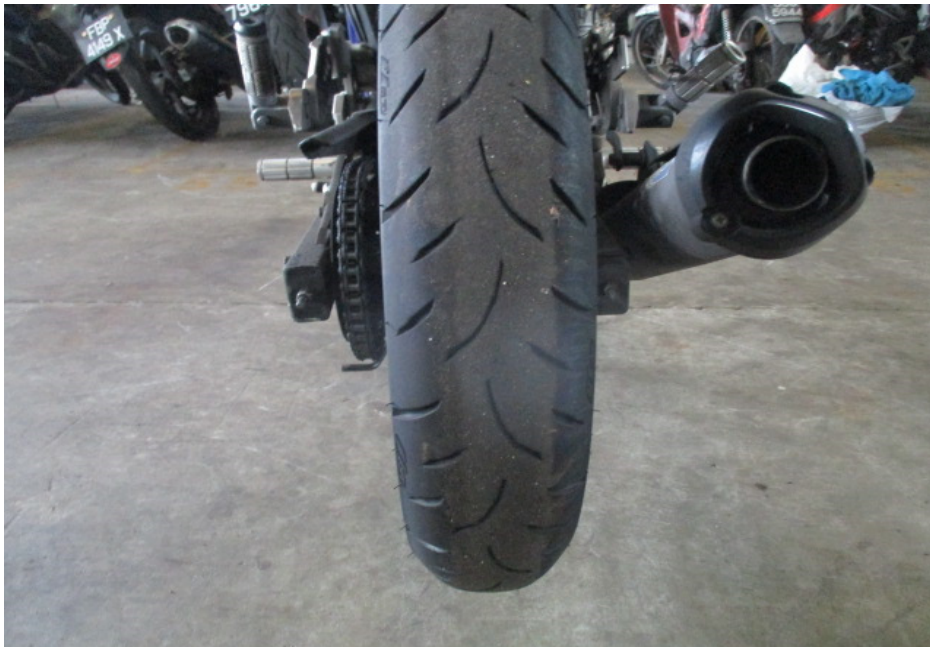
Photo 13 shows the condition of the Motorcycle's rear tyre. The rear tyre was observed to be in serviceable condition with remaining tread depth of approximately 3mm. The tyre was also observed to be sufficiently inflated for vehicular operation. We did not observe any tear, burst mark(s) and/or punctured hole(s) on the sidewalls as well as across the tread of the rear tyre.

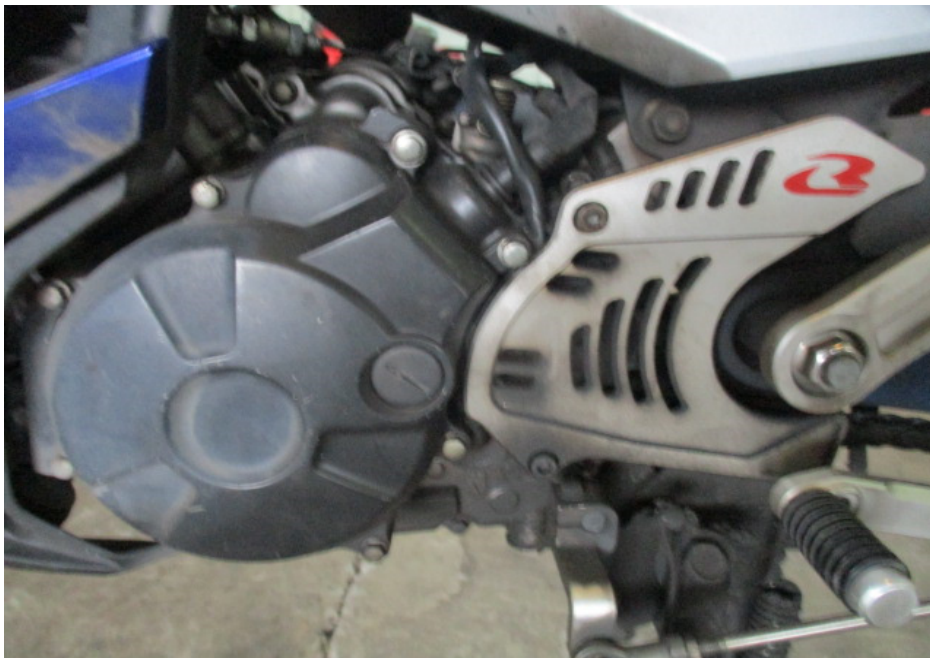
Photo 14 shows the left side of the engine of the Motorcycle at the time of our inspection. The various engine related parts and components were found to be intact with no visible damage. There was also no sign(s) or indication(s) of fluid leak observed around the left engine area of the Motorcycle.

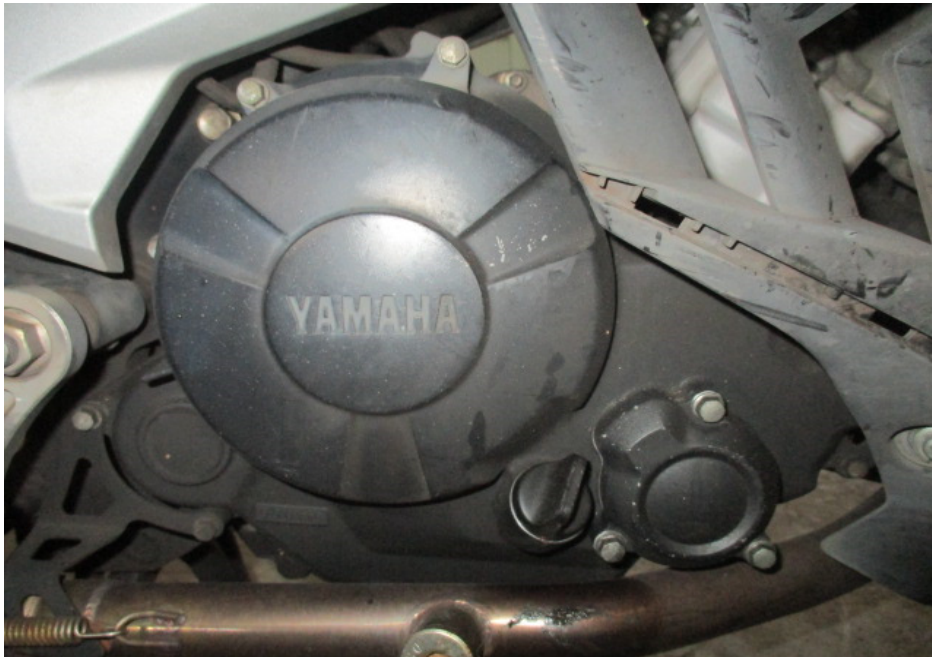
Photo 15 shows the right side of the engine of the Motorcycle at the time of our inspection. The various engine related parts and components were found to be intact with no visible damage. There was also no sign(s) or indication(s) of fluid leak observed around the right engine area of the Motorcycle.

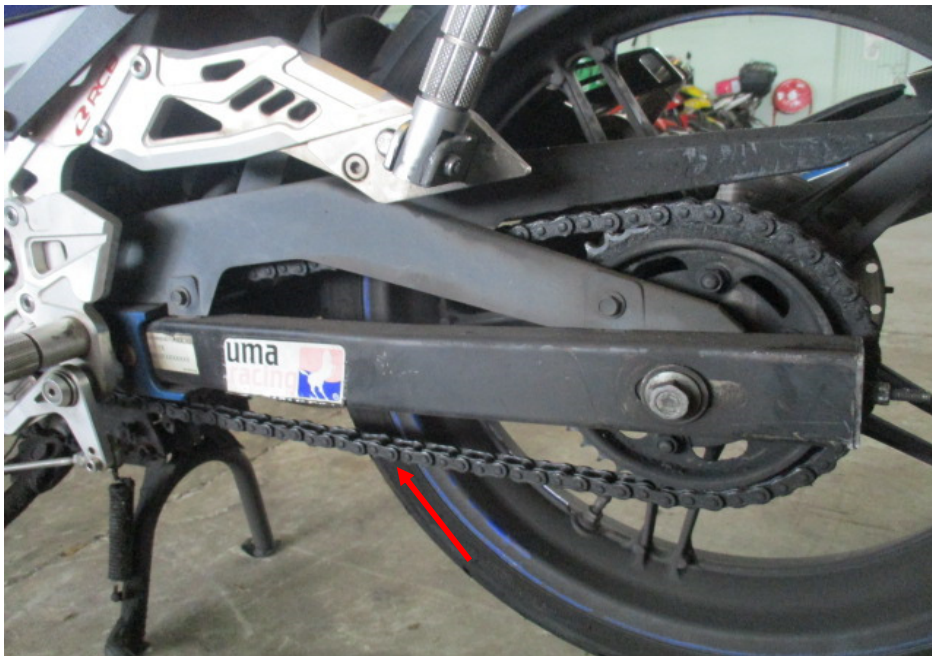
Photo 16 shows the general view of the gear train (arrowed) of the Motorcycle, which was observed to be intact with no misalignment. It was also adequately lubricated for operating purposes.

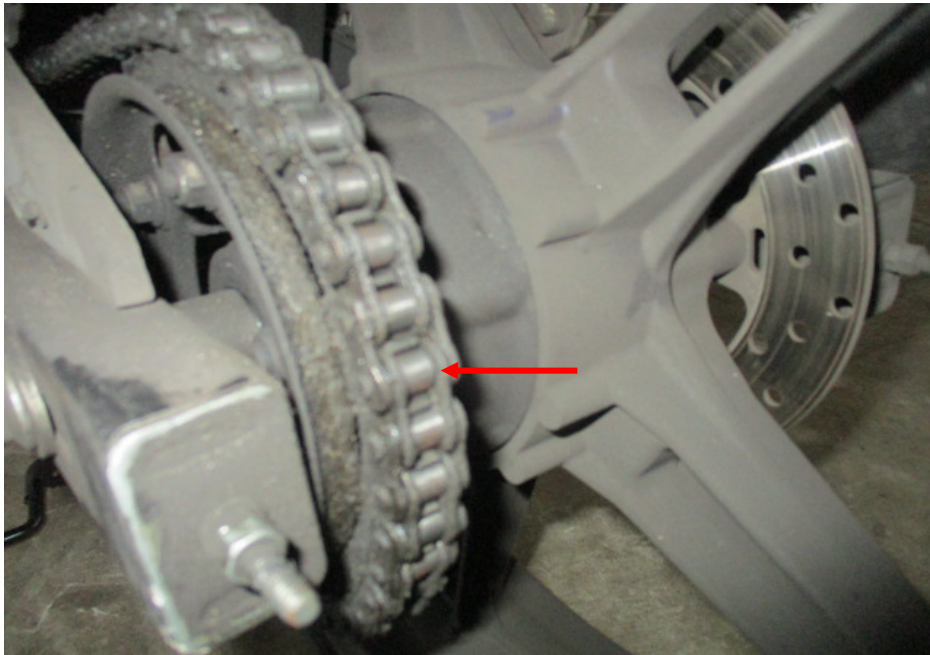
Photo 17 shows a closer view of the gear train (arrowed) of the Motorcycle, which was observed to be intact with no misalignment. It was also adequately lubricated for operating purposes.

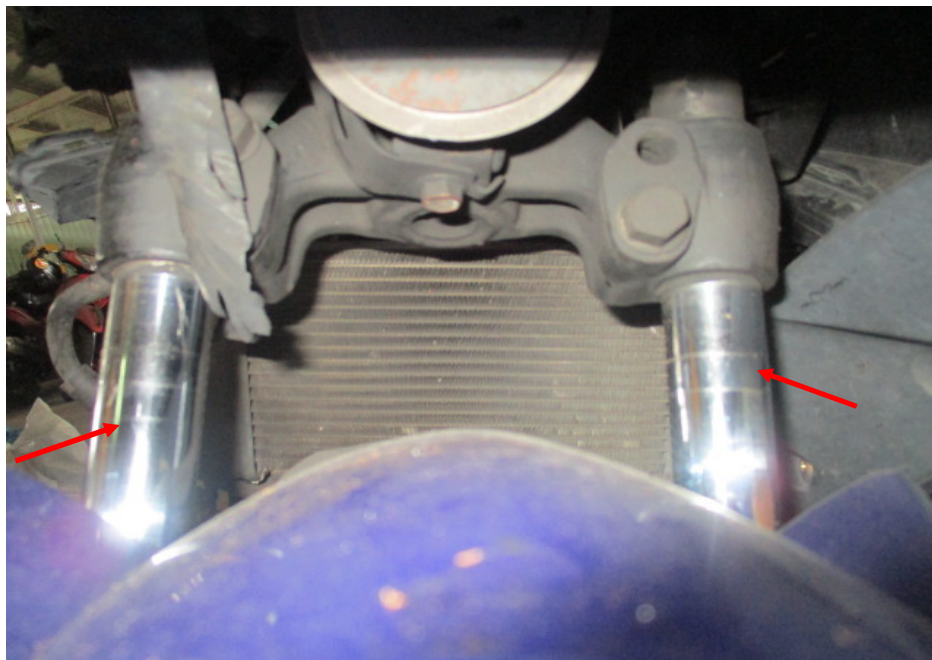
Photo 18 shows the front fork (arrowed) of the Motorcycle. The front fork and fork bracket of the Motorcycle were both found to be intact and undamaged. Turning the Motorcycle's handle bar towards the left and right did not produce any abnormal free play. The steering system of the Motorcycle was in serviceable condition at the time of our inspection.

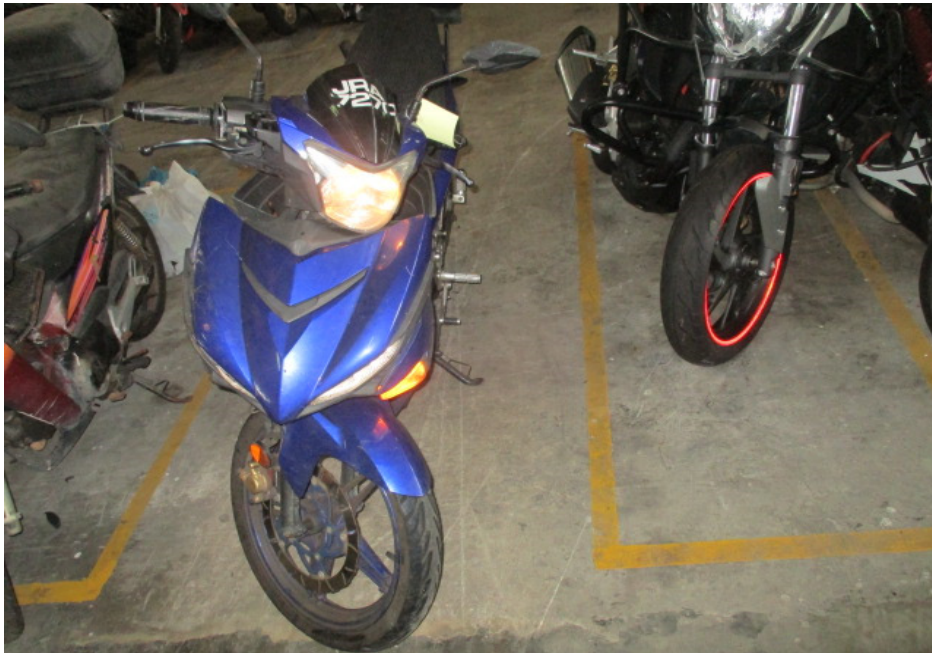
Photo 19 shows the front wheel of the Motorcycle turned towards its full left. Turning the Motorcycle's handle bar towards the left did not produce any abnormal free play and/or resistance. This would indicate that the steering system of the Motorcycle was in serviceable condition at the time of our inspection.

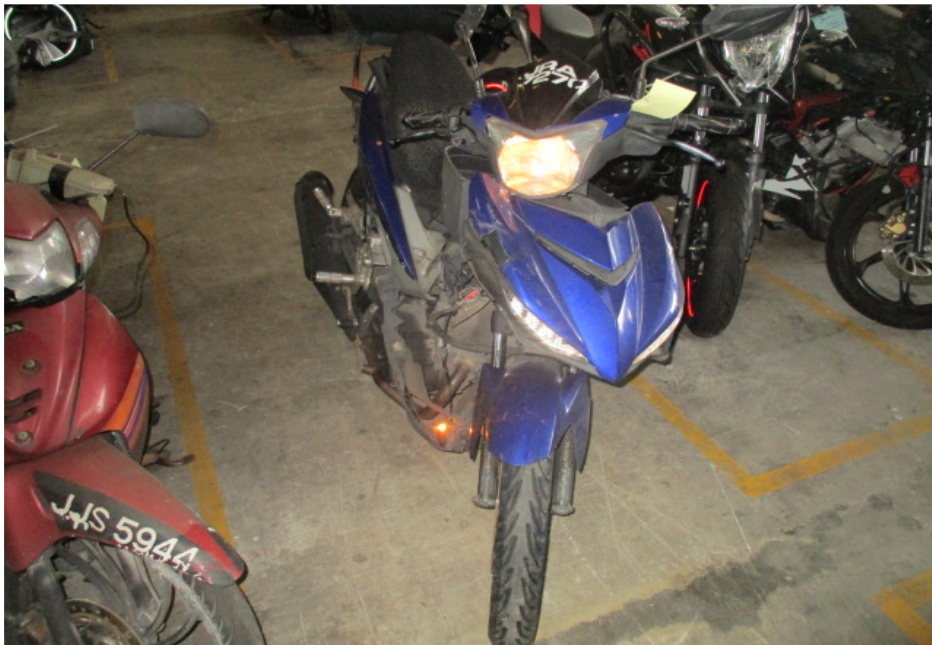
Photo 20 shows the front wheel of the Motorcycle turned towards its full right. Turning the Motorcycle's handle bar towards the right did not produce any abnormal free play and/or resistance. This would indicate that the steering system of the Motorcycle was in serviceable condition at the time of our inspection.

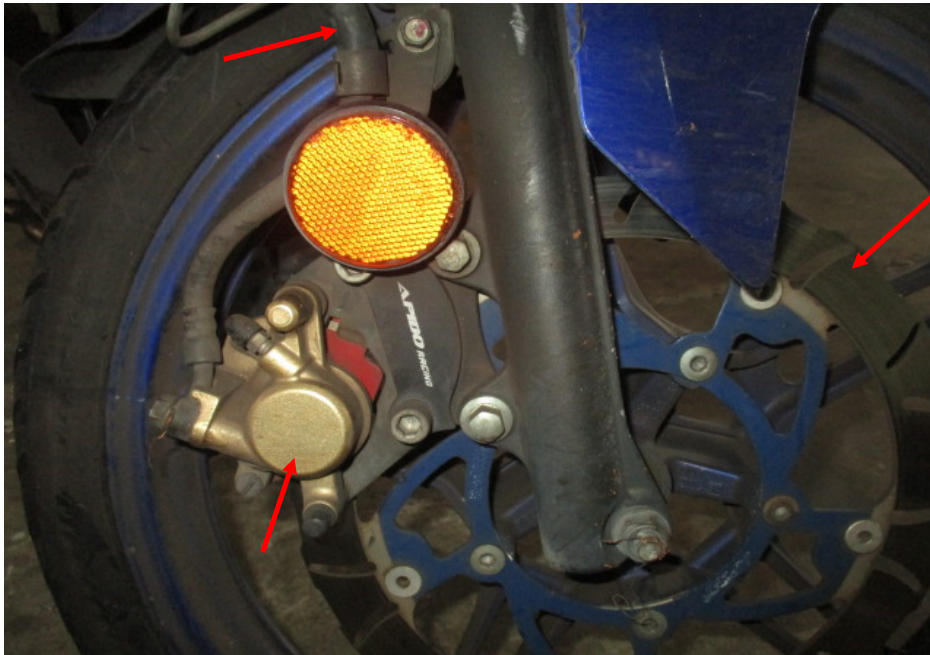
Photo 21 shows a close up view of the front brake caliper, front brake disc and front brake hose (arrowed) of the Motorcycle, which are all part of the components in the hydraulic front brake system of the Motorcycle. Our visual checks of these various components had revealed all to be intact with no visible damage. No leakage of brake fluid was also observed.

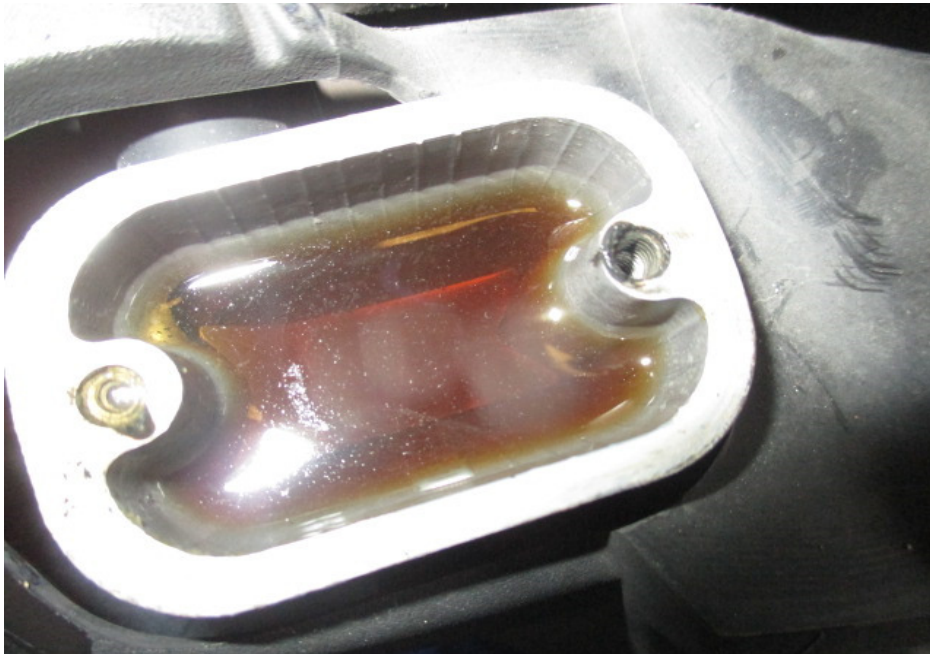
Photo 22 shows the brake fluid reservoir for the front brake of the Motorcycle. The brake fluid was observed to be of sufficient level and without contamination for operational purposes.

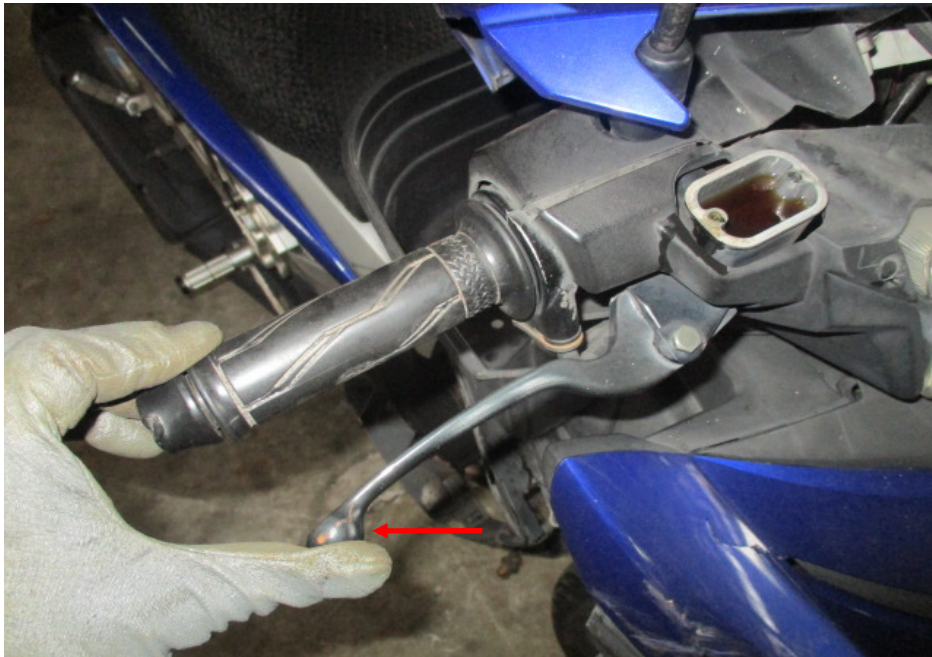
Photo 23 shows the front brake lever being depressed. There was some resistance felt (spongy like feel) upon pressing the front brake lever (arrowed). This would indicate that there is no leakage of pressure/vacuum in the brake system.

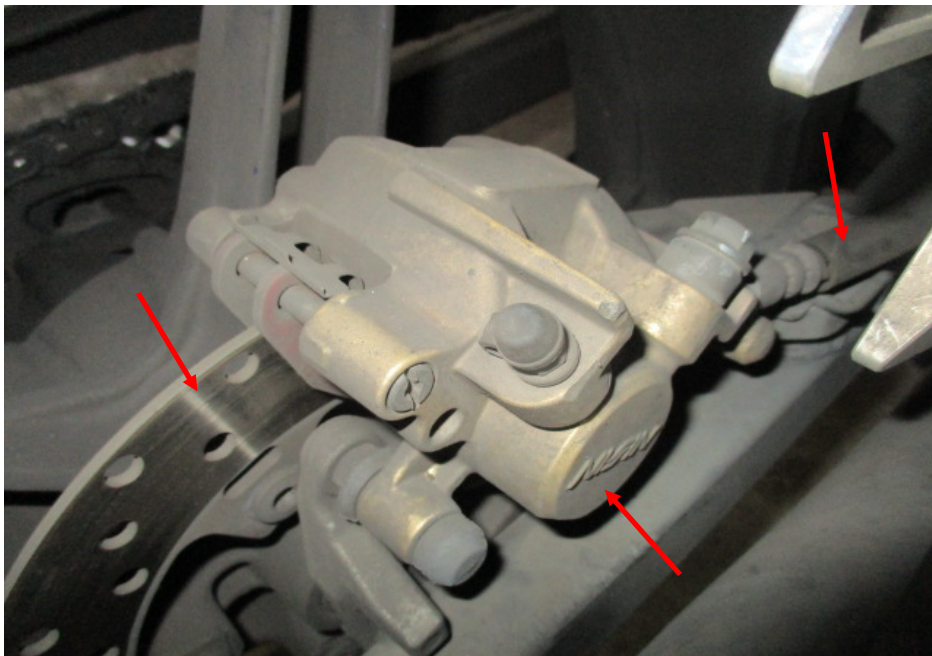
Photo 24 shows a close up view of the rear brake caliper, rear brake disc and rear brake hose (arrowed) of the Motorcycle, which are all part of the components in the hydraulic rear brake system of the Motorcycle. Our visual checks of these various components had revealed all to be intact with no visible damage. No leakage of brake fluid was also observed.
