# PRECISION APPRAISAL SERVICES

## AUTOMOBILE INSPECTION REPORT

Registration No. : SLX 5599 M  
Make/Model : MERCEDES BENZ E250 CGI A  
Yr of Manuf/Regn : 2010  
Carrying Capacity : 4 Seater  
Chassis No. : WDD2120472A199270  
Engine No. : 27186030053247  
Colour : Metallic White  
Class : Passenger ( Private )

VEHICLE REGN NO : SLX 5599 M  
 OUR REFERENCE : PAS/HH/200317/TP  
 INSPECTION REPORT DATE : 29-Mar-20

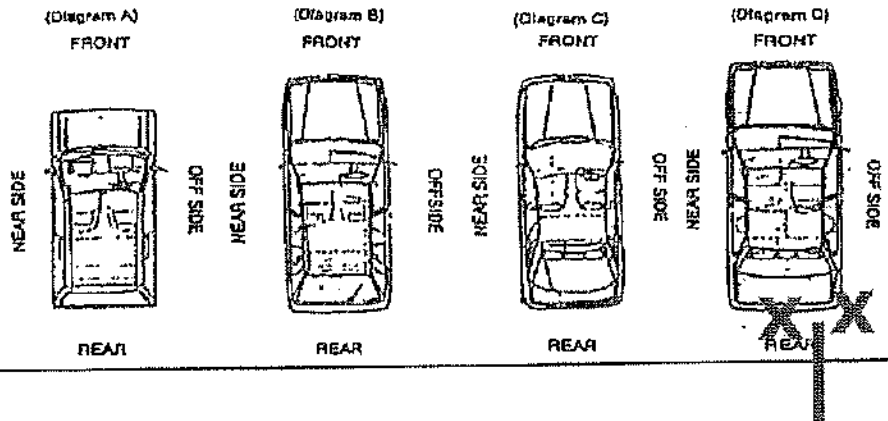
Direction of impact/damage marked (→) (X)

The vehicle sustained impact on its Rear O/s Portion. (see Diagram D)
