Your Ref: OD / SNM20D202009/SGR7134Z/TANKL  
Our Ref : CS/CTI20006022/N

29 May 2020

**TECHNICAL INVESTIGATION REPORT OF FIRE INCIDENT INVOLVING THE  
INSURED VEHICLE SGR 7134Z ON 28 MAY 2020**

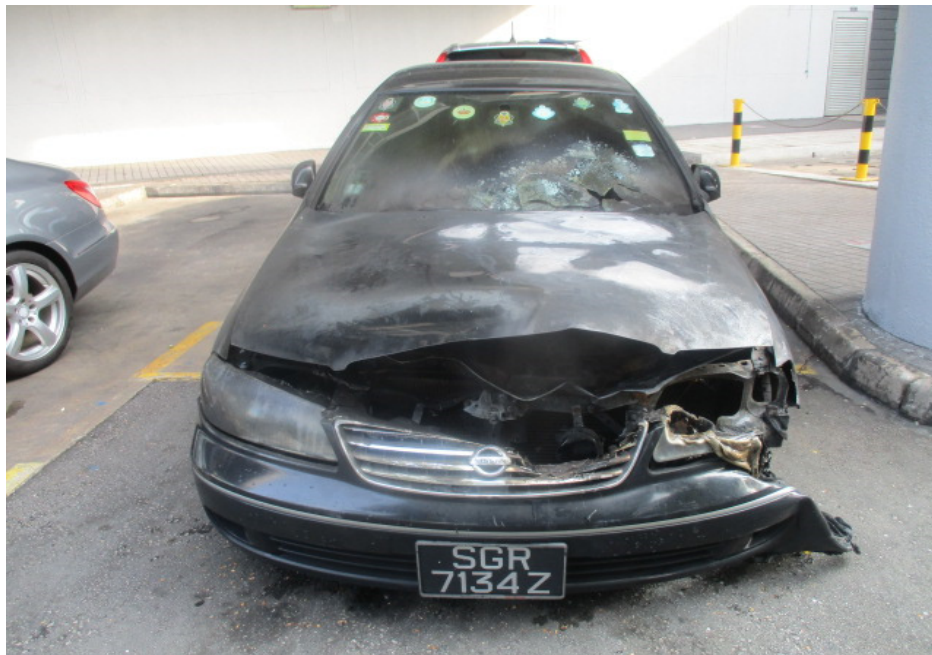
**Photo 1** shows the general view of the front portion of the Insured Vehicle at the time of our inspection. The fire damage to the Insured Vehicle was confined to its front portion. Its front bonnet, front grille, front windscreen and front headlamps were amongst the body parts that were found to have been affected as a result of the fire.

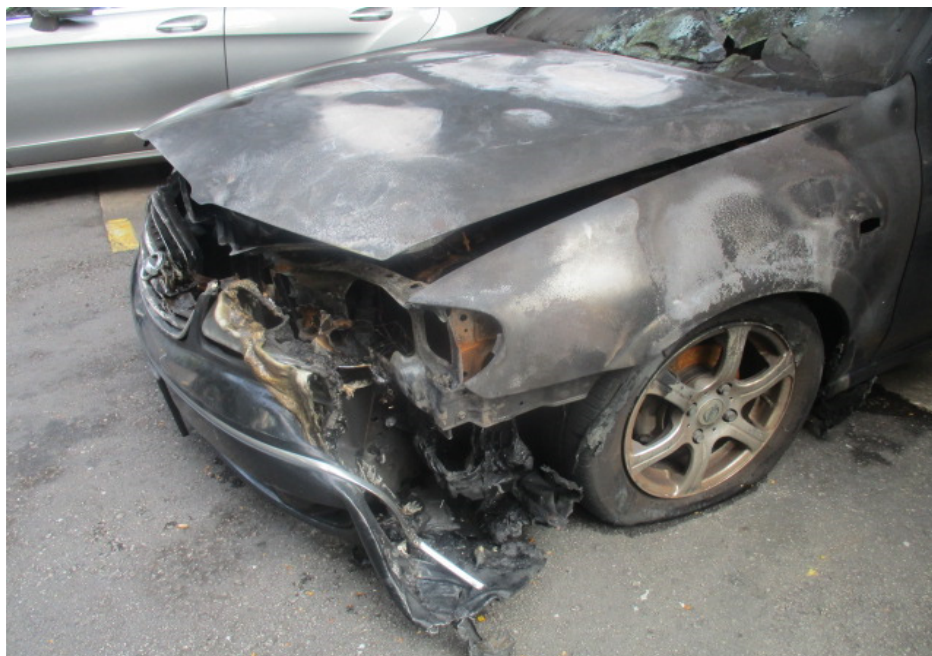
**Photo 2** shows the general view of the front left portion of the Insured Vehicle at the time of our inspection. The fire damage to the Insured Vehicle was confined to its front portion. Its front bonnet, left front panel and front left headlamp were amongst the body parts that were found to have been affected as a result of the fire.

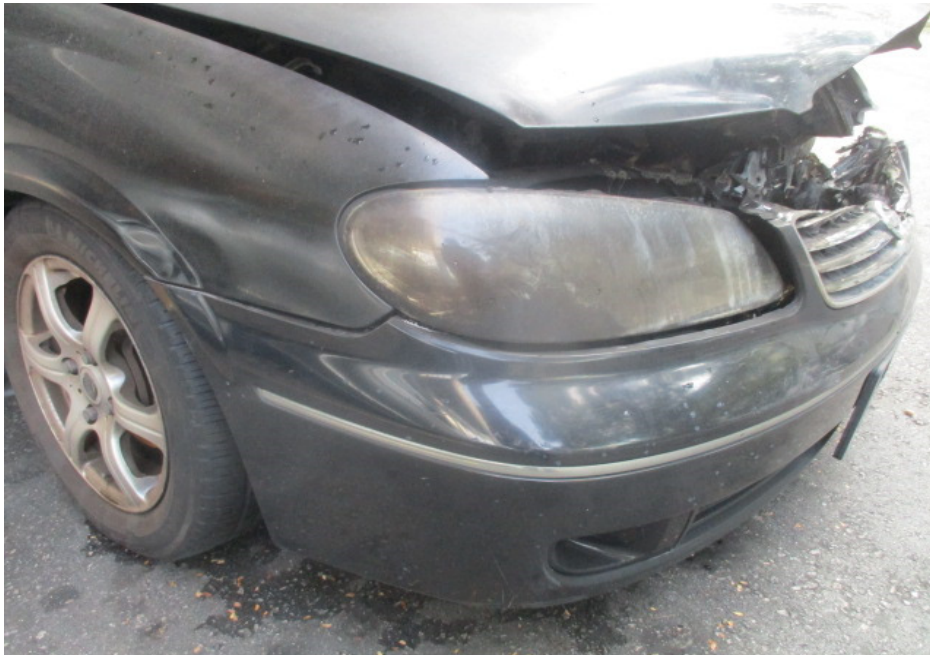
**Photo 3** shows the general view of the front right portion of the Insured Vehicle at the time of our inspection. The fire damage to the Insured Vehicle was confined to its front portion. Its front bonnet, right front panel and front right headlamp were amongst the body parts that were found to have been affected as a result of the fire.

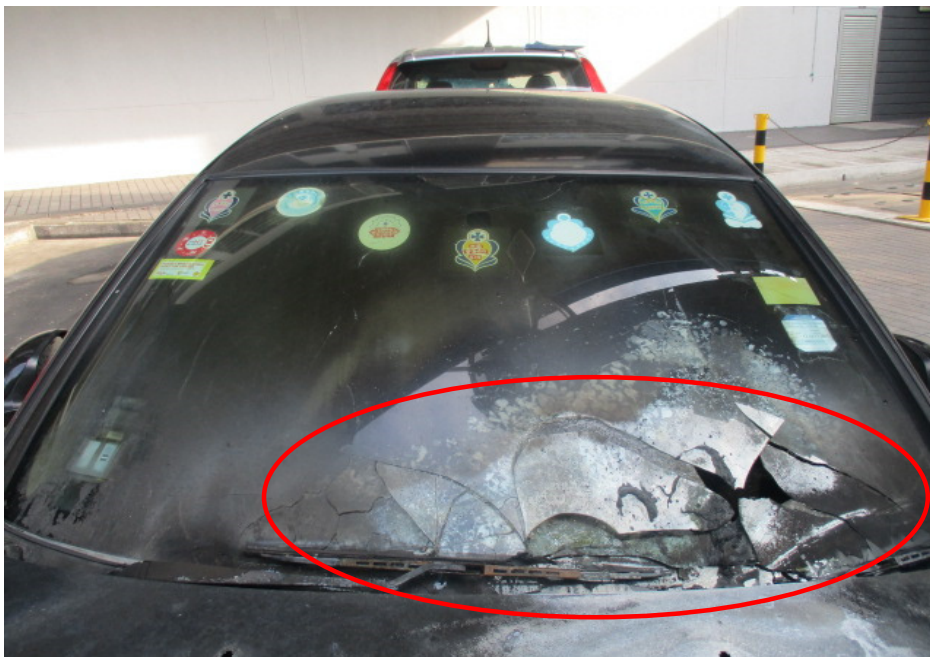
**Photo 4** shows the general view of the front windscreen of the Insured Vehicle at the time of our inspection. The fire damage to the Insured Vehicle was confined to its left portion (circled).

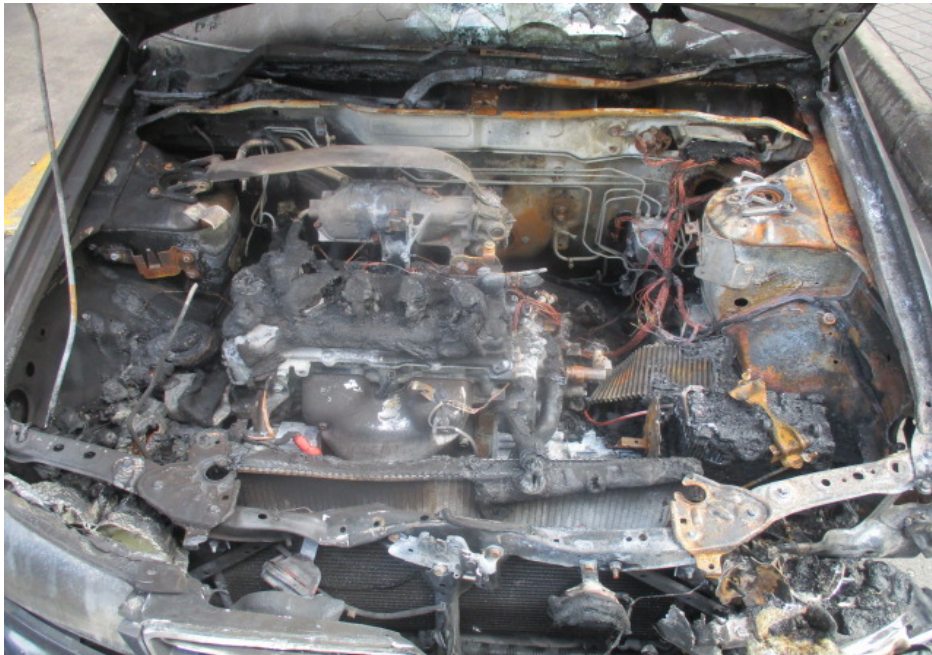
**Photo 5** shows the engine compartment of the Insured Vehicle at the time of our inspection. The nature of fire damage to the engine compartment of the Insured Vehicle was observed to be extensive. Most of the parts inside the engine compartment were found to be severely burnt and/or melted as a result of the fire.

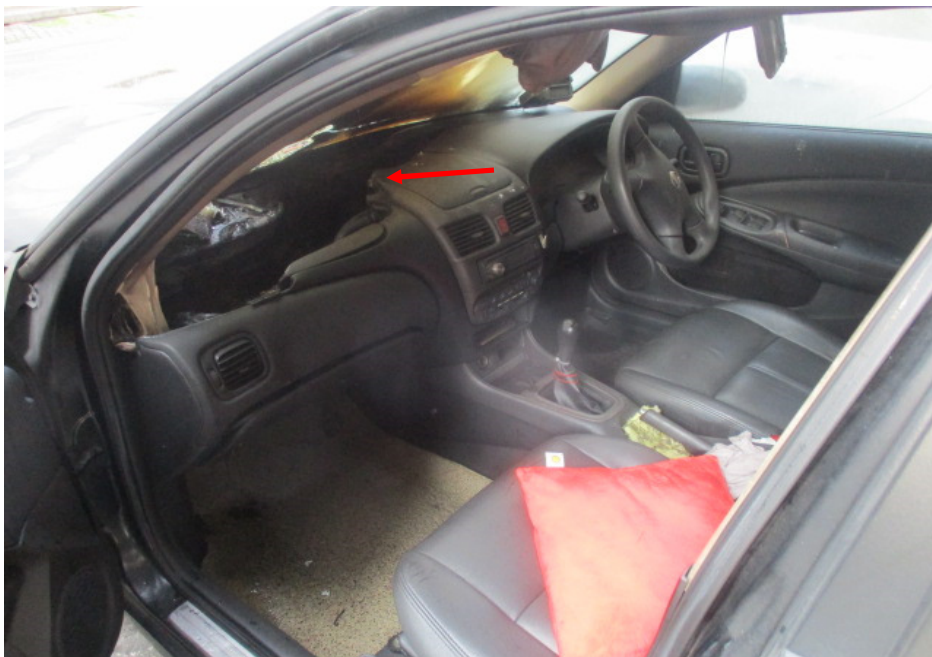
**Photo 6** shows the interior compartment of the Insured Vehicle which was observed to be slightly affected by the fire, particularly the left portion of the dashboard (arrowed).

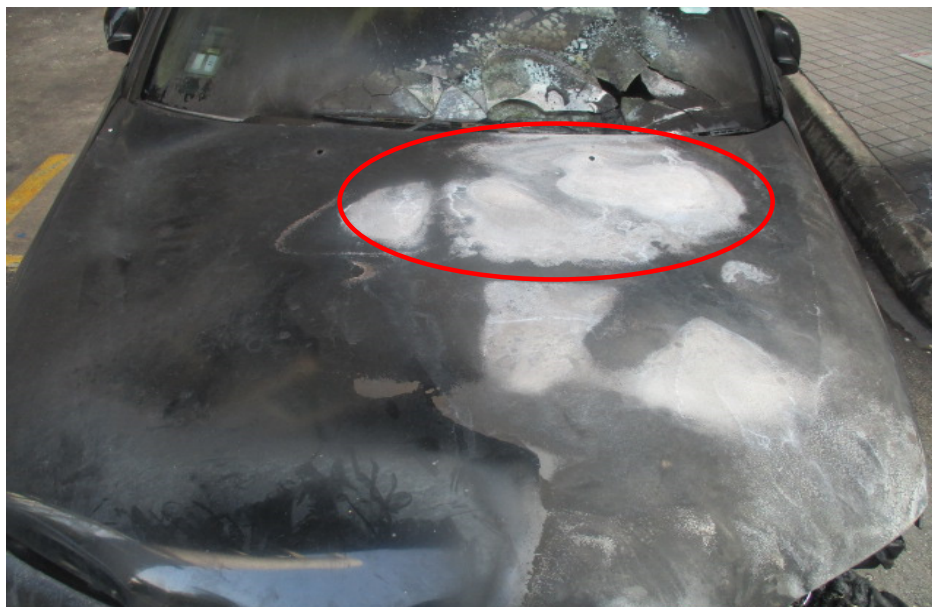
8. For this particular case, the fire appears to have originated within the engine compartment of the Insured Vehicle, somewhere around the rear left portion of the engine compartment. This can be determined from the burn pattern and the high heat intensity burn marks (whitish burn marks) found on the rear left side of the front bonnet of the Insured Vehicle and also the rust that had developed on the underside of the front bonnet, at the bottom left area.

9. The whitish burn marks are a result of exposure to prolonged heat intensity. Rust would normally start to develop around these areas soon after a fire as prolonged exposure to high heat intensity usually causes steel/metal material body parts to be exposed to natural environmental condition. The rust that had developed on the underside of the front bonnet, around the rear left area, is an indication that the rear left portion of the engine compartment had sustained exposure to prolonged high heat intensity. See photos 7 & 8 below.

**Photo 7** shows the burn pattern and whitish burn marks (circled) that were found on the rear left side of the front bonnet of the Insured Vehicle. Such whitish burn marks are a result of exposure to prolonged heat intensity, which may indicate where the fire had started. Rust would also begin to develop on these areas soon after the fire.

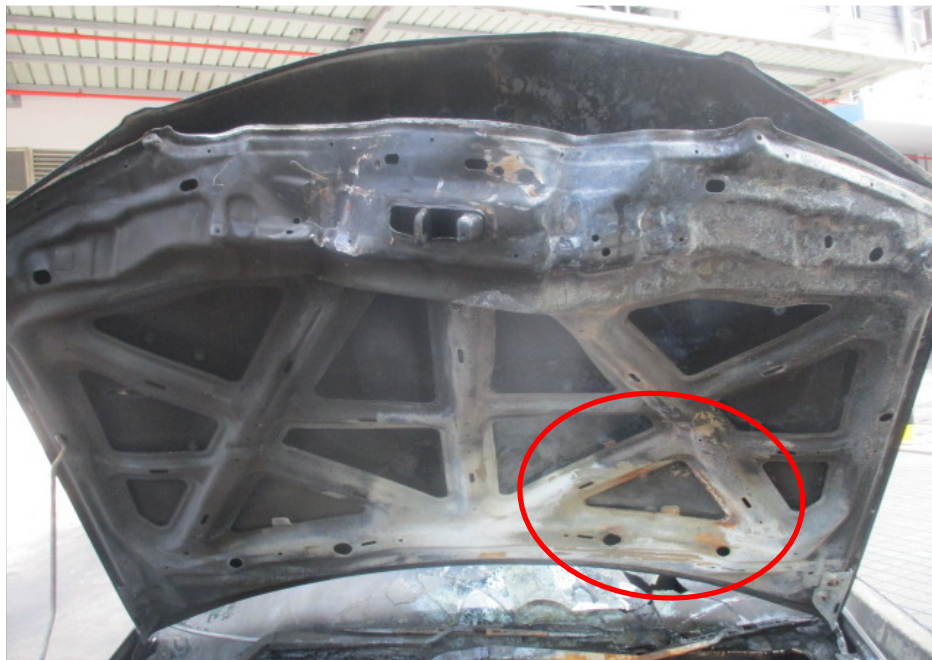
**Photo 8** shows the rust (circled) that had developed on the underside of the front bonnet, around the bottom left area. The development of rust is an indication that this area was exposed to prolonged exposure to high heat intensity, which had caused the steel/metal material of the front bonnet to be exposed to natural environmental condition. Hence the fire to the Insured Vehicle can be determined to have originated towards the rear left portion of the engine compartment.

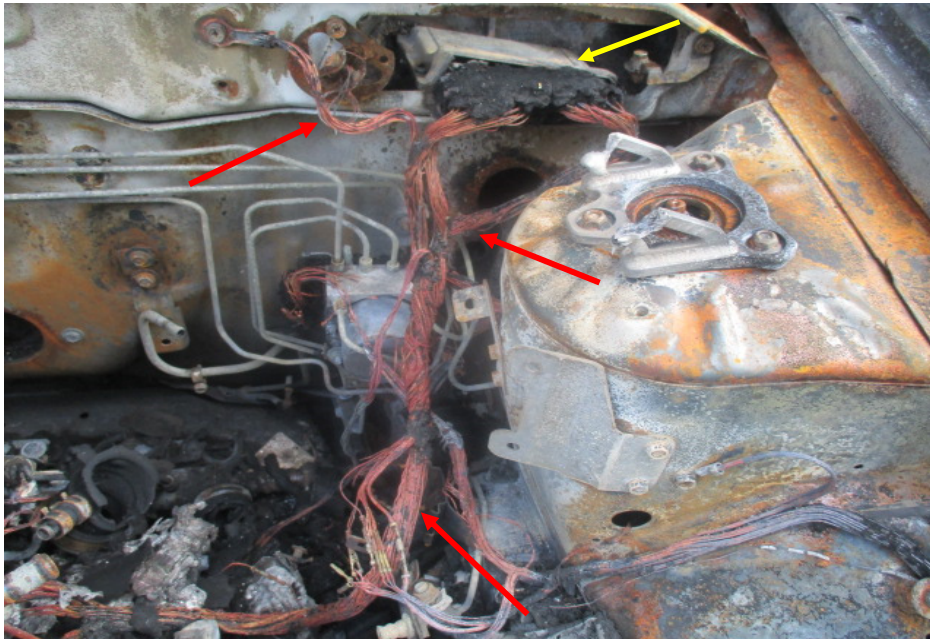
10. Upon closer examination of the rear left portion of the engine compartment, where the fire to the Insured Vehicle had likely started, we had found several stretches of wirings burnt internally to its bare copper state. The wirings were original factory fitted wirings leading towards the Engine Control Module (ECM) of the Insured Vehicle. The bright reddish colour of the copper wires suggests that the wirings were exposed to high heat. Such condition normally indicates internal heating of copper wires which is a sign of an electrical short circuit occurring. In addition, we also found greenish residue on some of the wirings. The presence of greenish residue further indicates internal heating of copper wires, another sign of an electrical short circuit occurring. The greenish residue is normally left behind from oxidation as a result of chemical reaction involving the copper wires. These physical evidences would then appear to suggest that the cause of fire to the Insured Vehicle could have possibly been due to electrical in nature. See photos 9 – 11 below.

**Photo 9** shows the wirings around the rear left portion of the engine compartment, which is in the immediate vicinity where the fire to the Insured Vehicle had likely started. Several stretches of wirings leading towards the Engine Control Module (ECM) (yellow arrow) were found burnt internally to its bare copper state (red arrows). The bright reddish colour of the copper wires suggests that the wirings were exposed to high heat. Such condition normally indicates internal heating of copper wires which is a sign of an electrical short circuit occurring.

25. Having investigated and technically analysed the damages of burnt nature to the Insured Vehicle, we are of the view that the cause of fire to the Insured Vehicle was of electrical in nature. For this particular case, the fire had originated along the wirings inside the engine compartment, somewhere around the rear left portion of the engine compartment. The wirings were original factory wirings leading to the Engine Control Module (ECM) of the Insured Vehicle.

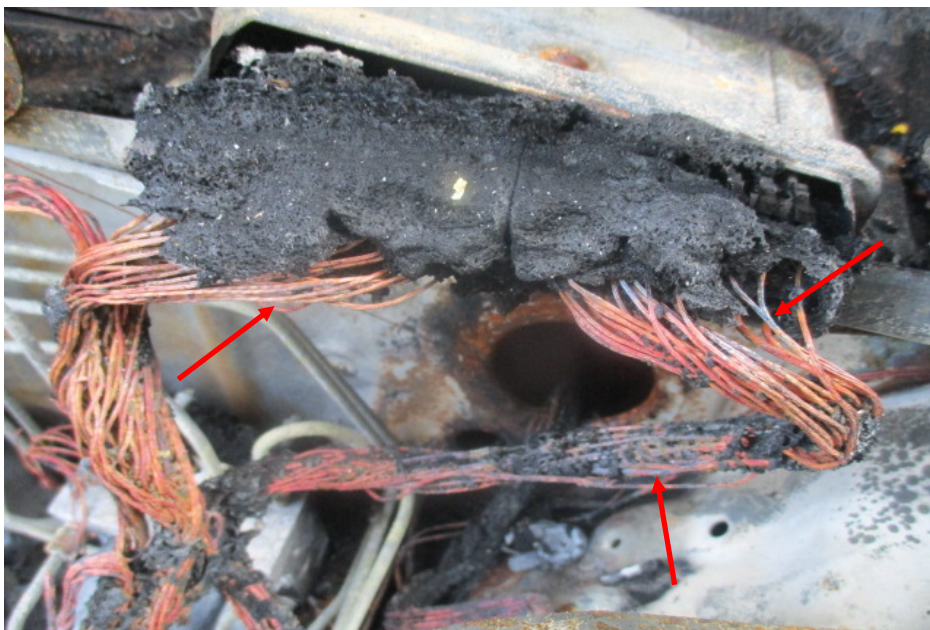
**Photo 10** shows a closer view of some of the wirings with greenish residue (red arrows). The presence of such greenish residue suggest occurrence of an electrical short circuit.

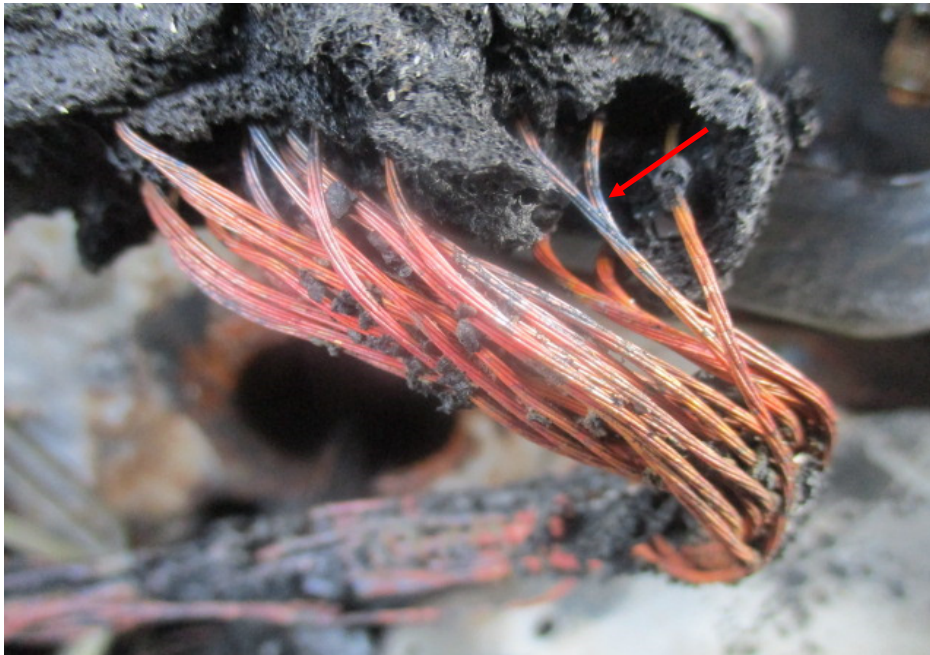
**Photo 11** shows a close up view of some of the wirings with greenish residue (arrowed). The presence of such greenish residue suggest occurrence of an electrical short circuit.

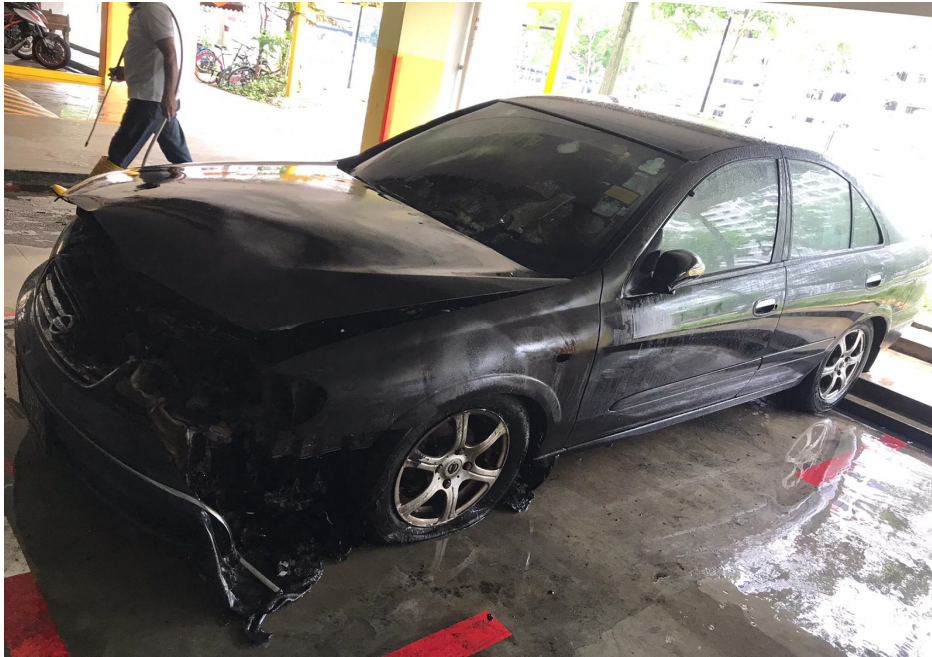
**Photo 12** shows the Insured Vehicle at the incident scene after the fire was extinguished. In general, the information that could be gathered from this photograph had corresponded to the events that were related to us by Mr Ng, which is the Insured Vehicle was parked at level 1 of the multi- storey carpark when the fire occurred.

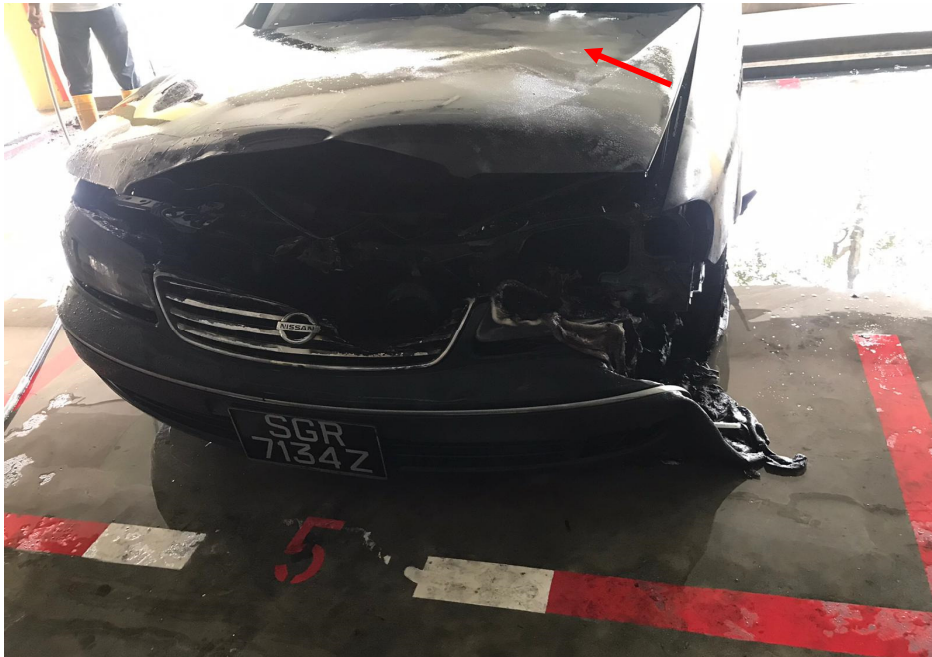
**Photo 13** shows the Insured Vehicle at the incident scene after the fire was extinguished. Whitish burn marks (arrowed) were observed on the rear left portion of the front bonnet, which indicates that the fire had started in the engine compartment.
