LKK Auto Consultants Pte Ltd

Affiliated to Federation Internationale Des Experts En Automobile				
SOMPO INSURANCE SINGAPORE PL		Ref : CS/SMO20006066/Kqf3n2		
50 RAFFLES PLACE #05-01/06 SINGAPORE LAND TOWERSINGAPORE 048623		Date : 24-06-2020

ADJUSTMENT ON REPAIR COST FOR VEHICLE NO. SLJ 9396D

PHOTOGRAPHS FOR VEHICLE NO. SLJ 9396D

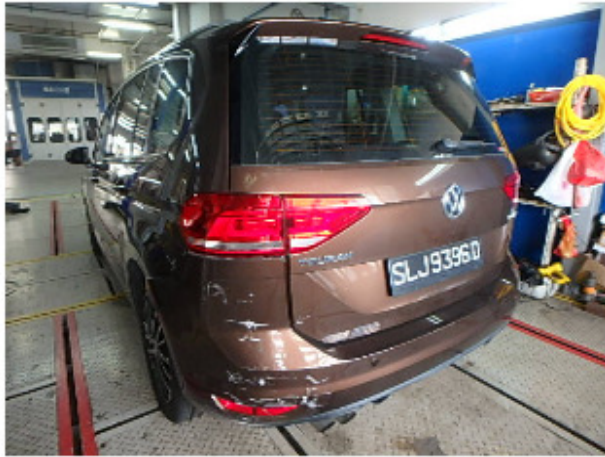
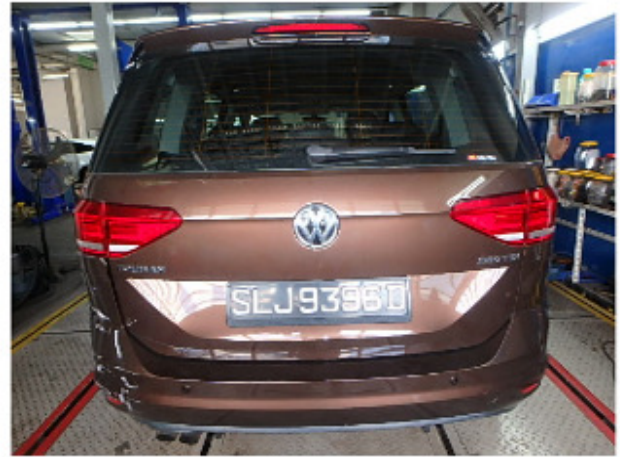
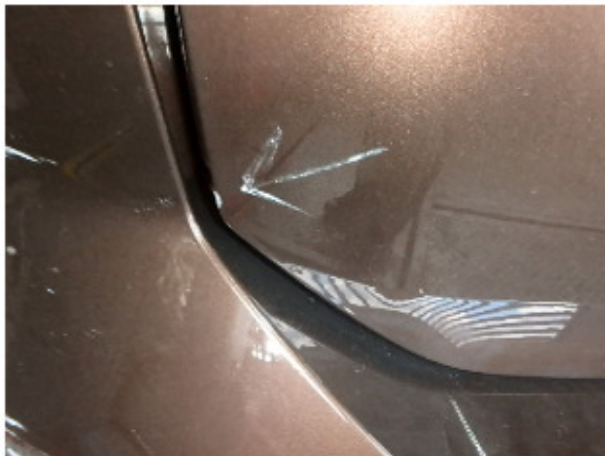
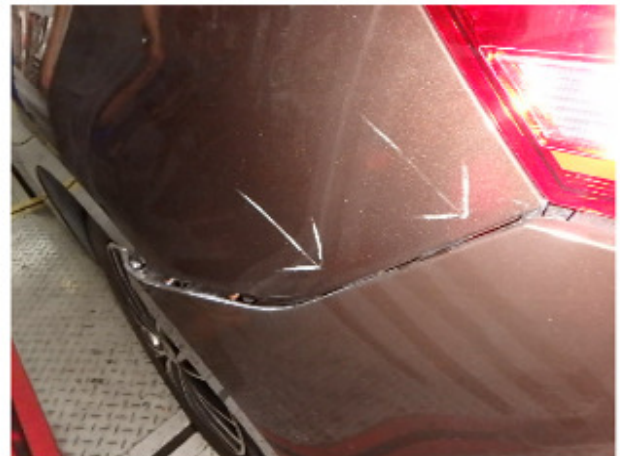
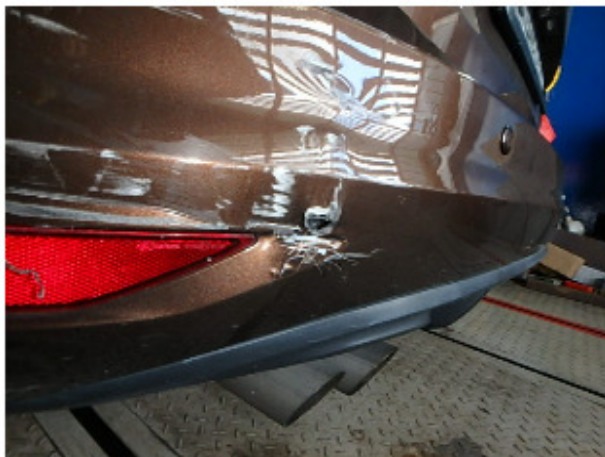
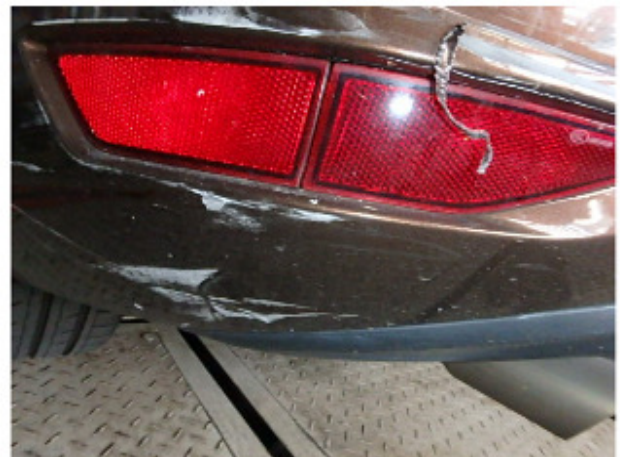
4. Description of Damages				
THE VEHICLE SUSTAINED DAMAGES AT THE REAR N/S PORTION. DAMAGES SEE DETAILS.				
5. General Information				
Accident Date	31/05/2020	Inspection Date	02/06/2020	
Survey held at	KUM CHEW MOTOR WORKSHOP 160 SIN MING DRIVE #05-08 SIN MING AUTOCITY SINGAPORE 575722			
5a. Remarks				
A)THE INSPECTION WAS CONDUCTED ON A"WITHOUT PREJUDICE" BASIS. B)IN ACCORDANCE TO YOUR INSTRUCTIONS, WE HAVE NOT AUTHORISED REPAIRS.				
5b. Estimate Days of Repair				
ESTIMATED NORMAL PERIOD FOR REPAIR:		3 Working Days
