LKK Auto Consultants Pte Ltd

1. Policy Particulars :- THIRD PARTY CLAIM

4. Description of Damages

ADJUSTMENT ON REPAIR COST FOR VEHICLE NO. SHD 9354D

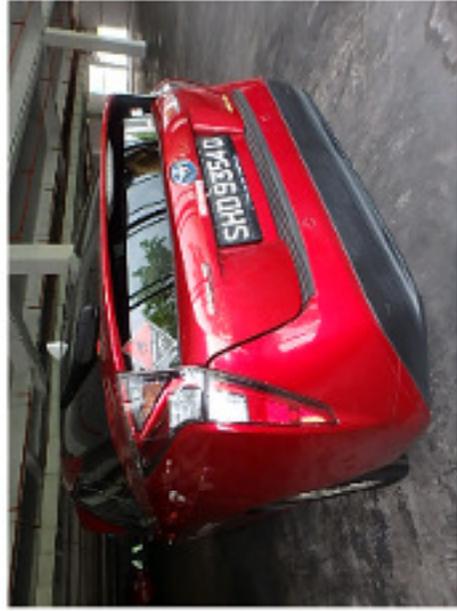
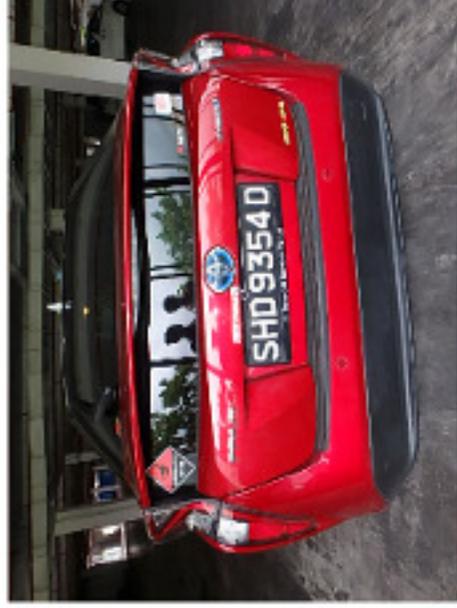
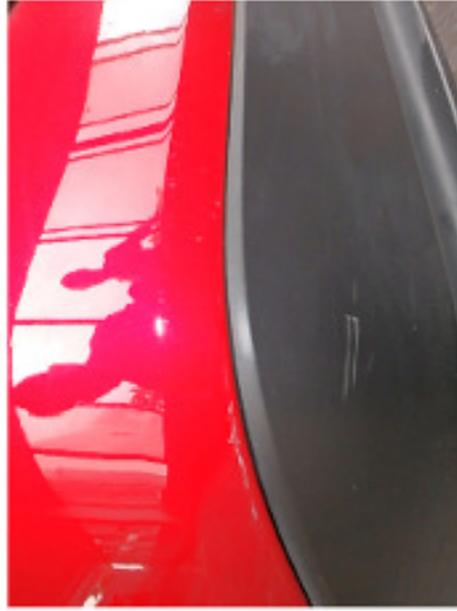
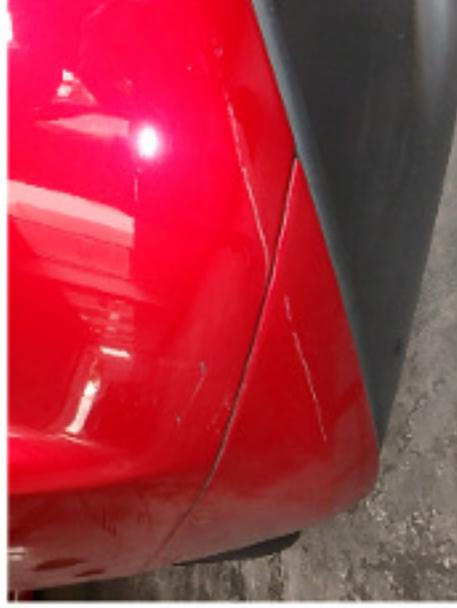
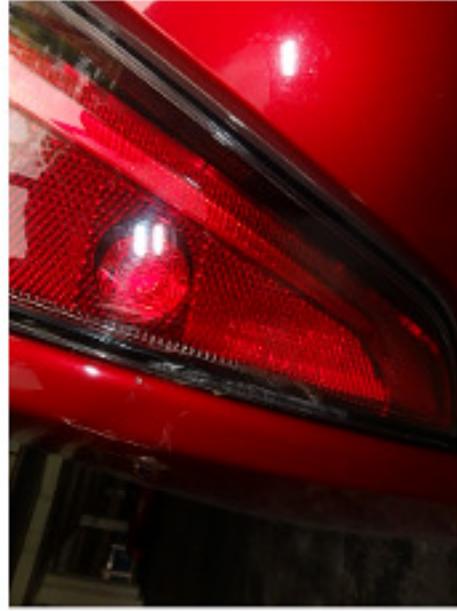
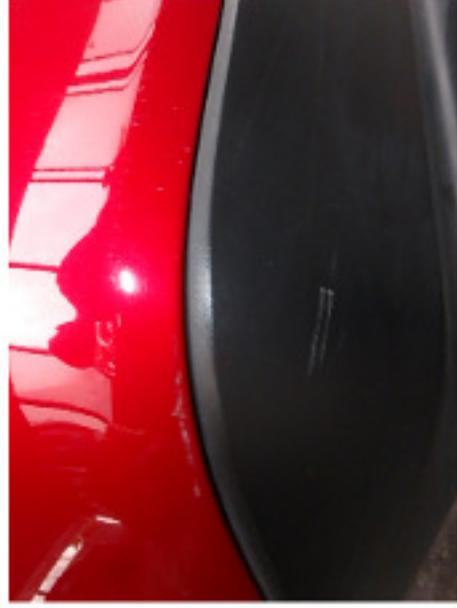
INSPECTION

THE VEHICLE SUSTAINED DAMAGES AT THE REAR N/S PORTION.
DAMAGES SEE DETAILS.
