Your Ref: TP/IP/23721/2020
Our Ref : CI/TPD20006182/P

19th June 2020

MECHANICAL INSPECTION REPORT OF MOTOR CAR SCN 6831U

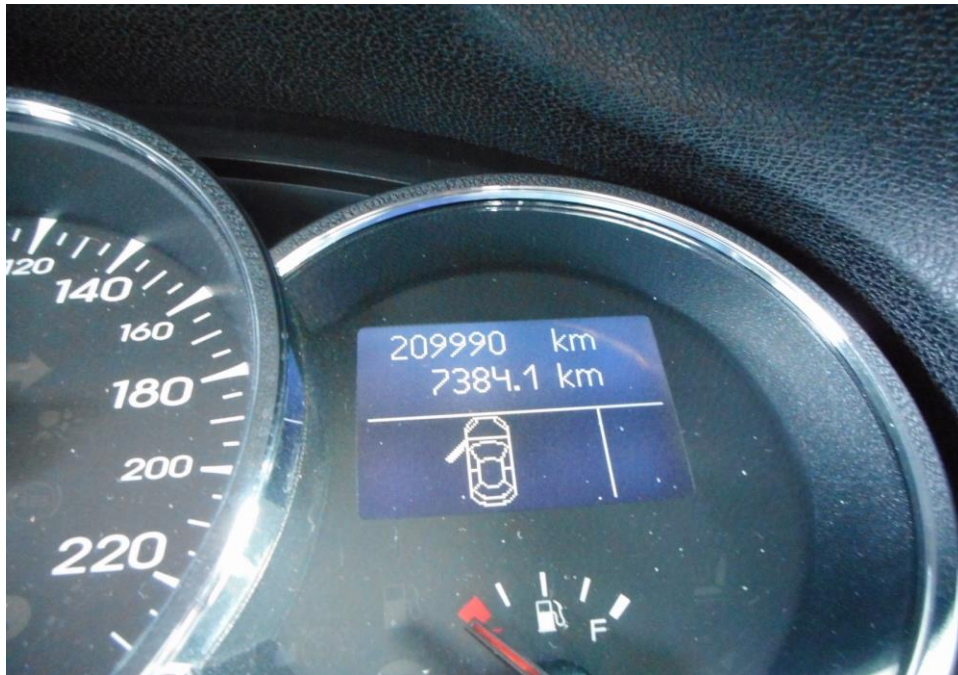
Photo 1 shows the mileage of the Motor Car at the time of my inspection. The mileage observed was 209,990km.

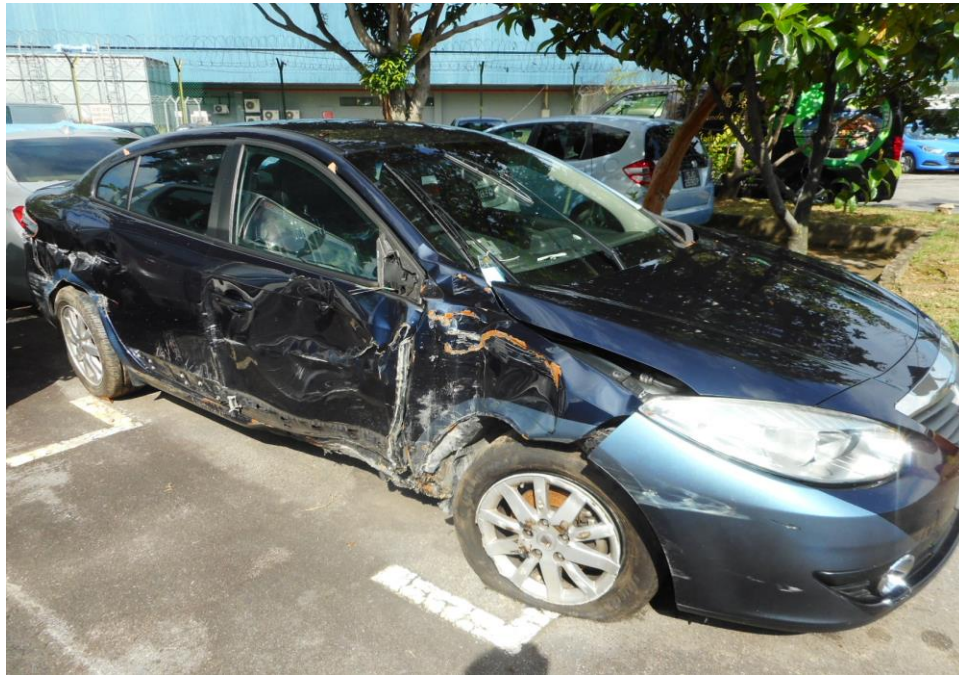
4. The mileage of the Motor Car at the time of my inspection was 209,990km.
5. The Motor Car was observed to have sustained damage at its right portion. Its front bumper, front right fender and right body panels were amongst the body parts that were damaged as a result of the accident.

Photo 2 shows a general view of the Motor Car's right body at the time of my inspection. The Motor Car was observed to have sustained damage at its right portion. Its front bumper, front right fender and right body panels were amongst the body parts that were damaged as a result of the accident.

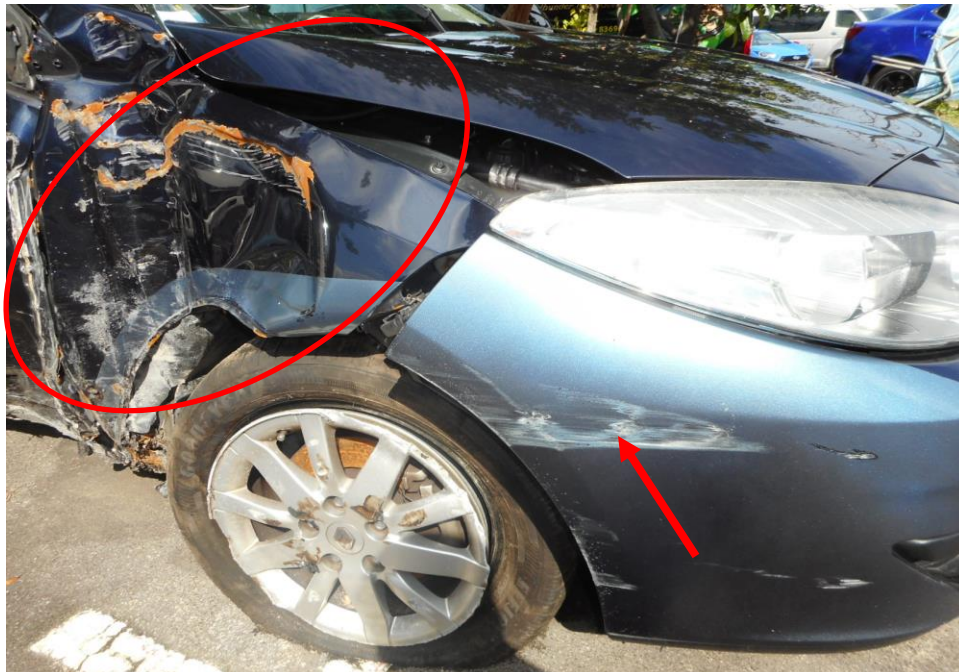
Photo 3 shows the close up view of the Motor Car's right portion at the time of my inspection. The Motor Car was observed to have sustained damage at its front bumper (arrowed) and front right fender (circled) as a result of the accident.

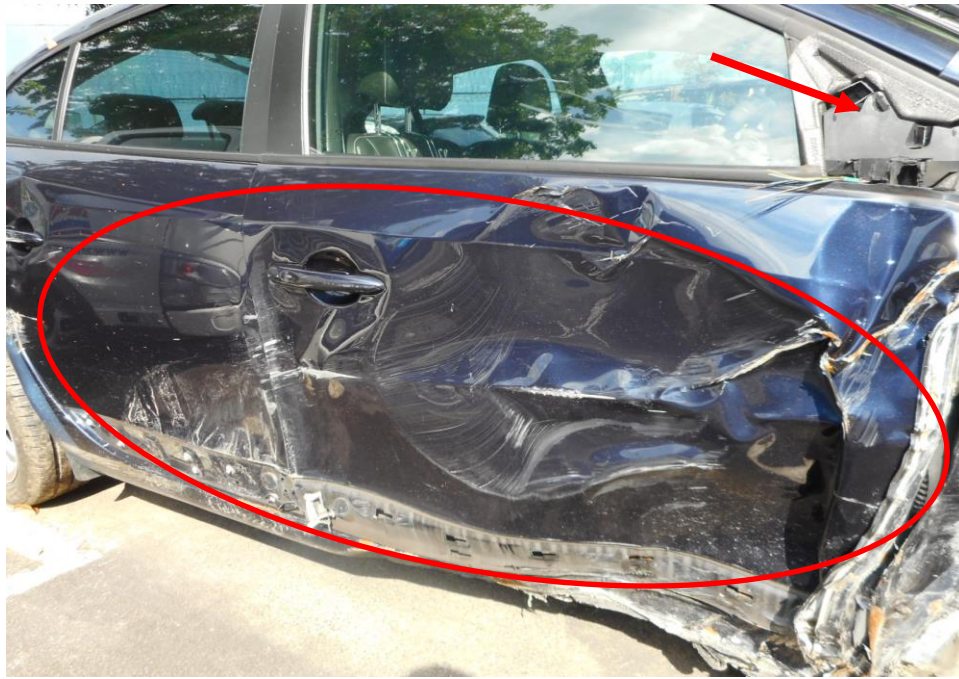
Photo 4 shows the close up view of the Motor Car's front right body at the time of my inspection. The Motor Car was observed to have sustained damage at its right rear view mirror (arrowed) right body panel (circled) as a result of the accident.

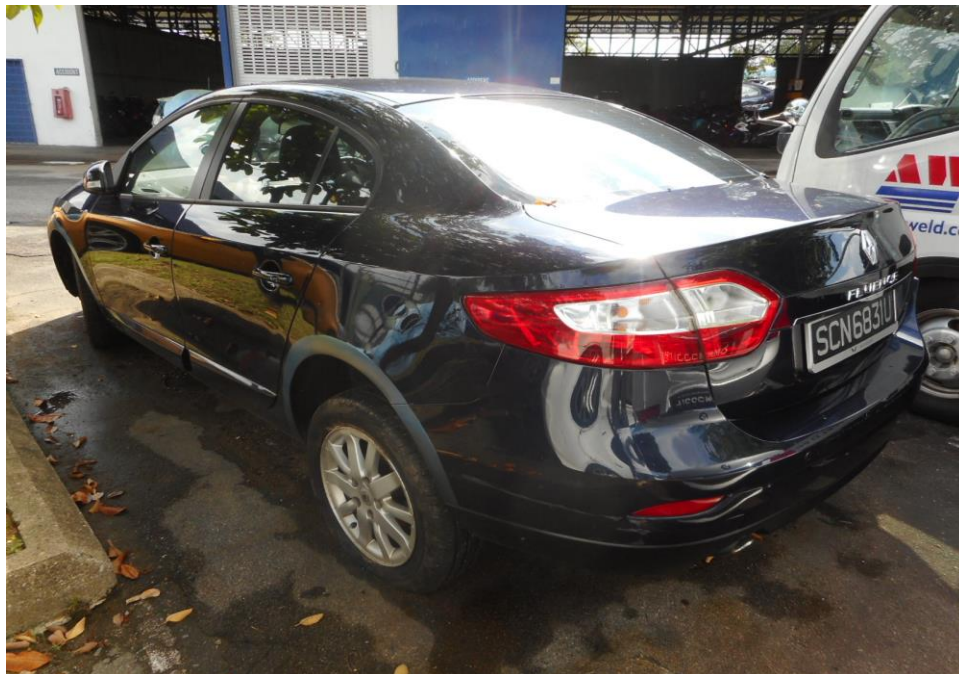
Photo 5 shows a general view of the Motor Car's left body at the time of my inspection. The left portion of the Motor Car was observed to have been unaffected by the accident.

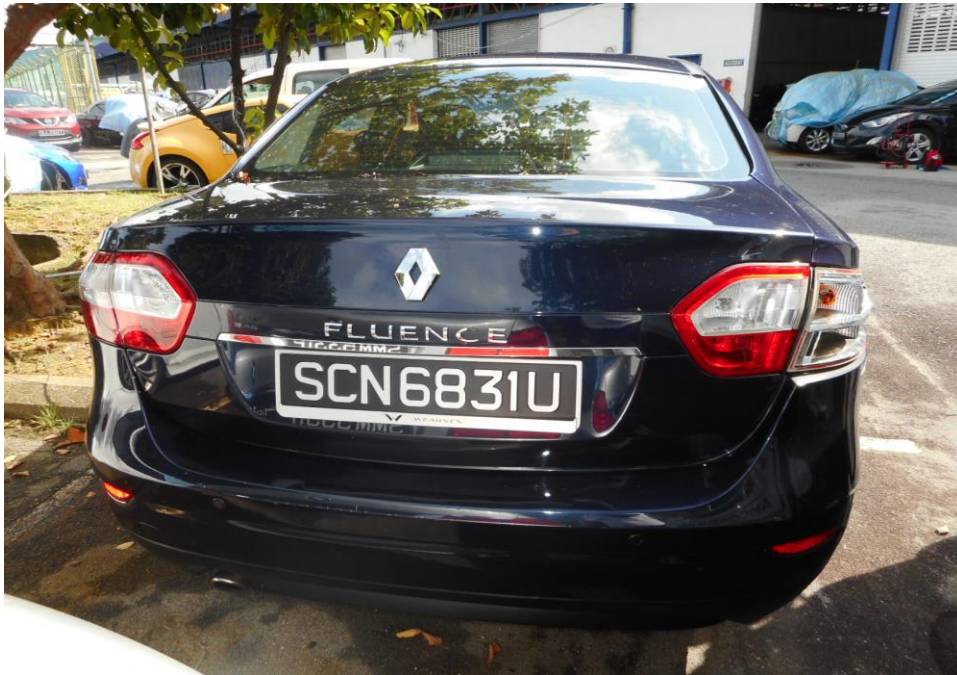
Photo 6 shows the general view of the Motor Car's rear body at the time of my inspection. The Motor Car rear was observed to be unaffected by the accident.

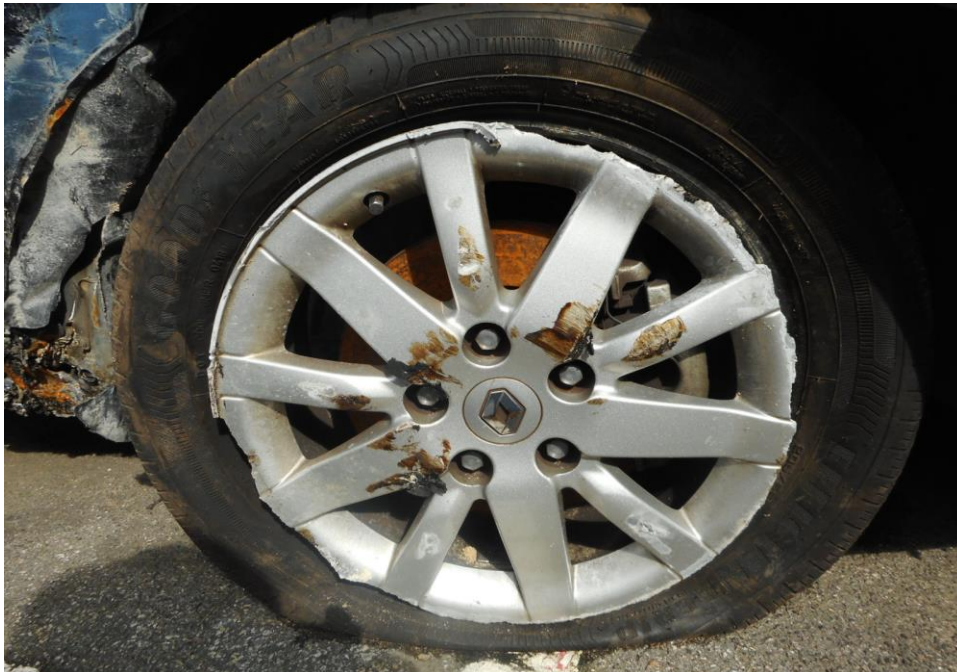
Photo 7 shows the condition of the front right tyre of the Motor Car, which was observed to be in unserviceable condition as it was damaged as a result of the accident with remaining tread depth of approximately 5.7mm.

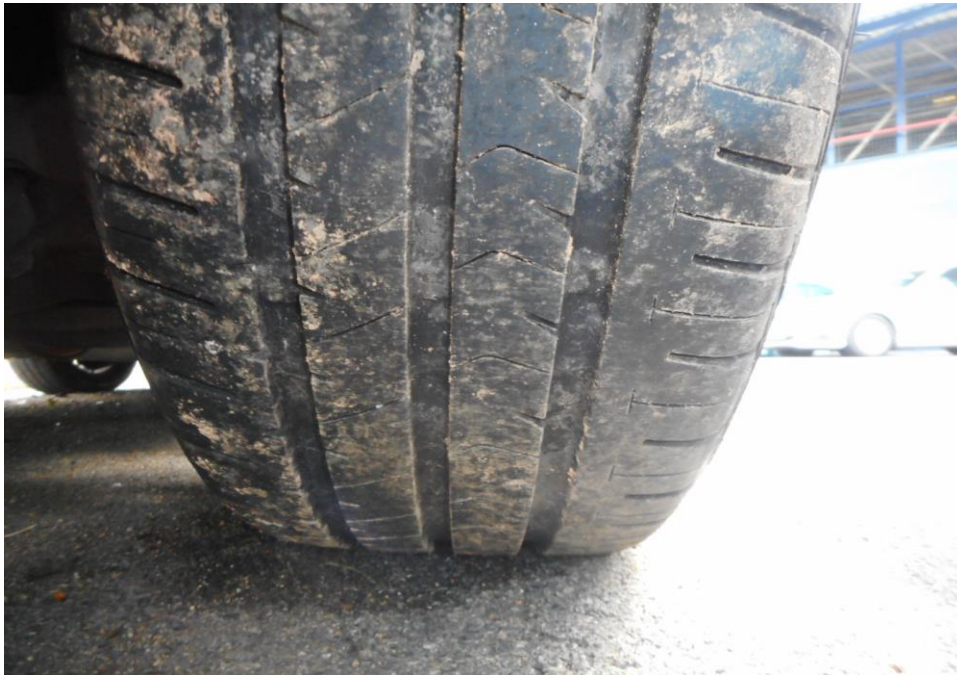
Photo 8 shows the condition of the rear right tyre of the Motor Car, which was observed to be in serviceable condition with remaining tread depth of approximately 6.1mm. The tyre was also observed to be sufficiently inflated for vehicular operation with no tear, cut or burst mark(s).

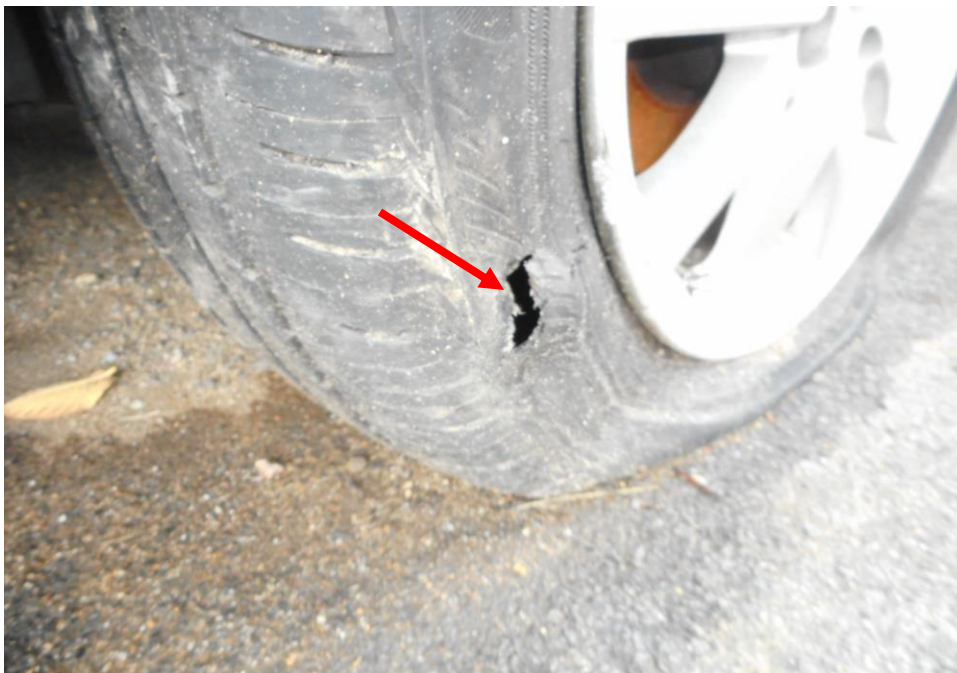
Photo 9 shows the condition of the rear left tyre of the Motor Car, which was observed to be in unserviceable condition as the tyre was observed with a cut mark (arrowed) at the side wall of the tyre. The remaining tread depth of the tyre was approximately 6.3mm.

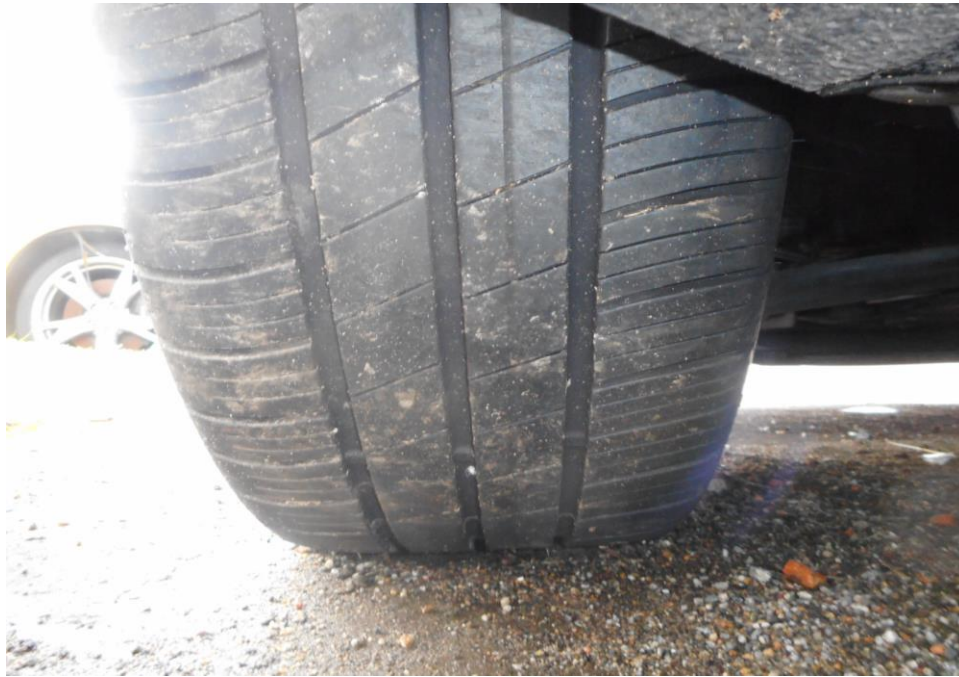
Photo 10 shows the condition of the front left tyre of the Motor Car, which was observed to be in serviceable condition with remaining tread depth of approximately 5.5mm. There was also no tear, cut or burst mark(s) on the outer and the inner sidewalls as well as across the tread of the Motor Car's 3 tyres.

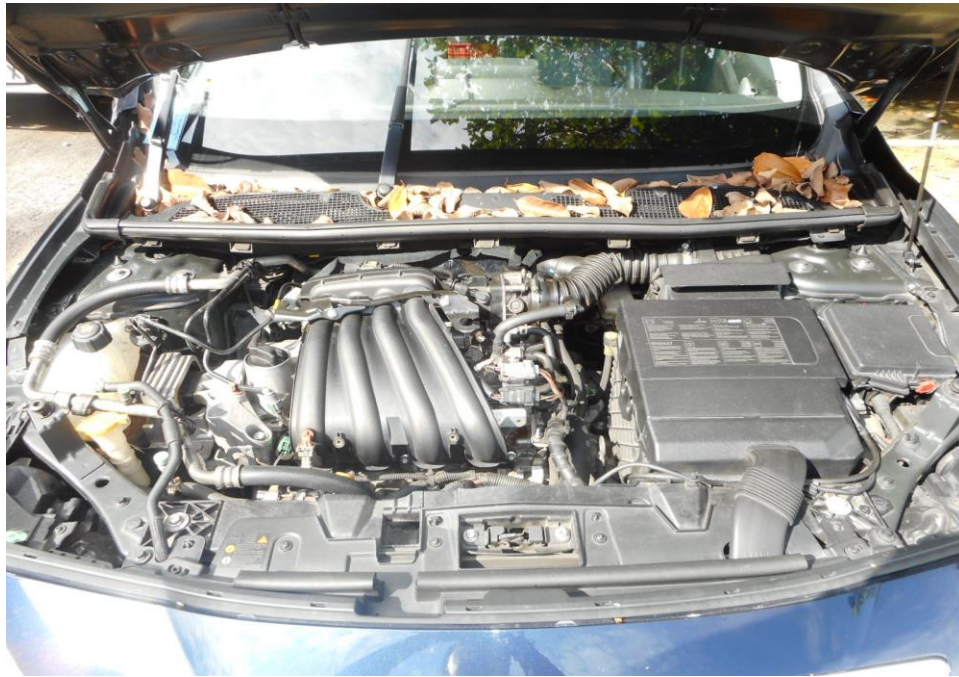
Photo 11 shows a general view of the Motor Car's engine compartment. The various parts and components inside the engine compartment were unaffected by the accident. There was also no sign(s) or indication(s) of fluid leakage and/or fluid stain within the engine compartment.

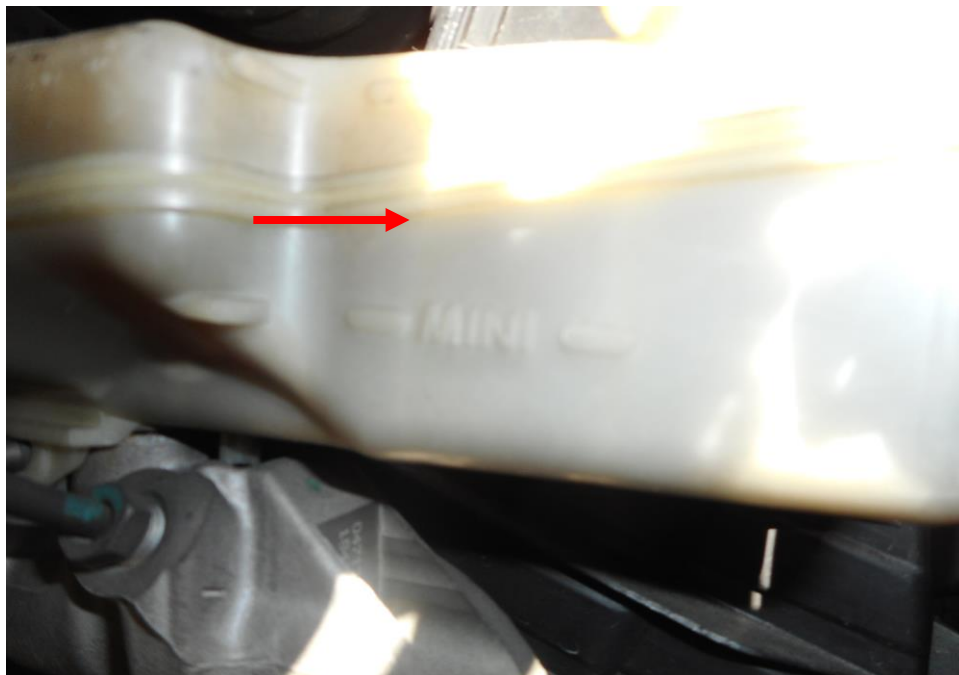
Photo 12 shows the brake fluid reservoir of the Motor Car at the time of my inspection. The brake fluid was observed to be of sufficient level (arrowed) and without any visible contamination.

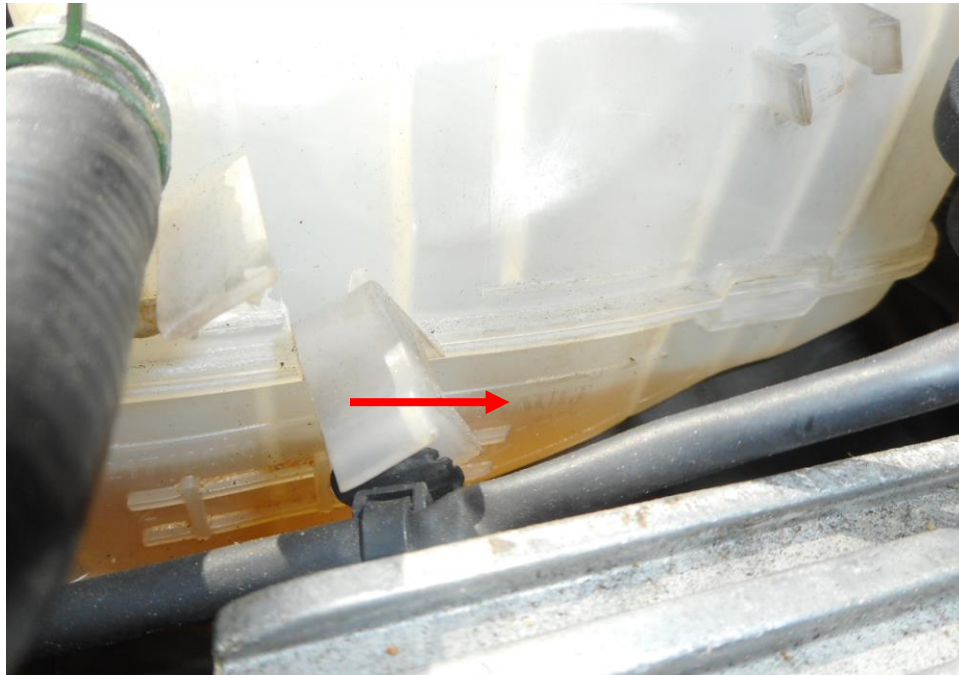
Photo 13 shows checks being carried out to the engine coolant of the Motor Car at the time of my inspection. The engine coolant was observed to be of sufficient level (arrowed) and without any visible contamination.

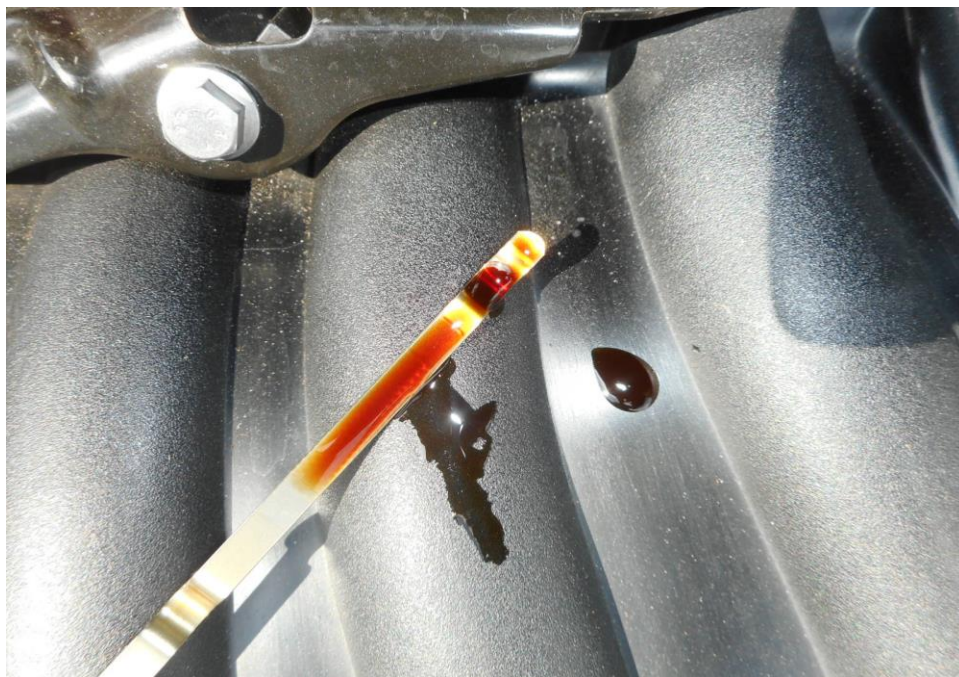
Photo 14 shows the engine oil dip stick of the Motor Car at the time of my inspection. The engine oil was observed to be of sufficient level and without any visible contamination.

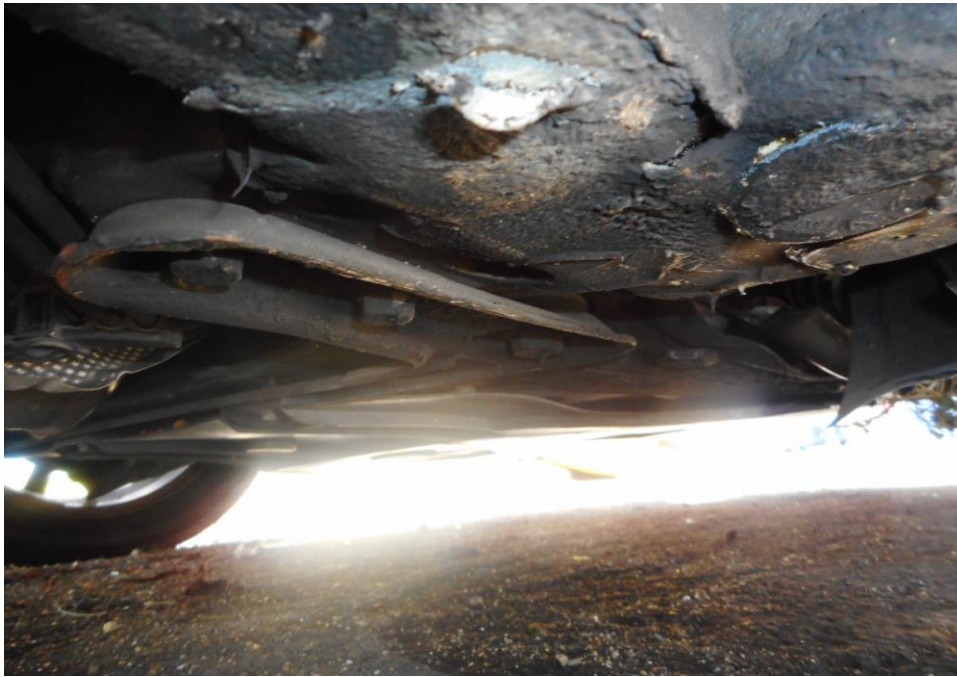
Photo 15 shows the undercarriage of the Motor Car, at the area where the engine housing and transmission housing are located. I did not find any sign(s) or indication(s) of fluid leak and/or fluid stain(s) on the underside of the Motor Car.

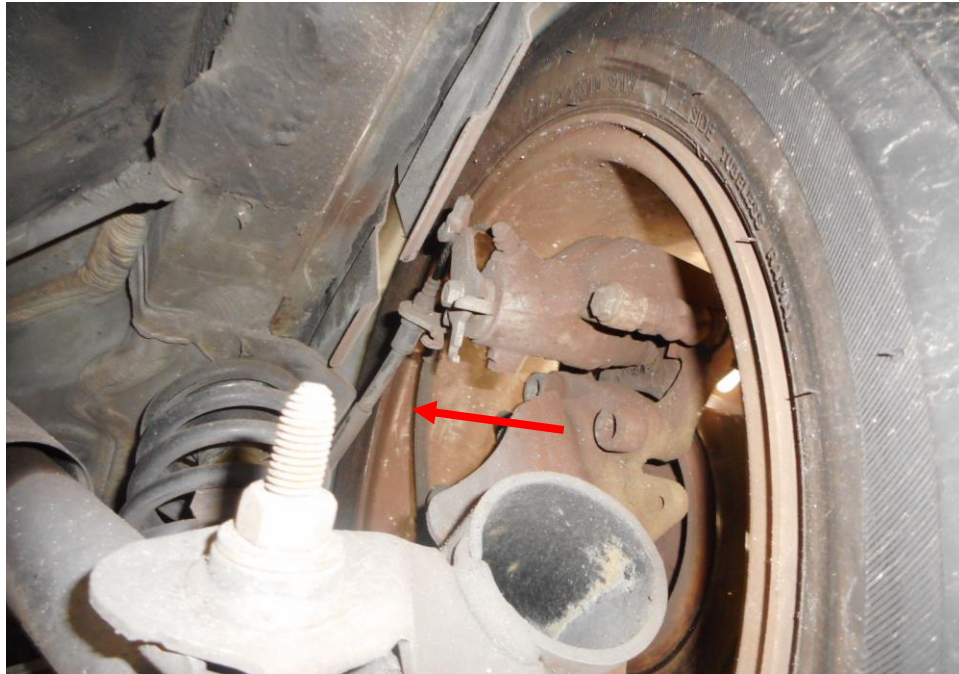
Photo 16 shows the brake hose/pipe (arrowed) at the rear right wheel of the Motor Car. No leakage of brake fluid was observed. Visual examination of the various components of the braking system like the drum brake, brake booster, brake pedal etc. had revealed all to be intact and without visible damage.

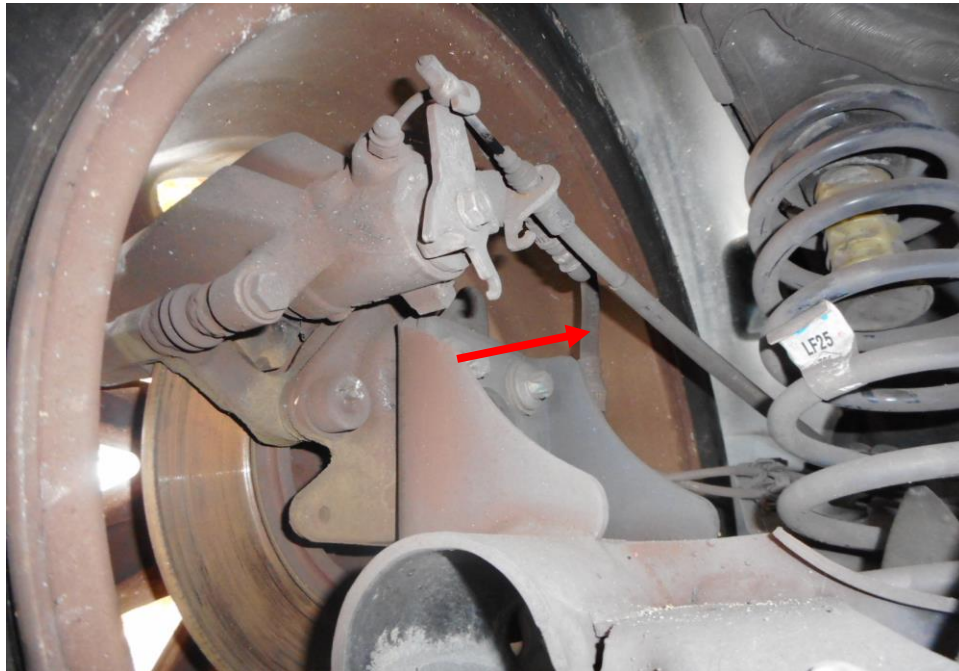
Photo 17 shows the brake hose/pipe (arrowed) at the rear left wheel of the Motor Car. I did not observe any leakage of brake fluid at the time of my inspection of the Motor Car. Static tests of the Motor Car's braking system had indicated that there was no internal leakage of pressure/vacuum. The undercarriage components of the Motor Car were also all found to be intact and without any visible damage.

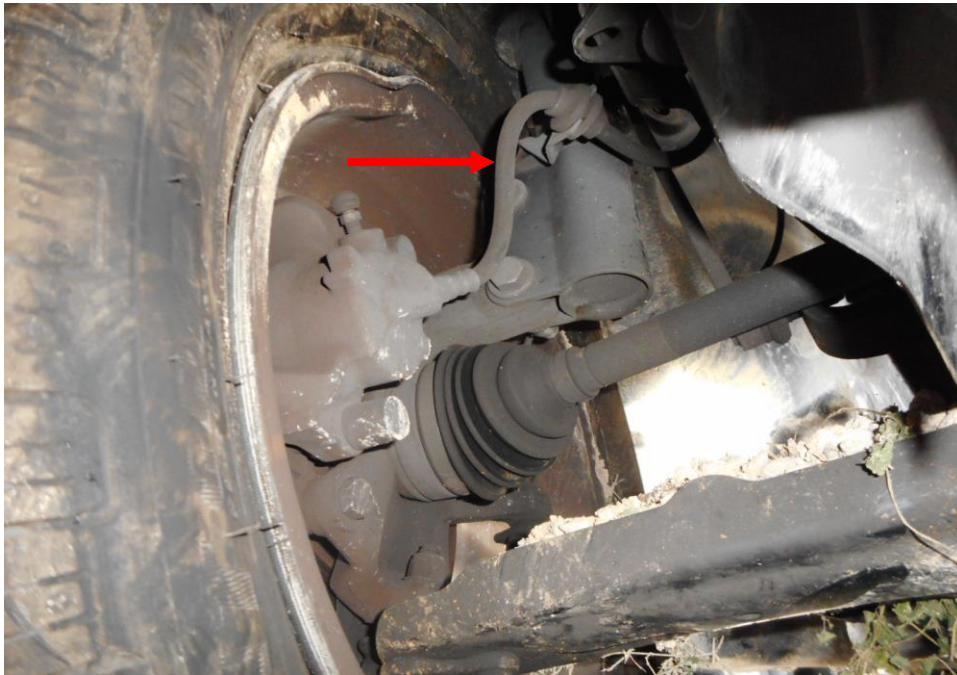
Photo 18 shows the brake hose/pipe (arrowed) at the front right wheel of the Motor Car. I did not observe any leakage of brake fluid at the time of my inspection of the Motor Car. Static tests of the Motor Car's braking system had indicated that there was no internal leakage of pressure/vacuum. The undercarriage components of the Motor Car were also all found to be intact and without any visible damage.

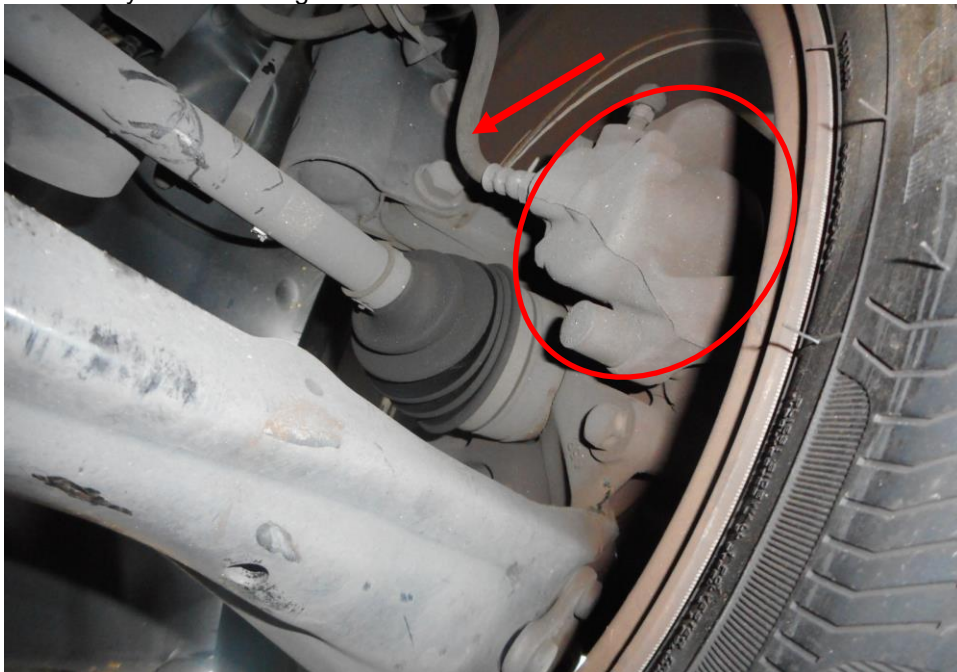
Photo 19 shows the brake hose/pipe (arrowed) at the front left wheel of the Motor Car. No leakage of brake fluid was observed. Visual examination of the various components of the braking system like the brake caliper (circled), brake booster, brake pedal etc had revealed all to be intact and without visible damage.

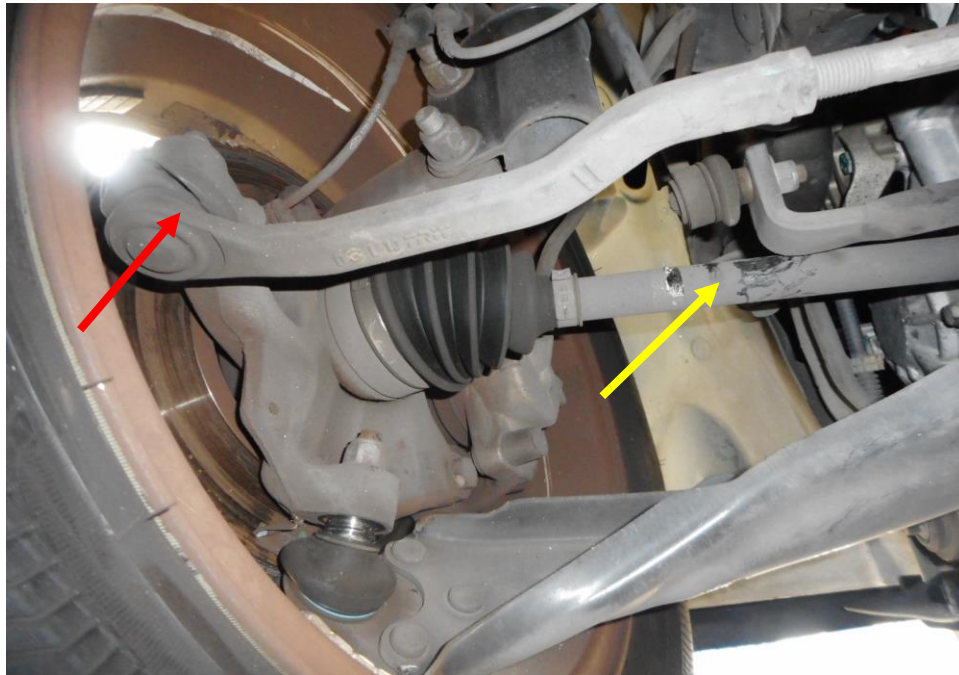
Photo 20 shows the various undercarriage components at the front left wheel of the Motor Car, in particular the steering tie rod (red arrow) and drive shaft (yellow arrow). The various steering components were all found to be intact, suggesting that the steering system of the Motor Car was likely to be in serviceable condition at the material time of accident. There was also no sign of fluid stain observed on the various undercarriage components at the front left wheel of the Motor Car.

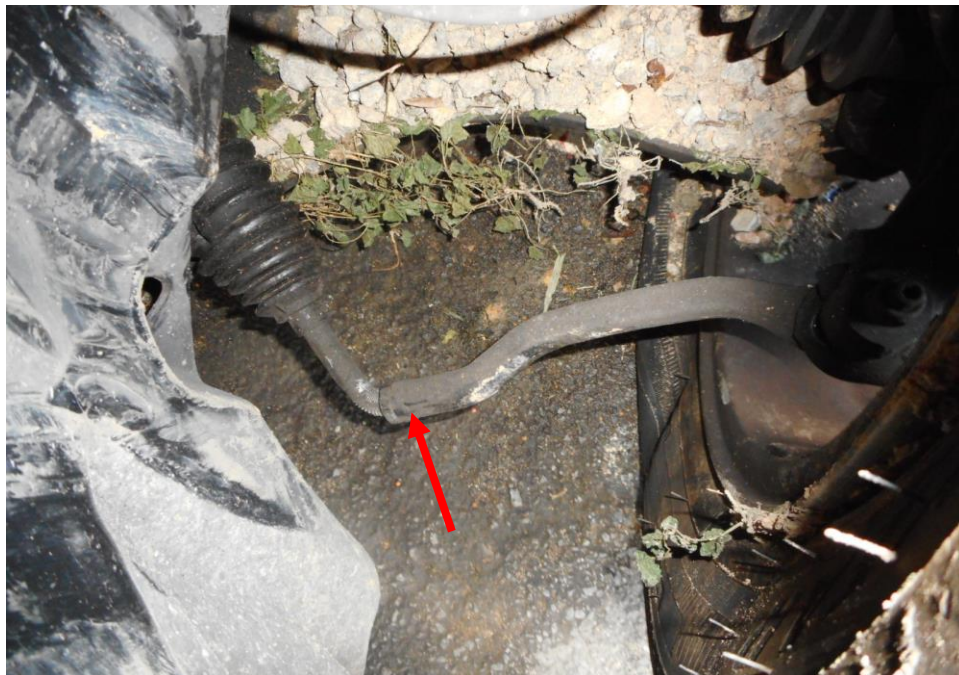
12. Static test on the steering system of the Motor Car also revealed abnormality to the steering system. I experience abnormal free play and/or other resistance when turning the steering wheel left and right to full lock positions. My visual examination of the various steering components which had included the steering rack and pinion, tie rod ends and ball joints revealed that these components were all generally in good condition. However, the tie rod at the front right wheel was observed to be damaged as a result of the accident. See photo 16 - 21 below.

Photo 21 shows the various undercarriage components at the front right wheel of the Motor Car, the steering tie rod (red arrow) was observed to be damaged as a result of the accident.

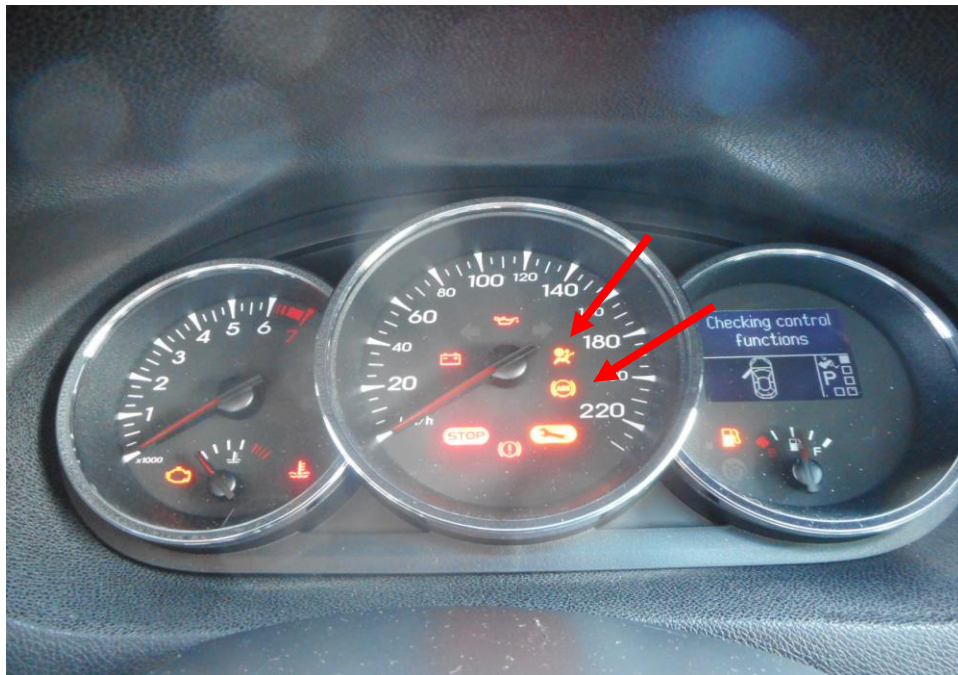
Photo 22 shows the warning light for Anti-Lock Brake System (ABS) and Supplemental Restraint System (SRS) (arrowed) appearing on the instrument panel of the Motor Car during the self-test of its various electronic operating systems when its engine was cranked.

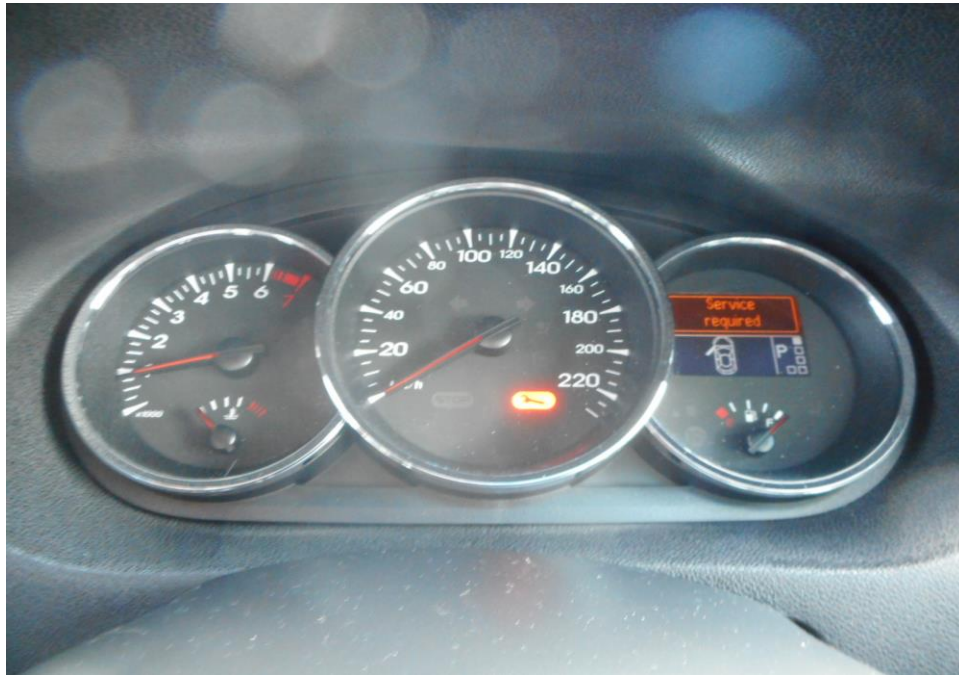
Photo 23 shows no warning lights illuminated on the instrument panel of the Motor Car after the engine was cranked. This would suggest that there was no abnormality to the electronic operating system of the Motor Car, like the ABS and SRS etc.
