You're Ref: TP/IP/78763/2019  
Our Ref: CI/TPD20006184/P

**General Investigation Team**

**MECHANICAL INSPECTION REPORT OF MOTOR CAR SLB 4678R**

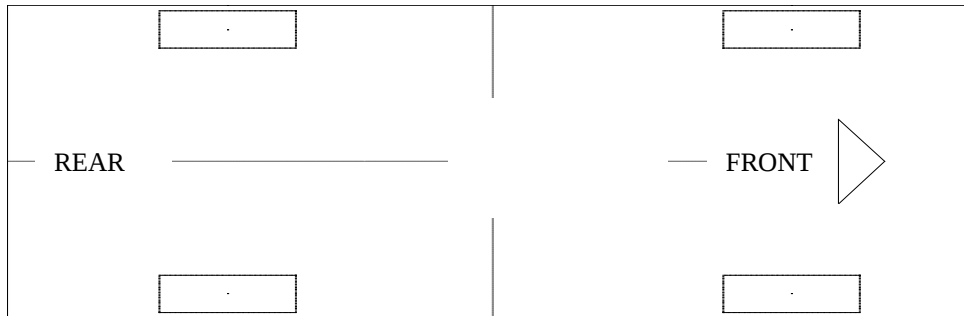
6. The condition of the Motor Car's 4 tyres was observed to be in serviceable condition. I did not find any tear, cut or burst mark(s) on the outer and the inner sidewalls as well as across the tread of the 4 tyres. The 4 tyres were also observed to be sufficiently inflated for vehicular operation. The tyre brand, tyre size and remaining tread depth of the 4 tyres were recorded as follows:-

Yokohama 225/55R18 (5.1mm)

Yokohama 225/55R18 (4.9mm)

Yokohama 225/55R18 (5.2mm)

Yokohama 225/55R18 (4.7mm)

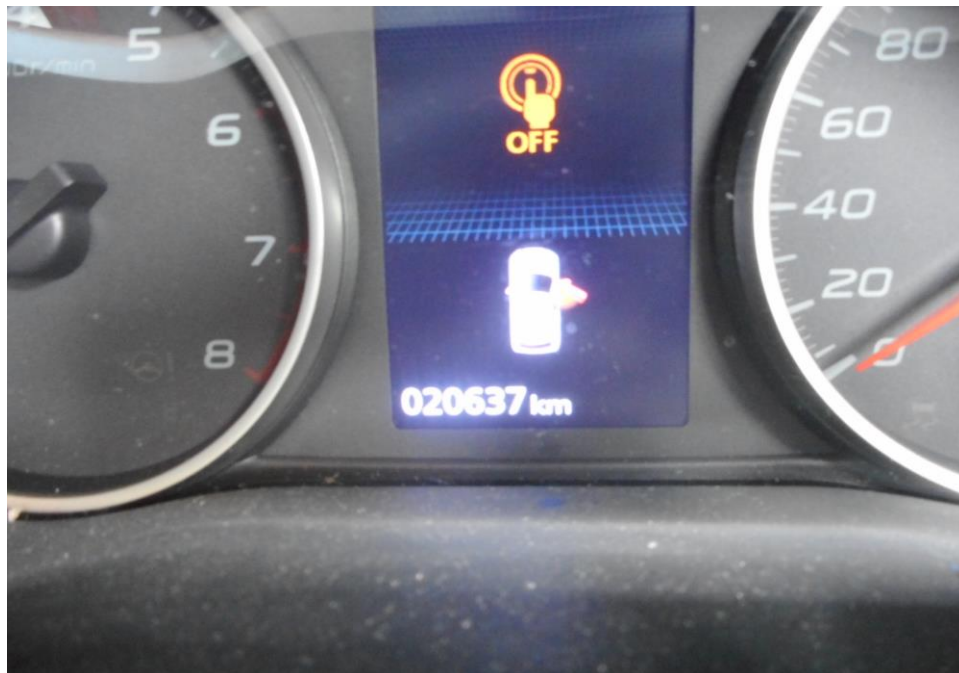
**Photo 1** shows the mileage of the Motor Car at the time of my inspection. The mileage observed was 20,637km.

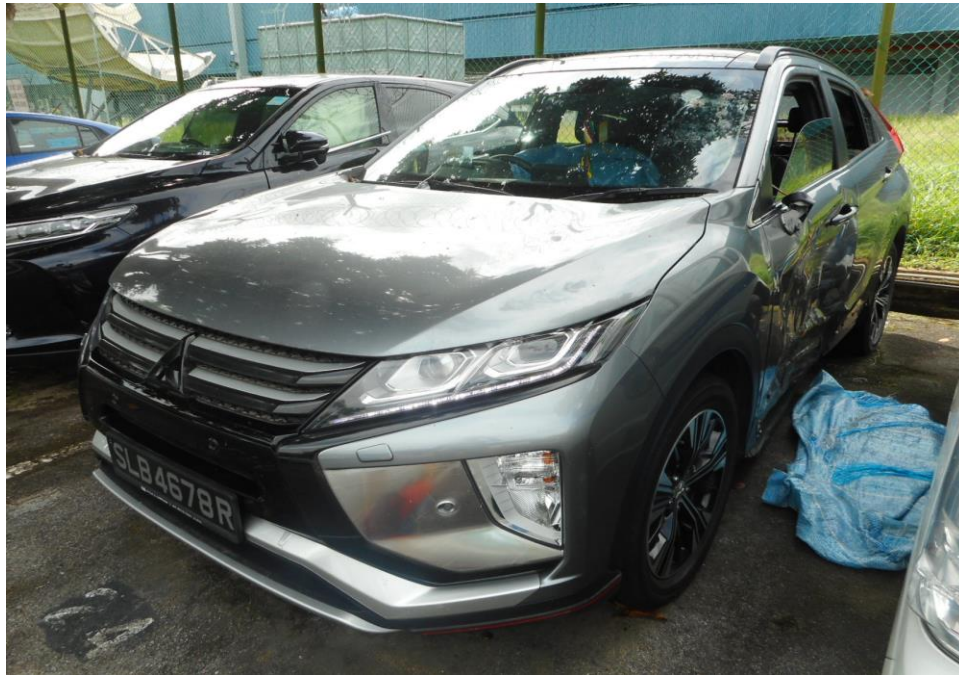
4. The mileage of the Motor Car at the time of my inspection was 20,637km.
5. The Motor Car was observed to have sustained damage at its left portion. Its front left door panel, its left rear view mirror and its rear windscreen was amongst the body part that were damaged as a result of the accident.

**Photo 2** shows a general view of the Motor Car's left body at the time of my inspection. The left portion of the Motor Car was observed to have sustained damage. Its front left door panel, its left rear view mirror and its rear windscreen was amongst the body part that were damaged as a result of the accident.

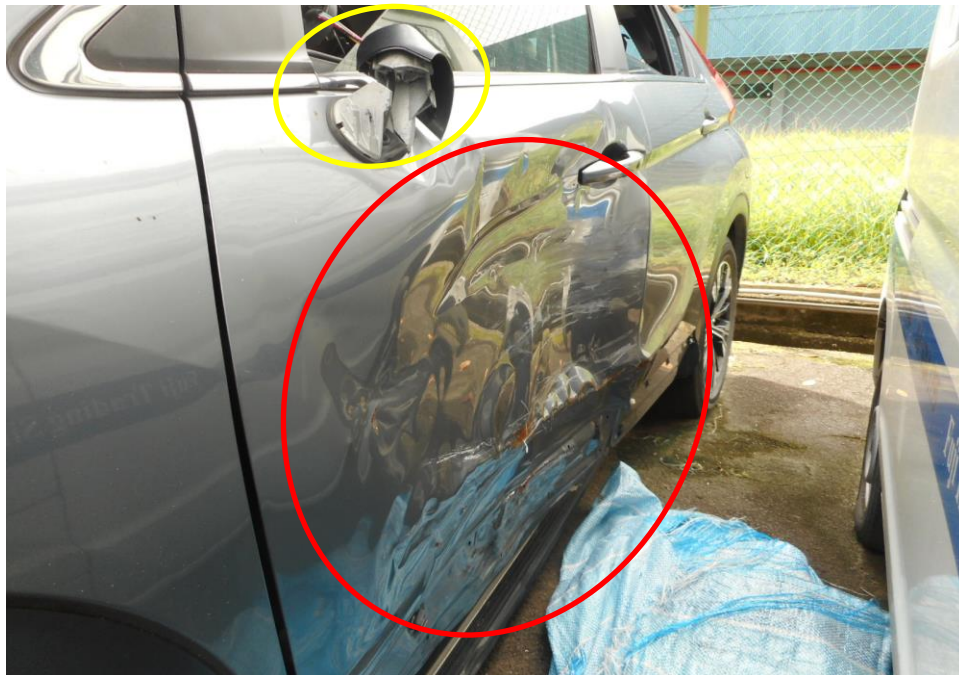
**Photo 3** shows the close up view of the Motor Car's left body at the time of my inspection. The Motor Car was observed to have sustained damage at its front left door panel (red circle) and its rear view mirror (yellow circle), as a result of the accident.

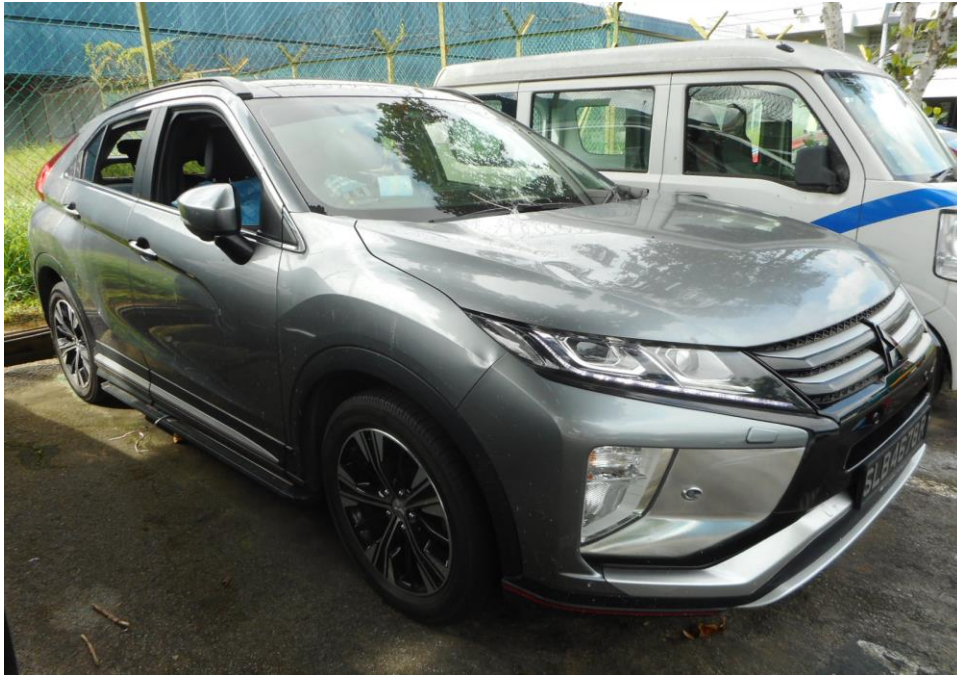
**Photo 4** shows a general view of the Motor Car's right body at the time of my inspection. The right portion of the Motor Car was observed to have been unaffected by the accident.

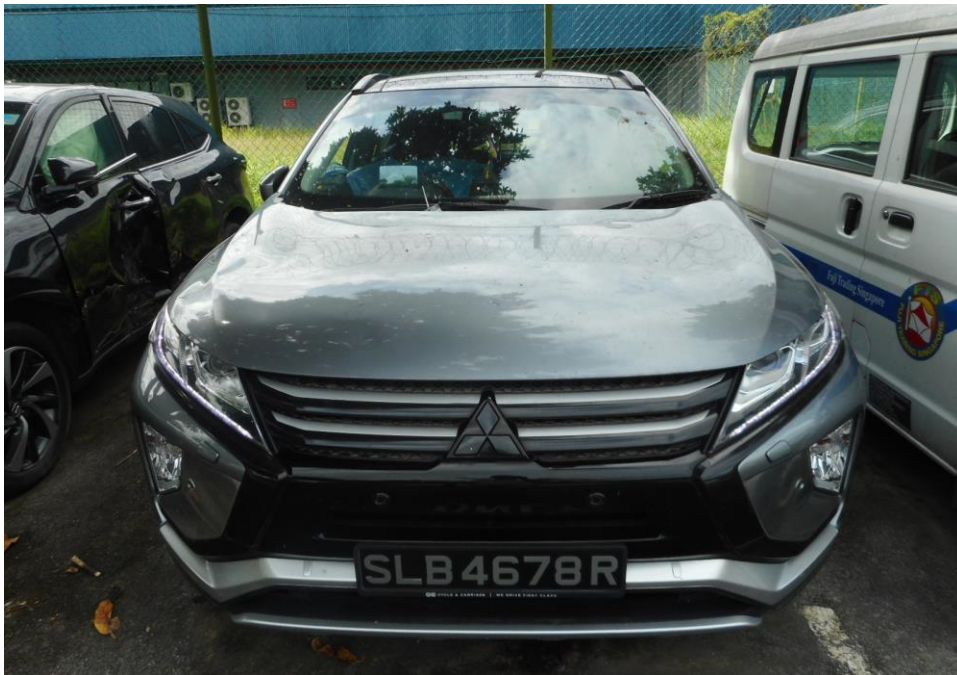
**Photo 5** shows a general view of the Motor Car's front body at the time of my inspection. The front portion of the Motor Car was observed to have been unaffected by the accident.

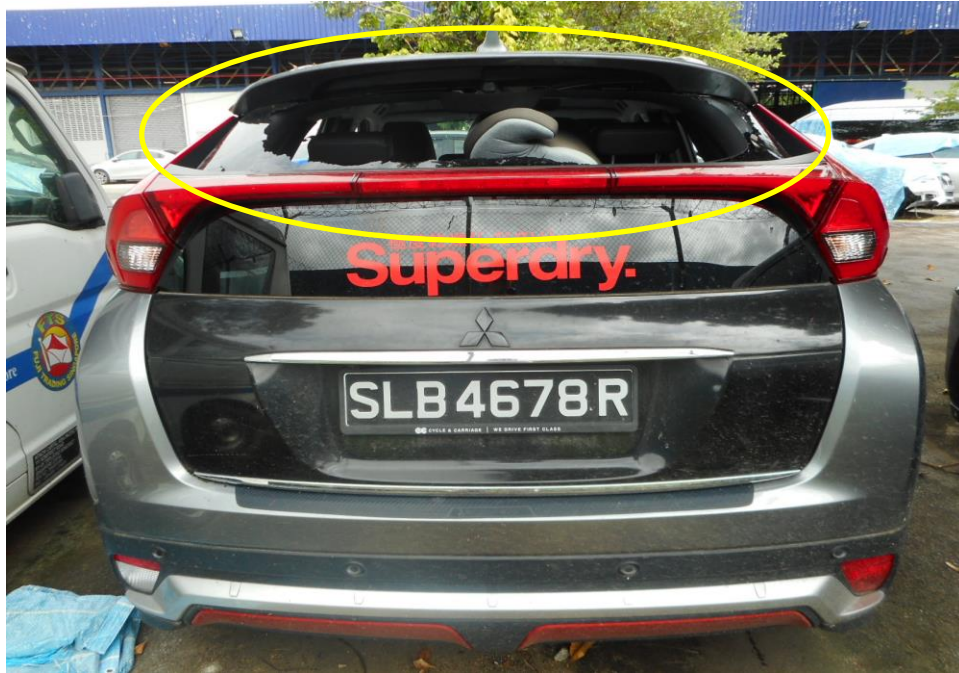
**Photo 6** shows the general view of the Motor Car's rear body at the time of my inspection. The Motor Car rear windscreen (circled) was observed to be damaged as a result of the accident.

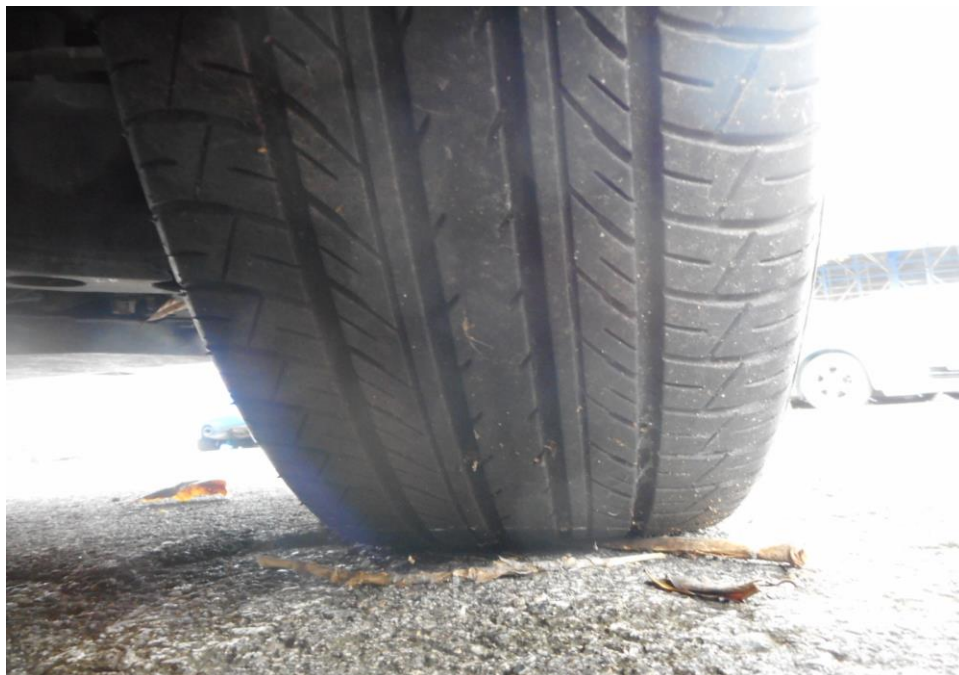
**Photo 7** shows the condition of the front right tyre of the Motor Car, which was observed to be in serviceable condition with remaining tread depth of approximately 4.7mm. The tyre was sufficiently inflated for vehicular operation with no tear, cut or burst mark(s) on the outer and the inner sidewalls as well as across the tread. The 4 tyres of the Motor Car were wrapped around standard steel wheel rims without any damage.

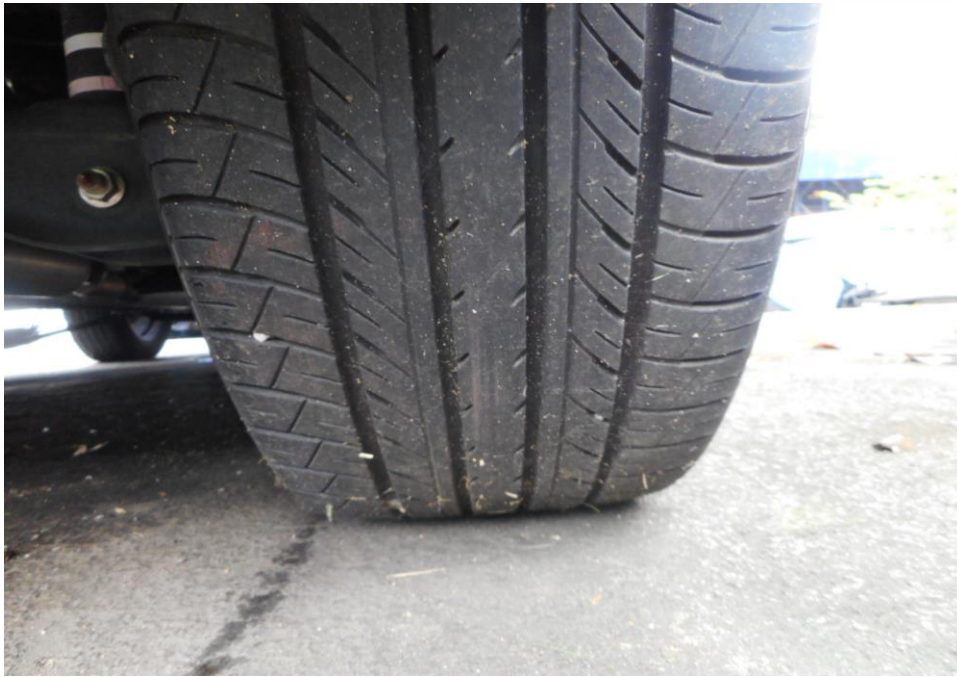
**Photo 8** shows the condition of the rear right tyre of the Motor Car, which was observed to be in serviceable condition with remaining tread depth of approximately 5.2mm. The tyre was also observed to be sufficiently inflated for vehicular operation with no tear, cut or burst mark(s).

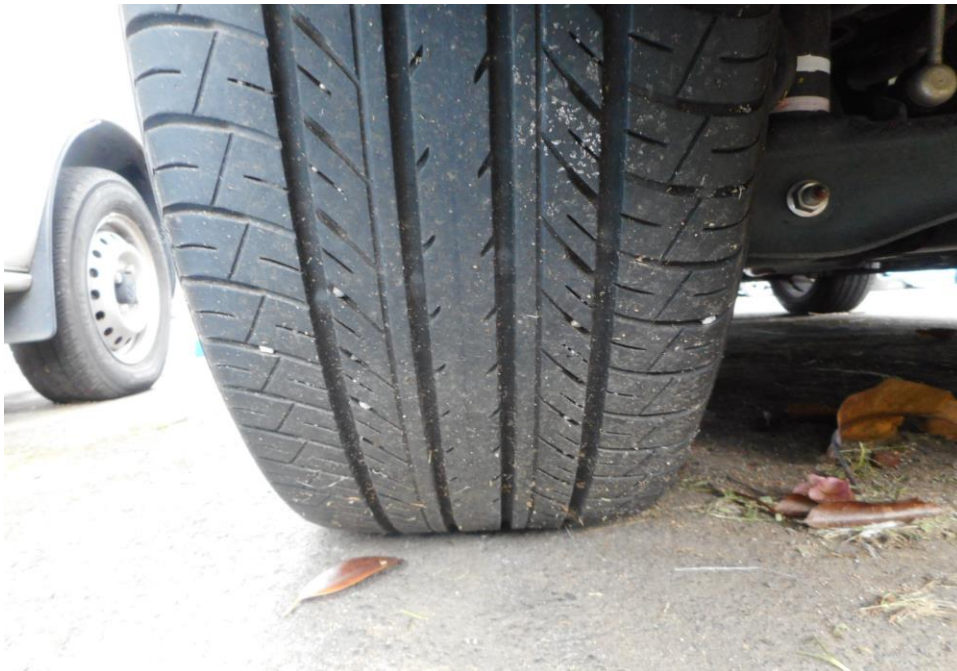
**Photo 9** shows the condition of the rear left tyre of the Motor Car, which was observed to be in serviceable condition with remaining tread depth of approximately 5.1mm. The tyre, which was wrapped around steel wheel rim, was also observed to be sufficiently inflated for vehicular operation. The 4 tyres of the Motor Car were wrapped around standard steel wheel rims.

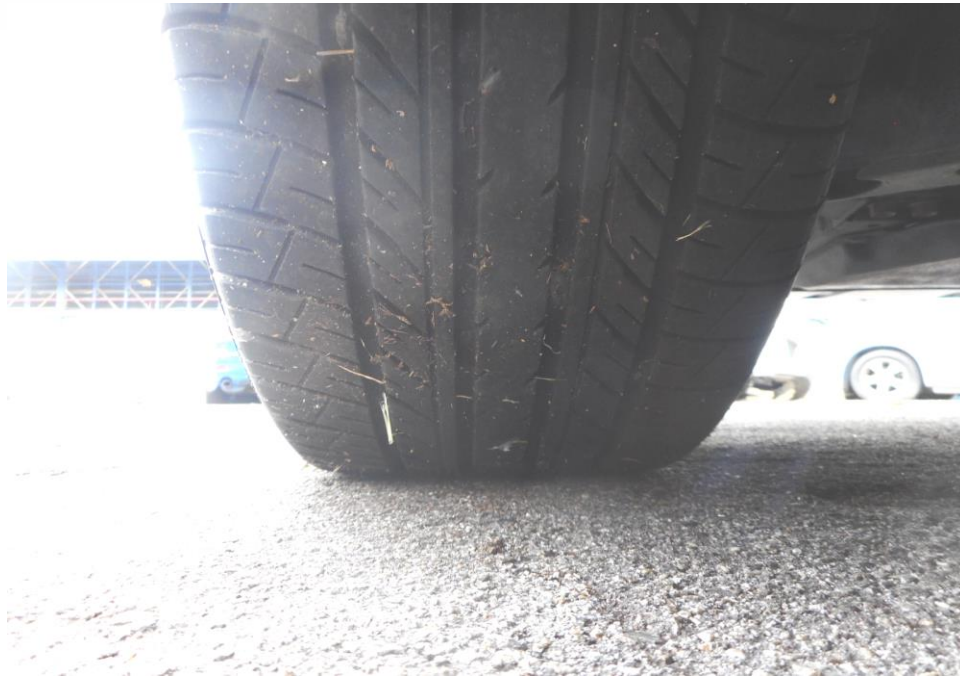
**Photo 10** shows the condition of the front left tyre of the Motor Car, which was observed to be in serviceable condition with remaining tread depth of approximately 4.9mm. There was also no tear, cut or burst mark(s) on the outer and the inner sidewalls as well as across the tread of the Motor Car's 4 tyres.

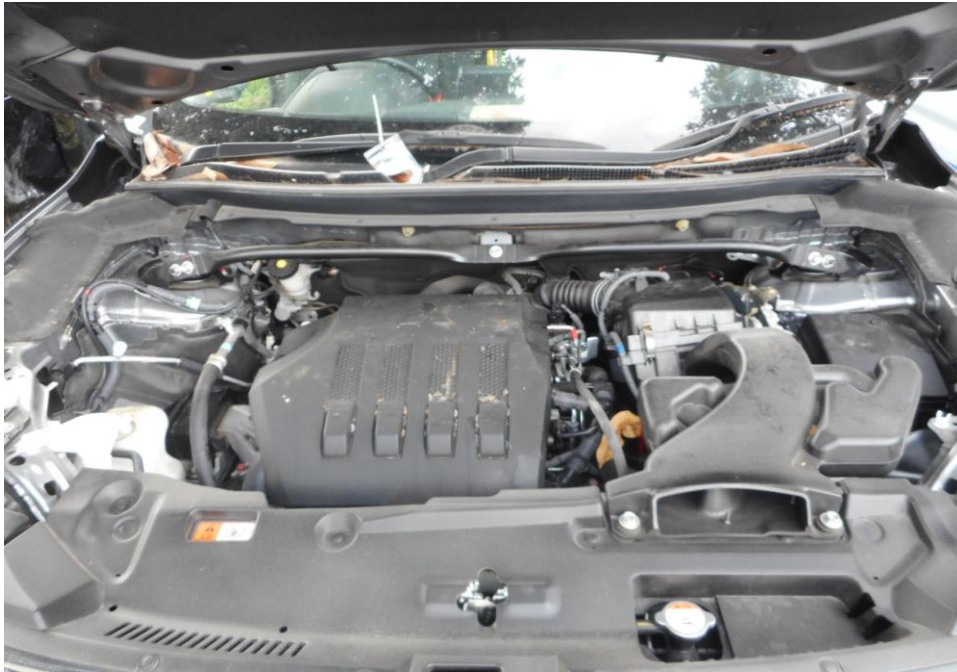
**Photo 11** shows a general view of the Motor Car's engine compartment. The various parts and components inside the engine compartment were unaffected by the accident. There was also no sign(s) or indication(s) of fluid leakage and/or fluid stain within the engine compartment.

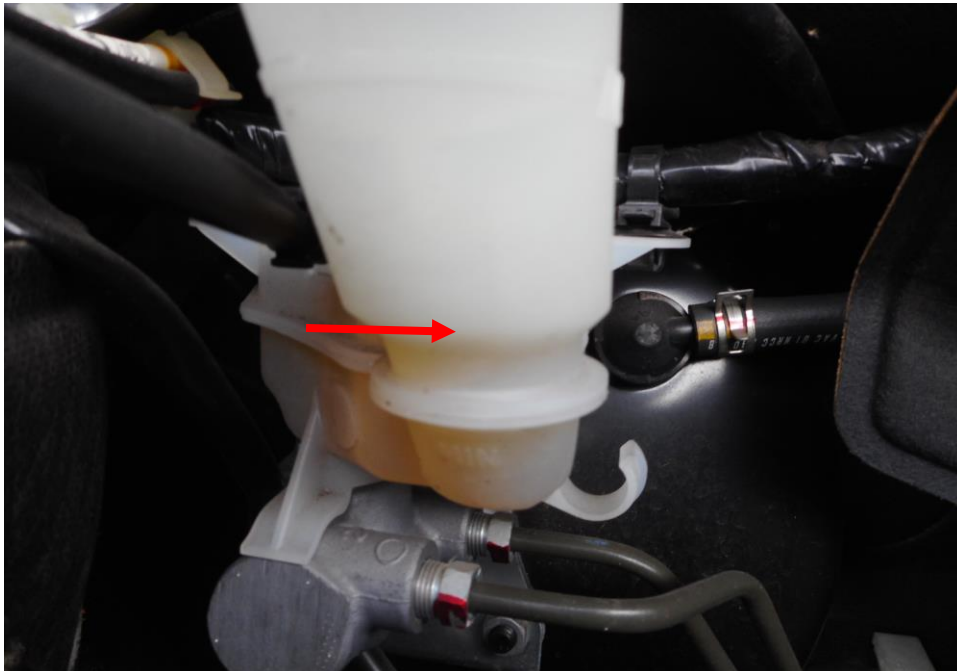
**Photo 12** shows the brake fluid reservoir of the Motor Car at the time of my inspection. The brake fluid was observed to be of sufficient level (arrowed) and without any visible contamination.

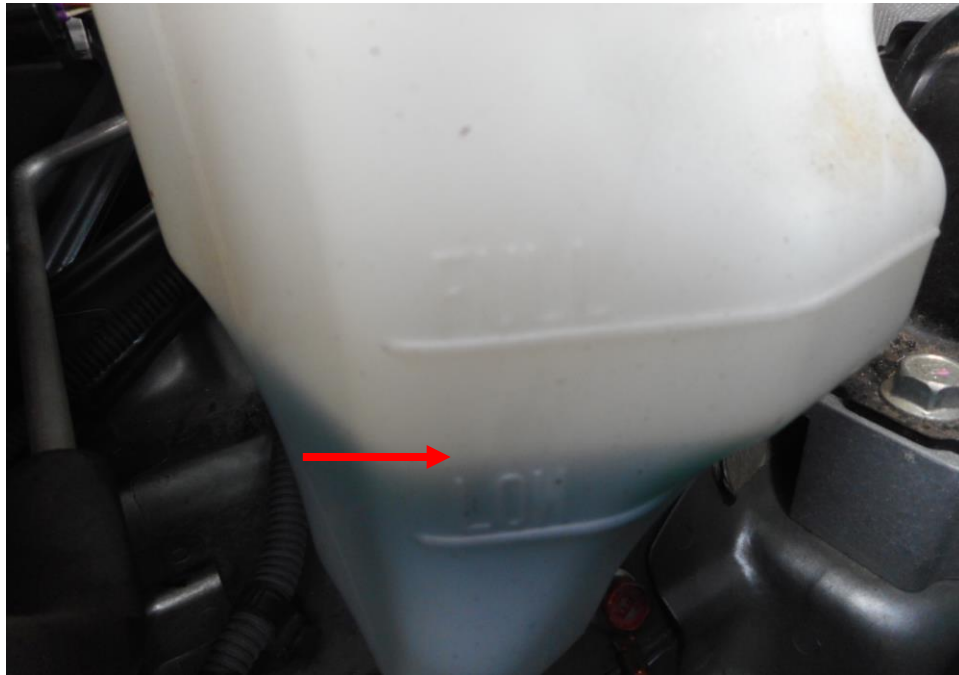
**Photo 13** shows checks being carried out to the engine coolant of the Motor Car at the time of my inspection. The engine coolant was observed to be of sufficient level (arrowed) and without any visible contamination.

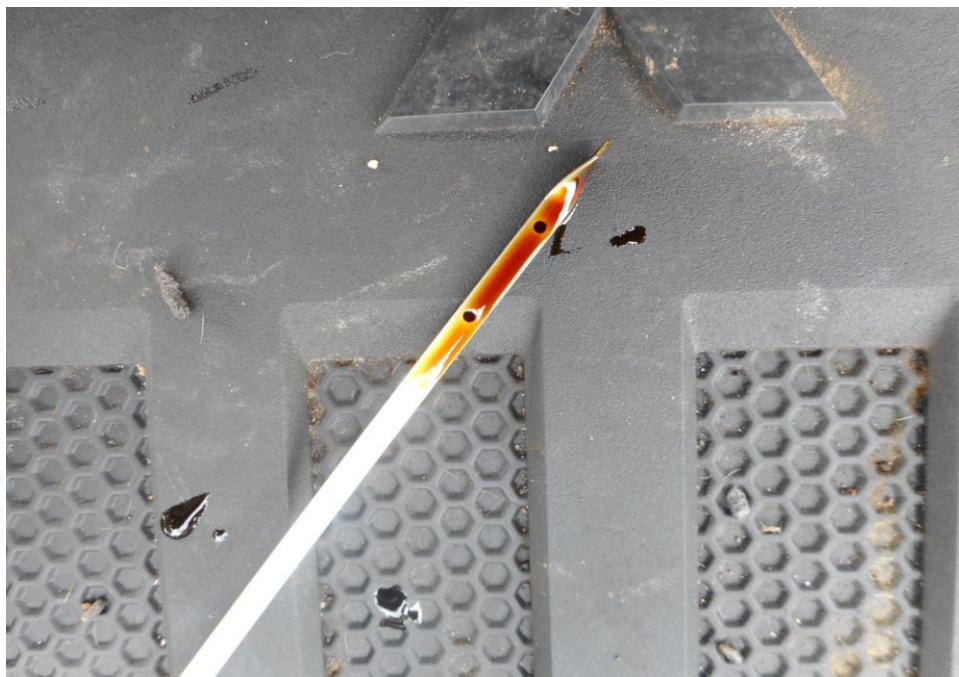
**Photo 14** shows the engine oil dip stick of the Motor Car at the time of my inspection. The engine oil was observed to be of sufficient level and without any visible contamination.

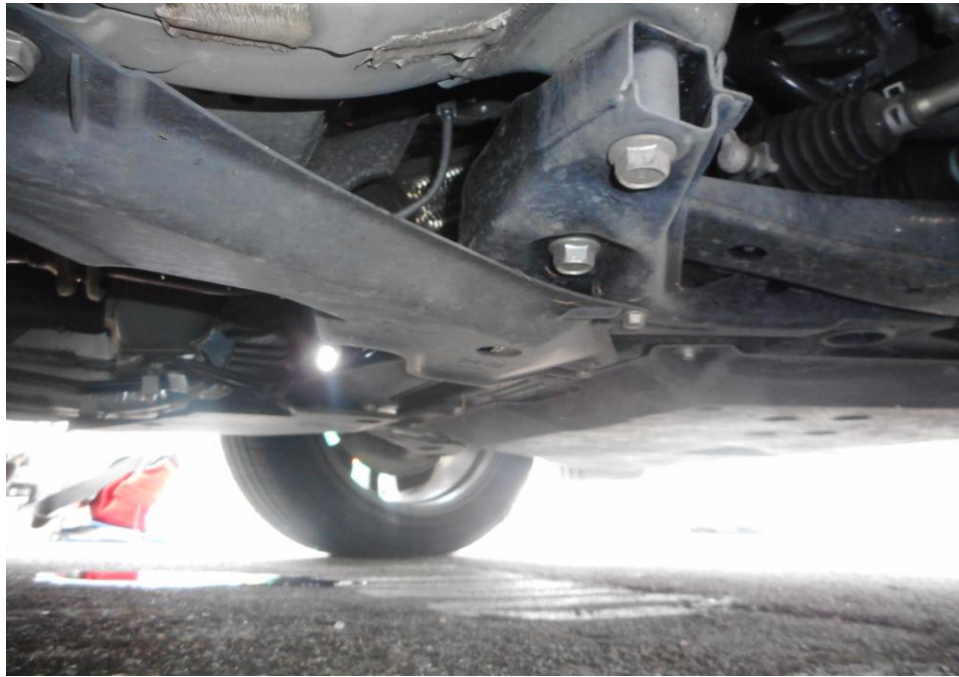
**Photo 15** shows the undercarriage of the Motor Car, at the area where the engine housing and transmission housing are located. I did not find any sign(s) or indication(s) of fluid leak and/or fluid stain(s) on the underside of the Motor Car.

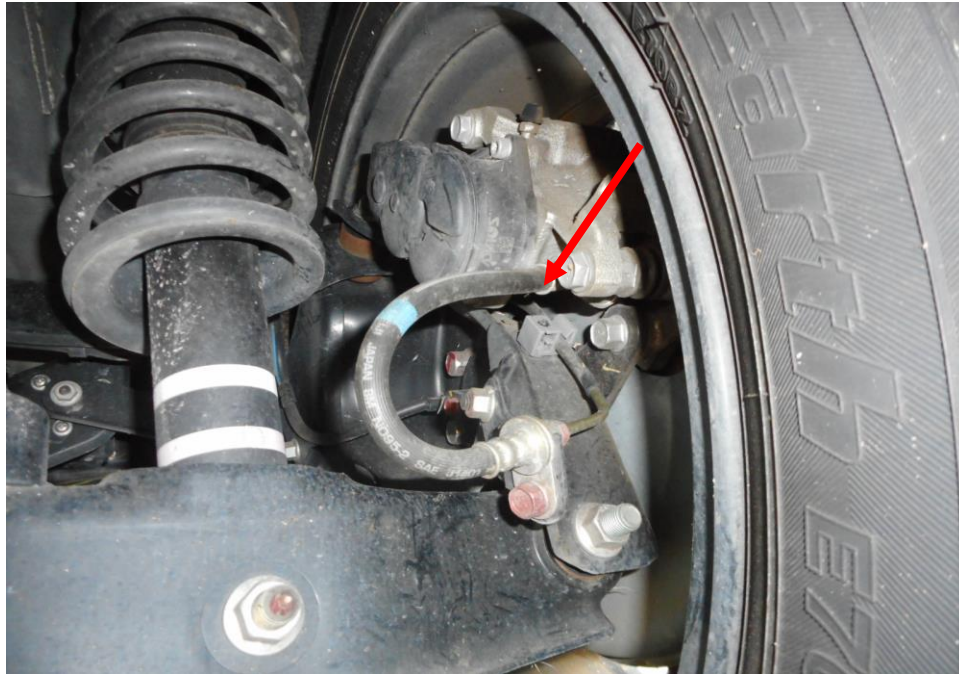
**Photo 16** shows the brake hose/pipe (arrowed) at the rear right wheel of the Motor Car. No leakage of brake fluid was observed. Visual examination of the various components of the braking system like the drum brake, brake booster, brake pedal etc. had revealed all to be intact and without visible damage.

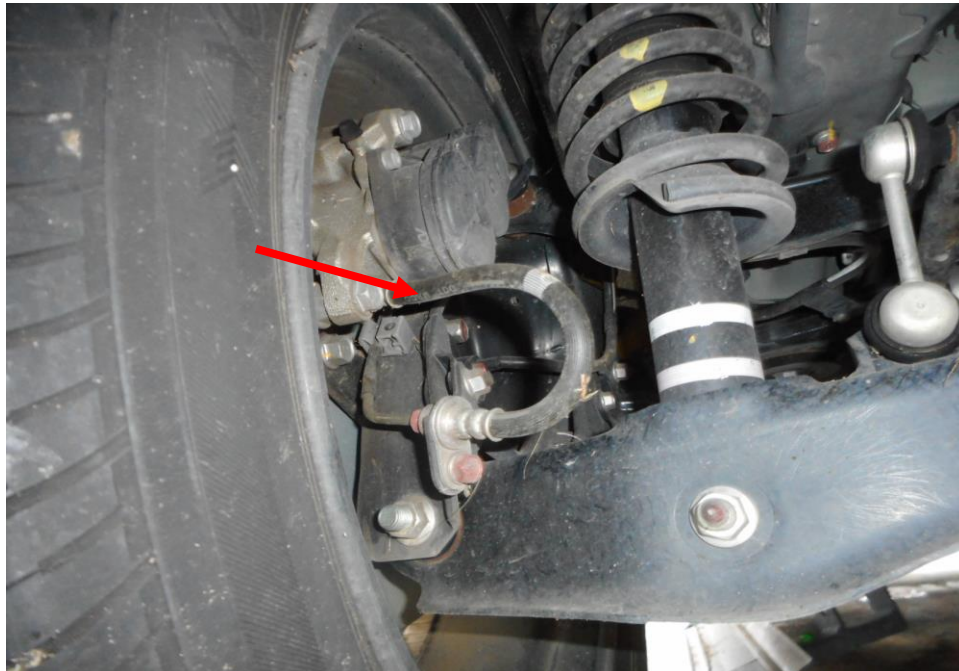
**Photo 17** shows the brake hose/pipe (arrowed) at the rear left wheel of the Motor Car. I did not observe any leakage of brake fluid at the time of my inspection of the Motor Car. Static tests of the Motor Car's braking system had indicated that there was no internal leakage of pressure/vacuum. The undercarriage components of the Motor Car were also all found to be intact and without any visible damage.

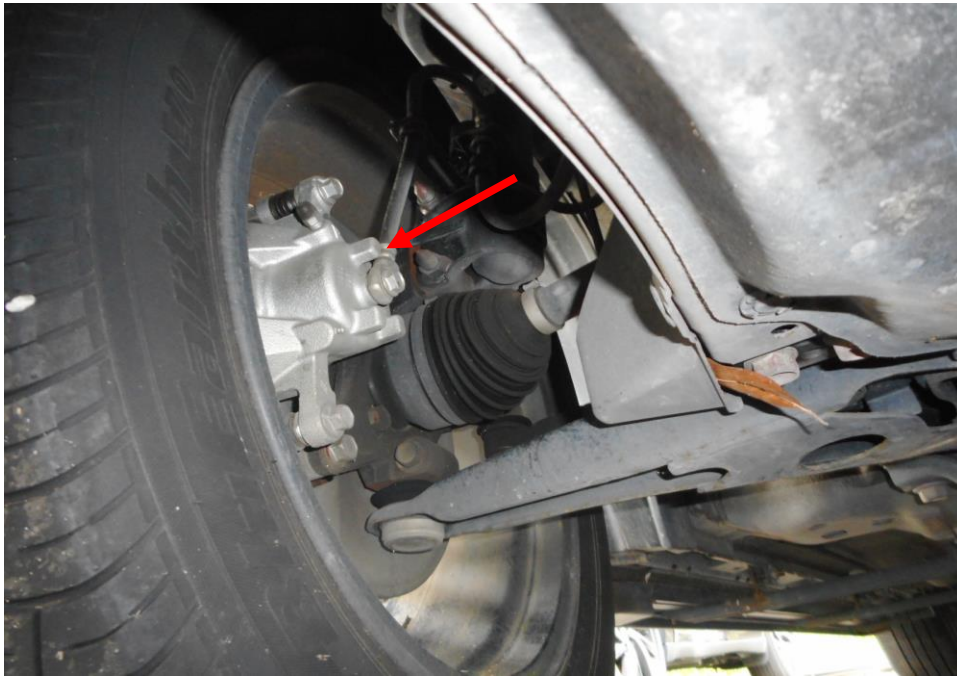
**Photo 18** shows the brake hose/pipe (arrowed) at the front right wheel of the Motor Car. I did not observe any leakage of brake fluid at the time of my inspection of the Motor Car. Static tests of the Motor Car's braking system had indicated that there was no internal leakage of pressure/vacuum. The undercarriage components of the Motor Car were also all found to be intact and without any visible damage.

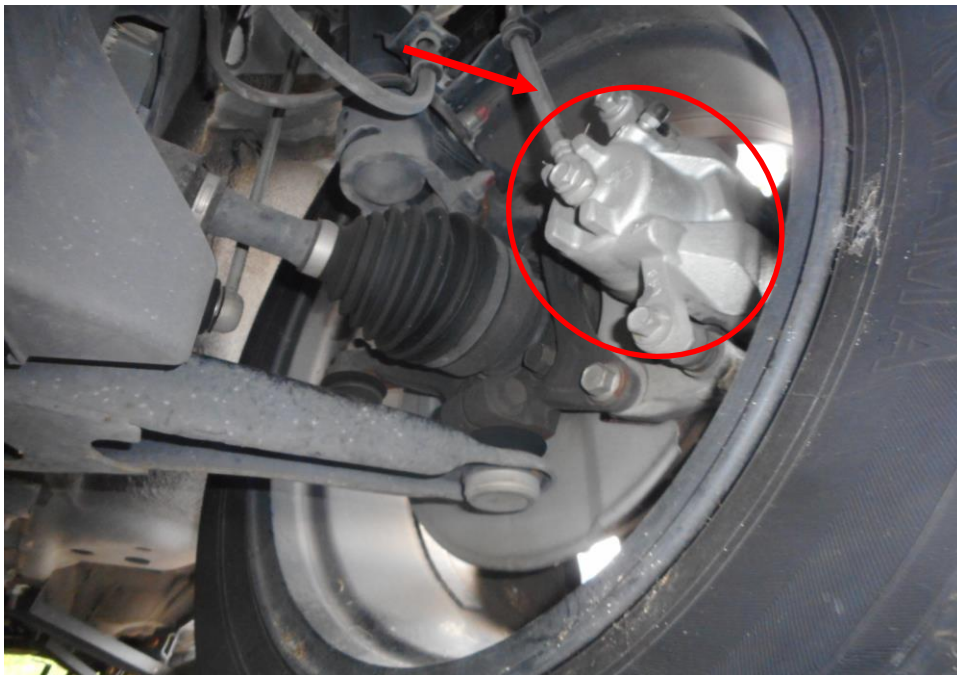
**Photo 19** shows the brake hose/pipe (arrowed) at the front left wheel of the Motor Car. No leakage of brake fluid was observed. Visual examination of the various components of the braking system like the brake caliper (circled), brake booster, brake pedal etc had revealed all to be intact and without visible damage.

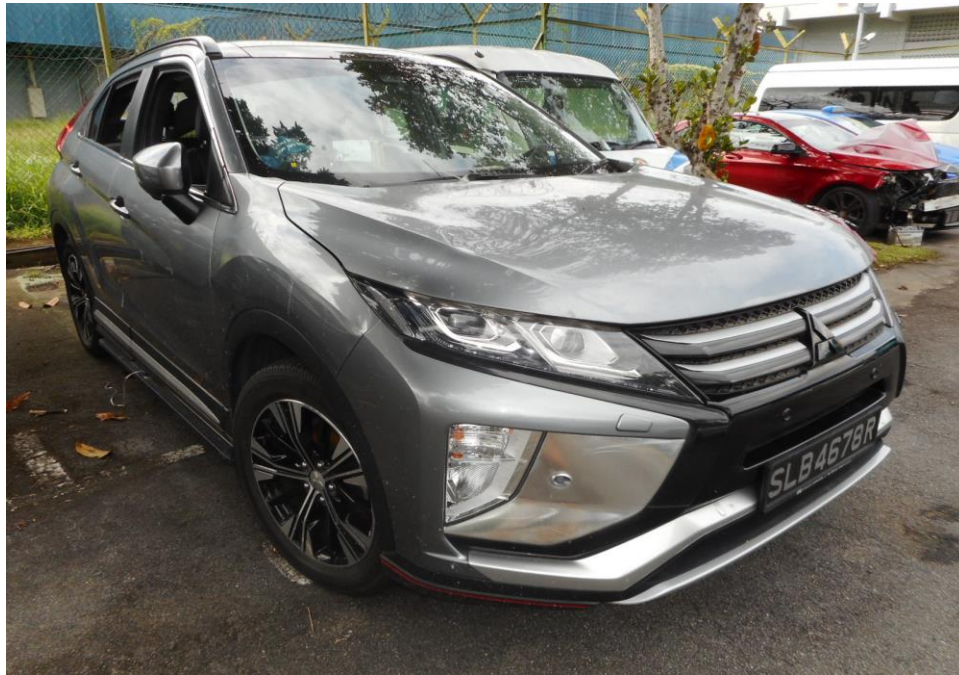
**Photo 20** shows the front right wheel of the Motor Car turned to its full left. During my steering system test, I did not experience any abnormal free play and/or resistance when I had turned the steering wheel towards the left and right. This would suggest that the steering system of the Motor Car was likely to be in serviceable condition at the material time of accident.

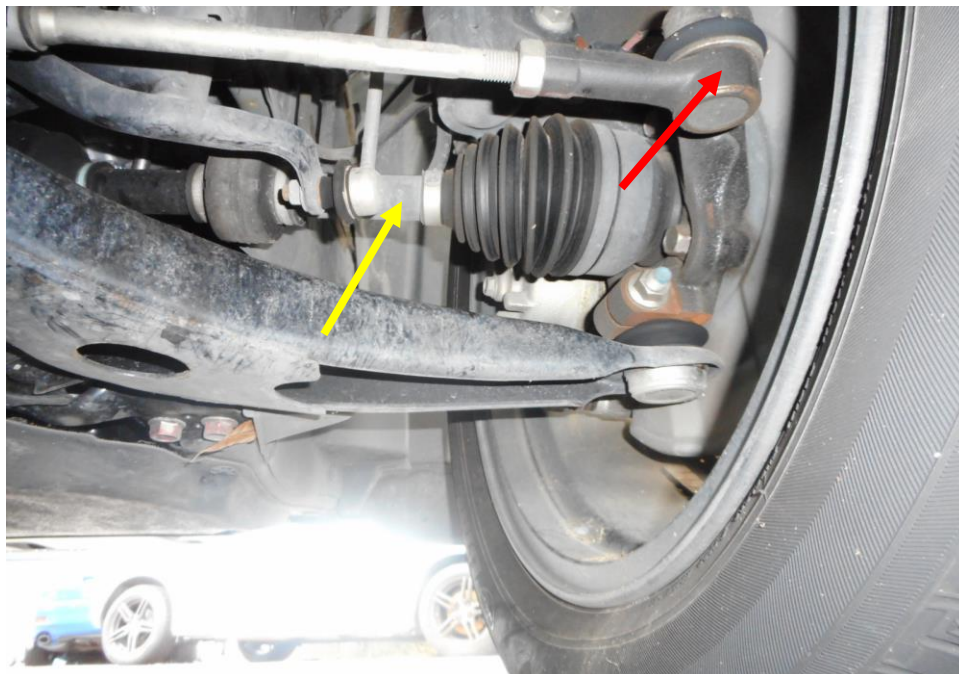
**Photo 21** shows the various undercarriage components at the front right wheel of the Motor Car, in particular the steering tie rod (red arrow) and drive shaft (yellow arrow). The various steering components were all found to be intact, suggesting that the steering system of the Motor Car was likely to be in serviceable condition at the material time of accident. There was also no sign of fluid stain observed on the various undercarriage components at the front right wheel of the Motor Car.

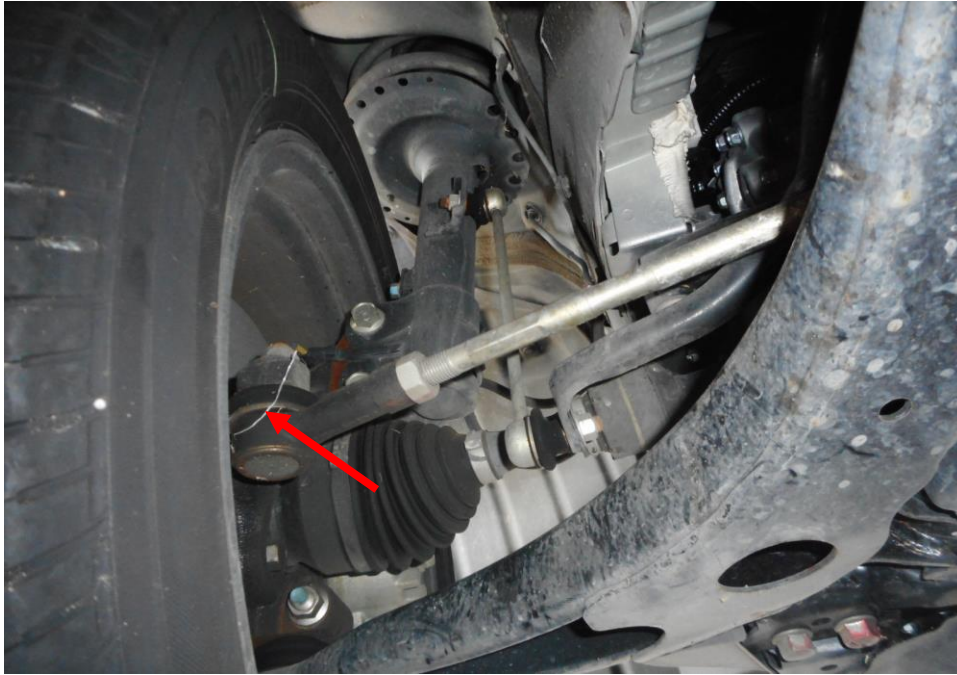
**Photo 22** shows the various undercarriage components at the front left wheel of the Motor Car, which had included the steering tie rod (arrowed). The various undercarriage components of the Motor Car were all found to be intact without any visible damage.

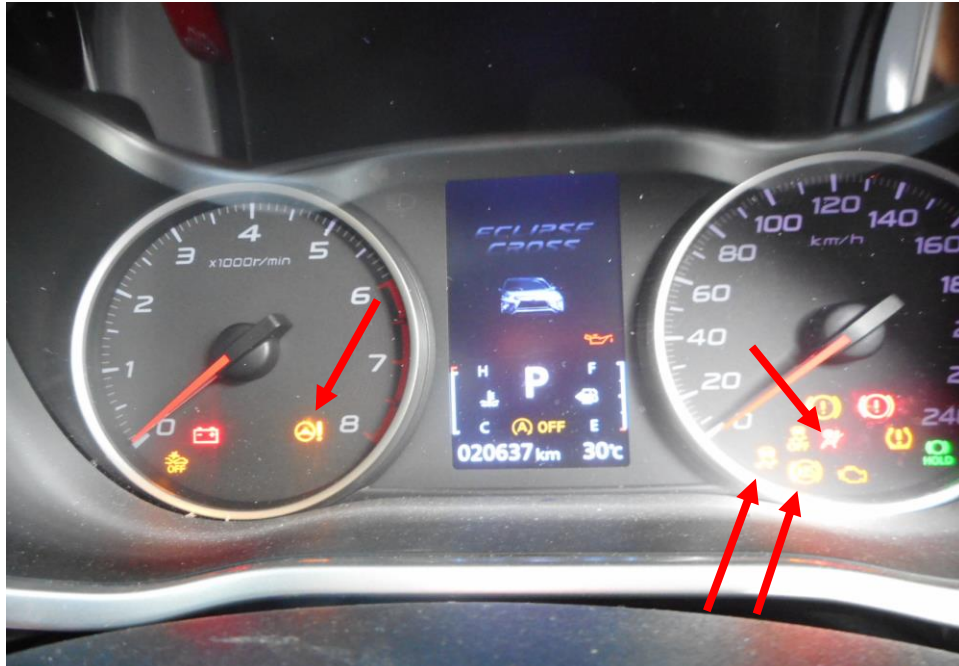
**Photo 23** shows the warning light for Anti-Lock Brake System (ABS) and Power Steering System (EPS), Supplemental Restraint System (SRS) and Traction Control (TC) (arrowed) appearing on the instrument panel of the Motor Car during the self-test of its various electronic operating systems when its engine was cranked.

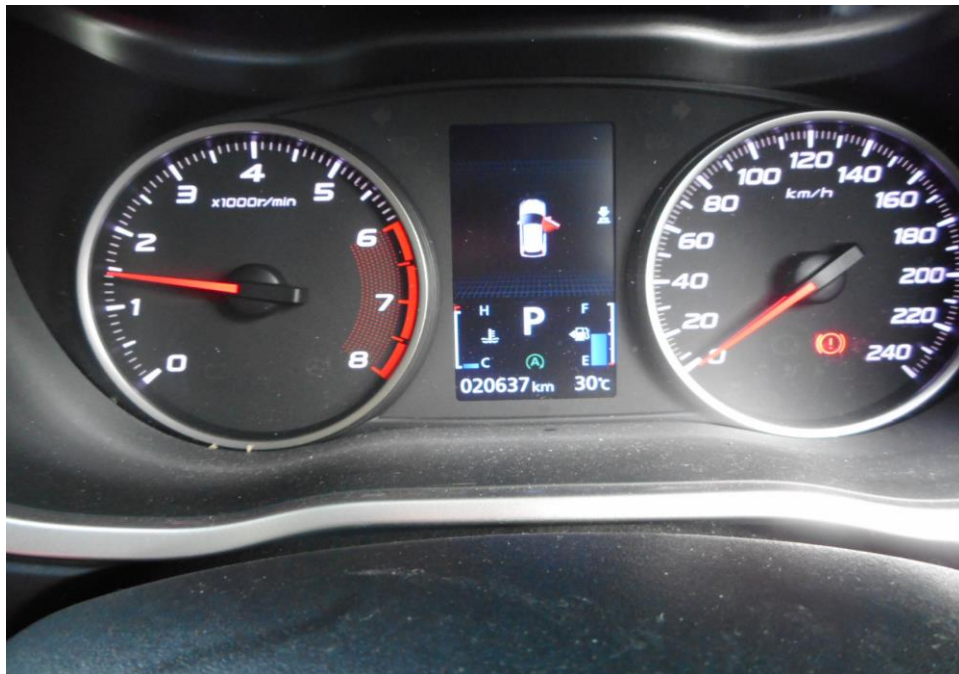
**Photo 24** shows no warning lights illuminated on the instrument panel of the Motor Car after the engine was cranked. This would suggest that there was no abnormality to the electronic operating system of the Motor Car, like the ABS, EPS, SRS, and TC etc.
