Your Ref: D20002401MFSH
Our Ref : CS4/FCI20006234/N

15 June 2020

TECHNICAL INVESTIGATION REPORT OF FIRE INCIDENT INVOLVING THE INSURED VEHICLE SHC 960T ON 8 JUNE 2020

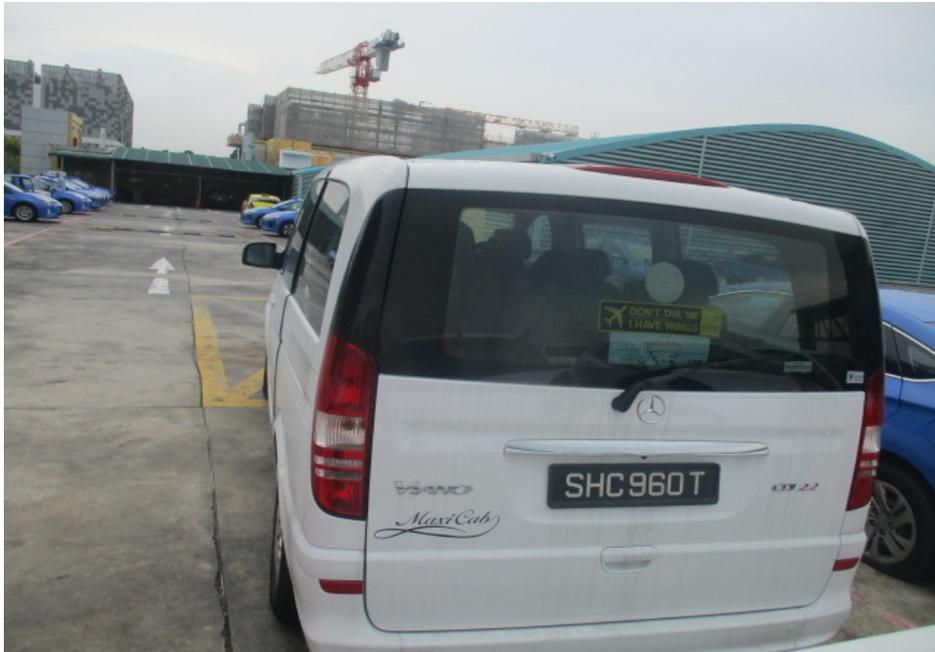
Photo 1 shows the rear view of the Insured Vehicle. The rear portion of the Insured Vehicle was observed to be relatively unaffected by the fire.

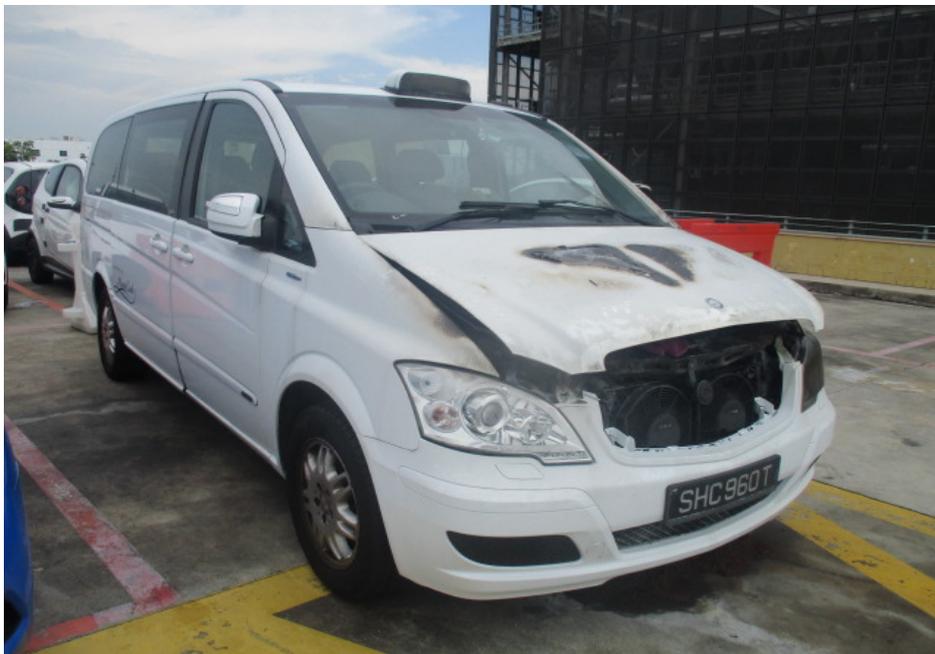
Photo 2 shows the general view of the right portion of the Insured Vehicle at the time of our inspection. The exterior body of the Insured Vehicle had sustained visible fire damage. This included its front windscreen, front bonnet, front bumper, and right front panel.

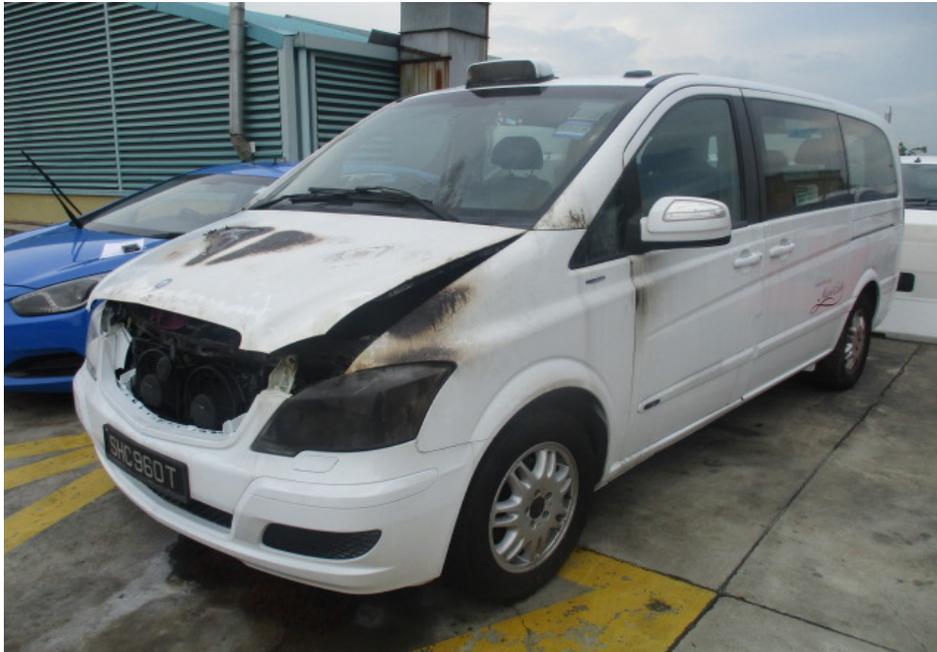
Photo 3 shows the general view of the left portion of the Insured Vehicle at the time of our inspection. The exterior body of the Insured Vehicle had sustained visible fire damage. This included its front windscreen, front bonnet, left headlight, front bumper, left front panel, left front wheel rim and left front tyre.

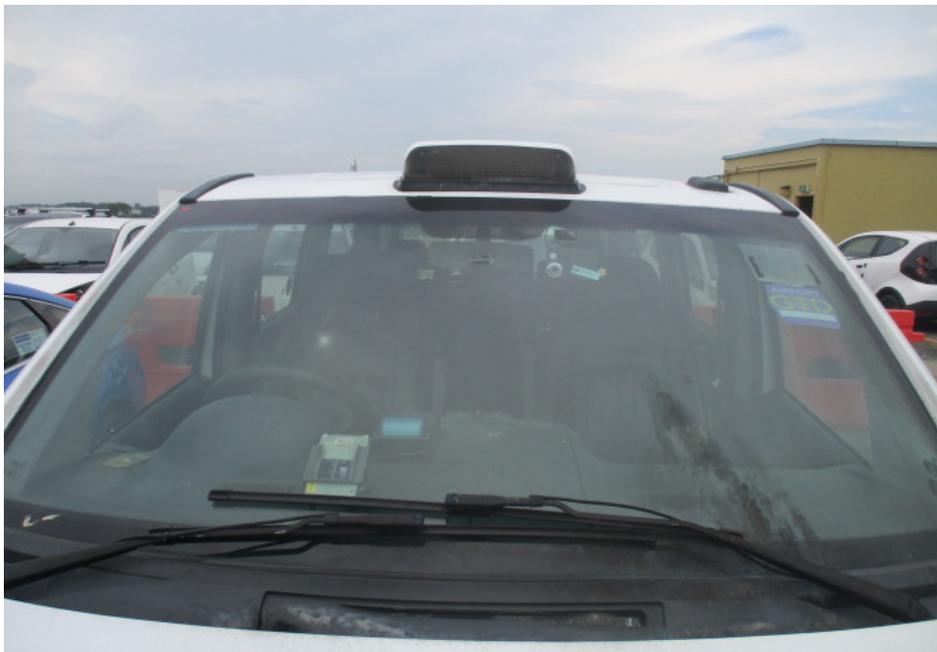
Photo 4 shows a closer view of the front windscreen of the Insured Vehicle at the time of our inspection. The front windscreen had sustained slight fire damage.

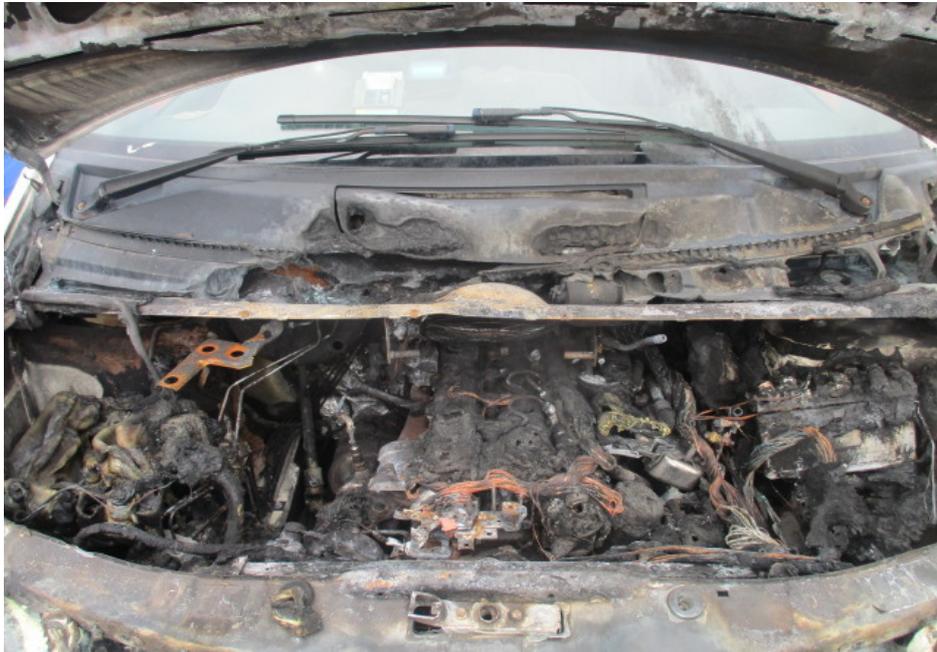
Photo 5 shows a general view of the engine compartment of the Insured Vehicle at the time of our inspection. Most of the components inside the engine compartment were found to be severely burnt and/or melted as a result of the fire.

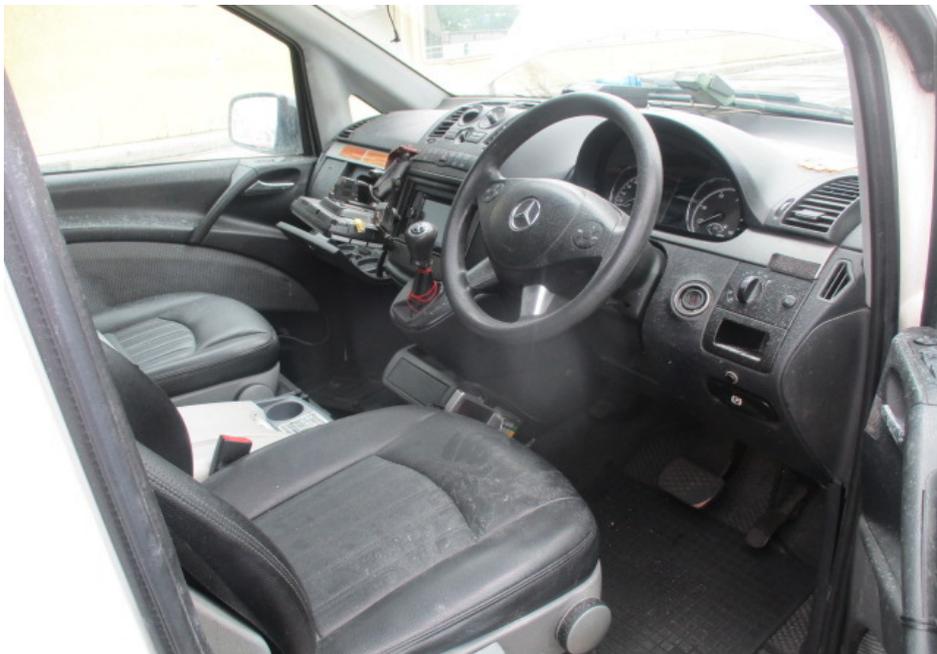
Photo 6 shows the interior compartment of the Insured Vehicle, which was observed to be relatively unaffected by the fire.

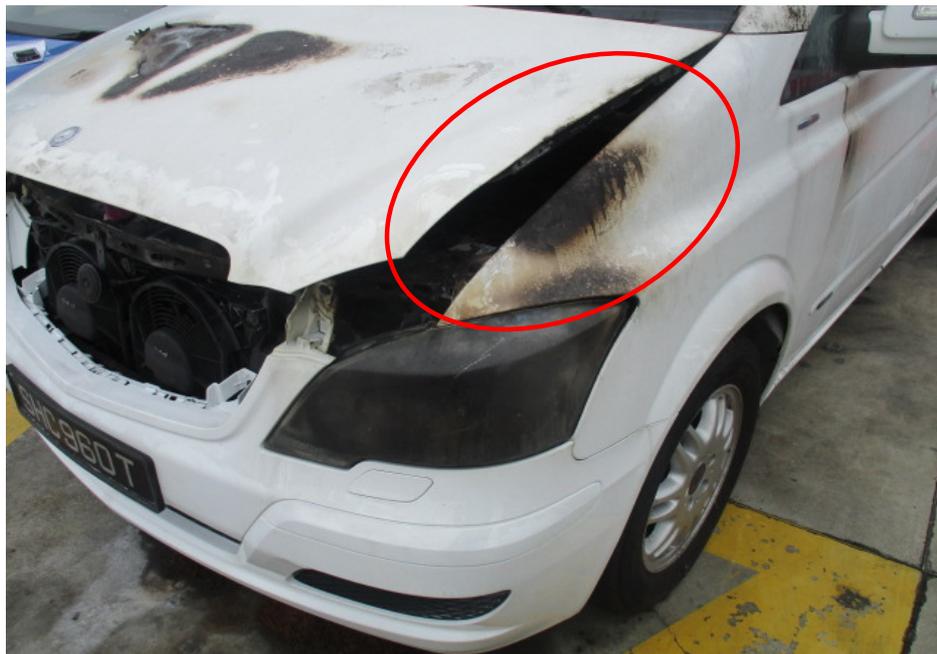
8. For this particular case, the fire appears to have originated within the engine compartment of the Insured Vehicle, somewhere around the left portion of the engine compartment due to the nature of the fire damage which was more extensive at the left portion. This can also be determined from the burn pattern and the high heat intensity burn marks (whitish burn marks) found on the bottom left portion of the underside bonnet of the Insured Vehicle. The whitish burn marks are a result of exposure to prolonged heat intensity. See photos 7 - 9 below.

Photo 7 shows the burn pattern which was found to be more extensive on the left portion of the front bonnet and left front fender of the Insured Vehicle (circled).

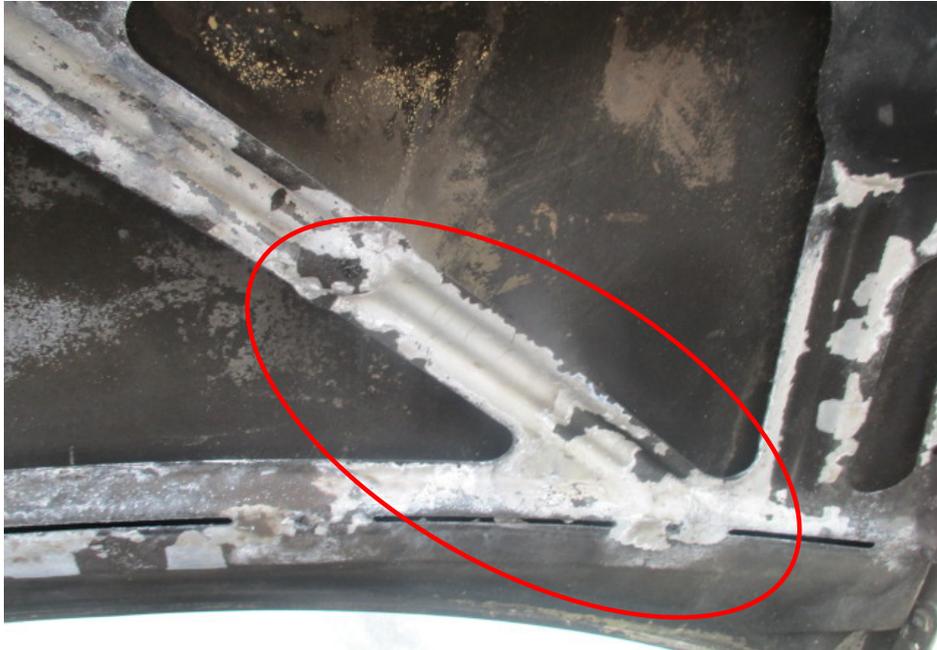
Photo 8 shows the whitish burn marks that were found on the bottom left portion of the underside of the front bonnet of the Insured Vehicle (circled). Such whitish burn marks are a result of exposure to prolonged heat intensity, which may indicate where the fire had started. Hence the fire to the Insured Vehicle can be determined to have originated towards the left portion of the engine compartment.

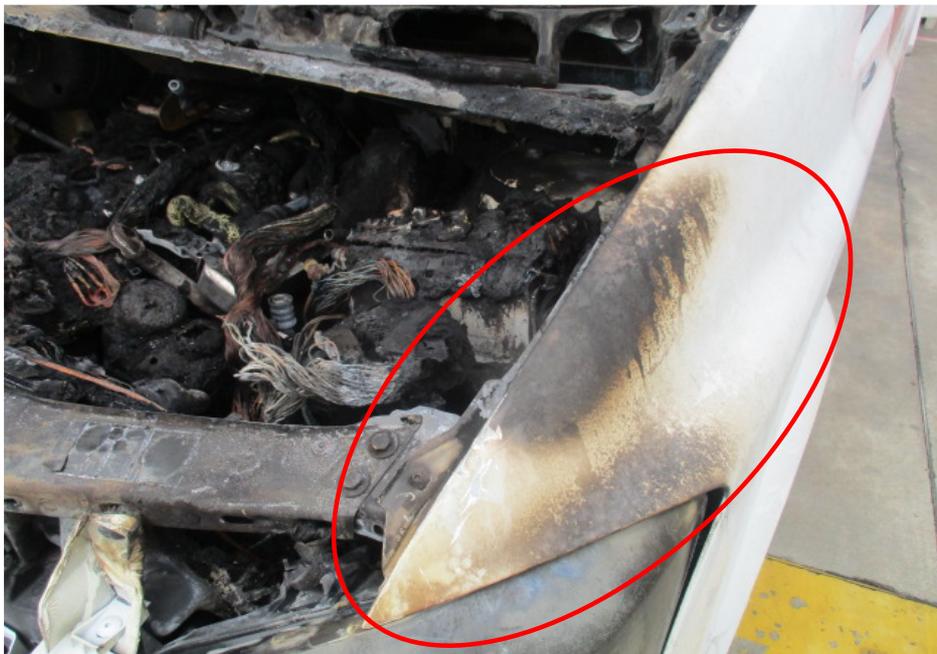
Photo 9 shows the burn pattern found on the left front fender of the Insured Vehicle (circled).

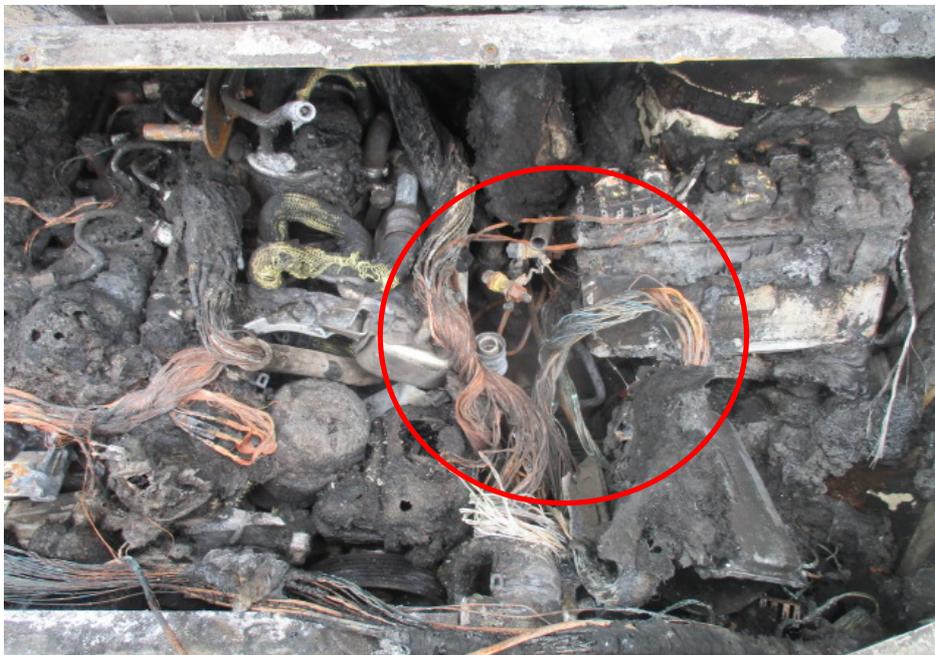
9. Upon closer examination of the left portion of the engine compartment, which was where the fire to the Insured Vehicle had likely started, we had found traces of greenish residue on several stretches of burnt wirings leading from the battery. The presence of greenish residue indicates internal heating of copper wires, a sign of an electrical short circuit occurring. The greenish residue is normally left behind from oxidation as a result of chemical reaction involving the copper wires. This physical evidence would then appear to suggest that the cause of fire to the Insured Vehicle could have possibly been due to electrical in nature. See photos 10 - 13 below.

Photo 10 shows the burnt wirings leading from the battery around the left portion of the engine compartment (circled), which is in the immediate vicinity where the fire to the Insured Vehicle had likely started.

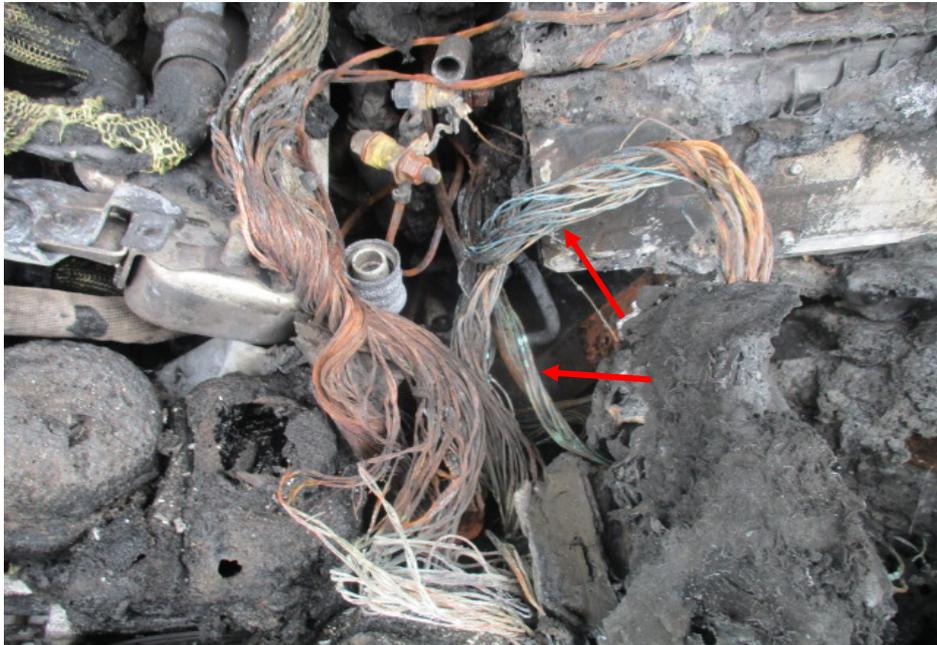
Photo 11 shows a closer view of the burnt wirings leading from the battery around the left portion of the engine compartment, which is in the immediate vicinity where the fire to the Insured Vehicle had likely started. We noticed greenish residue on several stretches of burnt wirings (arrowed). The presence of greenish residue indicates internal heating of copper wires, a sign of an electrical short circuit occurring. The greenish residue is normally left behind from oxidation as a result of chemical reaction involving the copper wires.

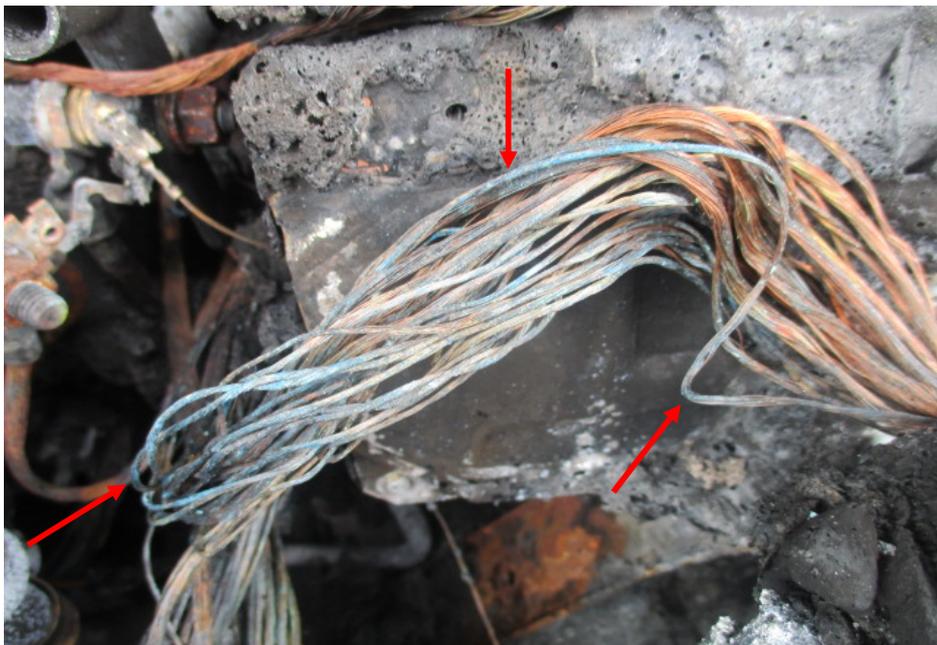
Photo 12 shows a close up view of the greenish residue found on several stretches of burnt wirings leading from the battery (red arrows). The presence of such greenish residue suggests occurrence of an electrical short circuit.

27. Having investigated and technically analysed the damages to the Insured Vehicle, we are of the view that the cause of fire to the Insured Vehicle was of electrical in nature. For this particular case, the fire had originated along the wirings inside the engine compartment, leading from the battery. The wirings were original factory wirings of the Insured Vehicle.
28. We did not find any evidence which had suggested that the cause of fire to the Insured Vehicle was due to poor maintenance and/or recurring electrical problem.
29. There were no modification(s) or additional electronic and/or electrical component(s) fitted on the Insured Vehicle at the time of our inspection of the Insured Vehicle.

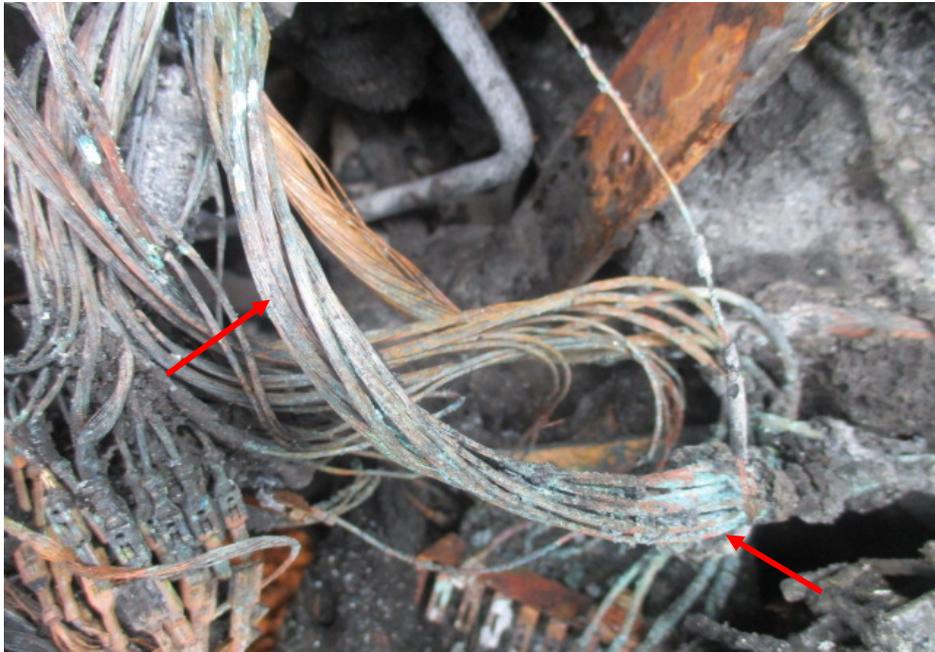
Photo 13 shows a close up view of the greenish residue found on several stretches of burnt wirings leading from the battery (red arrows). The presence of such greenish residue suggests occurrence of an electrical short circuit.

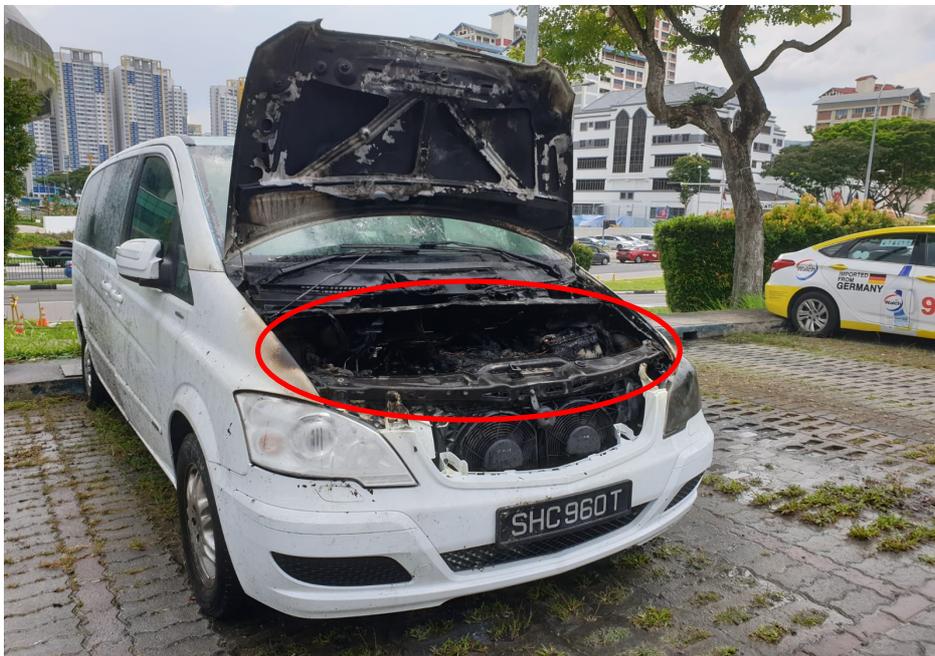
Photo 14 shows the Insured Vehicle at the incident scene after the fire was extinguished. In general, the information that could be gathered from this photograph had corresponded to the events that were related to us by Mr Seow, which is the fire had started in the engine compartment (circled).

24. The possibility of the fire being due to external factors (foreign material(s) stuck on hot surfaces, arson and sabotage amongst others) would also seem unlikely given that our examination of the available incident scene photograph did not reveal any unusual material(s)/object(s) found on the ground where the Insured Vehicle was positioned. The location of where the Insured Vehicle was positioned was also observed to be not at a secluded location.
