Your Ref : SHC 6289J  
Our Ref : CI/TP20006266/N

**TECHNICAL INVESTIGATION REPORT OF FIRE INCIDENT INVOLVING THE  
INSURED VEHICLE SHC 6289J ON 25 MAY 2020**

Vehicle Registration No.	: SHC 6289J
Make / Model	: KIA OPTIMA 1.7 (A) DIESEL
Chassis No	: KNAGM414MF5554572
Year of Registration	: November 2014
Mileage	: N.A. (battery melted)

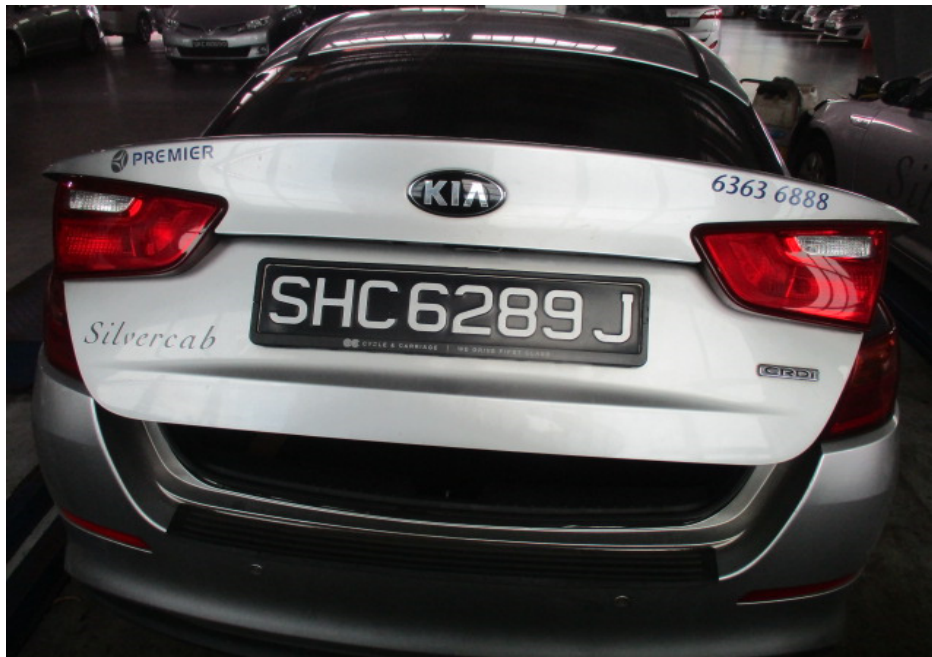
**Photo 1** shows the general view of the rear portion of the Insured Vehicle at the time of our inspection. The rear portion of the Insured Vehicle was relatively unaffected by the fire.

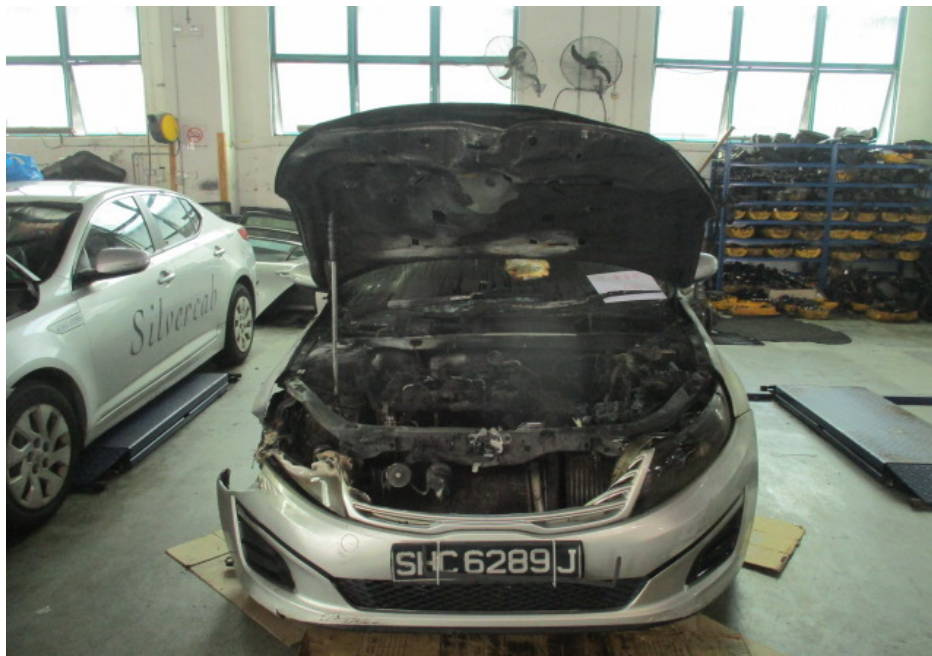
**Photo 2** shows the general view of the front portion of the Insured Vehicle at the time of our inspection. The fire damage to the Insured Vehicle was confined to its front portion. Its front bumper, front bonnet, front grille, front headlamps, front windscreen, front rims and front tyres were amongst the body parts that were found to have been affected as a result of the fire.

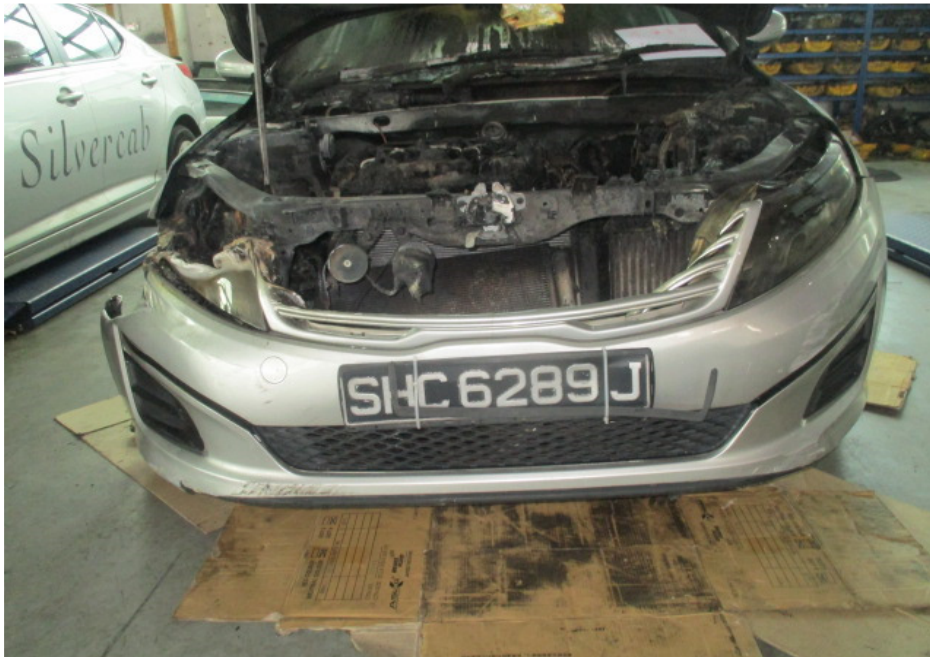
**Photo 3** shows a closer view of the front portion of the Insured Vehicle at the time of our inspection. The fire damage to the Insured Vehicle was confined to its front portion. Its front bumper, front bonnet, front tyres and front headlamps were amongst the body parts that were found to have been affected by the fire.

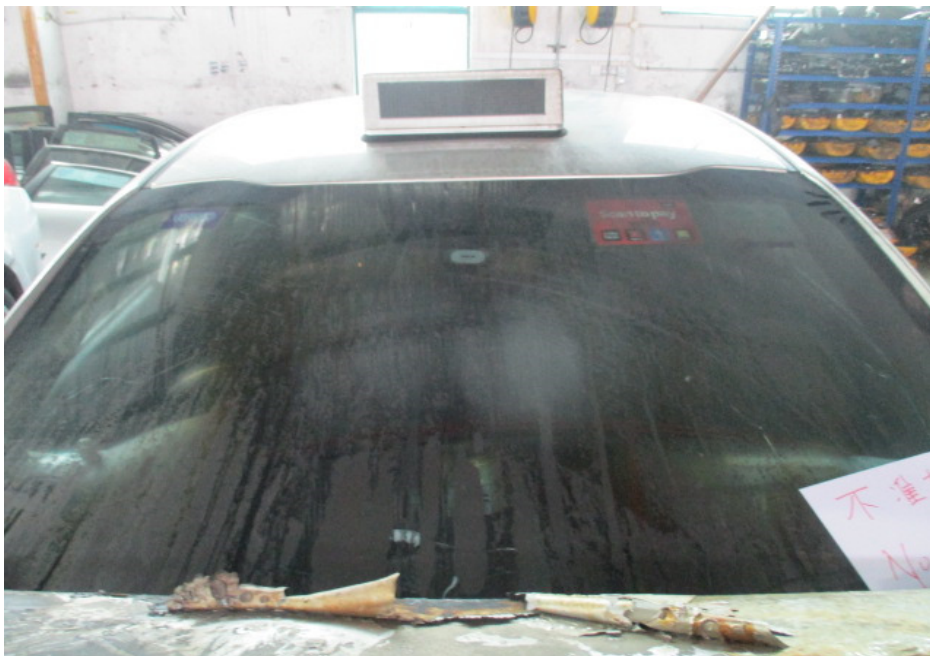
**Photo 4** shows the general view of the front windscreen of the Insured Vehicle at the time of our inspection. The front windscreen was seriously affected by the fire.

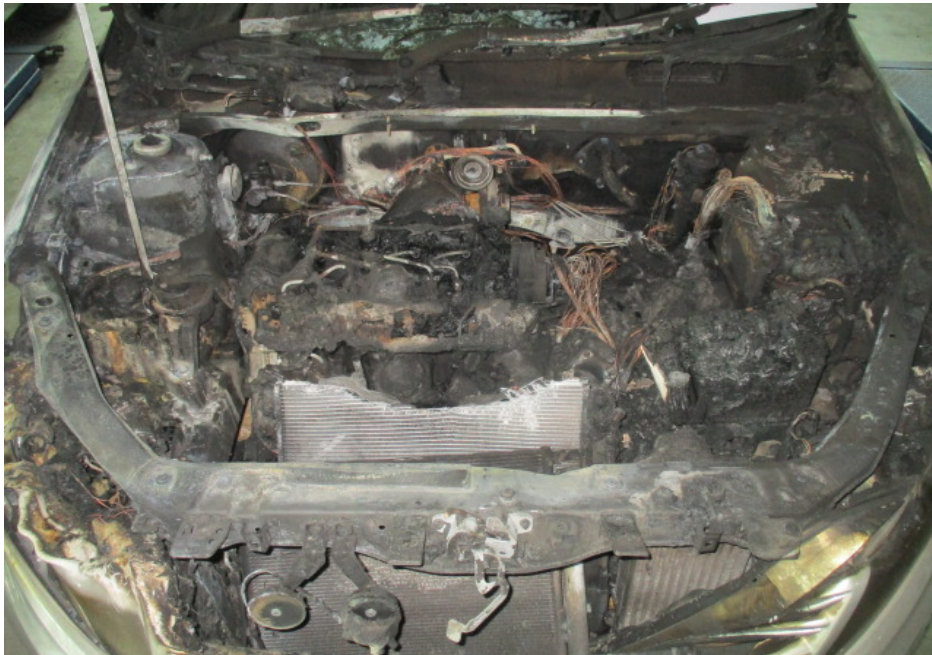
**Photo 5** shows the engine compartment of the Insured Vehicle at the time of our inspection. The entire engine compartment of the Insured Vehicle was observed to be severely burnt. Most of the parts inside the engine compartment were found to be burnt and/or melted as a result of the fire.

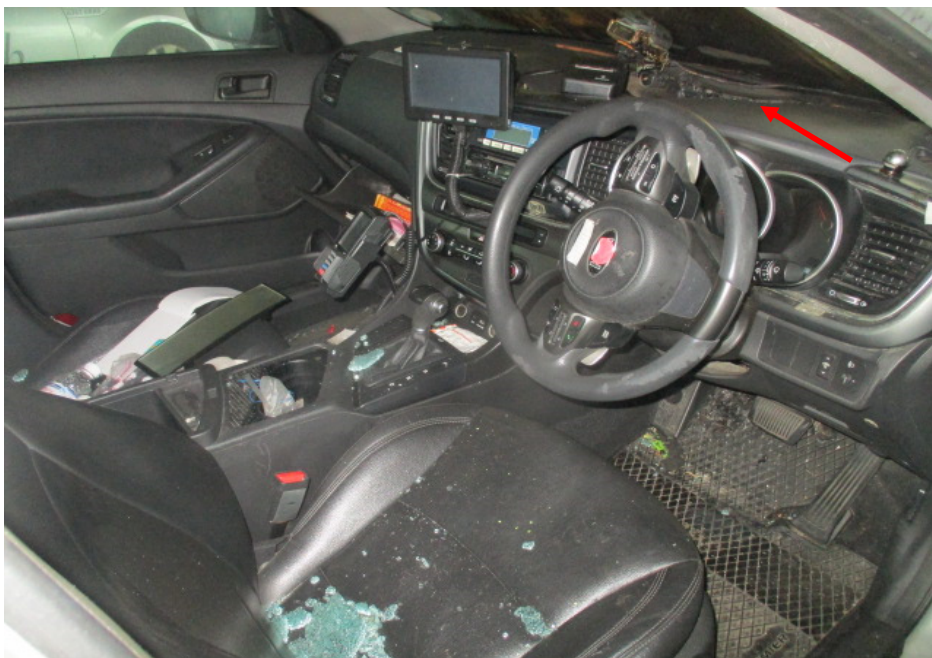
**Photo 6** shows the interior compartment of the Insured Vehicle, which was slightly affected by the fire, particularly the dashboard (arrowed).

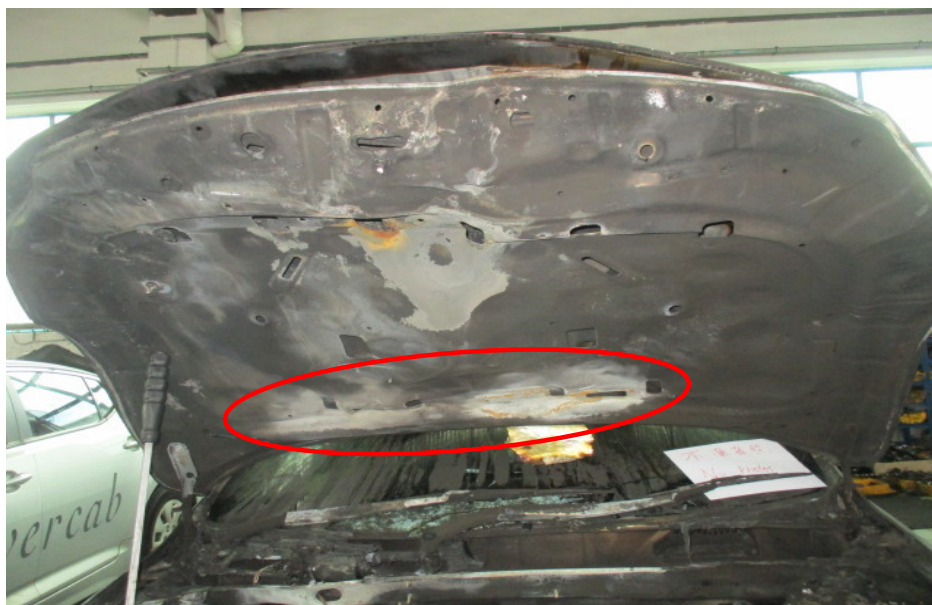
7. For this particular case, the fire appears to have originated within the engine compartment of the Insured Vehicle, somewhere around the rear centre portion of the engine compartment. This can be determined from the burn pattern and the high heat intensity burn marks (whitish burn marks) and also the rust that had developed on the underside of the front bonnet, at the bottom centre portion.

**Photo 7** shows the burn pattern and whitish burn marks and also the rust that had developed on the underside of the front bonnet, at the bottom centre portion of the Insured Vehicle (circled). Such whitish burn marks are a result of exposure to prolonged heat intensity, which may indicate where the fire had started. Rust would also begin to develop on these areas soon after the fire.

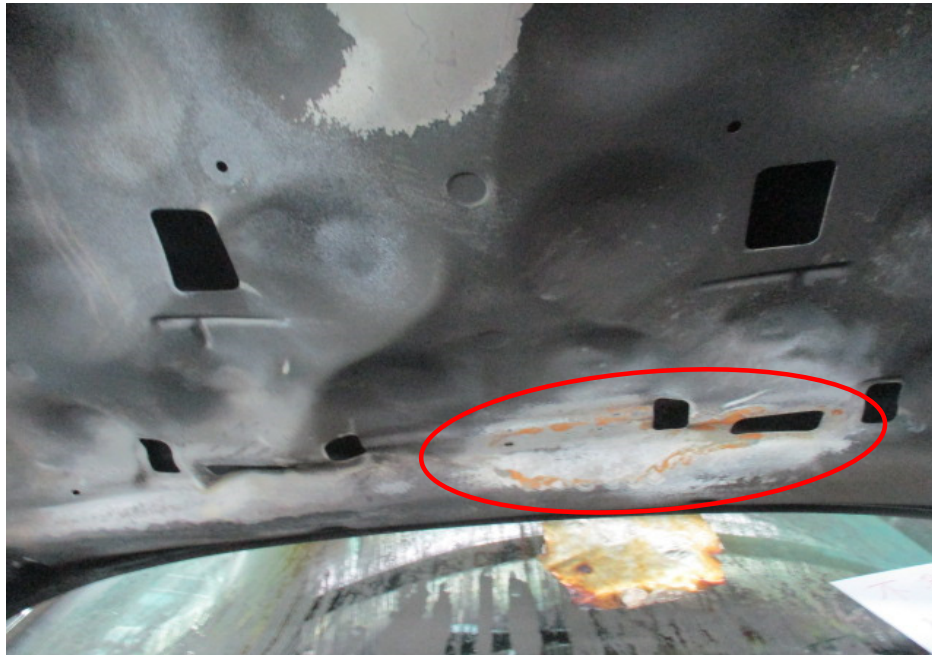
8. The whitish burn marks are a result of exposure to prolonged heat intensity. Rust would normally start to develop around these areas soon after a fire as prolonged exposure to high heat intensity usually causes steel/metal material body parts to be exposed to natural environmental condition. The rust that had developed on the underside of the front bonnet, around the bottom centre portion, is an indication that the rear centre portion of the engine compartment had sustained exposure to prolonged high heat intensity. See photos 7 & 8 below.

**Photo 8** shows the rust that had developed on the underside of the front bonnet, around the bottom centre portion (circled). The development of rust is an indication that this area was subjected to prolonged exposure to high heat intensity, which had caused the steel/metal material of the front bonnet to be exposed to natural environmental condition. Hence the fire to the Insured Vehicle can be determined to have originated towards the rear centre portion of the engine compartment.

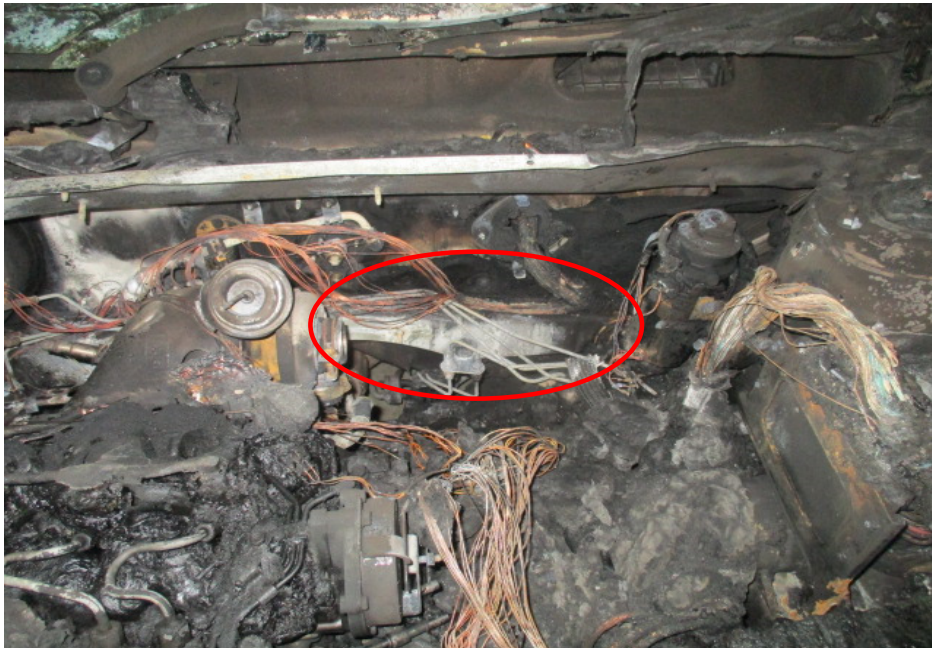
9. Upon closer examination of the rear centre portion of the engine compartment, which was where the fire to the Insured Vehicle had likely started, we had found greenish residue on several burnt stretches of original factory fitted wirings around the rear centre portion of the engine compartment. The presence of such greenish residue indicates internal heating of copper wires, a sign of an electrical short circuit occurring. The greenish residue is normally left behind from oxidation as a result of chemical reaction involving the copper wires. This physical evidence would then appear to suggest that the cause of fire to the Insured Vehicle could have possibly been due to electrical in nature. See photos 9 - 12 below.

**Photo 9** shows the original factory fitted wirings around the rear centre portion of the engine compartment, which is in the immediate vicinity where the fire to the Insured Vehicle had likely started. We had found greenish residue on several burnt stretches of these wirings (circled). The presence of such greenish residue indicates internal heating of copper wires, a sign of an electrical short circuit occurring. The greenish residue is normally left behind from oxidation as a result of chemical reaction involving the copper wires.

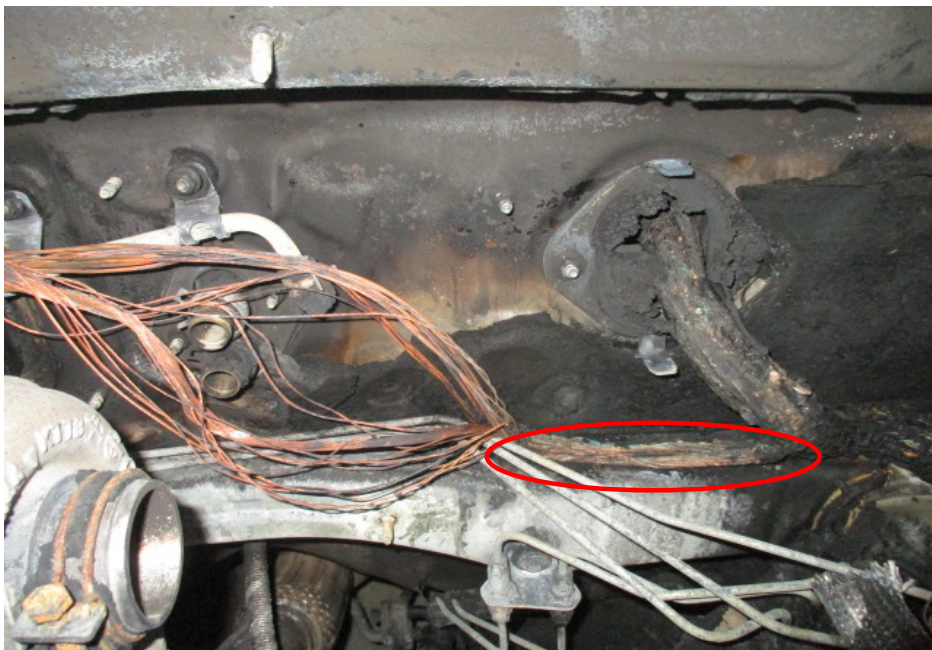
**Photo 10** shows a closer view of the greenish residue found on some of the burnt stretches of original factory fitted wirings (circled). The presence of such greenish residue suggests occurrence of an electrical short circuit.

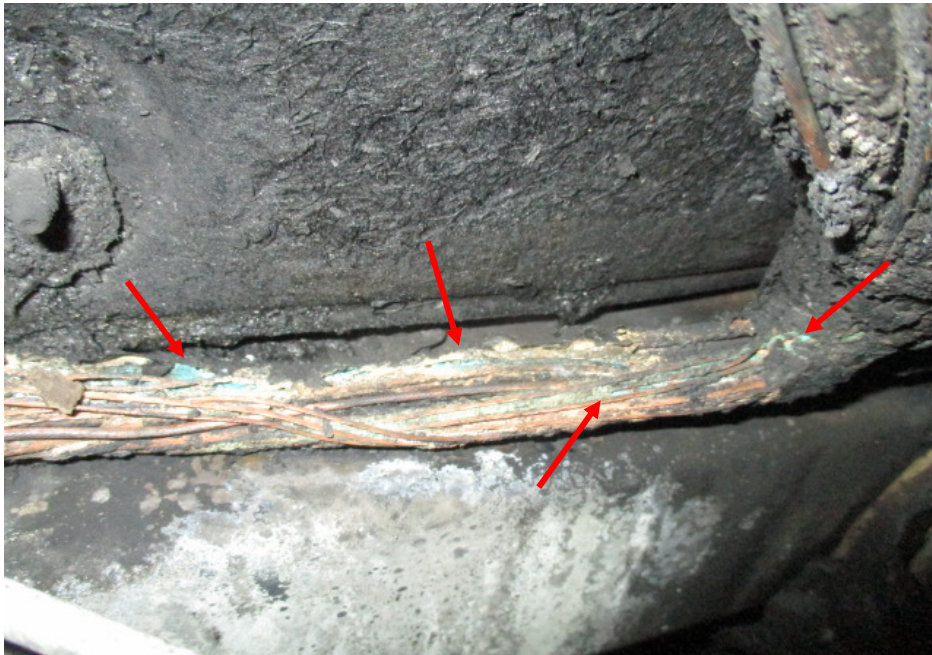
**Photo 11** shows a close up view of the greenish residue found on some of the burnt stretches of original factory fitted wirings (arrowed). The presence of such greenish residue suggests occurrence of an electrical short circuit.

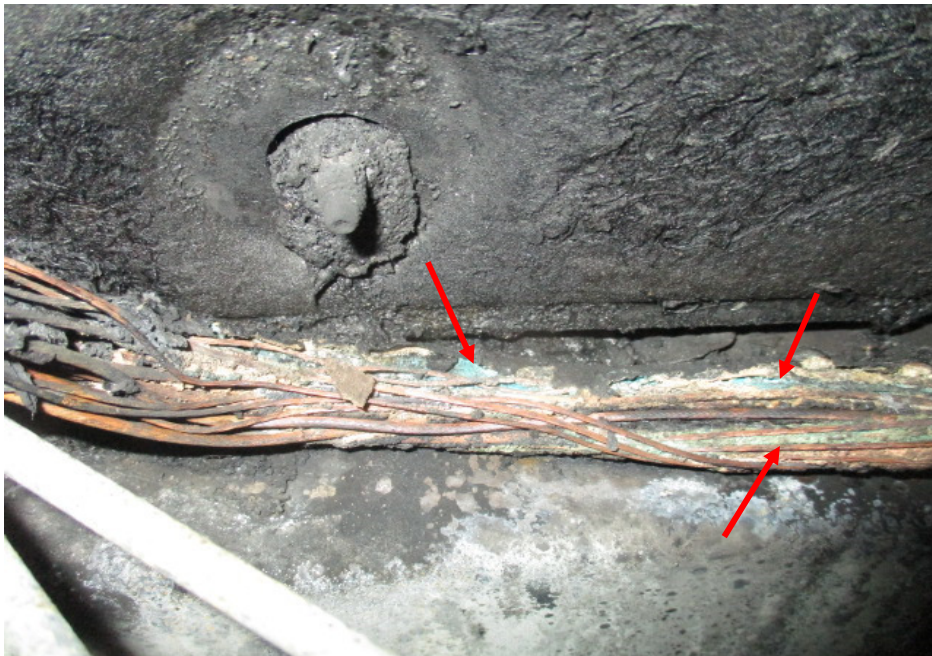
**Photo 12** shows a close up view of the greenish residue found on some of the burnt stretches of original factory fitted wirings (arrowed). The presence of such greenish residue suggests occurrence of an electrical short circuit.

26. Having investigated and technically analysed the damages of burnt nature to the Insured Vehicle, we are of the view that the cause of fire to the Insured Vehicle was of electrical in nature. For this particular case, the fire had originated along the original factory fitted wirings inside the engine compartment, somewhere around the rear centre portion of the engine compartment.

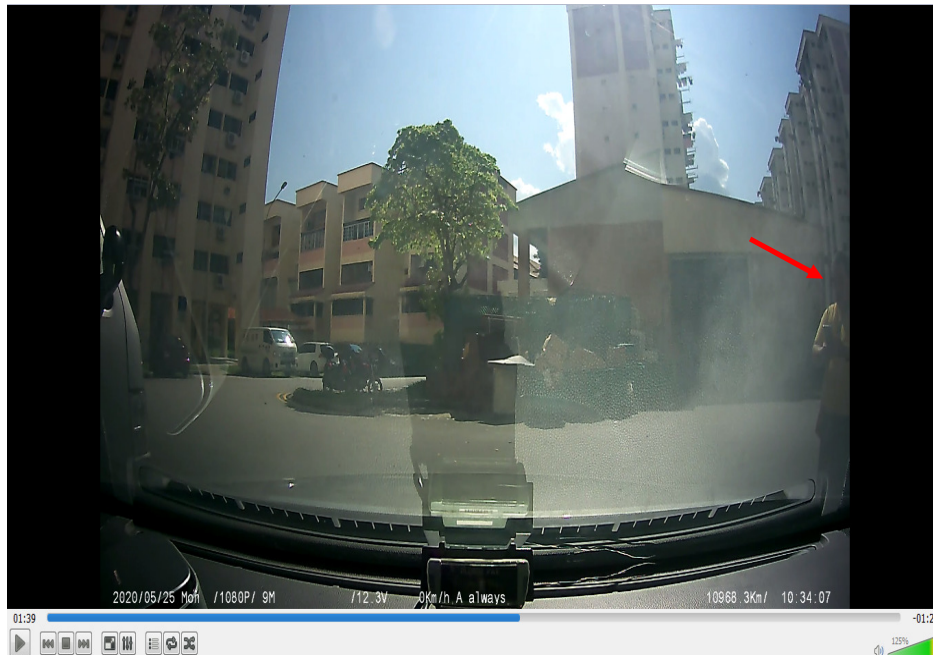
**Screenshot 1** shows white smoke emitting from the front bonnet of the Insured Vehicle after Mr Soon had parked at his house carpark. Mr Soon is seen standing in front of the Insured Vehicle (arrowed).

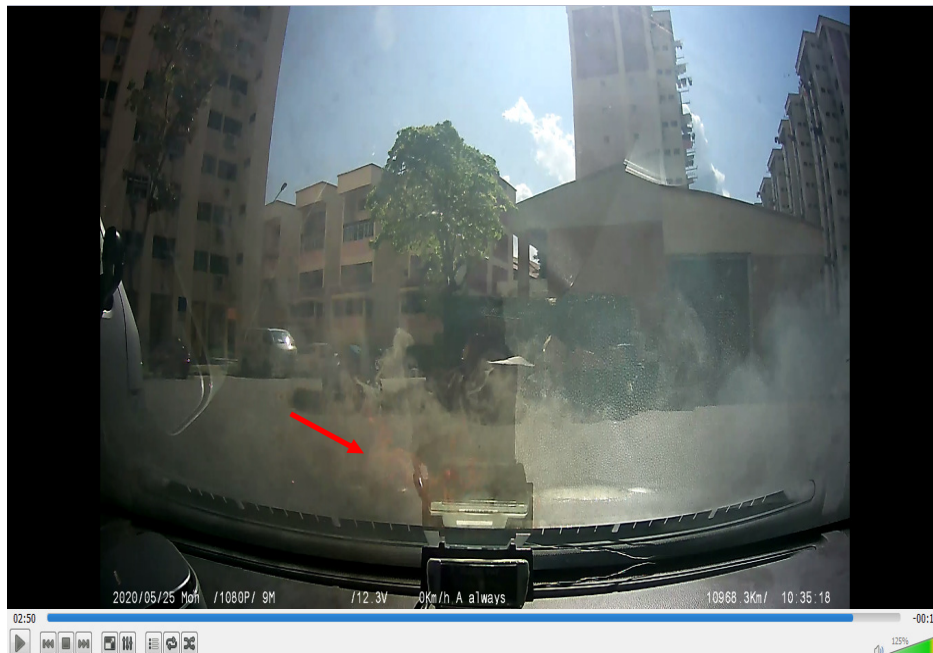
**Screenshot 2** shows the Insured Vehicle on fire (arrowed) after Mr Soon entered and switched on the engine. He immediately switched off the engine.
