### **INVESTIGATION REPORT:**

Our Ref : CS4/FCI20006356/N  
Policy No : D-20094877MFCV/1  
Insured : GBG 2683E  
Date of Incident : 13 June 2020  
Location : AYE (Tuas) after Clementi Ave 6 exit

### **Interview Summary of the Driver of the Insured Vehicle GBG 2683E**

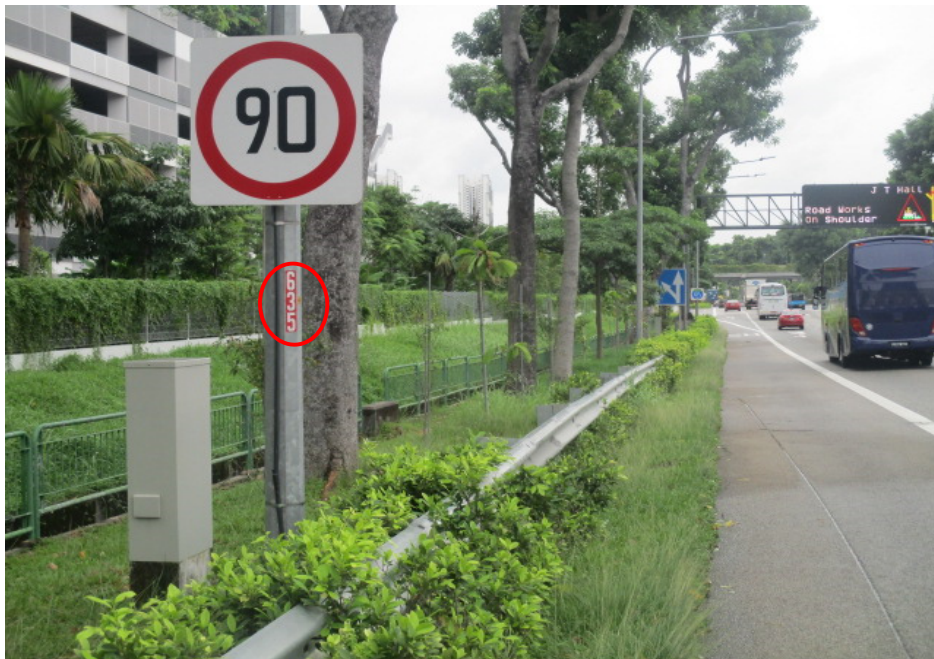
**Photo 1** shows the location where the incident had occurred, along the extreme left lane of AYE (Tuas) after the Clementi Avenue 6 exit, near to lamp post 635 (circled). We noticed that the vicinity was not monitored by CCTV camera(s).

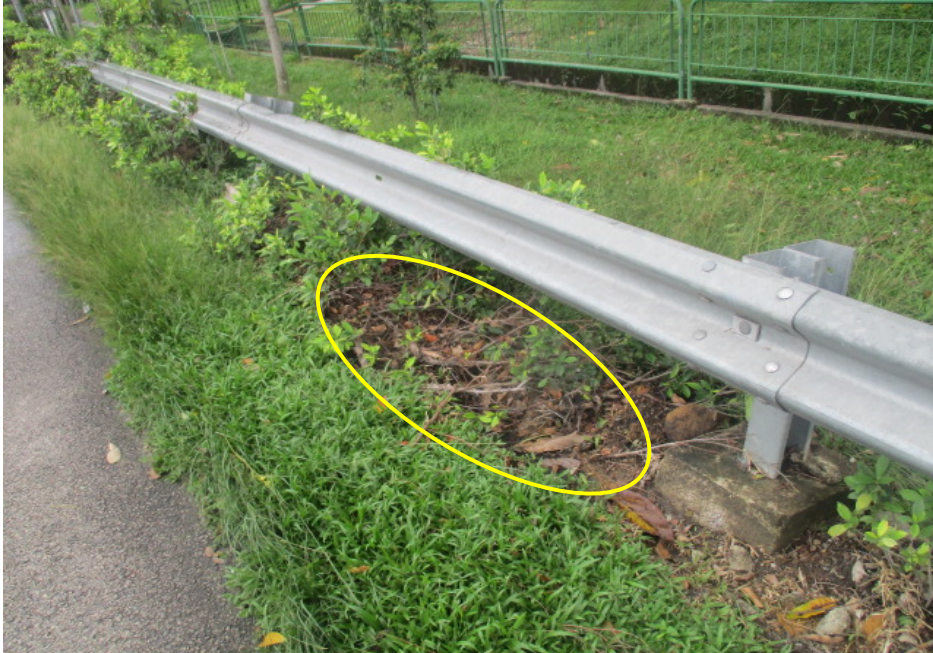
**Photo 2** shows the skid marks on the grass patch near to the railings where the incident occurred (circled).

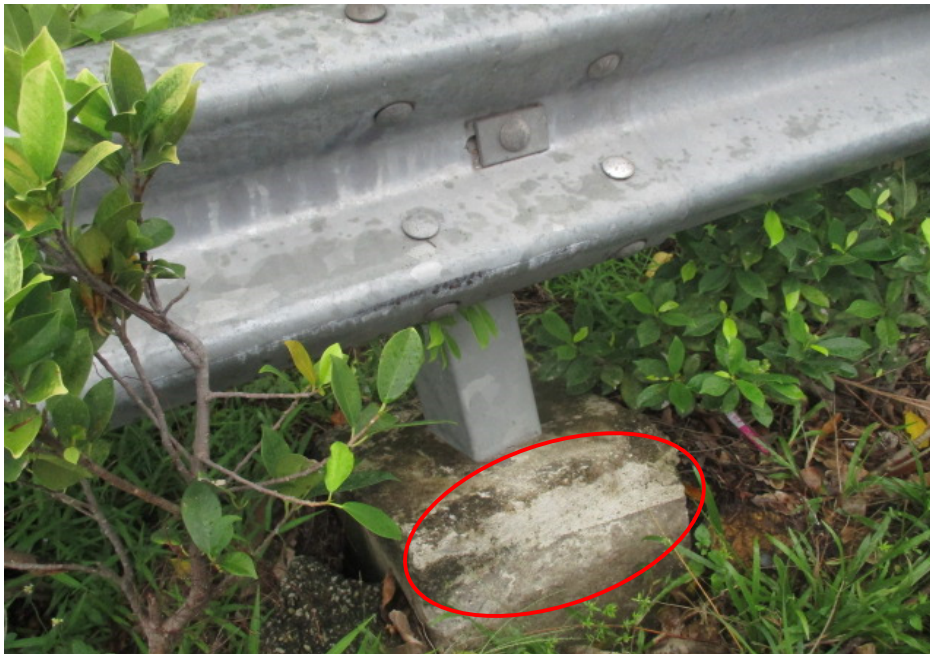
**Photo 3** shows a close up view of the minor damage to the base of a railing adjacent to lamp post 635 (circled).

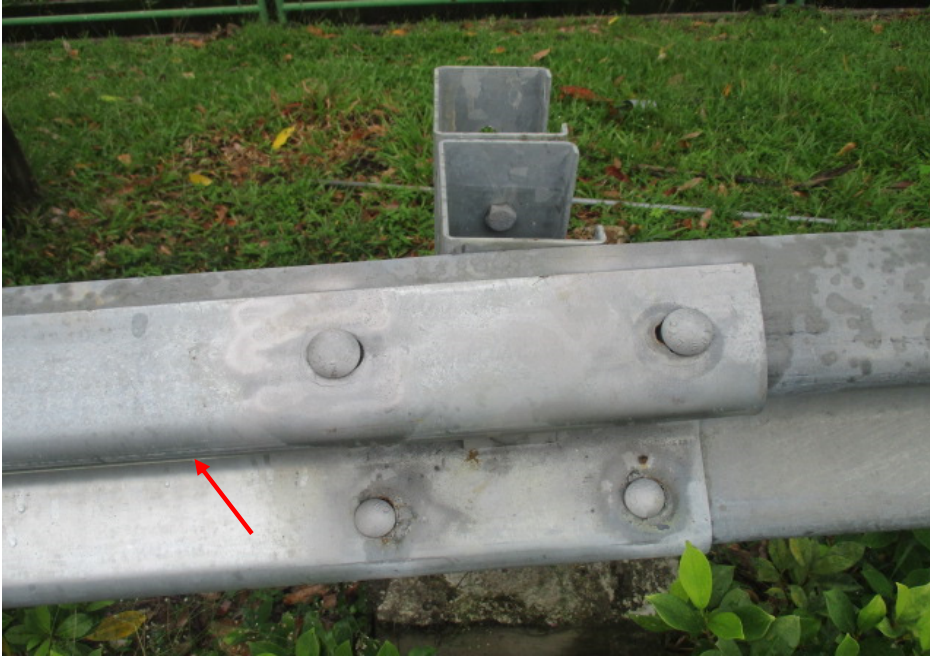
**Photo 4** shows upon closer inspection of the railings, we observed whitish paint graze marks along some of the railings (arrowed).

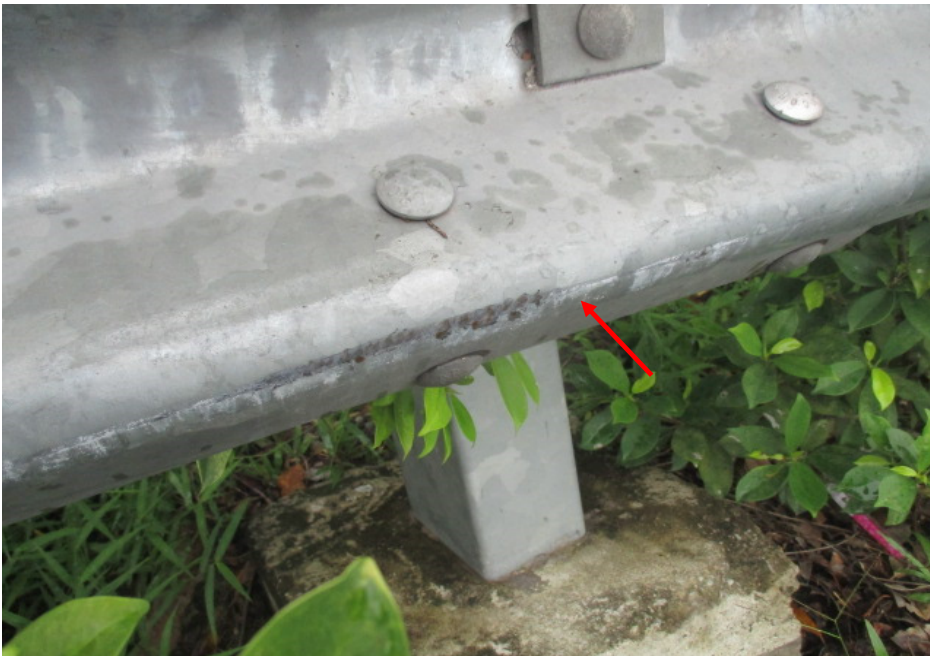
**Photo 5** shows a close up view of the whitish paint graze marks along some of the railings (arrowed).

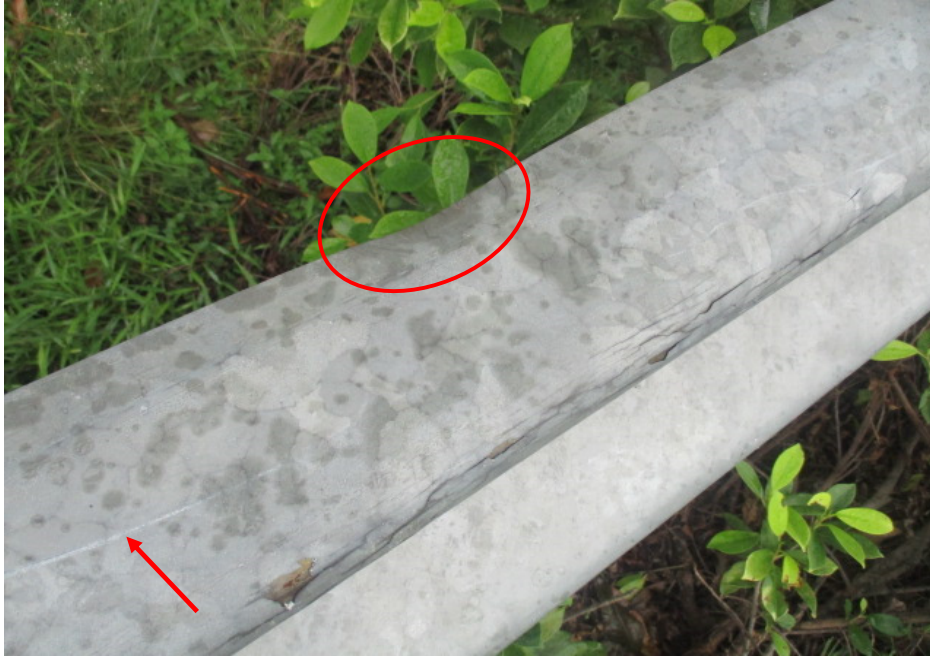
**Photo 6** shows a close up view of the whitish paint graze marks along some of the railings (arrowed). A portion of the railings was also found to be dented (circled).

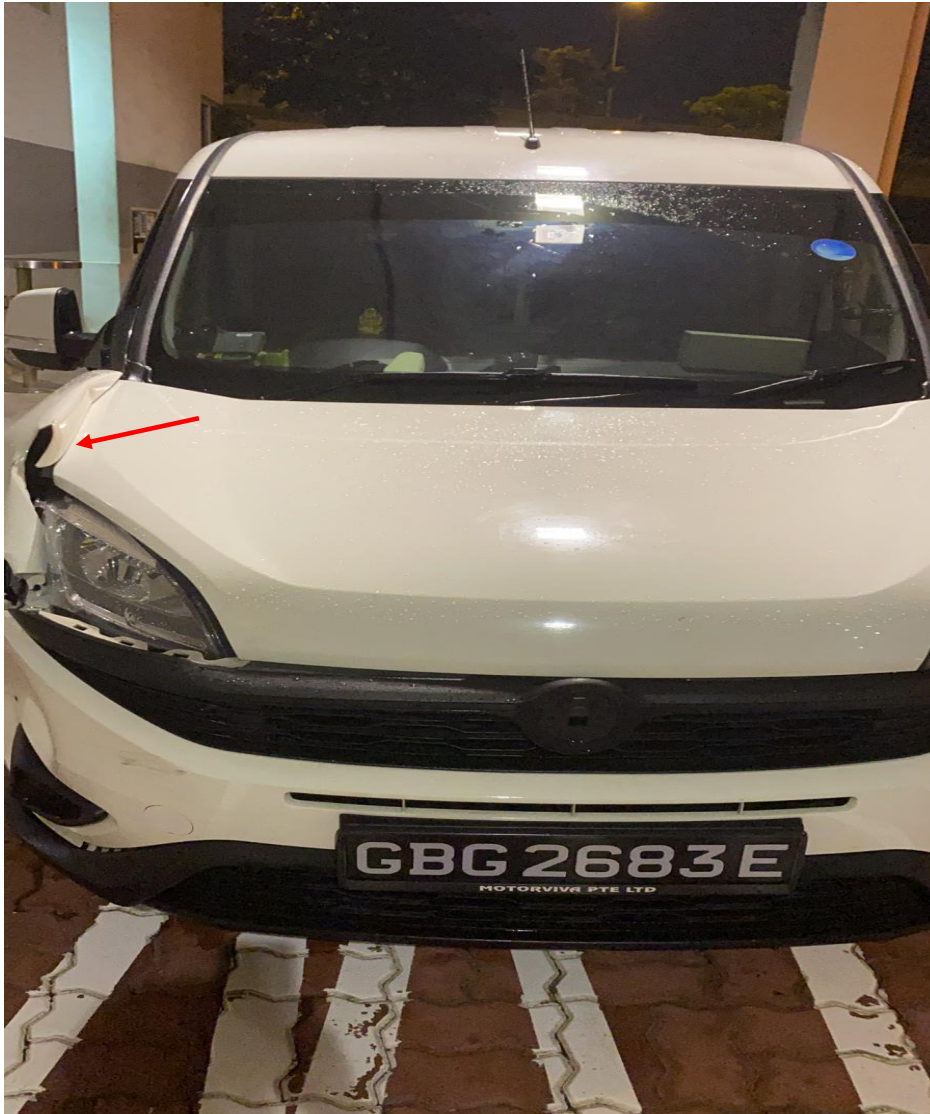
**Photo 7** shows the Insured Vehicle at his office premises post- incident. The Insured Vehicle had sustained damages at its right portion (arrowed). The ability of Mr Siva to drive to the office and take clear photographs of the damages post-incident would suggest that there was no drink driving involved in this particular incident.

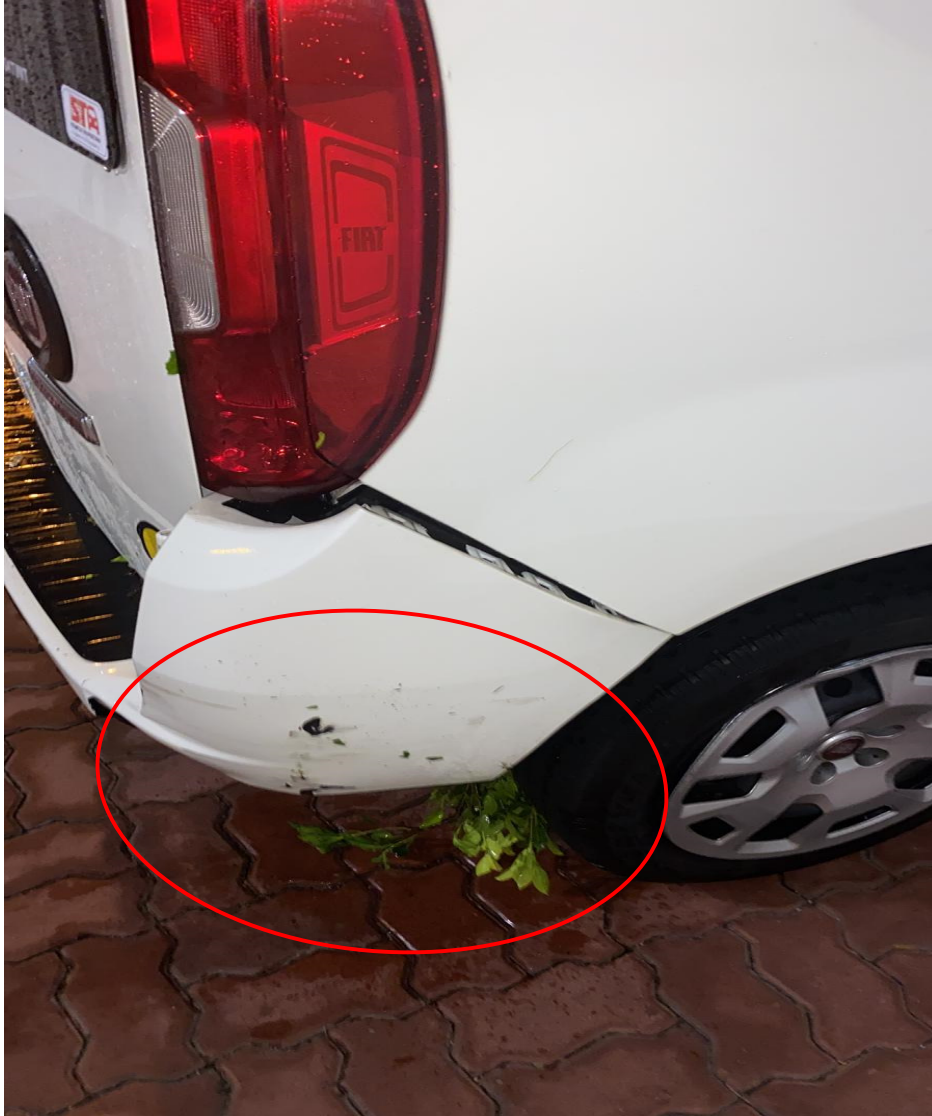
**Photo 8** shows the right rear portion of the Insured Vehicle at the office premises post- incident. The Insured Vehicle had sustained damages at its right portion. The grass that was found stuck to the right rear portion of the Insured Vehicle (circled) correlates with Mr Siva's statement that the Insured Vehicle spun out of control into a grass patch along the road shoulder after he drove through a puddle of water.

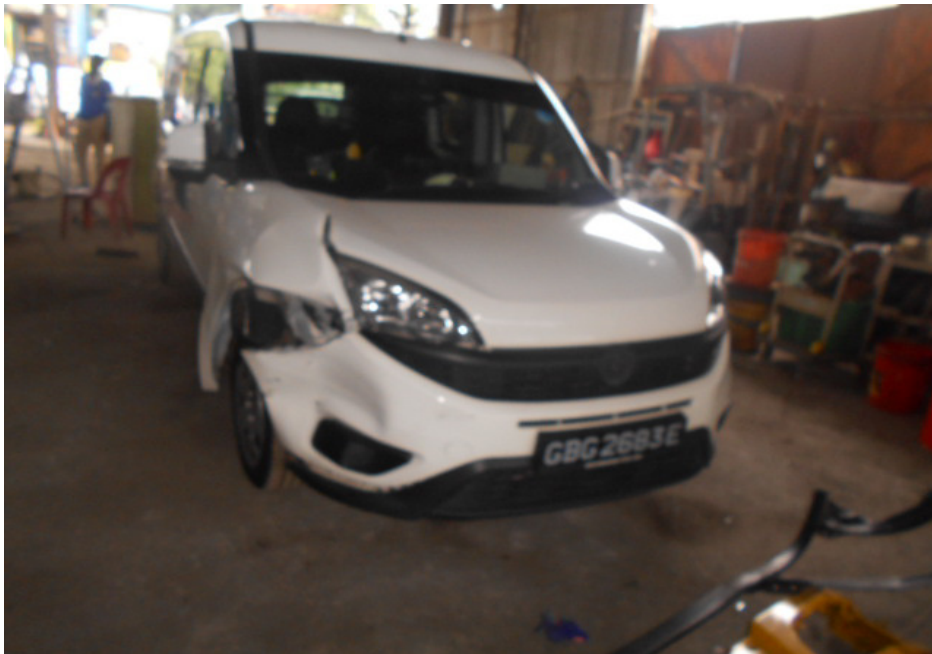
17. Based on the incident scene photographs provided to us by Mr Siva, the Insured Vehicle had sustained significant damages to its right portion.
18. Our physical inspection of the Insured Vehicle at YK revealed that the Insured Vehicle had sustained significant damages to its right portion, particularly to its front bonnet, front bumper, right front fender, right headlamp and rear bumper. There were also some relatively minor marks of grazing nature observed around the edges of the front right wheel rim of the Insured Vehicle as a result of grazing the base of the railings. There were no remains of both airbags in the interior compartment of the Insured Vehicle which corroborates with Mr Siva's statement that none of the airbags were deployed post-incident.

**Photo 9** shows the general front view of the Insured Vehicle during the physical inspection at YK. The Insured Vehicle had sustained significant damages to its right portion, particularly to its front bonnet, front bumper, right front fender, right headlamp, and rear bumper.

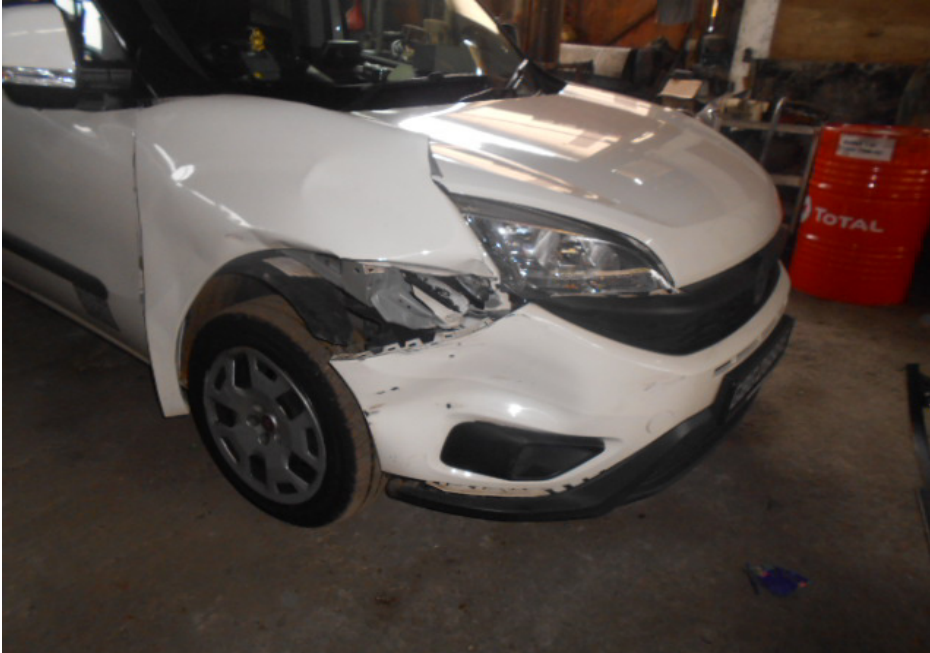
**Photo 10** shows a closer view of the damaged front bonnet, front bumper, right front fender and right headlamp of the Insured Vehicle as a result of the incident.

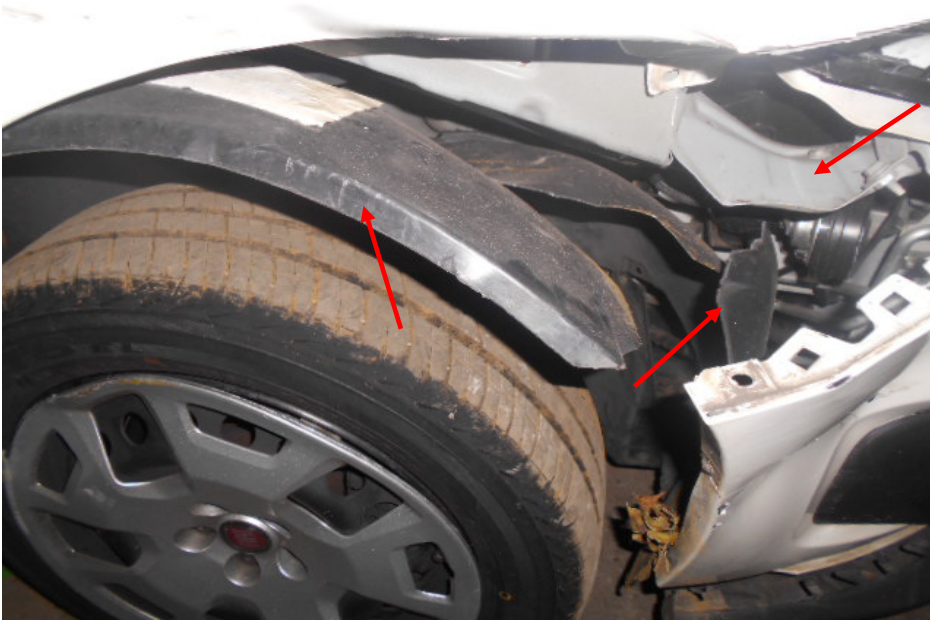
**Photo 11** shows upon closer inspection, the Insured Vehicle also sustained damages to the front bumper retainer, right front fender liner and right front fender top garnish (arrowed).

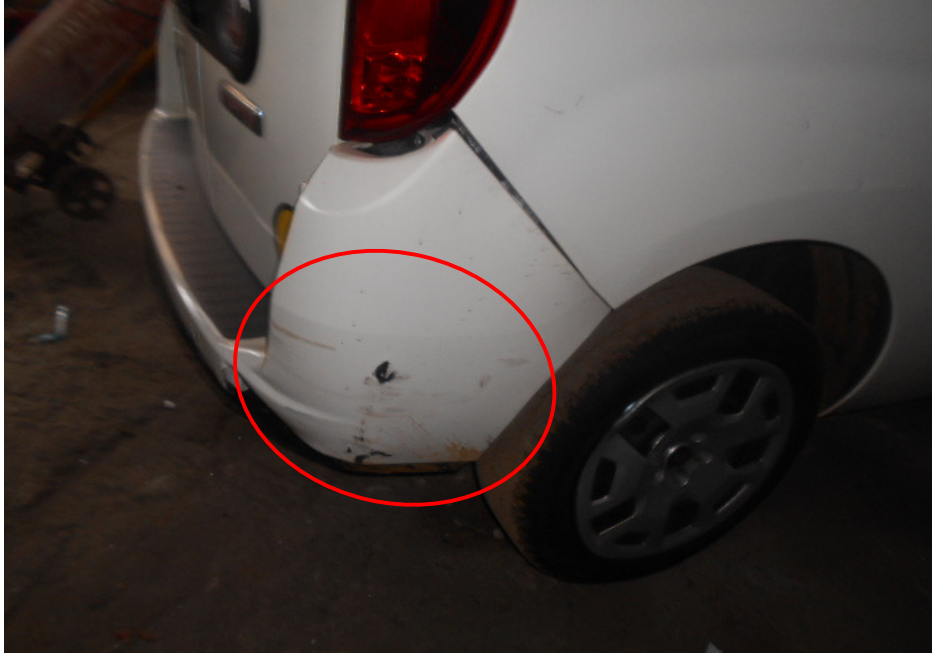
**Photo 12** shows the damaged rear bumper of the Insured Vehicle as a result of the incident (circled).

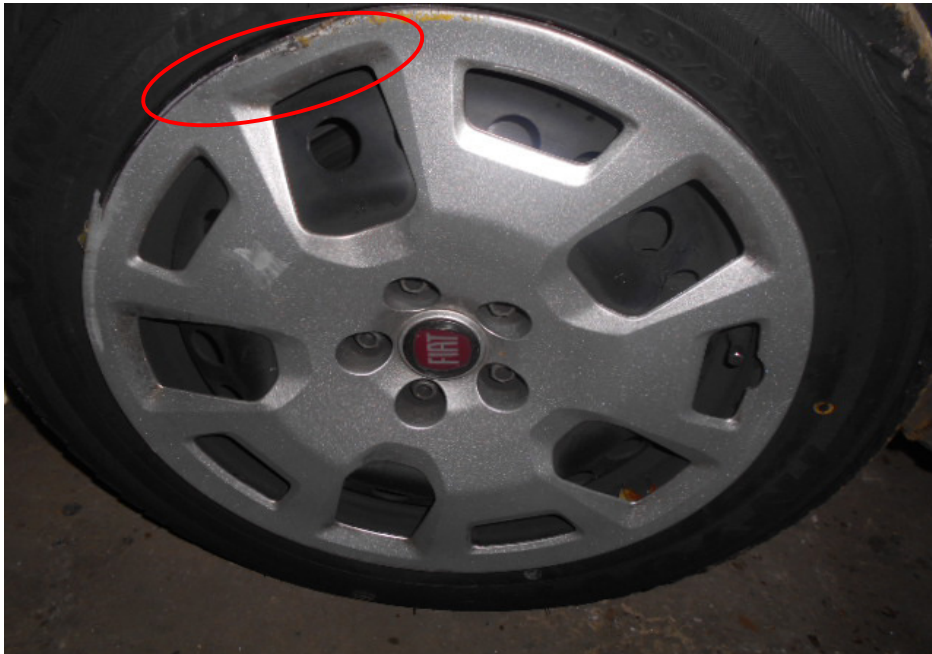
**Photo 13** shows some relatively minor marks of grazing nature observed around the edges of the front right wheel rim (circled) as a result of Mr Siva grazing the base of the railings.

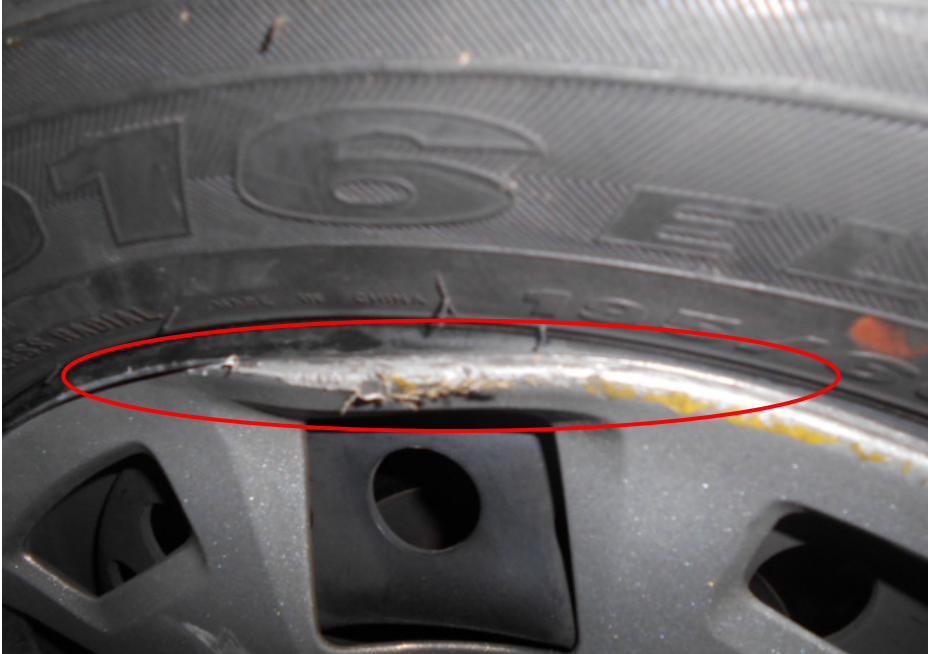
**Photo 14** shows a close up view of the relatively minor marks of grazing nature observed around the edges of the front right wheel rim (circled) as a result of Mr Siva grazing the base of the railings.
