INVESTIGATION REPORT:

Our Ref : CS4/FCI20006356/N
Policy No : D-20094877MFCV/1
Insured : GBG 2683E
Date of Incident : 13 June 2020
Location : AYE (Tuas) after Clementi Ave 6 exit

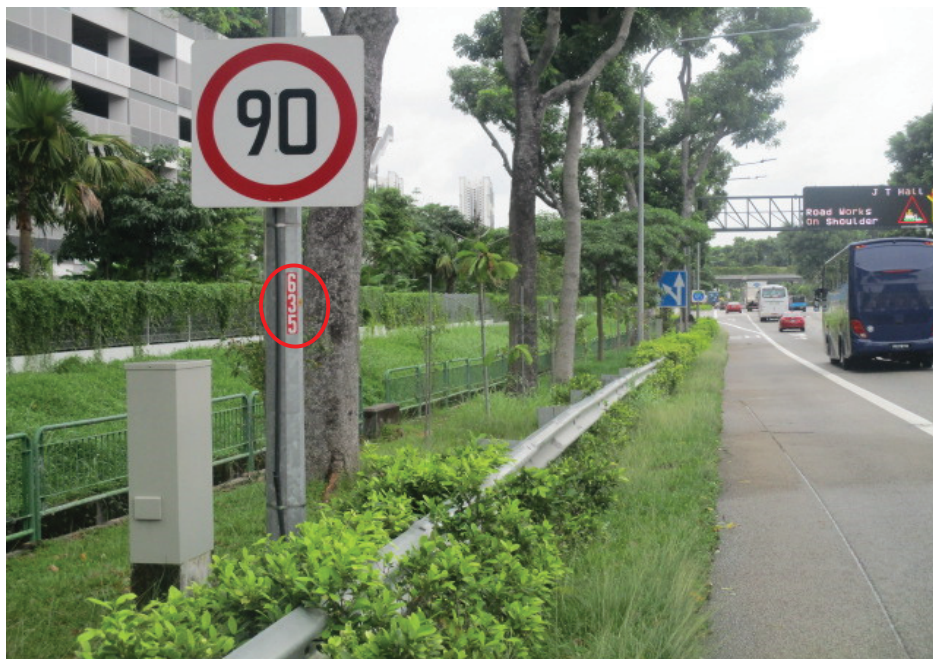
Photo 1 shows the location where the incident had occurred, along the extreme left lane of AYE (Tuas) after the Clementi Avenue 6 exit, near to lamp post 635 (circled). We noticed that the vicinity was not monitored by CCTV camera(s).

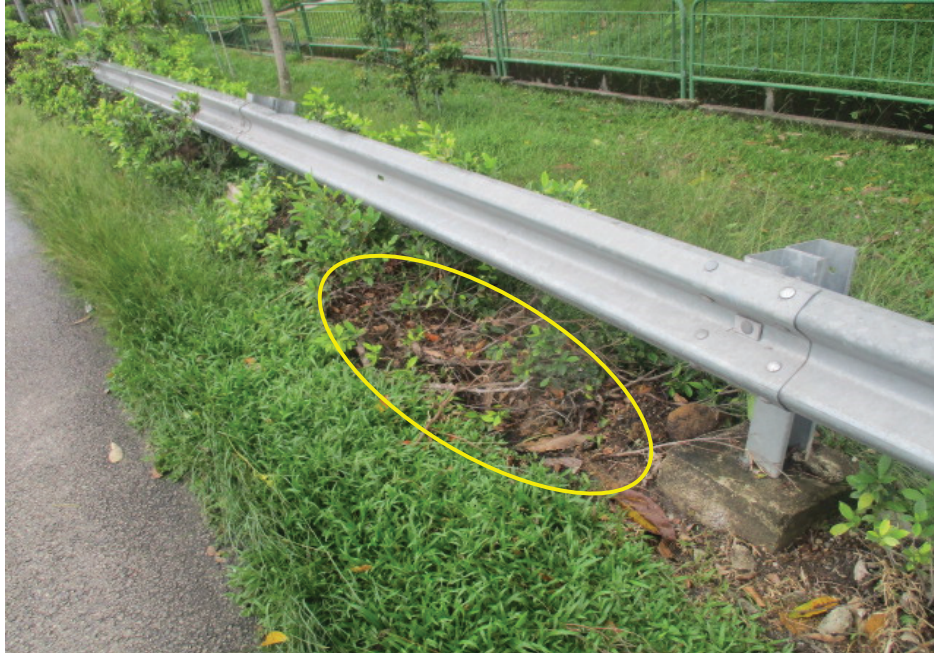
Photo 2 shows the skid marks on the grass patch near to the railings where the incident occurred (circled).

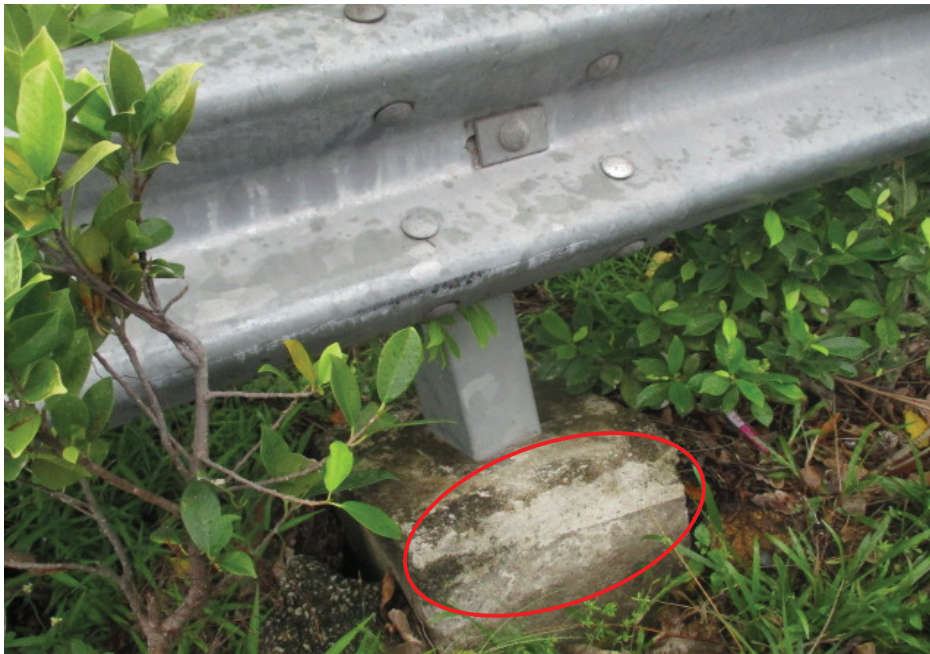
Photo 3 shows a close up view of the minor damage to the base of a railing adjacent to lamp post 635 (circled).

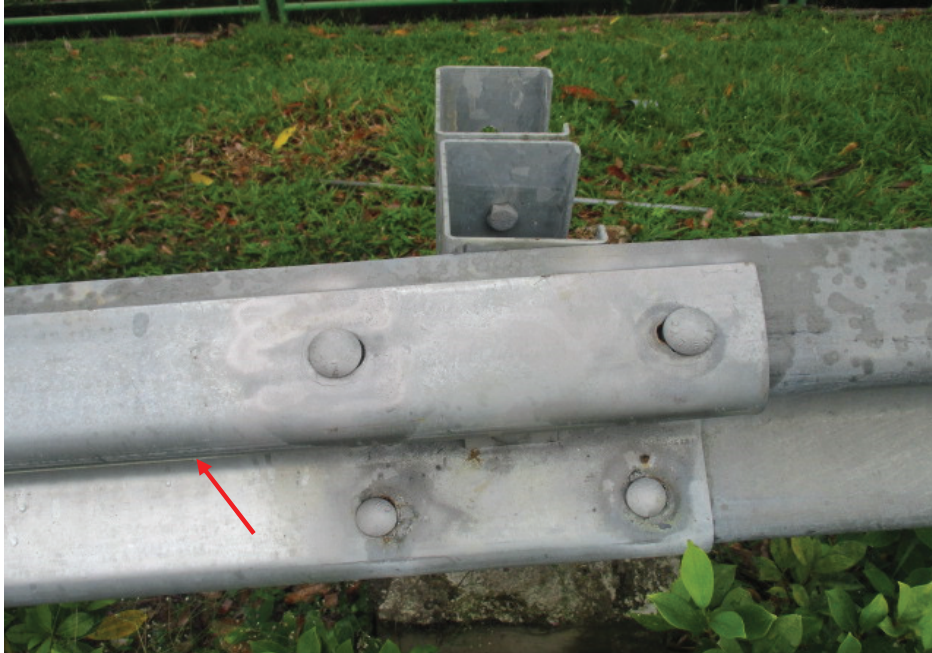
Photo 4 shows upon closer inspection of the railings, we observed whitish paint graze marks along some of the railings (arrowed).

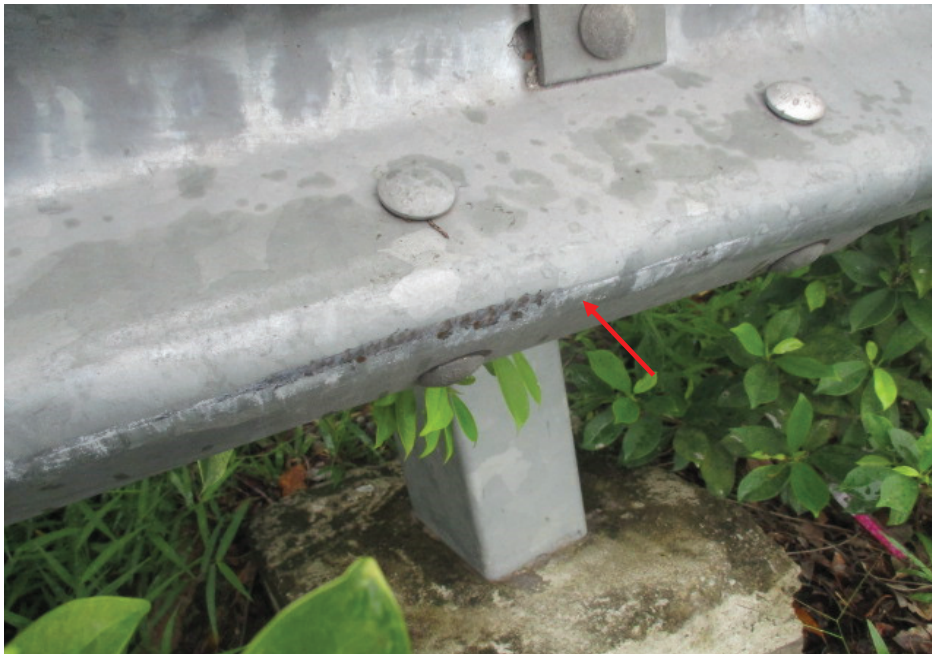
Photo 5 shows a close up view of the whitish paint graze marks along some of the railings (arrowed).

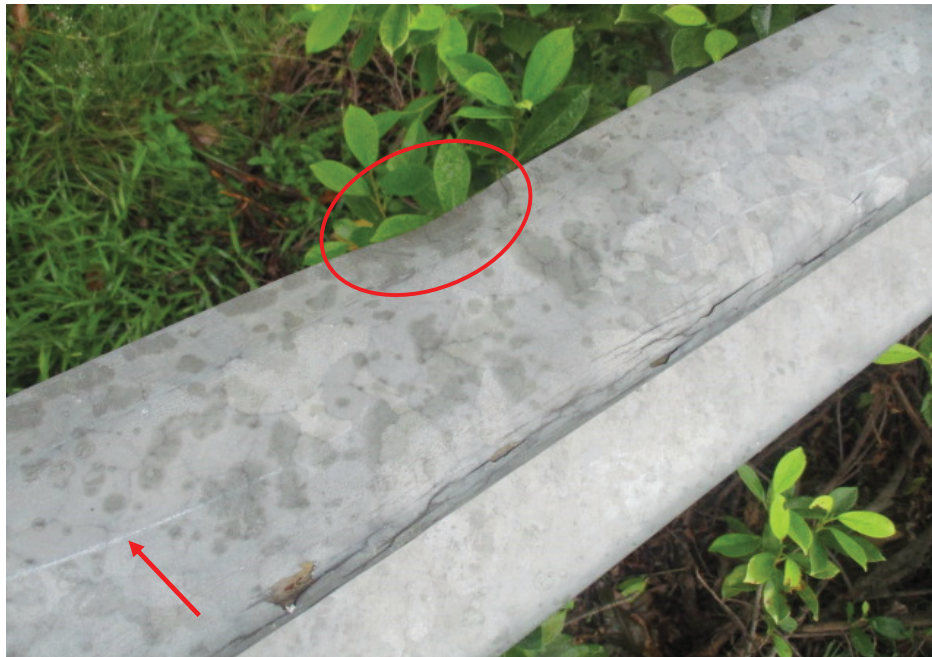
Photo 6 shows a close up view of the whitish paint graze marks along some of the railings (arrowed). A portion of the railings was also found to be dented (circled).

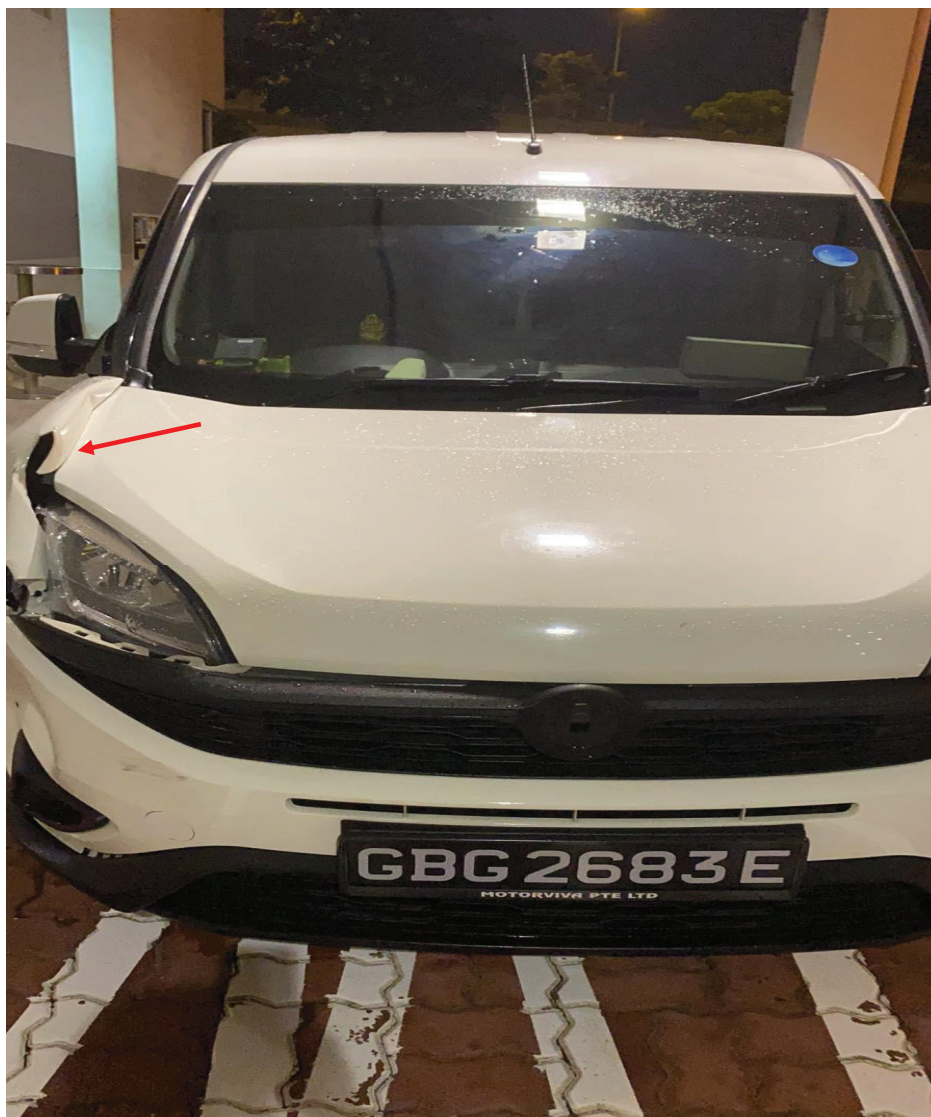
Photo 7 shows the Insured Vehicle at his office premises post- incident. The Insured Vehicle had sustained damages at its right portion (arrowed). The ability of Mr Siva to drive to the office and take clear photographs of the damages post-incident would suggest that there was no drink driving involved in this particular incident.

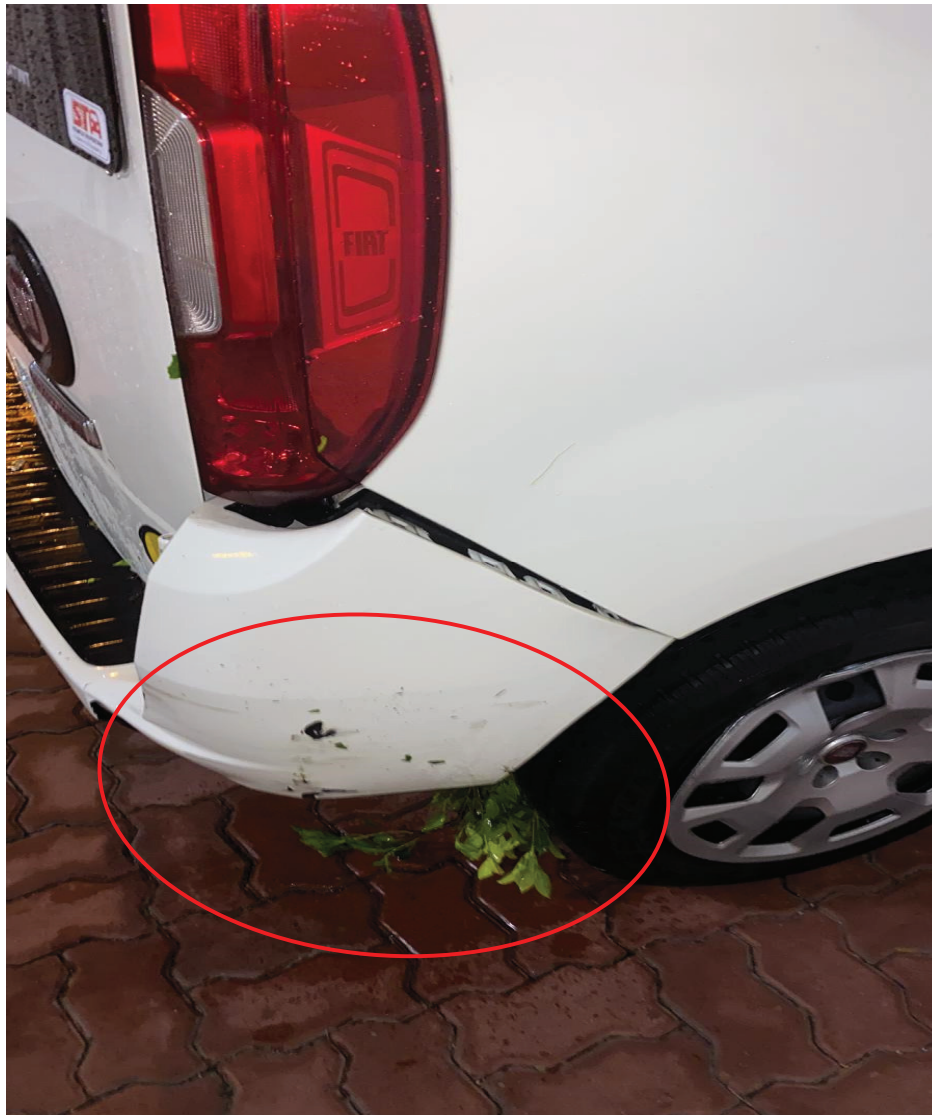
Photo 8 shows the right rear portion of the Insured Vehicle at the office premises post- incident. The Insured Vehicle had sustained damages at its right portion. The grass that was found stuck to the right rear portion of the Insured Vehicle (circled) correlates with Mr Siva's statement that the Insured Vehicle spun out of control into a grass patch along the road shoulder after he drove through a puddle of water.

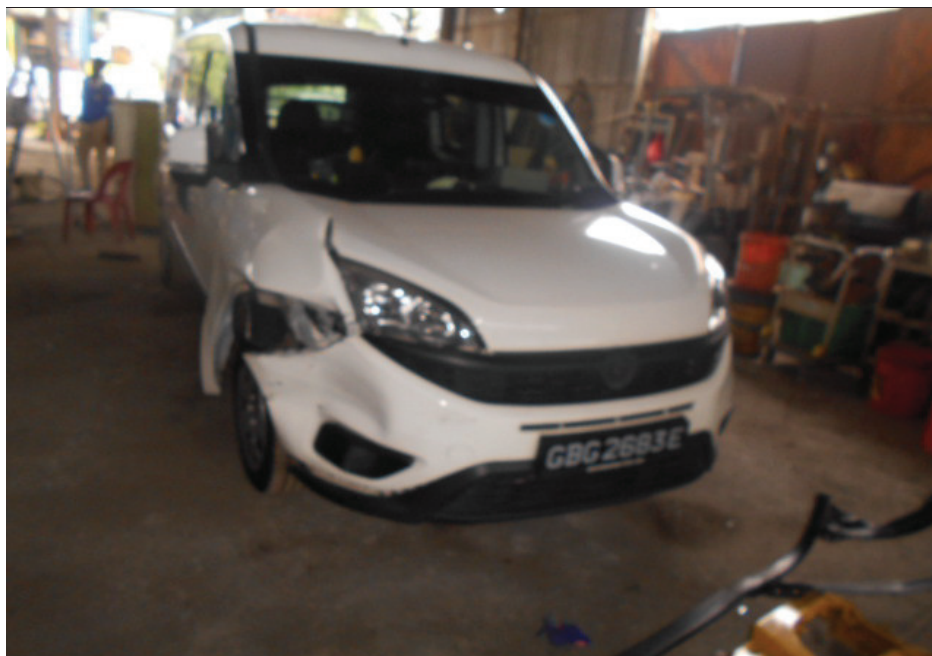
Photo 9 shows the general front view of the Insured Vehicle during the physical inspection at YK. The Insured Vehicle had sustained significant damages to its right portion, particularly to its front bonnet, front bumper, right front fender, right headlamp, and rear bumper.

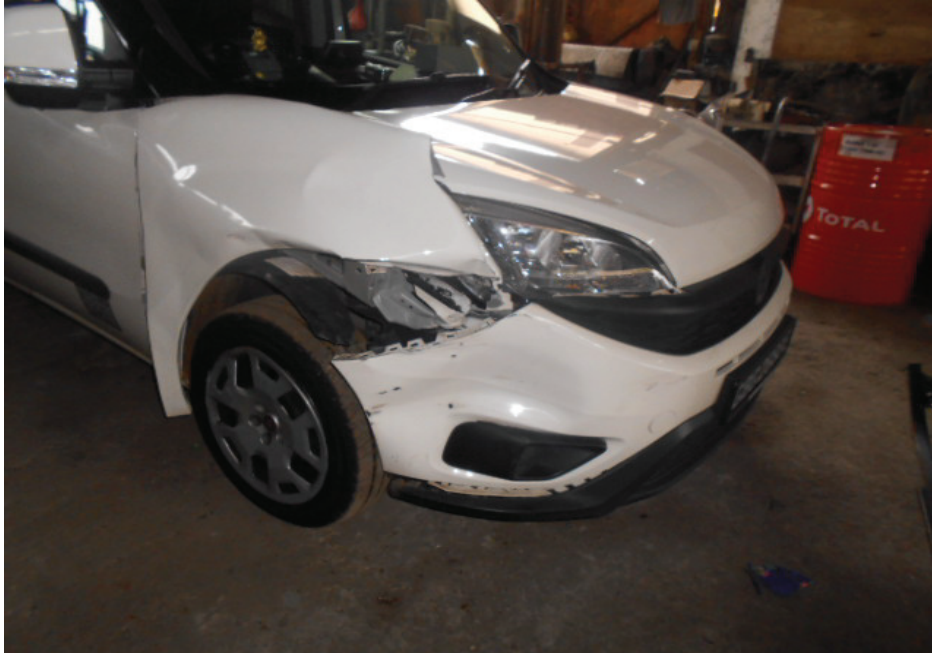
Photo 10 shows a closer view of the damaged front bonnet, front bumper, right front fender and right headlamp of the Insured Vehicle as a result of the incident.

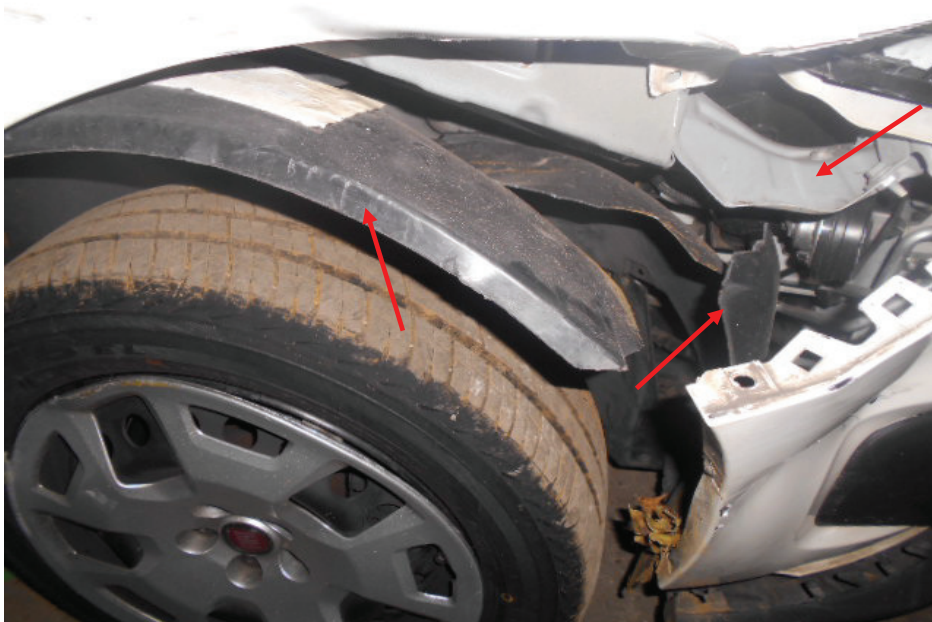
Photo 11 shows upon closer inspection, the Insured Vehicle also sustained damages to the front bumper retainer, right front fender liner and right front fender top garnish (arrowed).

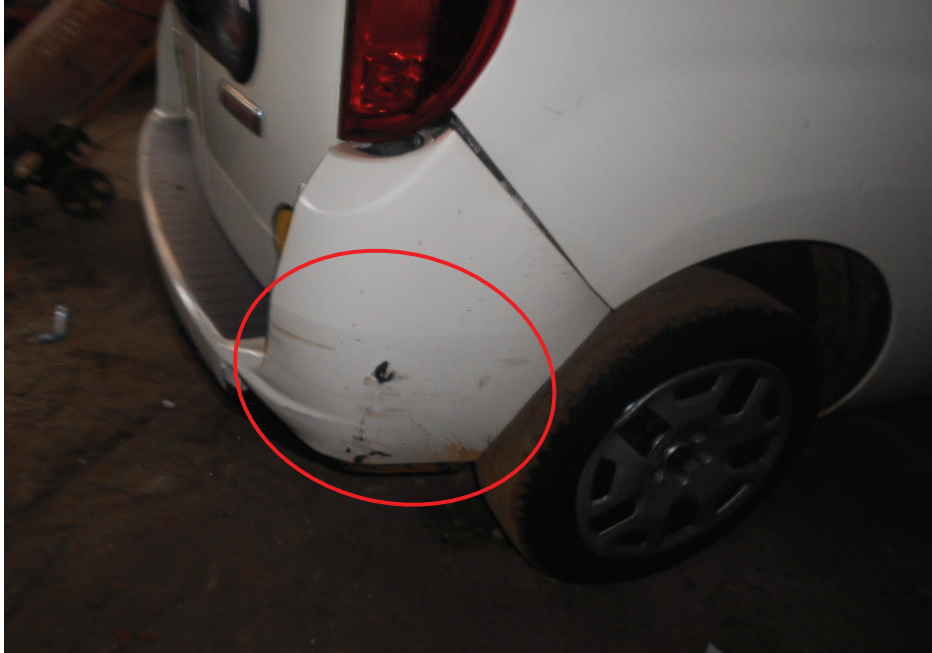
Photo 12 shows the damaged rear bumper of the Insured Vehicle as a result of the incident (circled).

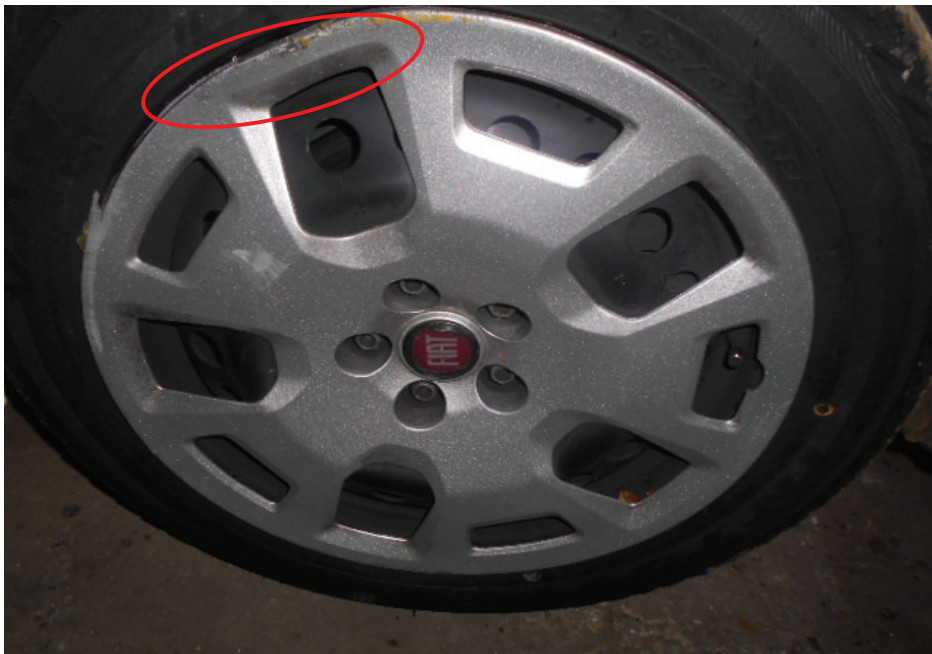
Photo 13 shows some relatively minor marks of grazing nature observed around the edges of the front right wheel rim (circled) as a result of Mr Siva grazing the base of the railings.

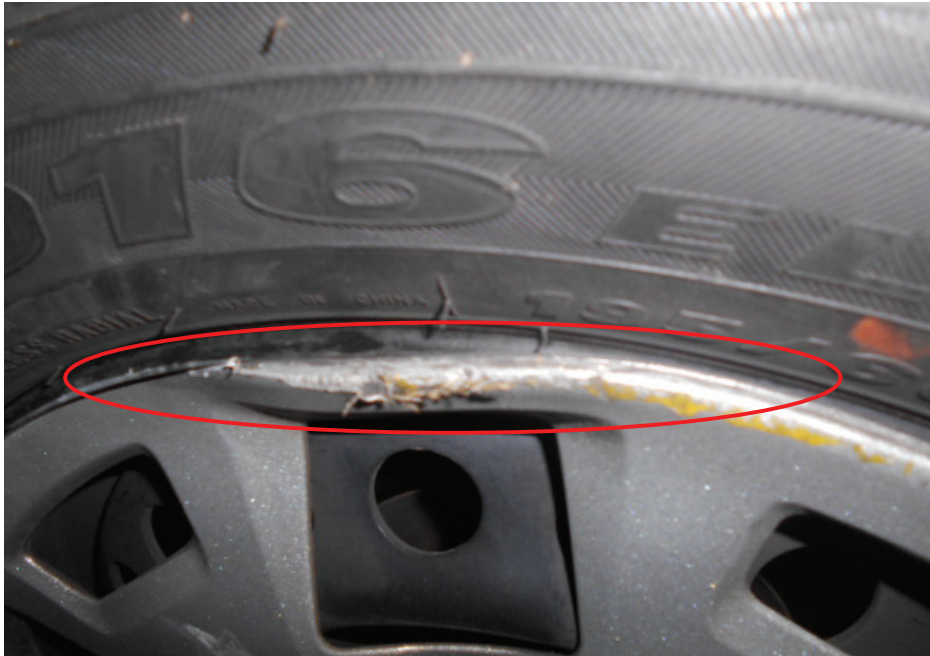
Photo 14 shows a close up view of the relatively minor marks of grazing nature observed around the edges of the front right wheel rim (circled) as a result of Mr Siva grazing the base of the railings.
