LKK Auto Consultants Pte Ltd

ADJUSTMENT ON REPAIR COST FOR VEHICLE NO. SHD 321H

PHOTOGRAPHS FOR VEHICLE NO. SHD 321H

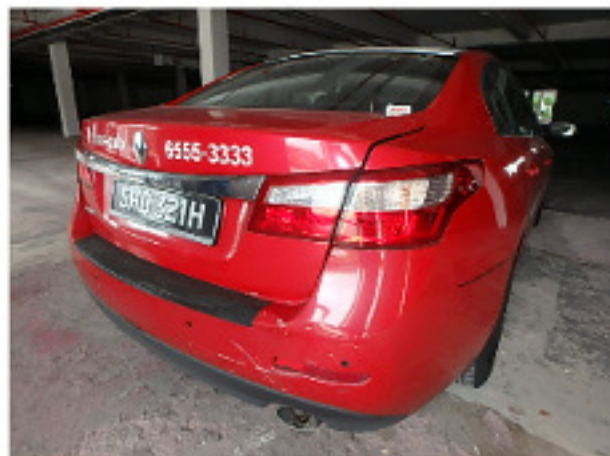
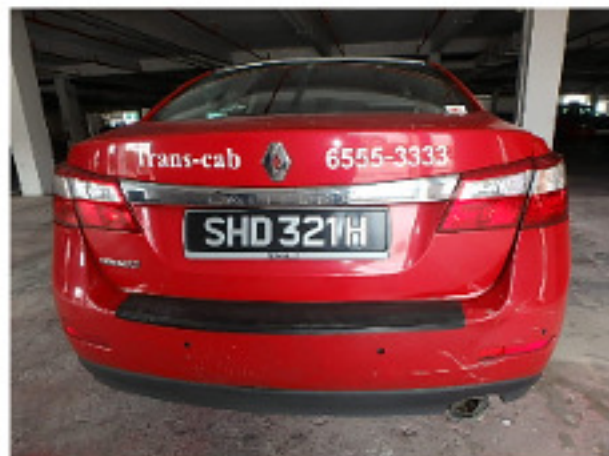
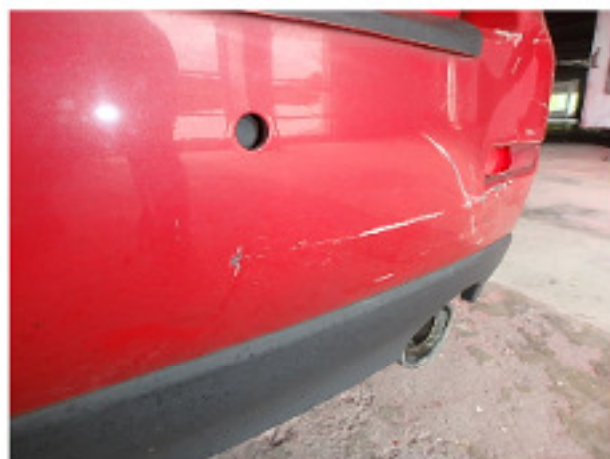
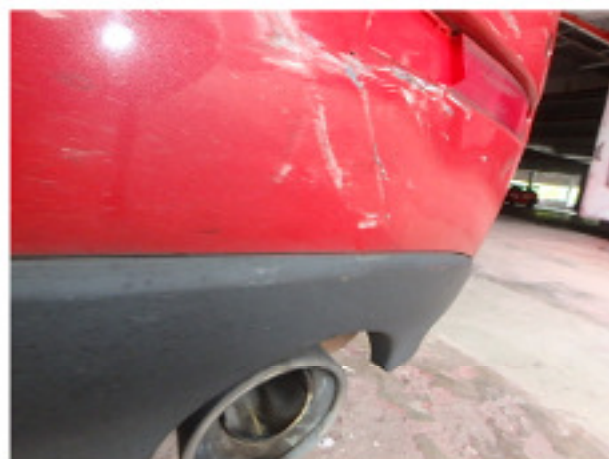
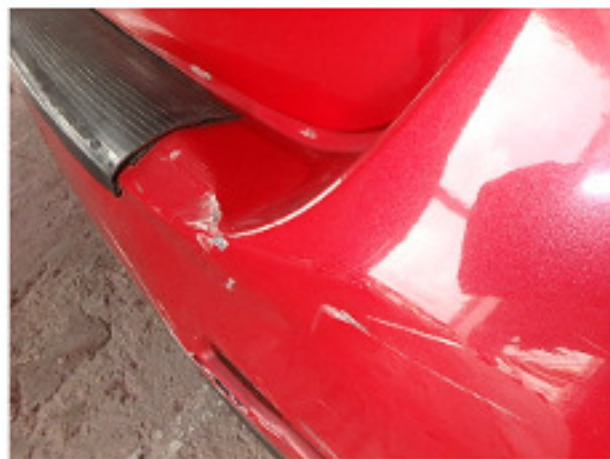
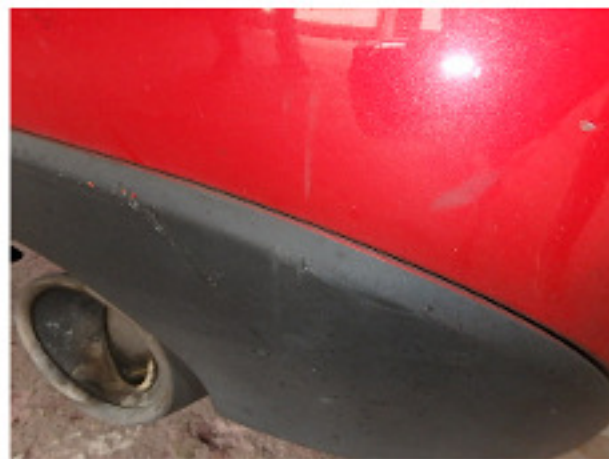
4. Description of Damages				
THE VEHICLE SUSTAINED DAMAGES AT THE REAR O/S PORTION. DAMAGES SEE DETAILS.				
5. General Information				
Accident Date	15/06/2020	Inspection Date	16/06/2020	
Survey held at	TRANS-CAB AUTO SERVICES PTE LTD NO.2 ANG MO KIO ST 63 SINGAPORE 569111			
5a. Remarks				
A)THE INSPECTION WAS CONDUCTED ON A"WITHOUT PREJUDICE" BASIS. B)IN ACCORDANCE TO YOUR INSTRUCTIONS, WE HAVE NOT AUTHORISED REPAIRS.				
5b. Estimate Days of Repair				
ESTIMATED NORMAL PERIOD FOR REPAIR:		4 Working Days
