### 1. Policy Particulars :- THIRD PARTY CLAIM

## ADJUSTMENT ON REPAIR COST FOR VEHICLE NO. SJM 9712H

PHOTOGRAPHS FOR VEHICLE NO. SJM 9712H

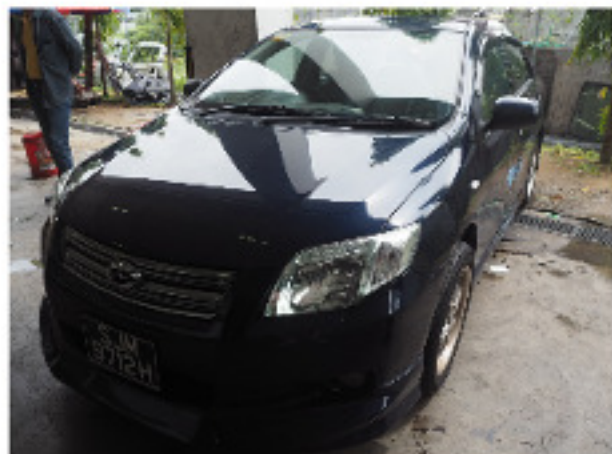
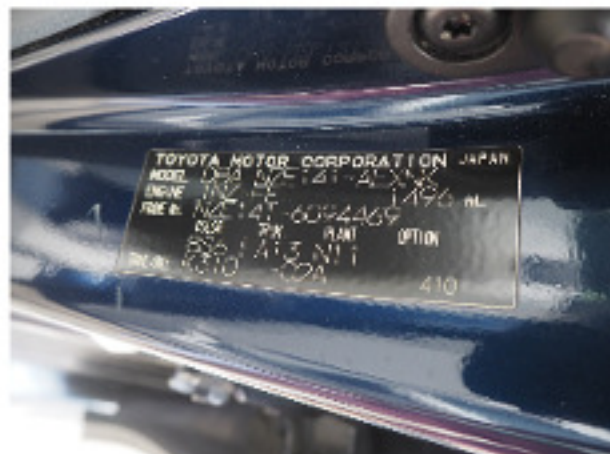
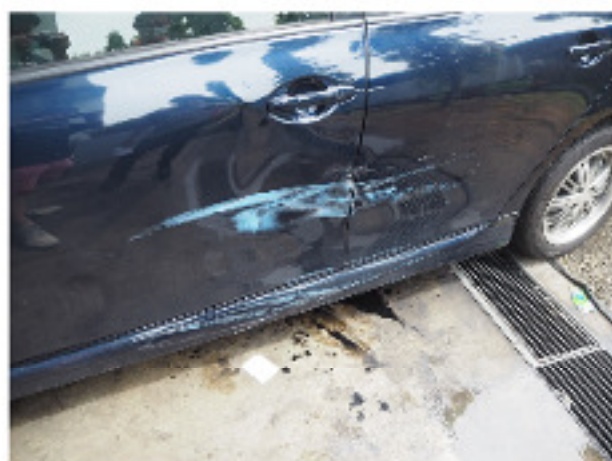
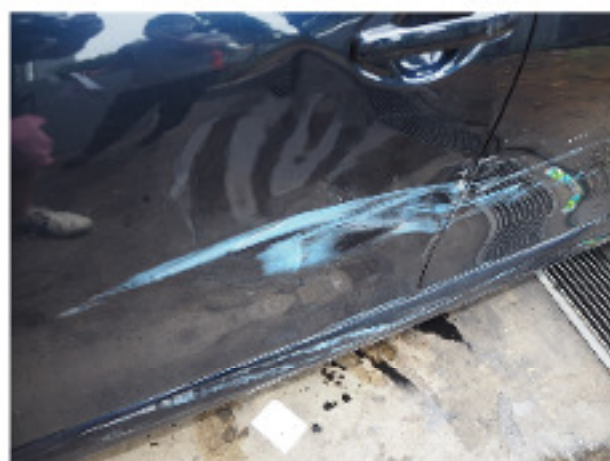
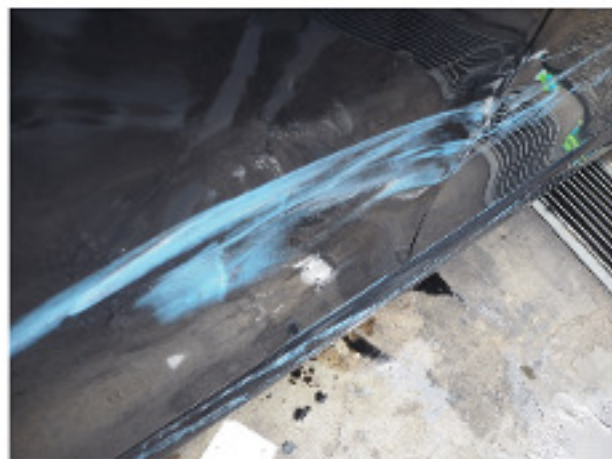
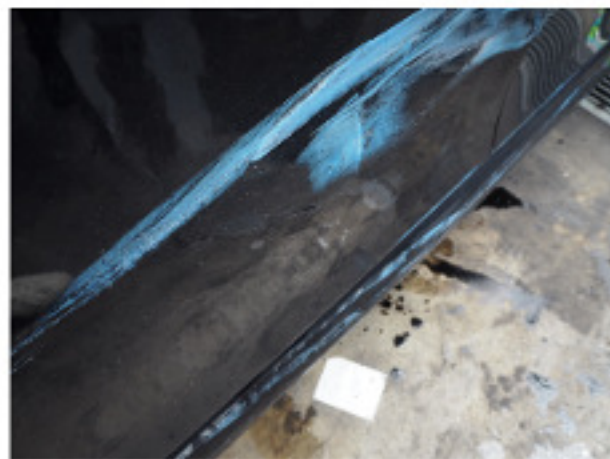
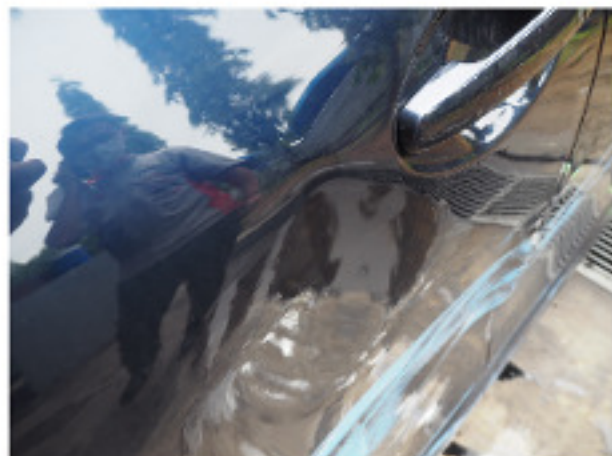
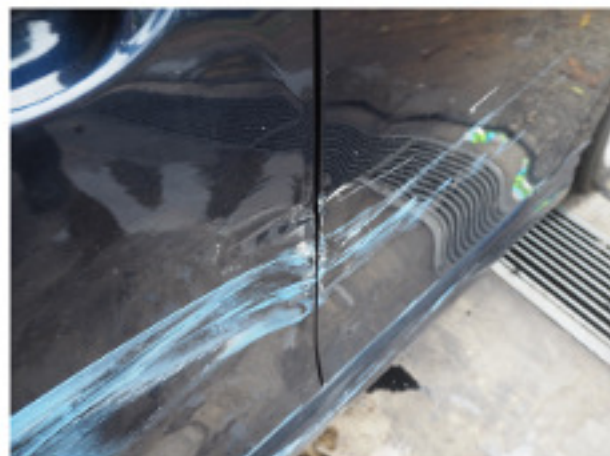
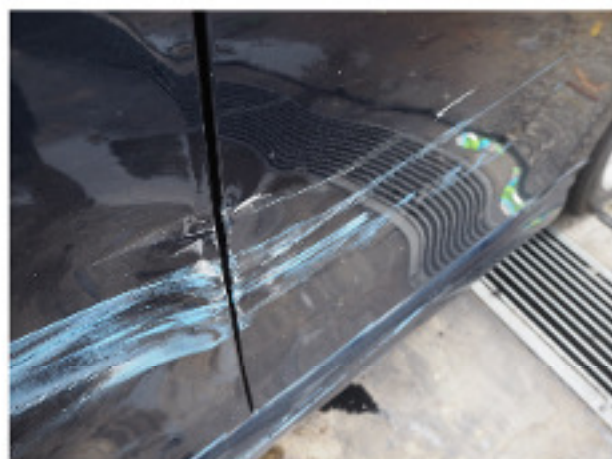
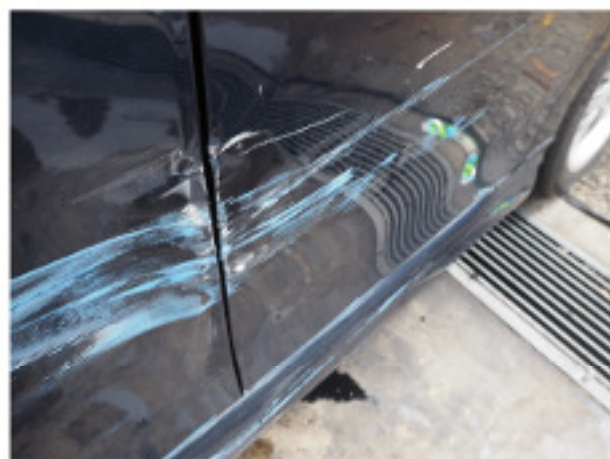
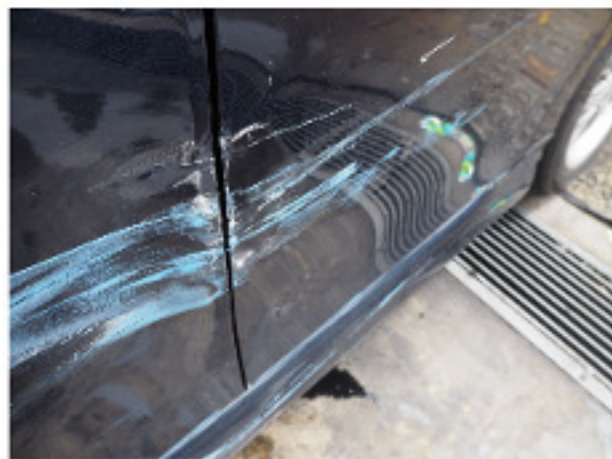
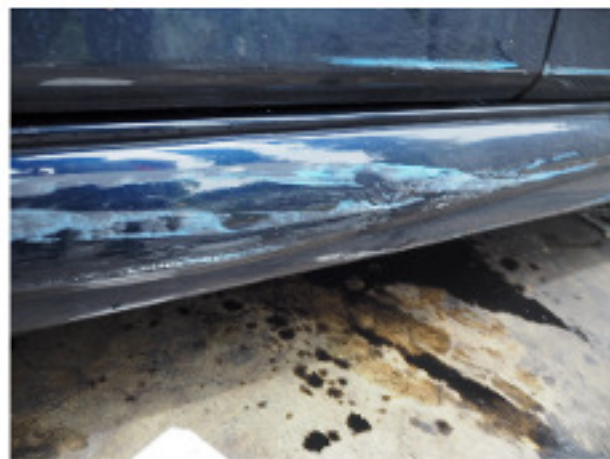
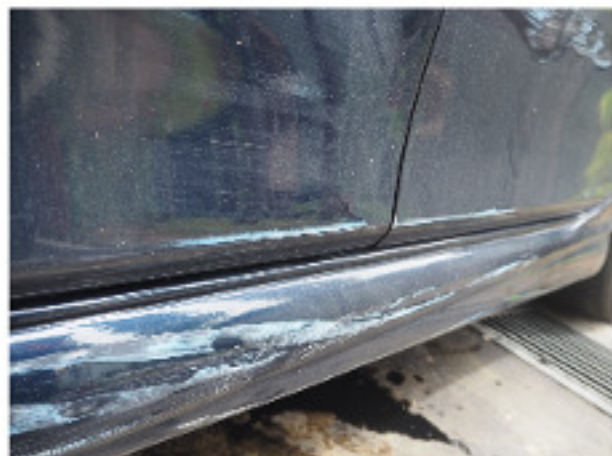
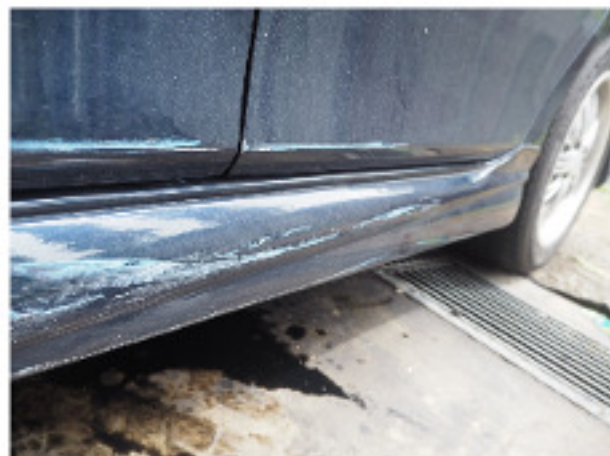
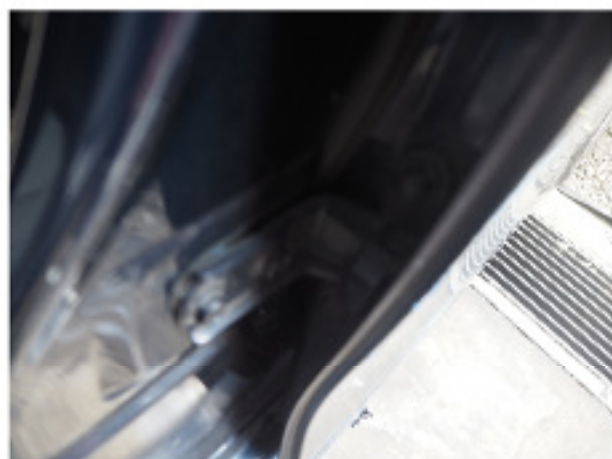
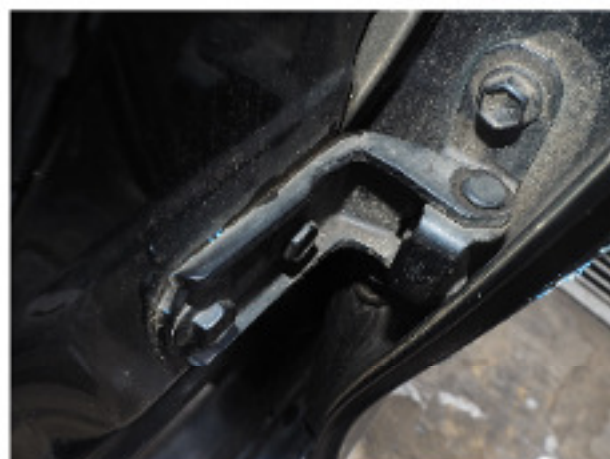
INSPECTION

| THE VEHICLE SUSTAINED DAMAGES AT THE N/S BODY.<br>DAMAGES SEE DETAILS. |
