# LKK Auto Consultants Pte Ltd

### 1. Policy Particulars :- THIRD PARTY CLAIM

## ADJUSTMENT ON REPAIR COST FOR VEHICLE NO. GBJ 1005D

### PHOTOGRAPHS FOR VEHICLE NO. GBJ 1005D

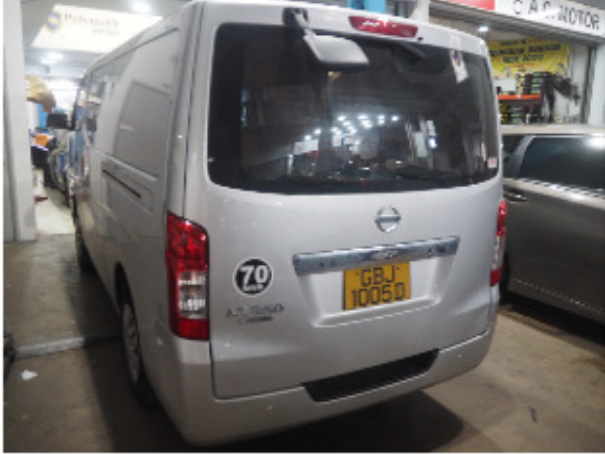
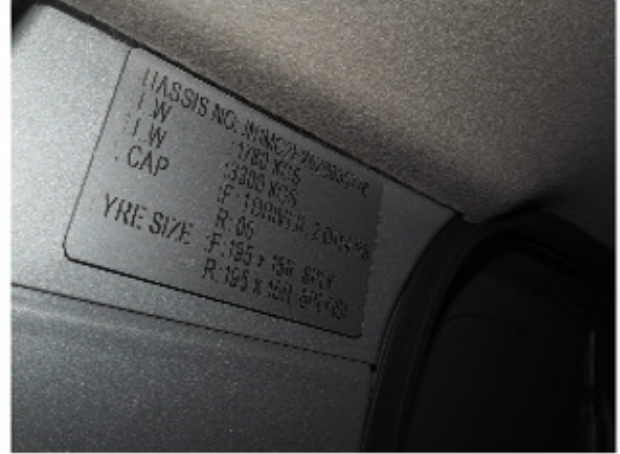
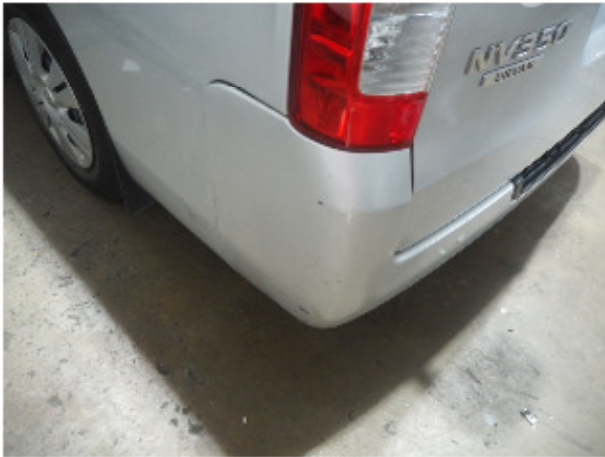
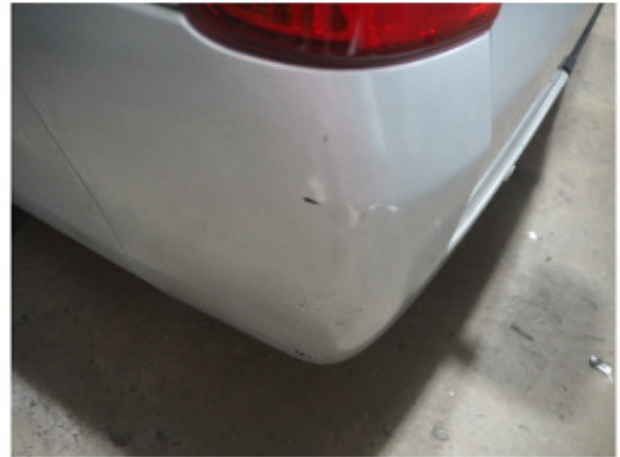
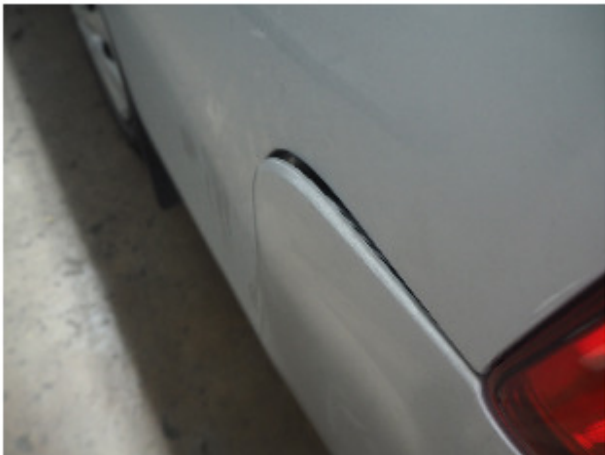
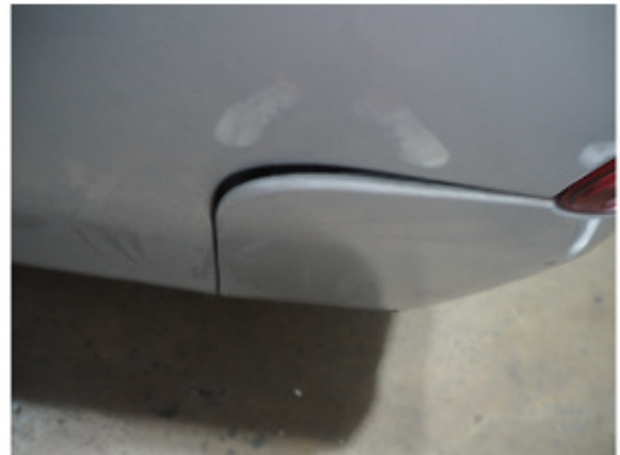
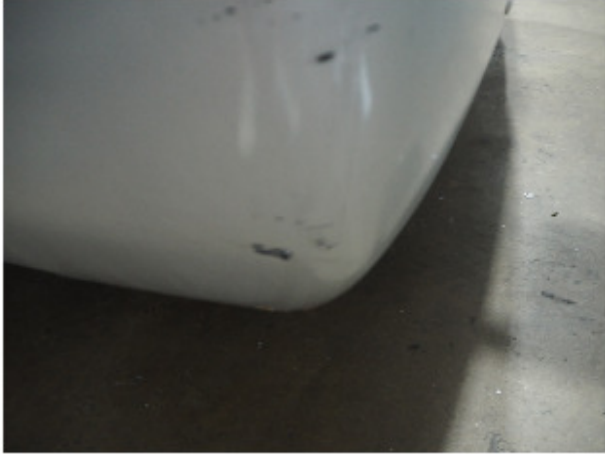
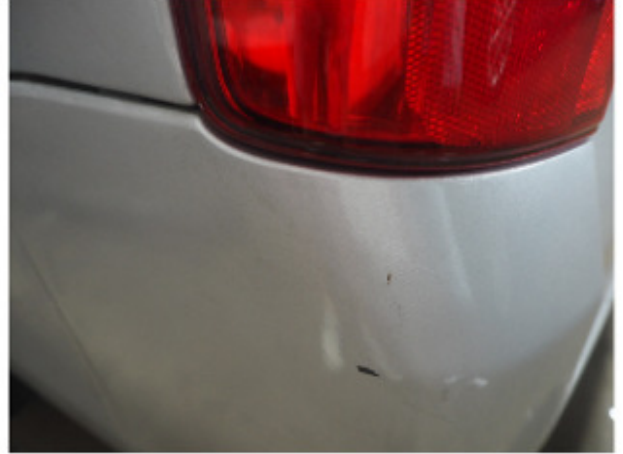
### INSPECTION

THE VEHICLE SUSTAINED DAMAGES AT THE REAR N/S PORTION. DAMAGES SEE DETAILS.
--

Qty	Description of Parts	Condition	Estimate By Workshop (\$)	Our Adjusted (\$)
	<b><u>REPLACEMENT OF PARTS</u></b>			
1	REAR BUMPER	TORN	667.20	667.20
1	REAR BUMPER CLIPS	NECESSARY	30.00	30.00
2	REAR BUMPER SIDE HOLDER @\$24.20	NOT NECESSARY	48.40	-
1	TAILLAMP LH	CRACKED	224.80	224.80
	LESS 10% DISCOUNT		-	-92.20
			970.40	829.80
	<b><u>SPECIAL NETT ITEMS</u></b>			
1	REVERSE SENSOR (SN)	NOT NECESSARY	280.00	-
			280.00	-
	<b><u>LABOUR</u></b>			
	PANEL BEATING.		300.00	200.00
	SPRAY PAINTING.		300.00	200.00
	WIRING.		50.00	30.00
	TO REMOVE REVERSE SENSOR.		100.00	50.00
			750.00	480.00
<b>GRAND TOTAL</b>			<b>2,000.40</b>	<b>1,309.80</b>
<b>RECOMMENDED COST OF LUMP SUM REPAIRS (TO ITS PRE-ACCIDENT CONDITION)</b>				<b>1,000.00</b>
