Your Ref: TP/IP/25501/2020  
Our Ref : CI/TPD20006671/D

31 August 2020

**Fatal Accident Investigation Team**

**AUTOMOBILE TECHNICAL INSPECTION REPORT OF POLICE HEARSE YN 3128B**

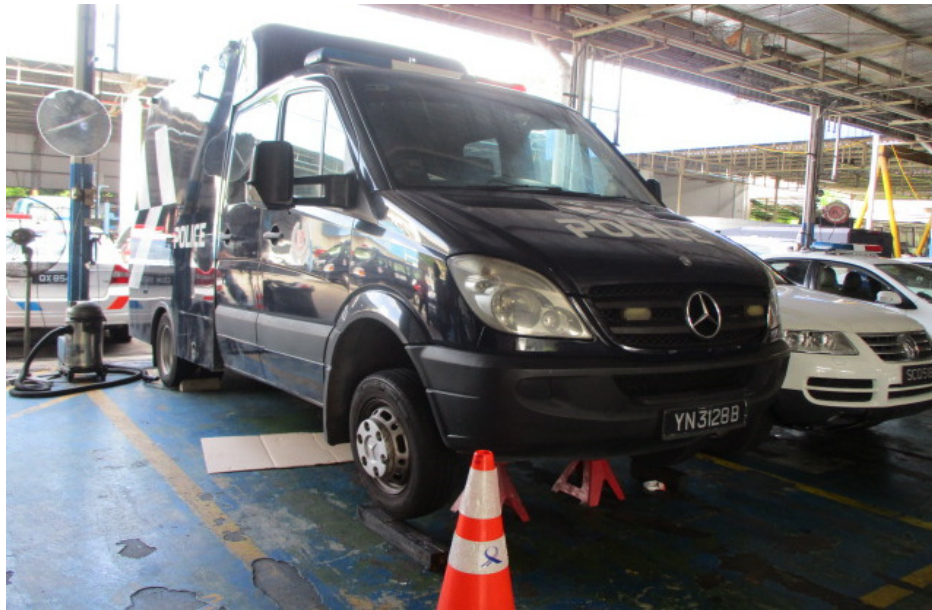
**Photo 1** shows the front right body of the PH. The PH was observed to be in a satisfactory condition with no loose exterior fittings observed. The mileage of the PH recorded at the time of my inspection was 317,444km.

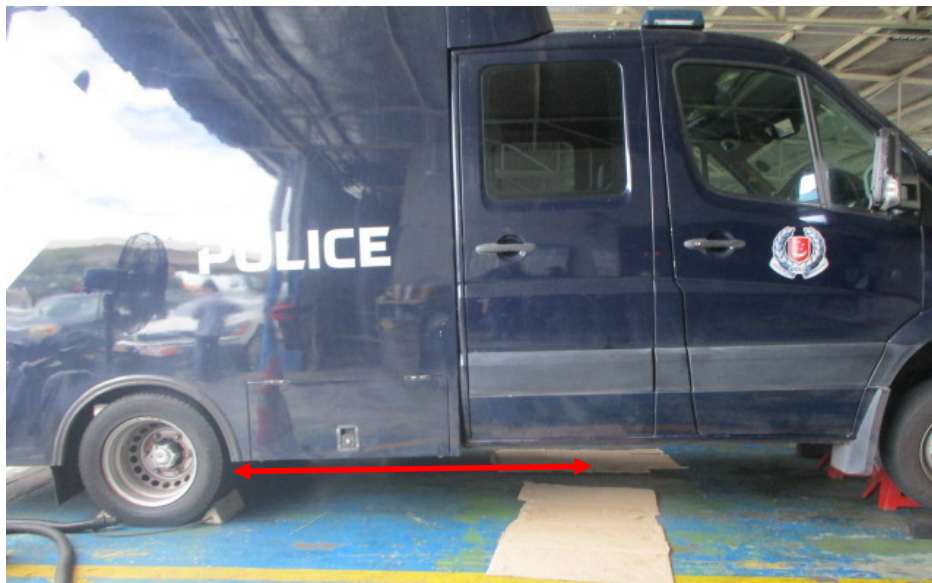
**Photo 2** shows a general view of the side body of the PH at the time of my inspection. The part that was dislodged from the PH was the rear section of the PH's propeller shaft, which was fitted at the underside of the PH. The location of this rear section, from a side view perspective, is indicated by the red arrow.

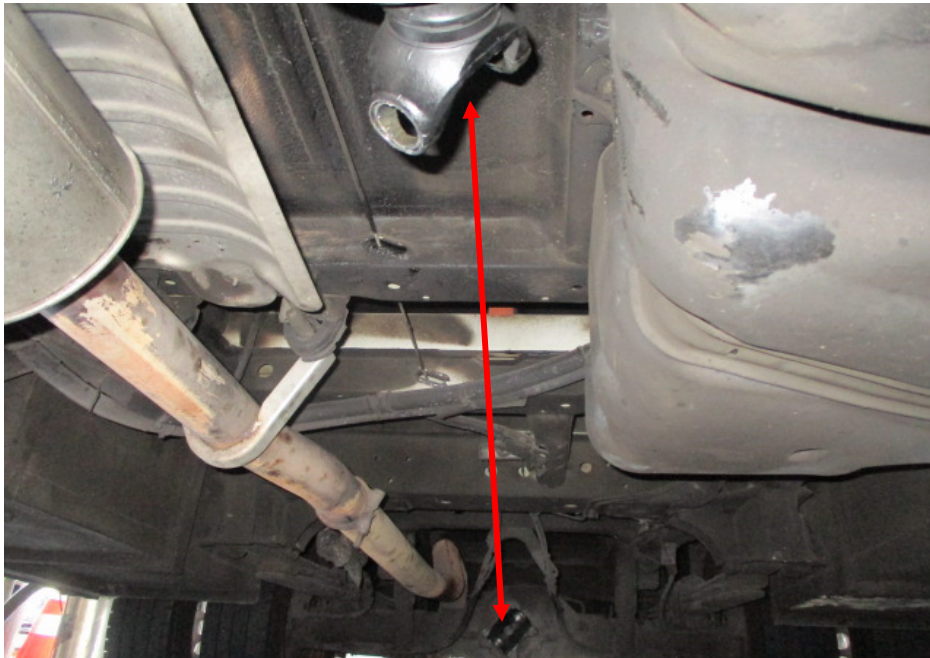
**Photo 3** shows the underside of the PH. The part that was dislodged from the PH was the rear section of the PH's propeller shaft, which was fitted at the underside of the PH. The location of this rear section, from an underside view, is indicated by the red arrow.

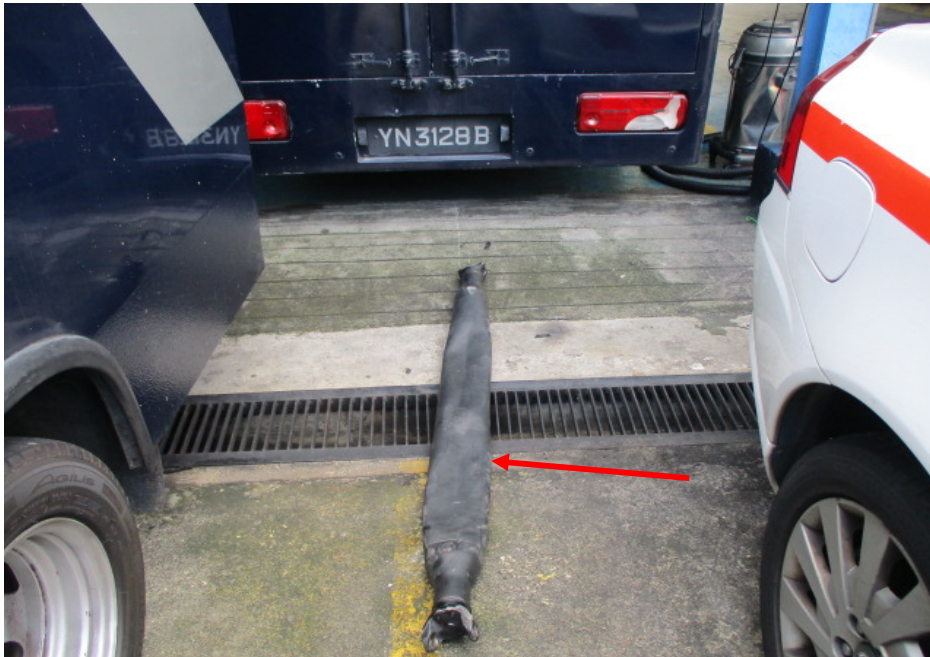
6. Upon examination of the dislodged rear section propeller shaft, I had found it to be dented. From an original cylindrical shape, it was dented to a flatten shape with grazed/cut marks at multiple areas on the top and bottom sides. See photo 1 – 10 below.

**Photo 4** shows the dislodged rear section of the PH's propeller shaft (arrowed). From an original cylindrical shape, the rear section was observed to be dented to a flattened shape with grazed/cut marks at multiple areas on the top and bottom sides.

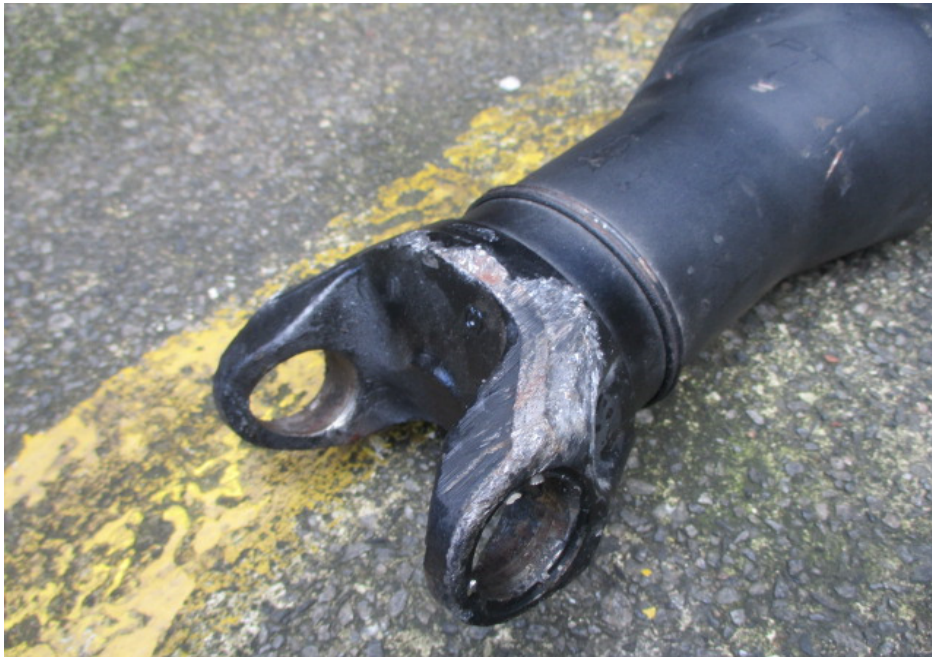
**Photo 5** shows a close up view of the grazed/cut marks at one end of the PH's propeller shaft rear section.

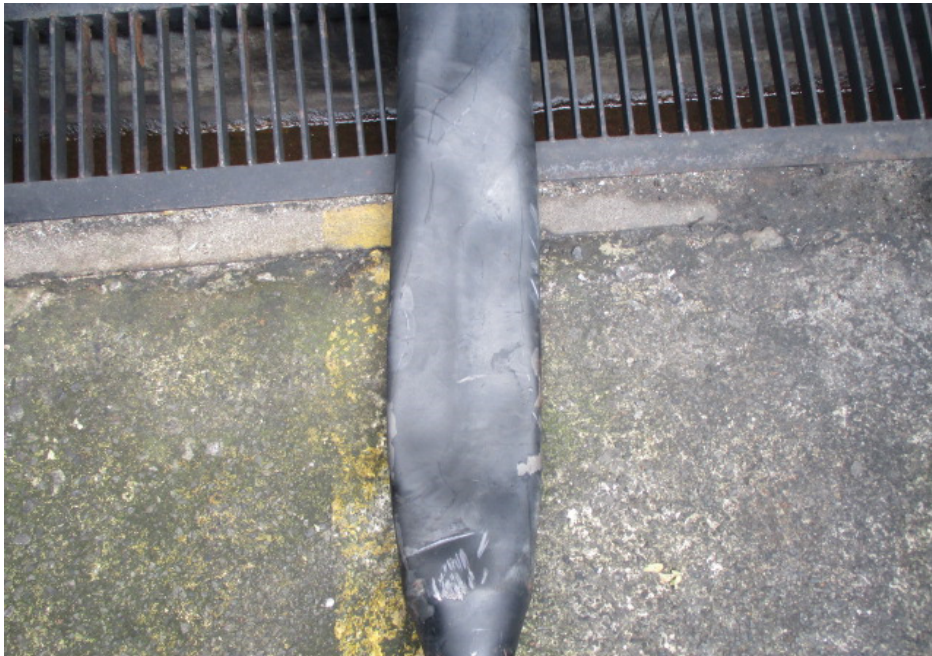
**Photo 6** shows the propeller shaft rear section dented to a flatten shape from an original cylindrical shape.

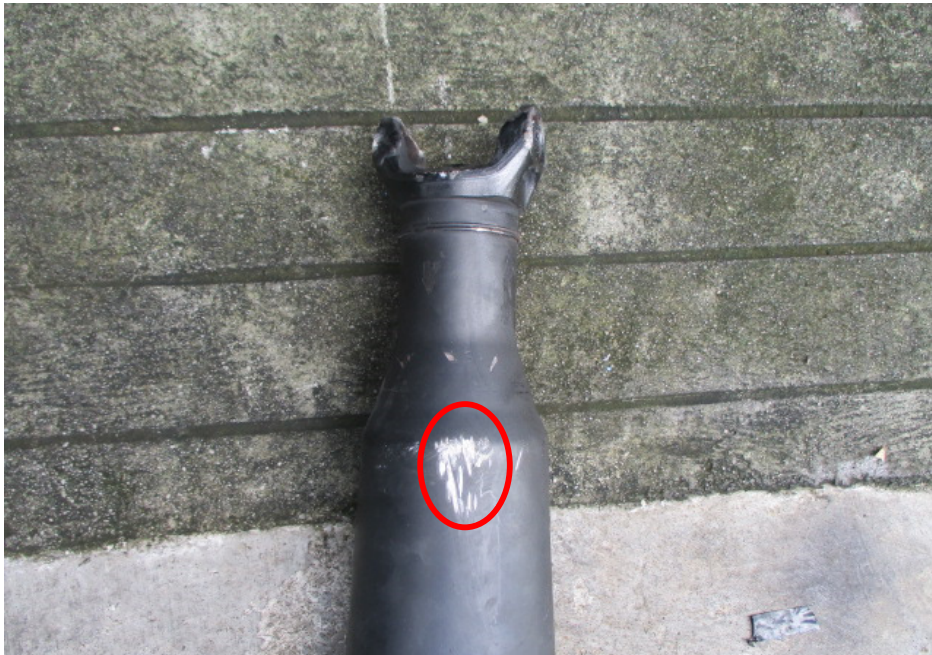
**Photo 7** shows the grazed/cut marks (circled) at another area of the PH's propeller shaft rear section. Grazed/cut marks were found on multiple areas on the top and bottom sides of the rear section.

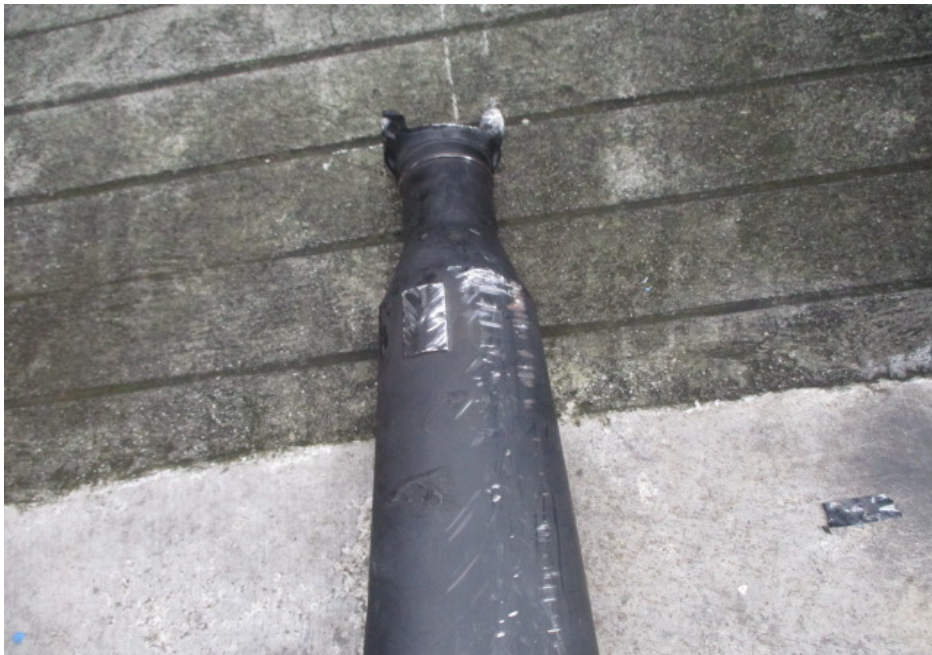
**Photo 8** shows the grazed/cut marks at another area on the bottom side of the propeller shaft rear section.

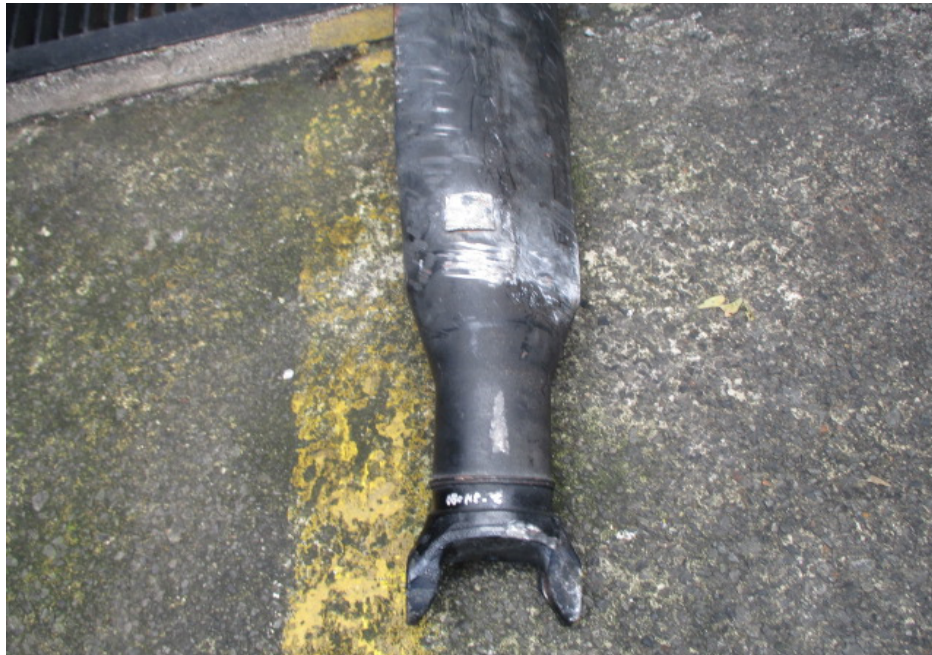
**Photo 9** shows the grazed/cut marks at another area on the bottom side of the propeller shaft rear section. Generally, the dislodged rear section of the PH's propeller shaft, was observed to be dented. From an original cylindrical shape, it was dented to a flatten shape with grazed/cut marks at multiple areas on the top and bottom sides.

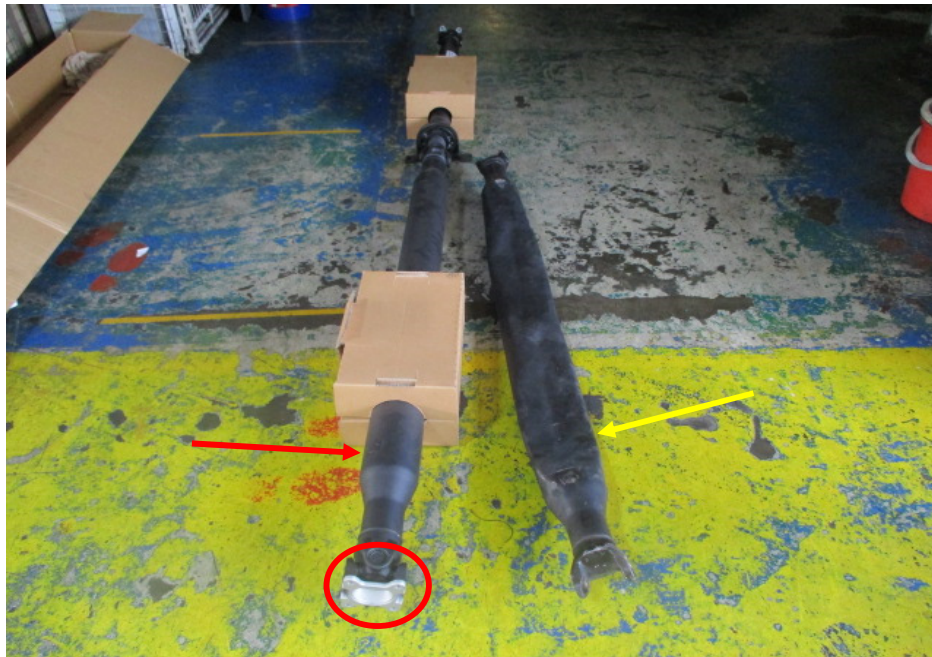
**Photo 11** shows the PH's damaged propeller shaft rear section (yellow arrow) together with a new propeller shaft rear section (red arrow). Upon comparison, it was observed that the "U" joint at the end of both sides of the PH's damaged propeller shaft rear section was missing. The location of the "U" joint at one end of the propeller shaft rear section is highlighted by the red circle.

13. Since the propeller shaft rear section is secured to the propeller shaft front section and to the differential gearbox by only a "U" joint at each of its end (without any other support bracket in between), the cause of the propeller shaft rear section detaching from the PH would, in all likelihood, be failure of one or both of its "U" joints. This is also taking into consideration that the propeller shaft front section and the differential gearbox of the PH was undamaged and still intact.

14. Based on the observations gathered during my inspection of the PH, which also included comparison with an undamaged propeller shaft rear section, it would appear to me that the dislodging of the PH's propeller shaft rear section was due to failure of one or both of its "U" joints.

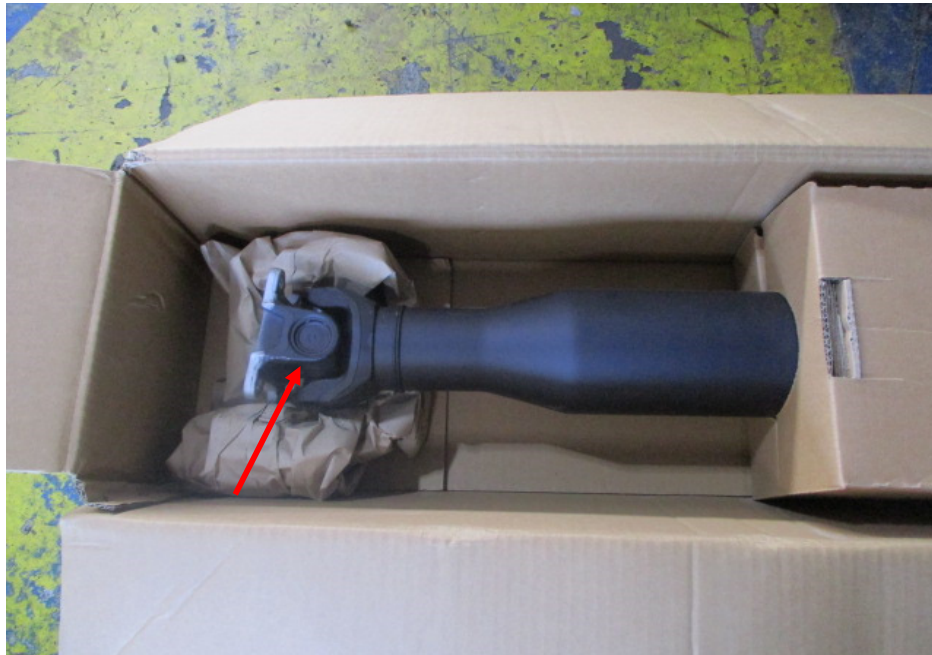
**Photo 12** shows the "U" joint (arrowed) of a new propeller shaft rear section. The purpose of the "U" joint is for securing/attaching one end of the propeller shaft rear section to the propeller shaft front section and the other end to the input shaft of the differential gearbox. The "U" joint, shown in the photograph above, is for the end that is secured/attached to the input shaft of the differential gearbox. The "U" joint at the end of both sides of the PH's damaged propeller shaft rear section was missing. Refer to photograph 5, 7 & 9 above.

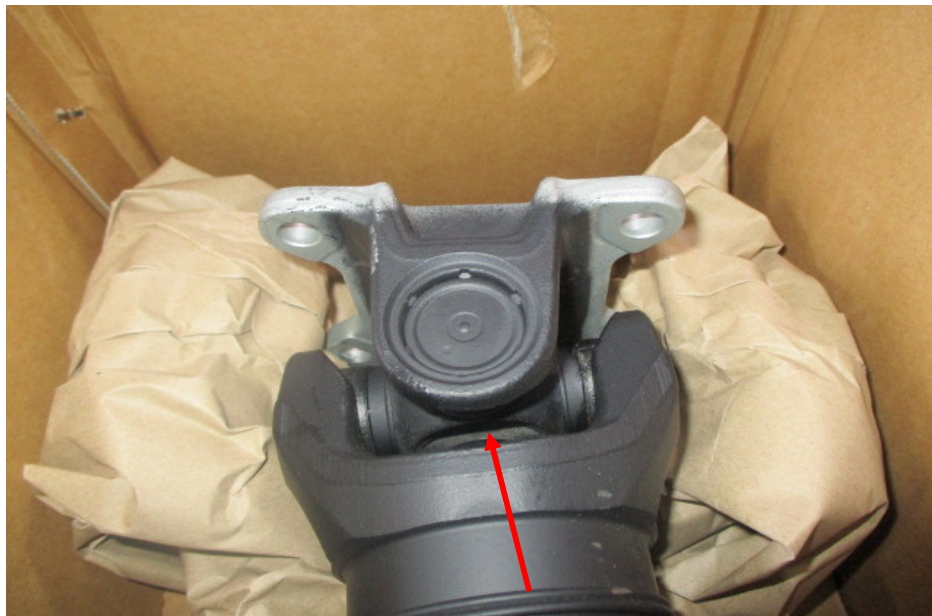
**Photo 13** shows a closer view of the "U" joint (arrowed) of a new propeller shaft rear section. The purpose of the "U" joint is for securing/attaching one end of the propeller shaft rear section to the propeller shaft front section and the other end to the input shaft of the differential gearbox. The "U" joint at both ends of the PH's damaged propeller shaft rear section was missing.

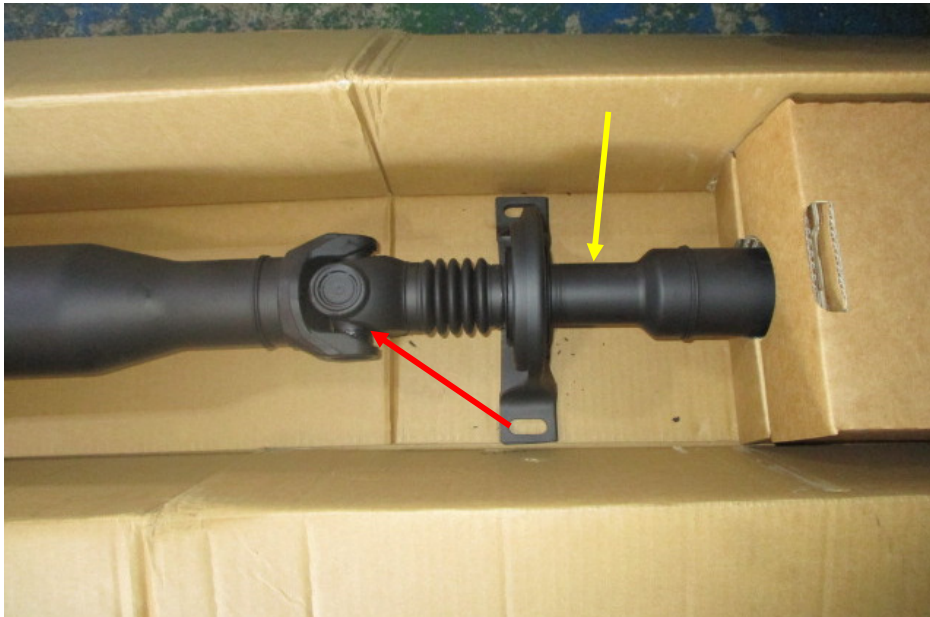
**Photo 14** shows the “U” joint (red arrow) of a new propeller shaft rear section. The “U” joint, shown in the photograph above, is for the end that secures/attach the propeller shaft rear section to the propeller shaft front section (yellow arrow). The “U” joint at the end of both sides of the PH’s damaged propeller shaft rear section was missing. Refer to photograph 5, 7 & 9 above.

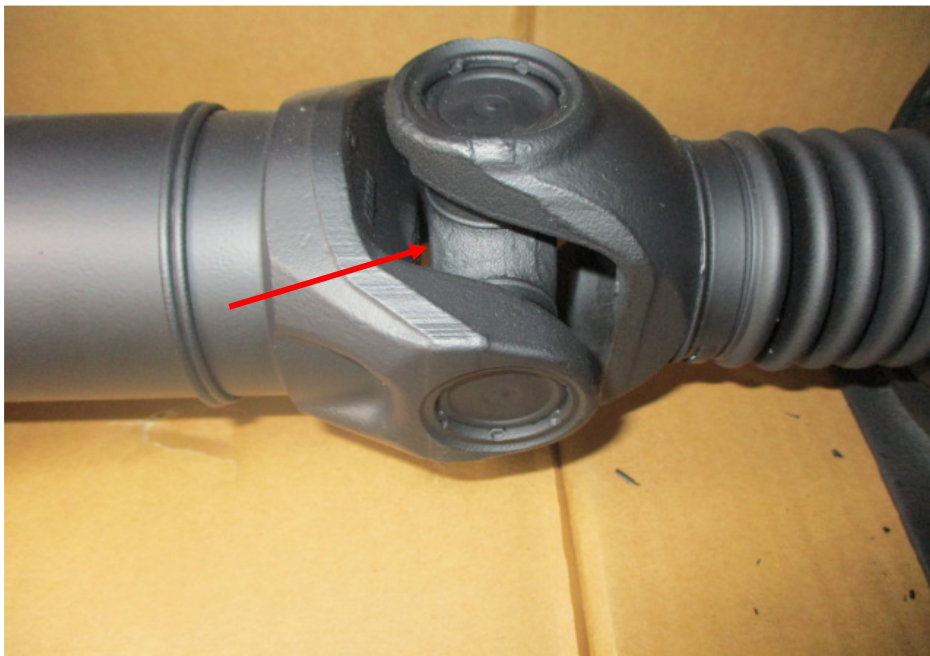
**Photo 15** shows a closer view of the “U” joint (arrowed) of a new propeller shaft rear section. The “U” joint shown is for the end where the propeller shaft rear section is secured/attached to the propeller shaft front section. The purpose of the “U” joint is to secure/attach one end of the propeller shaft rear section to the propeller shaft front section and the other end to the input shaft of the differential gearbox. The “U” joint at the end of both sides of the PH’s damaged propeller shaft rear section was missing. Refer to photograph 5, 7 & 9 above.

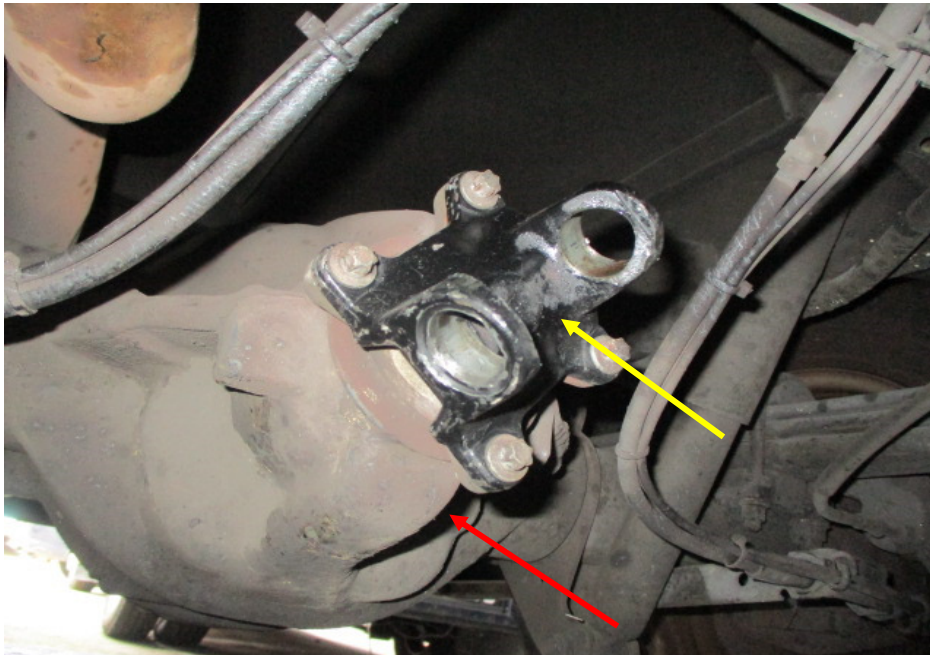
10. During my examination of the PH’s underside, I had checked on the differential gearbox, which is secured/attached to one end of the propeller shaft rear section. I had found the differential gearbox to be intact and undamaged. See photo 16 below.

**Photo 16** shows the differential gearbox (red arrow) of the PH, which was observed to be intact and undamaged. One end of the propeller shaft rear section is secured/attached to this differential gearbox at the location as highlighted by the yellow arrow via a "U" joint. As seen from the photograph, the "U" joint was missing.

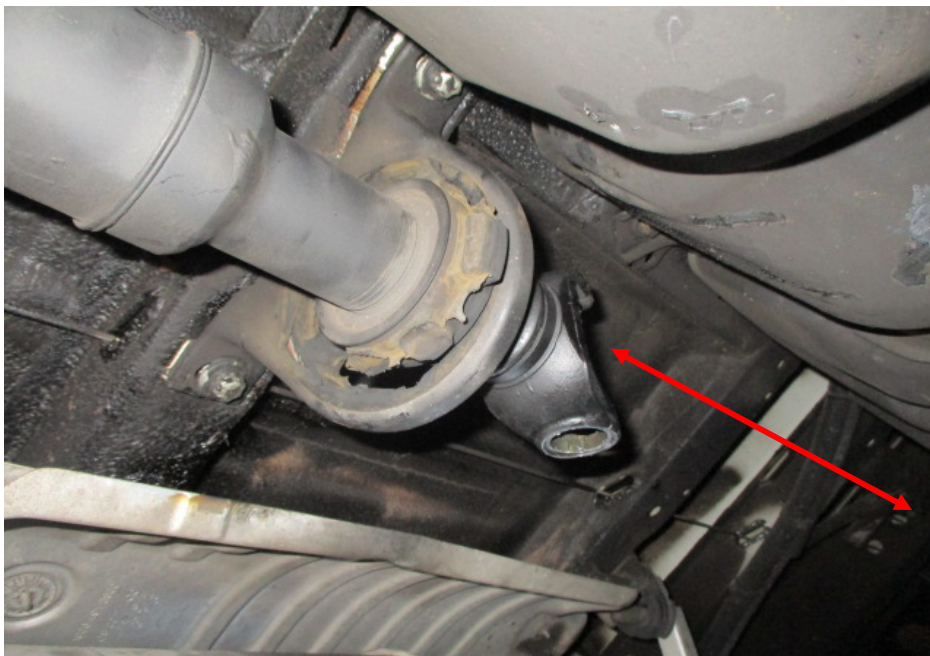
**Photo 17** shows the propeller shaft front section of the PH. One end of the propeller shaft rear section is secured/attached to this front section via a "U" joint while the other end of the propeller shaft rear section is secured/attached to the differential gearbox as shown in photograph 16 above. The location where the propeller shaft rear section was supposed to be fitted is indicated by the red arrow. As seen from the photograph, the "U" joint was missing.

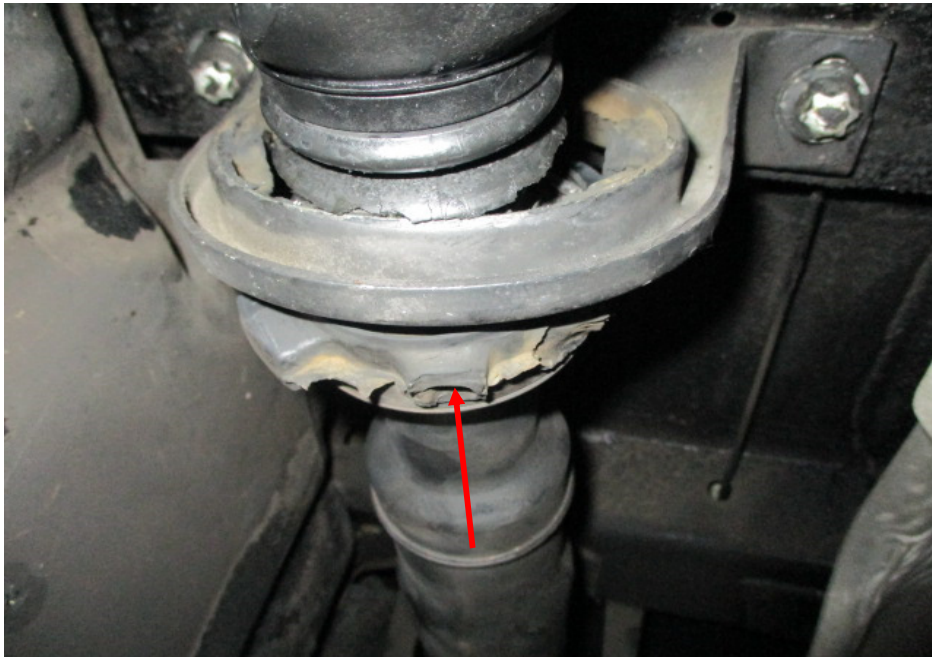
11. The propeller shaft front section, which is secured/attached to the other end of the propeller shaft rear section was also still intact. I had found the front section relatively undamaged apart for its rubber bushing, which was broken due to the front section falling and resting on the support bracket when the propeller shaft rear section became dislodged. This rubber bushing was at the end of the propeller shaft front section that secures/attaches to the rear section via the “U” joint. See photo 17 - 19 below.

**Photo 18** shows the propeller shaft front section of the PH at the time of my inspection. The rubber bushing (arrowed) of the propeller shaft front section was observed to be broken. This was due to the front section falling and resting on the support bracket when the propeller shaft rear section became detached. Other than this, the propeller shaft front section of the PH was observed to be relatively undamaged.

12. The rubber bushing covers a set of bearings surrounding the propeller shaft front section. When tested manually, the bearings were able to rotate, indicating that the bearings were in serviceable/working condition. If the bearings were unable to rotate, this would cause a counter rotating reaction to the rotating propeller shaft of the PH during operation, which could lead to the propeller shaft rear section being detached from the propeller shaft front section. A video showing this manual test is attached together with this report.

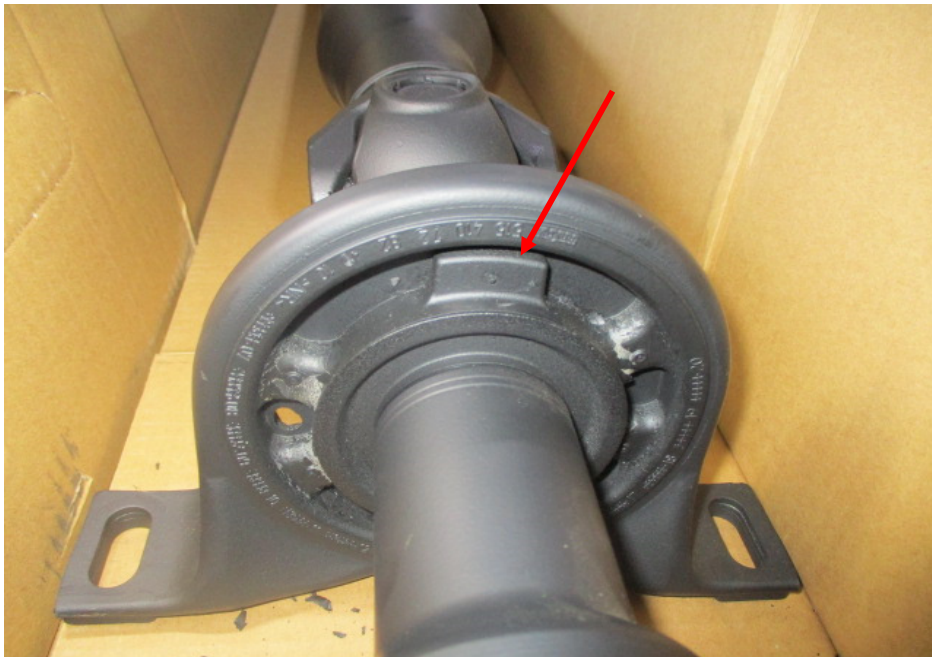
**Photo 19** shows the same rubber bushing (arrowed) of a new propeller shaft front section for comparison purposes with the rubber bushing as seen in photograph 17 & 18 above.
