Affiliated to Federation Internationale Des Experts En Automobile				
CHINA TAIPING INSURANCE (S) PTE LTD 3 ANSON ROAD #16-00 SPRINGLEAF TOWERSINGAPORE 079909			Ref: CC3/CTI20006673/T1es3q2 Date: 03/06/2021 Code: CTI

ADJUSTMENT ON REPAIR COST FOR VEHICLE NO. SHC 1094L

PHOTOGRAPHS FOR VEHICLE NO. SHC 1094L

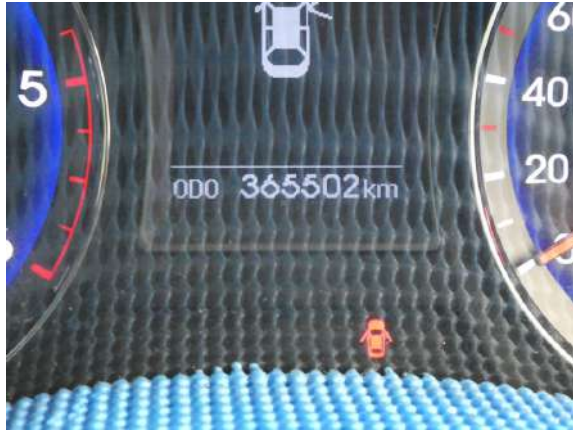
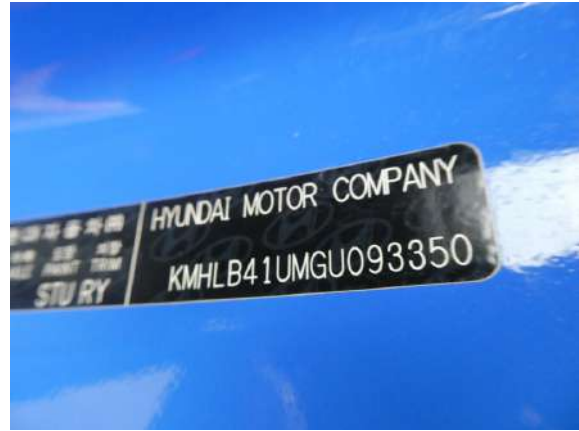
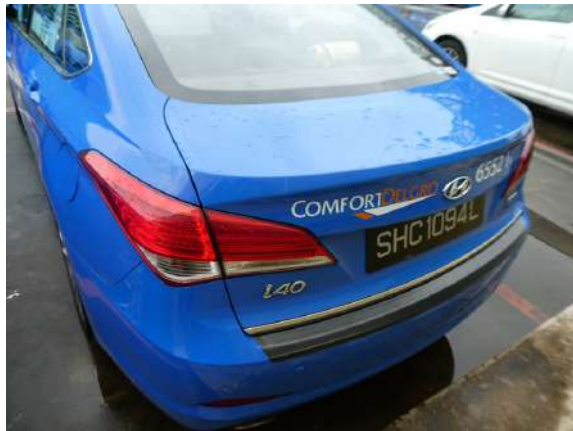
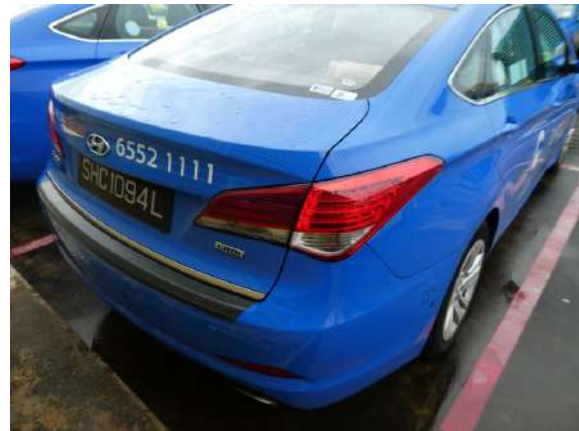
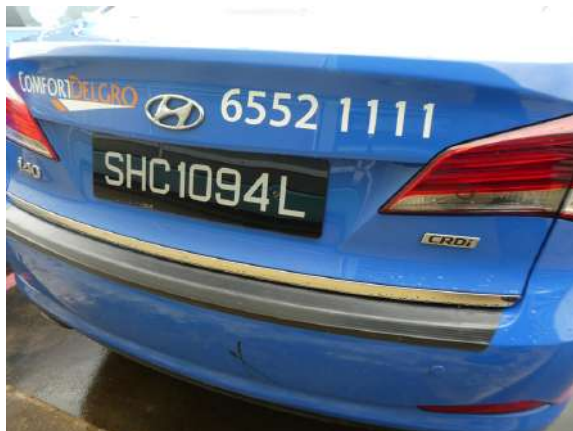
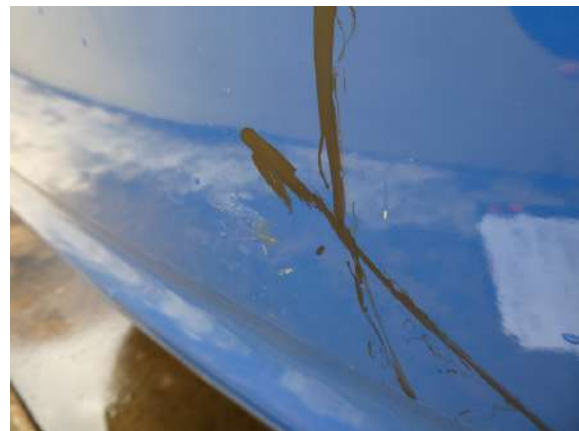
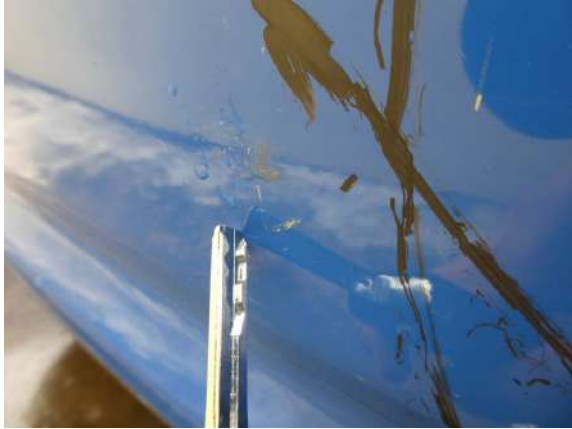
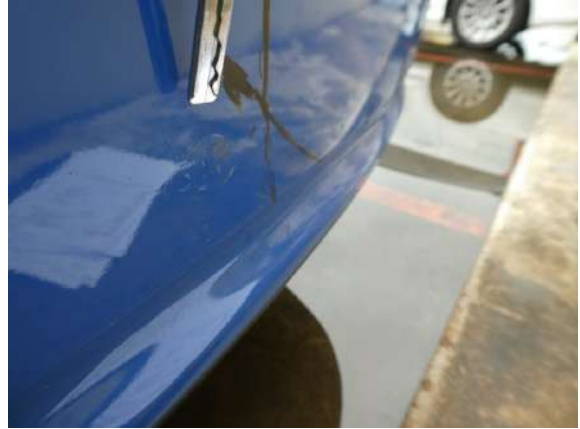
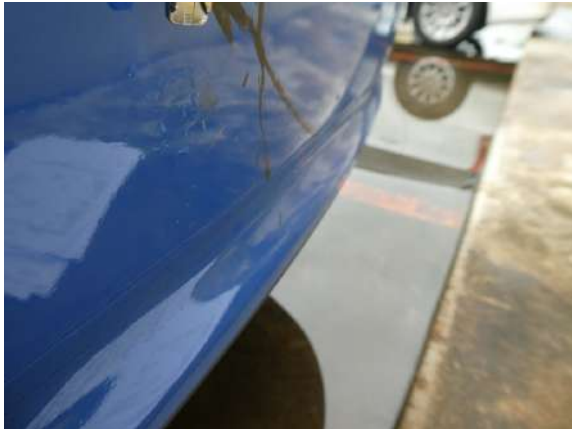
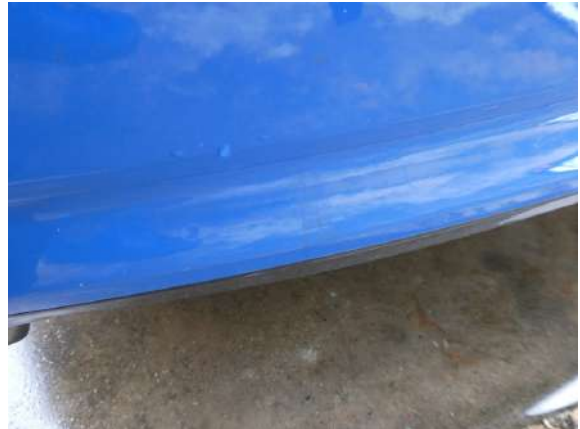
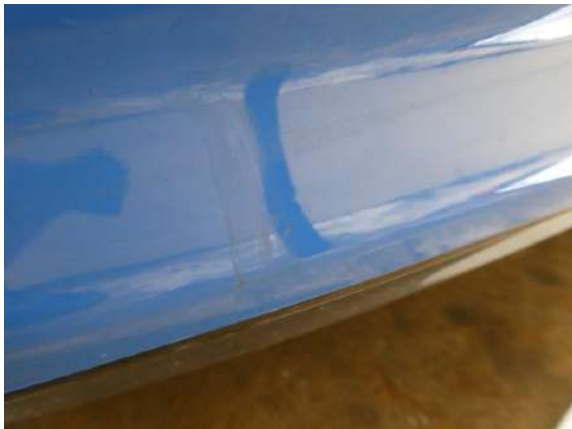
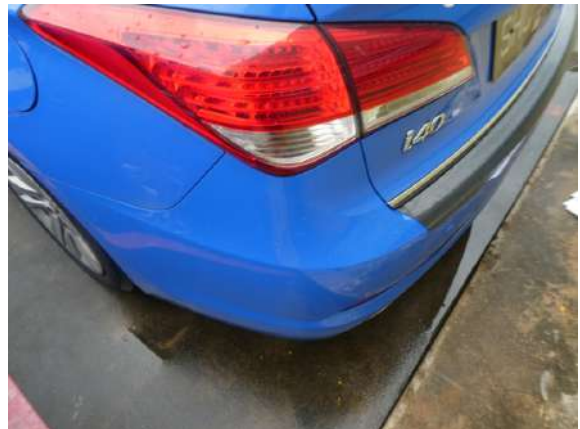
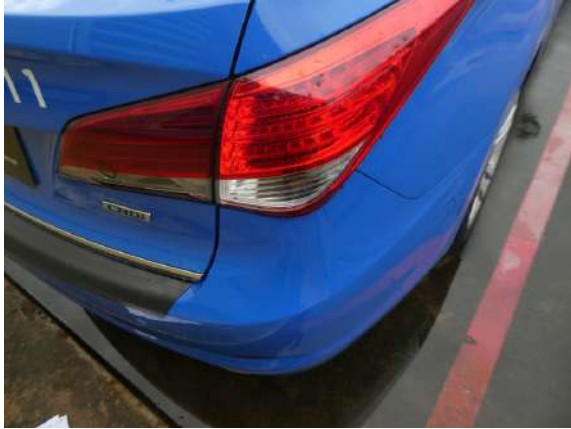
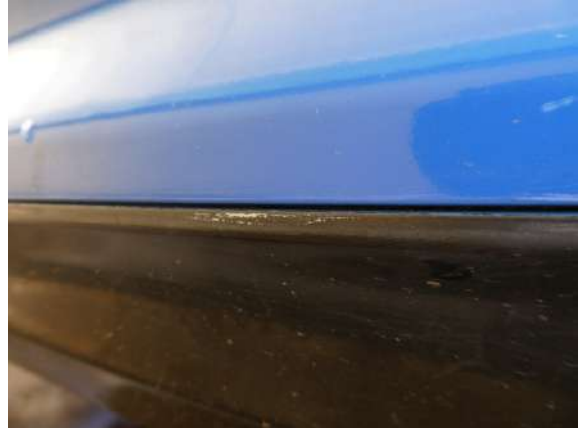
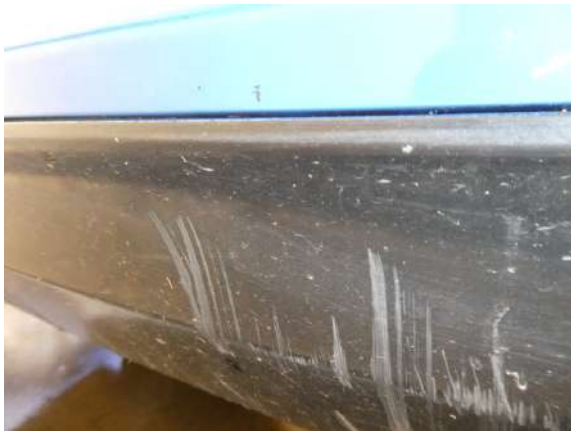
4. Description of Damages				
THE VEHICLE SUSTAINED DAMAGES AT THE REAR PORTION. DAMAGES SEE DETAILS.				
5. General Information				
Accident Date	22/06/2020	Inspection Date	23/06/2020	
Survey held at	COMFORTDELGRO ENGINEERING PTE LTD 59 LOYANG DRIVE SINGAPORE 508969			
5a. Remarks				
A)THE INSPECTION WAS CONDUCTED ON A"WITHOUT PREJUDICE" BASIS. B)IN ACCORDANCE TO YOUR INSTRUCTIONS, WE HAVE NOT AUTHORISED REPAIRS.				
5b. Estimate Days of Repair				
ESTIMATED NORMAL PERIOD FOR REPAIR:		2 Working Days
