Your Ref: Honda Engine  
(number K20A5824204)  
Our Ref : CI/TP20006718/D

26 June 2020

### **INSPECTION REPORT OF A HONDA ENGINE WITH NUMBER K20A5824204**

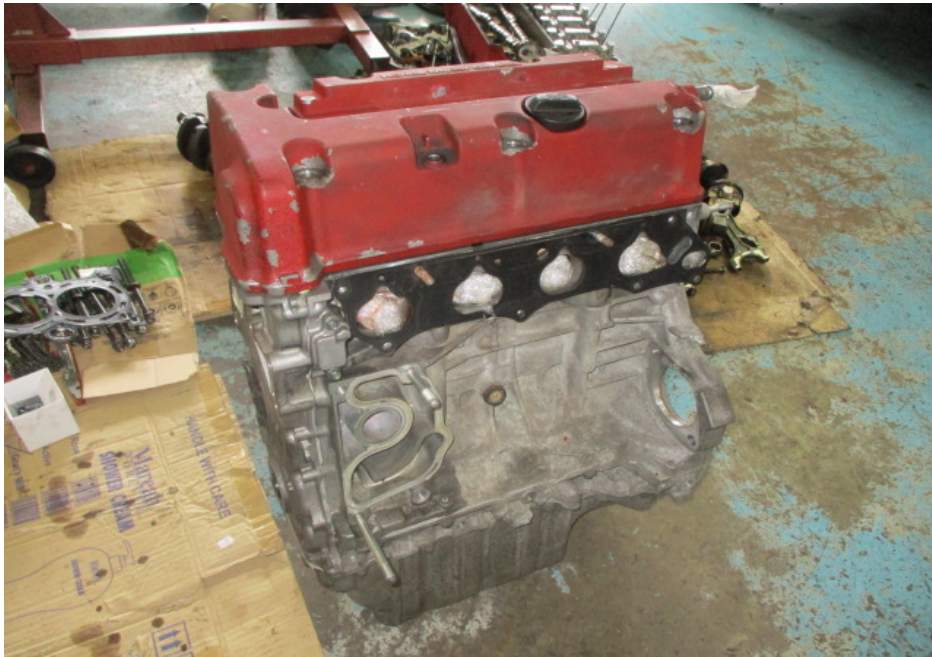
**Photo 1** shows a general view of the Honda engine that I had inspected. The Honda engine was observed to be a used engine and was not fitted on any motor car. It was also observed to be a complete assembly with all mechanical parts still intact, within the engine housing.

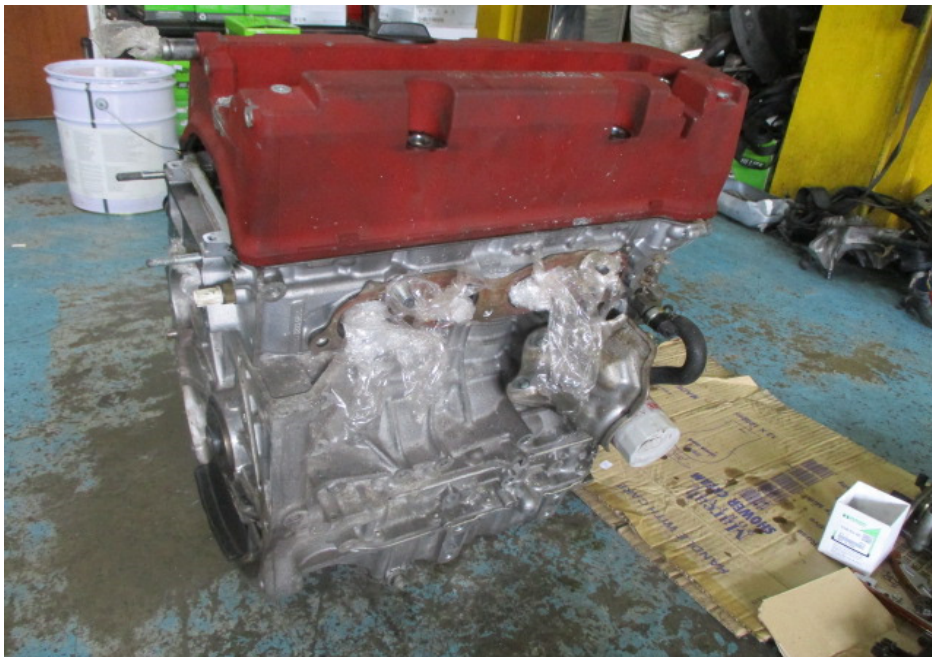
**Photo 2** shows a general view of the Honda engine that I had inspected. My visual examination of the engine housing revealed the housing to be of serviceable/satisfactory condition. There was no crack and/or hole observed on the engine housing.

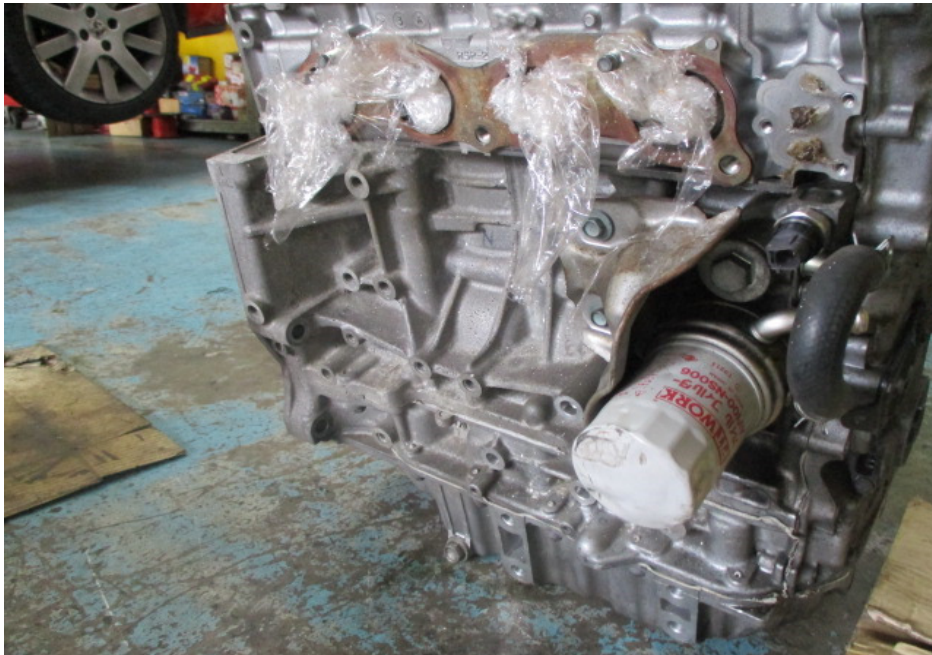
**Photo 3** shows a closer view of the Honda engine that I had inspected. My visual examination of the engine housing revealed the housing to be of serviceable/satisfactory condition. There was no crack and/or hole observed on the engine housing.

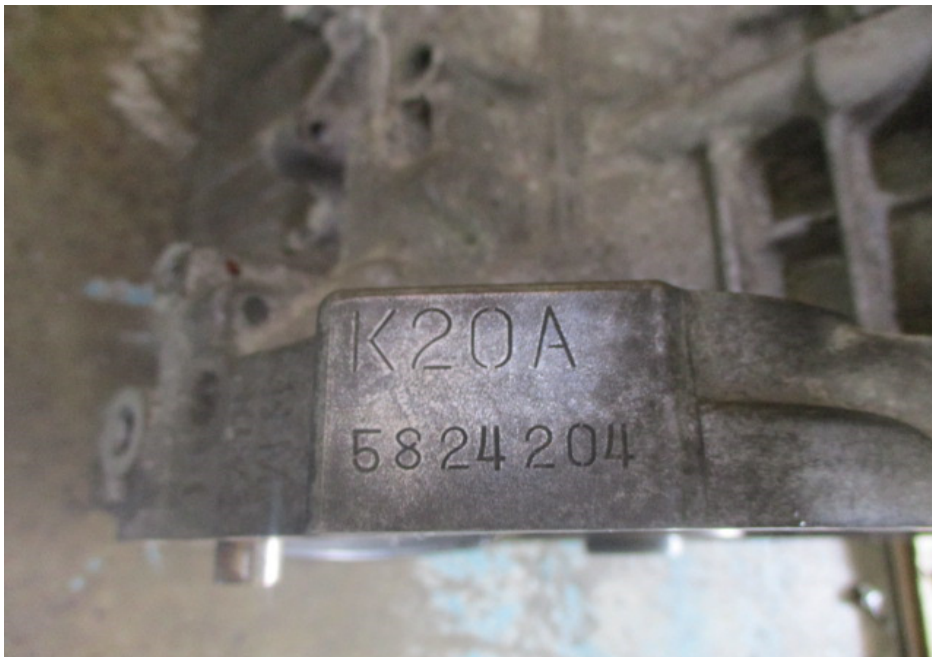
**Photo 4** shows the engine number engraved on the housing of the Honda engine that I had inspected. The engine number was K20A5824204.

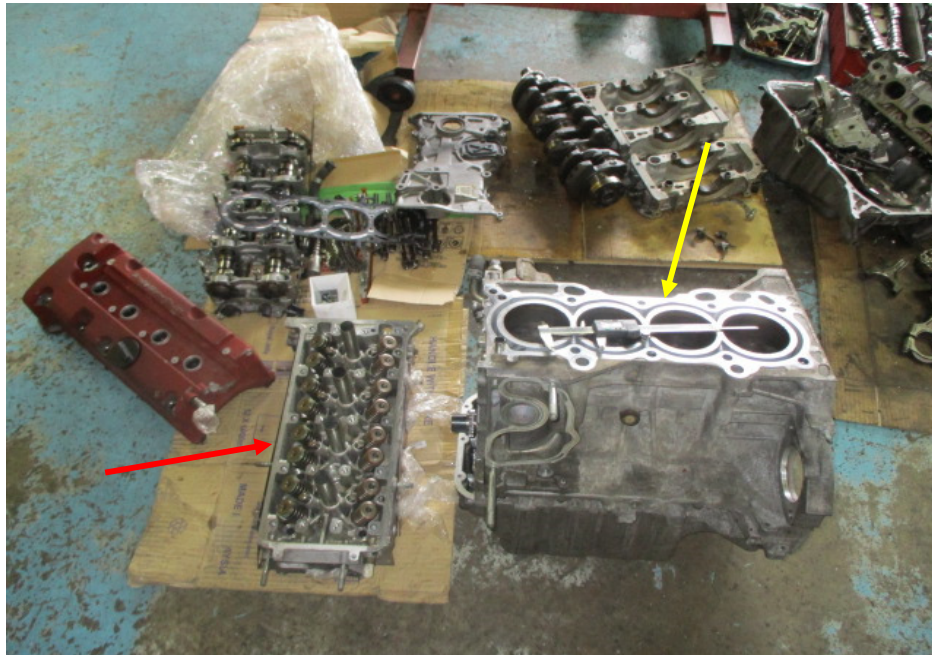
**Photo 5** shows the top block (red arrow) of the Honda engine separated from its bottom block (yellow arrow). This was to enable me to carry out measurements of its cylinders, in particular the bore and stroke measurements of each cylinder, which typically can be used to determine the engine displacement or more commonly referred to as engine cc.

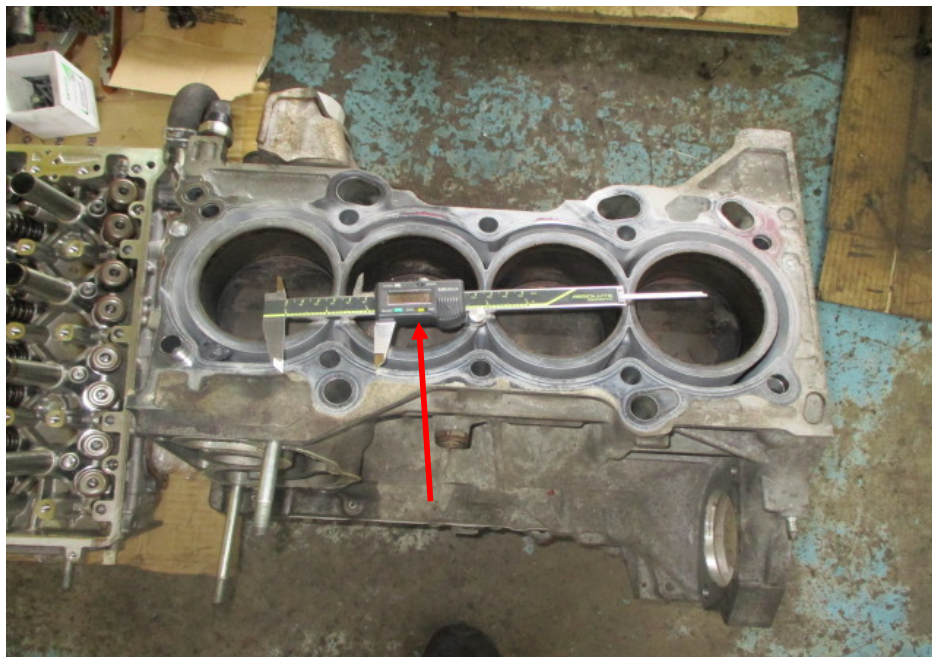
**Photo 6** shows the bottom block of the Honda engine and the digital Vernier Caliper (arrowed) that was used to measure the bore and stroke measurements of each cylinder, which typically can be used to determine the engine displacement or more commonly referred to as engine cc. The digital Vernier Caliper was calibrated before the start of the measurements.

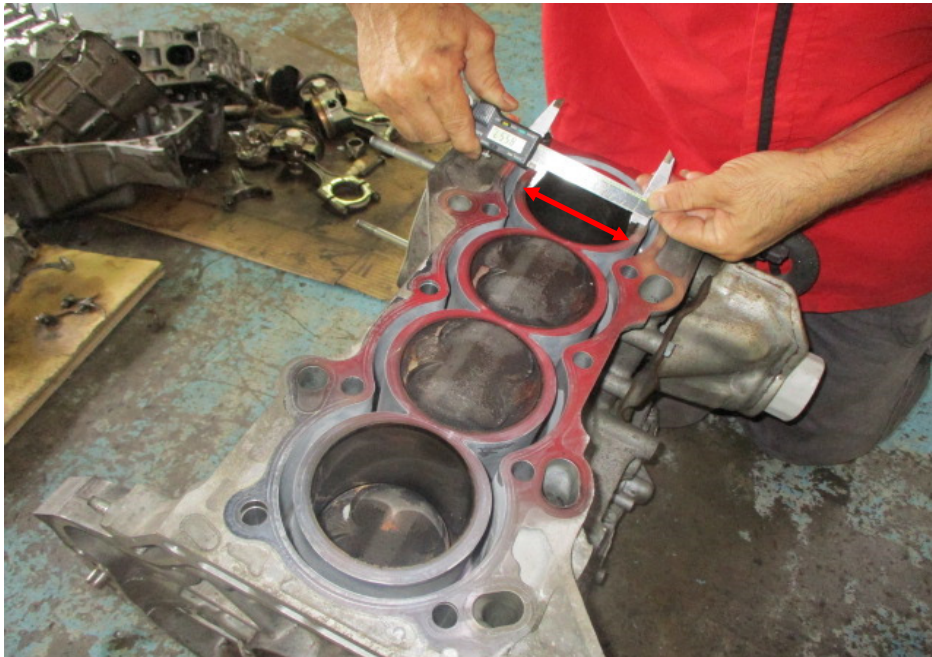
**Photo 7** shows measurement being carried out to the bore (arrowed) of cylinder 1 of the Honda engine. The measurements were carried out using a digital Vernier Caliper that was calibrated before the start of the measurements.

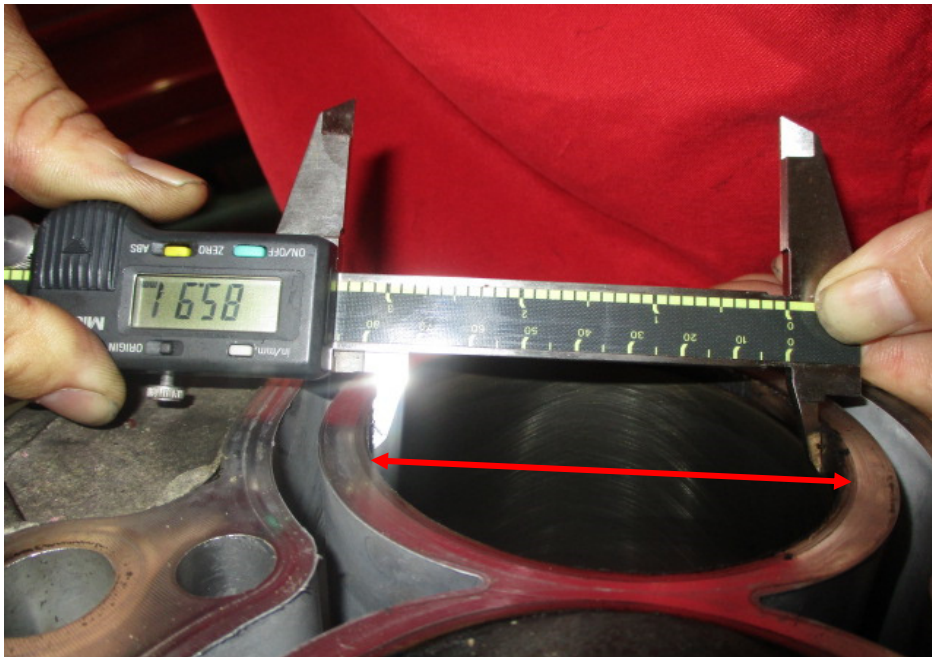
**Photo 8** shows the bore measurement of cylinder 1, which was recorded to be 85.91mm.

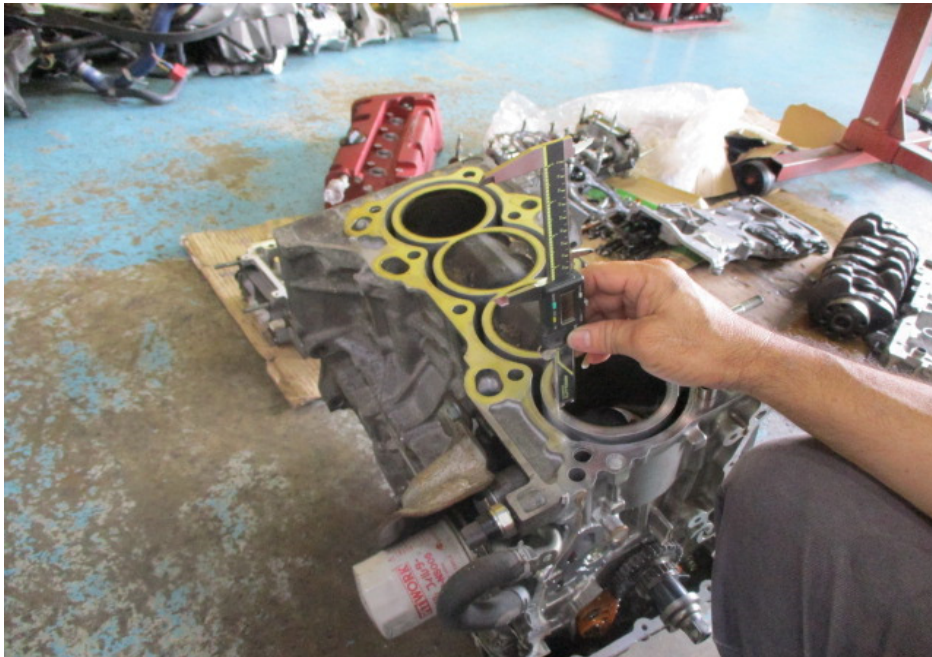
**Photo 9** shows measurement being carried out to the stroke of cylinder 1 of the Honda engine. The bore and stroke measurements of the Honda engine were carried out using a digital Vernier Caliper.

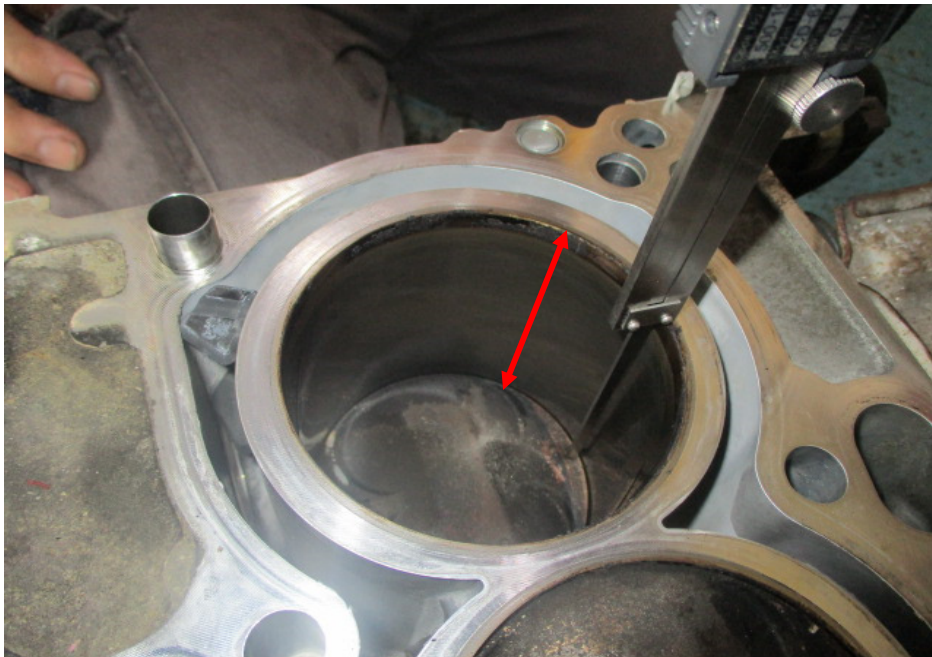
**Photo 10** shows measurement being carried out to the stroke (arrowed) of cylinder 1 of the Honda engine. The bore and stroke measurements of the Honda engine were carried out using a digital Vernier Caliper that was calibrated before the start of the measurements,

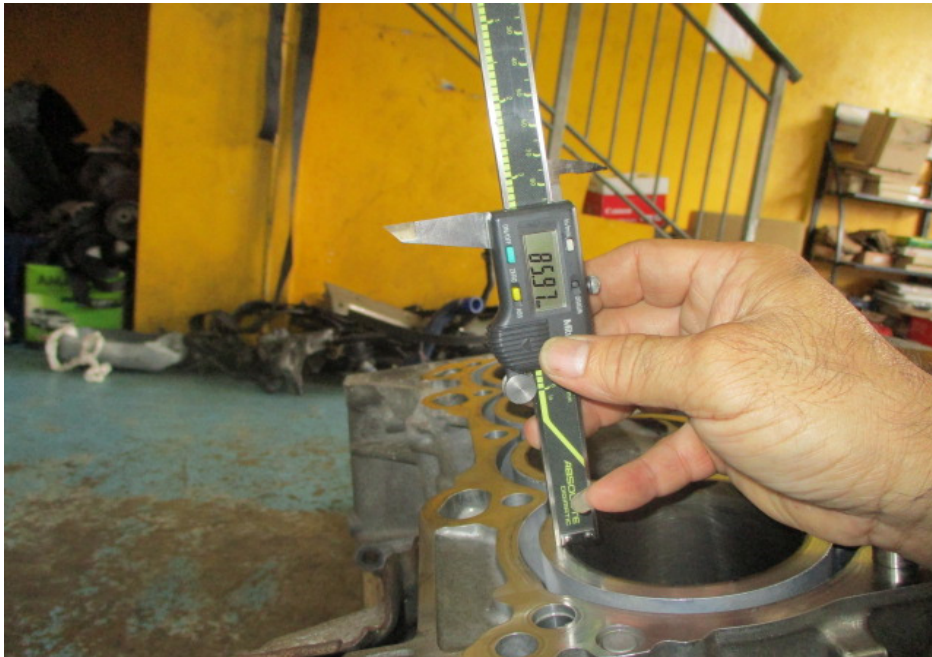
**Photo 11** shows the stroke measurement of cylinder 1, which was recorded to be 85.97mm.

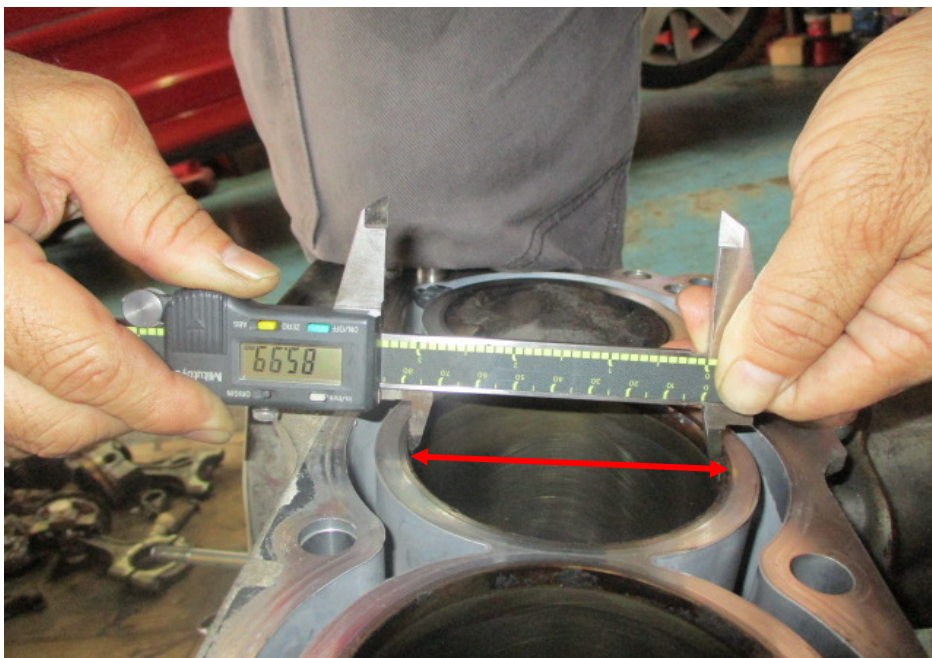
**Photo 12** shows measurement being carried out to the bore (arrowed) of cylinder 2 of the Honda engine. The bore measurement of cylinder 2 was recorded to be 85.99mm.

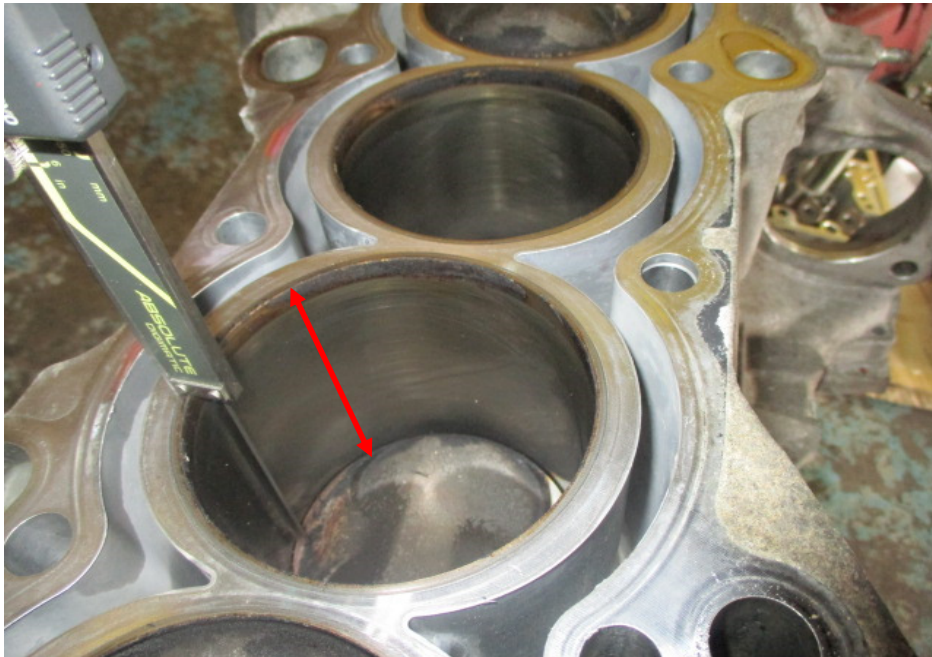
**Photo 13** shows measurement of the stroke (arrowed) for cylinder 2 of the Honda engine that I had inspected.

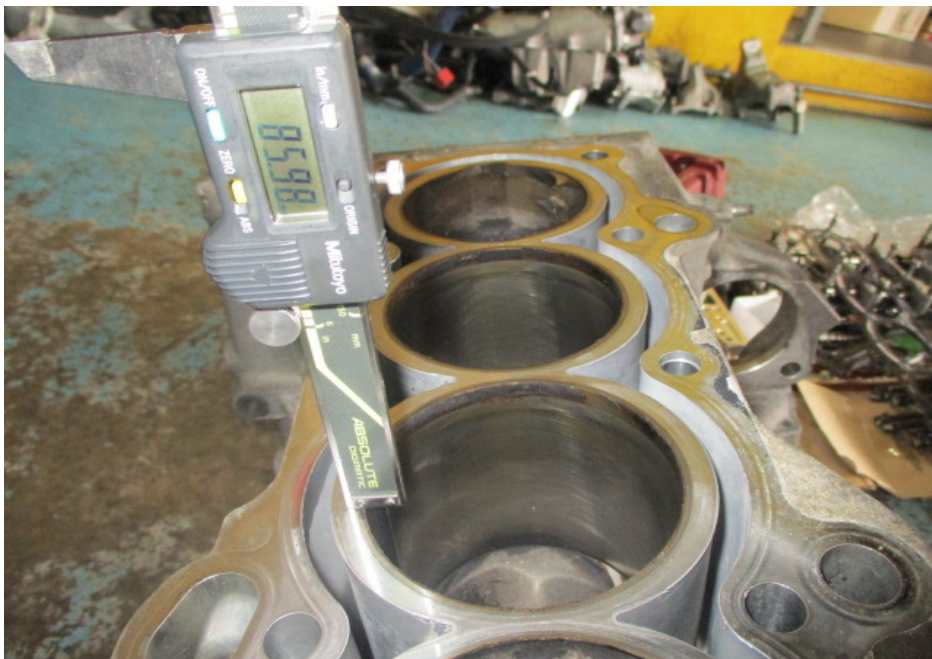
**Photo 14** shows the stroke measurement of cylinder 2, which was recorded to be 85.98mm.

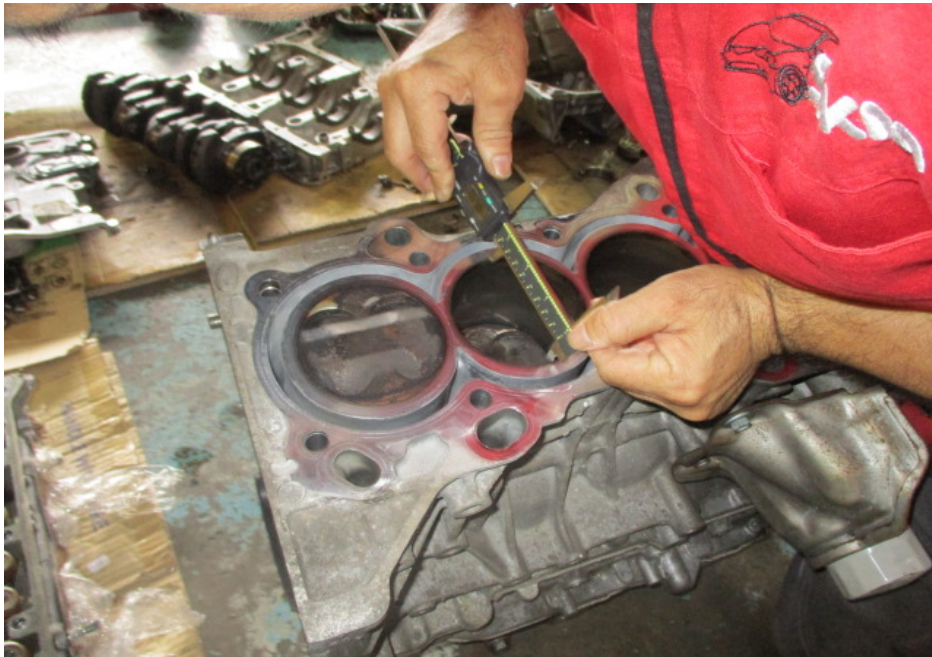
**Photo 15** shows measurement being carried out to the bore of cylinder 3 of the Honda engine. The bore and stroke measurements of the Honda engine were carried out using a digital Vernier Caliper.

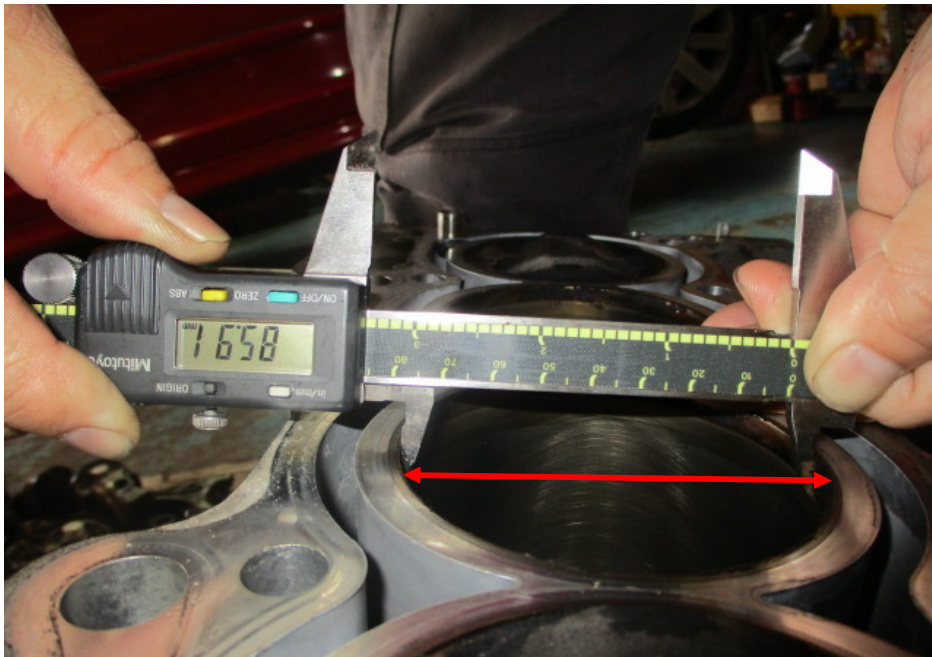
**Photo 16** shows measurement being carried out to the bore (arrowed) of cylinder 3 of the Honda engine. The bore measurement of cylinder 3 was recorded to be 85.91mm.

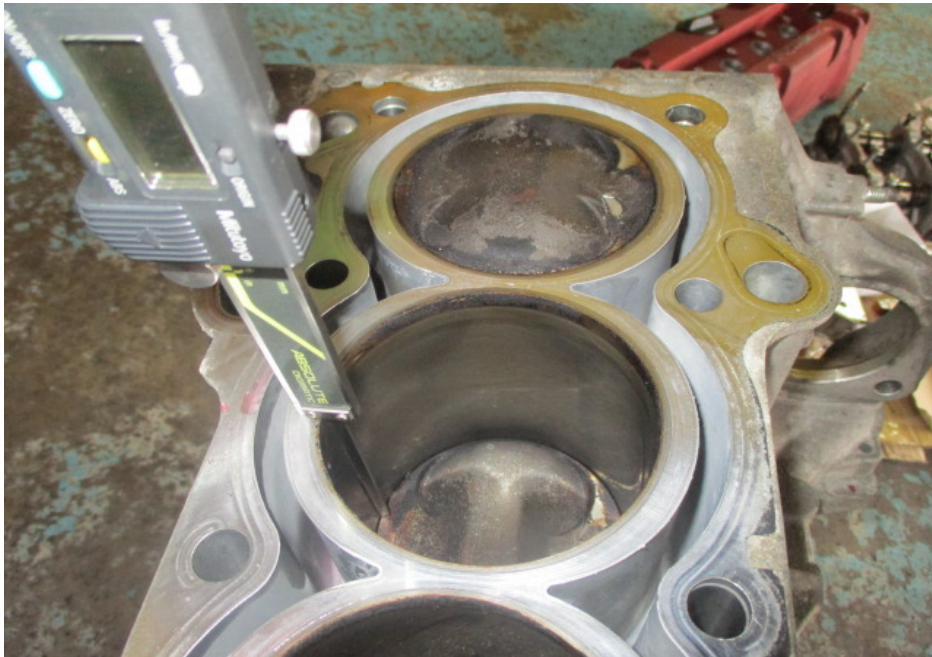
**Photo 17** shows measurement of the stroke for cylinder 3 of the Honda engine that I had inspected. The bore and stroke measurements of the Honda engine were carried out using a digital Vernier Caliper that was calibrated before the start of measurements.

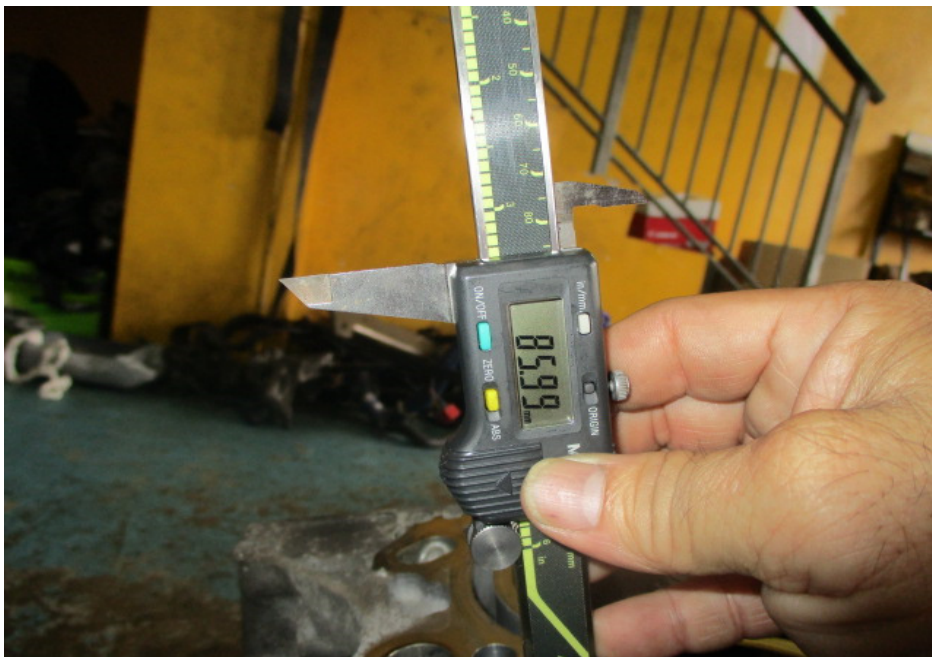
**Photo 18** shows the stroke measurement of cylinder 3, which was recorded to be 85.99mm.

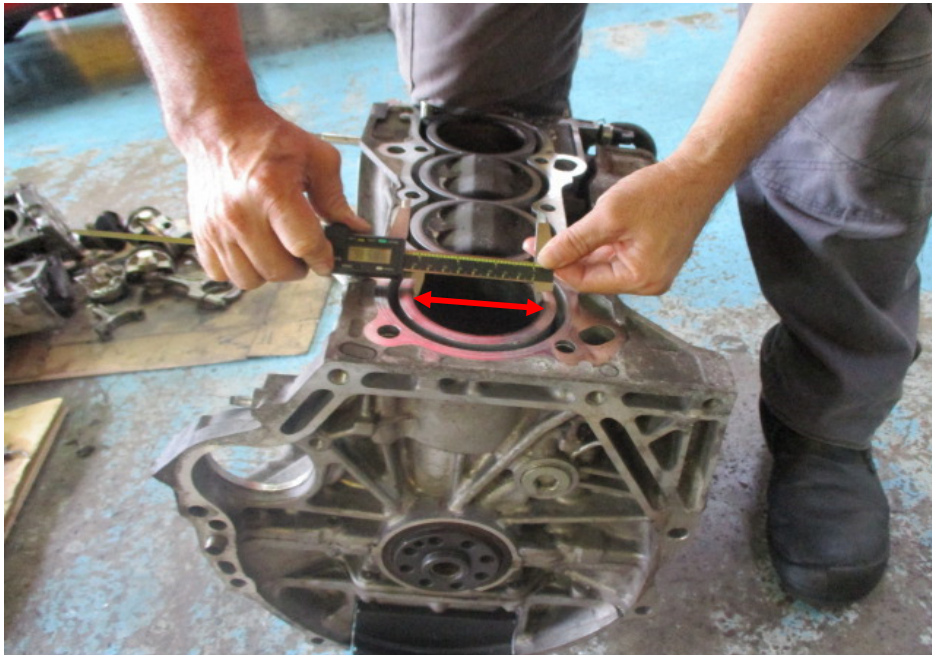
**Photo 19** shows measurement being carried out to the bore (arrowed) of cylinder 4 of the Honda engine. The bore and stroke measurements of the Honda engine were carried out using a digital Vernier Caliper.

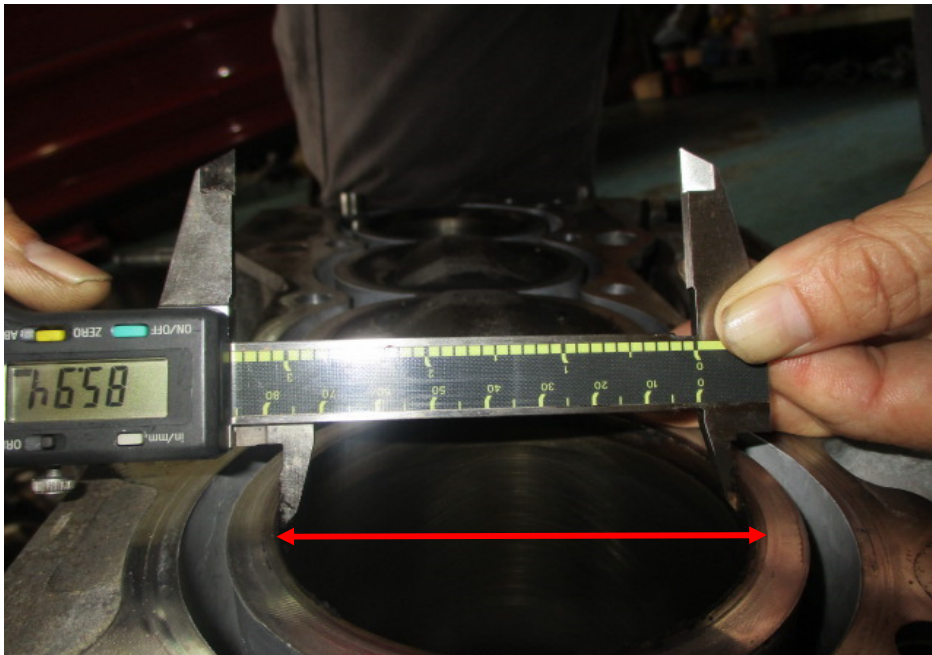
**Photo 20** shows the bore measurement of cylinder 4, which was recorded to be 85.94mm.

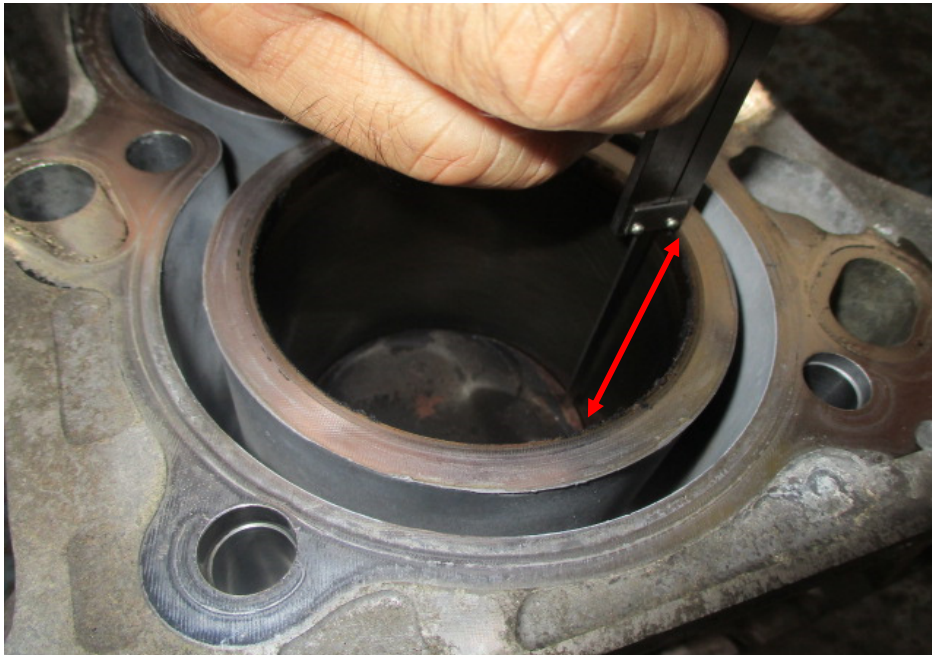
**Photo 21** shows measurement being carried out to the stroke (arrowed) of cylinder 4 of the Honda engine. The bore and stroke measurements of the Honda engine were carried out using a digital Vernier Caliper that was calibrated prior to the start of measurements.

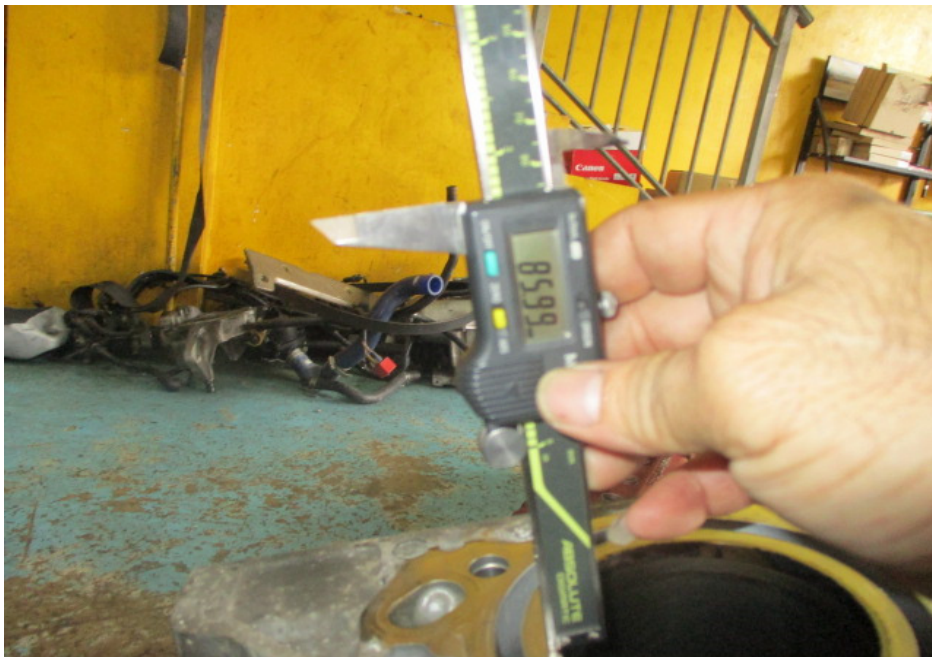
**Photo 22** shows the stroke measurement of cylinder 4, which was recorded to be 85.99mm.
