Your Ref: BMW 530e  
(chassis number WBAJA92020WB38431)  
Our Ref : CI/TP20006719/D

24 June 2020

**INSPECTION REPORT OF AN UNREGISTERD BMW 530e MOTOR CAR  
WITH CHASSIS NUMBER WBAJA92020WB38431**

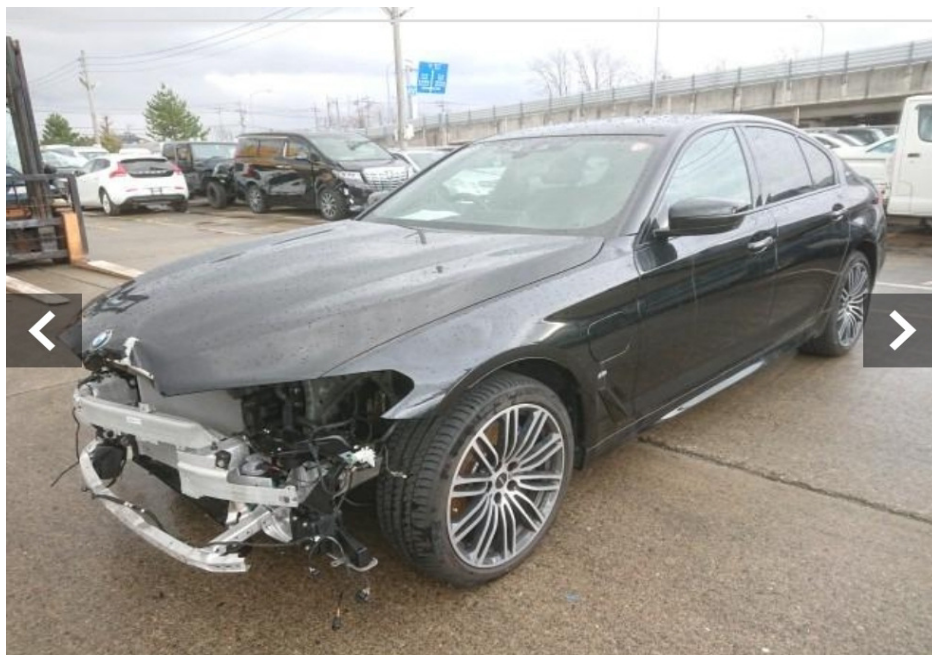
3. From the photographs provided to me, it was observed that the Motor Car had sustained damages at its frontal portion. Body parts observed to have been damaged and/or dislodged include its front bumper, front bonnet, front headlamps, front bumper reinforcement, front radiator grilles and front lower grille amongst others.
4. Photograph showing the engine compartment of the Motor Car had indicated no damage to parts within the engine compartment, including its engine assembly. The airbags of the Motor Car were also not deployed as seen from the photographs provided to me. See photo 1 – 3 below.

**Photo 1** shows the front left body of the Motor Car prior to any repairs being carried out (photograph provided to me). The Motor Car was observed to have sustained damages at its frontal portion. The body parts observed to be damaged and/or dislodged had included its front bumper, front left headlamp, front bonnet, front bumper reinforcement and front radiator grilles amongst others. Basing on the photographs provided to me, the airbags of the Motor Car were not deployed.

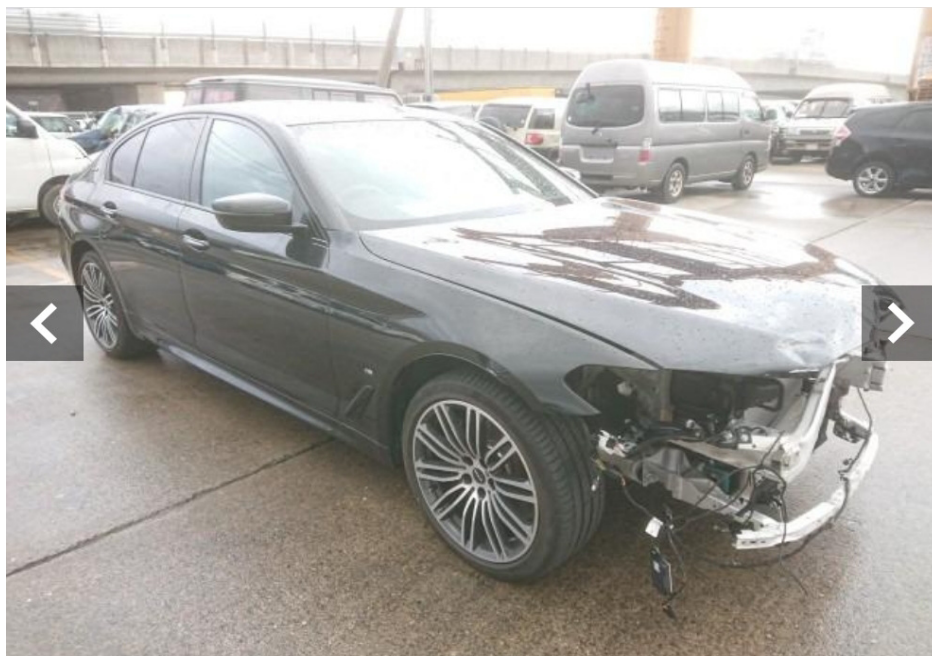
**Photo 2** shows the front right body of the Motor Car prior to any repairs being carried out (photograph provided to me). The Motor Car was observed to have sustained damages at its frontal portion. The body parts observed to be damaged and/or dislodged had included its front bumper, front right headlamp and front bonnet amongst others.

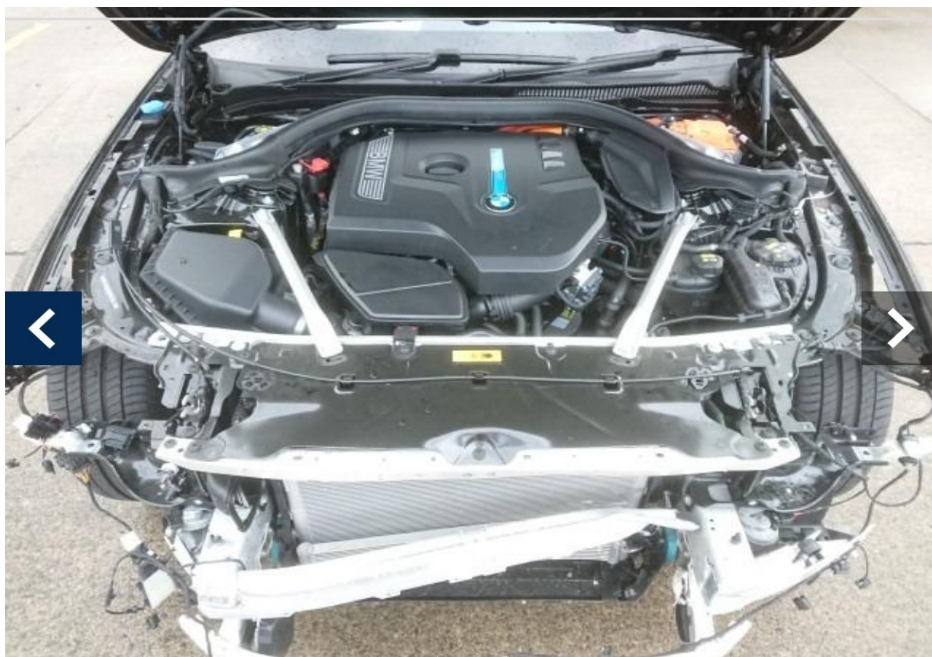
**Photo 3** shows the engine compartment of the Motor Car prior to any repairs being carried out (photograph provided to me). Parts within the engine compartment were observed to be intact and undamaged, including the engine assembly of the Motor Car.

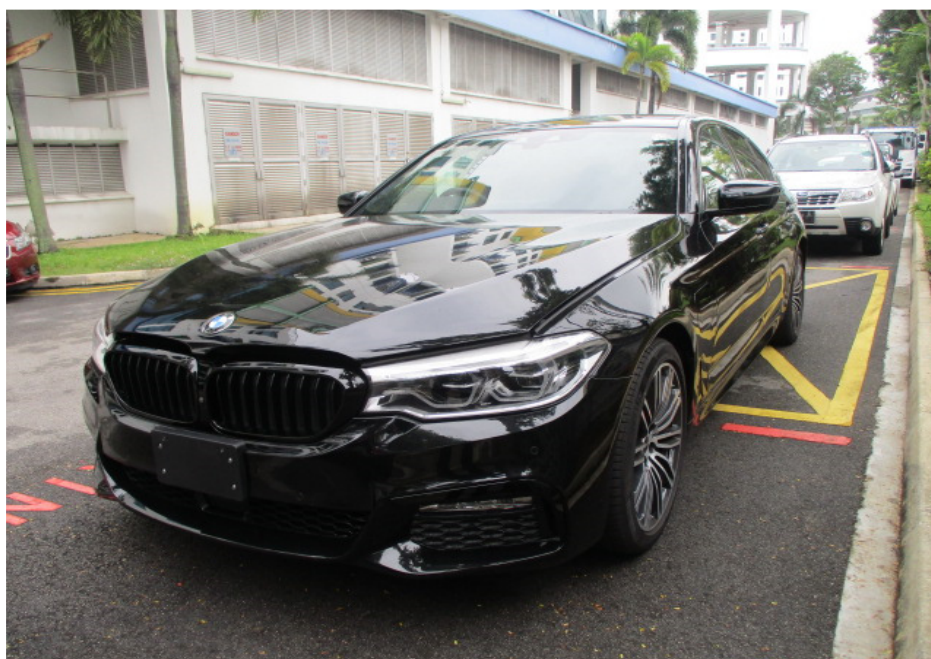
**Photo 4** shows a general view of the front left body of the Motor Car at the time of my inspection. The Motor Car was observed to be in relatively good general condition with no loose exterior fittings observed. The body parts at the frontal portion of the Motor Car were visually examined and it was observed that the repair/restoration works carried out to the damaged area of the Motor Car (refer photograph 1 to 3 above) were reasonably adequate and in order.

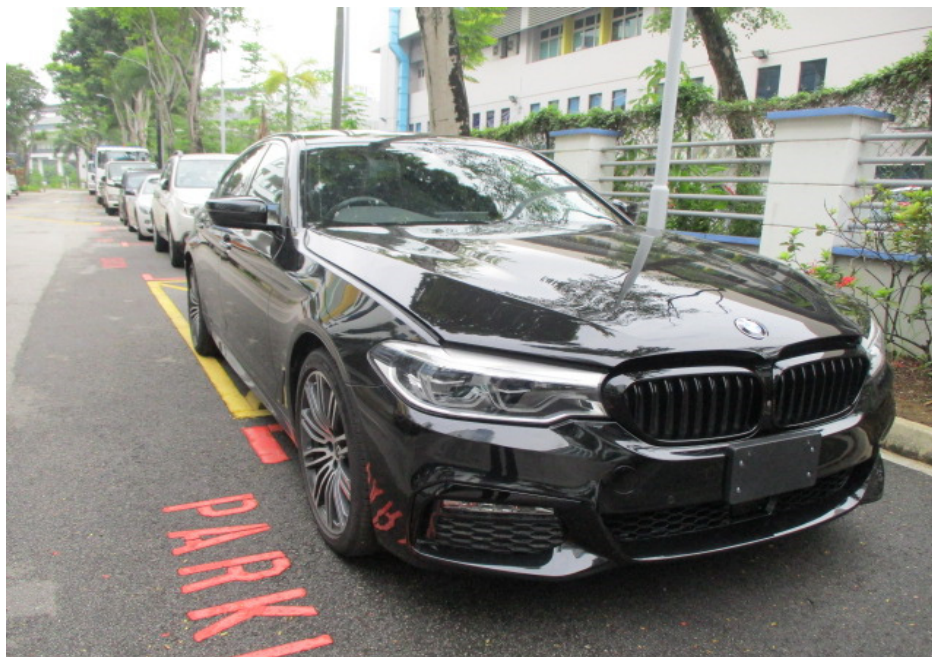
**Photo 5** shows a general view of the front right body of the Motor Car at the time of my inspection. The Motor Car was observed to be in relatively good general condition with no loose exterior fittings observed. The body parts at the frontal portion of the Motor Car were visually examined and it was observed that the repair/restoration works carried out to the damaged area of the Motor Car (refer photograph 1 to 3 above) were reasonably adequate and in order.

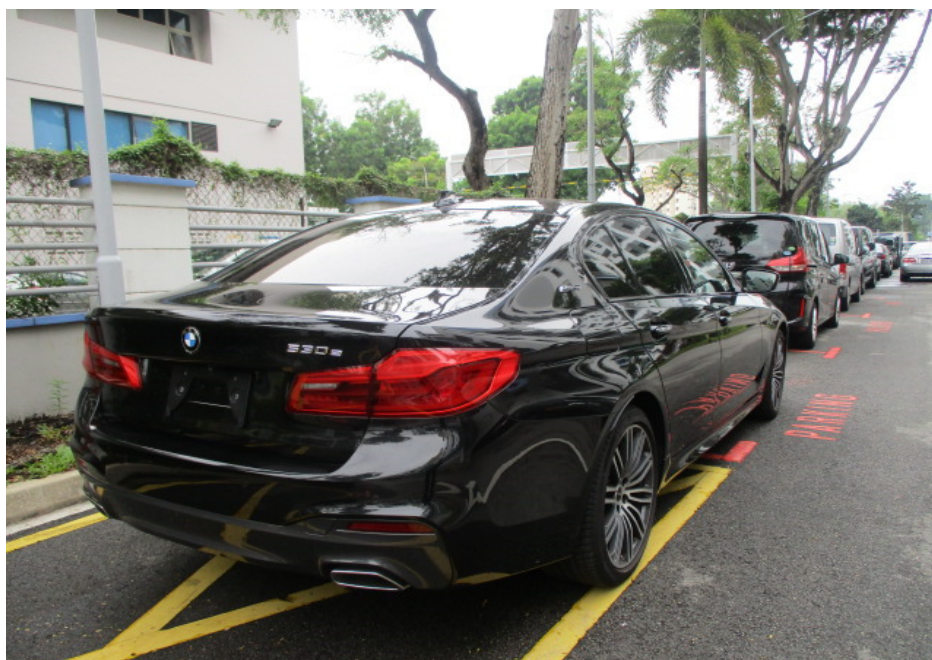
**Photo 6** shows a general view of the rear right body of the Motor Car at the time of my inspection. The Motor Car was observed to be in relatively good general condition with no loose exterior fittings observed.

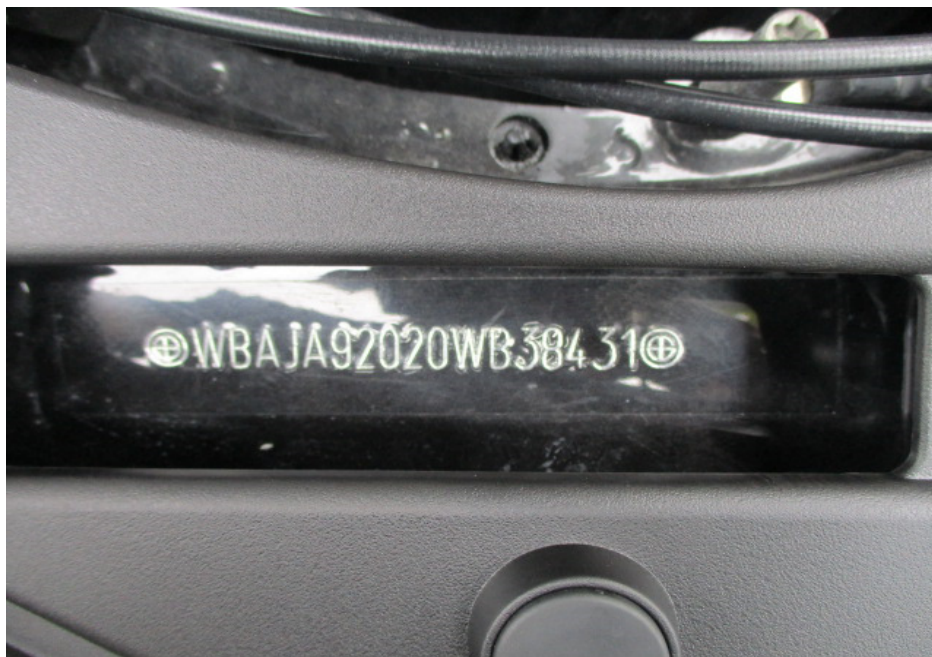
**Photo 7** shows the chassis number of the Motor Car. The chassis number recorded was WBAJA92020WB38431.

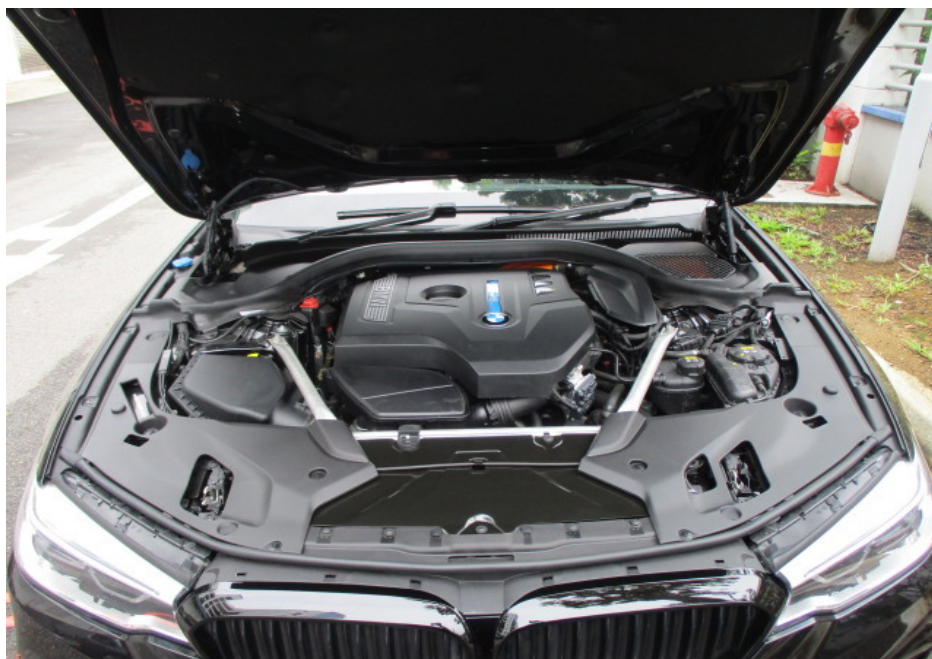
14. My examination of the engine compartment of the Motor Car revealed that the various parts and components inside the engine compartment were all intact and properly fitted. The engine oil, brake fluid and engine coolant were all found to be of sufficient level for operating purposes. Visually, there was also no contamination found to these fluids.
15. My checks on the underside of the Motor Car revealed no sign(s) or indication(s) of fluid leakage and/or fluid stain(s). The engine block and automatic transmission assembly were both secured properly. They were not mounted onto the chassis/structure body or any integral body part of the Motor Car. All undercarriage components of the Motor Car were also observed to be intact and secured in an appropriate manner.

**Photo 8** shows a general view of the engine compartment of the Motor Car at the time of my inspection. The various parts and components inside the engine compartment were all observed to be intact and properly fitted. There was also no sign(s) or indication(s) of fluid leak and/or fluid stain found inside the engine compartment.

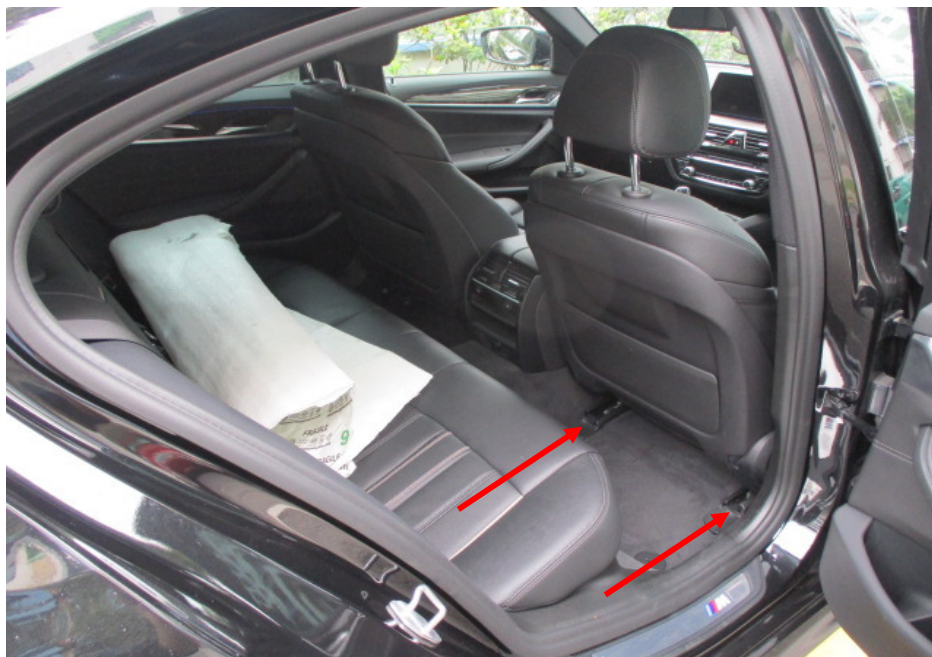
12. The seats of the Motor Car were found to be secured to the floor board of the Motor Car via seat rails bolted onto the floor board. Retractable seat belt reels and pre-tensioners were fitted on all seats of the Motor Car. The seat belt reels were tested and were able to be fastened securely into the respective pre-tensioners that were fixed to the side of all the seats.

**Photo 9** shows the seats of the Motor Car, which were secured via seat rails (arrowed) to the floor board. All the seats of the Motor Car were fitted with a retractable seat belt reel and pre-tensioner. The seat belts were tested and able to be fastened into the respective pre-tensions that were fitted on the side of each individual seat.

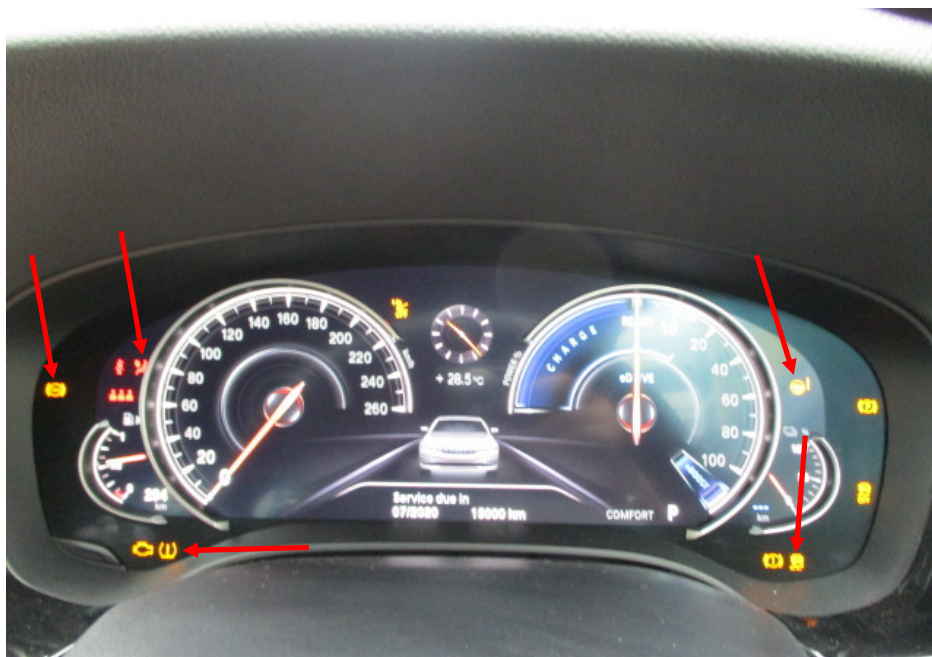
**Photo 10** shows the warning lights for the various electronic safety features appearing on the instrument panel of the Motor Car during its self-test when the engine is cranked, in particular the ABS, SRS, IAS, TPM and DSC lights (arrowed).

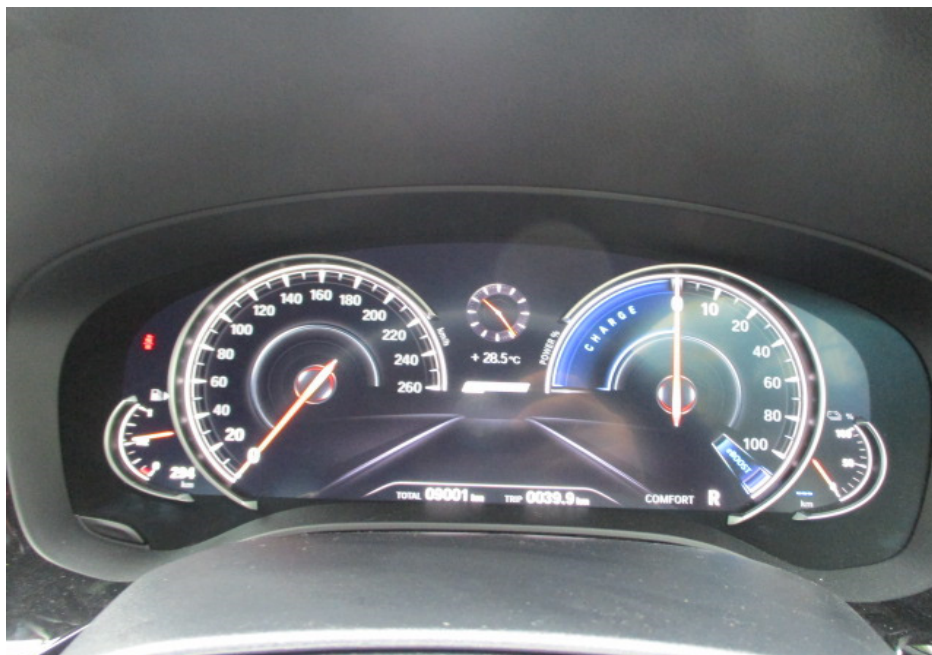
13. The Motor Car's automatic self-test of the functionality of its various electronic safety features like the Anti-Lock Brake System (ABS), Supplemental Restraint System (SRS), Integral Active Steering (IAS), Tyre Pressure Monitor (TPM) and Dynamic Stability Control (DSC) during cranking of the engine had indicated that these electronic systems were in working condition. This was determined from the respective warning lights disappearing from the instrument panel after the self-test.

**Photo 11** shows the respective warning lights no longer illuminated, indicating that there is no fault detected to the ABS, SRS, IAS, TPM and DSC systems of the Motor Car during the self-test. These electronic systems were hence in working condition at the time of my inspection.

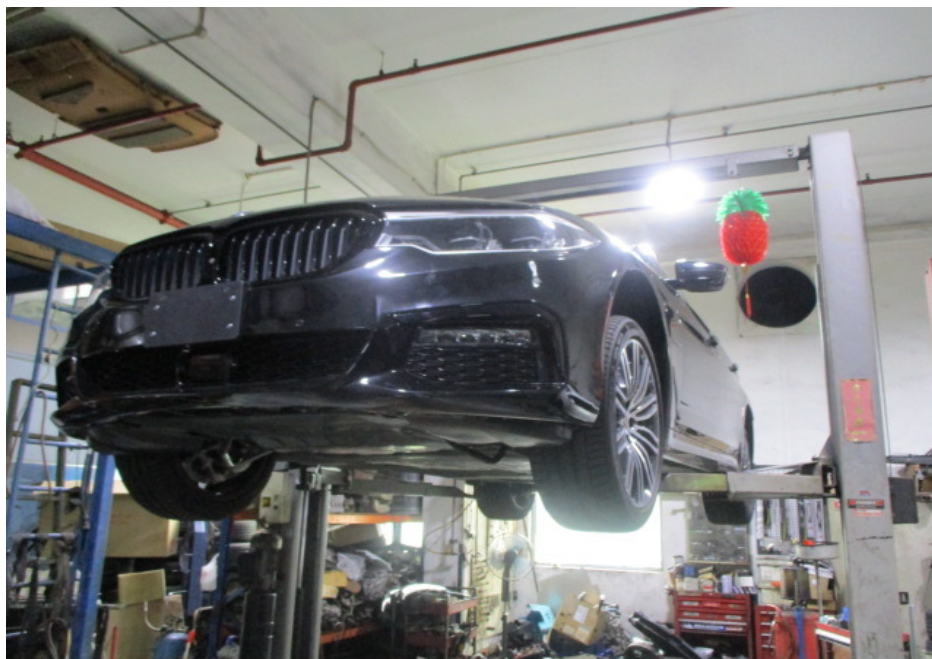
**Photo 12** shows the Motor Car hoisted up for checks on its undercarriage. There was no sign(s) or indication(s) of fluid leakage and/or fluid stain(s) on the underside of the Motor Car. The undercarriage components of the Motor Car were also all observed to be intact and secured in an appropriate manner.

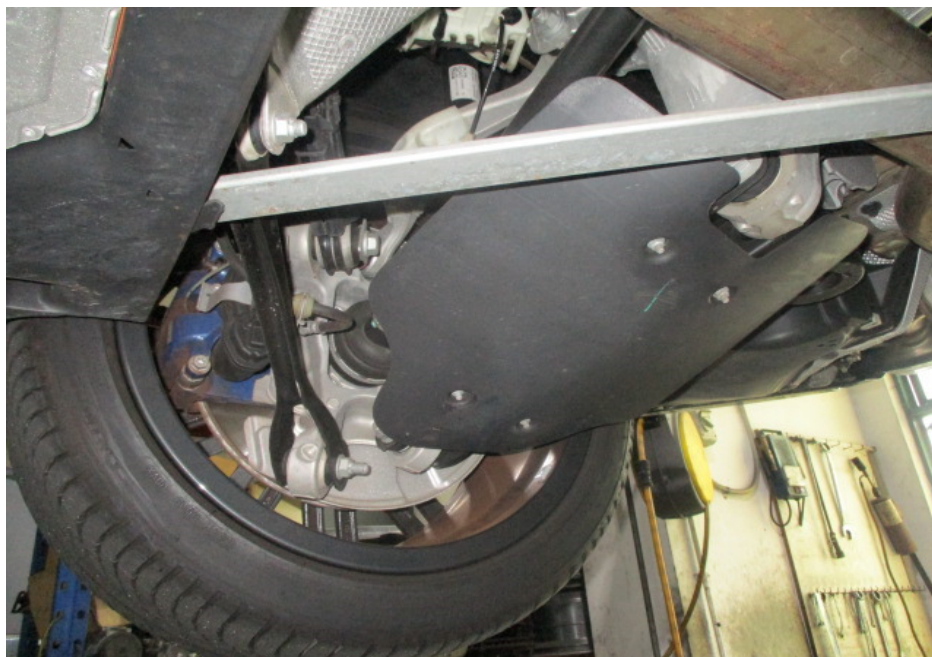
**Photo 13** shows a general view of the control arms and linkages at the rear right wheel of the Motor Car. I did not observe any fluid leak and/or fluid stain on the underside of the Motor Car. All of the Motor Car's undercarriage components were observed to be intact and secured in an appropriate manner.

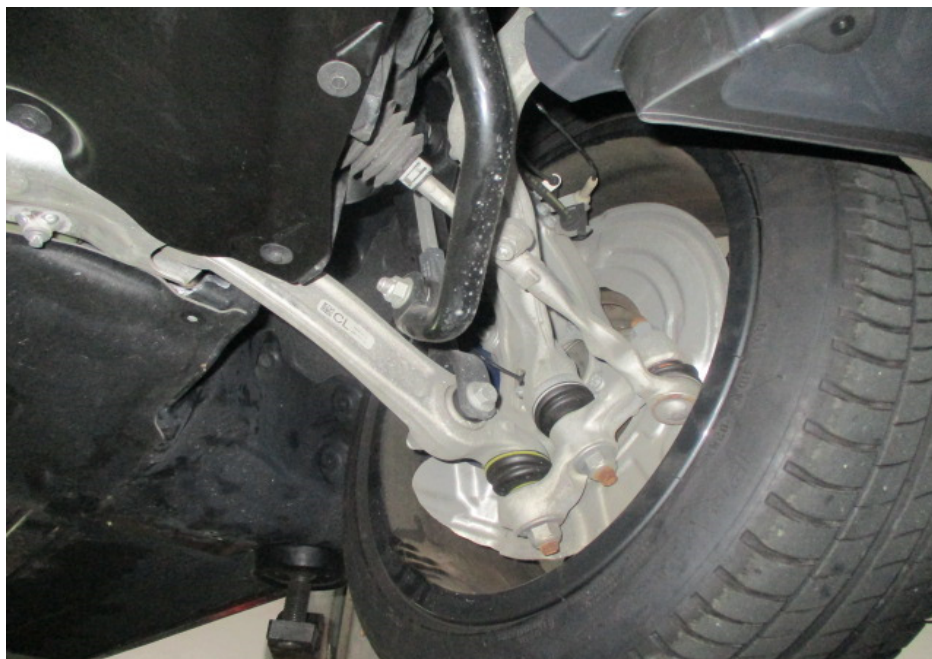
**Photo 14** shows the various undercarriage components at the front left wheel of the Motor Car. The mechanical components, control arms and linkages were all found to be intact and secured in an appropriate manner.

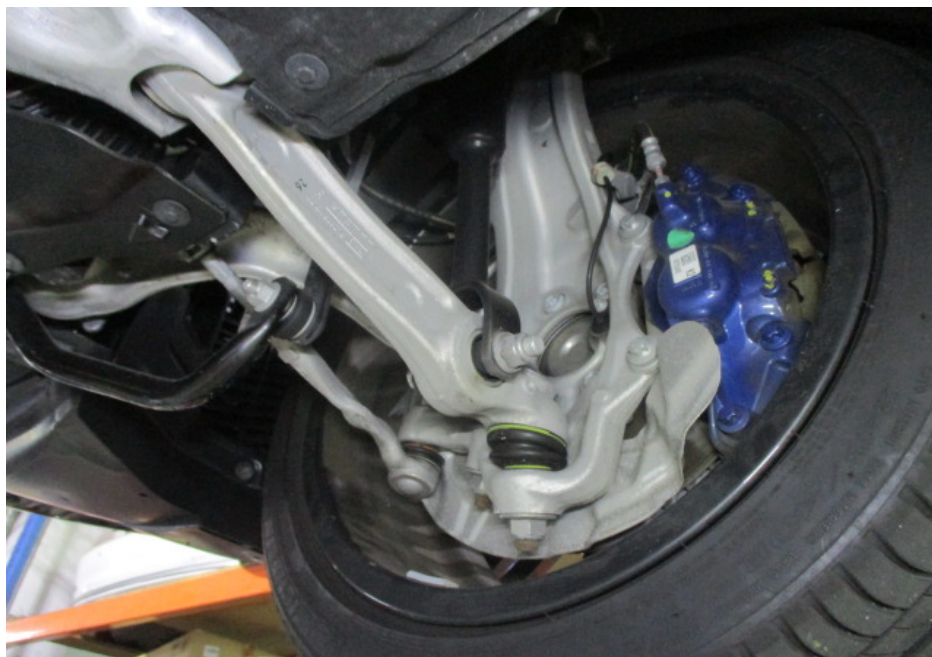
**Photo 15** shows the various undercarriage components at the front right wheel of the Motor Car. The mechanical components, control arms and linkages were all found to be intact and secured in an appropriate manner. I also did not observe any fluid leak and/or fluid stain on the underside of the Motor Car.

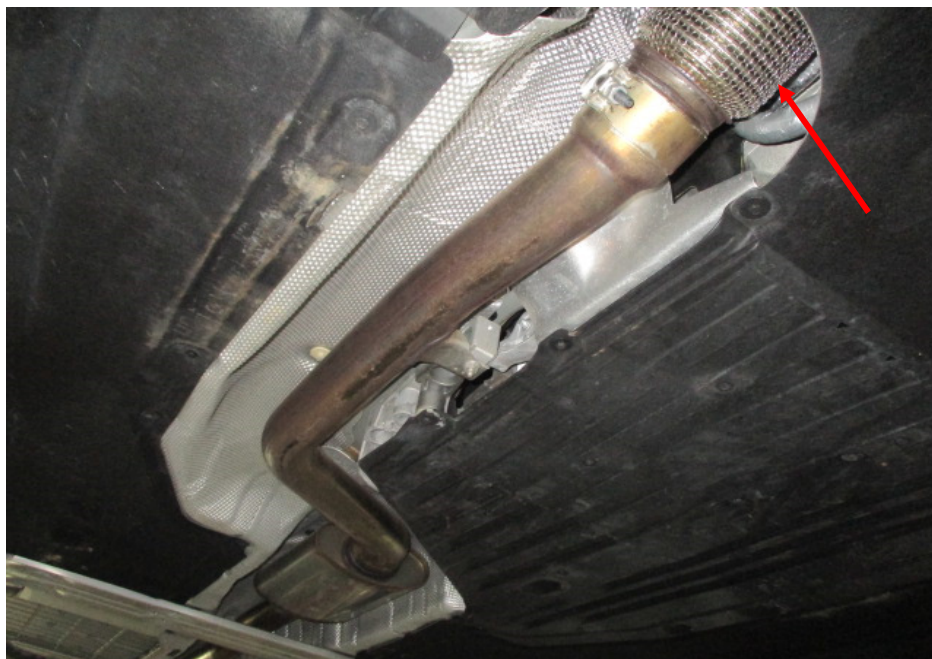
**Photo 16** shows the Motor Car's catalytic convertor (arrowed). My examination of the Motor Car's exhaust system revealed no sign(s) or indication(s) of any cut or weld marks along its exhaust pipes and on its rear muffler.

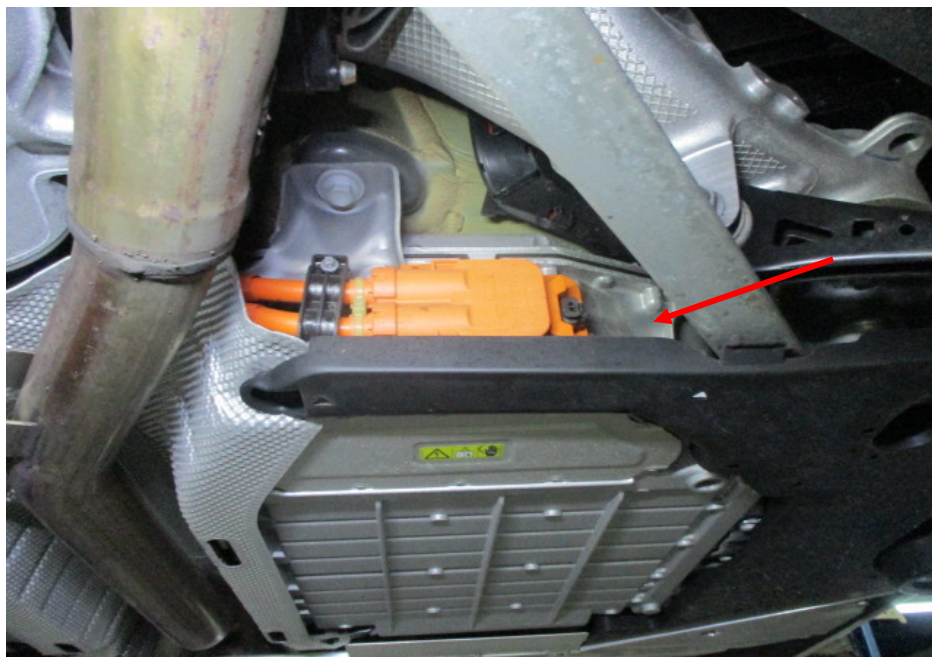
**Photo 17** shows the Motor Car's electric battery that was fitted on the underside rear floor board (arrowed). The cable connections were checked and found to be securely fitted into the respective connectors. The electric battery was also observed to be fitted securely and not mounted onto any part of the Motor Car's chassis/structural body.

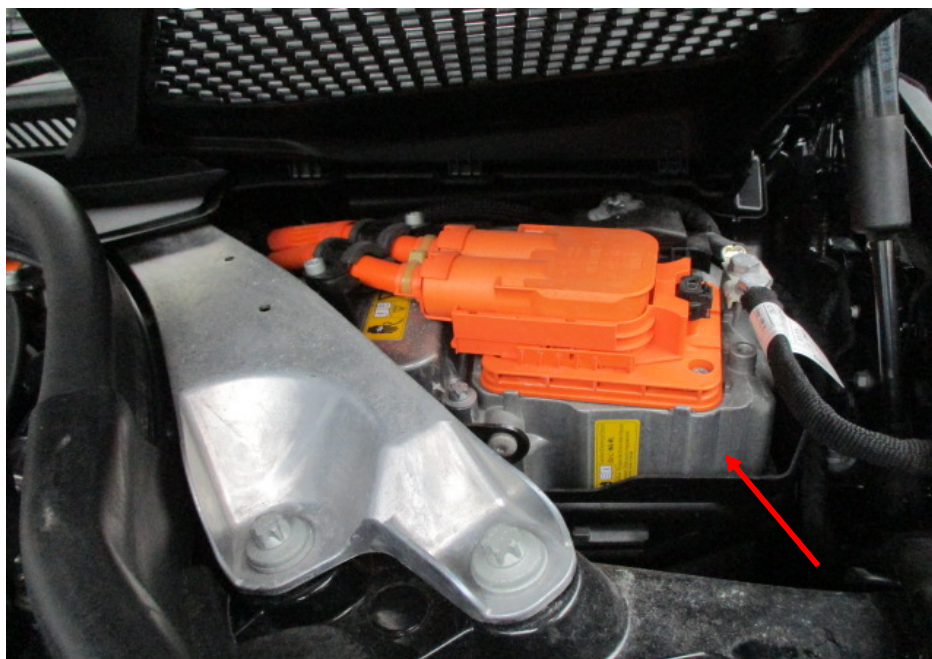
**Photo 18** shows the Motor Car's electric motor that was fitted within the engine compartment, at the rear left side (arrowed). The cable connections were checked and found to be securely fitted into the respective connectors.

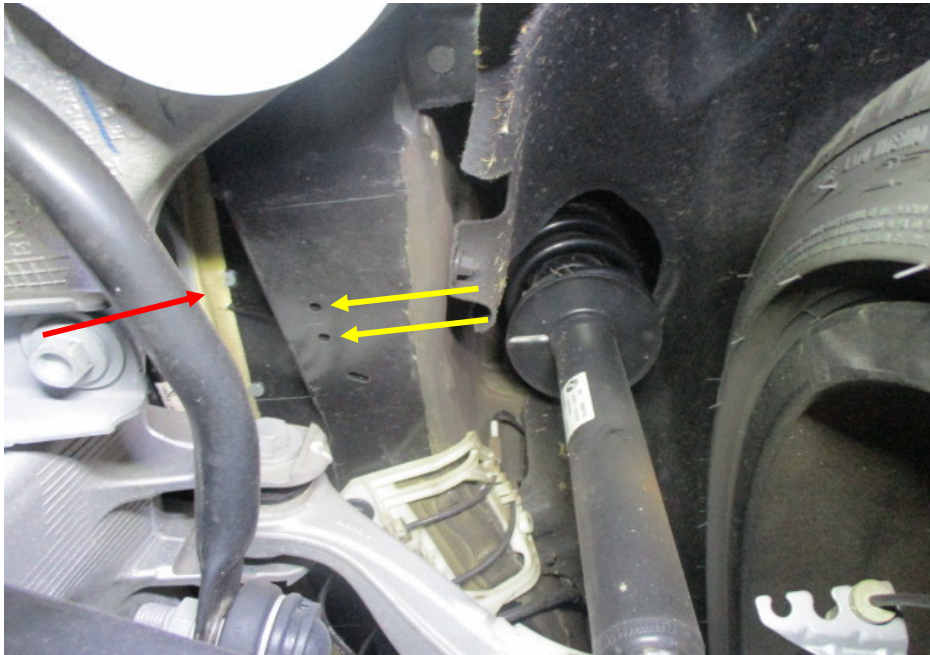
11. Visually, I did not find any weld marks, other than the original spot weld marks, on the chassis/structure body of the Motor Car. The original factory sealant at the joints along the chassis/structure body was also untouched, again indicating that no replacement of the chassis/structure body was carried out; and that the chassis/structure body was originally fitted.

**Photo 19** shows the chassis/structure body at the underside front right of the Motor Car. Visually, I did not find any weld marks other than original spot weld marks (yellow arrow) on the chassis/structure body of the Motor Car. The original factory sealant (red arrow) at the joints along the chassis/structure body was also untouched, indicating no work was done on the chassis/structure body of the Motor Car and that the chassis/structure body was originally fitted.

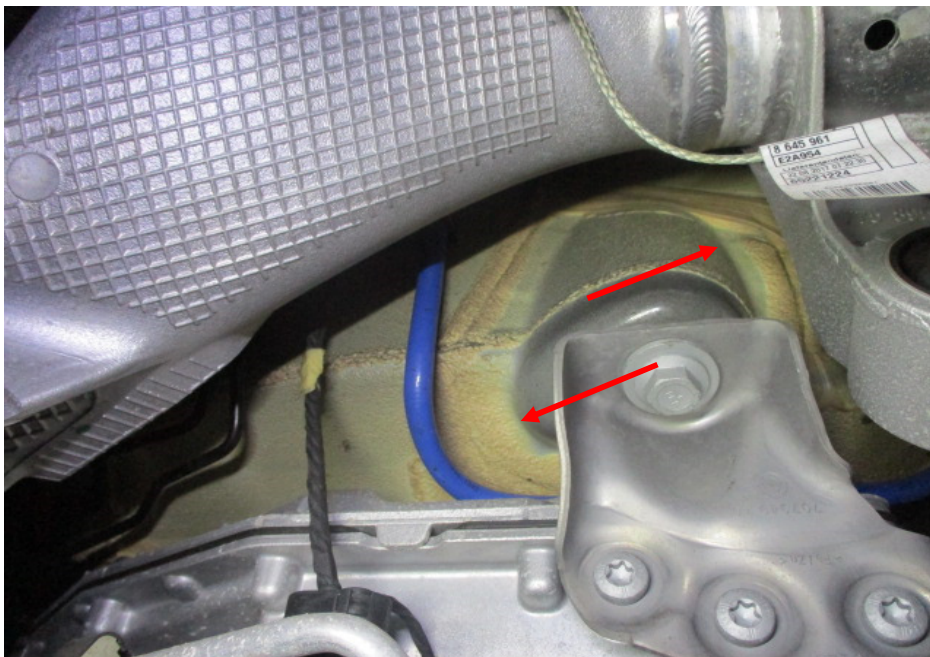
**Photo 20** shows the floor board at the underside rear left of the Motor Car. The original factory sealant at the joints along the non-detachable body panels were untouched, indicating no work was done on the non-detachable body panels of the Motor Car; and that these body panels were originally fitted.

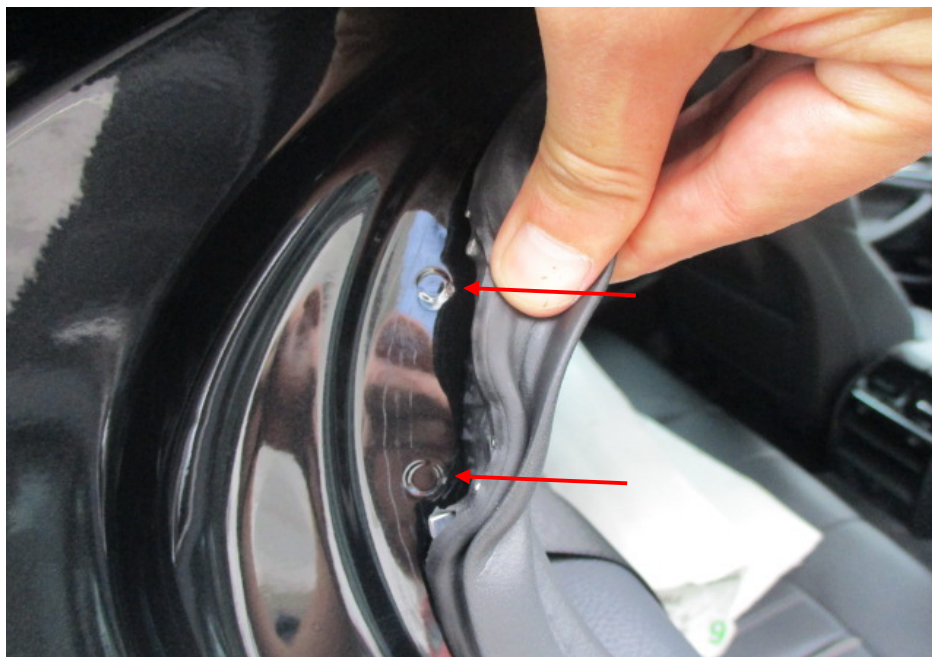
**Photo 21** shows the right "C" pillar of the Motor Car. I did not find any weld marks other than original spot weld marks (arrowed) on the non-detachable body panels of the Motor Car, indicating that there was no re-welding works carried out; and that the non-detachable body panels of the Motor Car were originally fitted.
