Your Ref: Mercedes Benz E43 AMG  
(chassis number WDD2130642A297178)  
Our Ref : CI/TP20006724/D

26 June 2020

**INSPECTION REPORT OF AN UNREGISTERD MERCEDES BENZ E43 AMG MOTOR CAR WITH CHASSIS NUMBER WDD2130642A297178**

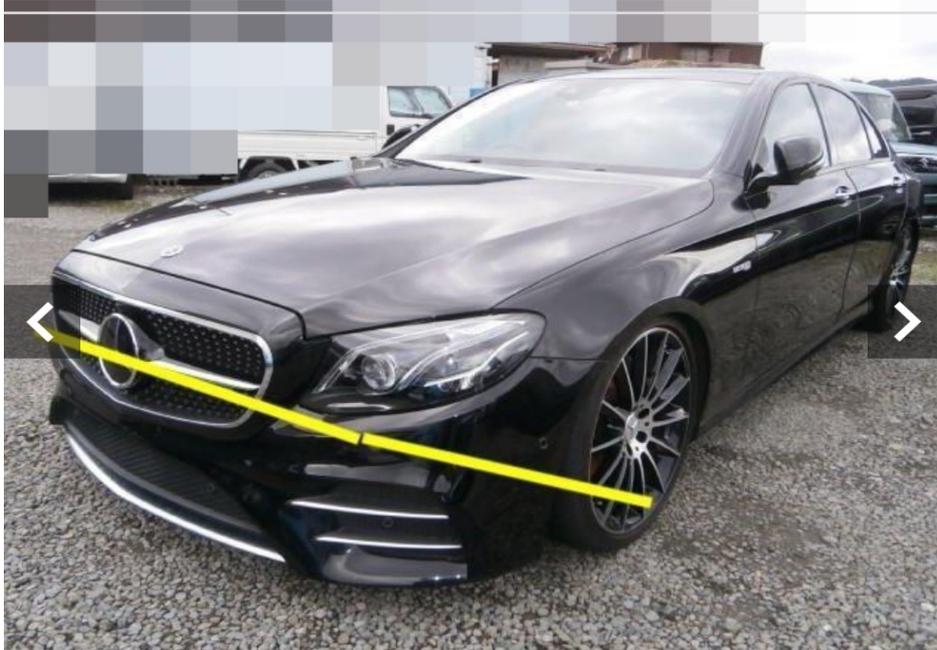
**Photo 1** shows the front left body of the Motor Car (photograph provided to me). I did not observe any visible damage to the Motor Car.

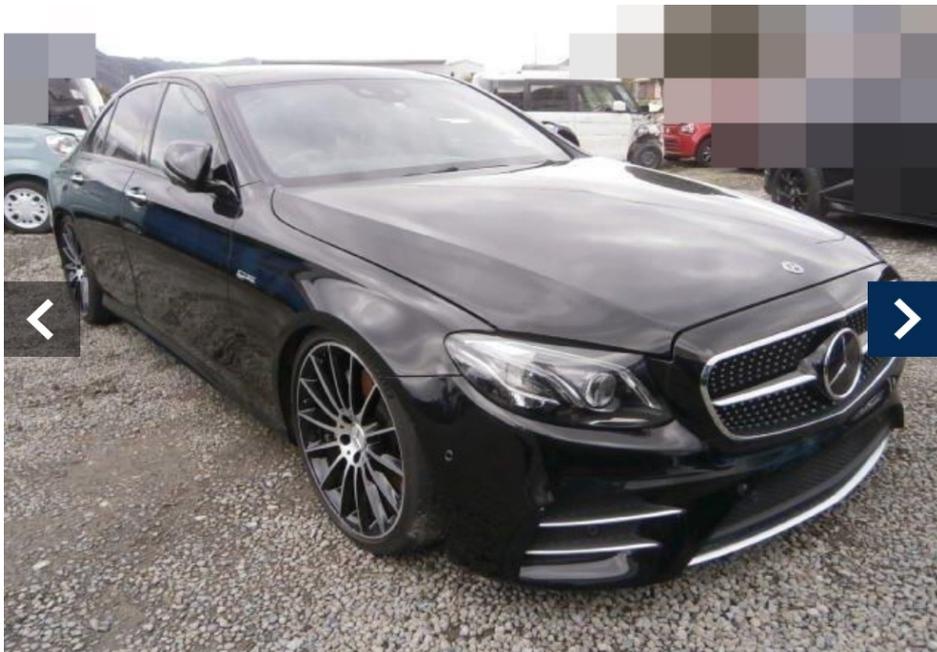
**Photo 2** shows the front right body of the Motor Car (photograph provided to me). I did not observe any visible damage to the Motor Car.

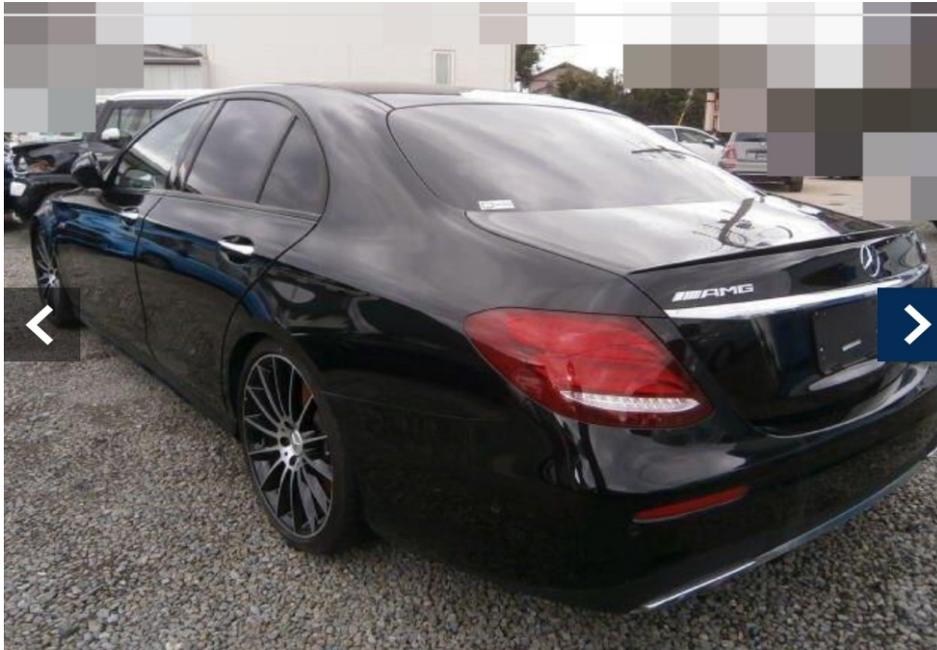
**Photo 3** shows the rear left body of the Motor Car (photograph provided to me). I did not observe any visible damage to the Motor Car.

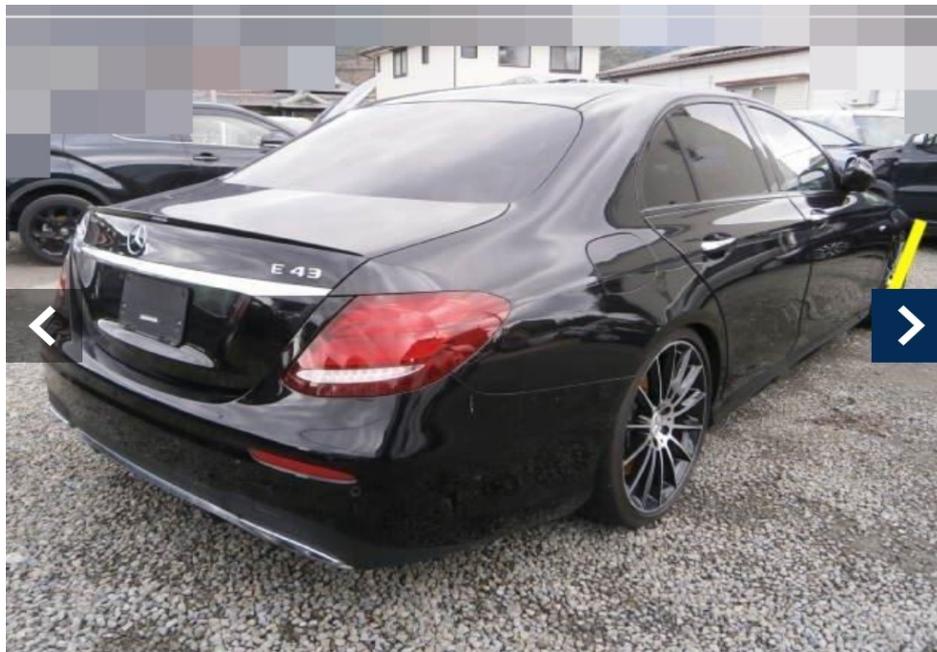
**Photo 4** shows the rear right body of the Motor Car (photograph provided to me). I did not observe any visible damage to the Motor Car.

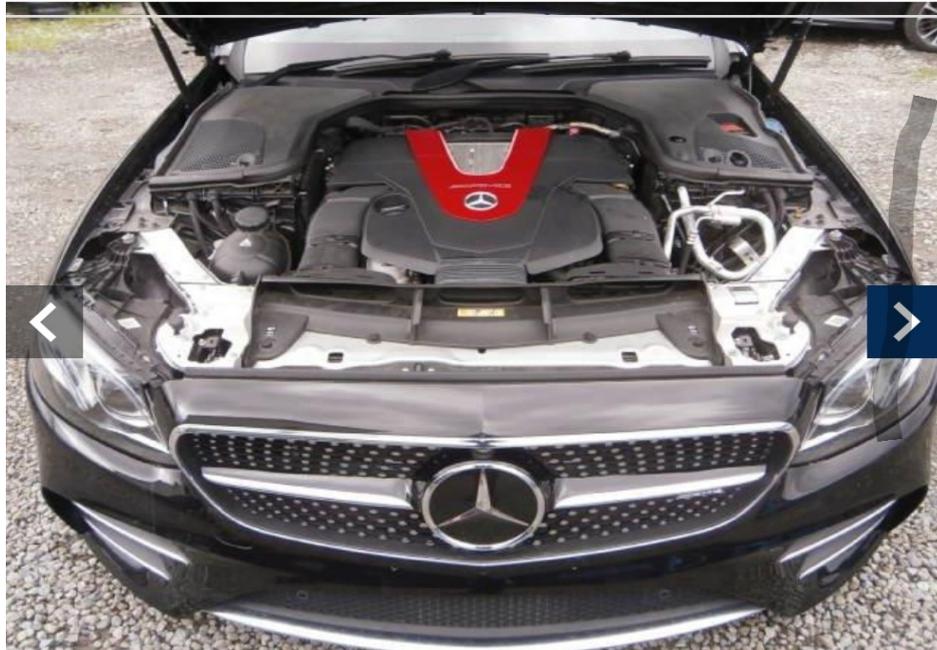
**Photo 5** shows the engine compartment of the Motor Car (photograph provided to me). Parts within the engine compartment were observed to be intact and without damage.

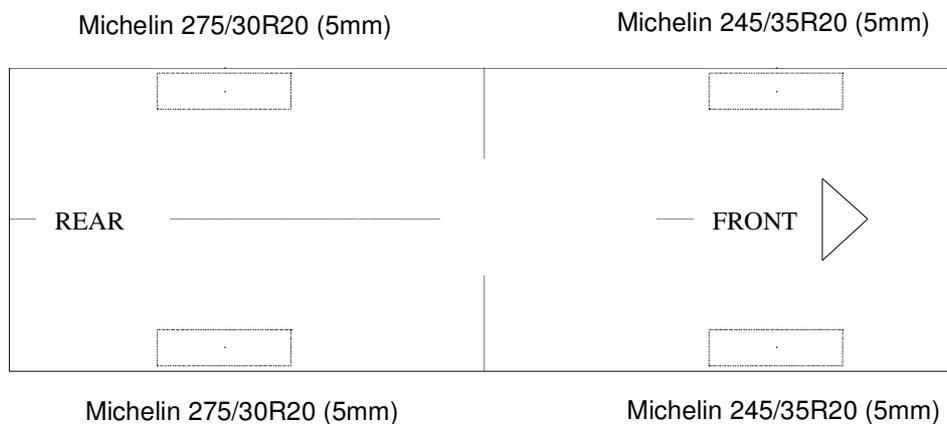
7. It was fitted with 20inch sport wheel rims that were wrapped with tyres that were observed to be of serviceable condition. The tyres were also sufficiently inflated for vehicular operation. The tyre brand, tyre size and approximate remaining tread depth of the 4 tyres of the Motor Car were recorded as follows: -

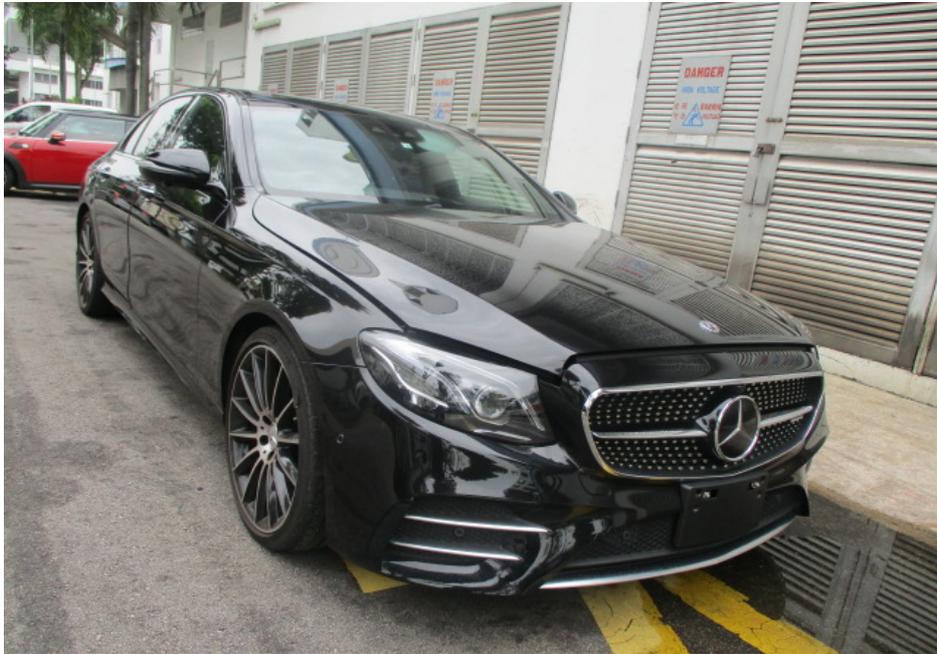
**Photo 6** shows a general view of the front right body of the Motor Car at the time of my inspection. The Motor Car was observed to be in relatively good general condition with no loose exterior fittings observed.

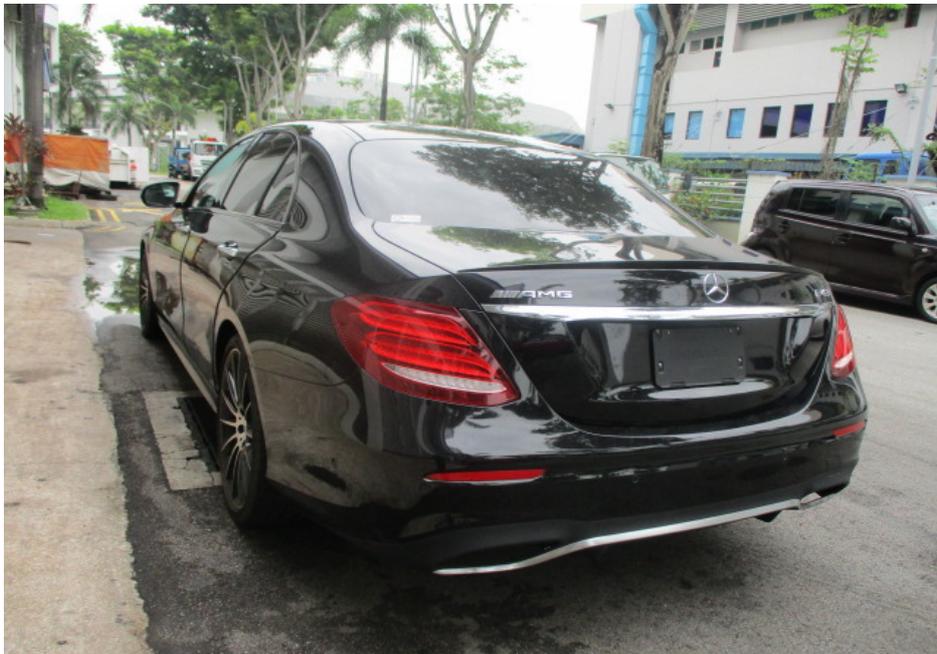
**Photo 7** shows a general view of the rear left body of the Motor Car at the time of my inspection. The Motor Car was observed to be in relatively good general condition with no loose exterior fittings observed.

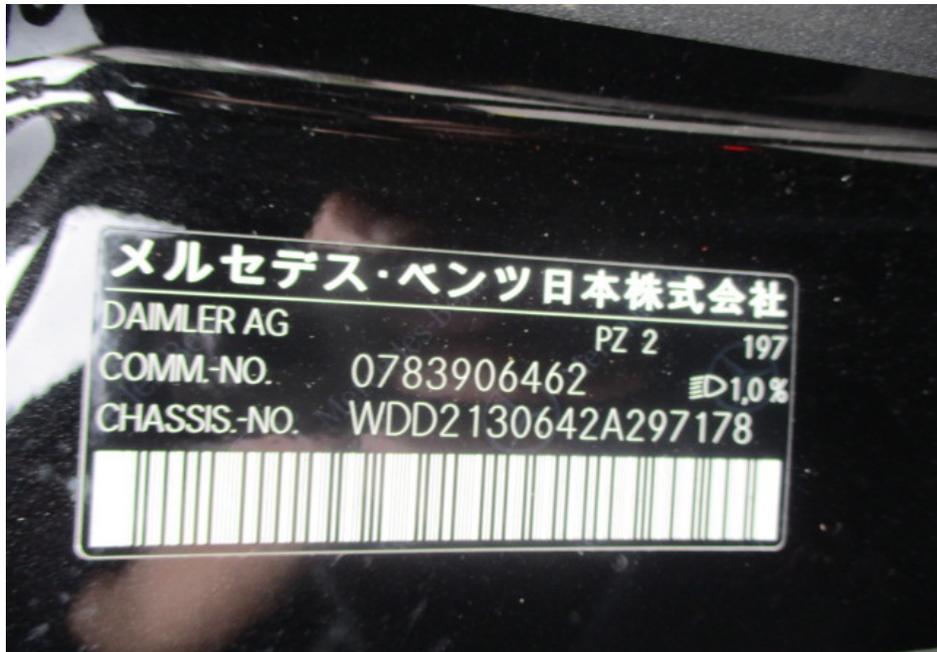
**Photo 8** shows the chassis number of the Motor Car. The chassis number recorded was WDD2130642A297178.

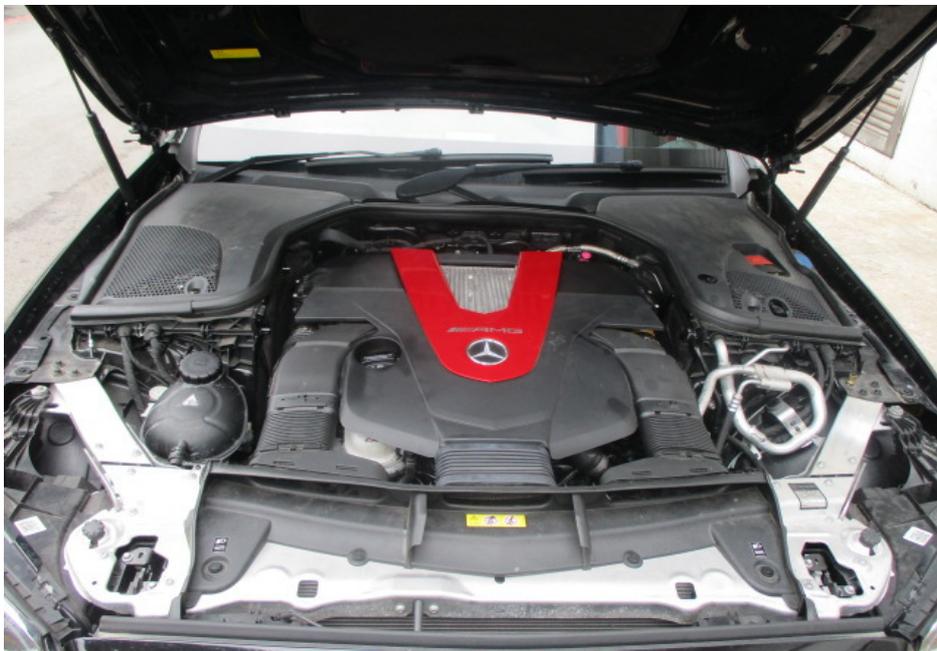
13. My examination of the engine compartment of the Motor Car revealed that the various parts and components inside the engine compartment were all intact and properly fitted. The engine oil, brake fluid and engine coolant were all found to be of sufficient level for operating purposes. Visually, there was also no contamination found to these fluids.

**Photo 9** shows a general view of the engine compartment of the Motor Car at the time of my inspection. The various parts and components inside the engine compartment were all observed to be intact and properly fitted. There was also no sign(s) or indication(s) of fluid leak and/or fluid stain found inside the engine compartment.

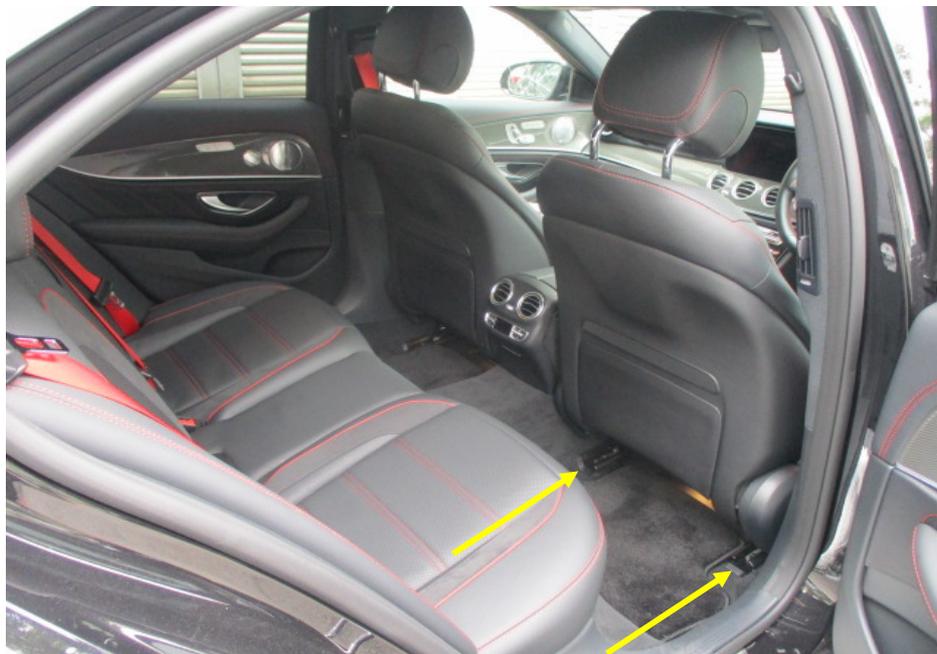
11. The seats of the Motor Car were found to be secured to the floor board of the Motor Car via seat rails bolted onto the floor board. Retractable seat belt reels and pre-tensioners were fitted on all seats of the Motor Car. The seat belt reels were tested and were able to be fastened securely into the respective pre-tensioners that were fixed to the side of all the seats.

**Photo 10** shows the seats of the Motor Car, which were secured via seat rails (arrowed) to the floor board. All the seats of the Motor Car were fitted with a retractable seat belt reel and pre-tensioner. The seat belts were tested and able to be fastened into the respective pre-tensions that were fitted on the side of each individual seat.

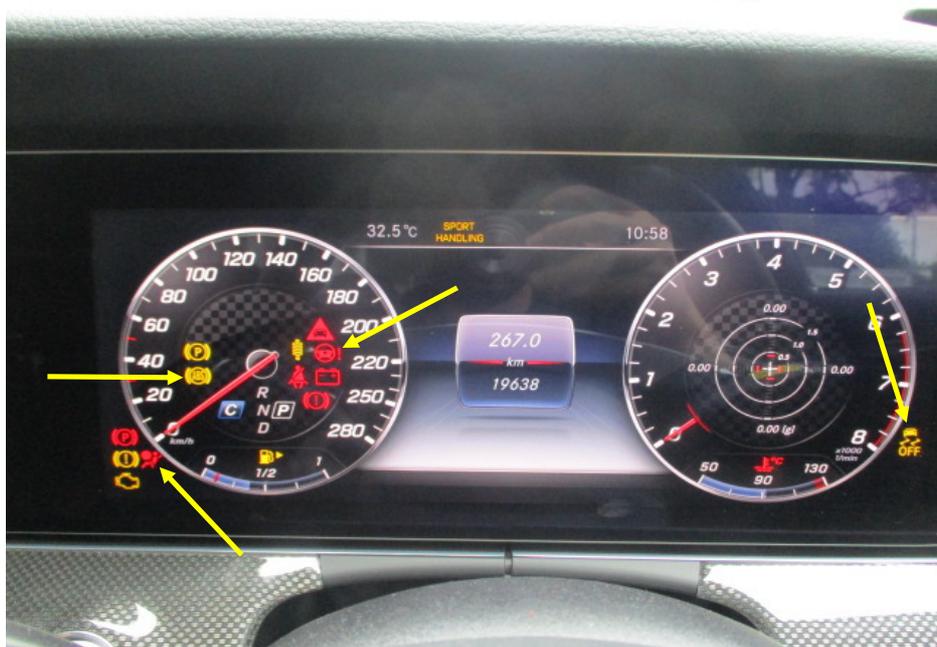
**Photo 11** shows the warning lights for the various electronic safety features appearing on the instrument panel of the Motor Car during its self-test when the engine is cranked, in particular the ABS, SRS, EPS and TCS lights (arrowed).

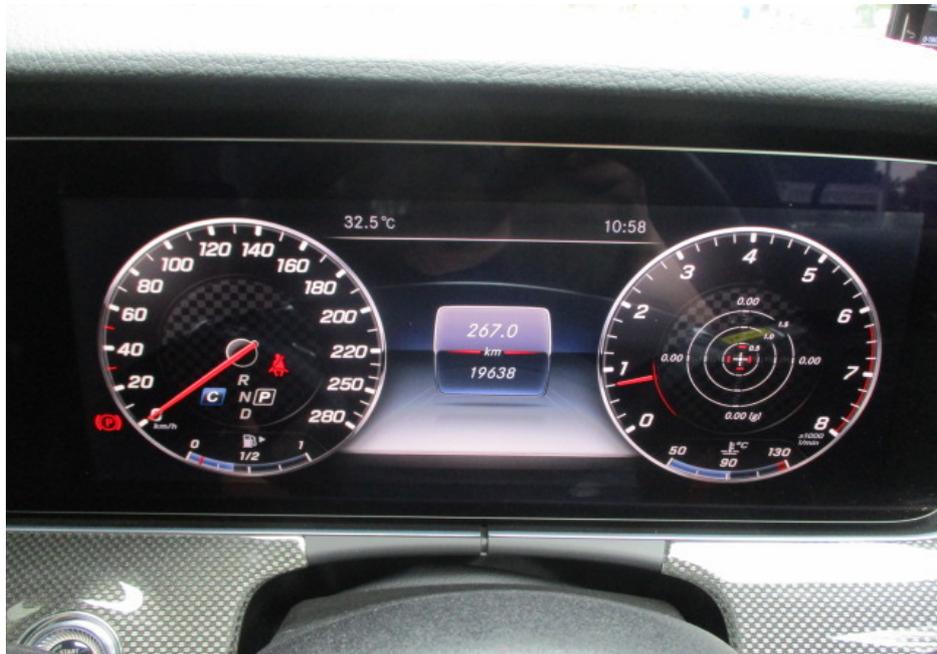
12. The Motor Car's automatic self-test of the functionality of its various electronic safety features like the Anti-Lock Brake System (ABS), Supplemental Restraint System (SRS), Electric Power Steering (EPS) and Traction Control System (TCS) during cranking of the engine had indicated that these electronic systems were in working condition. This was determined from the respective warning lights disappearing from the instrument panel after the self-test.

**Photo 12** shows the respective warning lights no longer illuminated, indicating that there is no fault detected to the ABS, SRS, EPS and TCS systems of the Motor Car during the self-test. These electronic systems were hence in working condition at the time of my inspection.

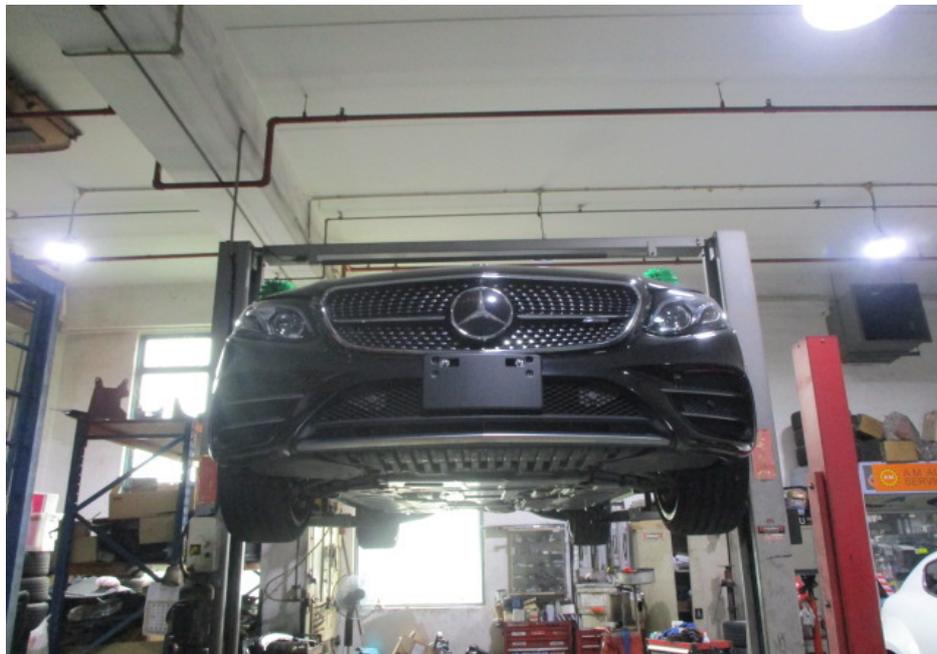
14. My checks on the underside of the Motor Car revealed no sign(s) or indication(s) of fluid leakage and/or fluid stain(s). The engine block and automatic transmission assembly were both secured properly. They were not mounted onto the chassis/structure body or any integral body part of the Motor Car. All undercarriage components of the Motor Car were also observed to be intact and secured in an appropriate manner.

**Photo 13** shows the Motor Car hoisted up for checks on its undercarriage. There was no sign(s) or indication(s) of fluid leakage and/or fluid stain(s) on the underside of the Motor Car. The undercarriage components of the Motor Car were also all observed to be intact and secured in an appropriate manner.

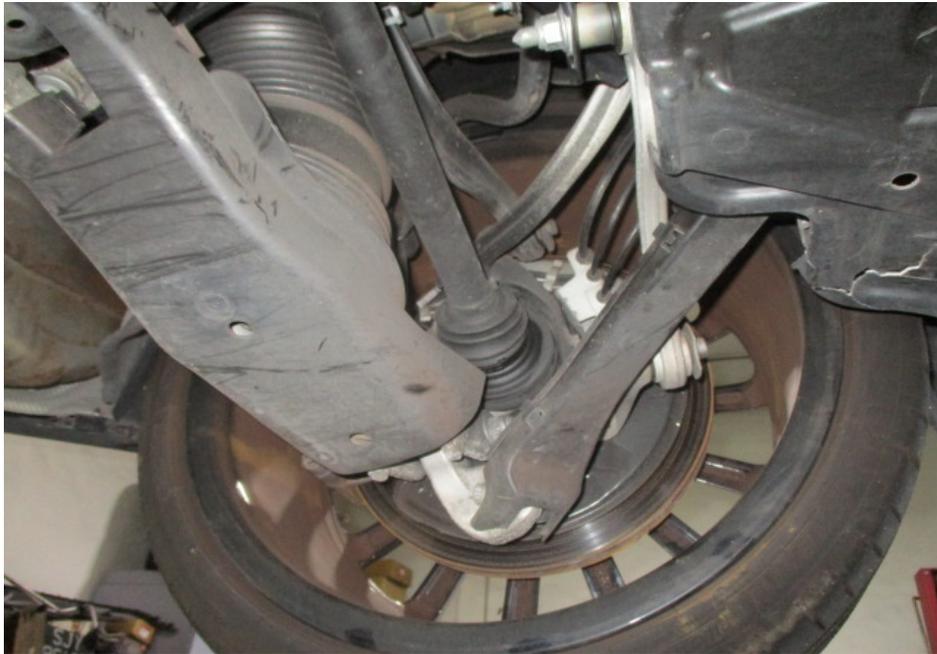
**Photo 14** shows a general view of the control arms and linkages at the rear left wheel of the Motor Car. I did not observe any fluid leak and/or fluid stain on the underside of the Motor Car. All of the Motor Car's undercarriage components were observed to be intact and secured in an appropriate manner.

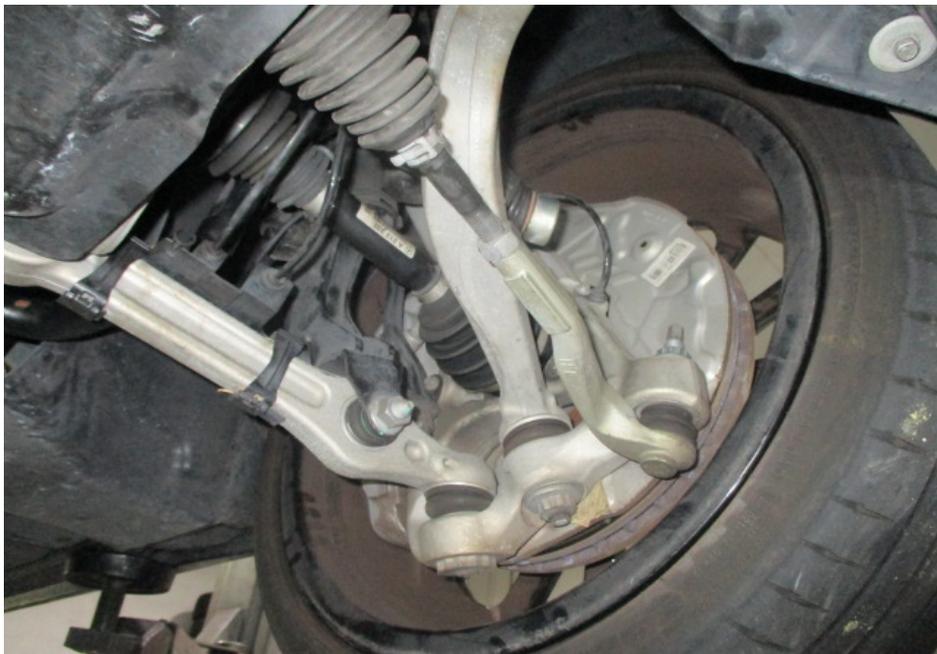
**Photo 15** shows the various undercarriage components at the front left wheel of the Motor Car. The mechanical components, control arms and linkages were all found to be intact and secured in an appropriate manner.

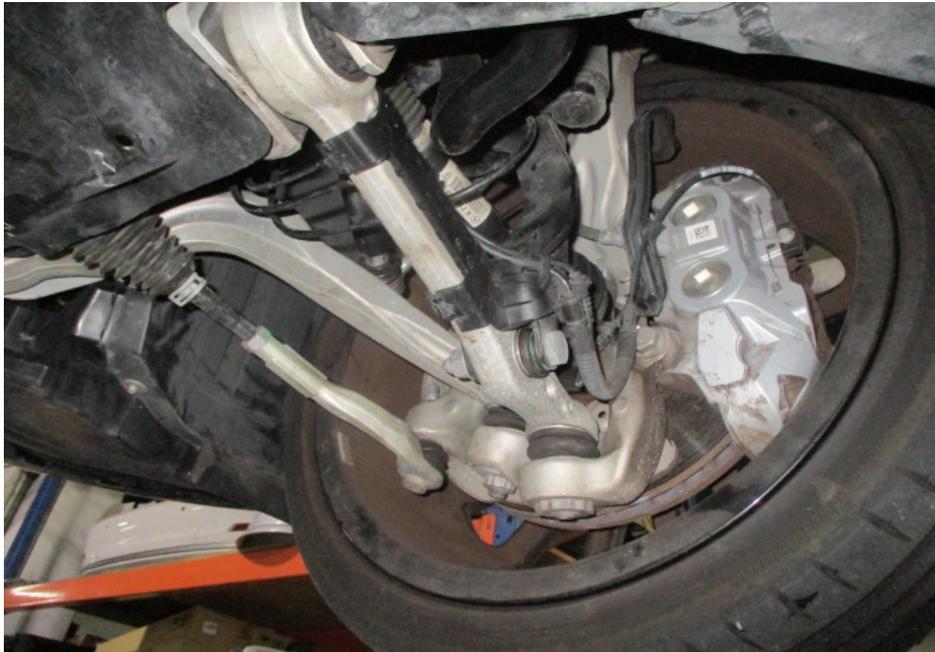
**Photo 16** shows the various undercarriage components at the front right wheel of the Motor Car. The mechanical components, control arms and linkages were all found to be intact and secured in an appropriate manner. I also did not observe any fluid leak and/or fluid stain on the underside of the Motor Car.

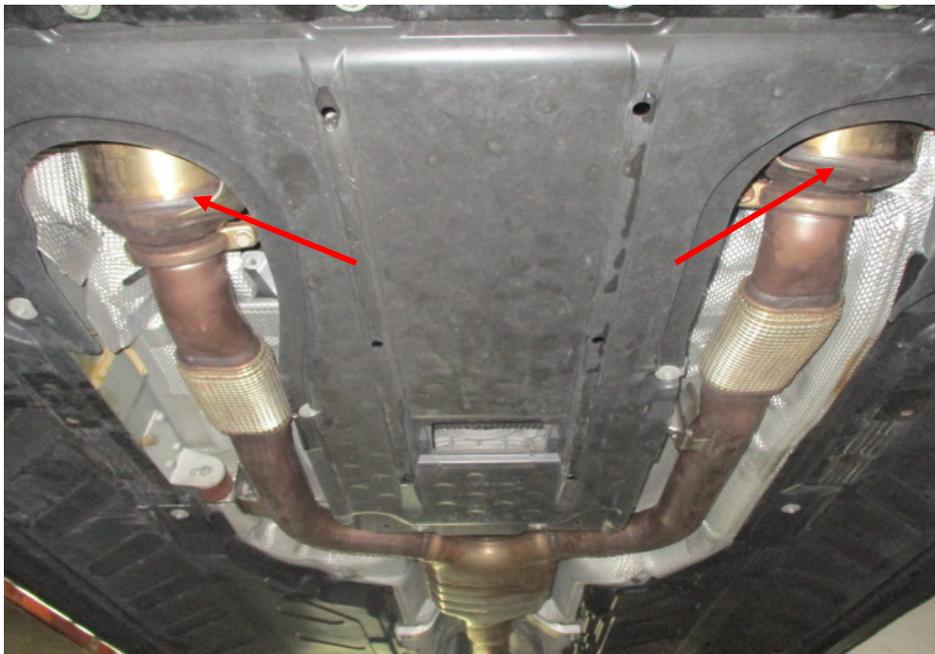
**Photo 17** shows the Motor Car's front catalytic converters (arrowed). My examination of the Motor Car's exhaust system revealed no sign(s) or indication(s) of any cut or weld marks along its exhaust pipes and on its rear muffler.

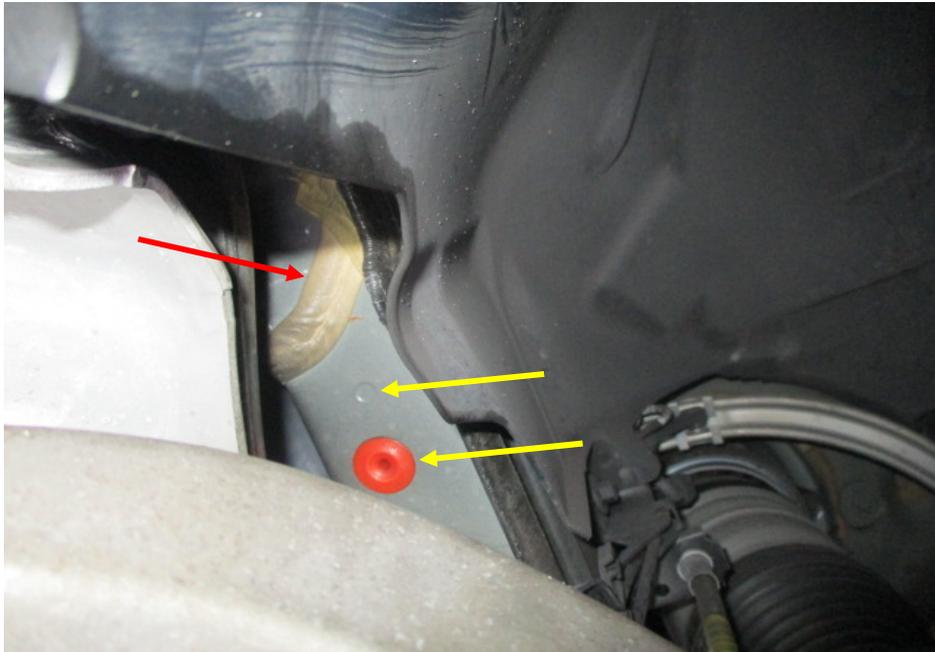
10. Visually, I did not find any weld marks, other than the original spot weld marks, on the chassis/structure body of the Motor Car. The original factory sealant at the joints along the chassis/structure body was also untouched, again indicating that no replacement of the chassis/structure body was carried out; and that the chassis/structure body was originally fitted.

**Photo 18** shows the chassis/structure body at the underside front left of the Motor Car. Visually, I did not find any weld marks other than original spot weld marks (yellow arrow) on the chassis/structure body of the Motor Car. The original factory sealant (red arrow) at the joints along the chassis/structure body was also untouched, indicating no work was done on the chassis/structure body of the Motor Car and that the chassis/structure body was originally fitted.

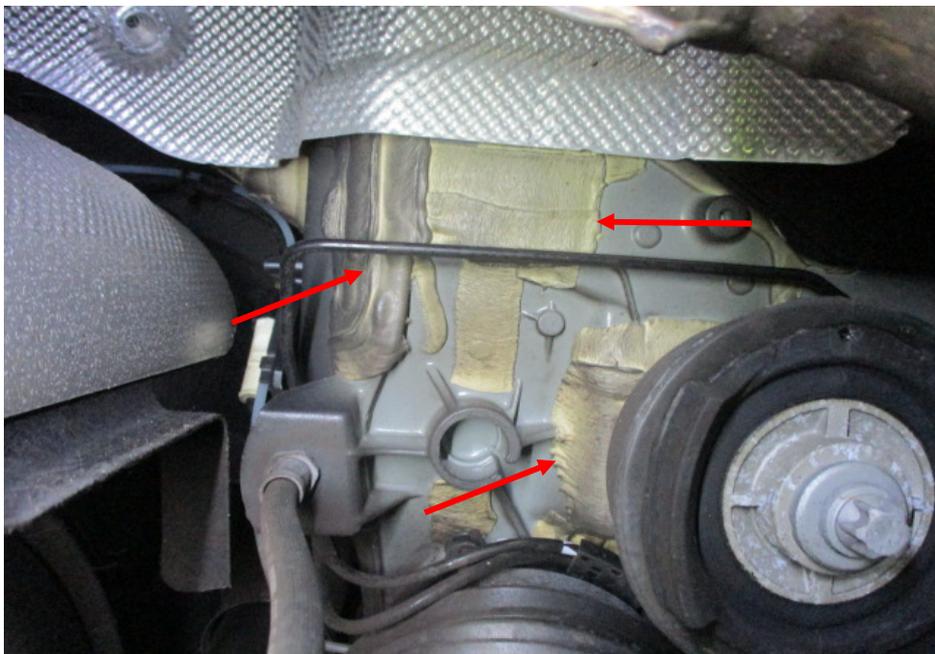
**Photo 19** shows the floor board at the underside rear left of the Motor Car. The original factory sealant at the joints along the non-detachable body panels were untouched, indicating no work was done on the non-detachable body panels of the Motor Car; and that these body panels were originally fitted.

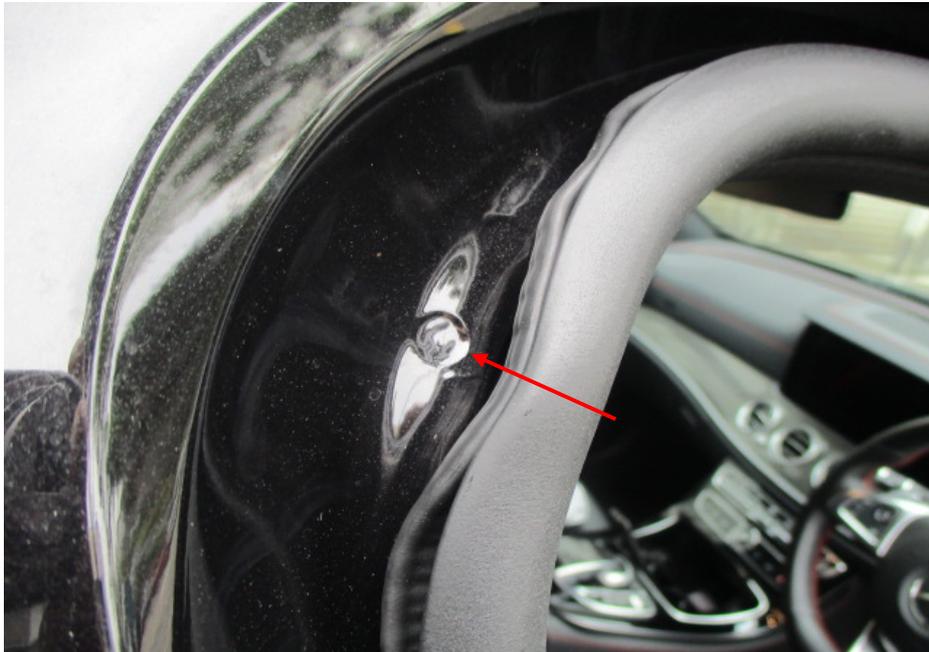
**Photo 20** shows the right "B" pillar of the Motor Car. I did not find any weld marks other than original spot weld marks (arrowed) on the non-detachable body panels of the Motor Car, indicating that there was no re-welding works carried out; and that the non-detachable body panels of the Motor Car were originally fitted.
