Your Ref: Honda Civic Type R  
(chassis number FK81201912)  
Our Ref : CI/TP20006756/D

29 June 2020

**INSPECTION REPORT OF AN UNREGISTERD HONDA CIVIC TYPE R  
MOTOR CAR WITH CHASSIS NUMBER FK81201912**

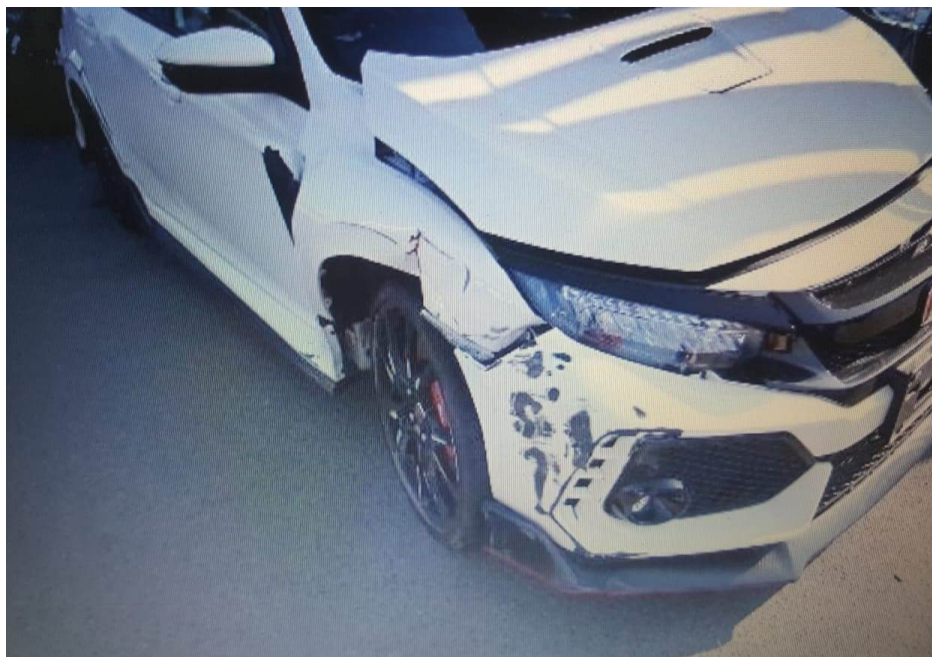
**Photo 1** shows the front right body of the Motor Car prior to any repairs being carried out (photograph provided to me). The Motor Car was observed to have sustained damages along its right side. The body parts observed to be damaged had included its front bumper, front right headlamp, front right fender, front bonnet and front right wheel rim amongst others.

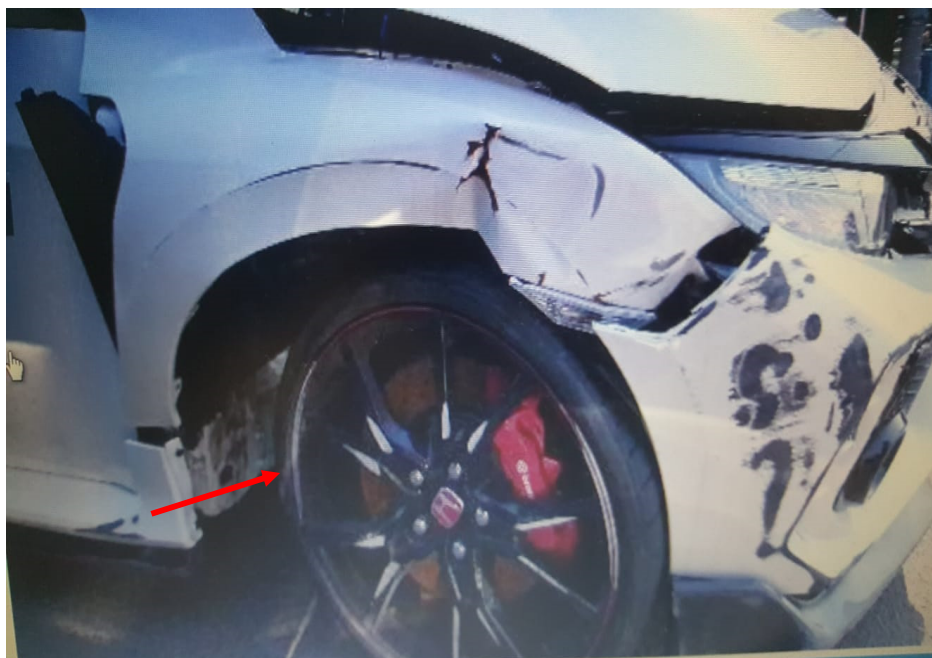
**Photo 2** shows a closer view of the front right body of the Motor Car prior to any repairs being carried out (photograph provided to me). The front bumper, front right fender and right rocker panel garnish were amongst the body parts that were observed to be damaged. The front right undercarriage parts of the Motor Car were also affected basing on the orientation and damage to the front right wheel rim (arrowed).

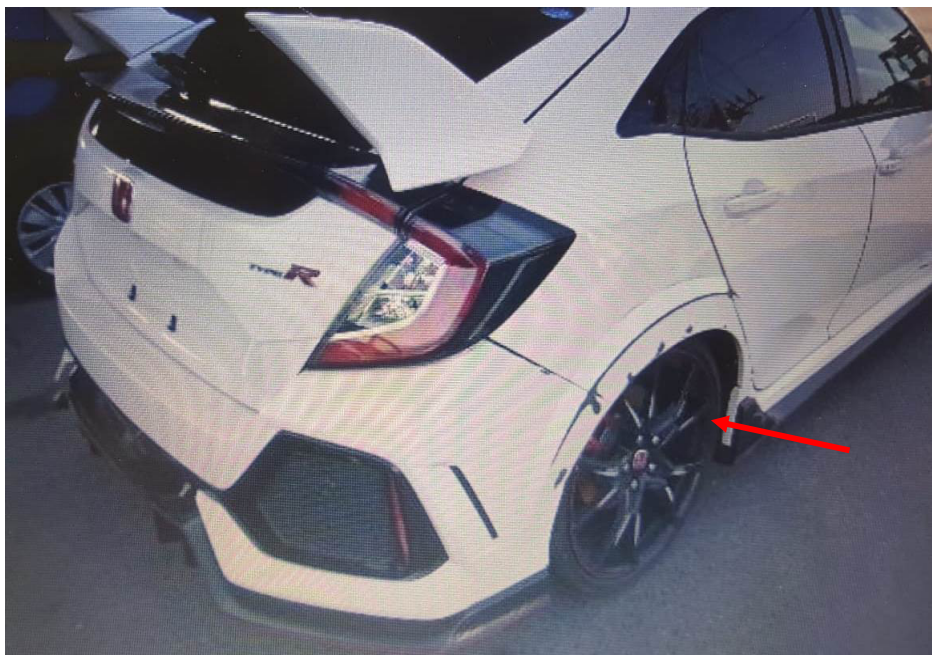
**Photo 3** shows the rear right body of the Motor Car prior to any repairs being carried out (photograph provided to me). The rear right fender and rear bumper were amongst the body parts that were observed to be damaged. The rear right undercarriage parts of the Motor Car were also affected basing on the orientation and damage to the rear right wheel rim (arrowed).

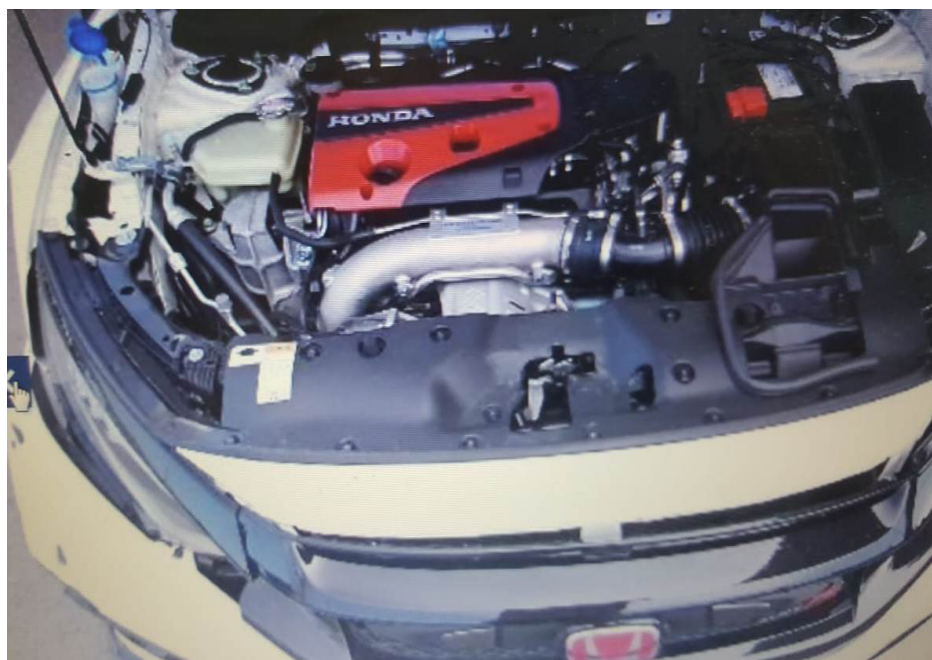
**Photo 4** shows the engine compartment of the Motor Car prior to any repairs being carried out (photograph provided to me). Parts within the engine compartment were observed to be intact and undamaged, including the engine assembly of the Motor Car.

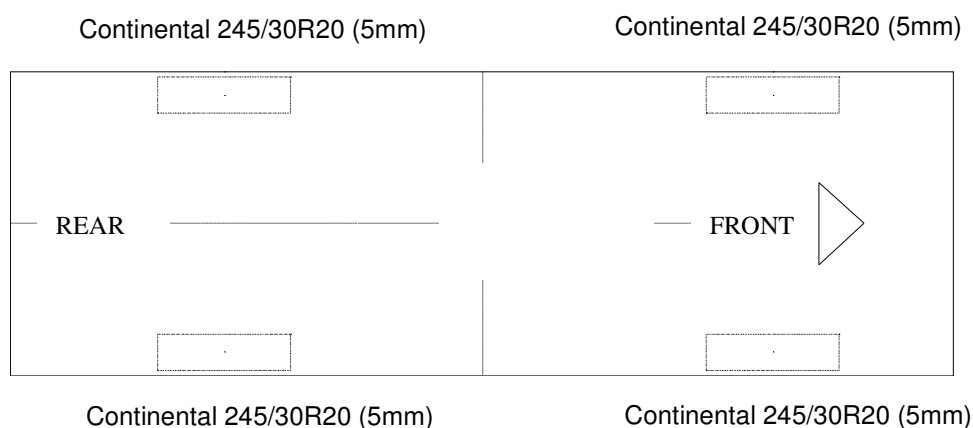
8. It was fitted with 20inch sport wheel rims that were wrapped with tyres that were observed to be of serviceable condition. The tyres were also sufficiently inflated for vehicular operation. The tyre brand, tyre size and approximate remaining tread depth of the 4 tyres of the Motor Car were recorded as follows: -

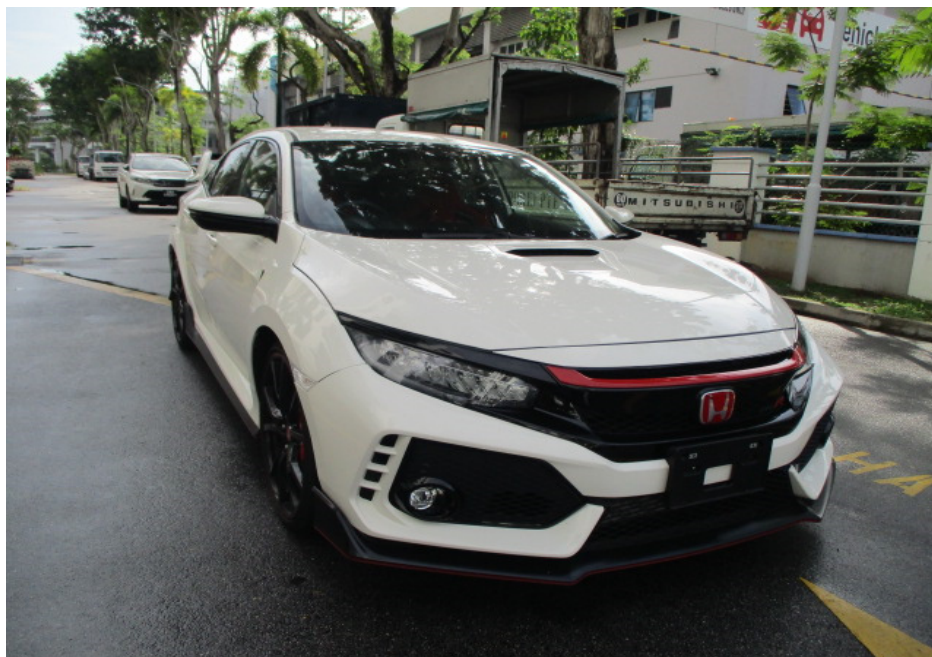
22. The body parts and undercarriage parts along the right side of the Motor Car were visually examined and it was noted that the repair/restoration works carried out to the damaged area of the Motor Car (refer photograph 1 to 3 above) were reasonably adequate and in order.

**Photo 5** shows a general view of the front right body of the Motor Car at the time of my inspection. The Motor Car was observed to be in relatively good general condition with no loose exterior fittings observed. The body parts along the right side of the Motor Car were visually examined and it was observed that the repair/restoration works carried out to the damaged area of the Motor Car (refer photograph 1 to 3 above) were reasonably adequate and in order.

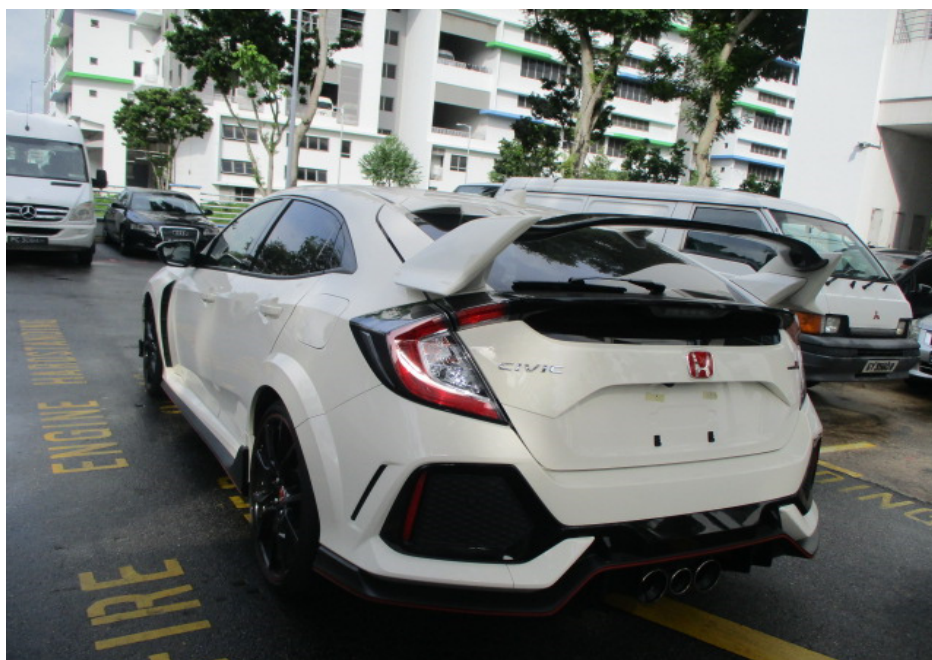
**Photo 6** shows a general view of the rear left body of the Motor Car at the time of my inspection. The Motor Car was observed to be in relatively good general condition with no loose exterior fittings observed.

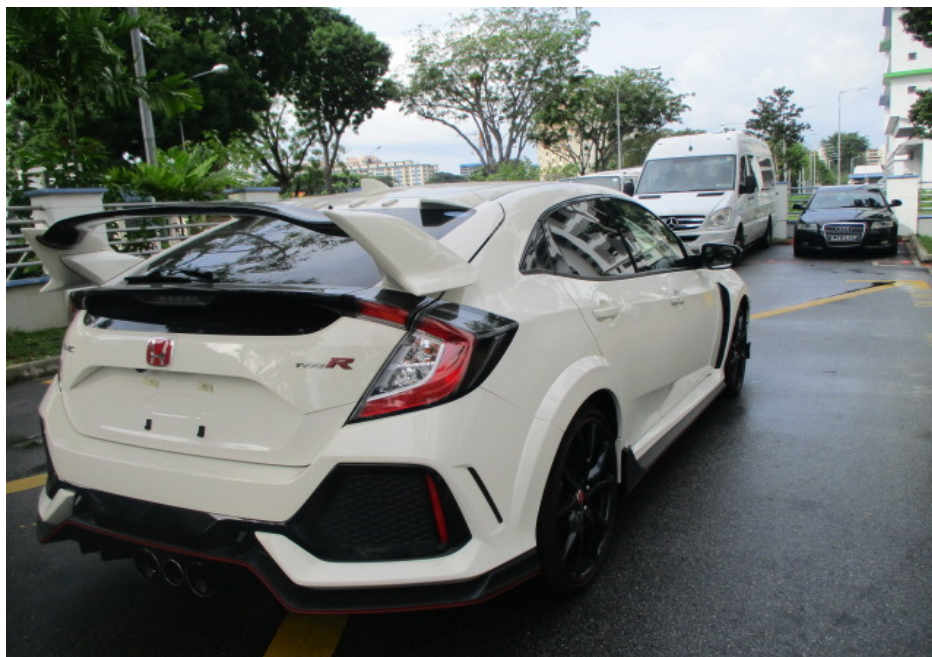
**Photo 7** shows a general view of the rear right body of the Motor Car at the time of my inspection. The Motor Car was observed to be in relatively good general condition with no loose exterior fittings observed. The body parts along the right side of the Motor Car were visually examined and it was observed that the repair/restoration works carried out to the damaged area of the Motor Car (refer photograph 1 to 3 above) were reasonably adequate and in order.

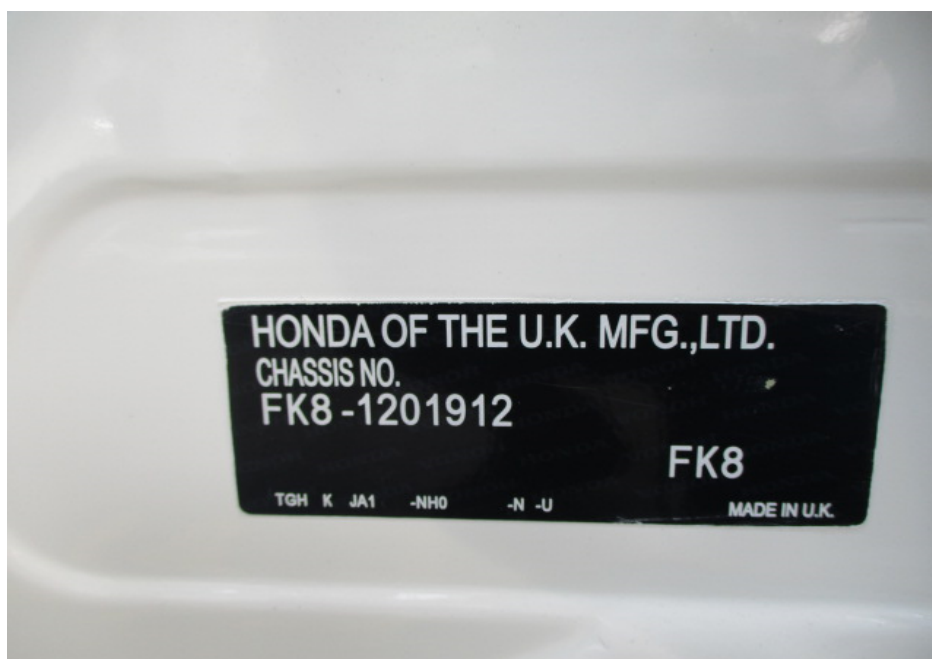
**Photo 8** shows the chassis number of the Motor Car. The chassis number recorded was FK81201912.

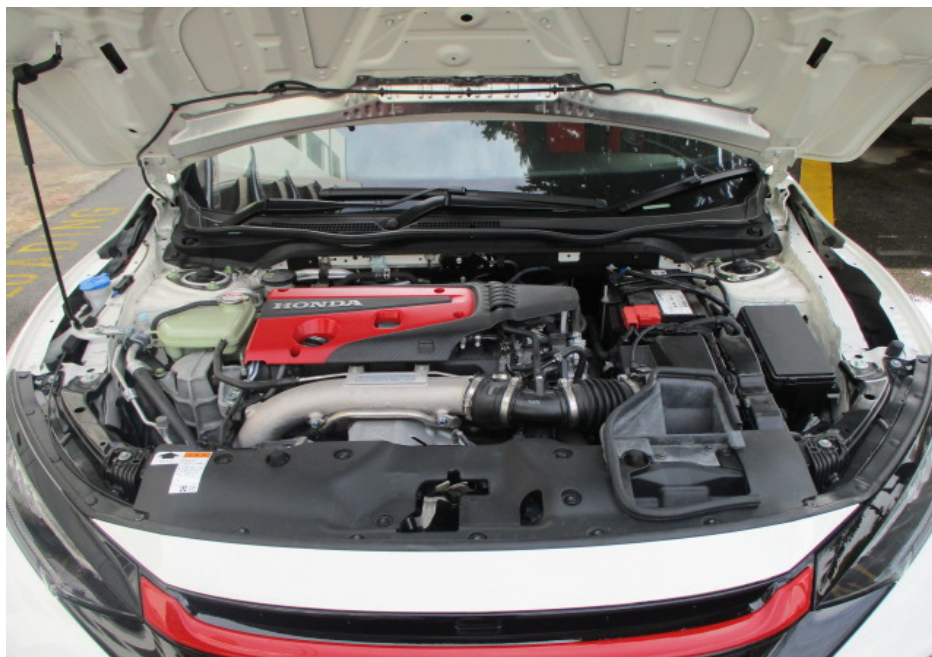
14. My examination of the engine compartment of the Motor Car revealed that the various parts and components inside the engine compartment were all intact and properly fitted. The engine oil, brake fluid and engine coolant were all found to be of sufficient level for operating purposes. Visually, there was also no contamination found to these fluids.
15. My checks on the underside of the Motor Car revealed no sign(s) or indication(s) of fluid leakage and/or fluid stain(s). The engine block and manual transmission assembly were both secured properly. They were not mounted onto the chassis/structural body or any integral body part of the Motor Car. All undercarriage components of the Motor Car were also observed to be intact and secured in an appropriate manner.

**Photo 9** shows a general view of the engine compartment of the Motor Car at the time of my inspection. The various parts and components inside the engine compartment were all observed to be intact and properly fitted. There was also no sign(s) or indication(s) of fluid leak and/or fluid stain found inside the engine compartment.

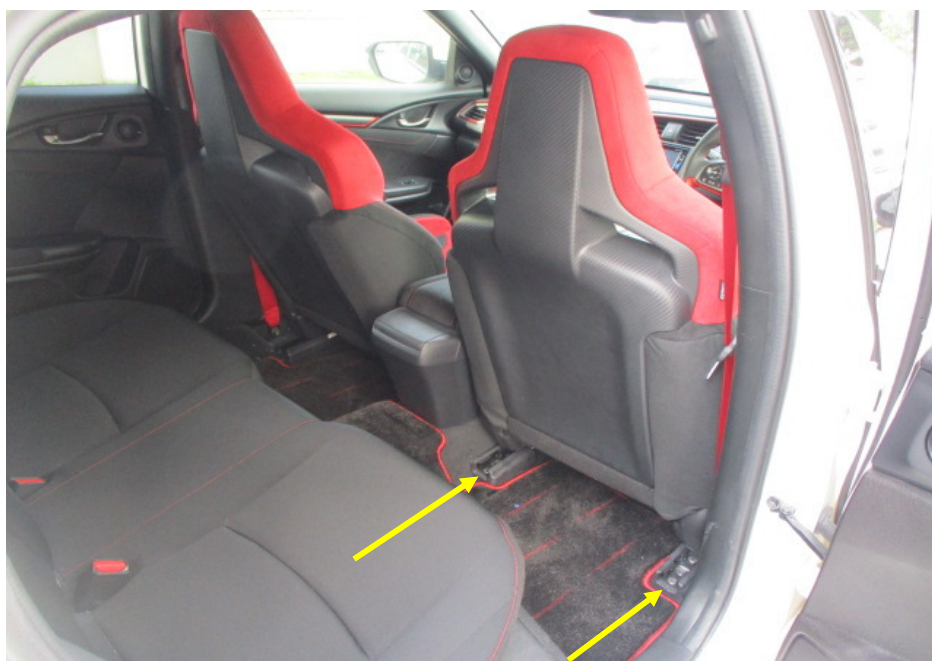
12. The seats of the Motor Car were found to be secured to the floor board of the Motor Car via seat rails bolted onto the floor board. Retractable seat belt reels and pre-tensioners were fitted on all seats of the Motor Car. The seat belt reels were tested and were able to be fastened securely into the respective pre-tensioners that were fixed to the side of all the seats.

**Photo 10** shows the seats of the Motor Car, which were secured via seat rails (arrowed) to the floor board. All the seats of the Motor Car were fitted with a retractable seat belt reel and pre-tensioner. The seat belts were tested and able to be fastened into the respective pre-tensions that were fitted on the side of each individual seat.

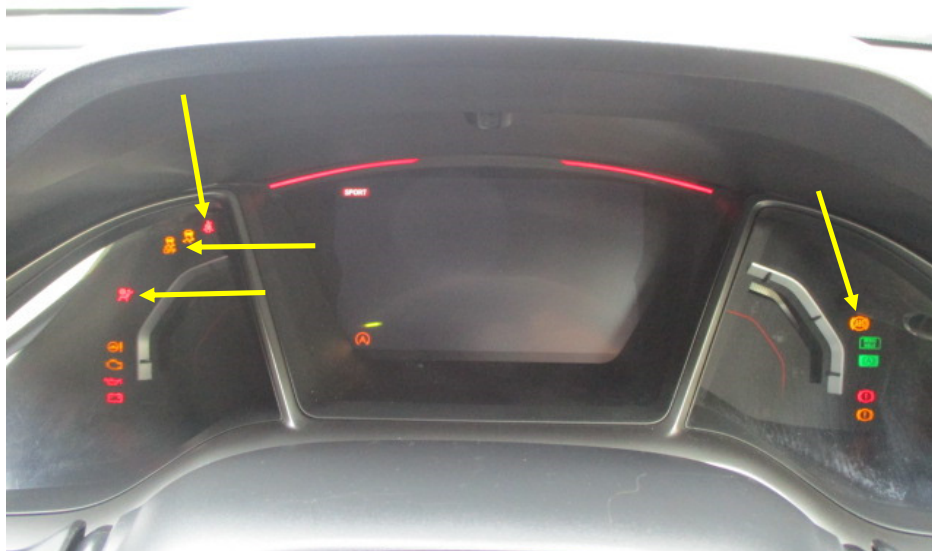
**Photo 11** shows the warning lights for the various electronic safety features appearing on the instrument panel of the Motor Car during its self-test when the engine is cranked, in particular the ABS, SRS, VSA and EPS lights (arrowed).

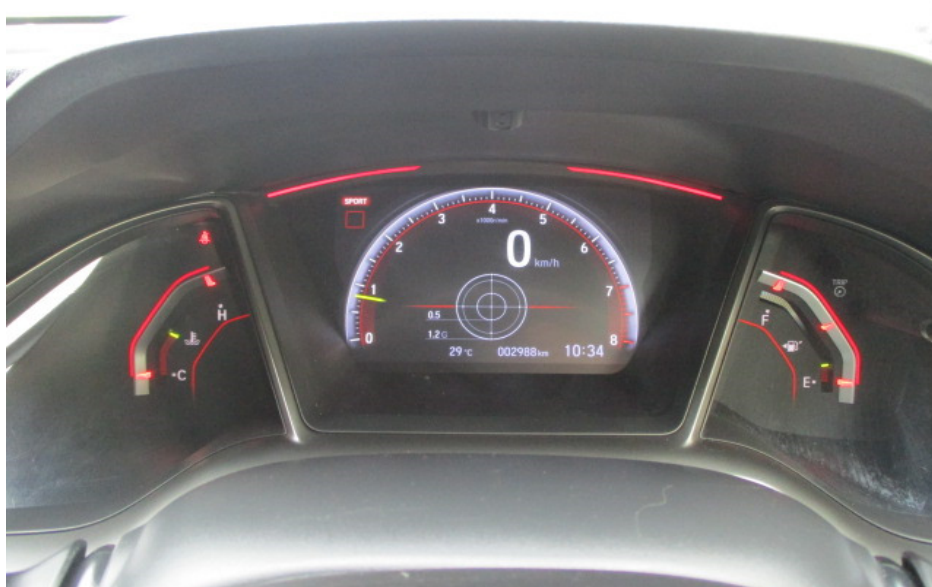
13. The Motor Car's automatic self-test of the functionality of its various electronic safety features like the Anti-Lock Brake System (ABS), Supplemental Restraint System (SRS), Vehicle Stability Assist (VSA) and Electric Power Steering (EPS) during cranking of the engine had indicated that these electronic systems were in working condition. This was determined from the respective warning lights disappearing from the instrument panel after the self-test.

**Photo 12** shows the respective warning lights no longer illuminated after the engine was started, indicating that there was no fault detected to the ABS, SRS, VSA and EPS systems of the Motor Car during the self-test. These electronic systems were hence in working condition at the time of my inspection.

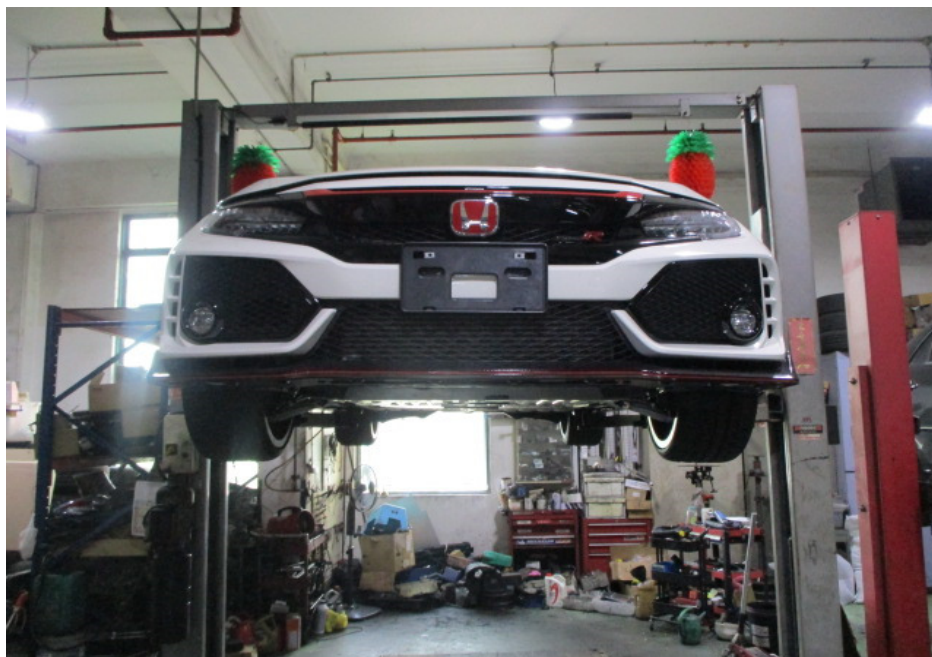
**Photo 13** shows the Motor Car hoisted up for checks on its undercarriage. There was no sign(s) or indication(s) of fluid leakage and/or fluid stain(s) on the underside of the Motor Car. The undercarriage components of the Motor Car were also all observed to be intact and secured in an appropriate manner.

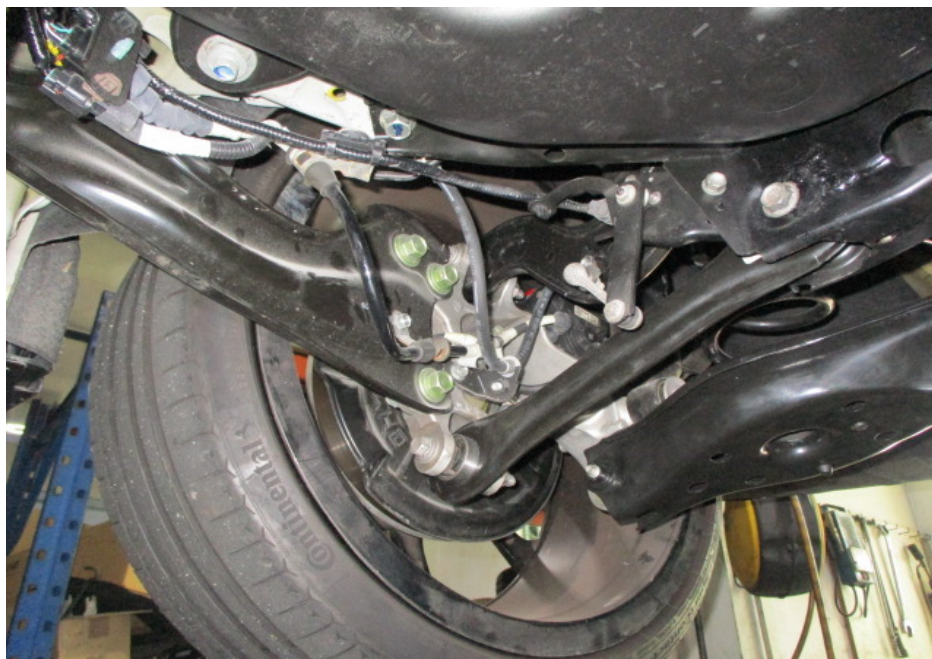
**Photo 14** shows a general view of the control arms and linkages at the rear right wheel of the Motor Car. I did not observe any fluid leak and/or fluid stain on the underside of the Motor Car. All of the Motor Car's undercarriage components were observed to be intact and secured in an appropriate manner.

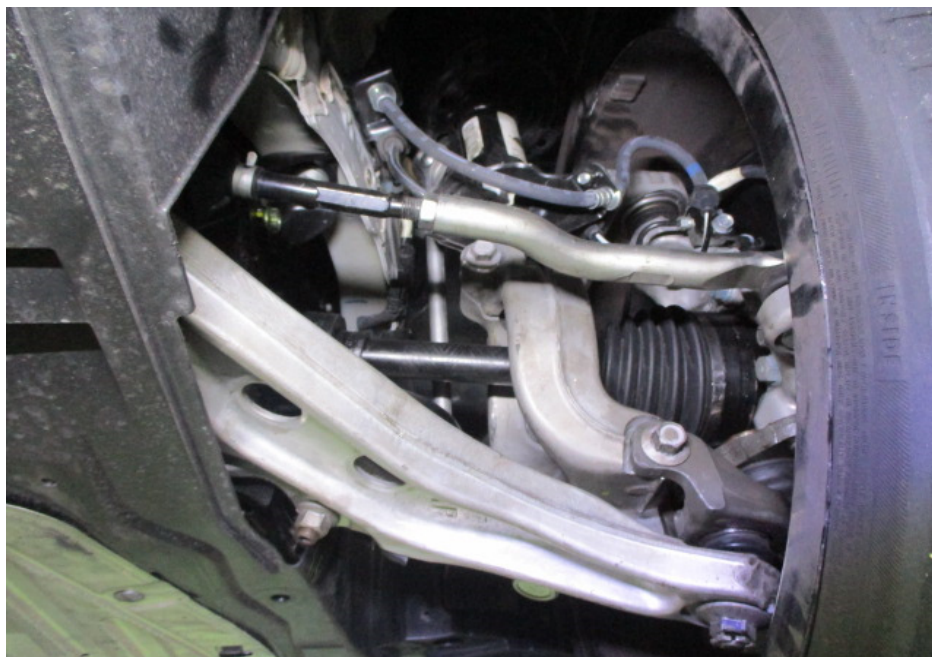
**Photo 15** shows the various undercarriage components at the front right wheel of the Motor Car. The mechanical components, control arms and linkages were all found to be intact and secured in an appropriate manner.

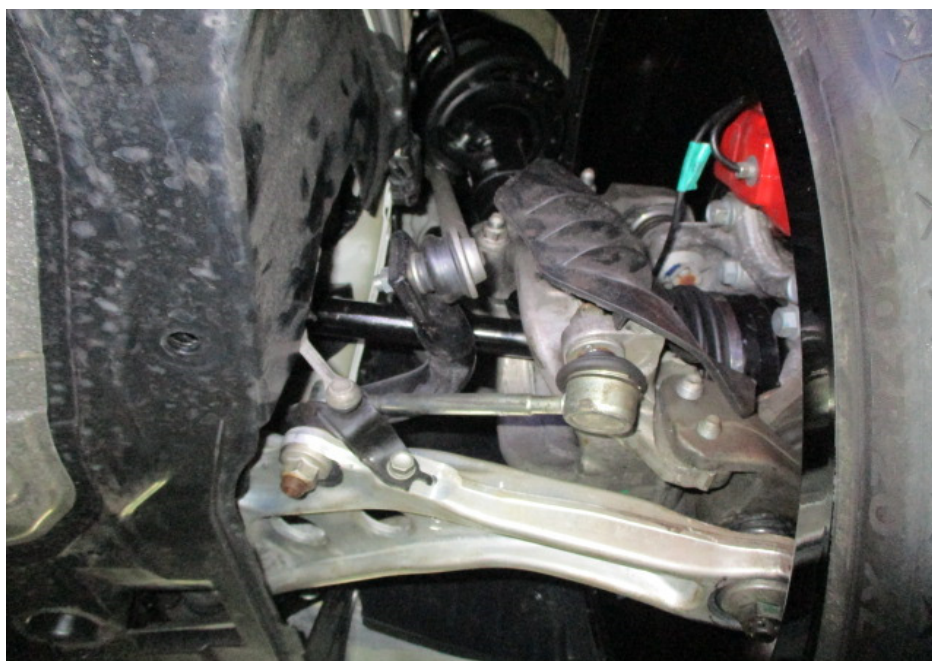
**Photo 16** shows the various undercarriage components at the front left wheel of the Motor Car. The mechanical components, control arms and linkages were all found to be intact and secured in an appropriate manner. I also did not observe any fluid leak and/or fluid stain on the underside of the Motor Car.

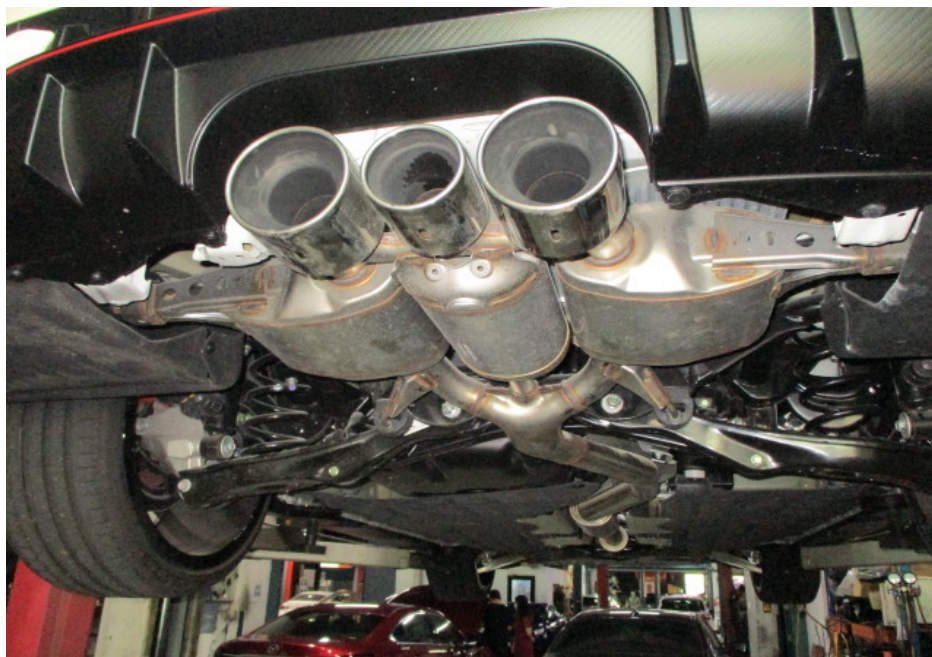
**Photo 17** shows the Motor Car's rear exhaust mufflers. My examination of the Motor Car's exhaust system revealed no sign(s) or indication(s) of any cut or weld marks along its exhaust pipes and on its catalytic converter.

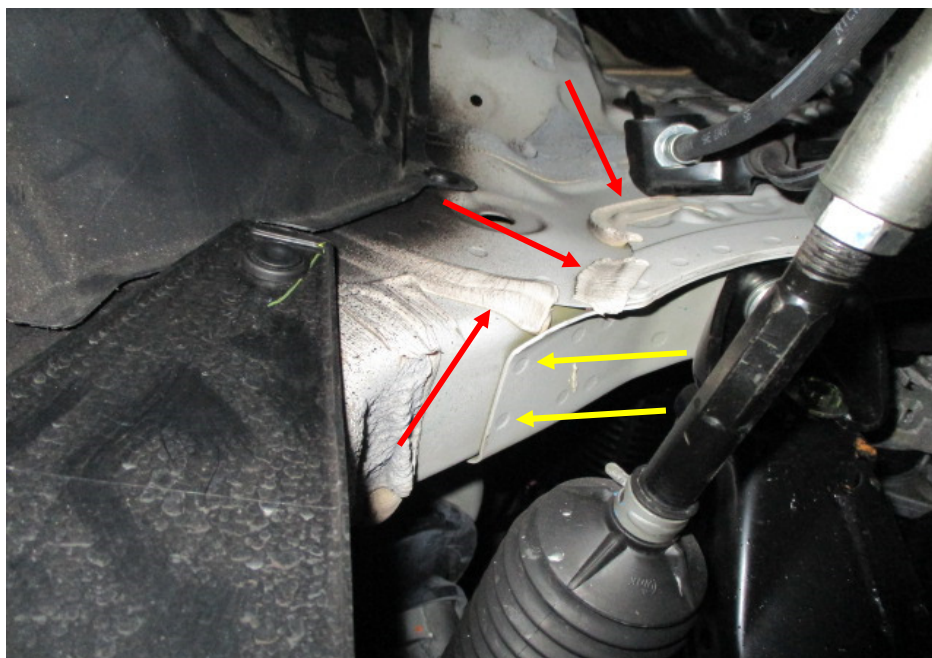
11. Visually, I did not find any weld marks, other than the original spot weld marks, on the chassis/structural body of the Motor Car. The original factory sealant at the joints along the chassis/structural body was also untouched, again indicating that no replacement of the chassis/structural body was carried out; and that the chassis/structural body was originally fitted.

**Photo 18** shows the chassis/structural body at the underside front right of the Motor Car. Visually, I did not find any weld marks other than original spot weld marks (yellow arrow) on the chassis/structural body of the Motor Car. The original factory sealant (red arrow) at the joints along the chassis/ structural body was also untouched, indicating no work was done on the chassis/ structural body of the Motor Car and that the chassis/structural body was originally fitted.

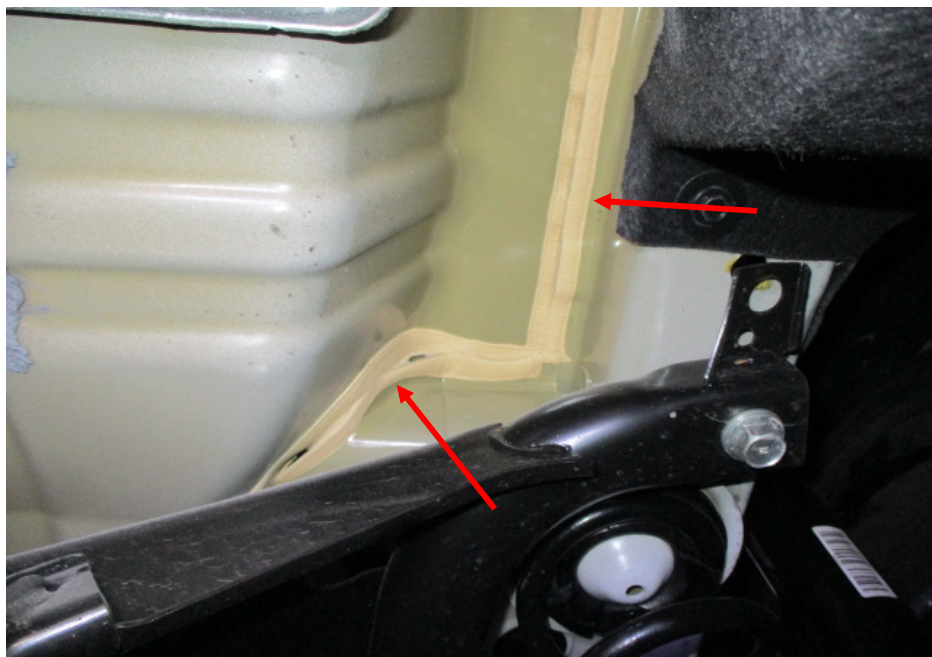
**Photo 19** shows the chassis/structural body at the underside rear right of the Motor Car. The original factory sealant (arrowed) at the joints along the chassis/structural body was untouched, indicating no work was done on the chassis/structural body of the Motor Car and that the chassis/structural body was originally fitted.

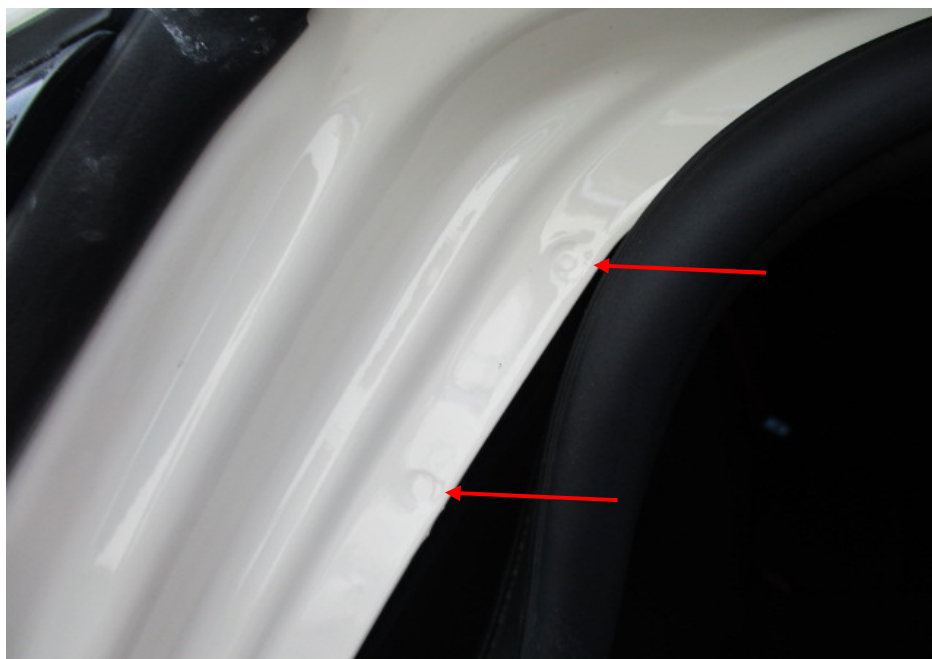
**Photo 20** shows the right "C" pillar of the Motor Car. I did not find any weld marks other than original spot weld marks (arrowed) on the non-detachable body panels of the Motor Car, indicating that there was no re-welding works carried out; and that the non-detachable body panels of the Motor Car were originally fitted.

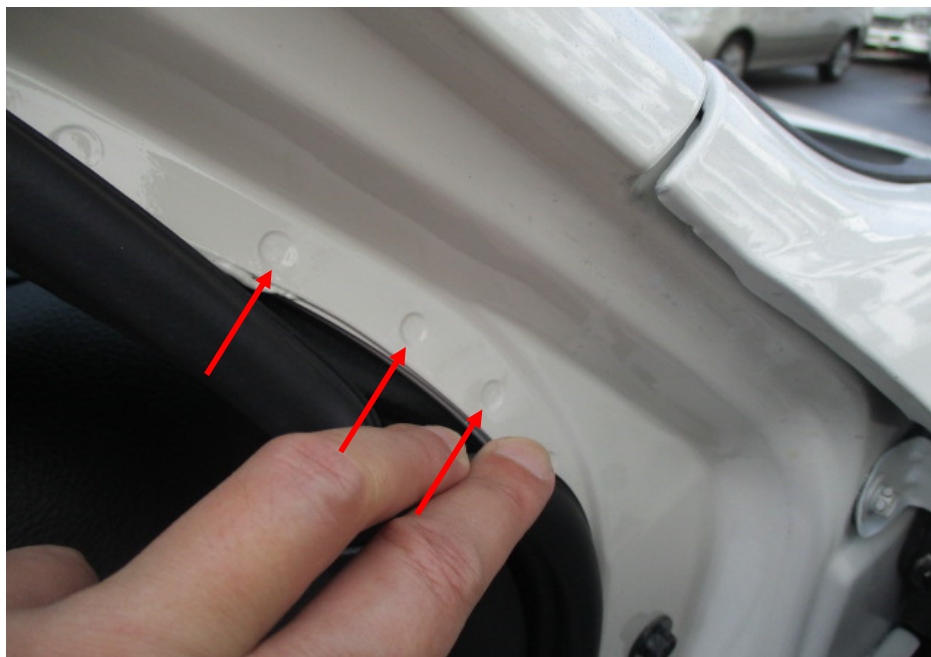
**Photo 21** shows the right "A" pillar of the Motor Car. I did not find any weld marks other than original spot weld marks (arrowed) on the non-detachable body panels of the Motor Car, indicating that there was no re-welding works carried out; and that the non-detachable body panels of the Motor Car were originally fitted.
