**From:** Hsiao Tong (LKKAUTO)  
**Sent:** Monday, 15 March 2021 2:55 PM  
**To:** Tan, Bennie-WZ  
**Subject:** AIG REF: 4681470446SG // LKK REF: CC6/AIG20006918/Apa3 [ACCIDENT INVOLVING GBD 288S(OI) AND SMS 2835R(TP) ON 30/06/2020]

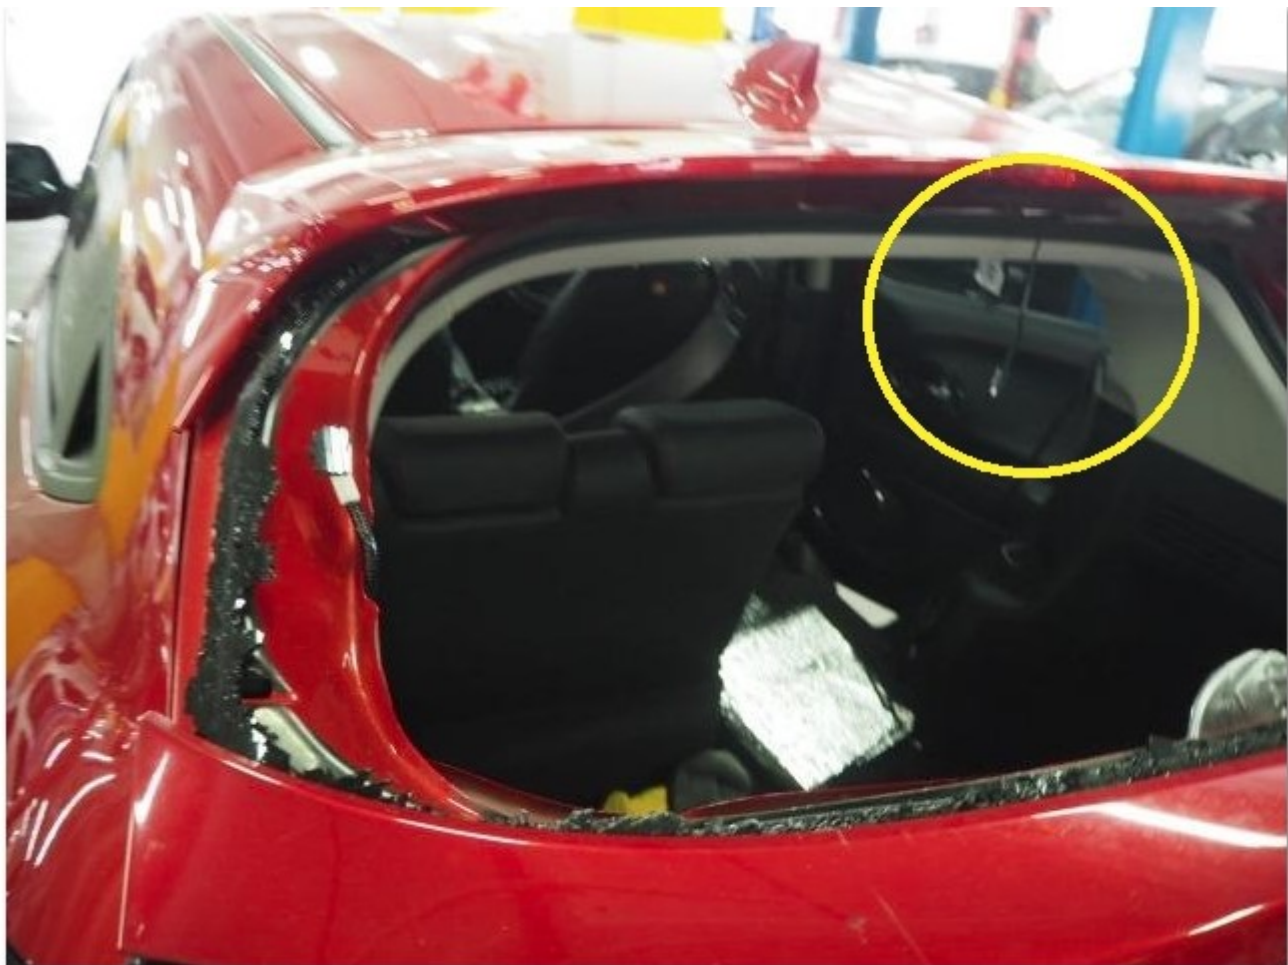
As for the In-Car Camera, the impact caused the rear camera damaged. Kindly refer to the photo No.14 in Merimen. There is a wire(connection for the rear camera) hang in the middle of the rear windscreen area. Furthermore, we have uploaded a copy of rear video footage submitted by third party to show that no video had been recorded after the accident impact.

Surveyor recommended repair cost at L/sum basis as third party vehicle is a Honda Vezel which is quite common on the road and 2<sup>nd</sup> hand parts are available in market.
