Your Ref: BMW 320i  
(chassis number WBA5F72090AK38544)  
Our Ref : CI/TP20006995/D

07 July 2020

**INSPECTION REPORT OF AN UNREGISTERD BMW 320i MOTOR CAR WITH CHASSIS NUMBER WBA5F72090AK38544**

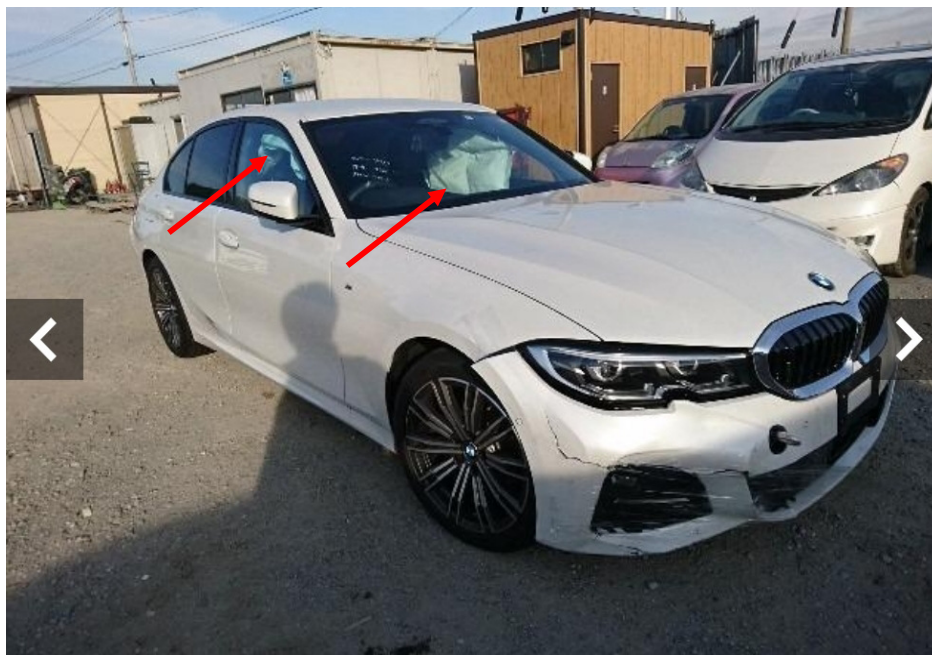
**Photo 1** shows the front right body of the Motor Car prior to any repairs being carried out (photograph provided to me). The Motor Car was observed to have sustained damages at its front portion. The body parts observed to be damaged had include its front bumper, front right headlamp and front right fender amongst others. The right side and left side curtain airbags (arrowed) were also observed to have been deployed.

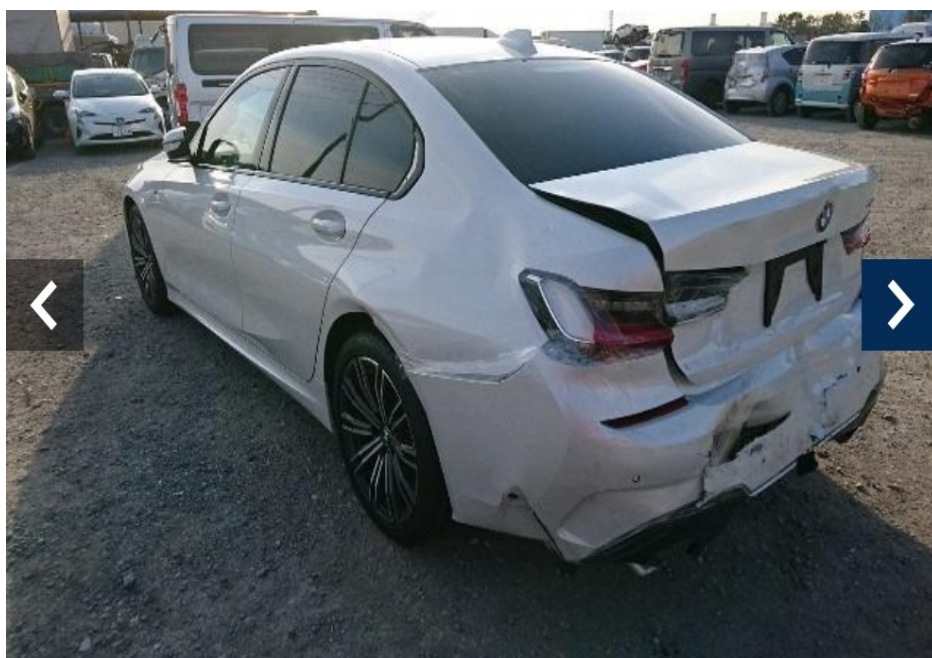
**Photo 2** shows the rear left body of the Motor Car prior to any repairs being carried out (photograph provided to me). Apart for the front portion, the Motor Car had also sustained damages at its rear portion. Body parts damaged had include its rear bumper, rear left taillamp, rear left fender and rear bootlid amongst others.

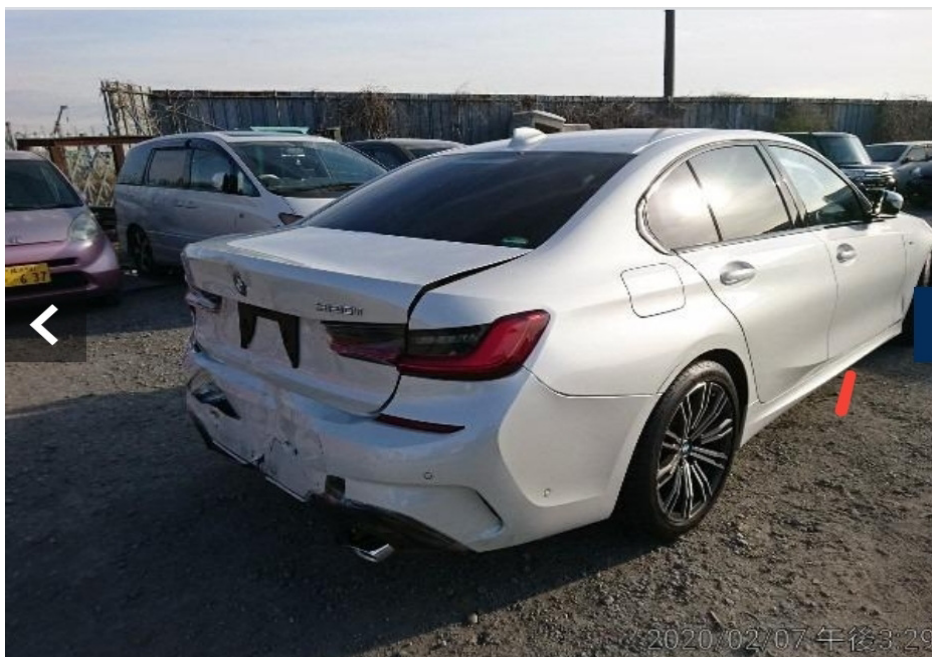
**Photo 3** shows the rear right body of the Motor Car prior to any repairs being carried out (photograph provided to me). The rear bumper and rear bootlid were amongst the parts at its rear portion that had sustained damages.

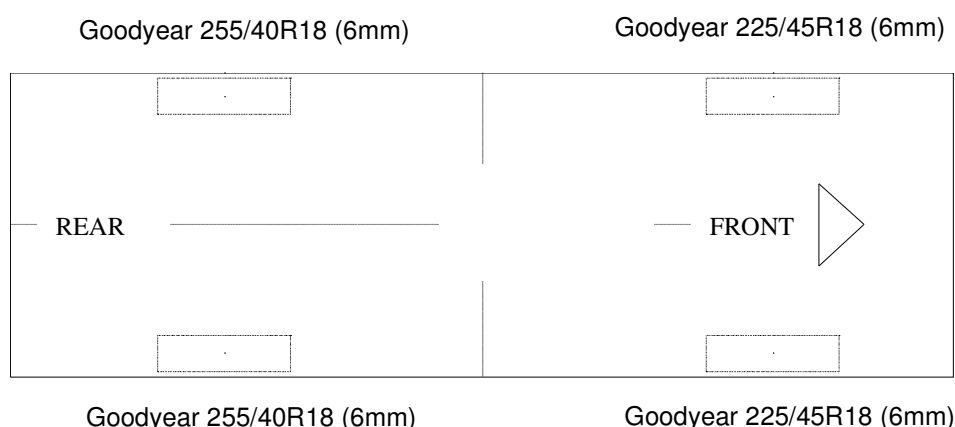
8. It was fitted with 18inch sport wheel rims that were wrapped with tyres that were observed to be of serviceable condition. The tyres were also sufficiently inflated for vehicular operation. The tyre brand, tyre size and approximate remaining tread depth of the 4 tyres of the Motor Car were recorded as follows: -

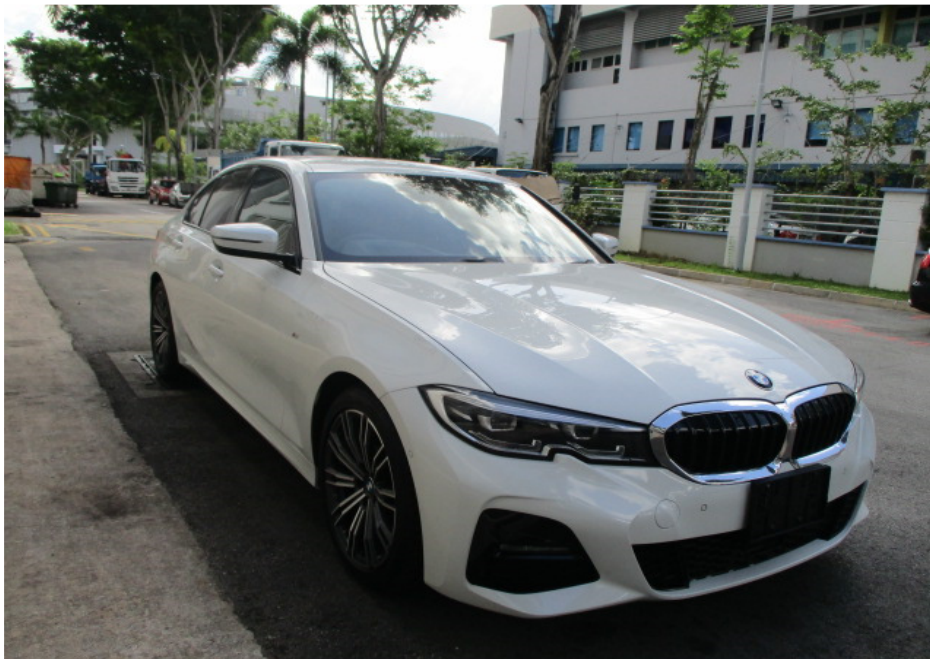
**Photo 4** shows a general view of the front right body of the Motor Car at the time of my inspection. The Motor Car was observed to be in relatively good general condition with no loose exterior fittings observed. The body parts at the front portion of the Motor Car were visually examined and it was observed that the repair/restoration works carried out to the damaged area of the Motor Car (refer to photograph 1 above) were reasonably adequate and in order.

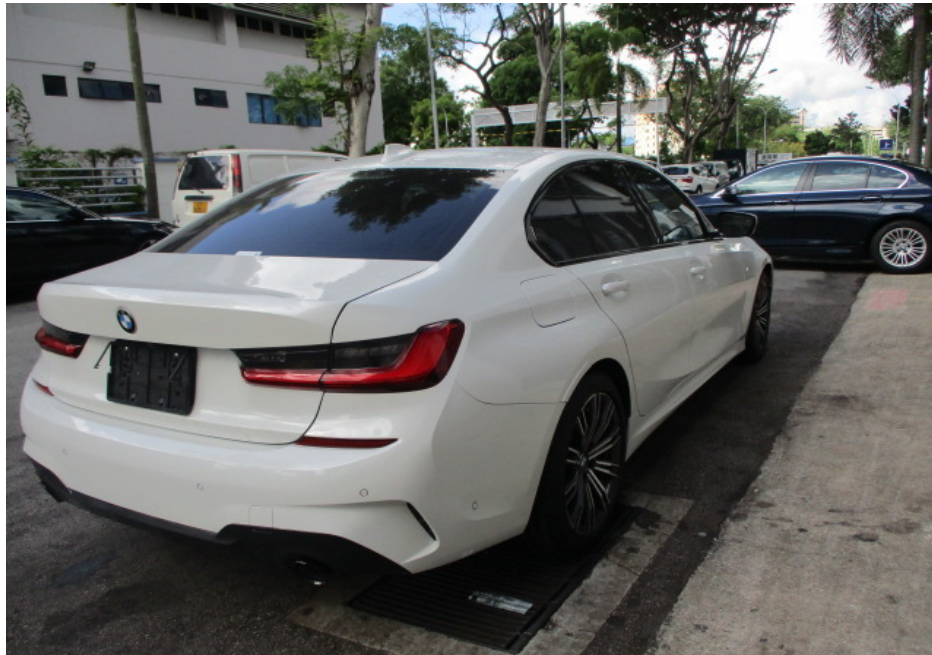
**Photo 5** shows a general view of the rear right body of the Motor Car at the time of my inspection. The Motor Car was observed to be in relatively good general condition with no loose exterior fittings observed. The body parts at the rear portion of the Motor Car were visually examined and it was observed that the repair/restoration works carried out to the damaged area of the Motor Car (refer photograph 2 & 3 above) were reasonably adequate and in order.

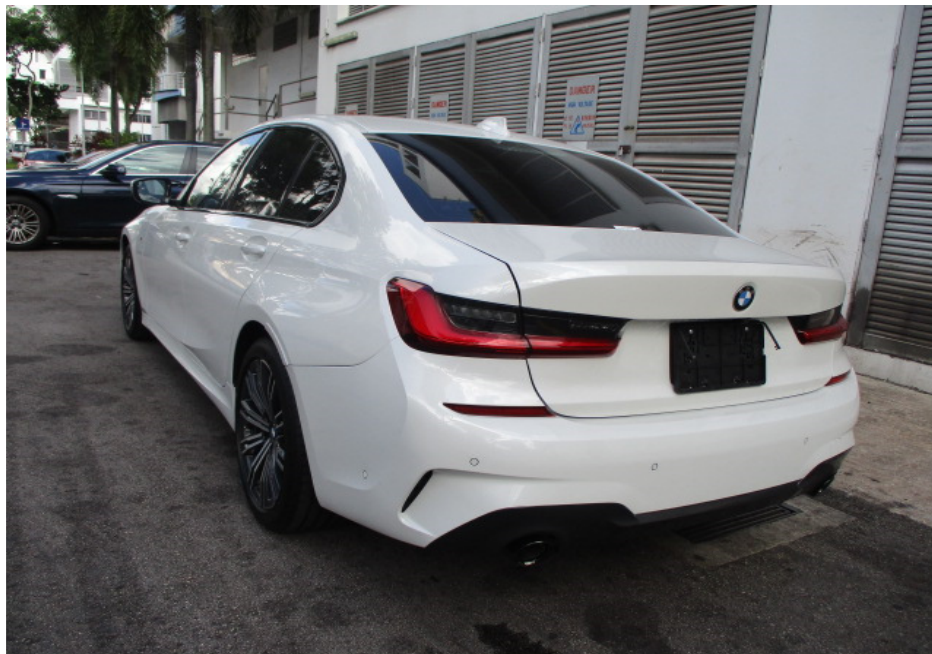
**Photo 6** shows a general view of the rear left body of the Motor Car at the time of my inspection. The body parts at the rear portion of the Motor Car were visually examined and it was observed that the repair/restoration works carried out to the damaged area of the Motor Car (refer photograph 2 & 3 above) were reasonably adequate and in order.

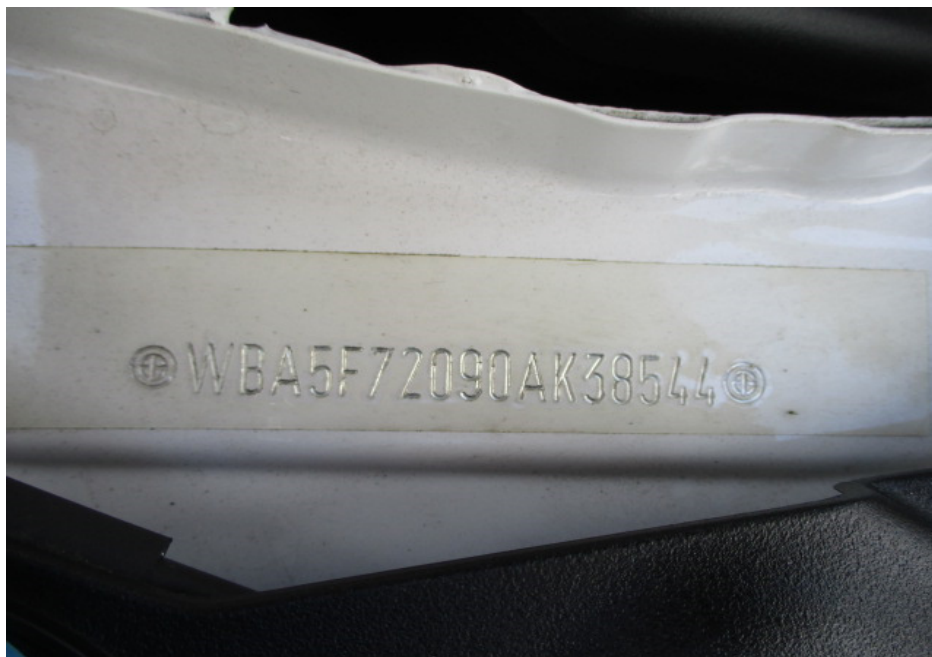
**Photo 7** shows the chassis number of the Motor Car. The chassis number recorded was WBA5F72090AK38544.

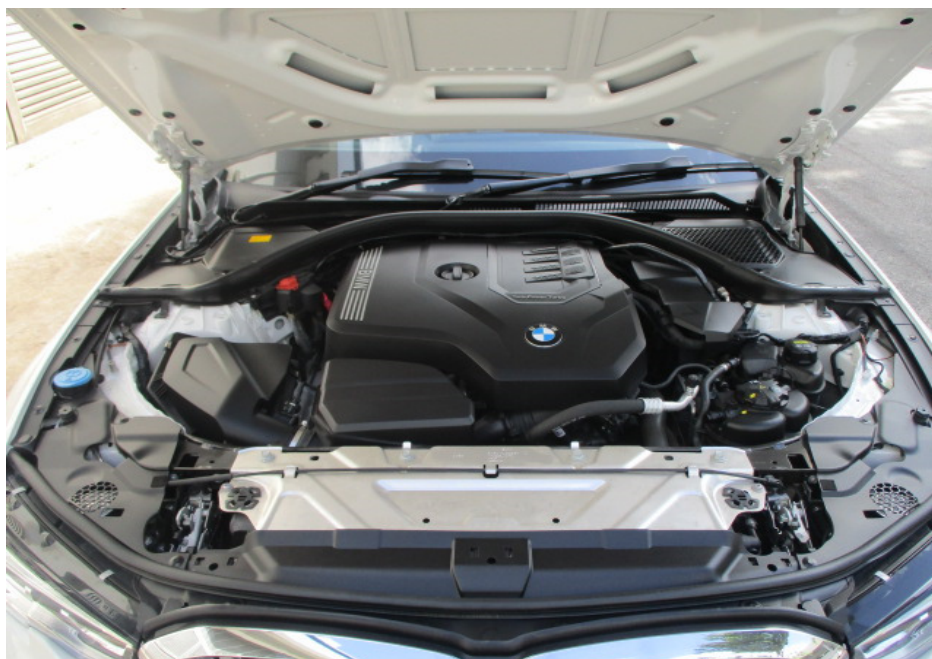
**Photo 8** shows a general view of the engine compartment of the Motor Car at the time of my inspection. The various parts and components inside the engine compartment were all observed to be intact and properly fitted. There was also no sign(s) or indication(s) of fluid leak and/or fluid stain found inside the engine compartment.

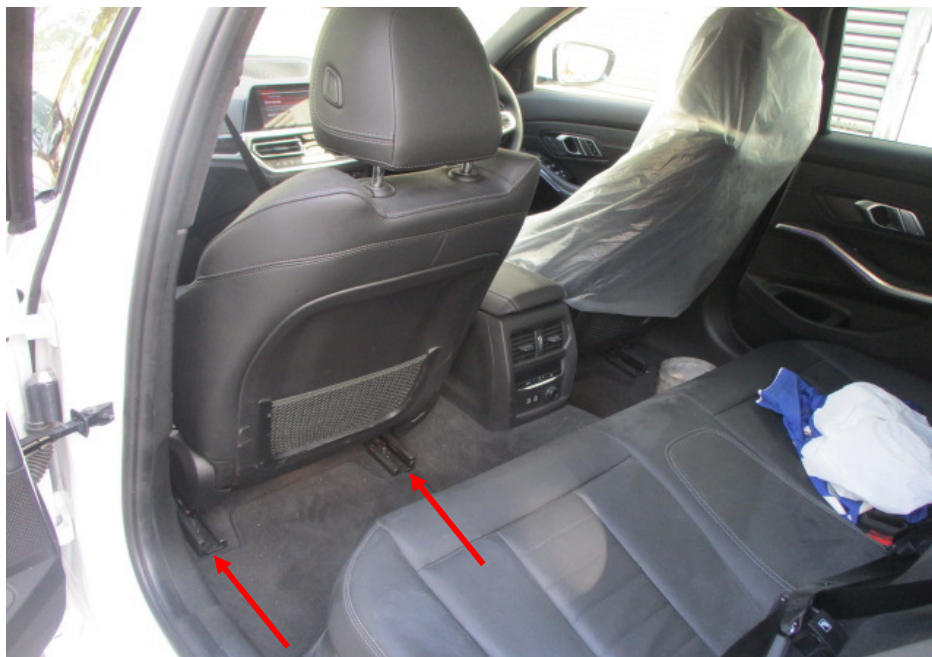
**Photo 9** shows the seats of the Motor Car, which were secured via seat rails (arrowed) to the floor board. All the seats of the Motor Car were fitted with a retractable seat belt reel and pre-tensioner. The seat belts were tested and able to be fastened into the respective pre-tensions that were fitted on the side of each individual seat.

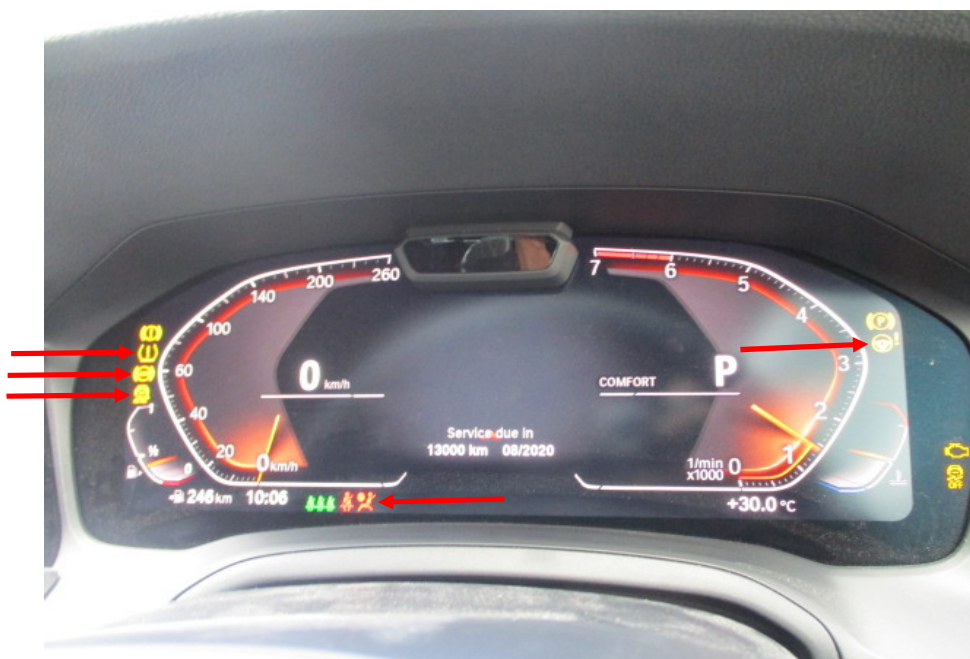
**Photo 10** shows the warning lights for the various electronic safety features appearing on the instrument panel of the Motor Car during its self-test when the engine is cranked, in particular the ABS, SRS, IAS, TPM and DSC lights (arrowed).

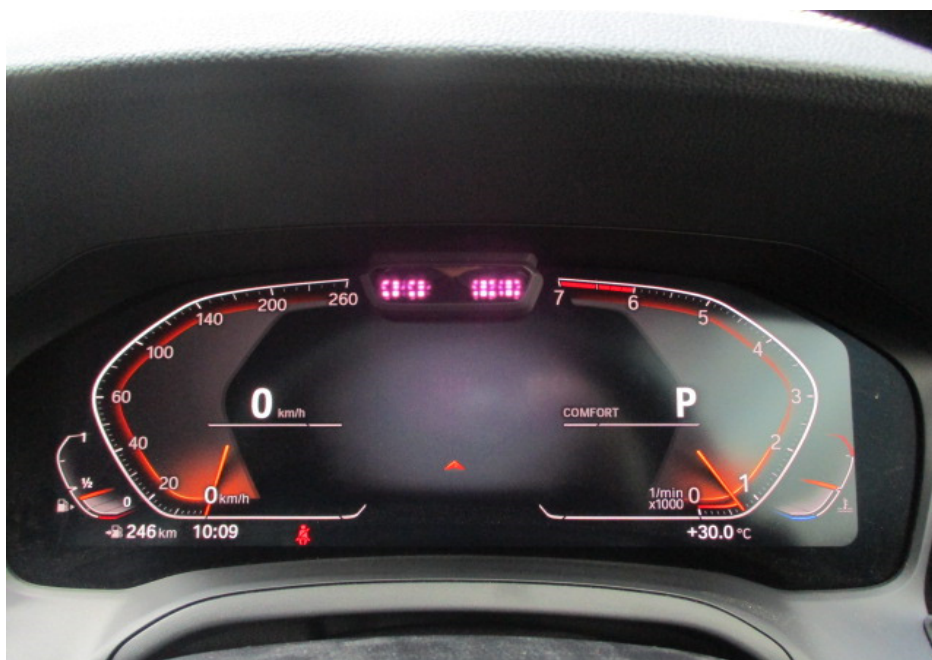
**Photo 11** shows the respective warning lights no longer illuminated, indicating that there is no fault detected to the ABS, SRS, IAS, TPM and DSC systems of the Motor Car during the self-test. These electronic systems were hence in working condition at the time of my inspection.

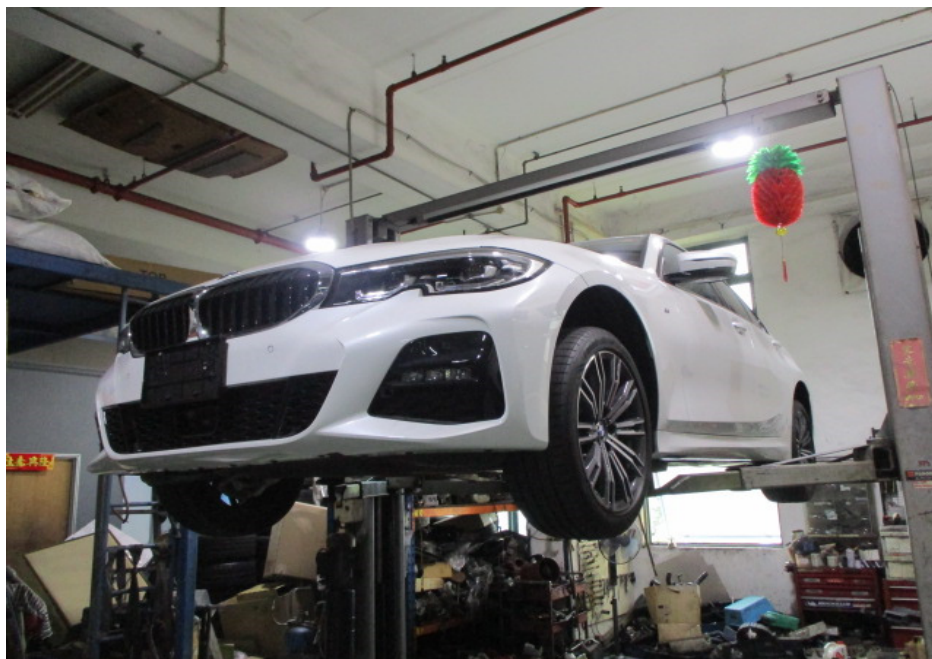
**Photo 12** shows the Motor Car hoisted up for checks on its undercarriage. There was no sign(s) or indication(s) of fluid leakage and/or fluid stain(s) on the underside of the Motor Car. The undercarriage components of the Motor Car were also all observed to be intact and secured in an appropriate manner.

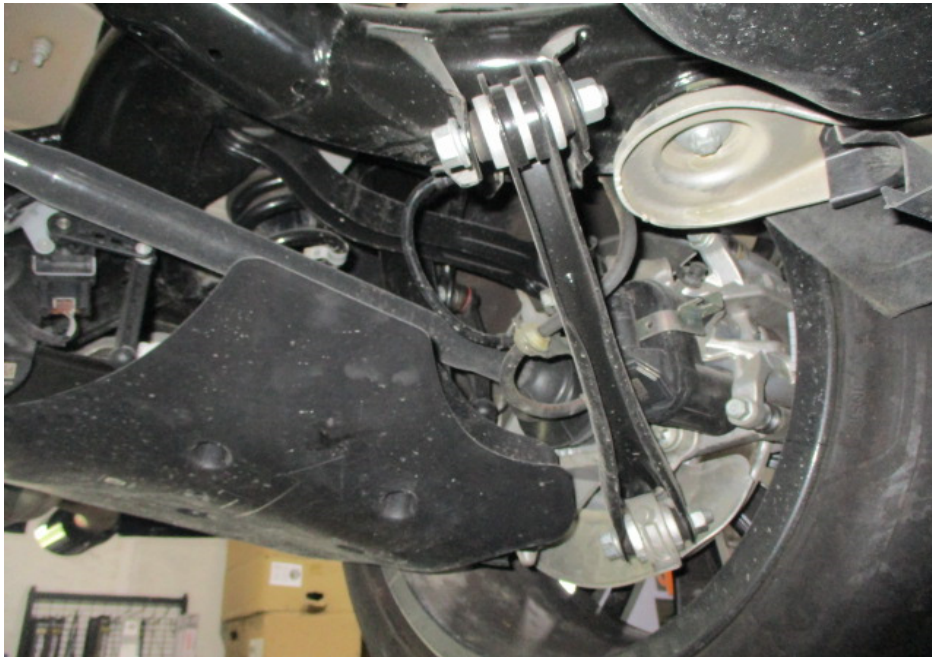
**Photo 13** shows a general view of the control arms and linkages at the rear left wheel of the Motor Car. I did not observe any fluid leak and/or fluid stain on the underside of the Motor Car. All of the Motor Car's undercarriage components were observed to be intact and secured in an appropriate manner.

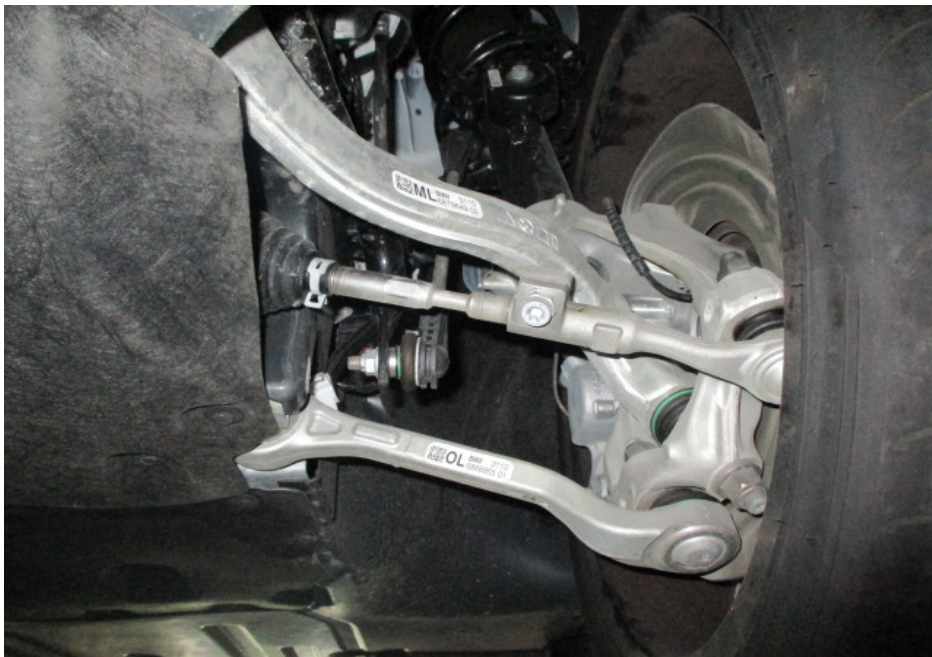
**Photo 14** shows the various undercarriage components at the front left wheel of the Motor Car. The mechanical components, control arms and linkages were all found to be intact and secured in an appropriate manner.

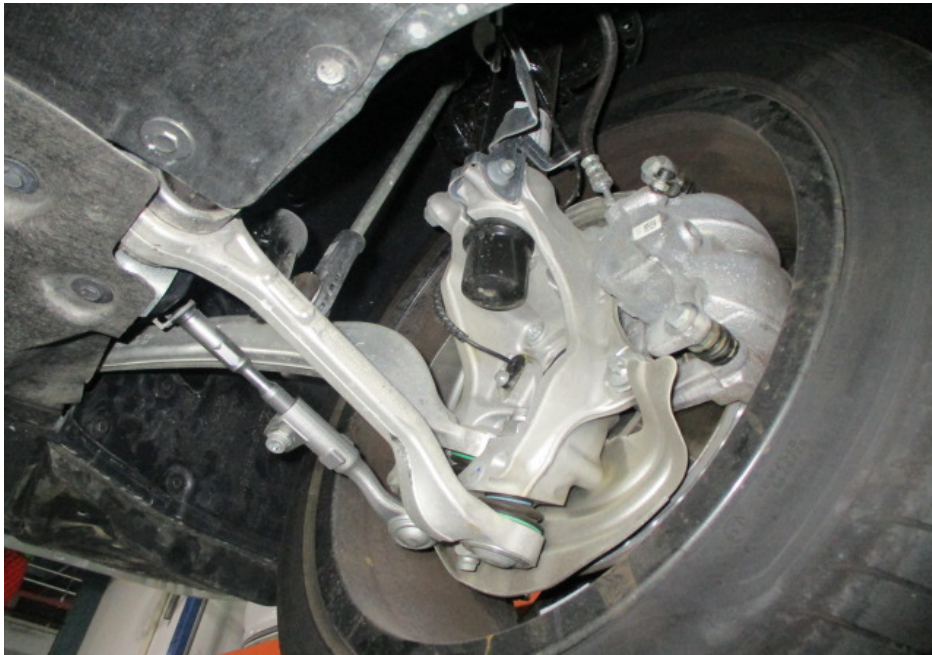
**Photo 15** shows the various undercarriage components at the front right wheel of the Motor Car. The mechanical components, control arms and linkages were all found to be intact and secured in an appropriate manner. I also did not observe any fluid leak and/or fluid stain on the underside of the Motor Car.

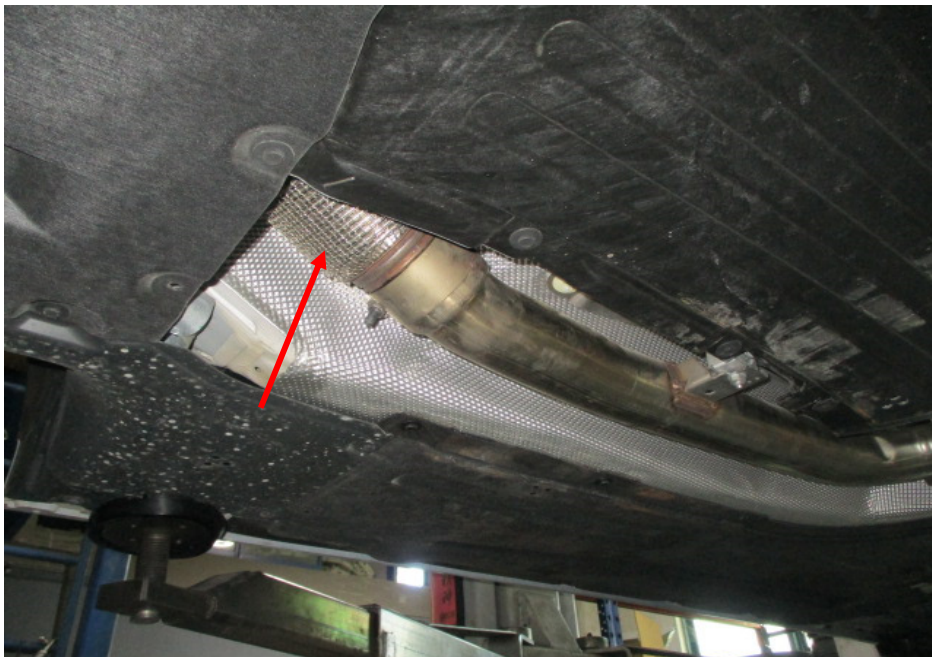
**Photo 16** shows the Motor Car's catalytic convertor (arrowed). My examination of the Motor Car's exhaust system revealed no sign(s) or indication(s) of any cut or weld marks along its exhaust pipes and on its rear muffler.

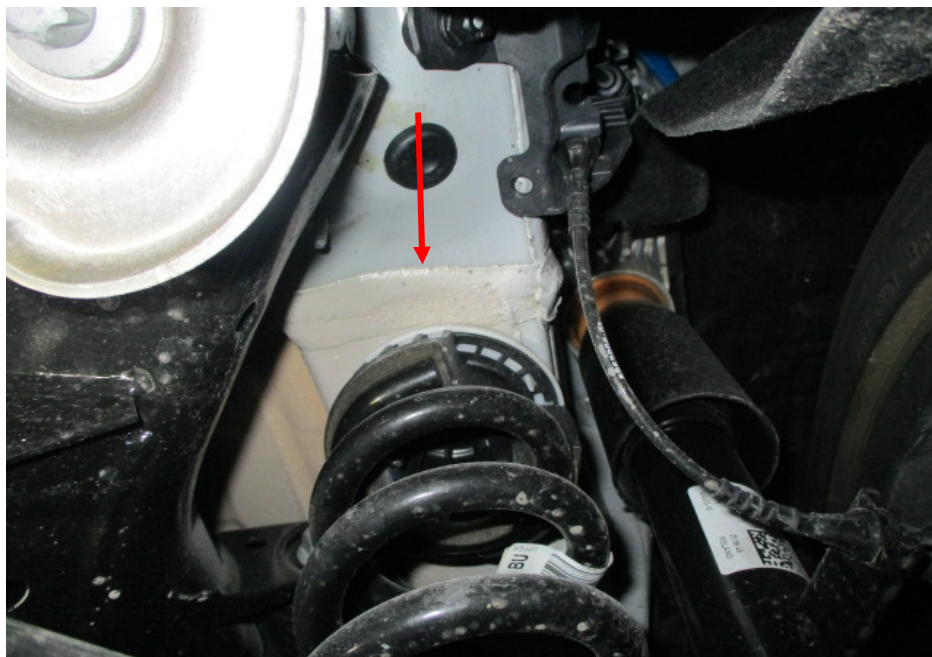
**Photo 17** shows the chassis/structure body at the underside rear right of the Motor Car. The original factory sealant (arrowed) at the joints along the chassis/structure body was also untouched, indicating no work was done on the chassis/structure body of the Motor Car and that the chassis/structure body was originally fitted.

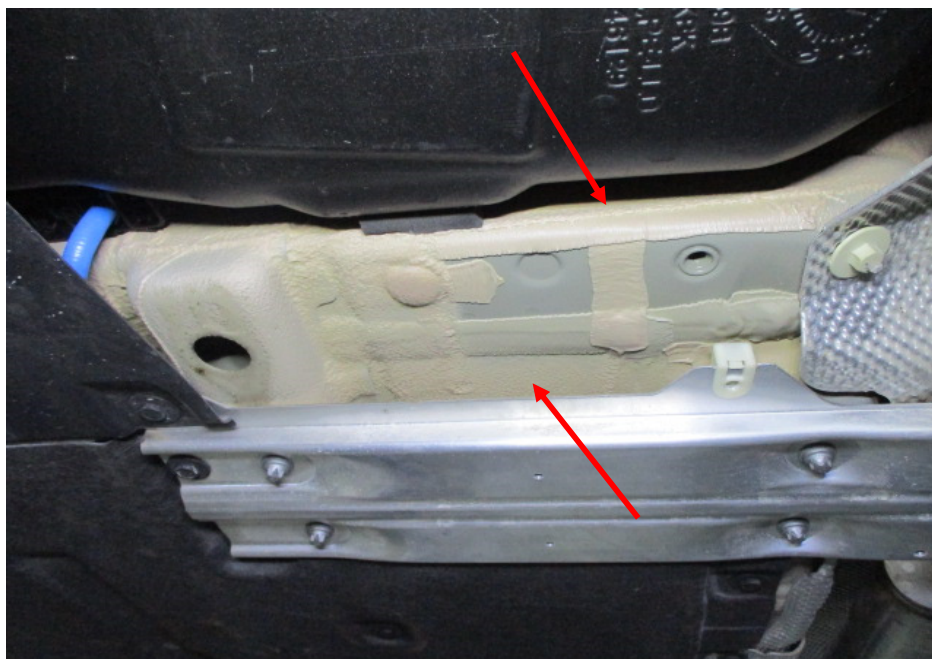
**Photo 18** shows the floor board at the underside centre left of the Motor Car. The original factory sealant at the joints along the non-detachable body panels were untouched, indicating no work was done on the non-detachable body panels of the Motor Car; and that these body panels were originally fitted.

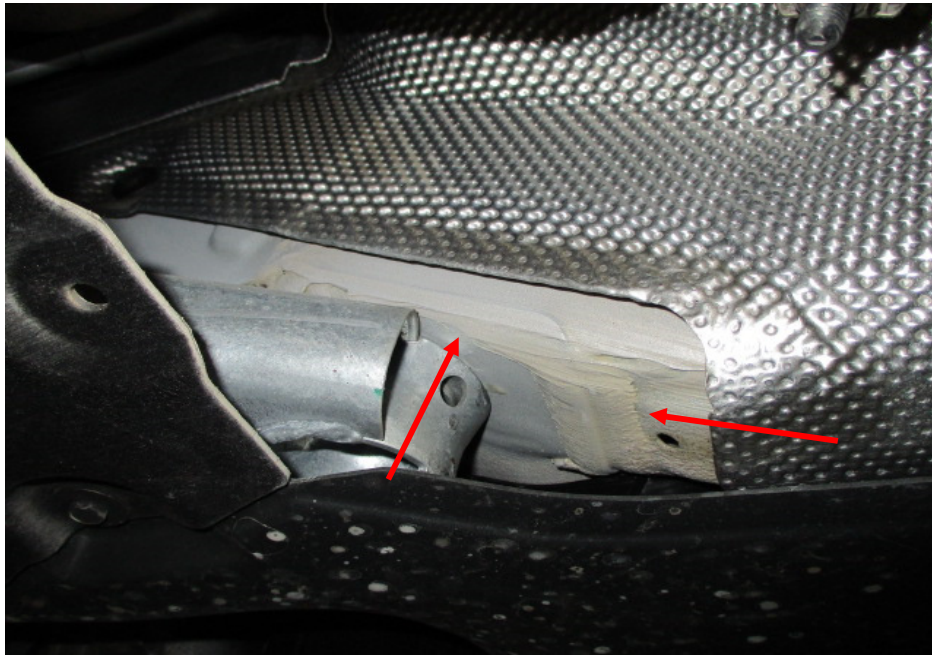
**Photo 19** shows the chassis/structure body at the underside front right of the Motor Car. The original factory sealant (arrowed) at the joints along the chassis/structure body was also untouched, indicating no work was done on the chassis/structure body of the Motor Car and that the chassis/structure body was originally fitted.

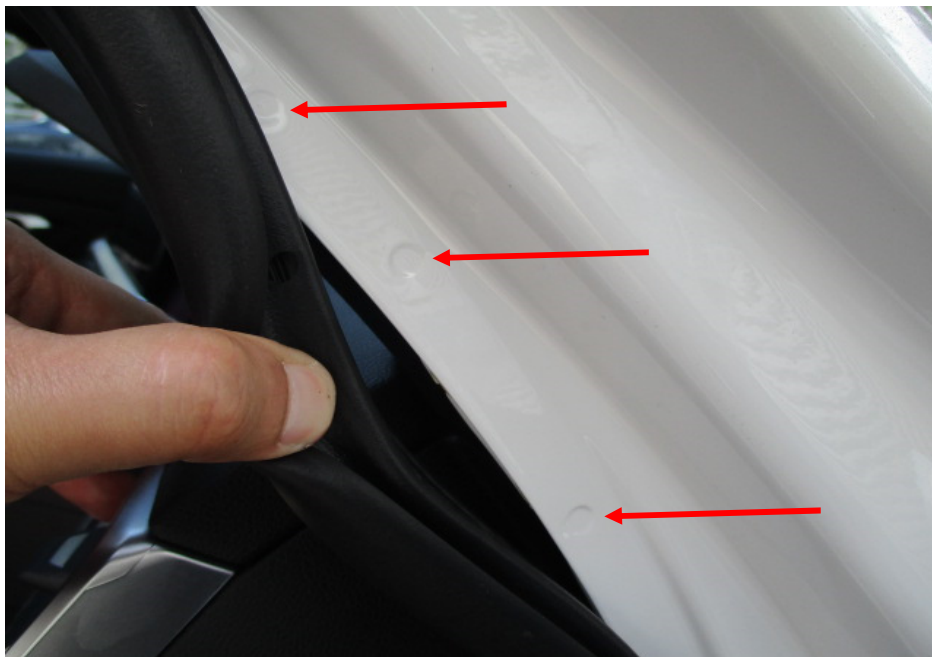
**Photo 20** shows the right "A" pillar of the Motor Car. I did not find any weld marks other than original spot weld marks (arrowed) on the non-detachable body panels of the Motor Car, indicating that there was no re-welding works carried out; and that the non-detachable body panels of the Motor Car were originally fitted.

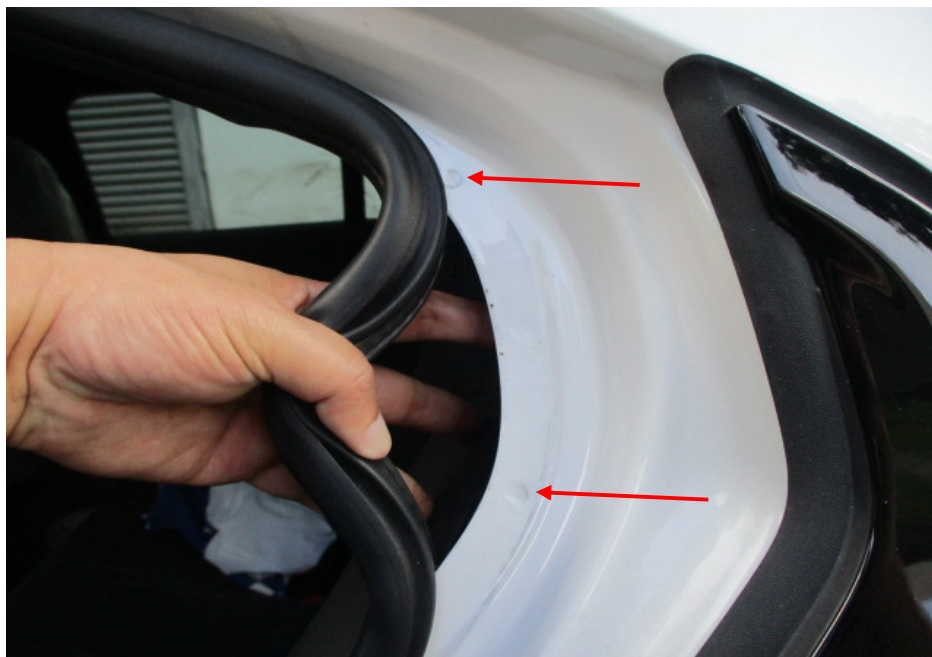
**Photo 21** shows the left "C" pillar of the Motor Car. I did not find any weld marks other than original spot weld marks (arrowed) on the non-detachable body panels of the Motor Car, indicating that there was no re-welding works carried out; and that the non-detachable body panels of the Motor Car were originally fitted.
