**Re : Third Party Claim For Vehicle Registration No. SKV7585L**

## VEHICLE INSPECTION REPORT

Our ref. : UAM20.4.10-AK-STP-HMS-SKV7585L

Registration no.	: SKV7585L	Odometer	: 176457 km
Make / Model	: Honda Vezel 1.5X CVT	Chassis no.	: RU11102032
Regn. date	: 30 Sep 2015	Engine no.	: L15B4022033
Body colour	: Black	Engine cap.	: 1496 cc

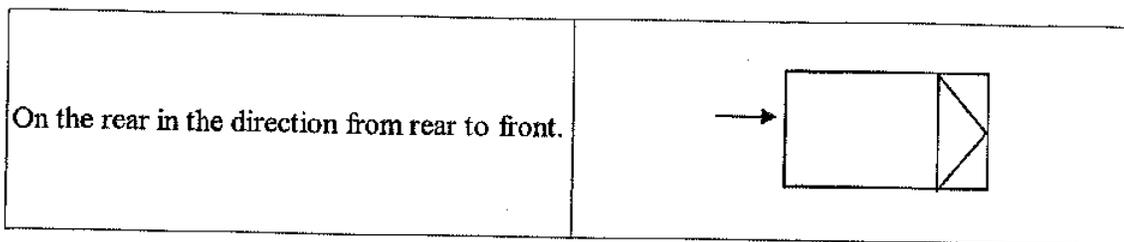
**POINT OF IMPACT**

The impact of the collision has damaged / affected the tailgate, taillamp, rear bumper, rear end panel, rear fender and etc...
