# UNITED Appraisal And Management Pte Ltd

**Re : Third Party Claim For Vehicle Registration No. SKV7585L**

## VEHICLE INSPECTION REPORT

Registration no.	: SKV7585L	Odometer	: 176457 km
Make / Model	: Honda Vezel 1.5X CVT	Chassis no.	: RU11102032
Regn. date	: 30 Sep 2015	Engine no.	: L15B4022033
Body colour	: Black	Engine cap.	: 1496 cc

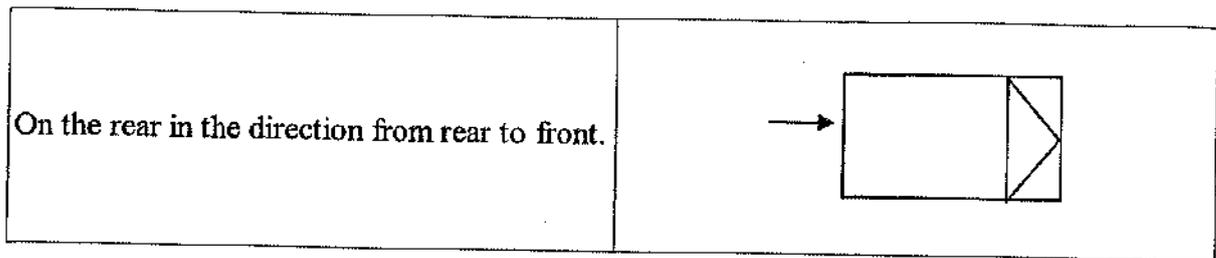
**POINT OF IMPACT**

The impact of the collision has damaged / affected the tailgate, taillamp, rear bumper, rear end panel, rear fender and etc...
