Vehicle No. SHD 5385R

Reg. No: 199607198R GST Reg. No. 19-9607198-R			
		Affiliated to Federation Internation	nale Des Experts En Automobi	le
AUT	JTO & GENERAL INSURANCE (S) PL Ref : CS/AGI20007048/Ksf3q2			
(BUDGET DIRECT INSURANCE) 190 CLEMENCEAU AVENUE #03-01 SINGAPORE SHOPPING CENTRESINGAPORE 239924		Date: 16-10-2020		
			Code: AGI

ADJUSTMENT ON REPAIR COST FOR VEHICLE NO. SHD 5385R

PHOTOGRAPHS FOR VEHICLE NO. SHD 5385R

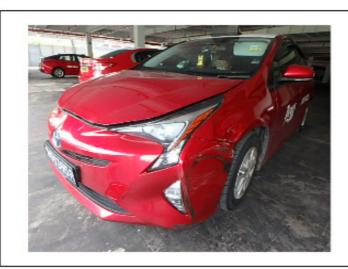
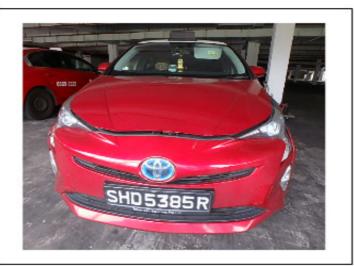
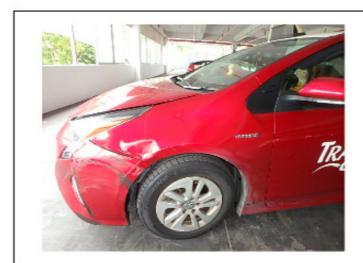
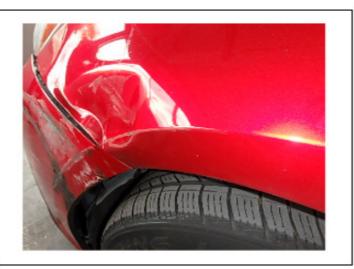
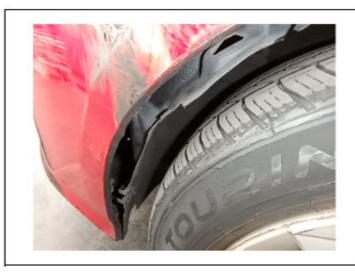
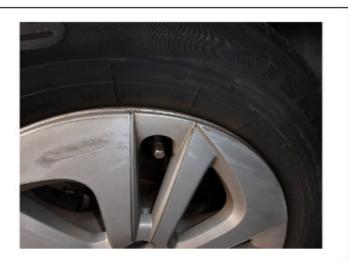
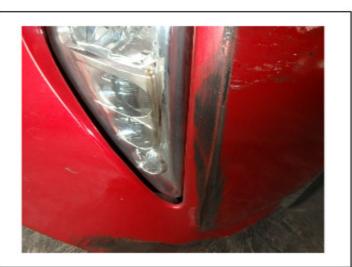
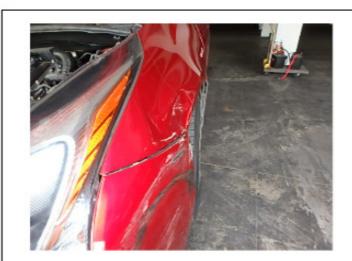
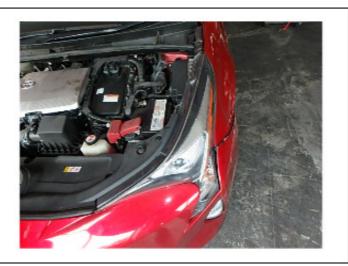
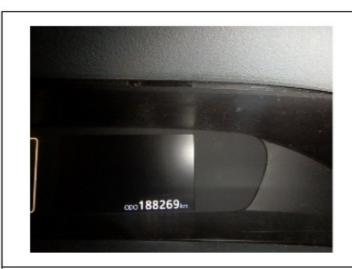
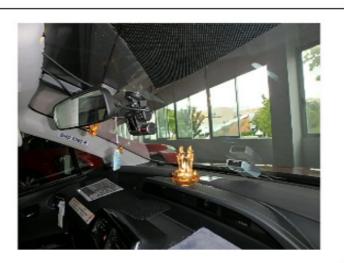
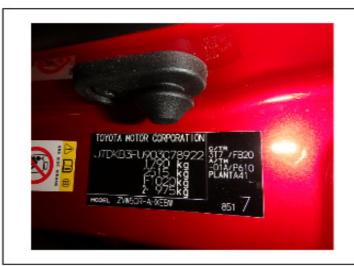
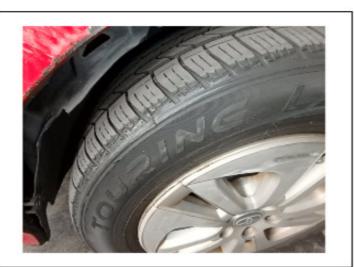
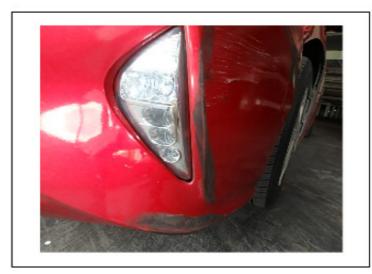
4.		Description	on of Damages	
	THE VEHICLE SU	STAINED DAMAGES AT THE N/S	FRONT PORTION.	
	DAMAGES SEE D	ETAILS.		
5.		General	Information	
	Accident Date	05/07/2020	Inspection Date	07/07/2020
	Survey held at	TRANS-CAB AUTO SERVICES	PTE LTD	
		NO.2 ANG MO KIO ST 63 SINGAPORE 569111		
5a.		Re	emarks	
	A)THE INSPECTION WAS CONDUCTED ON A"WITHOUT PREJUDICE" BASIS. B)IN ACCORDANCE TO YOUR INSTRUCTIONS, WE HAVE NOT AUTHORISED REPAIRS.			
5b.		Estimate	Days of Repair	
	1
