Vehicle No. SHB 9800T  
Insured Veh. SHA 8810B  
Claim No. D20002710MFSH  
Policy No. D-18088937MFSH  
Accident Date 05/07/2020  
Inspection Date 07/07/2020

## LKK Auto Consultants Pte Ltd

### ADJUSTMENT ON REPAIR COST FOR VEHICLE NO. SHB 9800T

PHOTOGRAPHS FOR VEHICLE NO. SHB 9800T

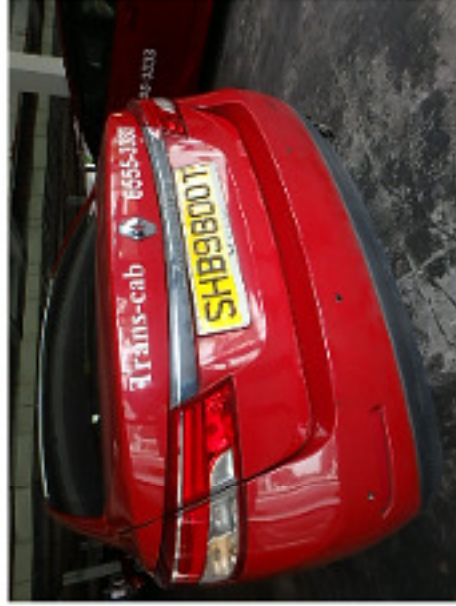
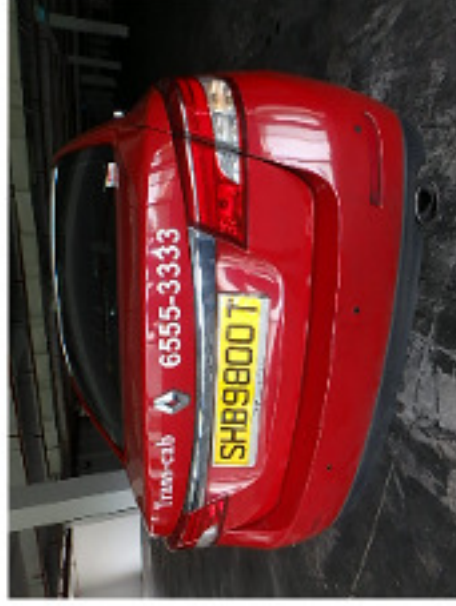
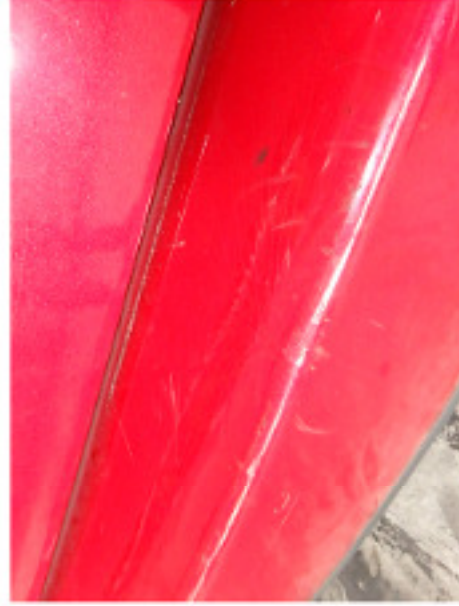
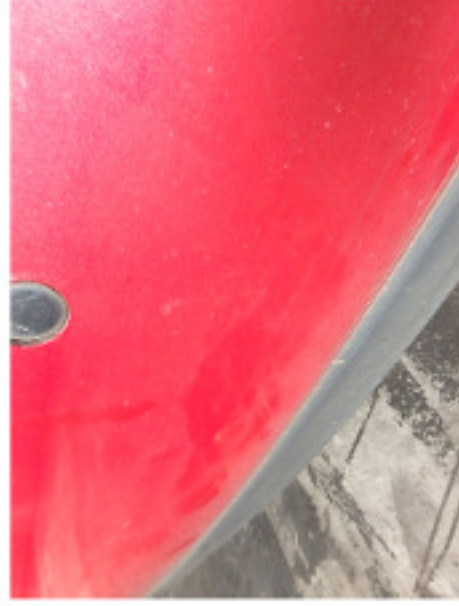
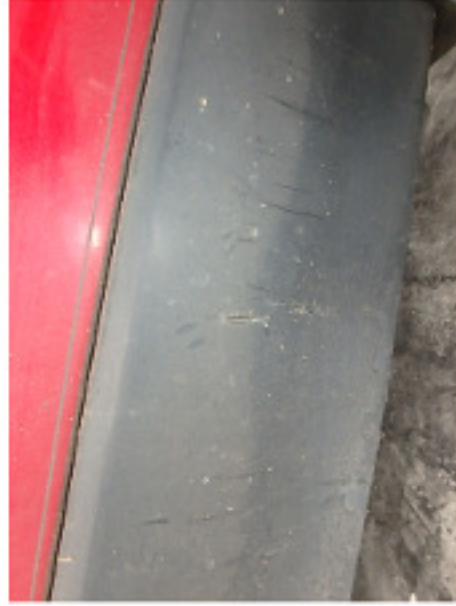
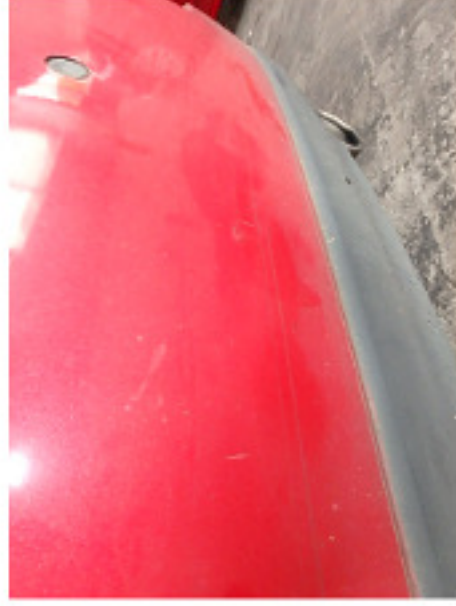
<b>4. Description of Damages</b>				
THE VEHICLE SUSTAINED DAMAGES AT THE REAR PORTION. DAMAGES SEE DETAILS.				
<b>5. General Information</b>				
Accident Date	05/07/2020	Inspection Date	07/07/2020	
Survey held at	TRANS-CAB AUTO SERVICES PTE LTD NO.2 ANG MO KIO ST 63 SINGAPORE 569111			
<b>5a. Remarks</b>				
A)THE INSPECTION WAS CONDUCTED ON A"WITHOUT PREJUDICE" BASIS. B)IN ACCORDANCE TO YOUR INSTRUCTIONS, WE HAVE NOT AUTHORISED REPAIRS.				
<b>5b. Estimate Days of Repair</b>				
ESTIMATED NORMAL PERIOD FOR REPAIR:		<b>2 Working Days</b>
