Your Ref: S0M02QCC  
Our Ref: CS4/ASM20007092/P

16<sup>th</sup> July 2020

**TECHNICAL INVESTIGATION REPORT OF FIRE INCIDENT INVOLVING THE  
INSURED VEHICLE GBA 9799R ON 1<sup>st</sup> July 2020**

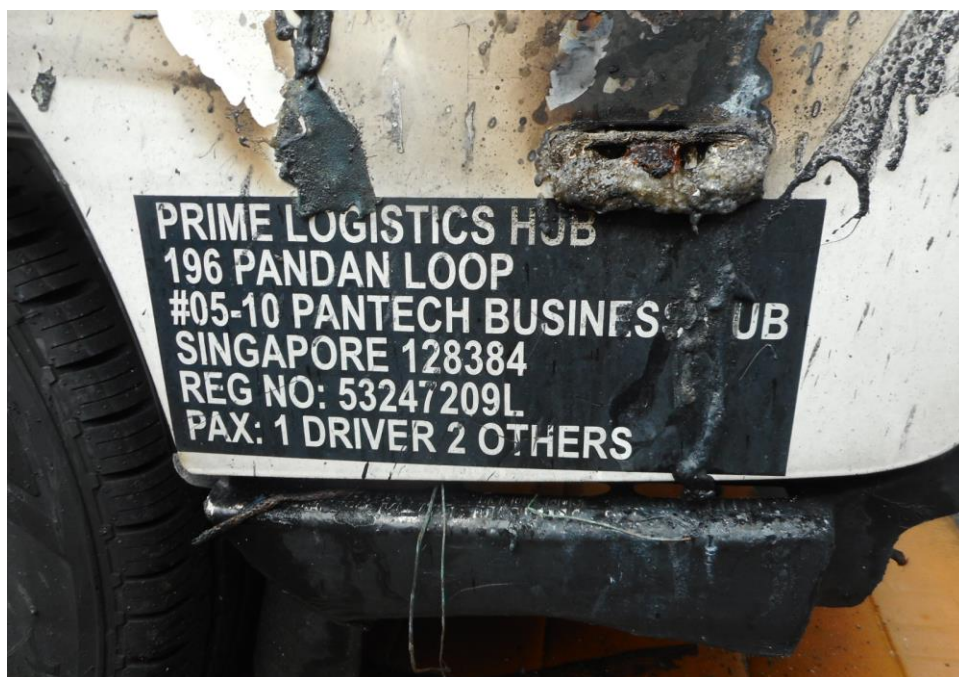
**Photo 1** shows the company registration of the Insured Vehicle at the time of our inspection. As the fire damage to the Insured Vehicle had burnt down the both the front and rear registration plates of the Insured Vehicle.

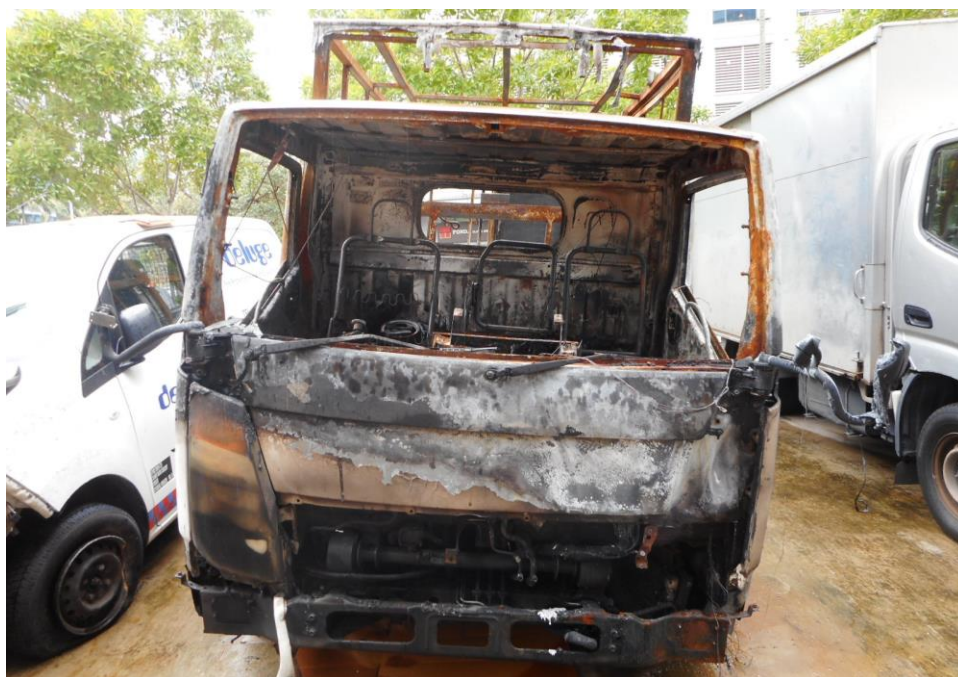
**Photo 2** shows the front view of the Insured Vehicle at the time of our inspection. The fire damage to the Insured Vehicle had affected the whole Insured Vehicle.

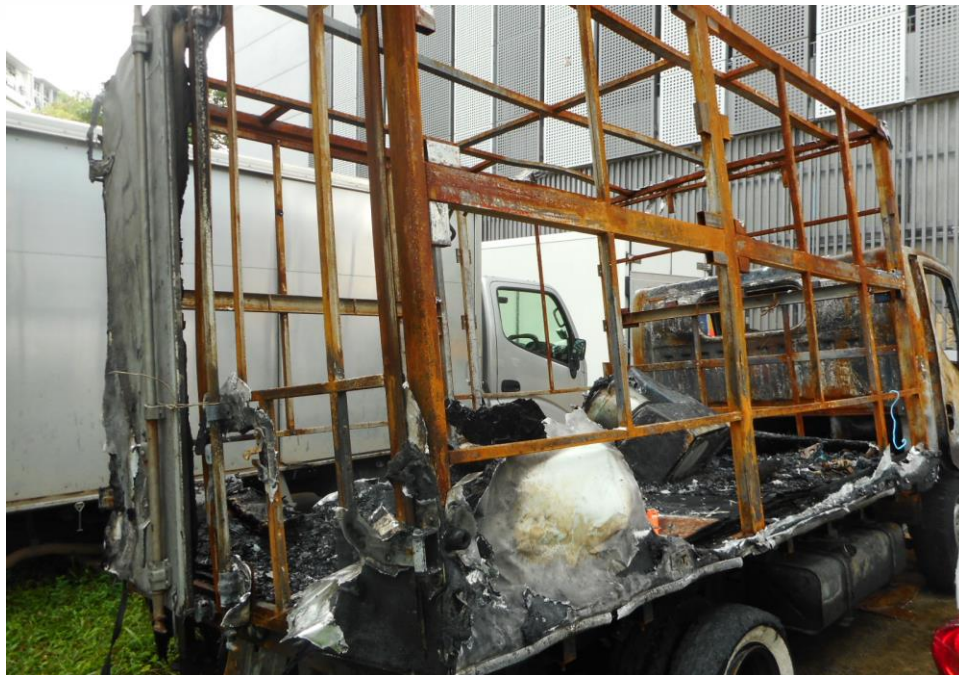
**Photo 5** shows the rear cabin of the Insured Vehicle from the right side at the time of our inspection. The fire damage to the Insured Vehicle had burnt down the entire rear portion compartment. The whole rear cabin panel were amongst the parts that were observed to have been affected by the fire.

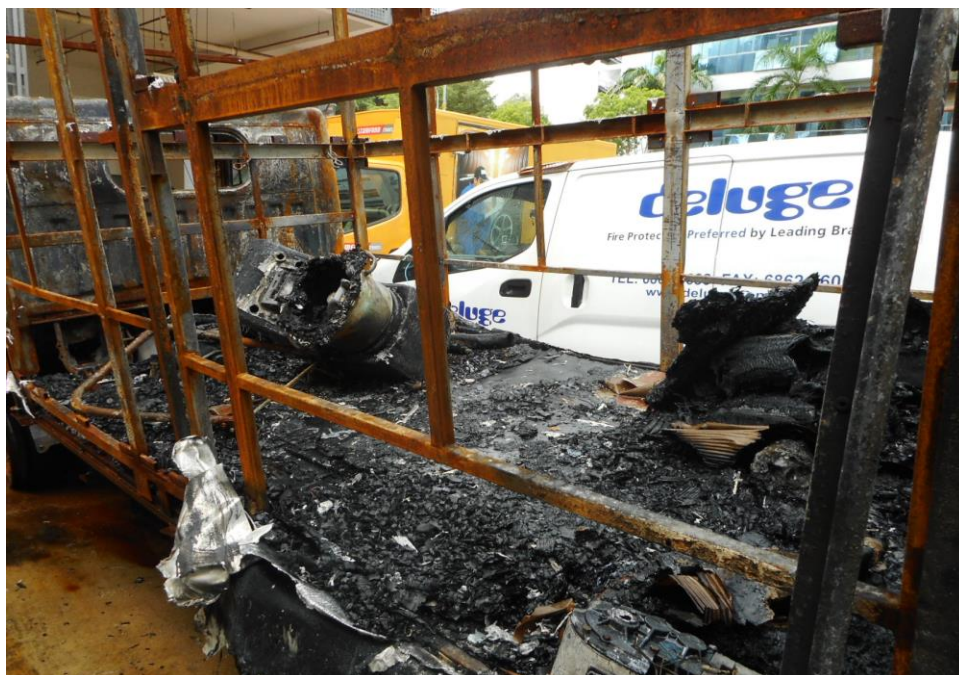
**Photo 6** shows the rear cabin of the Insured Vehicle from the left side at the time of our inspection. The fire damage to the Insured Vehicle had burnt down the entire rear portion compartment. The goods in the rear cabin that the Insured Vehicle was carrying were amongst the parts that were observed to have been burnt by the fire.

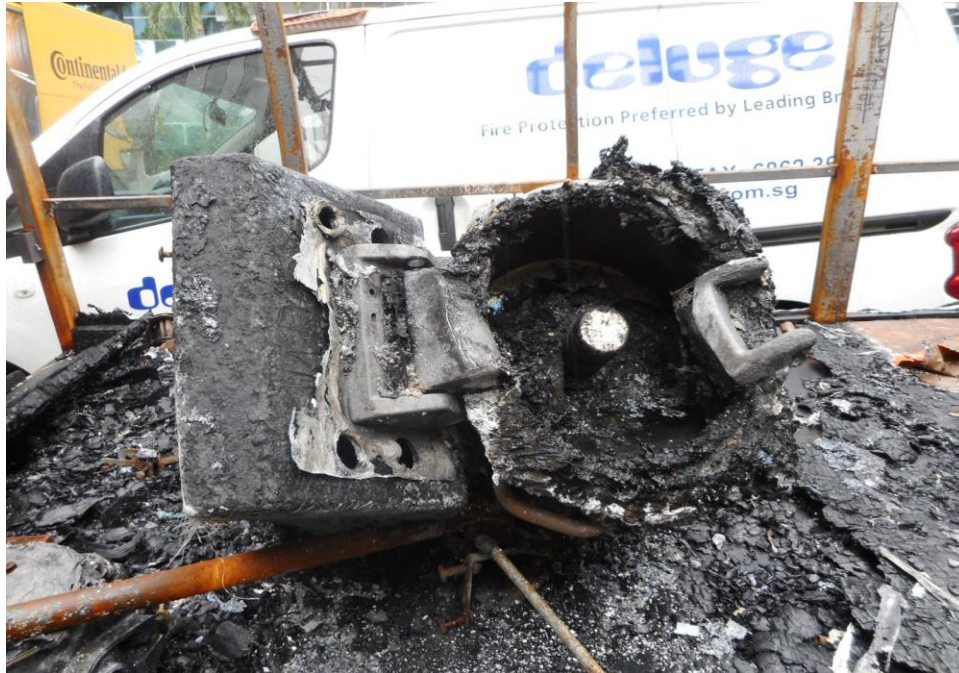
**Photo 7** shows the close up view of the goods in the rear cabin of the Insured Vehicle at the time of our inspection. The fire damage to the Insured Vehicle had burnt down the entire rear portion compartment. The goods in the rear cabin that the Insured Vehicle was carrying were amongst the parts that were observed to have been burnt by the fire.

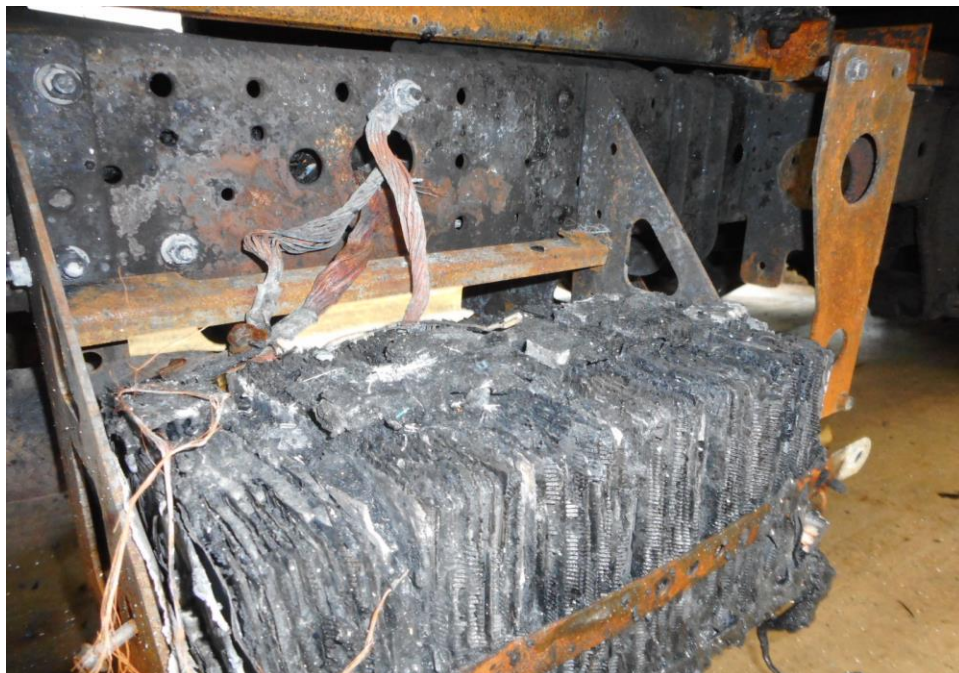
**Photo 8** shows the battery unit of the Insured Vehicle at the time of our inspection. The battery unit and the battery terminal was damaged by the fire of the Insured Vehicle.

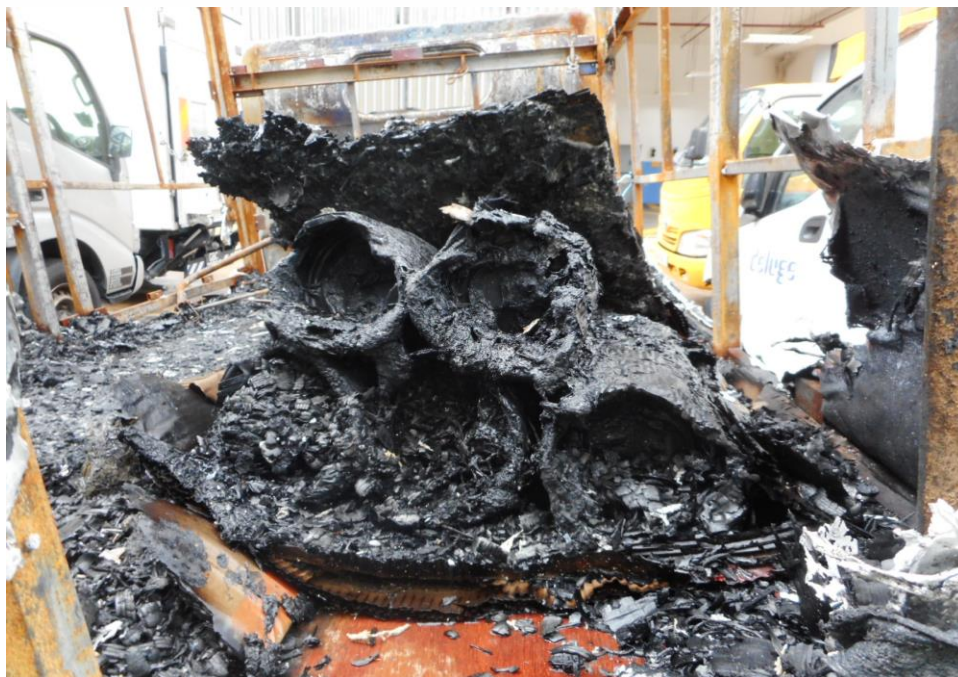
**Photo 11** shows a closer view of the rear cabin compartment of the Insured Vehicle at the time of our inspection. The rear cabin was significantly burnt and/or melted as a result of the fire. We also found remnants of cardboard and various other items in the rear cabin compartment.

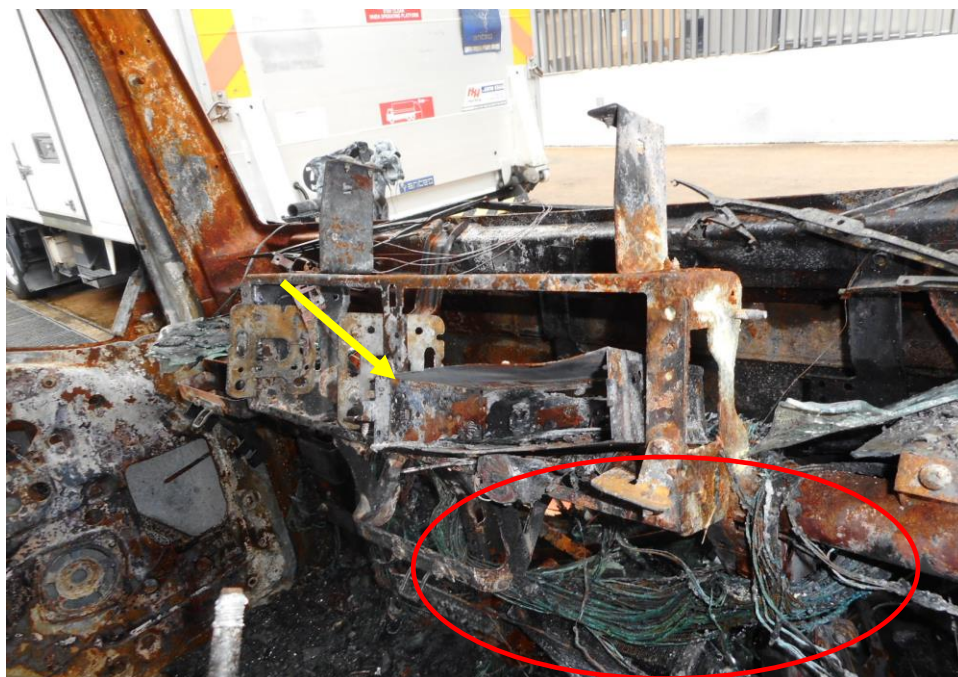
**Photo 12** shows the general view of the interior compartment of the Insured Vehicle at the time of our inspection. The fire damage to the Insured Vehicle has affected its engine and interior compartment. Its interior dashboard (circled), radio head unit (yellow arrow), various original wiring harnesses was amongst the parts in the compartment that were found to have been affected as a result of the fire.

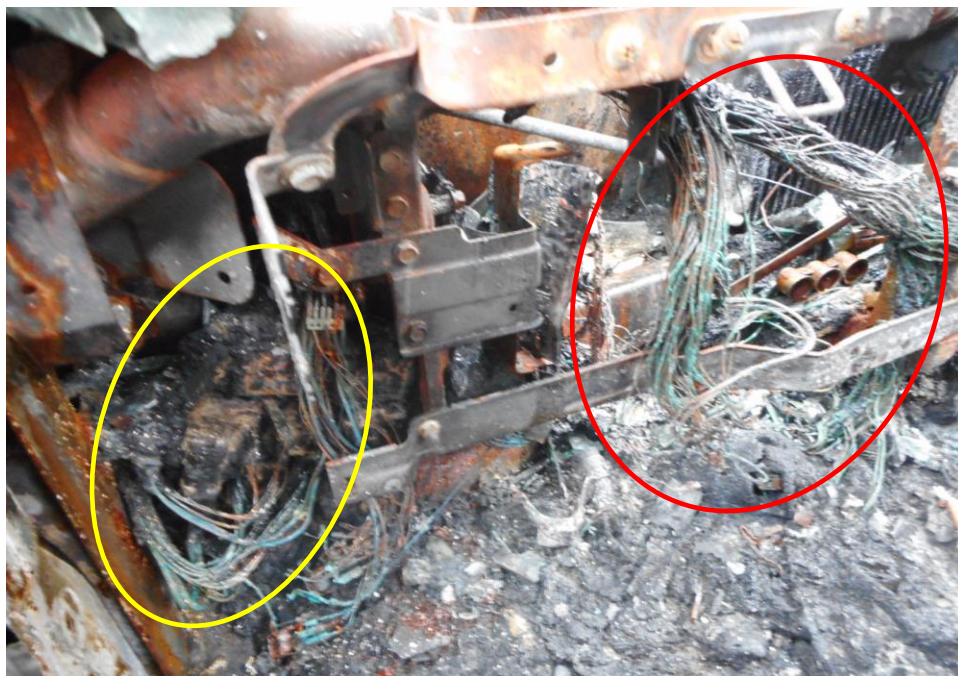
9. Upon closer examination of the front portion of the Insured Vehicle which was where the fire had started, we had found traces of greenish residue on the main wirings harnesses leading from the fuse box to the electrical components of the Insured Vehicle. The wirings were original wirings fitted from the manufacturer. The presence of greenish residue indicates internal heating of copper wires, a sign of an electrical short circuit occurring. The greenish residue is normally left behind from the oxidation as a result of chemical reaction involving the copper wires. This physical evidence would then appear to suggest that the cause of fire to the Insured Vehicle could have possibly been due to electrical in nature. See photos See photos 12 - 14 below.

**Photo 13** shows a close up view of the original wiring harness leading to the fuse box in the front cabin compartment. The original wiring harness (red circle) and fuse box wirings (yellow circle) was observed with greenish residue on the surface. The presence of greenish residue indicates internal heating of copper wires, a sign of an electrical short circuit occurring. The greenish residue is normally left behind from oxidation as a result of chemical reaction involving the copper wires.

27. The possibility of the fire being due to electrical in nature would then seem more likely given that engine overheating and external factors would both seem unlikely. The fire being due to electrical nature is also supported by the condition of the original wiring harnesses wirings that were found leading from the fuse box to the original wiring harnesses and the electrical components on the Insured Vehicle, which was earlier discussed in paragraph 9 above.

29. Having investigated and technically analysed the damages of burnt nature to the Insured Vehicle, we are of the view that the cause of fire to the Insured Vehicle was of electrical nature. For this particular case, the fire had originated along the original wiring harnesses leading to the fuse box and to the electrical components of the Insured Vehicle.

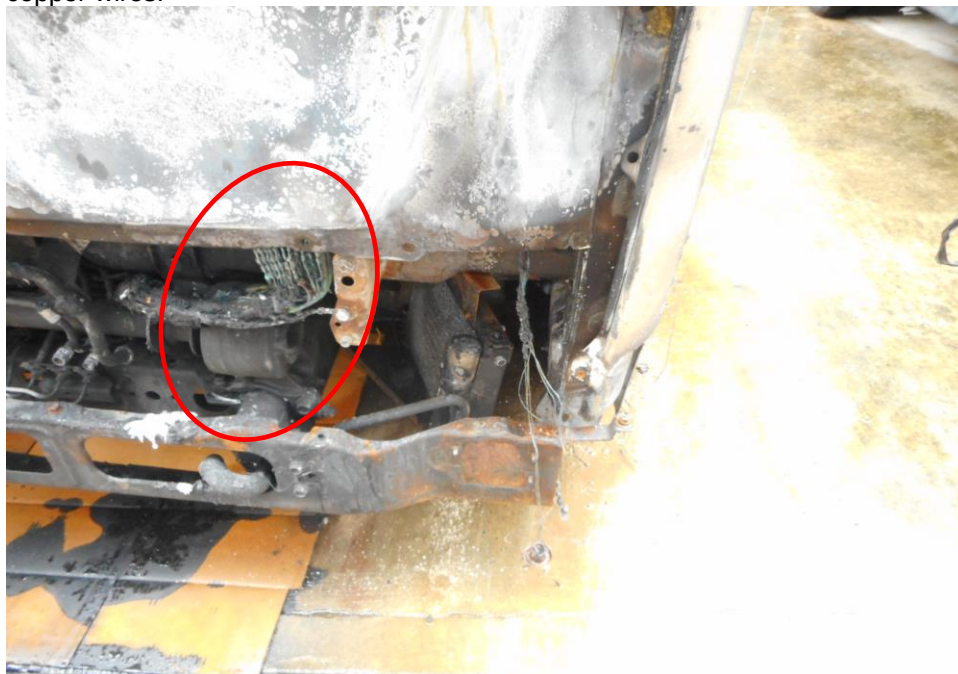
**Photo 14** shows a close up view of the original wiring harness leading to the fuse box into the front cabin compartment from the front of the Insured Vehicle. The original wiring harness (red circle) was observed with greenish residue on the surface. The presence of greenish residue indicates internal heating of copper wires, a sign of an electrical short circuit occurring. The greenish residue is normally left behind from oxidation as a result of chemical reaction involving the copper wires.

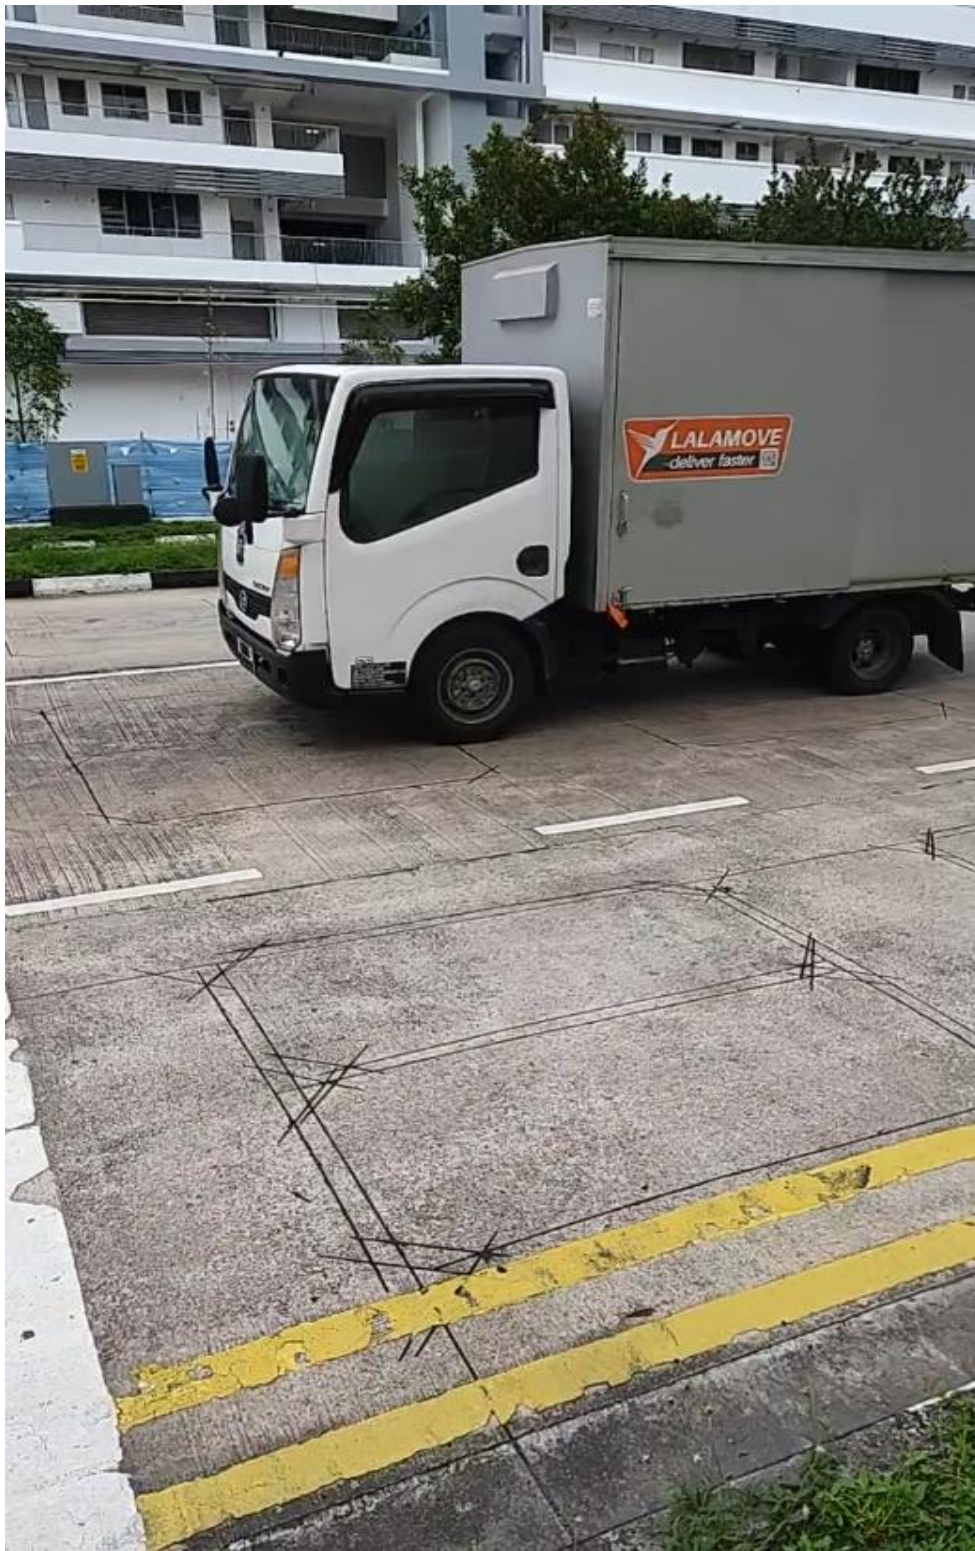
**Photo 15** shows the signs of smoke emitting from the front cabin of the Insured Vehicle. In general, the information that could be gathered from this photograph had corresponded to the events that were related to us by Mr Amli, location when the fire broke out.

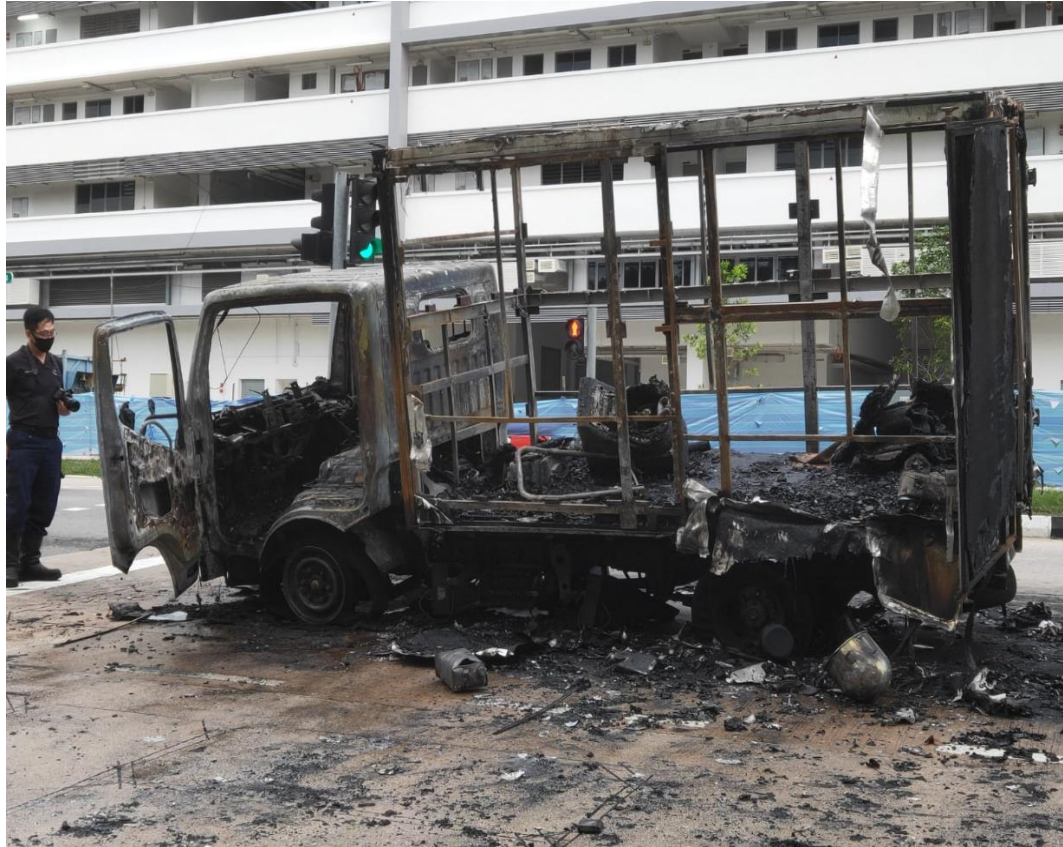
**Photo 20** shows a SCDF officer investigating the fire on scene, of the burnt down Insured Vehicle. In general, the information that could be gathered from this photograph had corresponded to the events that were related to us by Mr Amli, where the fire had started on the Insured Vehicle.
