Your Ref: S0M02QCC
Our Ref: CS4/ASM20007092/P

16th July 2020

**TECHNICAL INVESTIGATION REPORT OF FIRE INCIDENT INVOLVING THE
INSURED VEHICLE GBA 9799R ON 1st July 2020**

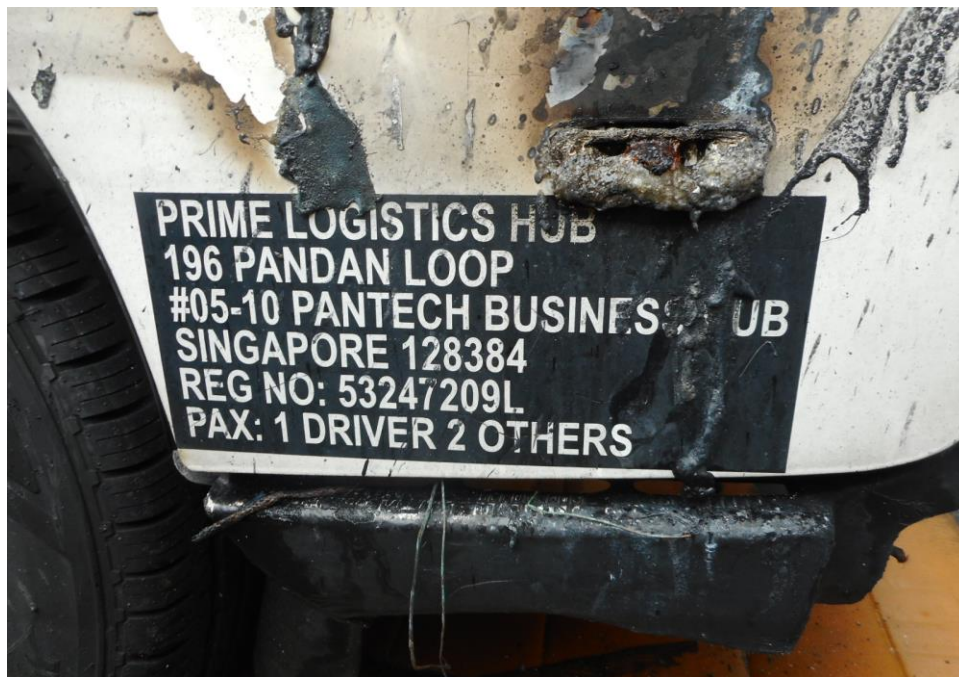
Photo 1 shows the company registration of the Insured Vehicle at the time of our inspection. As the fire damage to the Insured Vehicle had burnt down the both the front and rear registration plates of the Insured Vehicle.

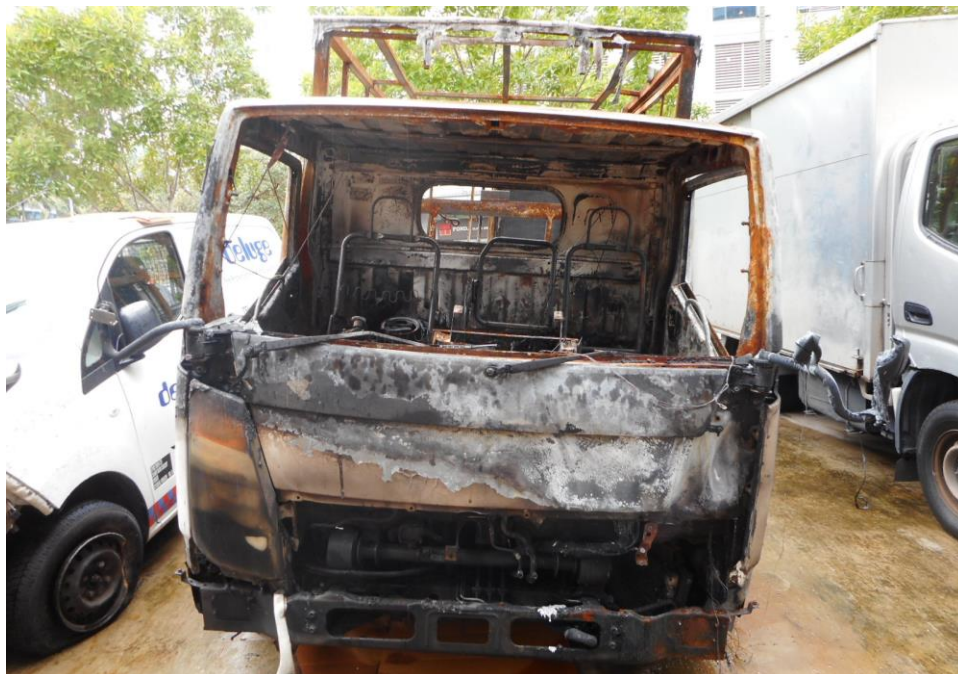
Photo 2 shows the front view of the Insured Vehicle at the time of our inspection. The fire damage to the Insured Vehicle had affected the whole Insured Vehicle.

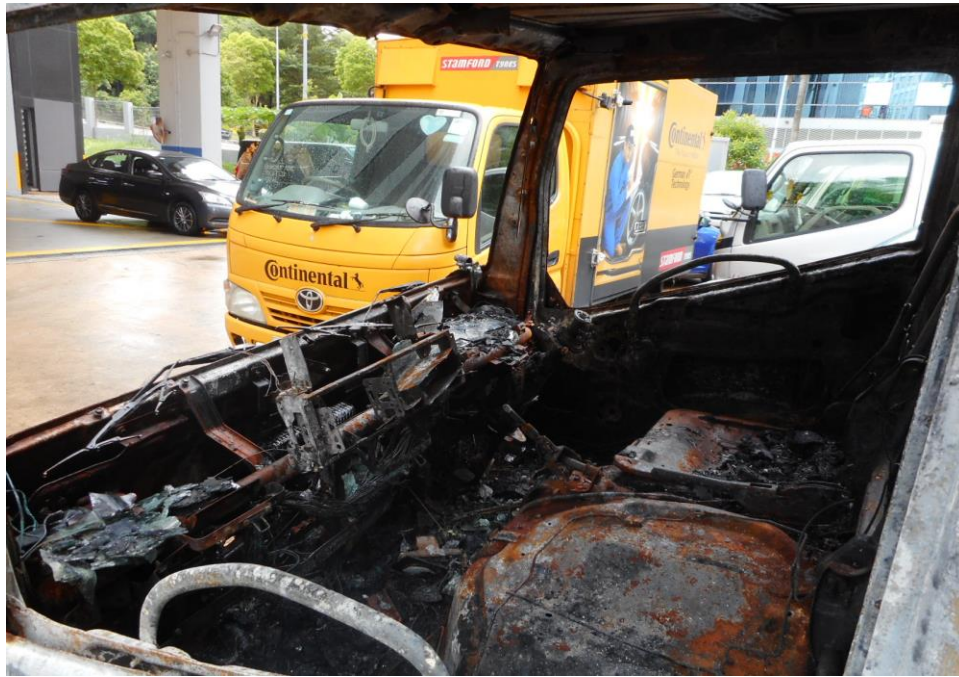
Photo 3 shows the general view of the interior compartment of the Insured Vehicle. The entire windscreen and the interior compartment have been badly burnt by the fire.

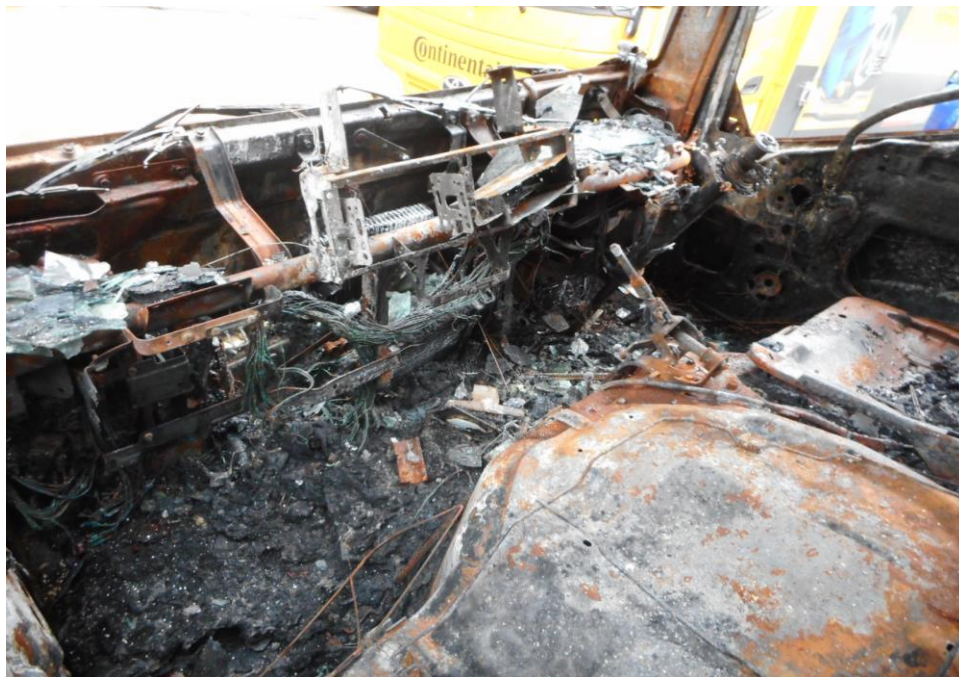
Photo 4 shows the close up view of the interior compartment of the Insured Vehicle. The interior compartment have been badly burnt by the fire.

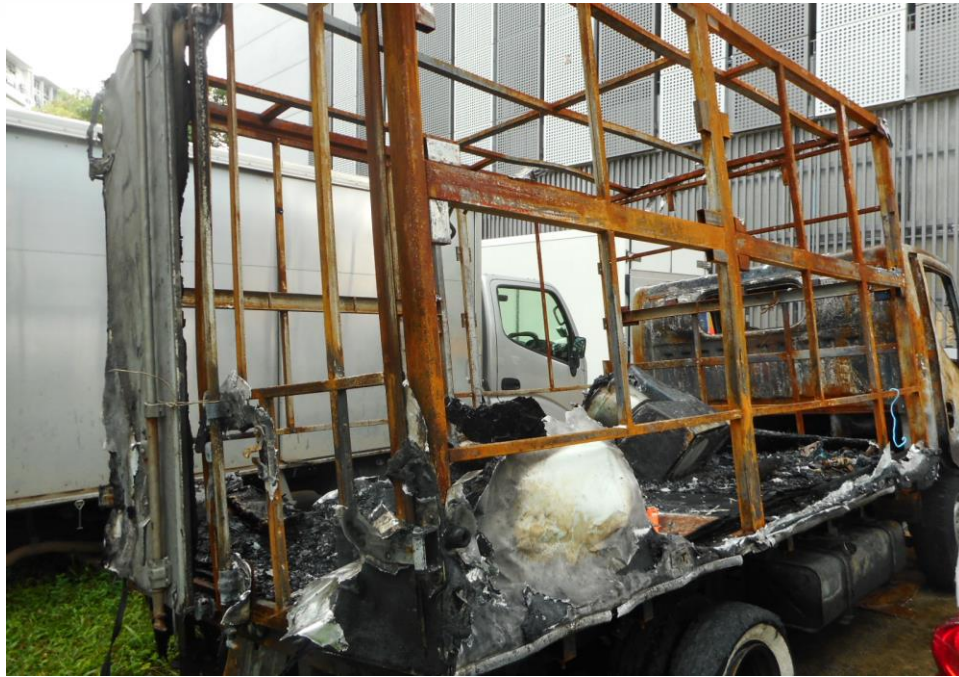
Photo 5 shows the rear cabin of the Insured Vehicle from the right side at the time of our inspection. The fire damage to the Insured Vehicle had burnt down the entire rear portion compartment. The whole rear cabin panel were amongst the parts that were observed to have been affected by the fire.

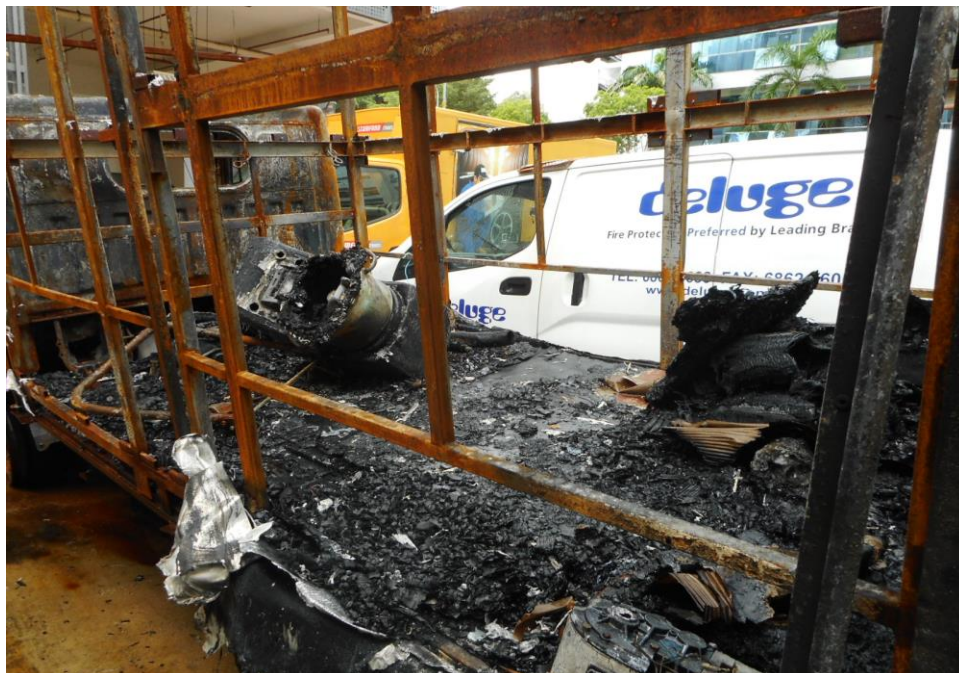
Photo 6 shows the rear cabin of the Insured Vehicle from the left side at the time of our inspection. The fire damage to the Insured Vehicle had burnt down the entire rear portion compartment. The goods in the rear cabin that the Insured Vehicle was carrying were amongst the parts that were observed to have been burnt by the fire.

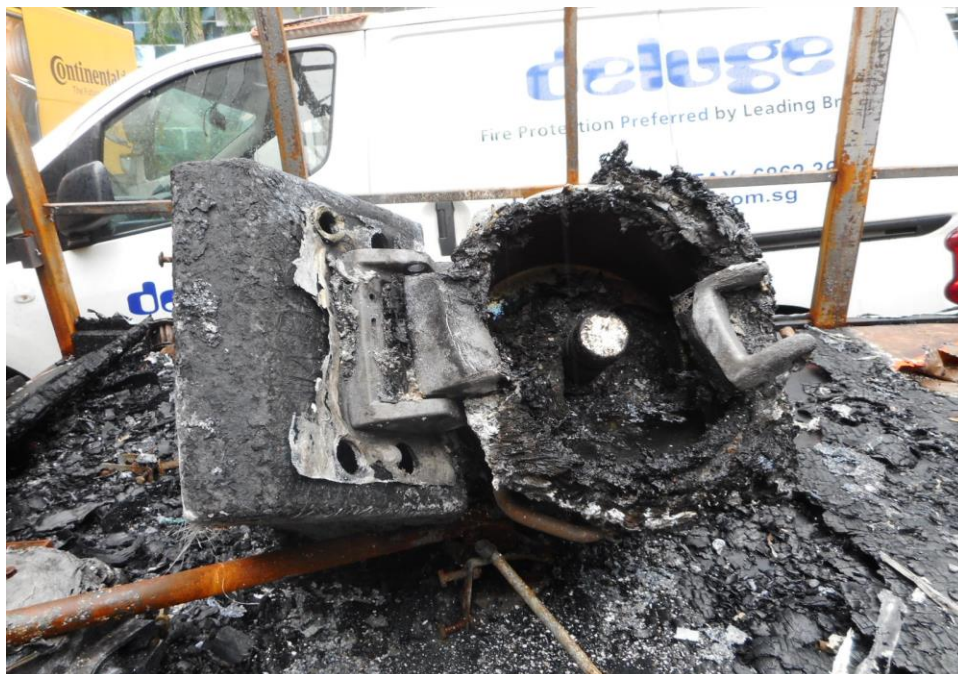
Photo 7 shows the close up view of the goods in the rear cabin of the Insured Vehicle at the time of our inspection. The fire damage to the Insured Vehicle had burnt down the entire rear portion compartment. The goods in the rear cabin that the Insured Vehicle was carrying were amongst the parts that were observed to have been burnt by the fire.

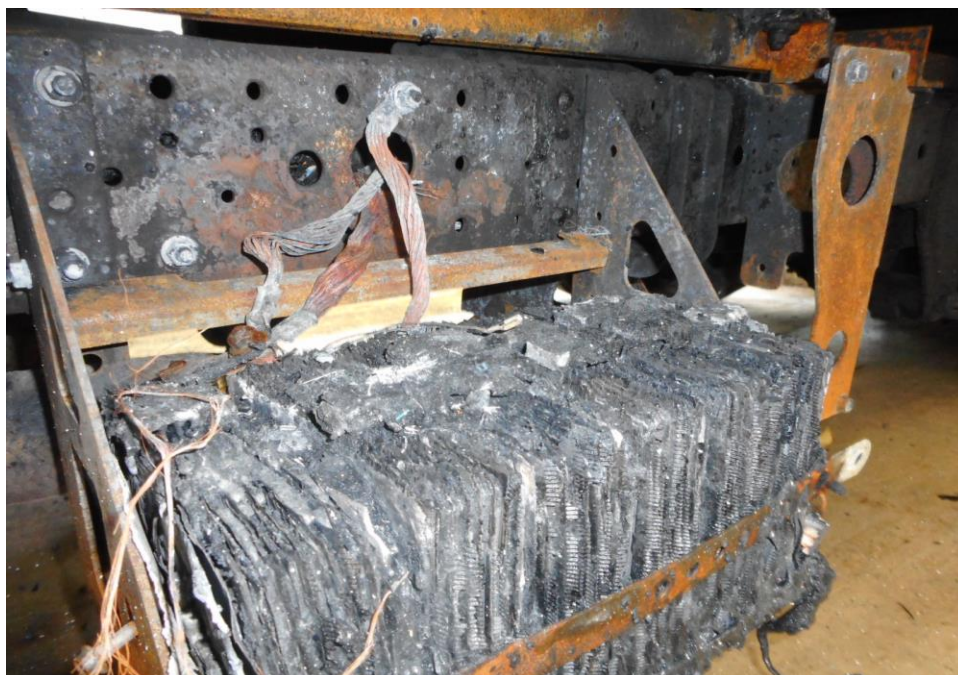
Photo 8 shows the battery unit of the Insured Vehicle at the time of our inspection. The battery unit and the battery terminal was damaged by the fire of the Insured Vehicle.

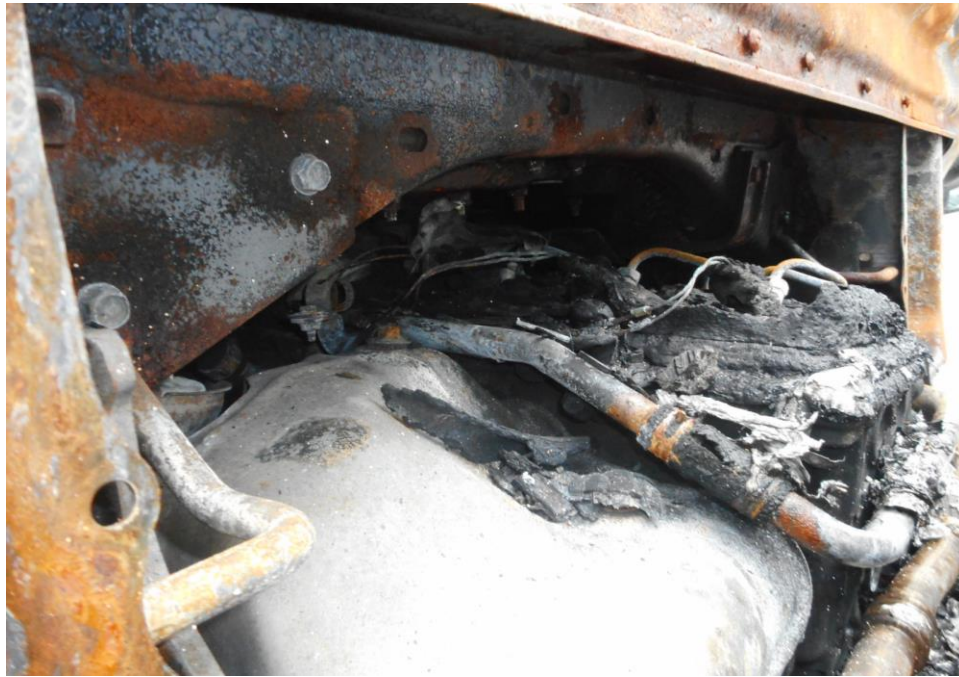
Photo 9 shows the engine compartment of the Insured Vehicle at the time of our inspection. The front cabin of the Insured Vehicle was not able to be lifted due to the damage it sustained from the fire, the engine unit was observed to be damaged by the fire.

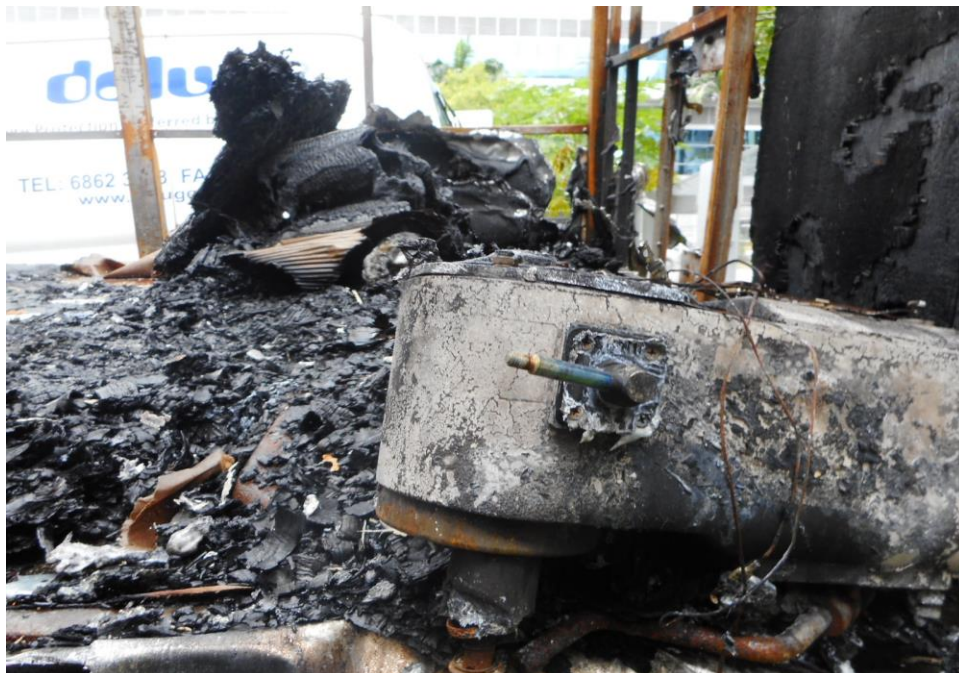
Photo 10 shows a closer view of the rear portion of the Insured Vehicle at the time of our inspection. The entire rear cabin compartment and the goods inside had sustained severe visible fire damage.

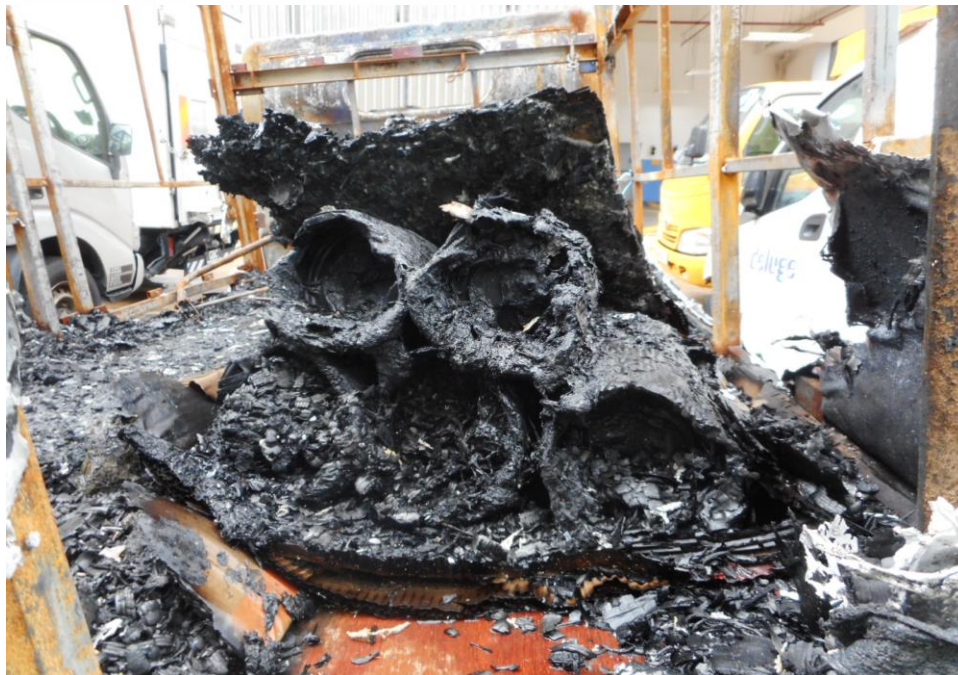
Photo 11 shows a closer view of the rear cabin compartment of the Insured Vehicle at the time of our inspection. The rear cabin was significantly burnt and/or melted as a result of the fire. We also found remnants of cardboard and various other items in the rear cabin compartment.

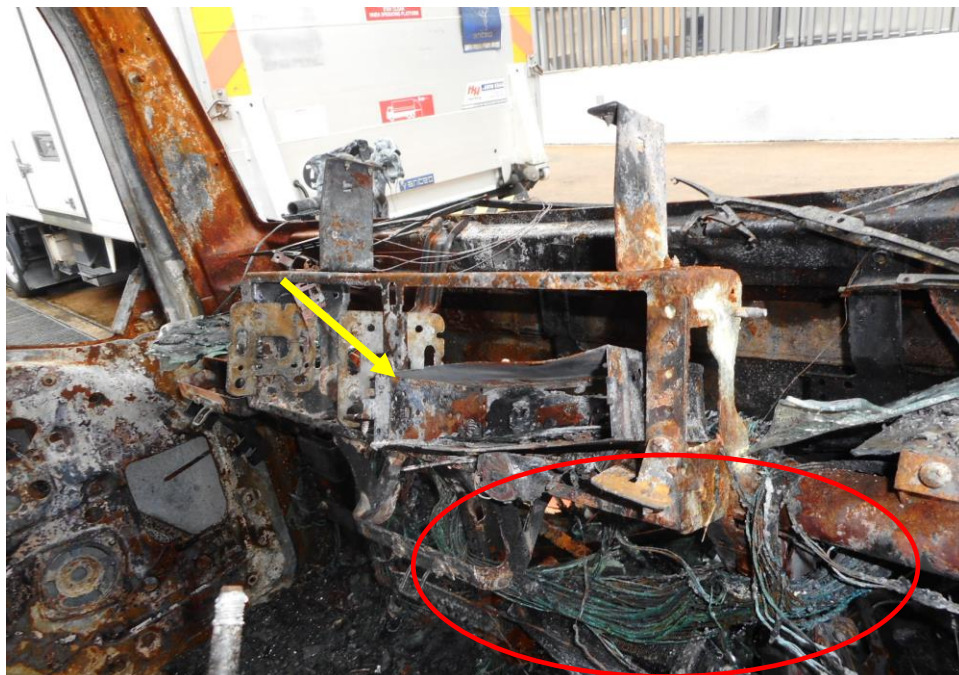
9. Upon closer examination of the front portion of the Insured Vehicle which was where the fire had started, we had found traces of greenish residue on the main wirings harnesses leading from the fuse box to the electrical components of the Insured Vehicle. The wirings were original wirings fitted from the manufacturer. The presence of greenish residue indicates internal heating of copper wires, a sign of an electrical short circuit occurring. The greenish residue is normally left behind from the oxidation as a result of chemical reaction involving the copper wires. This physical evidence would then appear to suggest that the cause of fire to the Insured Vehicle could have possibly been due to electrical in nature. See photos See photos 12 - 14 below.

Photo 12 shows the general view of the interior compartment of the Insured Vehicle at the time of our inspection. The fire damage to the Insured Vehicle has affected its engine and interior compartment. Its interior dashboard (circled), radio head unit (yellow arrow), various original wiring harnesses was amongst the parts in the compartment that were found to have been affected as a result of the fire.

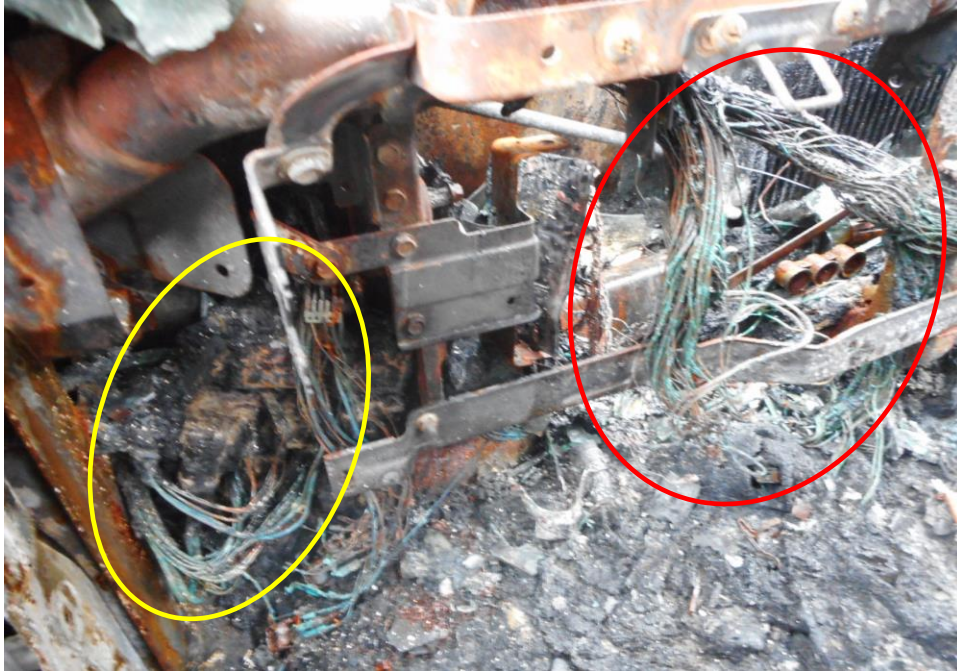
Photo 13 shows a close up view of the original wiring harness leading to the fuse box in the front cabin compartment. The original wiring harness (red circle) and fuse box wirings (yellow circle) was observed with greenish residue on the surface. The presence of greenish residue indicates internal heating of copper wires, a sign of an electrical short circuit occurring. The greenish residue is normally left behind from oxidation as a result of chemical reaction involving the copper wires.

27. The possibility of the fire being due to electrical in nature would then seem more likely given that engine overheating and external factors would both seem unlikely. The fire being due to electrical nature is also supported by the condition of the original wiring harnesses wirings that were found leading from the fuse box to the original wiring harnesses and the electrical components on the Insured Vehicle, which was earlier discussed in paragraph 9 above.

29. Having investigated and technically analysed the damages of burnt nature to the Insured Vehicle, we are of the view that the cause of fire to the Insured Vehicle was of electrical nature. For this particular case, the fire had originated along the original wiring harnesses leading to the fuse box and to the electrical components of the Insured Vehicle.

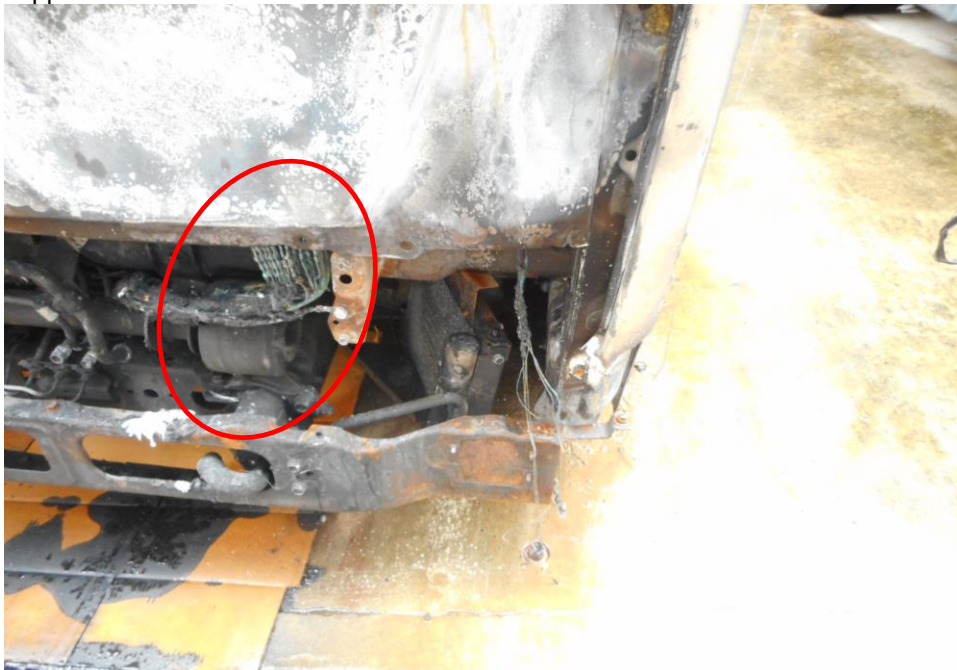
Photo 14 shows a close up view of the original wiring harness leading to the fuse box into the front cabin compartment from the front of the Insured Vehicle. The original wiring harness (red circle) was observed with greenish residue on the surface. The presence of greenish residue indicates internal heating of copper wires, a sign of an electrical short circuit occurring. The greenish residue is normally left behind from oxidation as a result of chemical reaction involving the copper wires.

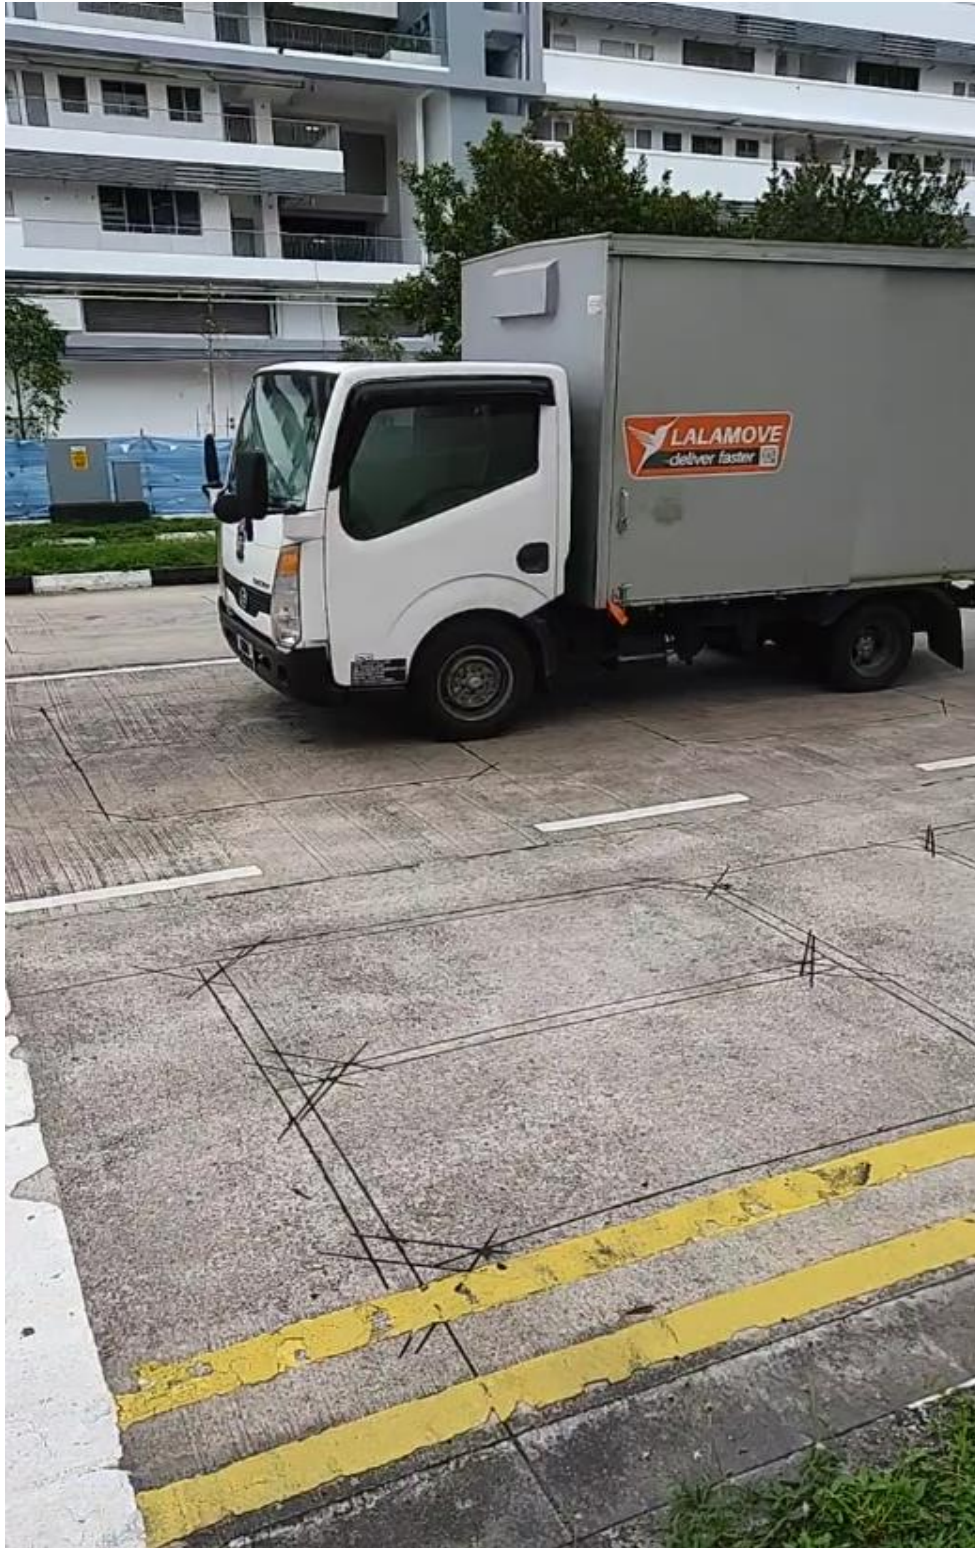
Photo 15 shows the signs of smoke emitting from the front cabin of the Insured Vehicle. In general, the information that could be gathered from this photograph had corresponded to the events that were related to us by Mr Amli, location when the fire broke out.

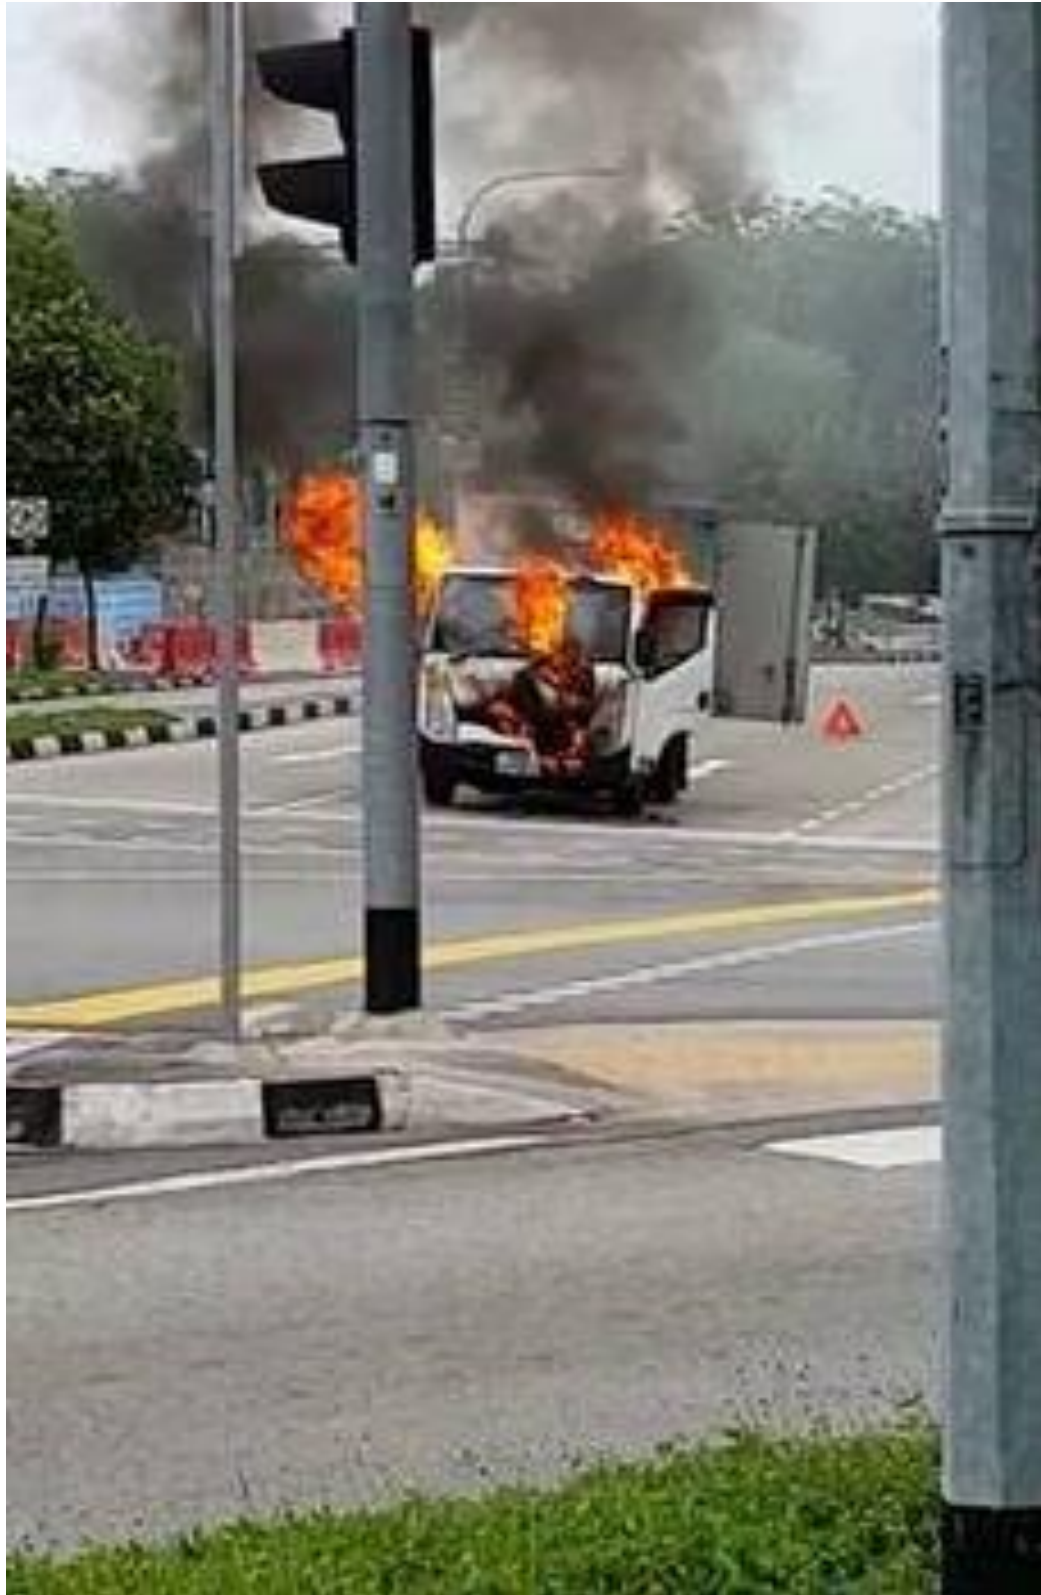
Photo 16 shows front view of the Insured Vehicle on fire. In general, the information that could be gathered from this photograph had corresponded to the events that were related to us by Mr Amli, where the fire had started on the Insured Vehicle.

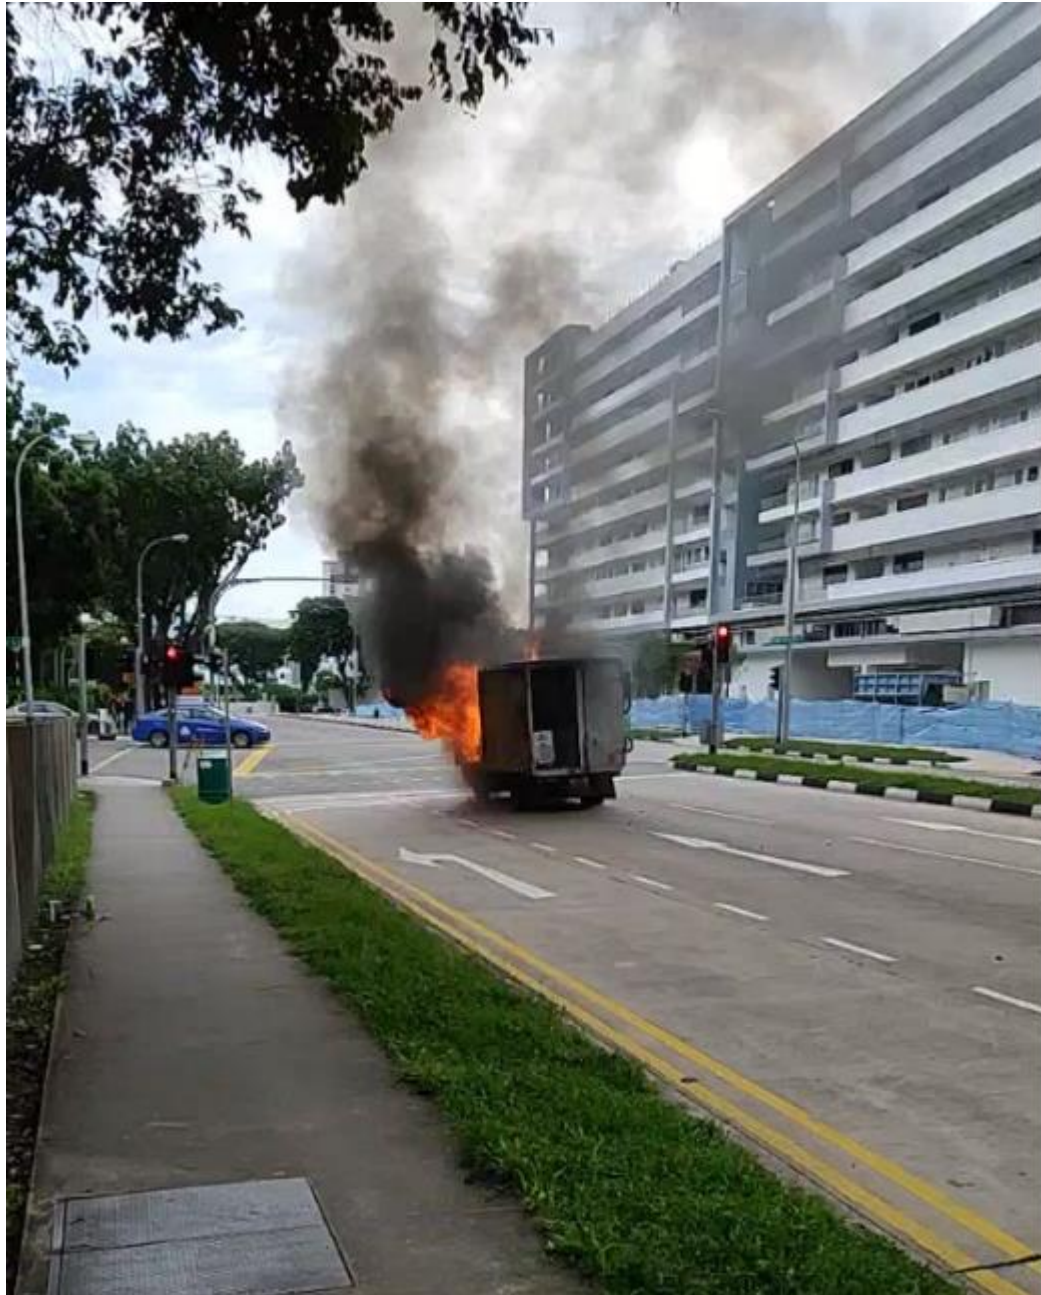
Photo 17 shows rear view of the Insured Vehicle on fire, as the fire has started from the front cabin and spread towards the rear cabin. In general, the information that could be gathered from this photograph had corresponded to the events that were related to us by Mr Amli, where the fire had started on the Insured Vehicle.

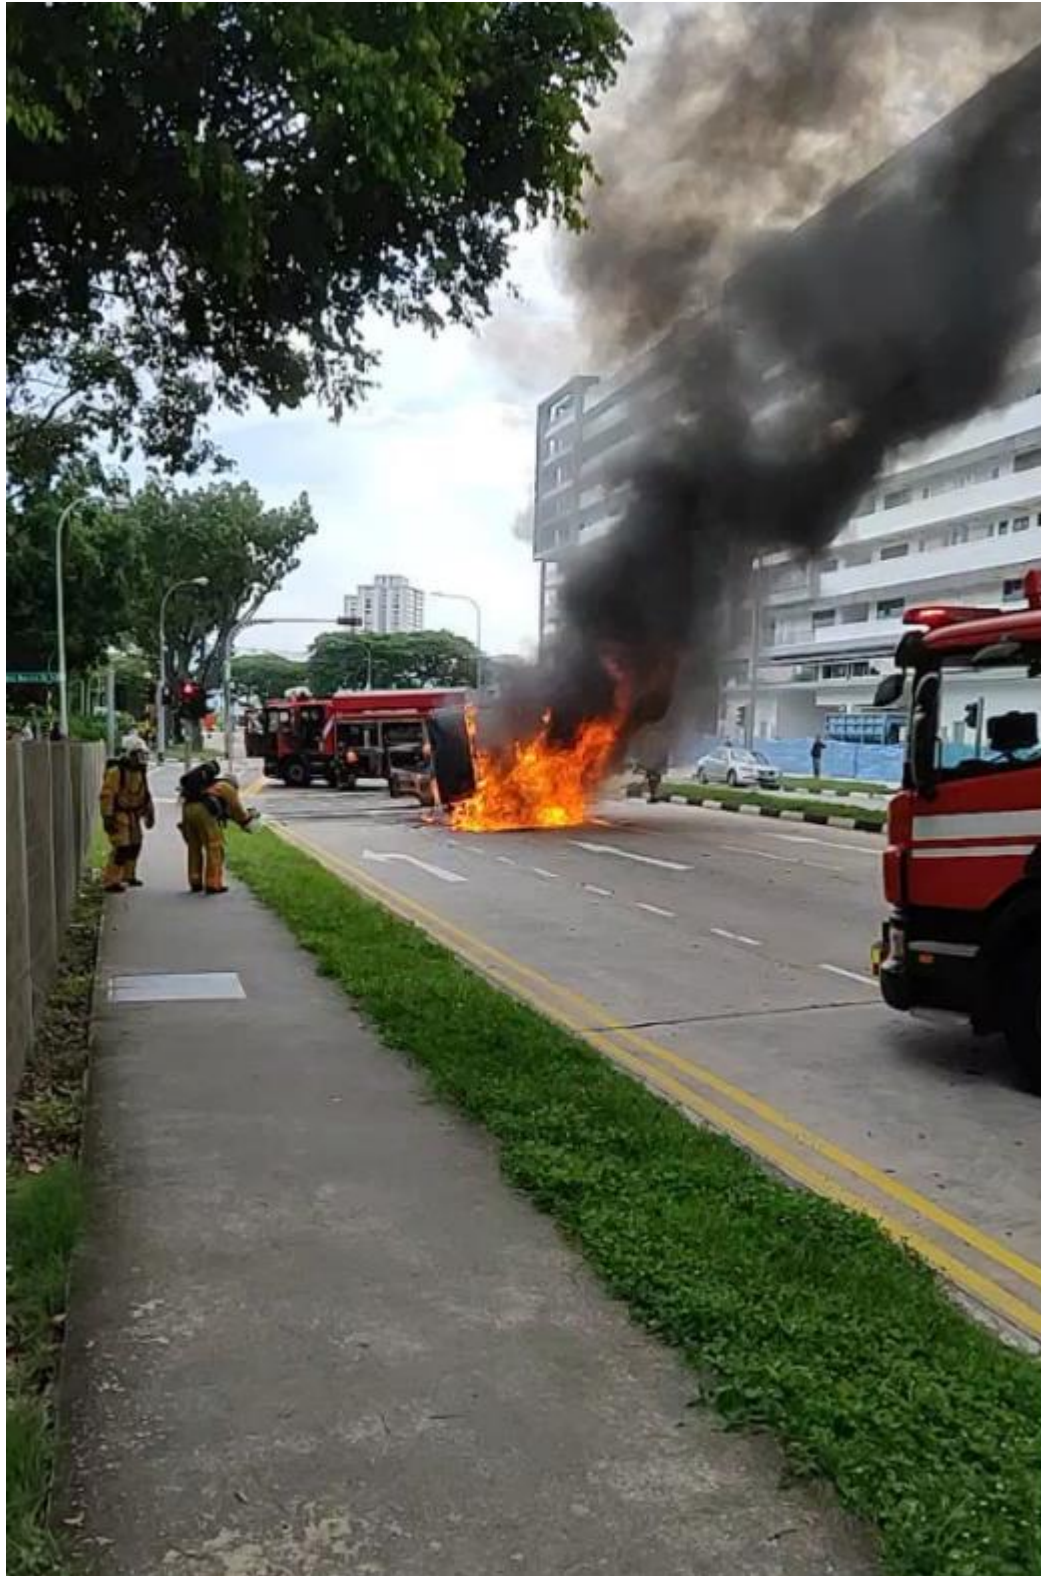
Photo 18 shows SCDF officers arriving on scene, as seen the fire had already engulfed the whole Insured Vehicle. In general, the information that could be gathered from this photograph had corresponded to the events that were related to us by Mr Amli, where the fire had started on the Insured Vehicle.

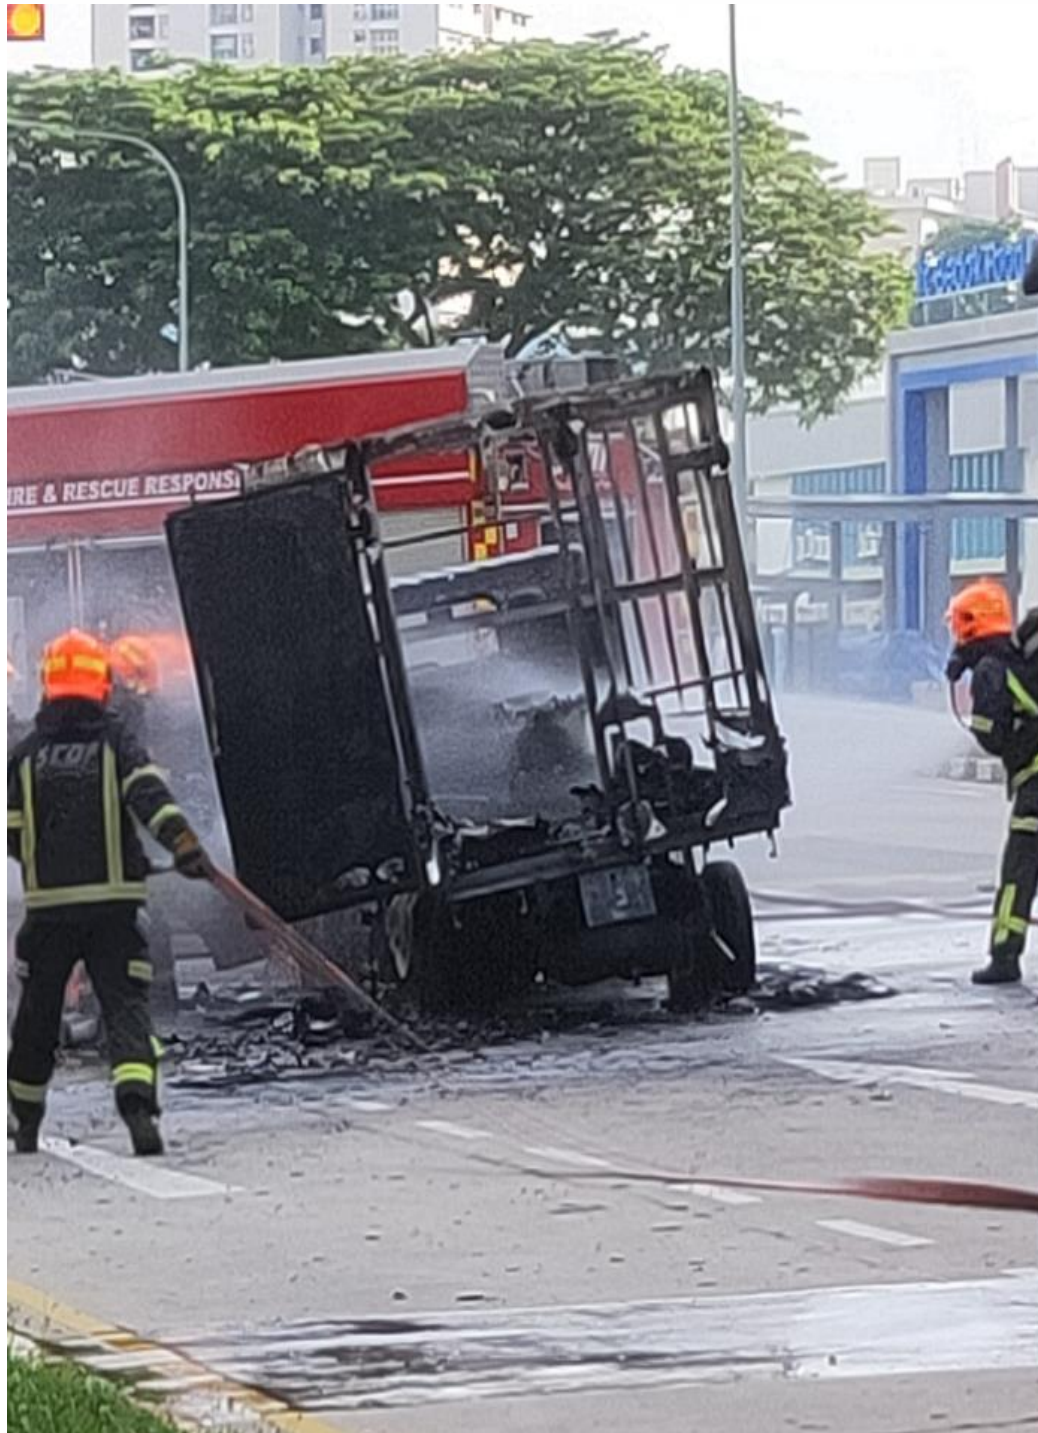
Photo 19 shows SCDF officers fighting the fire on scene, by than the fire than already burnt down the Insured Vehicle. In general, the information that could be gathered from this photograph had corresponded to the events that were related to us by Mr Amli, where the fire had started on the Insured Vehicle.

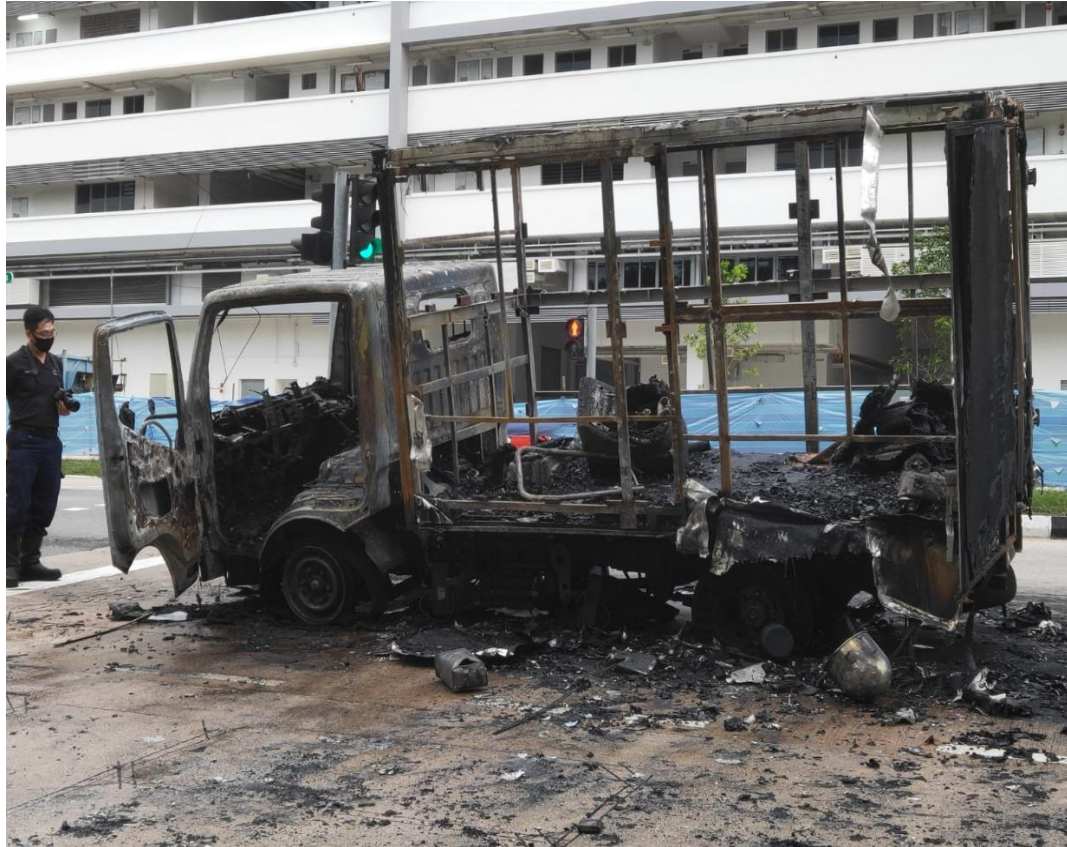
Photo 20 shows a SCDF officer investigating the fire on scene, of the burnt down Insured Vehicle. In general, the information that could be gathered from this photograph had corresponded to the events that were related to us by Mr Amli, where the fire had started on the Insured Vehicle.
