## LKK Auto Consultants Pte Ltd

Vehicle No. SH 7543L  
Insured Veh. SLD 7911L  
Claim No. SNM20D202368  
Policy No. DMHCSNA00001902000  
Accident Date 03/07/2020  
Inspection Date 06/07/2020

### ADJUSTMENT ON REPAIR COST FOR VEHICLE NO. SH 7543L

PHOTOGRAPHS FOR VEHICLE NO. SH 7543L

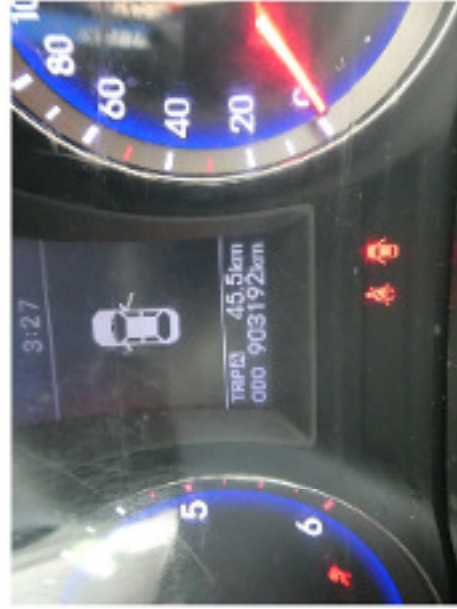
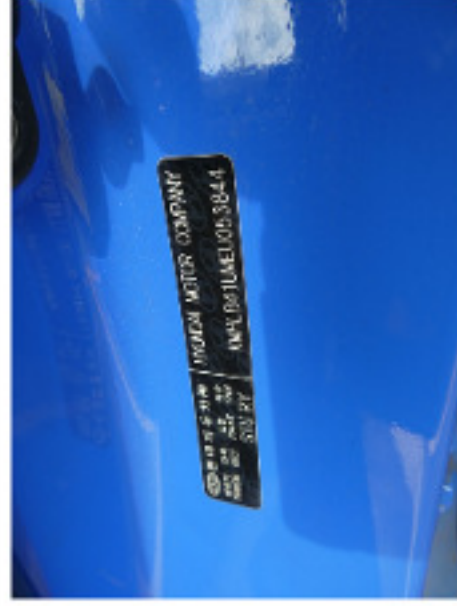
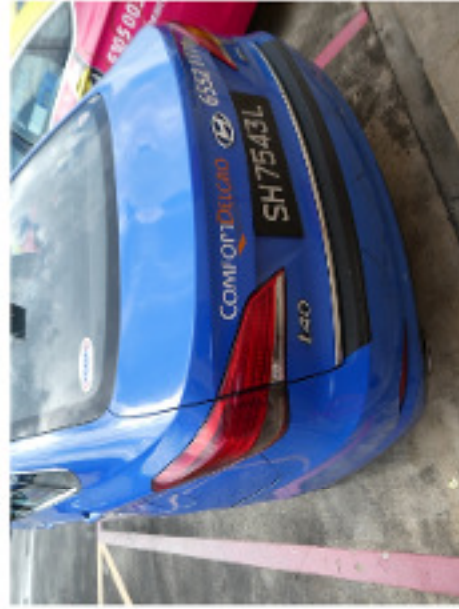
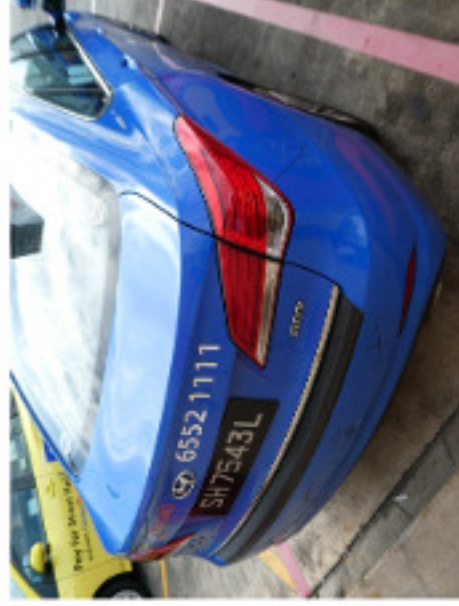
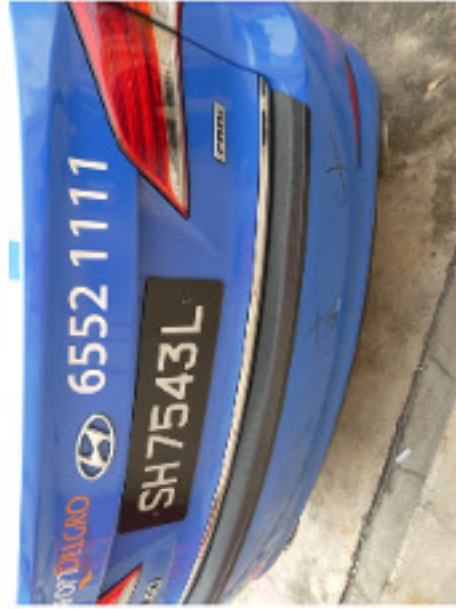
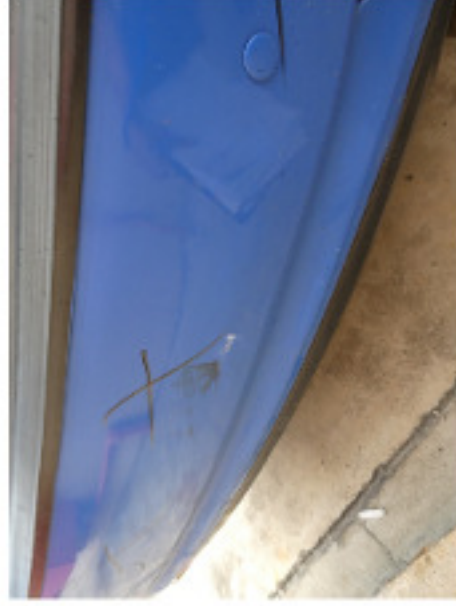
INSPECTION

THE VEHICLE SUSTAINED DAMAGES AT THE REAR PORTION. DAMAGES SEE DETAILS.
--
