Your Ref: M2003462
Our Ref :CS/TMI20007344/D

TECHNICAL INVESTIGATION REPORT OF FIRE INCIDENT INVOLVING THE INSURED VEHICLE SJZ 1578M ON 14 JULY 2020

Vehicle Registration No.	: SJZ 1578M
Make / Model	: Toyota Estima Aeras G-Edition 2.4 A
Chassis No	: ACR500120756
Year of Registration	: 2010 (October)
Mileage	: N.A (wiring affected)

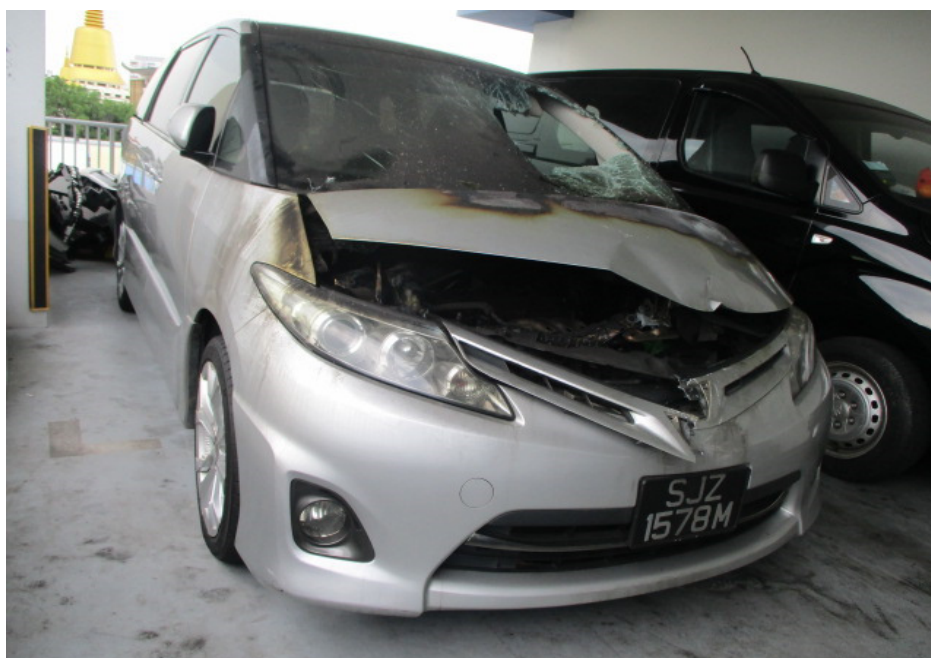
Photo 1 shows a general view of the front right body of the Insured Vehicle at the time of my inspection. The fire damage to the Insured Vehicle was confined to its frontal portion. Its front bumper, front bonnet, front right headlamp and front right fender were amongst the exterior body parts that were found to have been affected as a result of the fire.

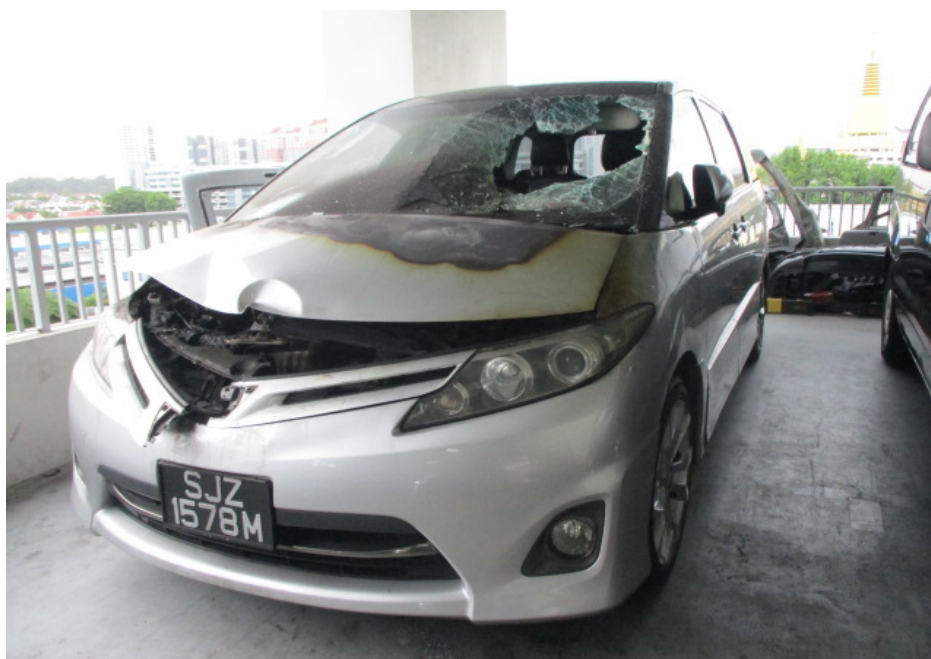
Photo 2 shows a general view of the front left body of the Insured Vehicle at the time of my inspection. The front left fender, front bonnet, front grille, front left headlamp and front windscreen were amongst the exterior body parts that were found to have been affected as a result of the fire.

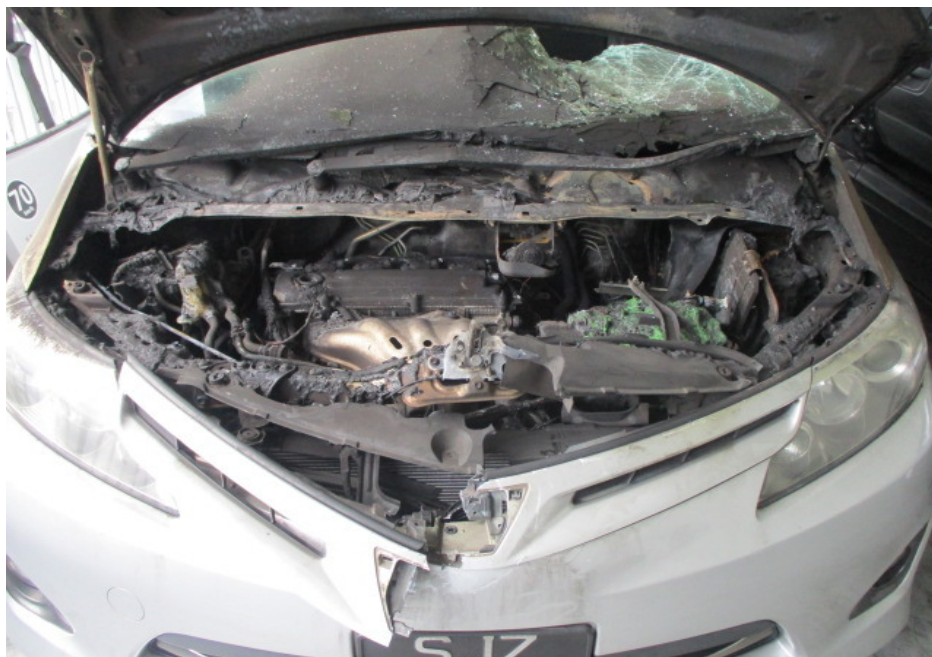
Photo 3 shows the engine compartment of the Insured Vehicle at the time of my inspection. Almost all the parts inside the engine compartment were observed to have been burnt and/or melted. The parts include the air intake manifold, engine top cover, battery, fuse box, various hoses and pipes amongst others.

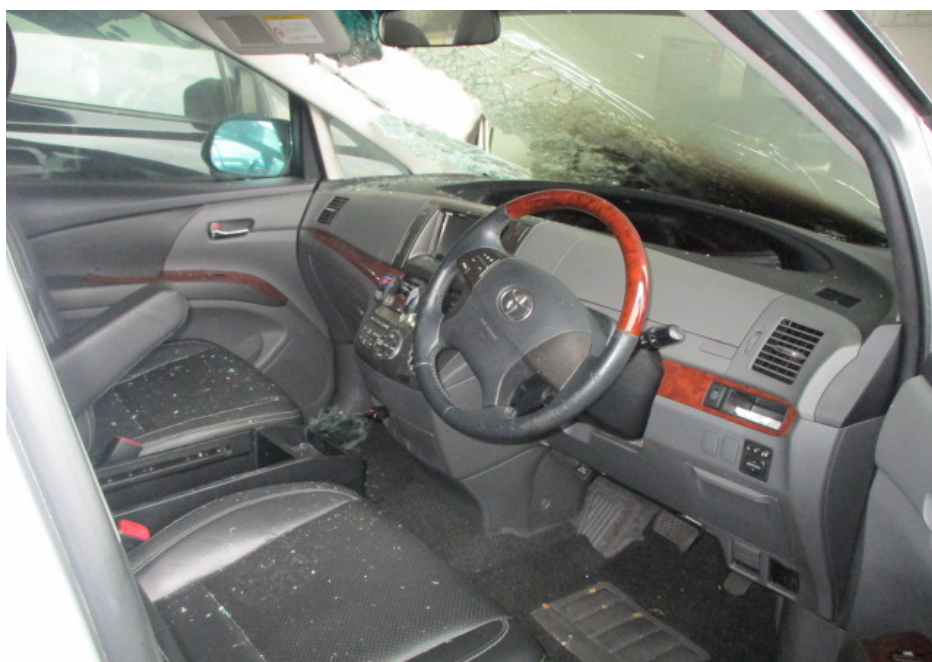
Photo 4 shows the interior compartment of the Insured Vehicle, which was not affected by the fire incident.

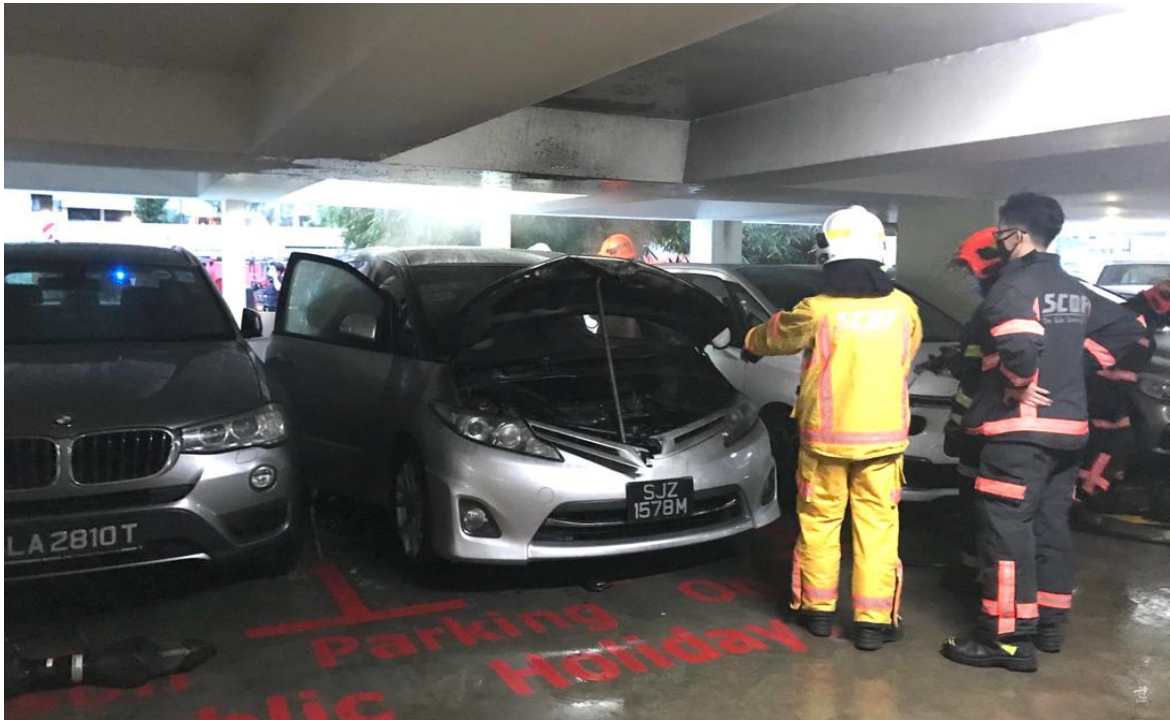
Photo 5 shows the Insured Vehicle at the incident scene after the fire was extinguished. The 2 vehicles that were parked at the immediate left and right of the Insured Vehicle appears to be unaffected by the fire. However, some areas of the ceiling above the Insured Vehicle were observed to be blackened.

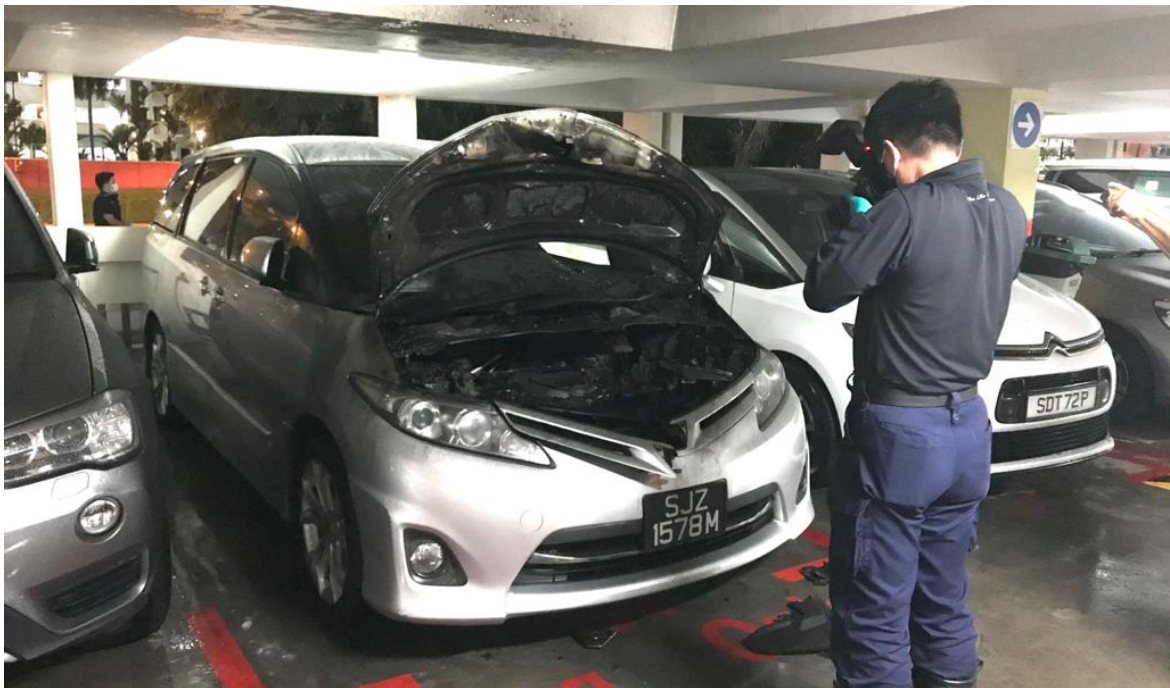
Photo 6 shows the Insured Vehicle at the incident scene after the fire was extinguished. The 2 vehicles that were parked at the immediate left and right of the Insured Vehicle appears to be unaffected by the fire. However, some areas of the ceiling above the Insured Vehicle were observed to be blackened.

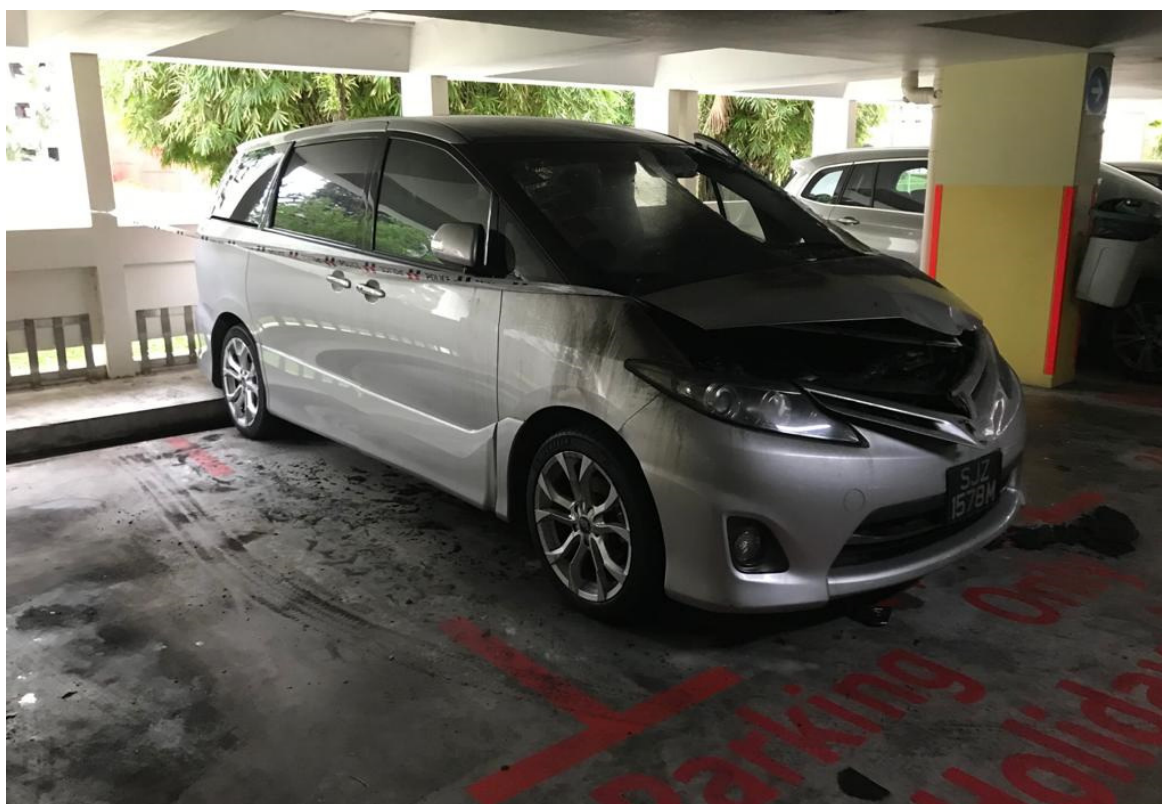
Photo 7 shows the Insured Vehicle at the incident scene. Upon closer examination of the photographs provided, I did not observe any unusual foreign material(s) and/or object(s) on the ground in the immediate area of where the Insured Vehicle was parked. In general, the observations gathered from my review of the photographs that were taken by Mr Lim at the incident scene had corresponded to the description of events that he had related to me during our conversation on 17 July 2020.

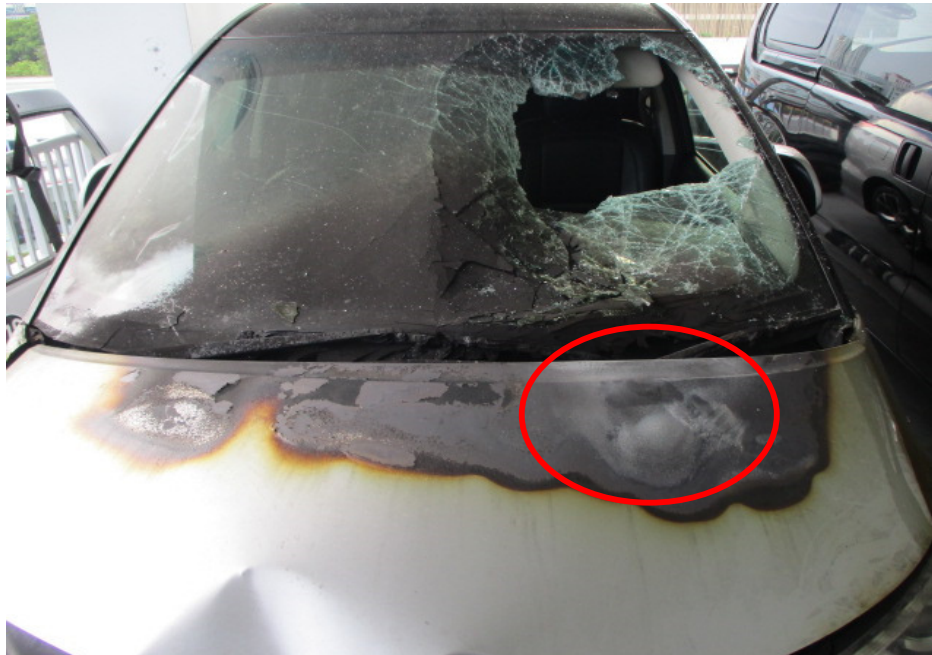
18. For this case, the origin of fire to the Insured Vehicle can be established basing on the burn pattern of the Insured Vehicle as seen at the time of my inspection. The area around the rear left of the Insured Vehicle's front bonnet was found to be blackened. What is referred to as high heat intensity burned marks (whitish burn marks) were observed to have been formed within the blackened paint area. These whitish burn marks are a result of exposure to prolong heat intensity. Rust would normally start to develop around these areas soon after a fire as prolonged exposure to high heat intensity causes steel/metal material body parts to be exposed to natural environmental condition, giving rise to the development of rust.

Photo 8 shows the high heat intensity burn marks (circled) that were found on the rear left area of the Insured Vehicle's front bonnet, within an area of the front bonnet that was found with paint blackened. Such whitish burn marks are a result of exposure to prolong heat intensity. Following the characteristic of heat rising upwards, the fire to the Insured Vehicle can then be determined to have originated around the rear left area of the engine compartment.

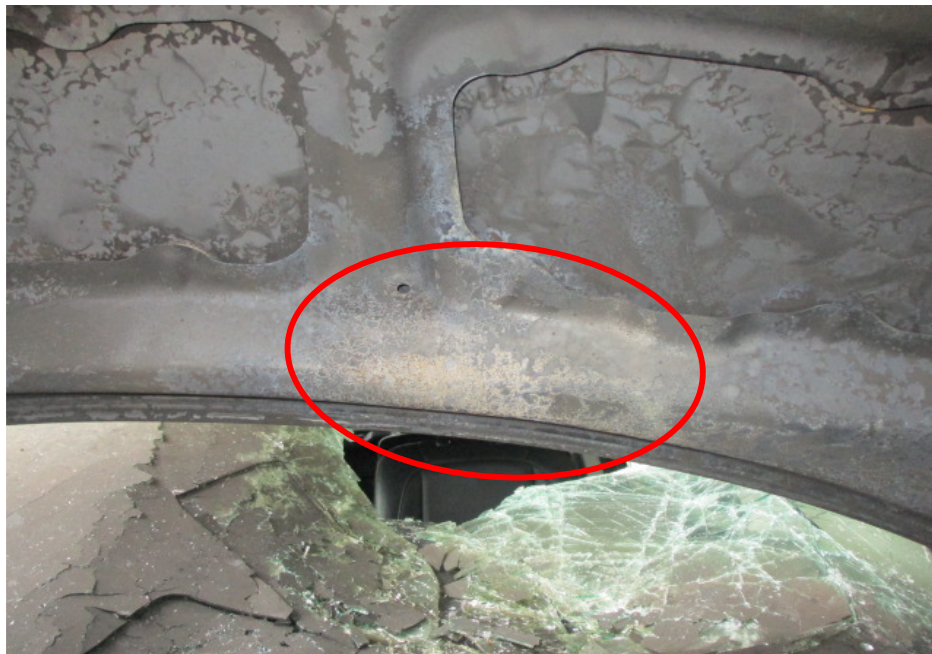
19. Following the characteristic of heat rising upwards, the underside of the front bonnet at the rear left area was also found with similar high intensity burn marks. Overall, the burn pattern of the front bonnet, in particular the high heat intensity burned marks, indicates that the origin of fire was around the rear left area of the Insured Vehicle's engine compartment. See photo 8 - 10 below.

Photo 9 shows the underside of the Insured Vehicle's front bonnet. Similar high heat intensity burn marks (circled) were found on the underside rear left area of the Insured Vehicle's front bonnet. This was directly below the area where similar nature of high heat intensity burn marks were formed on the top side of the Insured Vehicle's front bonnet.

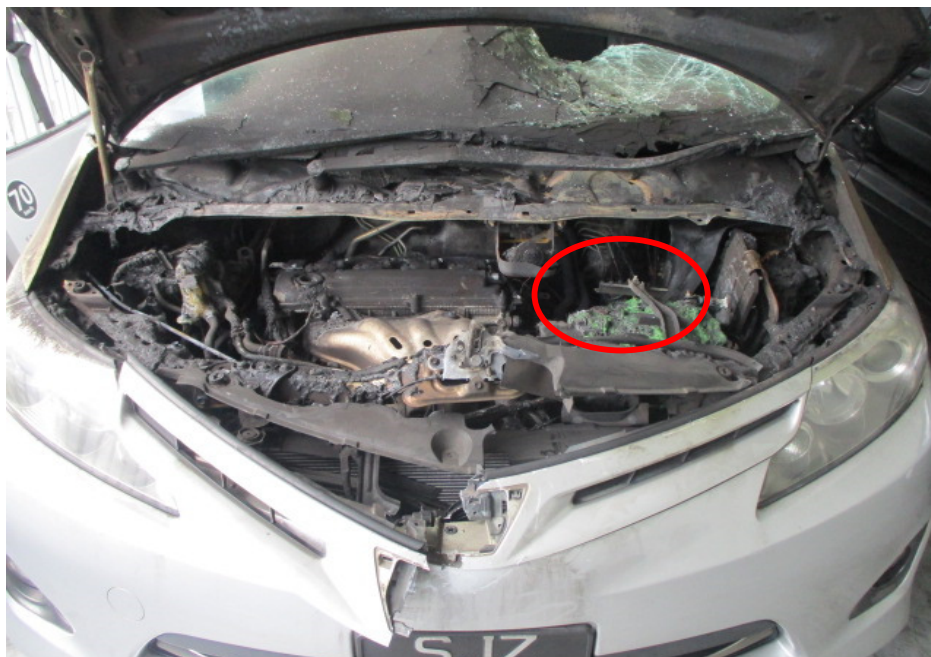
Photo 10 shows the engine compartment of the Insured Vehicle. Following the burn pattern, in particular the location where the high heat intensity burn marks were found on the front bonnet, and the characteristic of heat rising upwards, the fire to the Insured Vehicle can be determined to have originated around the rear left side (circled) of the engine compartment.

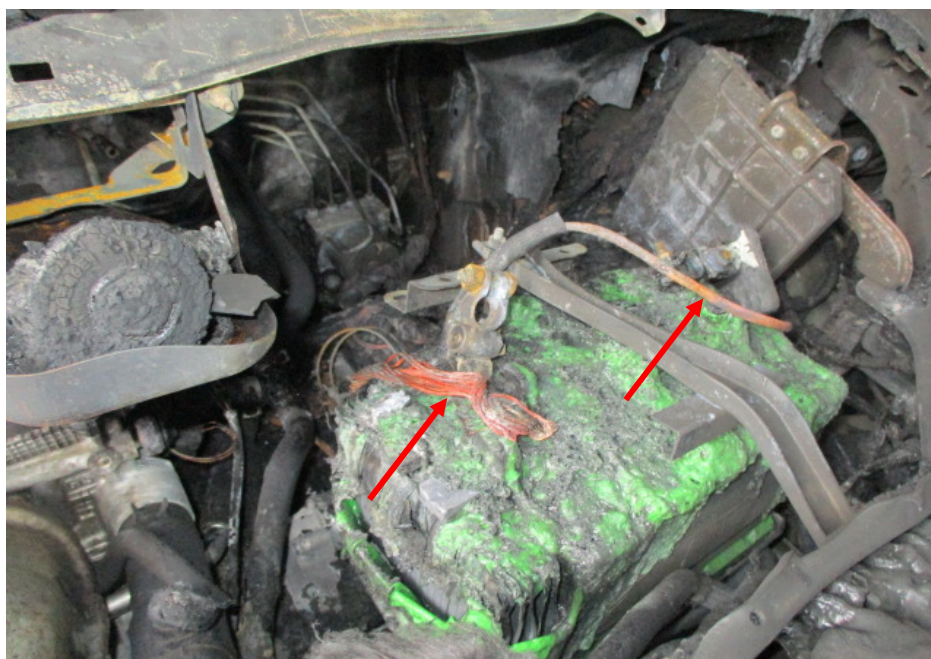
23. In fact, my examination of the rear left area of the engine compartment, which was the area where the fire to the Insured Vehicle had originated, revealed several stretches of original wire harnesses that were completely burned to its bare copper state. The battery wire cable for the positive terminal, in particular, was observed to be in bright reddish colour. This is an indication that the battery wire cable was exposed to high heat. Such condition normally indicates internal heating of copper wires, which is a sign of an electrical short circuit occurring. Hence, the condition of the wirings seen at the area where the fire had originated supports the cause of fire to the Insured Vehicle being due to electrical in nature. See photo 11 - 13 below.

Photo 11 shows the wirings around the area where the fire to the Insured Vehicle had originated. Several stretches of original wire harnesses around this area were found to be burnt to its bare copper state. The battery wire cable (arrowed) for the positive terminal was observed to be in bright reddish colour, indicating internal heating of copper wires, which is a sign of an electrical short circuit.

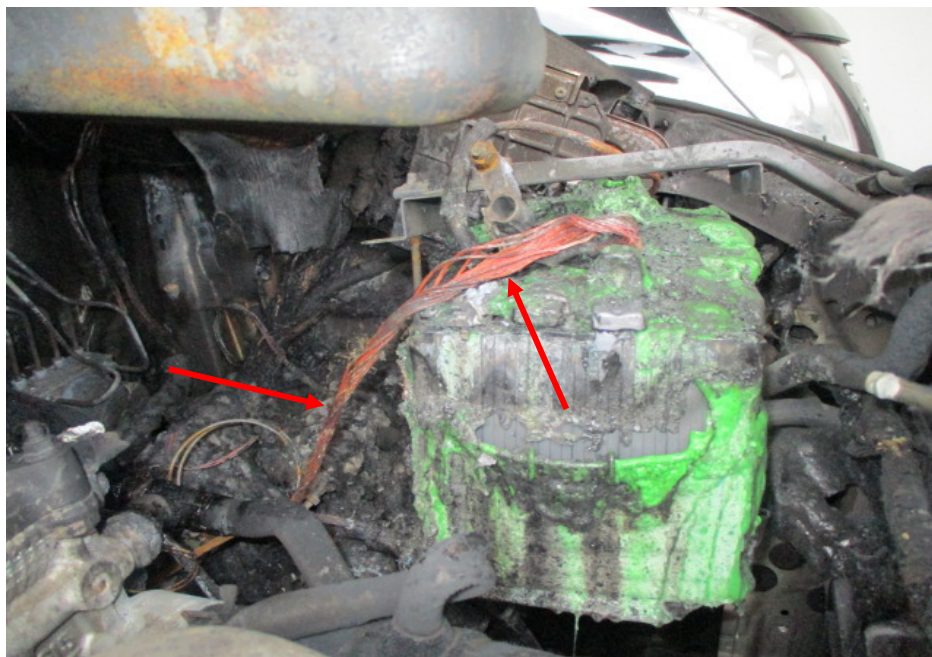
Photo 12 shows the condition of the battery wire cable (positive terminal) of the Insured Vehicle. The bright reddish colour (arrowed) of the wire cable indicates internal heating of copper wires which is a sign of an electrical short circuit occurring.

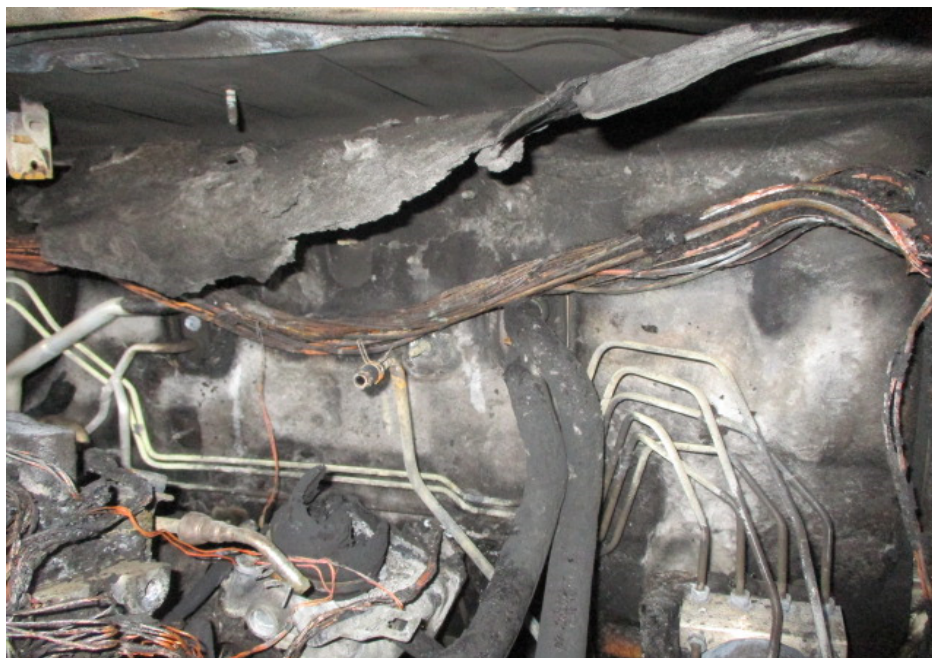
Photo 13 shows other stretches of original wire harnesses, around the rear left area of the Insured Vehicle's engine compartment, that were found burnt to its bare copper state. Such condition normally indicates internal heating of copper wires, which is a sign of an electrical short circuit. The condition of the wirings seen at the area where the fire had originated supports the cause of fire to the Insured Vehicle being due to electrical in nature.
