LKK Auto Consultants Pte Ltd

4. Description of Damages

ADJUSTMENT ON REPAIR COST FOR VEHICLE NO. SML 6474J

PHOTOGRAPHS FOR VEHICLE NO. SML 6474J

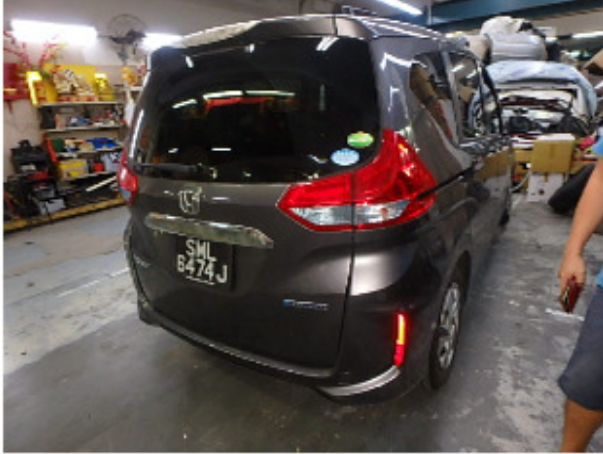
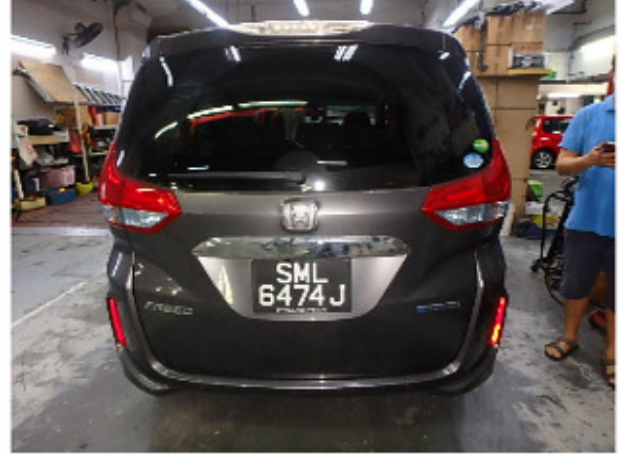
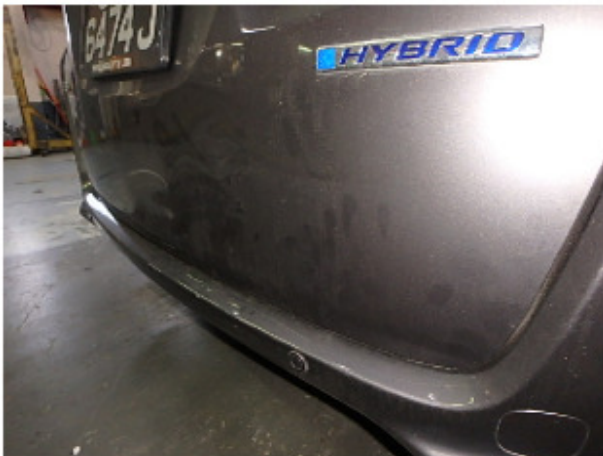
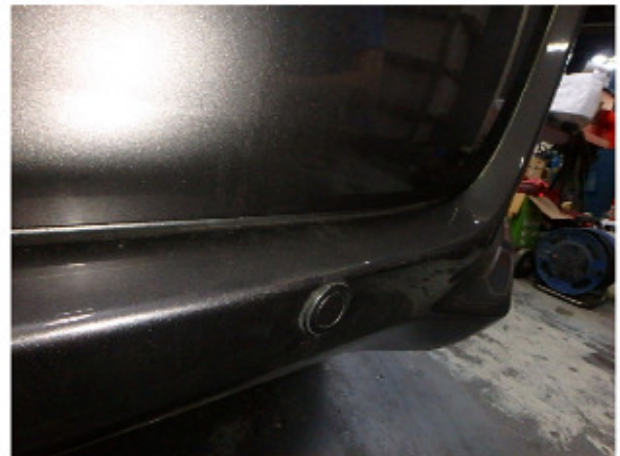
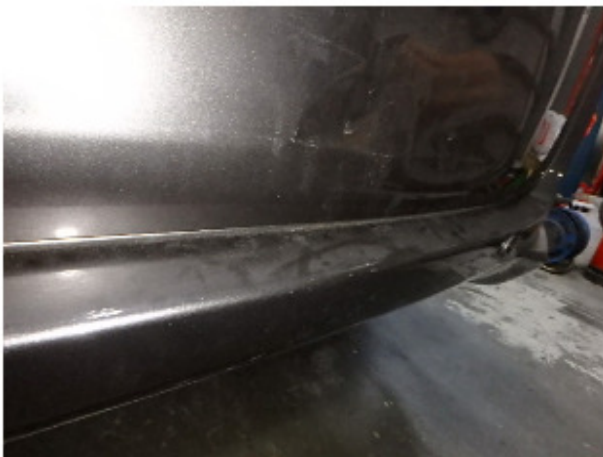
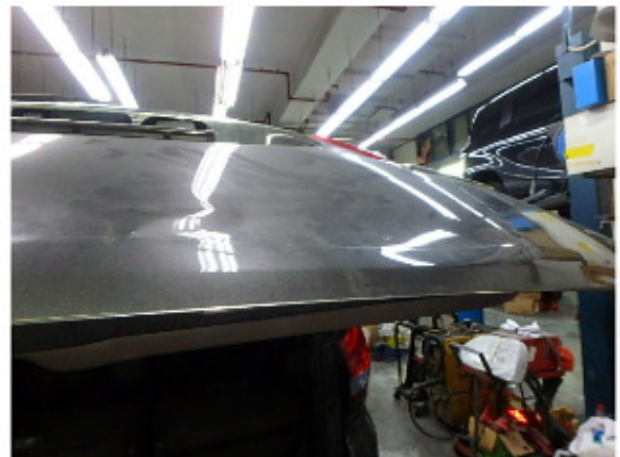
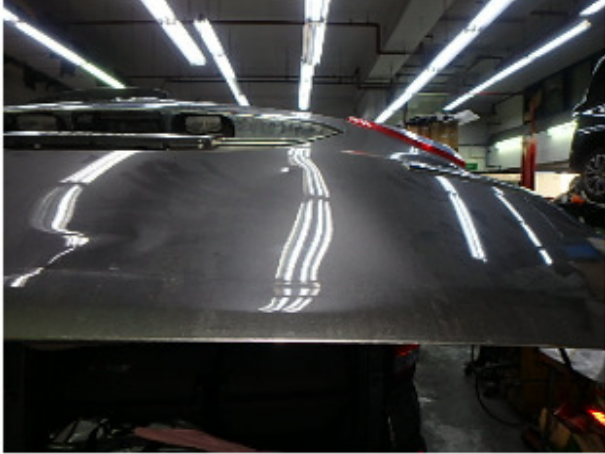
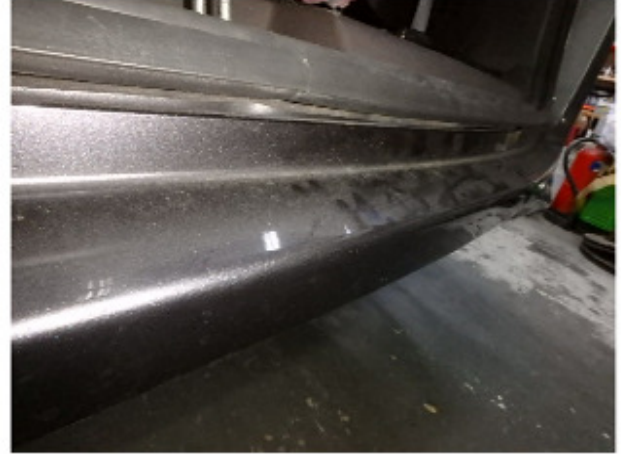
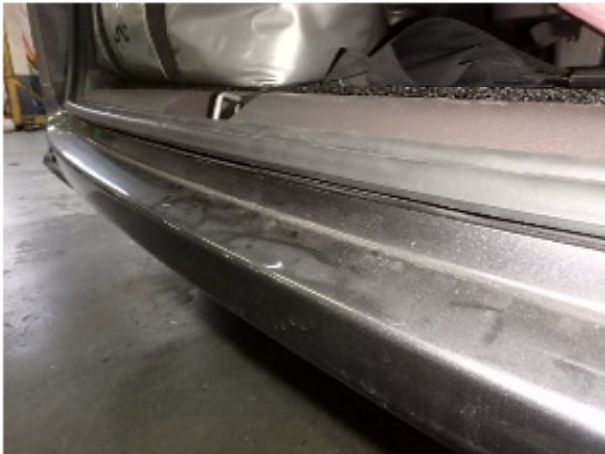
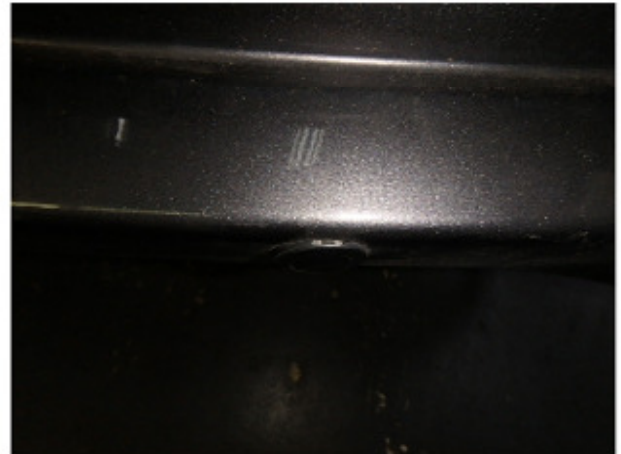
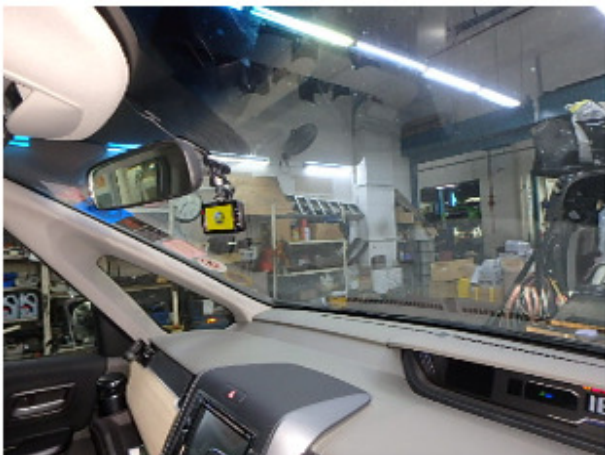
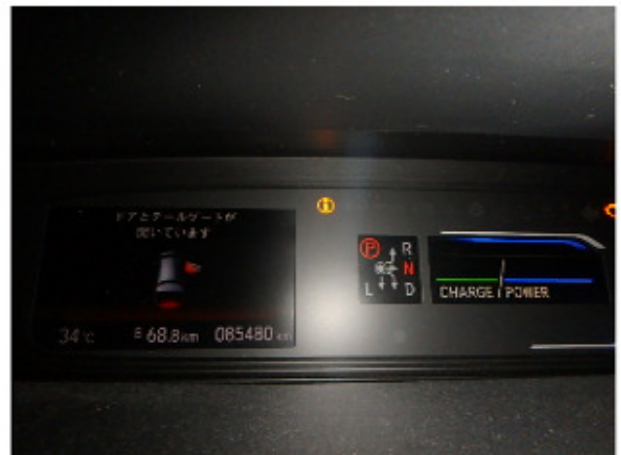
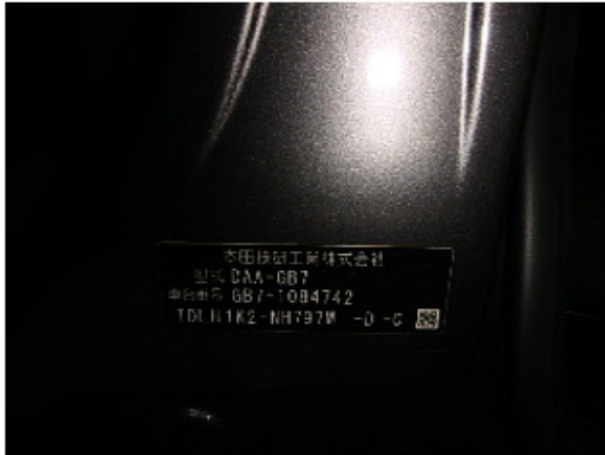
INSPECTION

THE VEHICLE SUSTAINED DAMAGES AT THE REAR PORTION. DAMAGES SEE DETAILS.
--
