Your Ref: SMH 8192E
Our Ref : CI/TP20007350/D

14 July 2020

**INSPECTION REPORT OF A MERCEDES BENZ CLA 180 MOTOR CAR WITH
REGISTRATION NUMBER SMH 8192E**

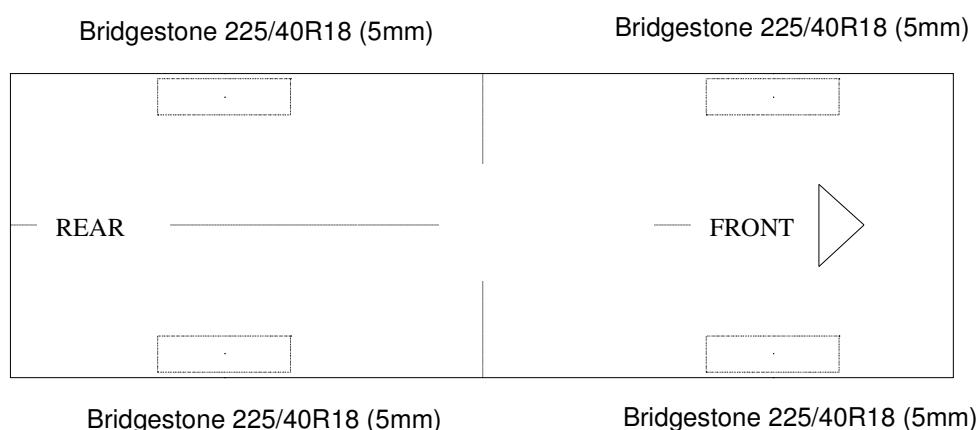
6. It was fitted with 18inch sport wheel rims that were wrapped with tyres that were observed to be of serviceable condition. The tyres were also sufficiently inflated for vehicular operation. The tyre brand, tyre size and approximate remaining tread depth of the 4 tyres of the Motor Car were recorded as follows: -

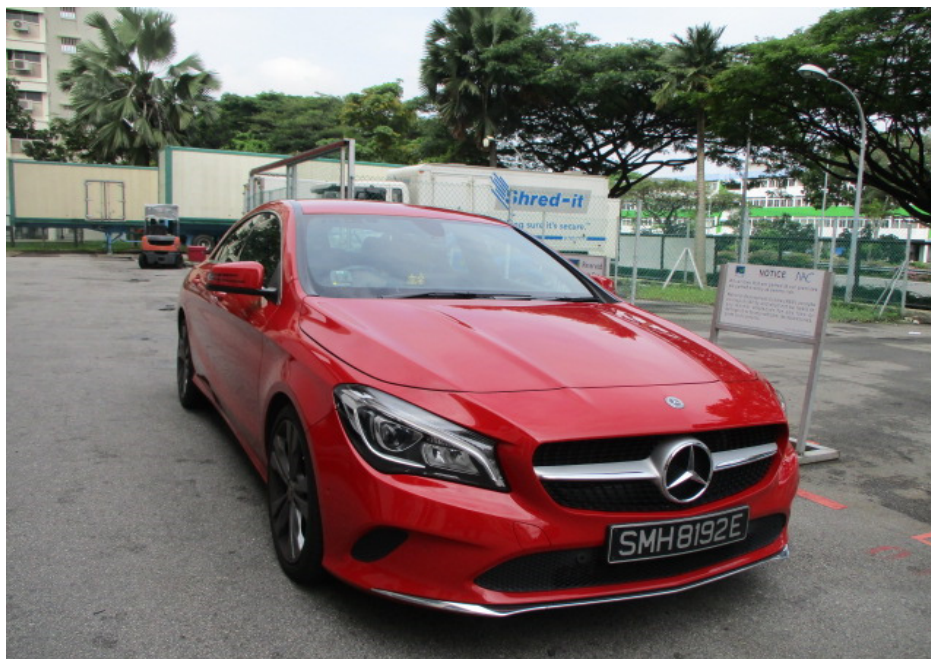
Photo 1 shows a general view of the front right body of the Motor Car at the time of my inspection. The Motor Car was observed to be in relatively good general condition with no loose exterior fittings observed.

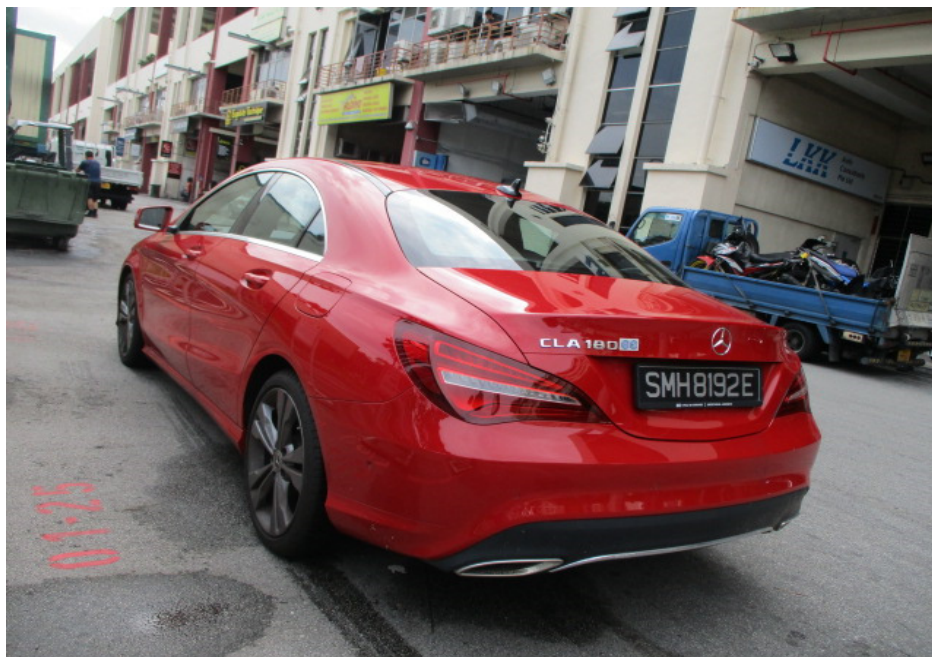
Photo 2 shows a general view of the rear left body of the Motor Car at the time of my inspection. The Motor Car was observed to be in relatively good general condition with no loose exterior fittings observed. The mileage of the Motor Car recorded at the time of my inspection was 22,456km.

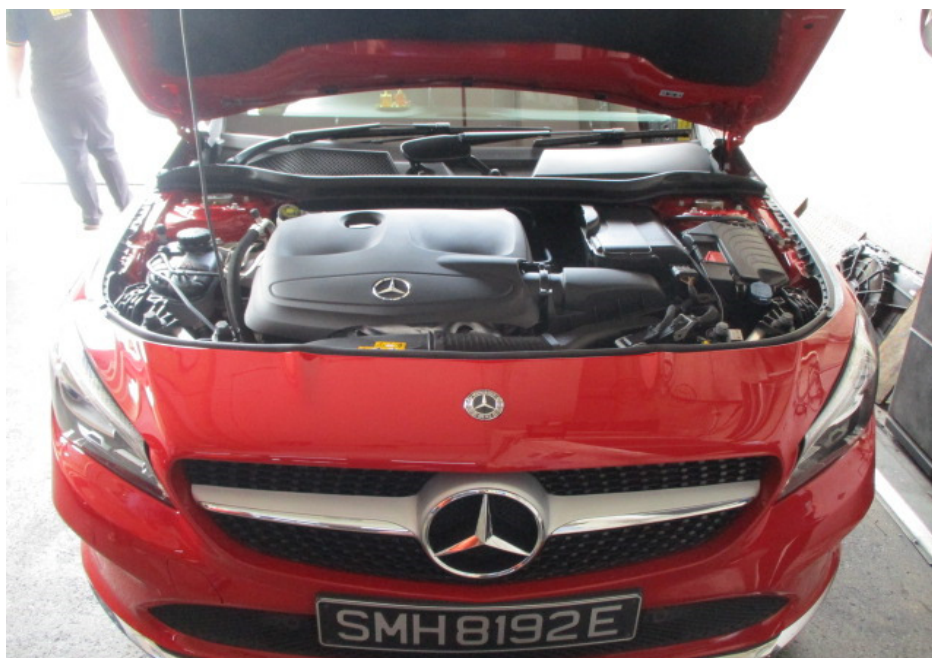
Photo 3 shows a general view of the engine compartment of the Motor Car at the time of my inspection. The various parts and components inside the engine compartment were all observed to be intact and properly fitted. There was also no sign(s) or indication(s) of fluid leak and/or fluid stain found inside the engine compartment.

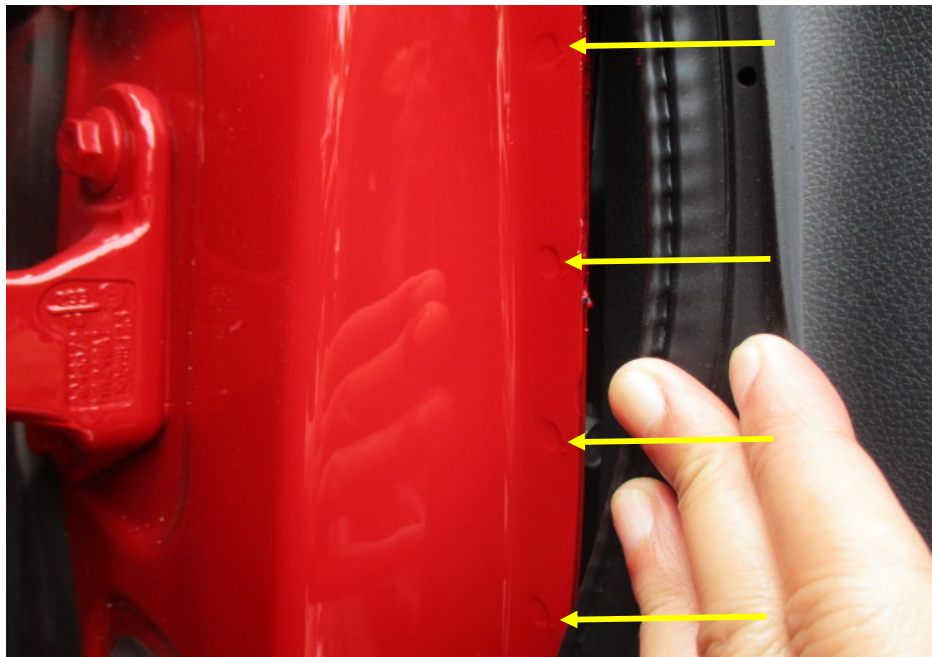
Photo 4 shows the left "A" pillar of the Motor Car. I did not find any weld marks other than original spot weld marks (arrowed) on the non-detachable body panels of the Motor Car, indicating that there was no re-welding works carried out. In general, I had found all the non-detachable body panels of the Motor Car to be originally fitted.

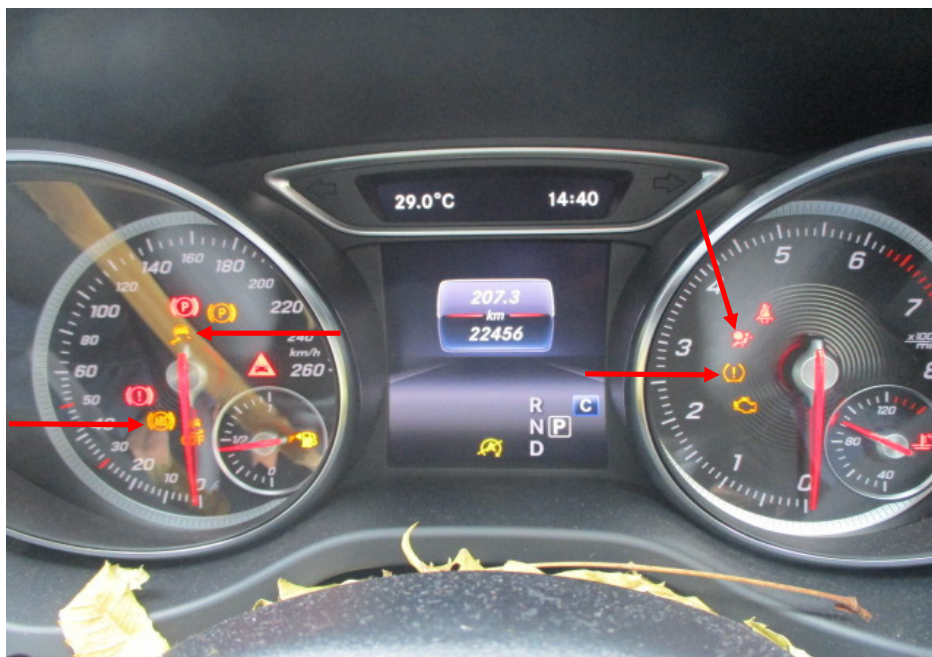
Photo 5 shows the warning lights for the various electronic safety features appearing on the instrument panel of the Motor Car during its self-test when the engine is cranked, in particular the ABS, SRS, TPM and TCS lights (arrowed).

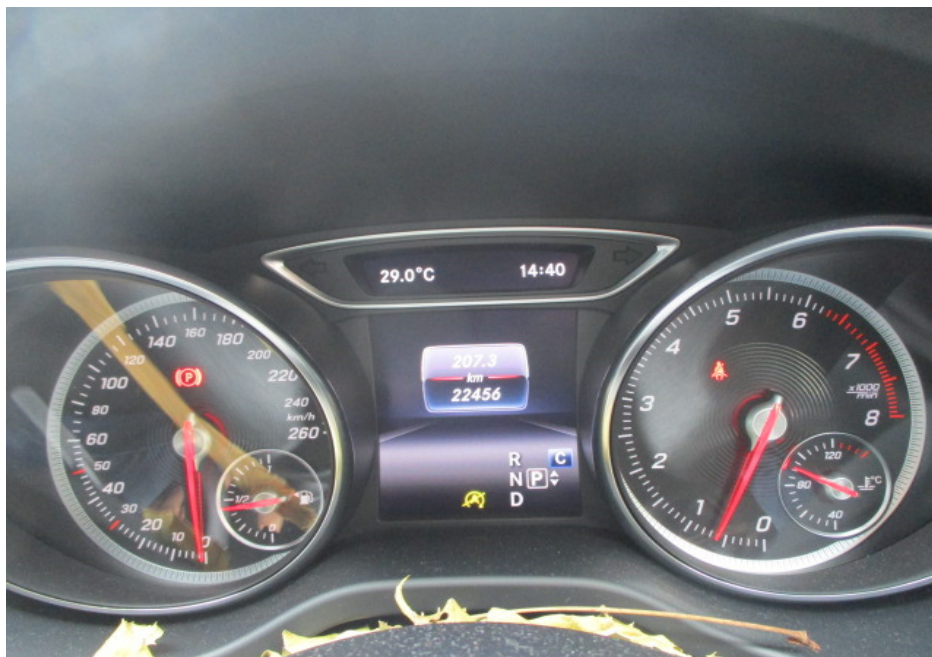
Photo 6 shows the respective warning lights no longer illuminated, indicating that there is no fault detected to the ABS, SRS, TPM and TCS systems of the Motor Car during the self-test. These electronic systems were hence in working condition at the time of my inspection.

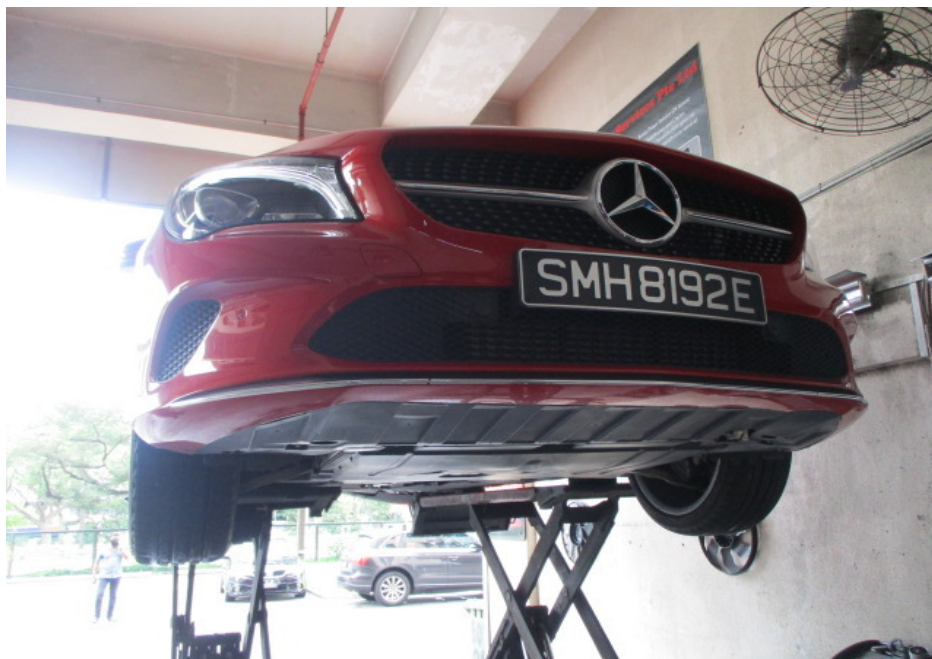
Photo 7 shows the Motor Car hoisted up for checks on its undercarriage. There was no sign(s) or indication(s) of fluid leakage and/or fluid stain(s) on the underside of the Motor Car. The undercarriage components of the Motor Car were also all observed to be intact and secured in an appropriate manner.

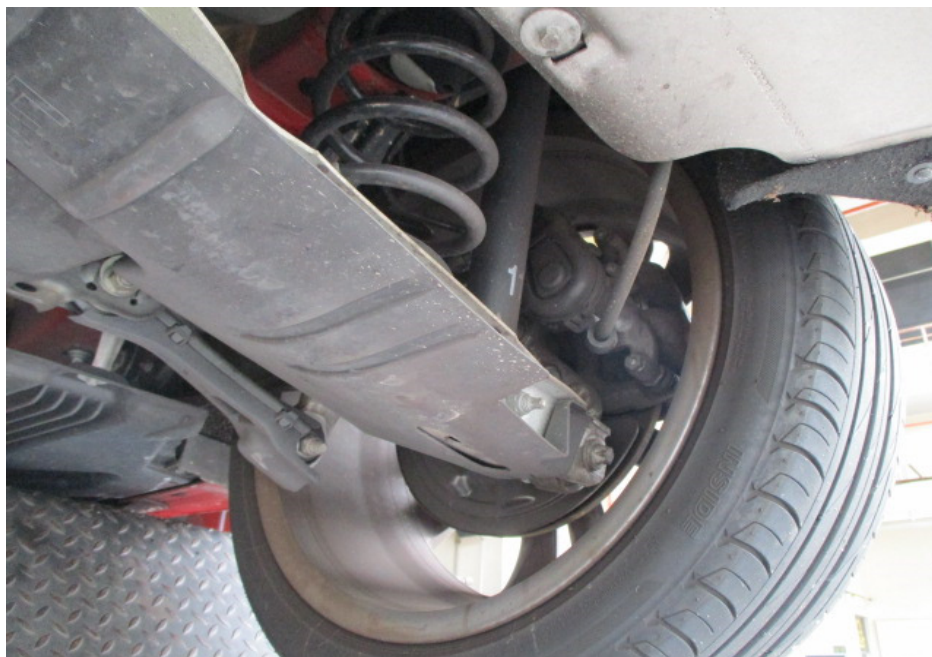
Photo 8 shows a general view of the control arms and linkages at the rear right wheel of the Motor Car. I did not observe any fluid leak and/or fluid stain on the underside of the Motor Car. All of the Motor Car's undercarriage components were observed to be intact and secured in an appropriate manner.

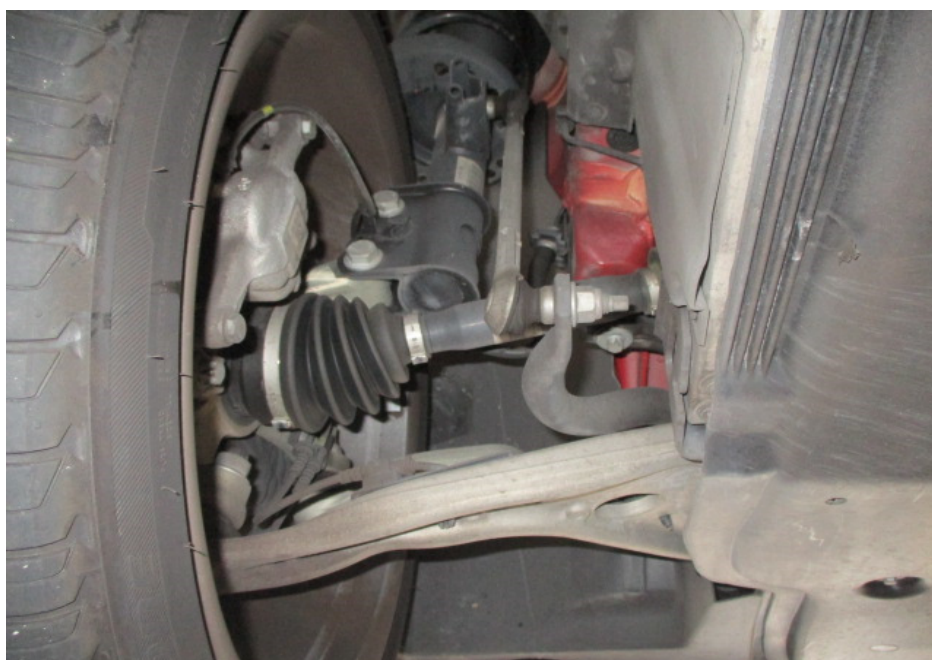
Photo 9 shows the various undercarriage components at the front right wheel of the Motor Car. The mechanical components, control arms and linkages were all found to be intact and secured in an appropriate manner.

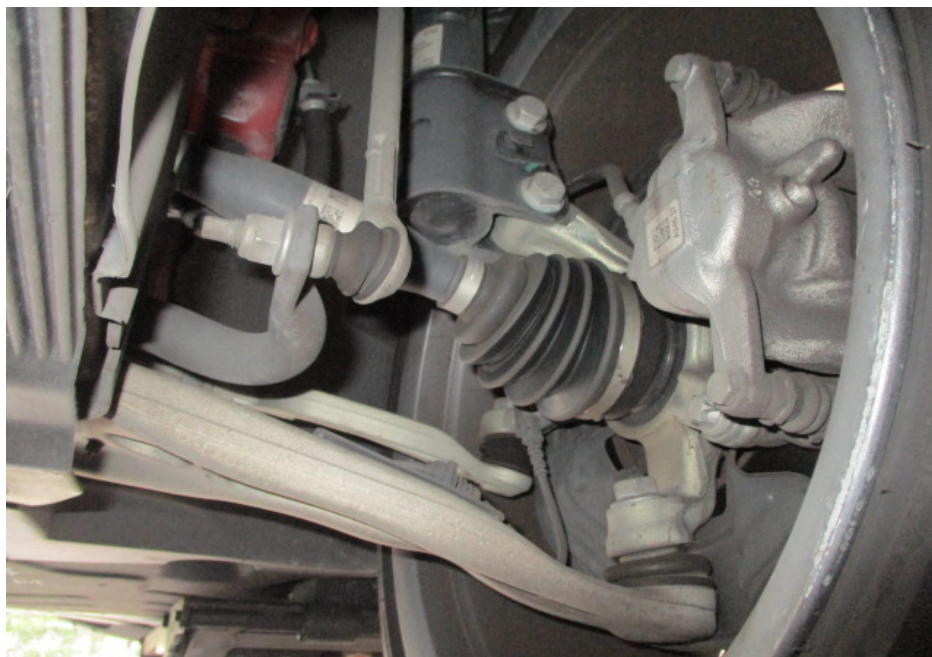
Photo 10 shows the various undercarriage components at the front left wheel of the Motor Car. The mechanical components, control arms and linkages were all found to be intact and secured in an appropriate manner. I also did not observe any fluid leak and/or fluid stain on the underside of the Motor Car.

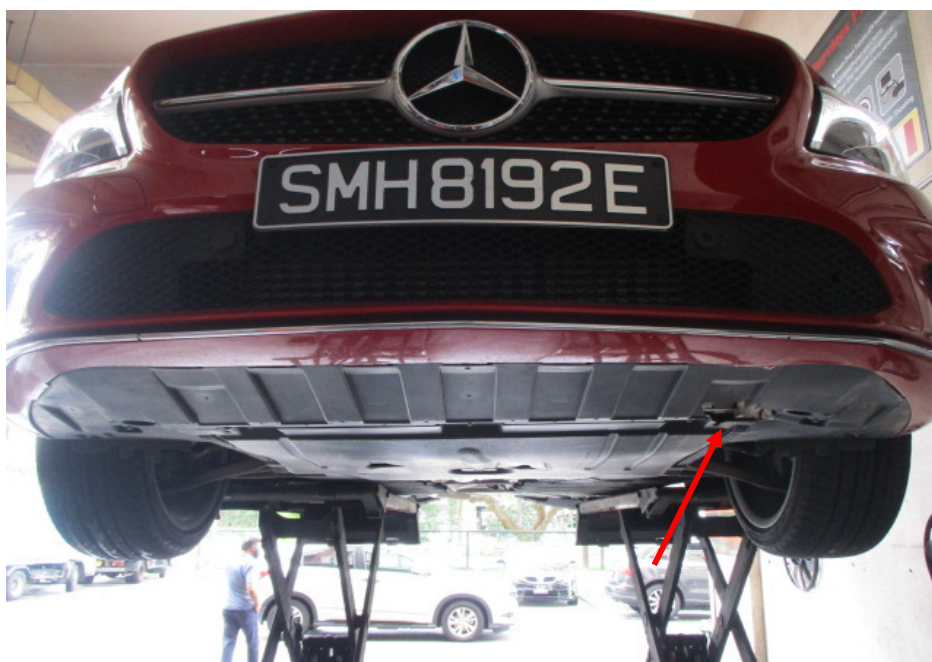
16. When the Motor Car was hoisted during the inspection, I had observed the engine undercover was broken at the left side. Upon closer examination, the aluminium crossmember was found to be dented/damaged at the area where the engine undercover was torn. Apart from these, the front section of the front left chassis member appears to be re-painted recently as compared to the same area of the front right chassis member.

Photo 11 shows the front underside of the Motor Car. During my examination of the Motor Car's underside, I had observed that the engine undercover was broken at the left side (arrowed).

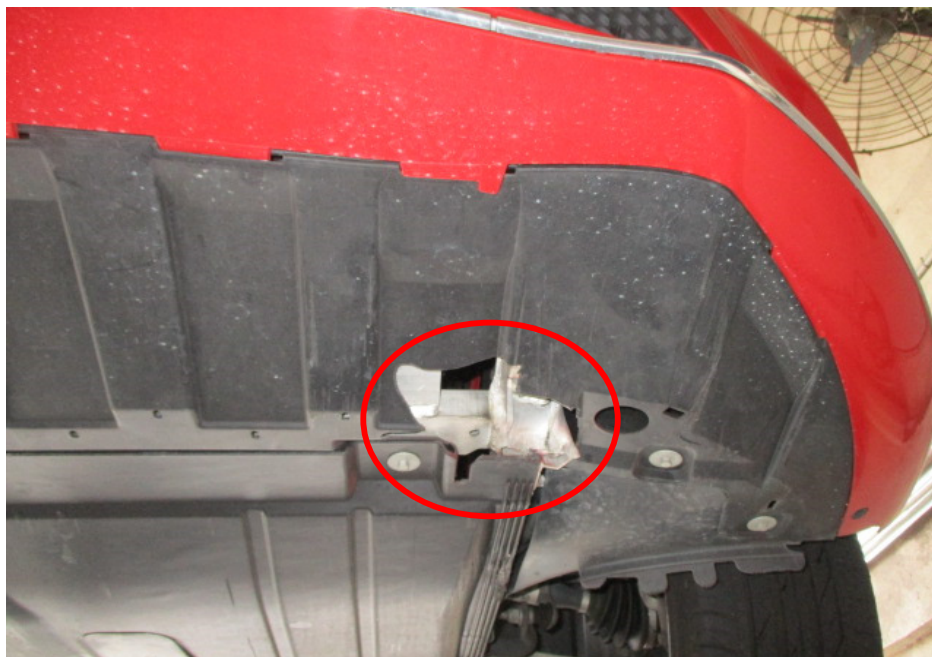
Photo 12 shows a closer view of the broken (circled) engine undercover. Upon closer examination, the Motor Car's aluminium crossmember was found to be dented/damaged at the area where the engine undercover was torn.

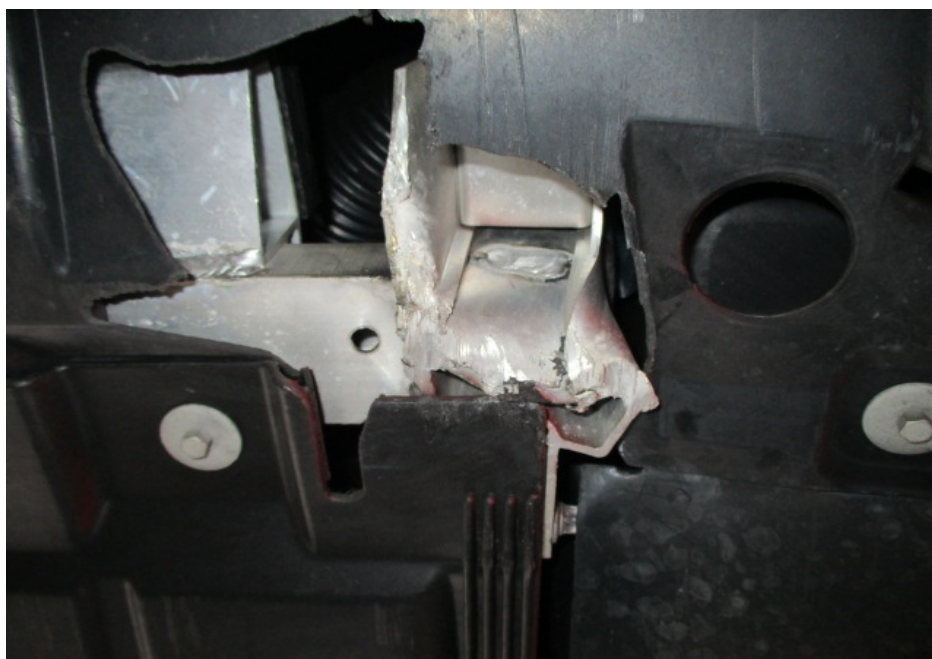
Photo 13 shows the aluminium crossmember that was found to be dented/damaged at the area where the Motor Car's engine undercover was torn.

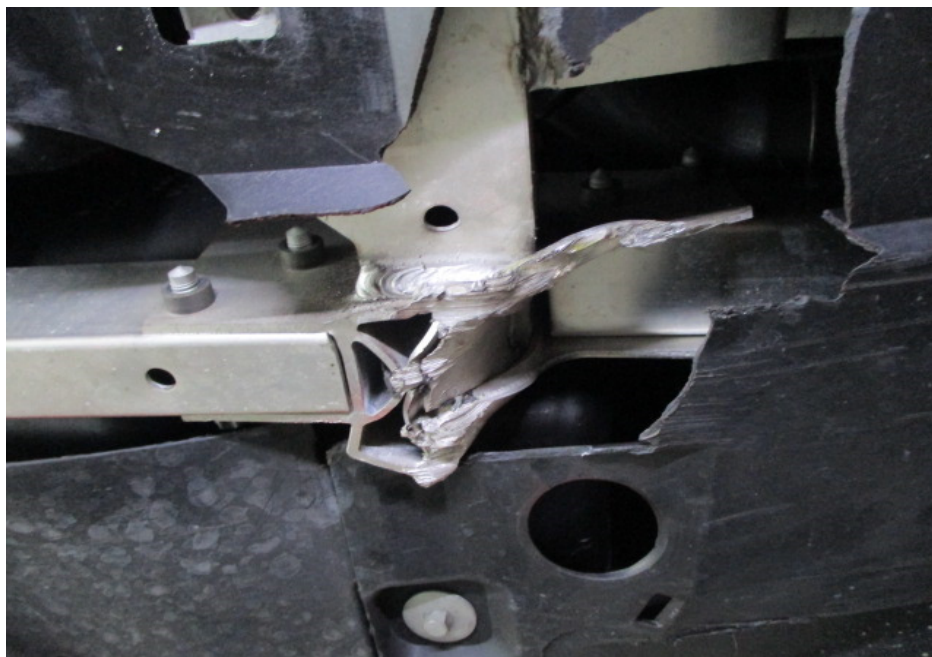
Photo 14 shows another view of the aluminium crossmember that was found to be dented/damaged.

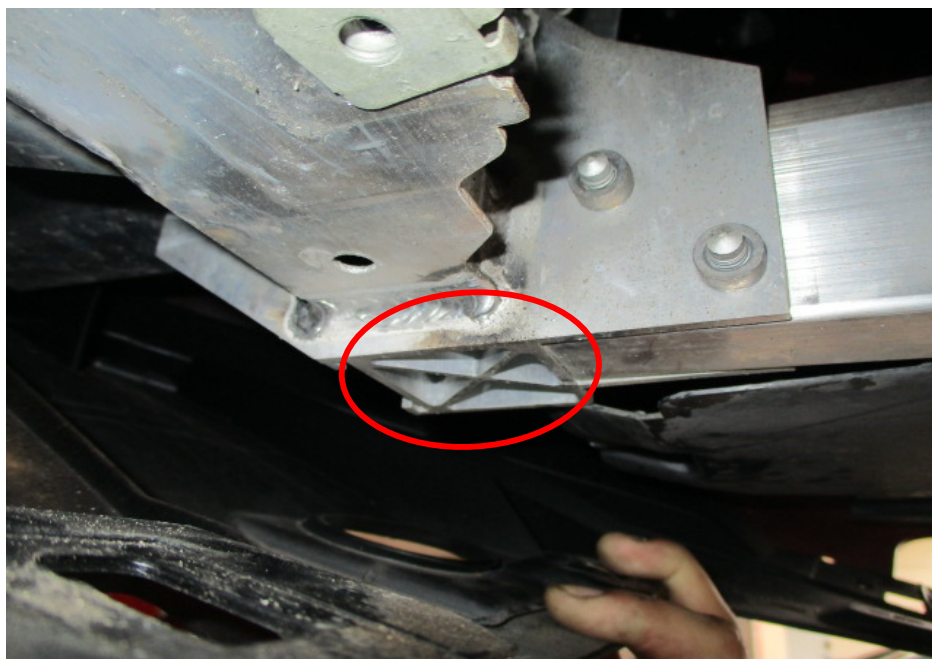
Photo 15 shows the same area (circled) at the right side of the aluminium crossmember, which was undamaged, for comparison with the dented/damaged area at the left side (refer to photograph 14 above).

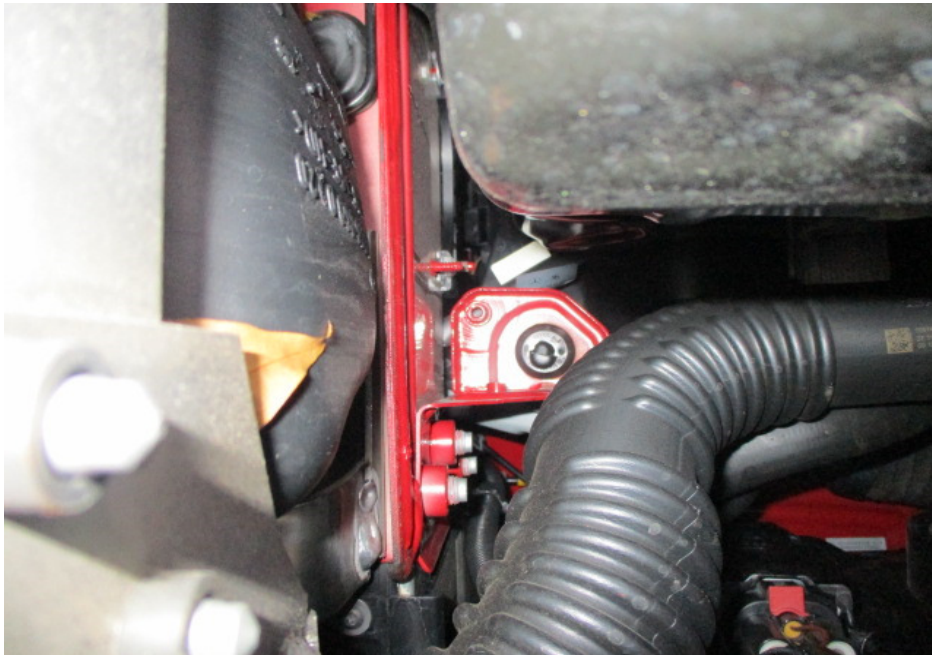
Photo 16 shows the front section of the front left chassis member of the Motor Car. The paint of the front section appears to be fresh as compared to the same area of the front right chassis member (refer to photograph 17 below).

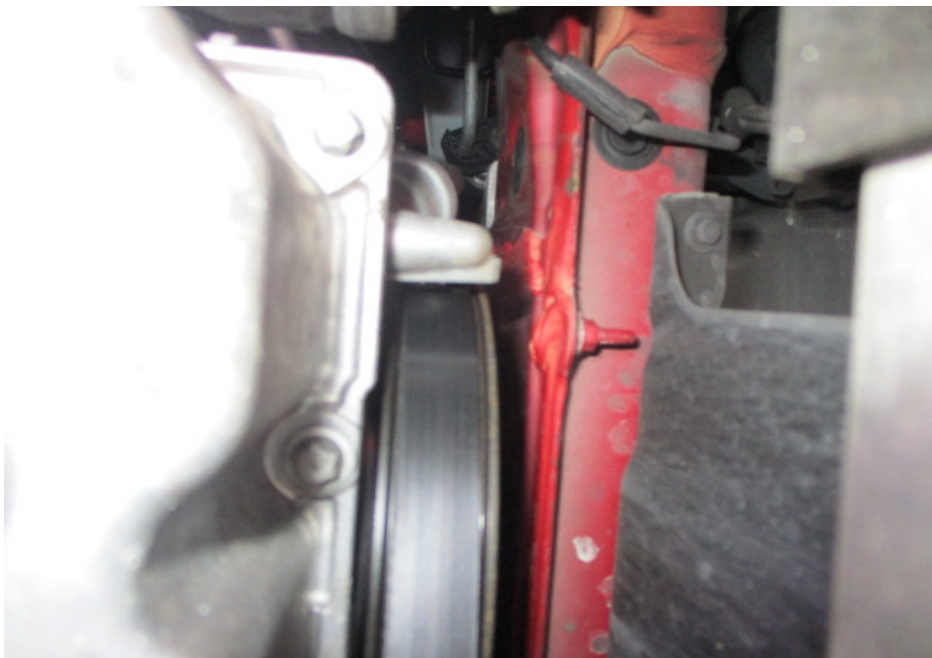
Photo 17 shows the front section of the front right chassis member of the Motor Car. The paint of the front section does not appear to be as bright when compared to the same area of the front left chassis member (refer to photograph 16 above). This would suggest that the front section of the front left chassis member of the Motor Car was recently repainted.

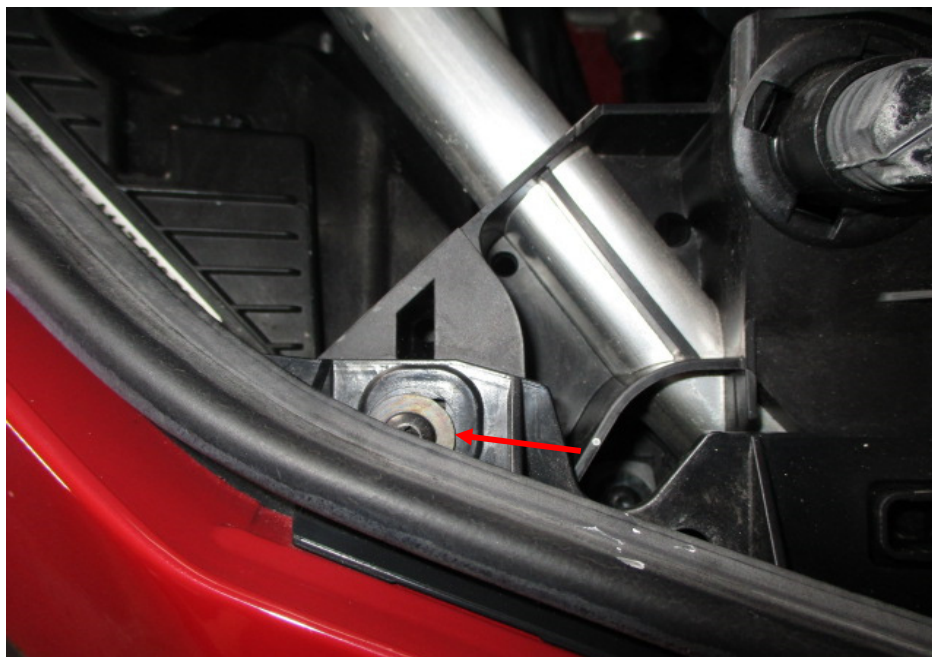
Photo 18 shows one of the Motor Car's front bumper attaching screws. Upon my close examination, this attaching screw at the right side of the front bumper appears to have been removed and re-fitted as the positioning of the washer (arrowed) was not align to its original position as seen from the circular imprint mark that was formed when the washer was at its original position.

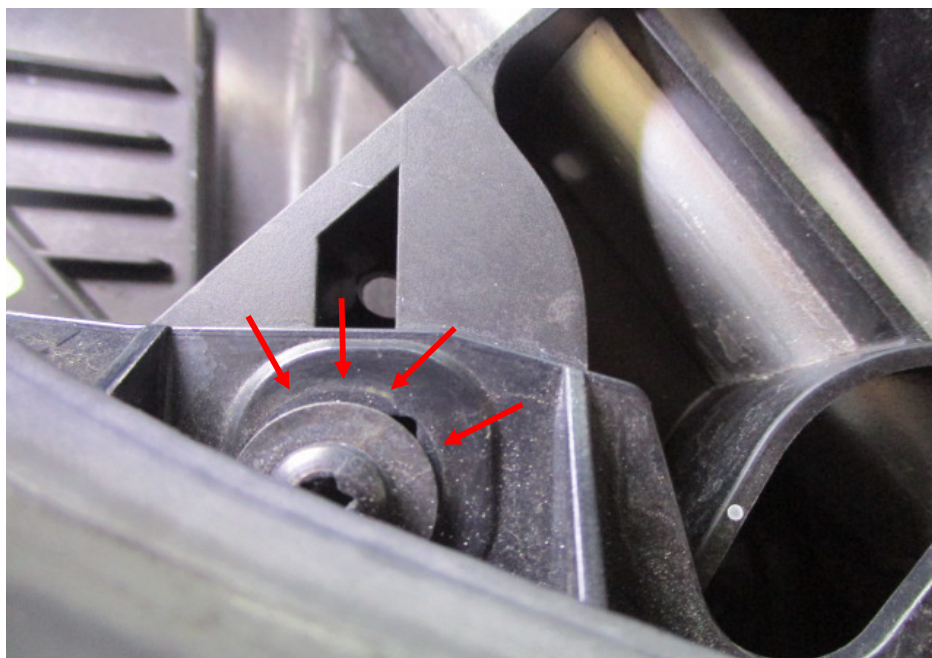
21. Notwithstanding paragraph 20, the Motor Car cannot be considered to be accident and/or damage free as I had found damage at the front left underside of the Motor Car that would seem to suggest that it was involved in an accident. The front bumper was also found with signs of removal and re-fitting works carried out.

Photo 19 shows a closer view of the imprint mark (arrowed) that was formed when the washer for the attaching screw was at its original position. Since the imprint marks could be seen, the positioning of the washer at the time of my inspection was hence not its original position, indicating that the attaching screw was removed and re-fitted. This would suggest work carried out previously to remove and re-fit the Motor Car's front bumper.

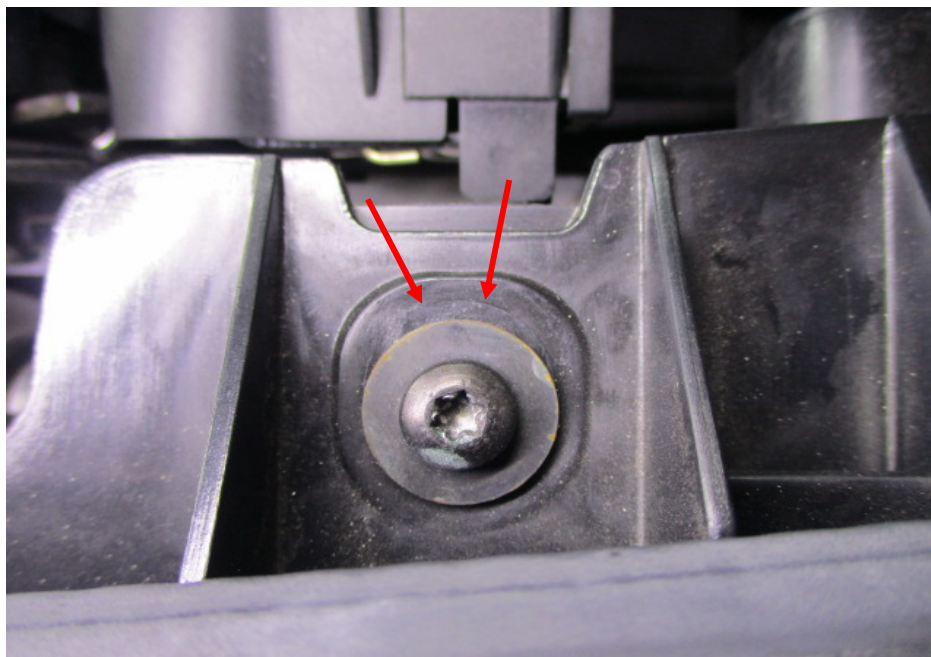
Photo 20 shows the other attaching screws for the Motor Car's front bumper. The circular imprint mark that was seen surrounding the washer for the attaching screw at the right side of the Motor Car's front bumper (refer to photograph 19 above) was similarly seen (arrowed) surrounding the washers for the other attaching screws.
