LKK Auto Consultants Pte Ltd

Vehicle No. SMN 7758Z
Insured Veh. SHC 7547H
Claim No. D20001038MFSH
Policy No. D-20094921MFSH
Accident Date 15/02/2020
Inspection Date 26/02/2020

ADJUSTMENT ON REPAIR COST FOR VEHICLE NO. SMN 7758Z

PHOTOGRAPHS FOR VEHICLE NO. SMN 7758Z

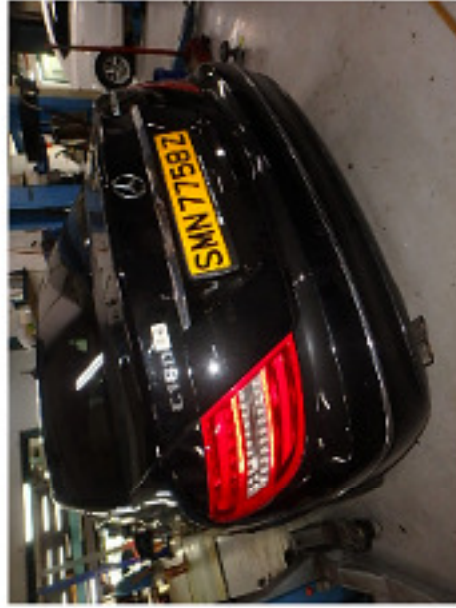
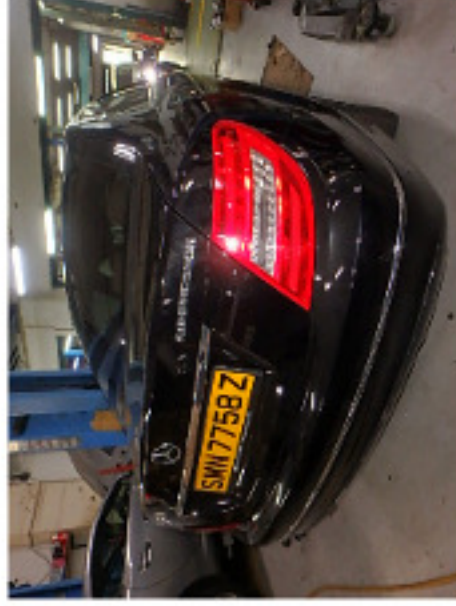
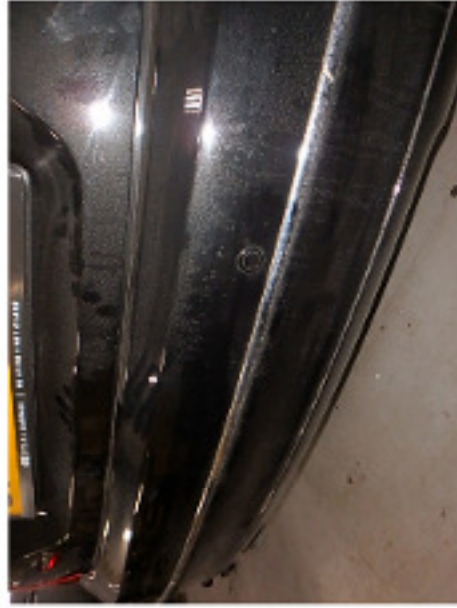
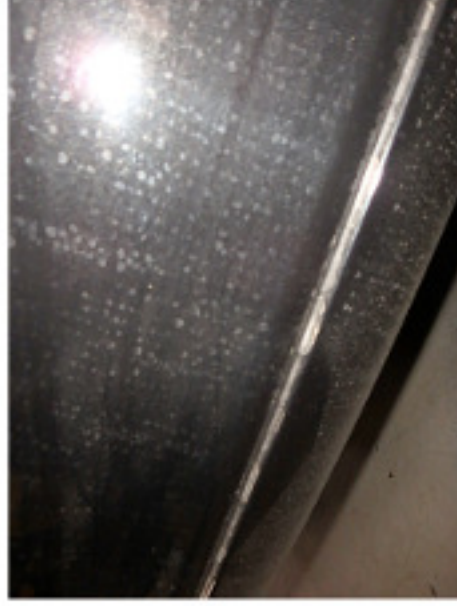
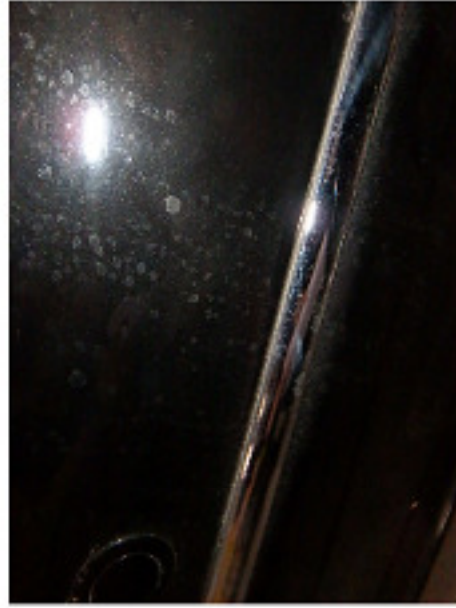
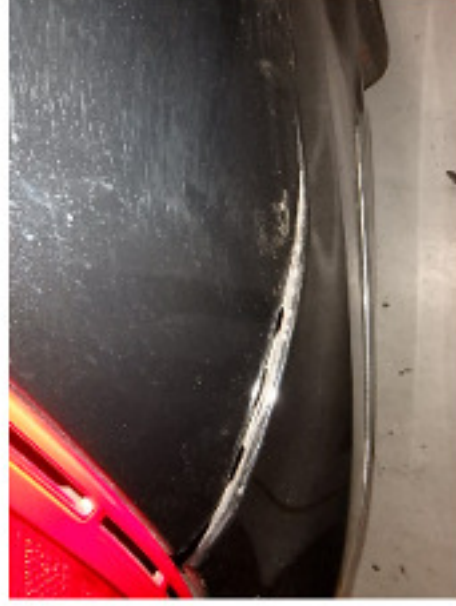
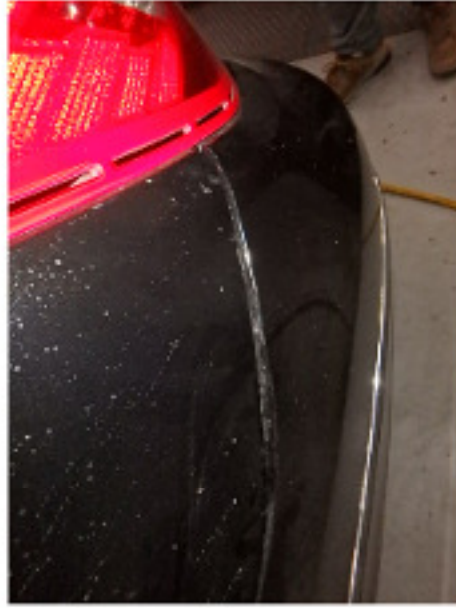
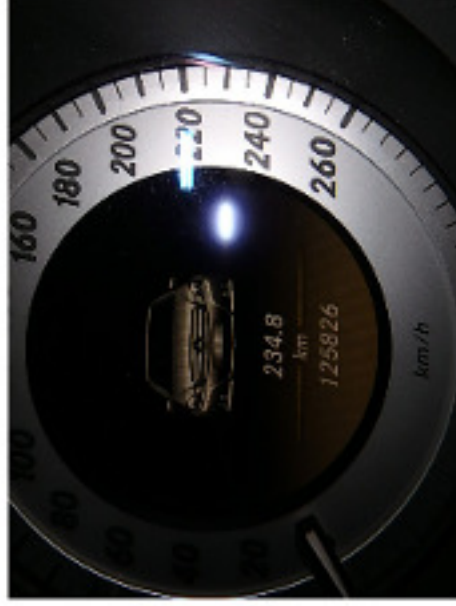
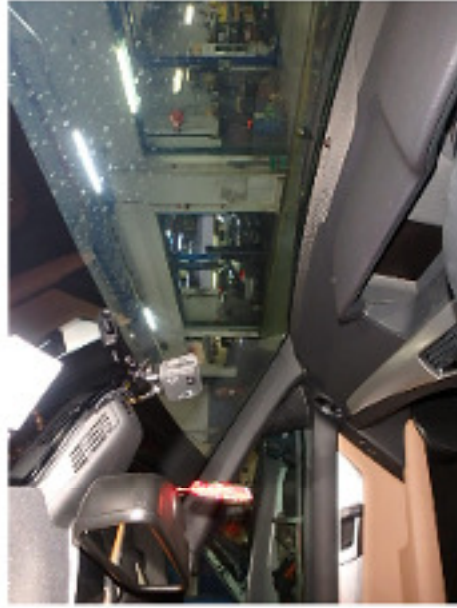
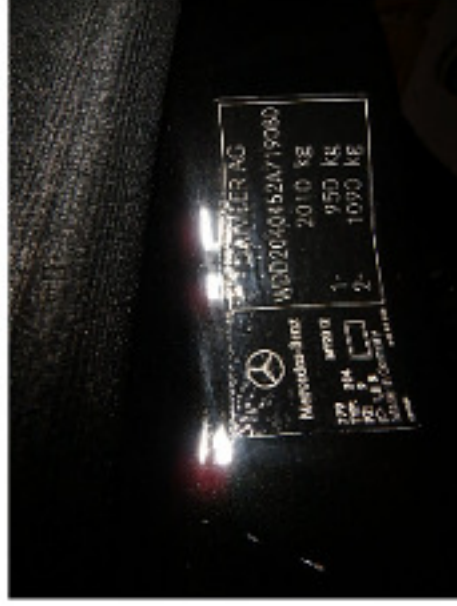
4. Description of Damages				
THE VEHICLE SUSTAINED DAMAGES AT THE REAR PORTION. DAMAGES SEE DETAILS.				
5. General Information				
Accident Date	15/02/2020	Inspection Date	26/02/2020	
Survey held at	COMPLETE VMS PTE LTD BLK 176 SIN MING DRIVE #03-14 SIN MING AUTOCARE COMPLEX SINGAPORE 575721			
5a. Remarks				
A)THE INSPECTION WAS CONDUCTED ON A"WITHOUT PREJUDICE" BASIS. B)IN ACCORDANCE TO YOUR INSTRUCTIONS, WE HAVE NOT AUTHORISED REPAIRS.				
5b. Estimate Days of Repair				
ESTIMATED NORMAL PERIOD FOR REPAIR:		2 Working Days

Qty	Description of Parts	Condition	Estimate By Workshop (\$)	Our Adjusted (\$)
<u>REPLACEMENT OF PARTS</u>				
1	REAR BUMPER (N)	MTG CRACKED	1,704.00	1,460.00
1	REAR BUMPER CENTER CHROME (N)	NECESSARY	168.00	168.00
1	REAR BUMPER BEAM (N)	TO REPAIR SEE LABOUR	763.00	-
4	REAR BUMPER BEAM BRACKET @\$55.80 (N)	TO REPAIR SEE LABOUR	223.20	-
8	REAR BUMPER CLIP @\$8.00 (N)	NECESSARY	64.00	64.00
2	REAR BUMPER CHROME MOULDING SIDE @\$168.00 (N) (ADDITIONAL)	NECESSARY	336.00	280.00
1	TAIL LAMP LOWER BRACKET L/H (N) (ADDITIONAL)	CRACKED	95.00	95.00
1	REAR BUMPER SIDE RETAINER L/H (N) (ADDITIONAL)	DISTORTED	74.00	74.00
	LESS 5% DISCOUNT		-171.36	-
	LESS 10% DISCOUNT		-	-214.10
			3,255.84	1,926.90
<u>SPECIAL NETT ITEMS</u>				
1	REAR REVERSE SENSOR (SN)	SERVICEABLE	280.00	-

280.00	-
<u>LABOUR</u>				
	SPRAY PAINT DAMAGED AREA AFFECTED .		980.00	280.00
	TO CHANGE ALL NECESSARY PARTS.INCLUSIVE OF THE REPAIR OF REAR BUMPER BEAM AND REAR BUMPER BEAM BRACKET.		850.00	250.00
			1,830.00	530.00
GRAND TOTAL			5,365.84	2,456.90
RECOMMENDED COST OF LUMP SUM REPAIRS (TO ITS PRE-ACCIDENT CONDITION)				1,950.00
